**From:** Cary, Richard H. <Richard.Cary@pseg.com>  
**Sent:** Thursday, April 15, 2021 3:52 PM  
**To:** incidental.take@noaa.gov; EndangeredSpecies Resource  
**Cc:** Neilan, Brian  
**Subject:** [External\_Sender] Salem Generating Station - Incidental Take Reports: Atlantic Sturgeon 04/15/2021  
**Attachments:** Sturgeon Incidental Take Report for 04152021 #1.pdf; Sturgeon Incidental Take Report for 04152021 #2.pdf

### Appendix C, Part 2A (Sturgeon)

# STURGEON DATA COLLECTION FORM

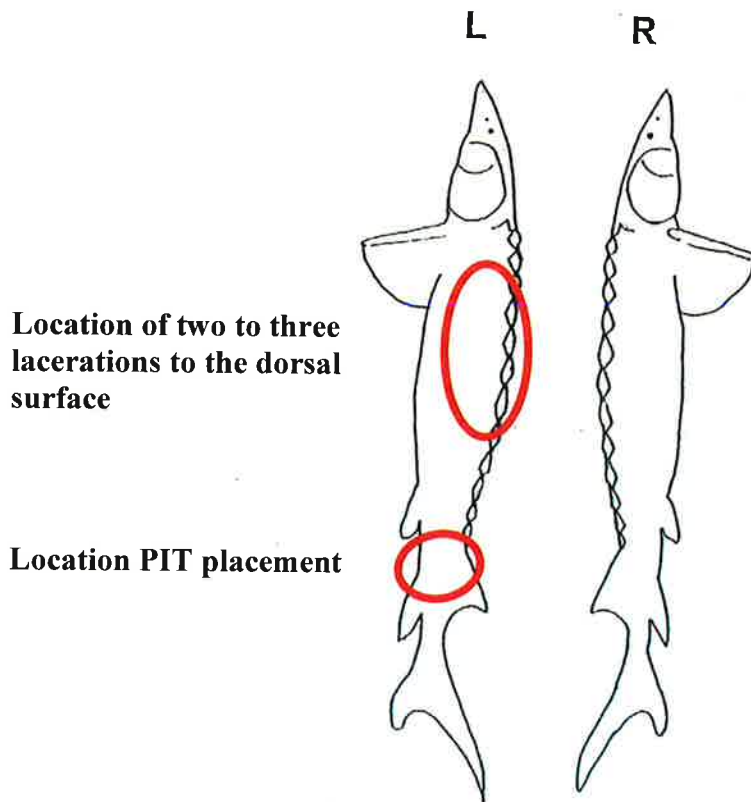
Describe any wounds / abnormalities (note tar or oil, gear or debris entanglement, propeller damage, etc.). **Please note if no wounds / abnormalities are found. Specimen was deceased at the time of this collection. A check for tags revealed the existence of a PIT, identified as #933000320184018. The same specimen, collected alive but showing moderate damage two days prior, had been released after tagging and processing. Comparison of photographs from both collection events revealed the same three lacerations on the dorsal surface, further verifying the specimen as being a recapture (refer to illustration).**

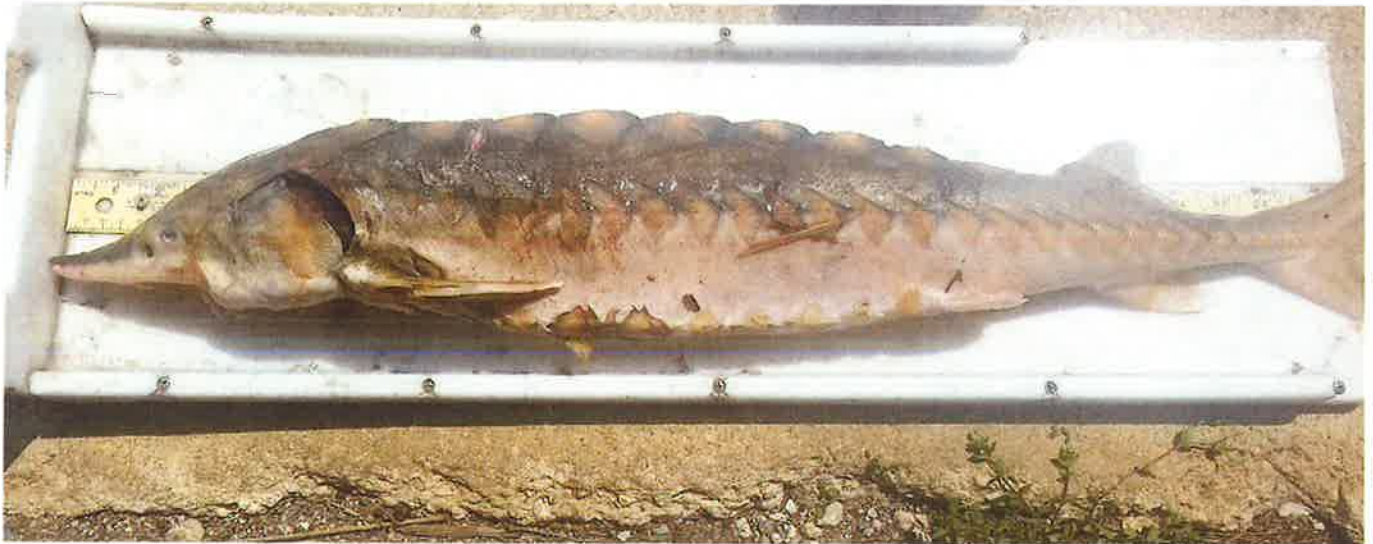
A dorsolateral view showing the size and condition of a deceased, Atlantic sturgeon (*Acipenser oxyrinchus*), retrieved at approximately 08:22 on 04/15/2021 from the Salem Circulating Water Intake trash collection basket by Salem Yard Crew personnel during routine trash rack cleaning at Salem Nuclear Generating Station (04/15/2021).

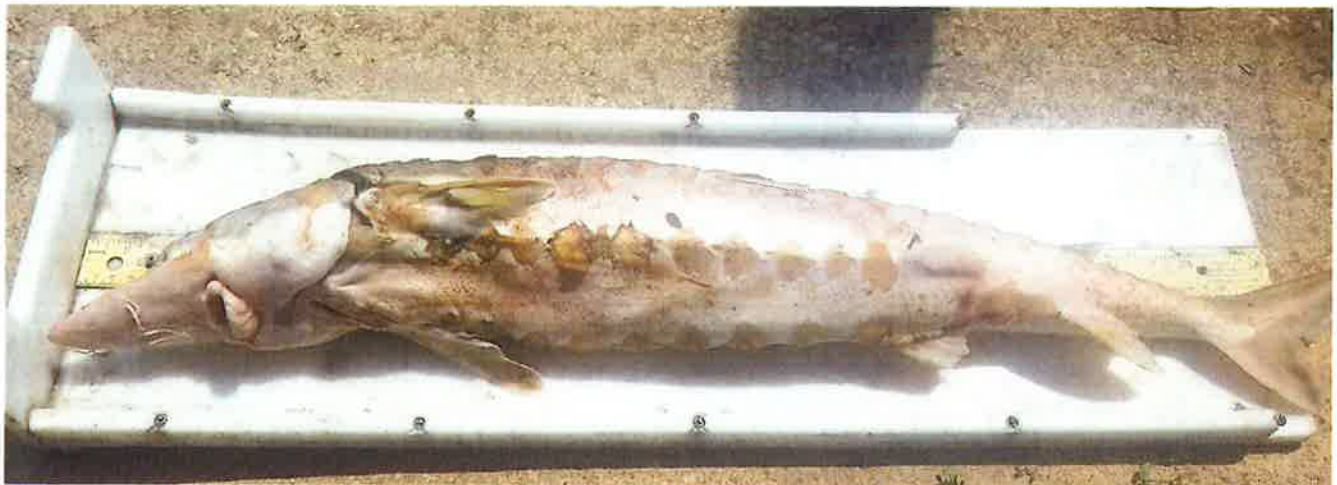
A ventral view of the specimen. At the time of processing, a PIT was indicated, identified as tag #933000320184018. Based on the tag number, the same specimen was collected during a prior incidental take event on 4/13/2021. The specimen was alive on that date, but exhibited some minor damage in the form of two or three lacerations along the dorsal surface, with the largest laceration extending down to the lateral line of scutes. Comparison of photos from that event with this specimen, in addition to the existing PIT, verify the individual as being a recapture (04/15/2021).

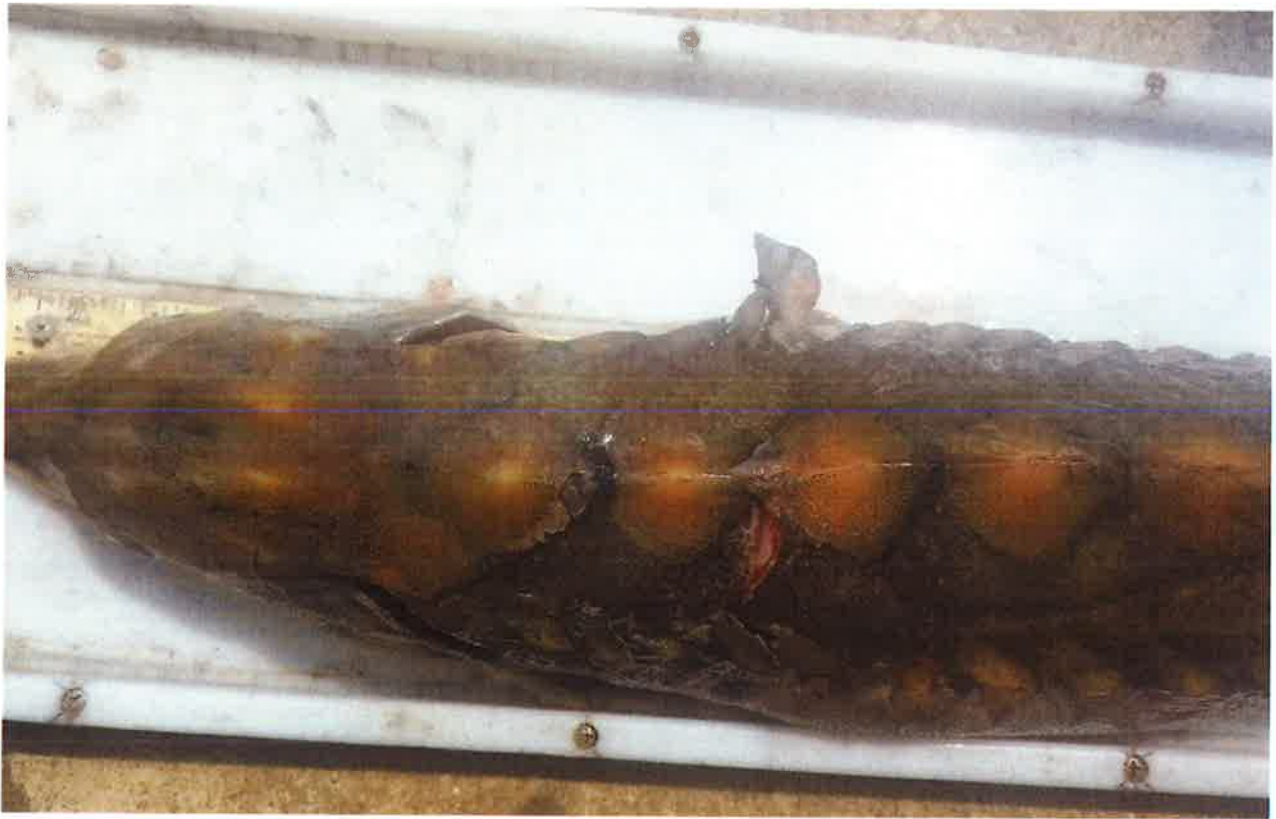
A dorsal view showing the location of a deep laceration to the dorsal surface, which extends down to the lateral line of scutes on the left side of the torso. The damage observed is consistent with the damage recorded in photos of the live sturgeon collected two days prior (04/15/2021).

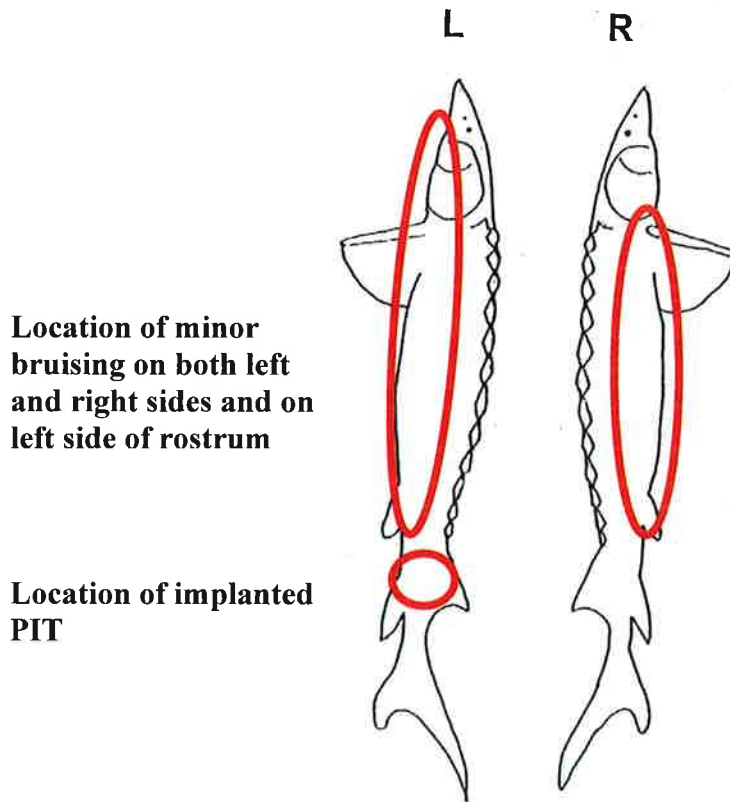
**Location of minor bruising on both left and right sides and on left side of rostrum**

**Location of implanted PIT**

Describe any wounds / abnormalities (note tar or oil, gear or debris entanglement, propeller damage, etc.). **Please note if no wounds / abnormalities are found. Specimen was alive at the time of collection, but exhibited some minor damage in the form of bruising along the lateral line of scutes on both the left and right side, as well as along the left side of the rostrum. No PIT was indicated, so tagging procedures were implemented. Specimen received a PIT (#933000320184017), implanted below the dorsal fin on the left side (refer to diagram above).**

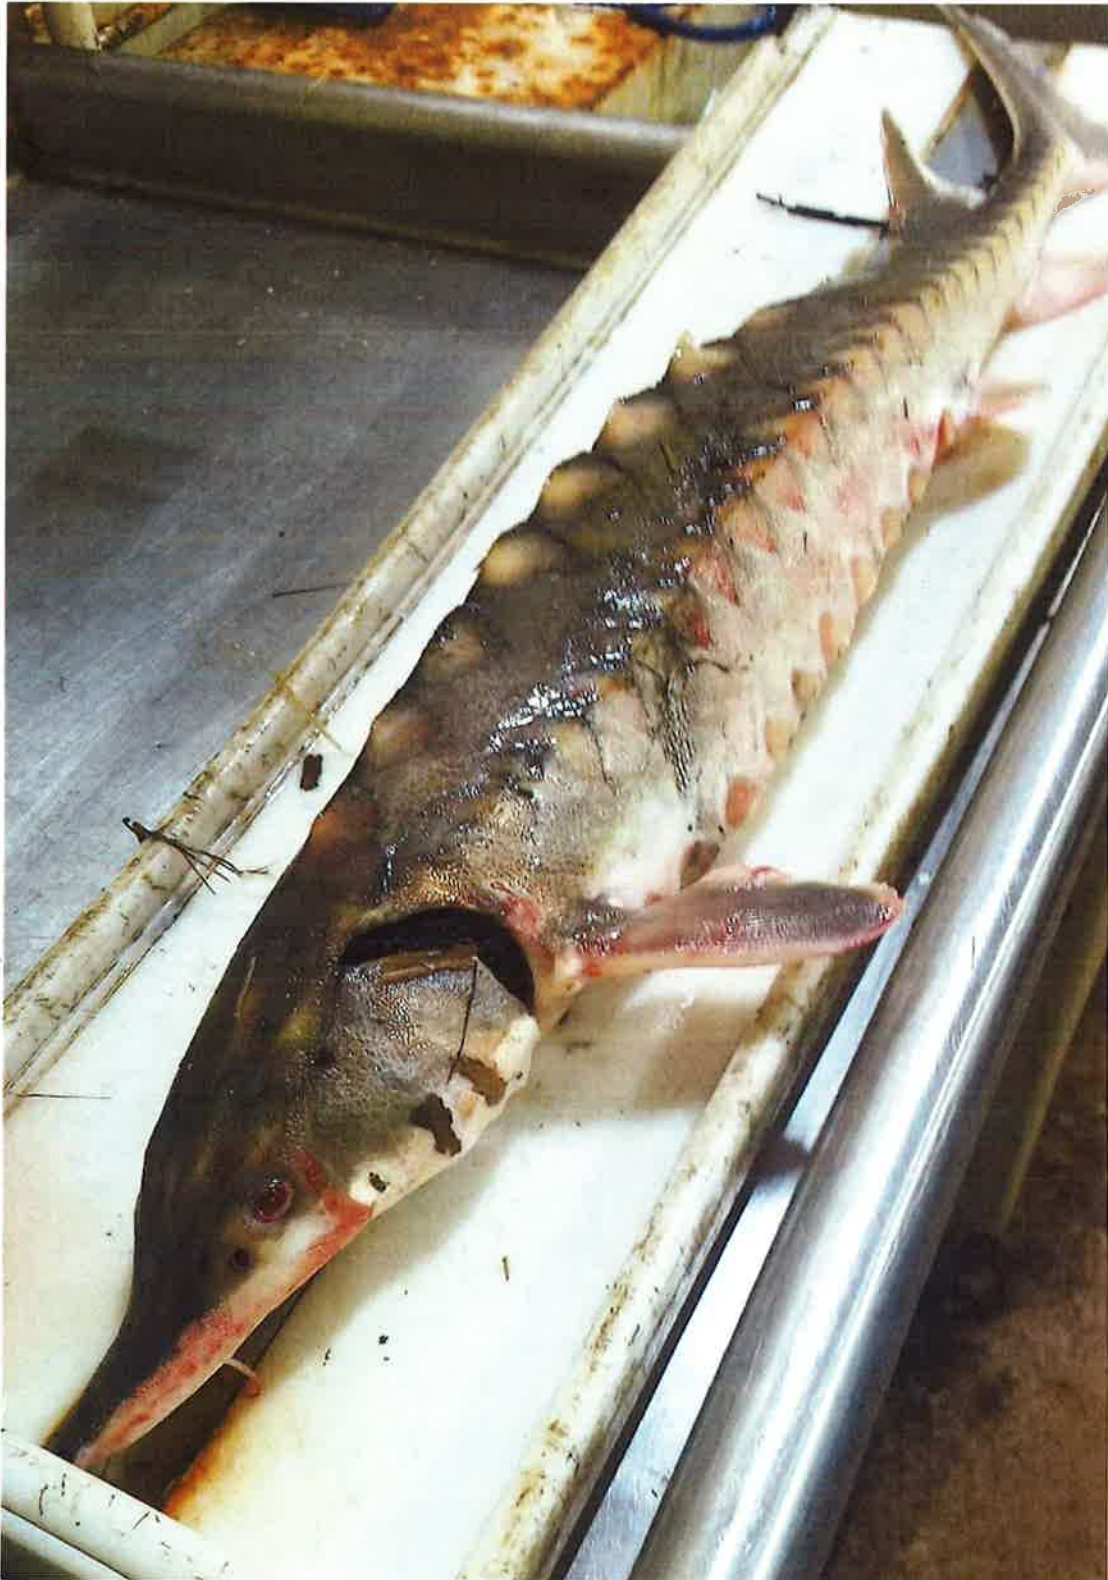
A dorsolateral view showing the size and condition of a second, Atlantic sturgeon (*Acipenser oxyrinchus*), retrieved alive at approximately 08:53AM on 04/15/2021 from the Salem Circulating Water Intake trash collection basket by Salem Yard Crew personnel during routine trash rack cleaning at Salem Nuclear Generating Station (04/15/2021).
