# RESPONSE TO REQUEST FOR ADDITIONAL INFORMATION RE: LICENSE RENEWAL APPLICATION FOR FACILITY OPERATING LICENSE NO. R-120 FOR THE NORTH CAROLINA STATE UNIVERSITY PULSTAR RESEARCH REACTOR (EPID NO. L-2020-NFR-0007); DATED SEPTEMBER 21, 2021

# NORTH CAROLINA STATE UNIVERSITY

LICENSE NO. R-120; DOCKET NO. 50-297

NOVEMBER 30<sup>TH</sup>, 2021

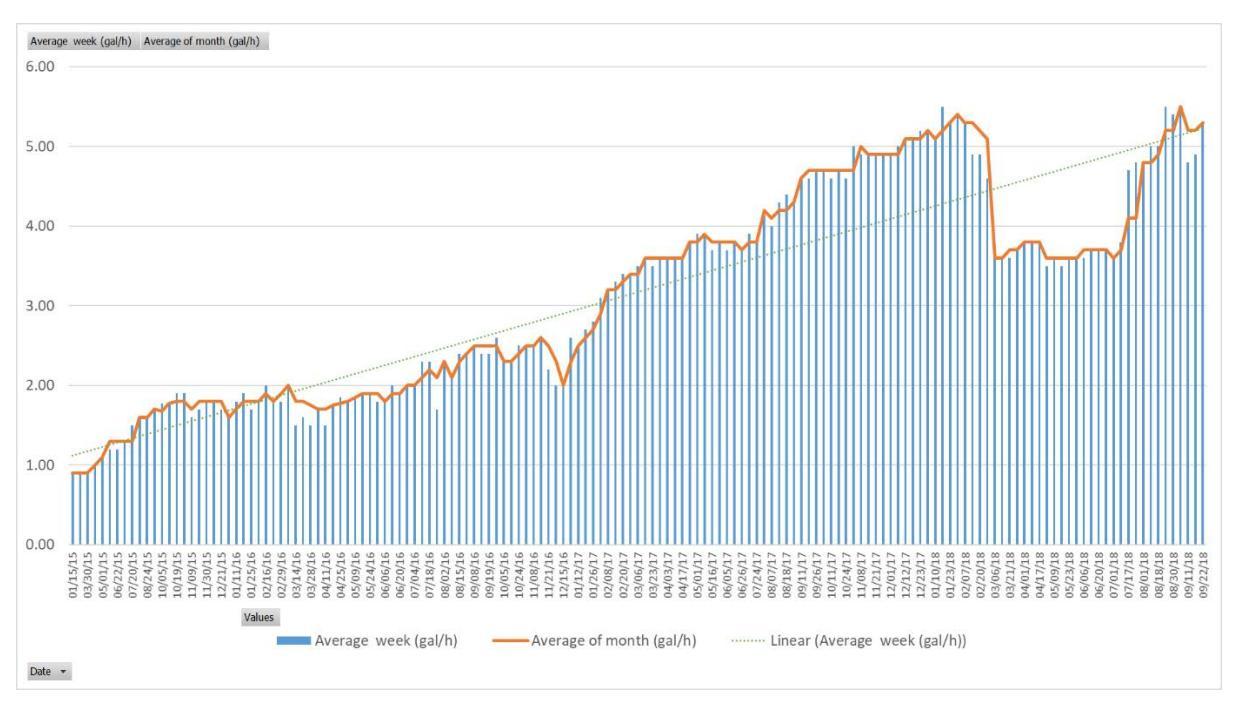
#### Reactor leak data shown to RSC:

A minor leak from the reactor primary coolant system (pool) is currently estimated to be 5.3 gallons per hour. Anew epoxy patch with a backing plate was applied on 8 Mar 2018. Since July 2018 the leak rate increased to over 5 gallons per hour and has been stable for since Sep 2018. Repair is planned for Dec 2018.

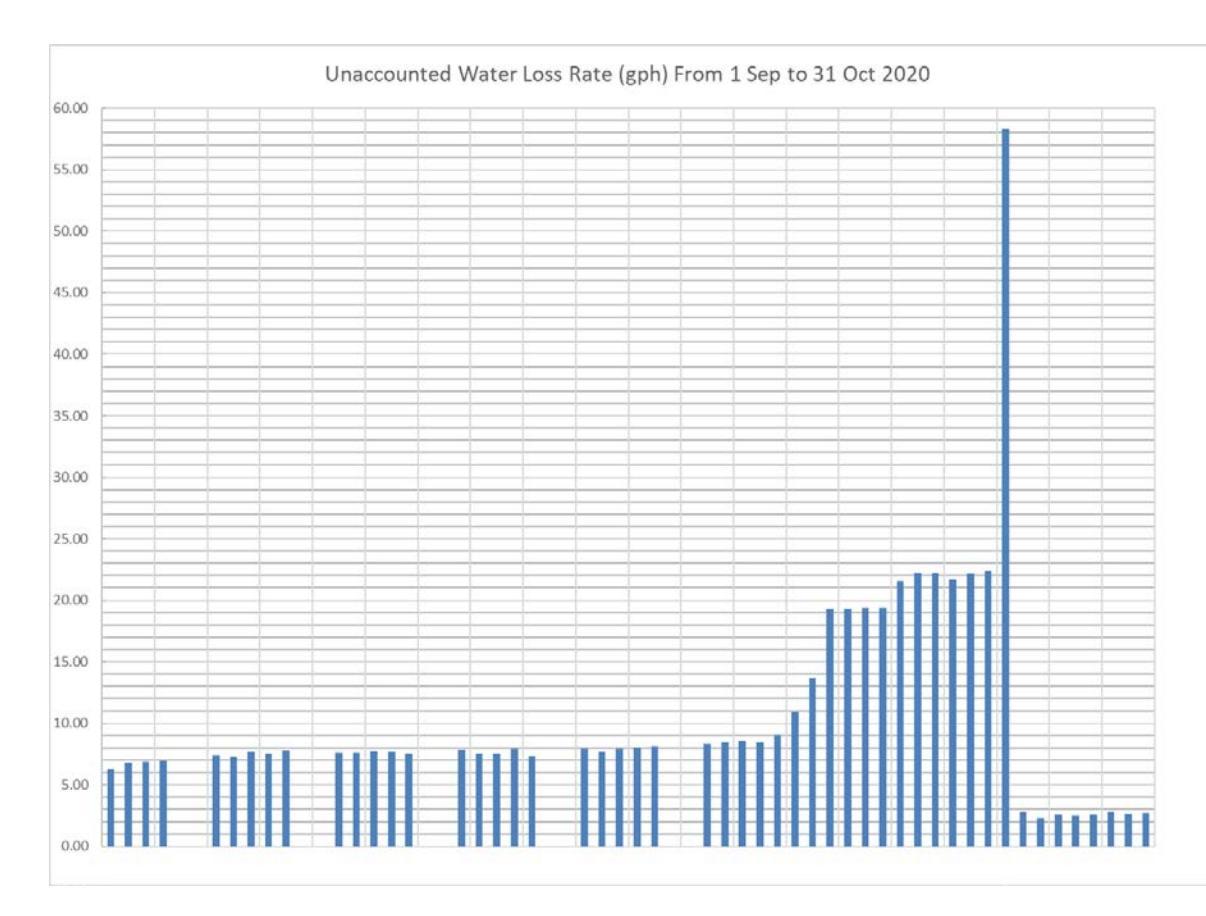
Summary of Oct 2020 Leak Site Repair:

An increased leak rate was observed on Oct 9-12, 2020. The leak rate increased to approximately 21 gph on Oct 13-22, 2020.
