## Finding of No Significant Hazard

December 23, 2021

## 3.9.2 Fuel Handling

## Description of tests in proposed changes to TS 3.9.2.1

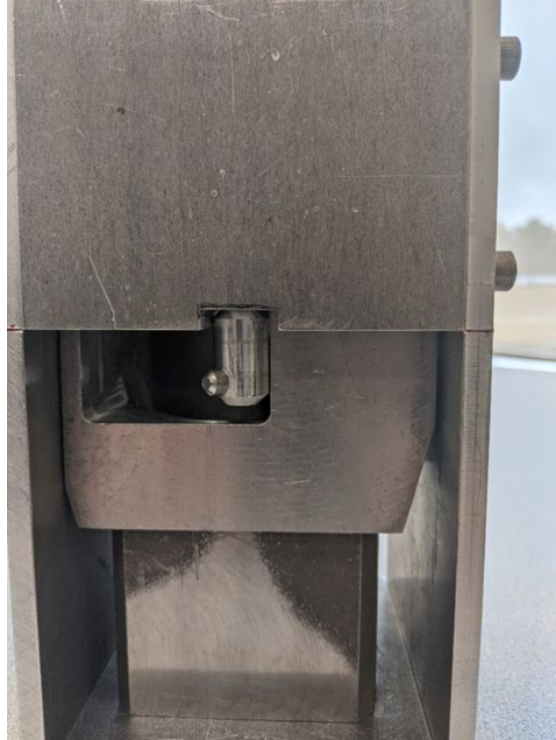
Upon movement of a fuel element to its intended position in the core grid, the final mechanical manipulation is to push down on the fuel element head via the pickup tool and compress the spring on the head to move the latch to below the bottom of the upper grid. The tool is then rotated counterclockwise about 45° to its full stop position thus moving the latch underneath the notch in the upper grid. The tool is then raised slightly to release the spring, thus setting the latch into the notch. See Figure 1.

**Figure 1.** Fuel element head latched into a mockup of the upper grid plate.

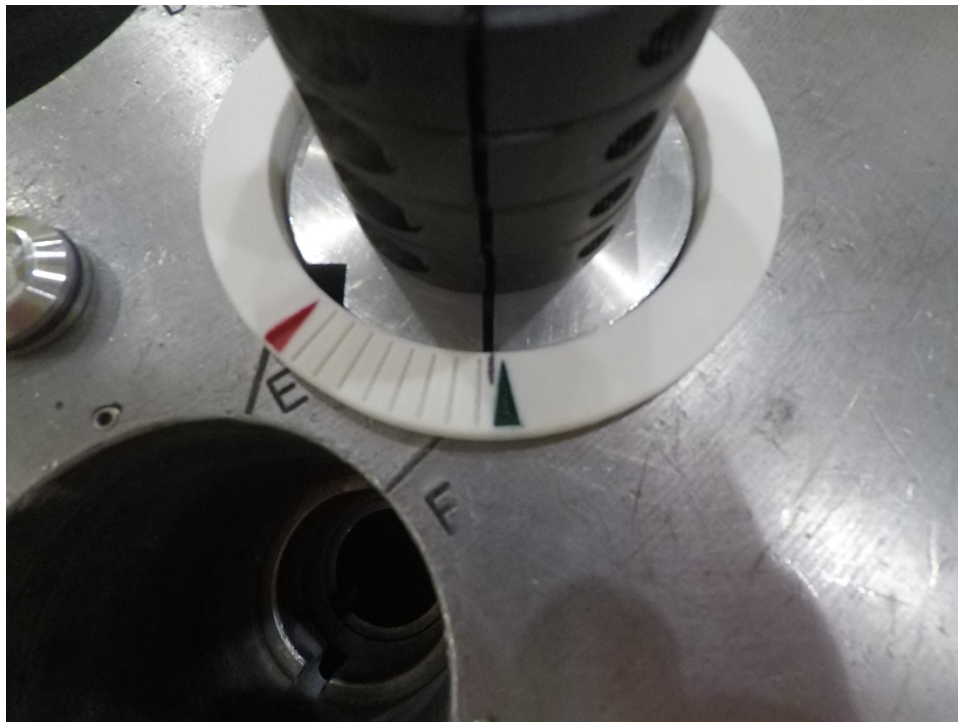
Prior to removal of the tool from the head, the azimuthal position of the collar affixed to the tool is checked against fiducial marks on a sleeve inserted into the element position in the index plate. Figure 2 shows the rotational check on a fully latched element against a prototype sleeve that is slipped into the tooling plate and that has fiducial marks indicating latched (green triangle) and fully unlatched (red triangle). These marks are true fiducial marks in that they relate back to machined notches in the bottom of the tooling plate that are true to the cartesian axis system of the upper grid plate. Figure 3 shows the rotational check of the same element with the latch bar in a position that is still within the notch, but rotated in a clockwise direction. Note that, although latched, this element *would be assessed as unacceptable* and would need to be rotated so that the indication aligns with the green fiducial reference mark. Obviously, elements found rotated further clockwise (and likely out of the notch) would also be found unacceptable. Variations of rotation angles due to tolerances in the upper grid plate and notches are being evaluated and will be clearly indicated on future designs of the marked sleeve to give a clear “passing” criterion.

**Figure 2.** Fuel element latched in position H-7 (note: in this prototype the fully latched green triangle is about  $2^\circ$  off of the actual fully latched position. This will be corrected in future prototype and design development.)

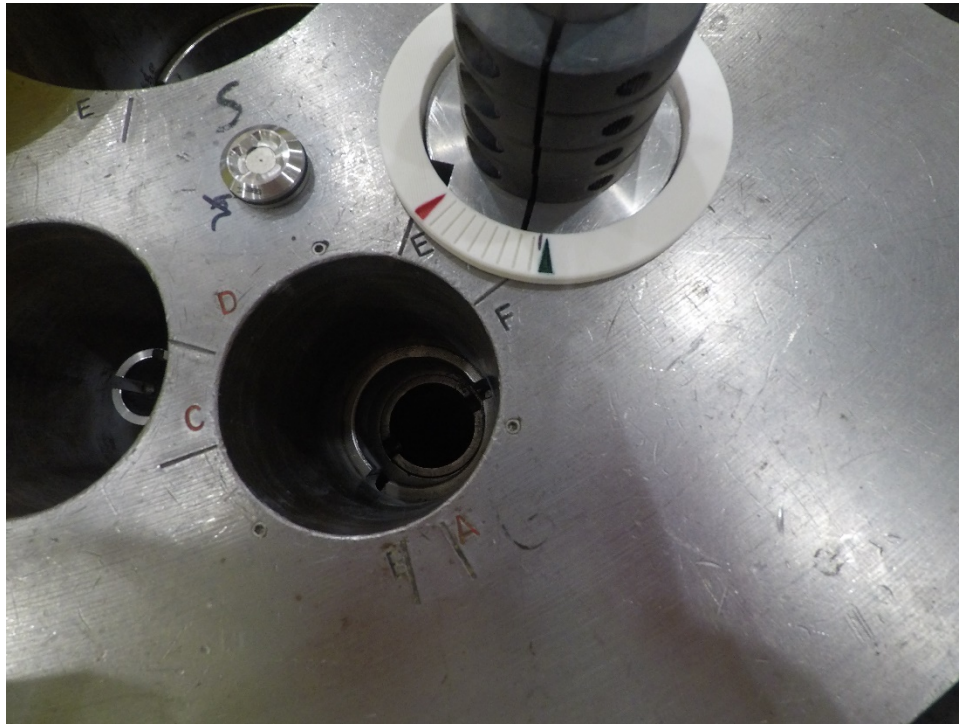
**Figure 3.** Fuel element in with latch about 6° off of full counterclockwise, but still in notch (H-7).

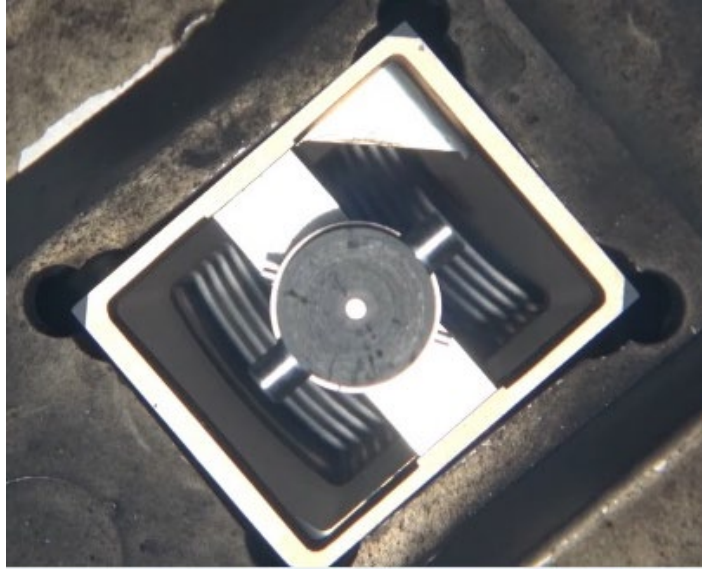
Photos of the video results of a test with a fully latched element in core position I-6 is shown in Figure 4. A photo of the H-7 element rotated about 6° off of full counterclockwise (the same as in Figure 3) is shown in Figure 5. The difference between the two can be easily seen, as the “ears” of the rotated element are clearly off perpendicular and would be rejected. Further rotation clockwise would also have the latch bar coming into view. As in the rotation check, evaluations are being made to clearly define acceptable visual check angle deviations.

**Figure 4.** Video capture of element in latched position (core position I-6)

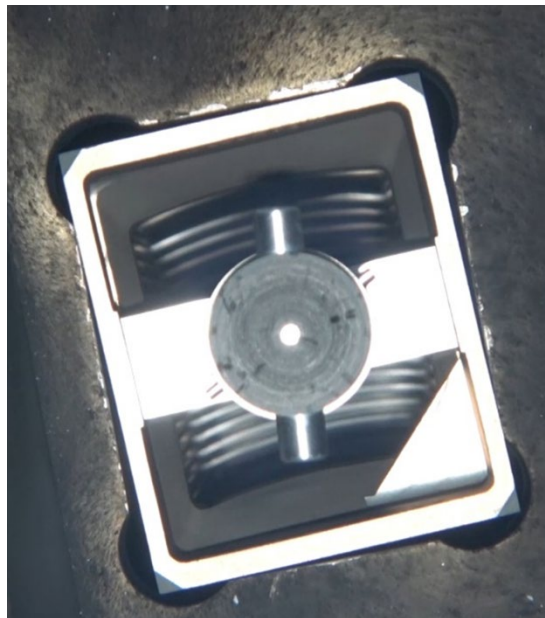
**Figure 5.** Video capture of element with latch rotated clockwise within the notch (core position H-7)
