Duane Arnold Energy Center (DAEC) Loss of Offsite Power (LOOP) Due to Derecho

Terry Brandt Fleet Online Director NEXTera ENERGY

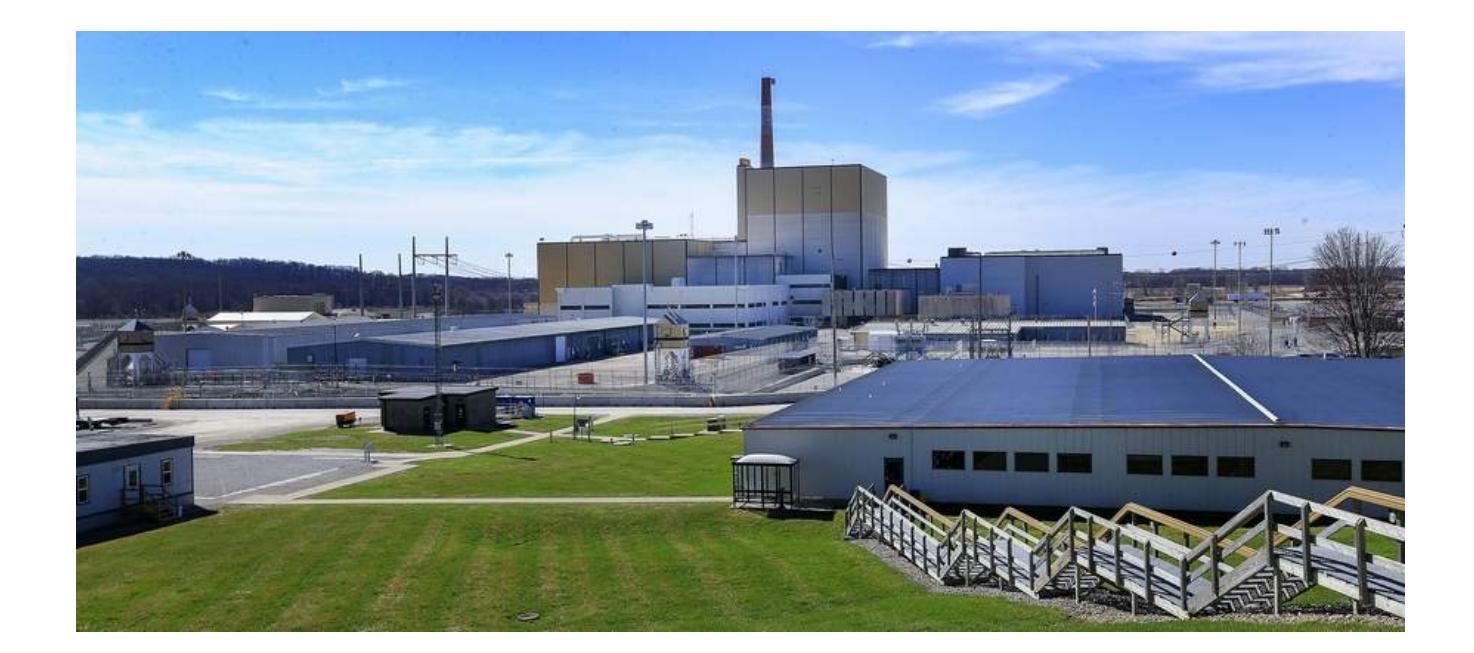
- Storm damage found on roof of the North FLEX building. FLEX function maintained by South FLEX Building equipment
- Forced draft Cooling towers severely damaged
