From: Cary, Richard H. <Richard.Cary@pseg.com>
Sent: Wednesday, May 17, 2023 8:48 AM
To: nmfs.gar.incidental-take@noaa.gov; EndangeredSpecies Resource
Cc: Corbett, Heather [DEP]; Fehring, Shana [DEP]; Neilan, Brian [DEP]
Subject: [External_Sender] Salem Generating Station - Incidental Take Report: Sturgeon 5/16/2023
Attachments: Sturgeon Incidental Take Report for 05-16-2023.pdf

Appendix C, Part 2A (Sturgeon)

Site of Collection: PSEG Salem Generating Station; SGS Unit 1, intake 12A

STURGEON DATA COLLECTION FORM

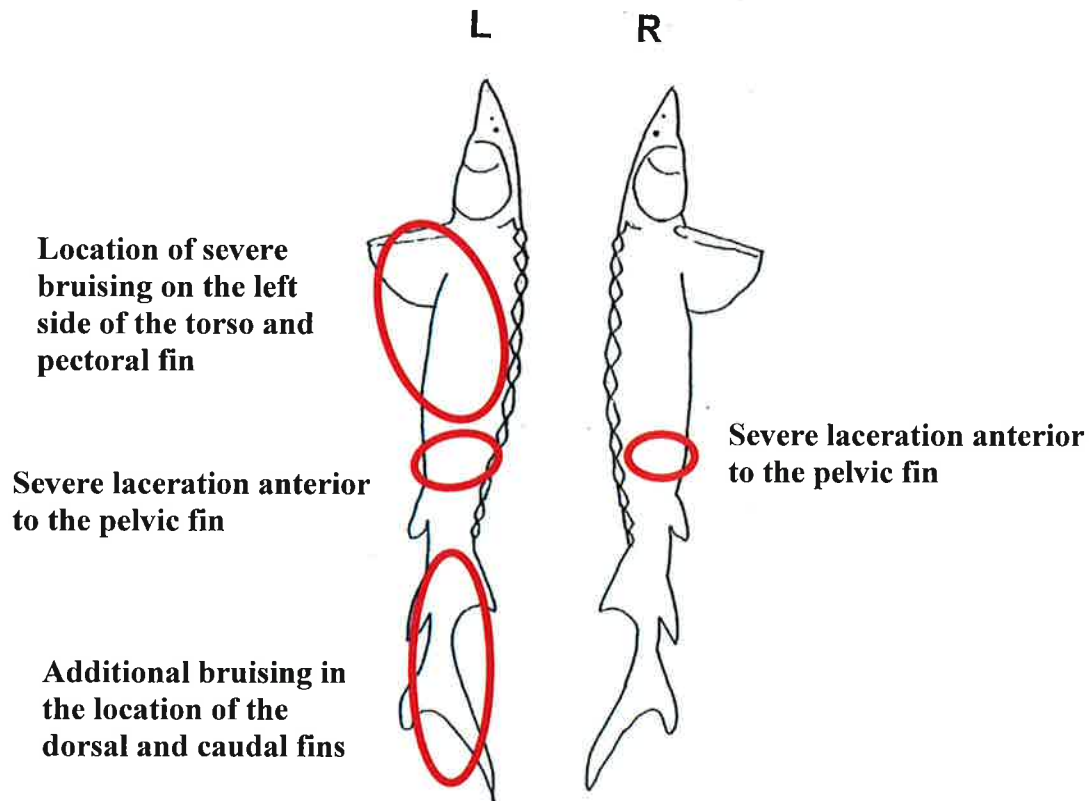
Describe any wounds / abnormalities (note tar or oil, gear or debris entanglement, propeller damage, etc.). **Please note if no wounds / abnormalities are found. Specimen was alive at the time of collection, but exhibited severe damage in the form of bruising on the left side of the torso, as well as two large corresponding lacerations, one on the left and one on the right side of the torso, anterior to the pelvic fins (refer to diagram above). Specimen received a PIT (#933000220017829), implanted below the dorsal fin on the left side**

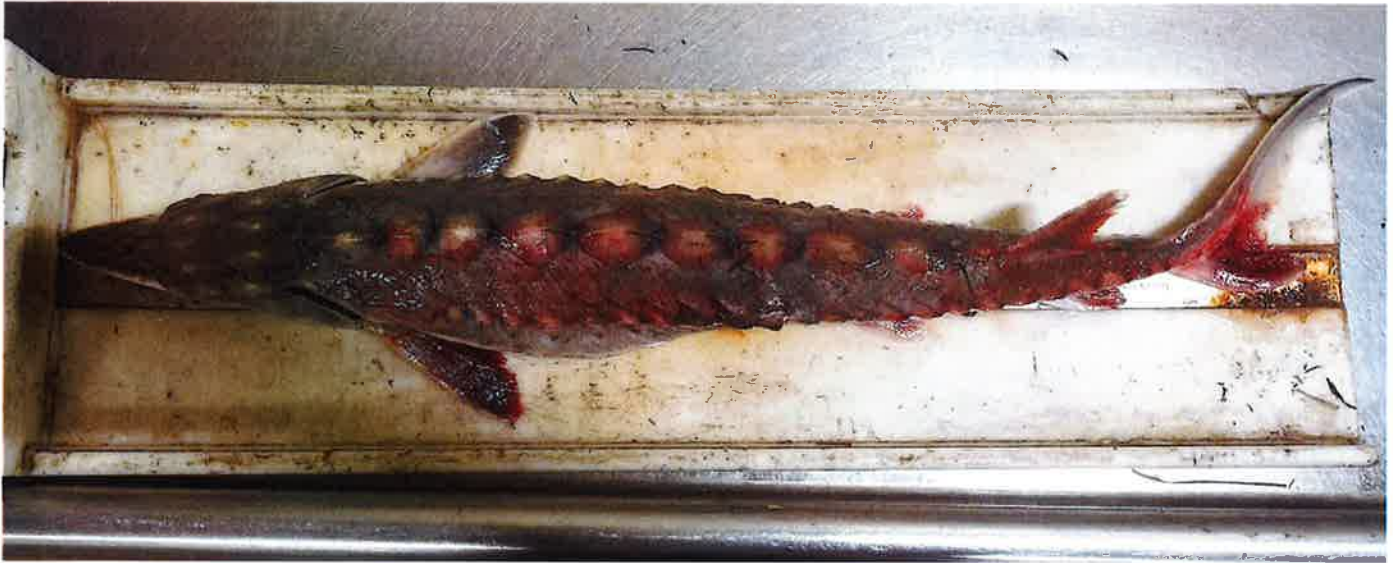
A dorsal view, showing the size and condition of a live, but severely damaged Atlantic sturgeon (*Acipenser oxyrinchus*), retrieved at approximately 09:05AM on 05/16/2023 from the Salem Circulating Water Intake by Salem Yard Crew personnel during routine trash rack cleaning at Salem Nuclear Generating Station (05/16/2023).

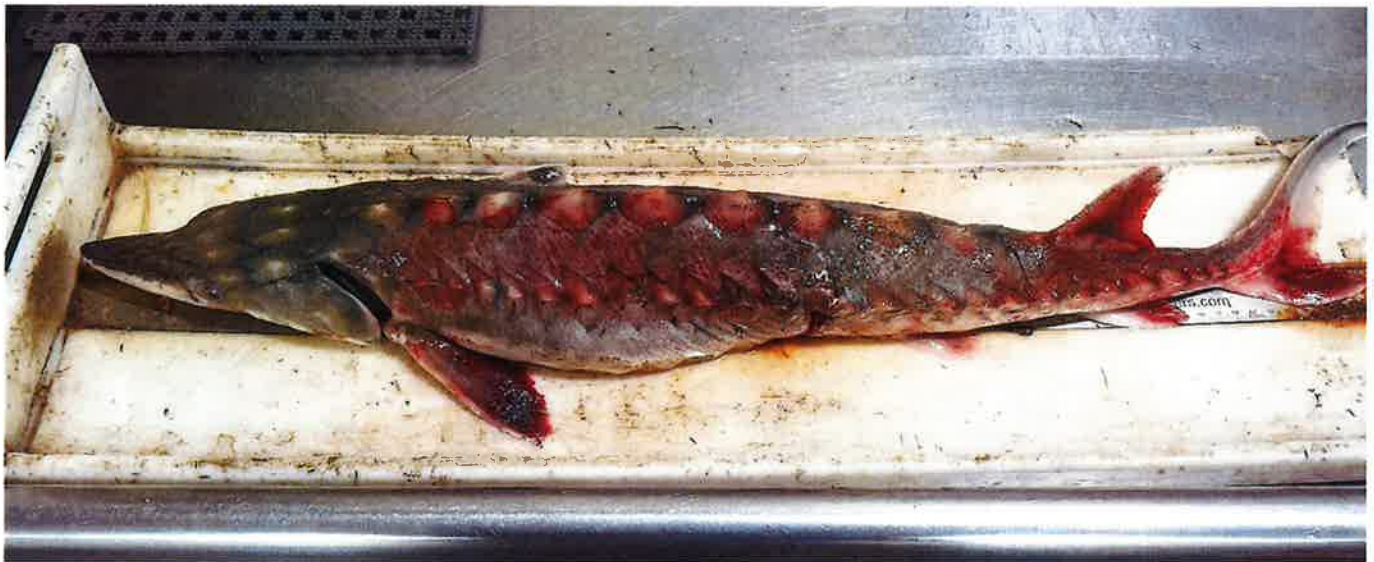
A left, dorsolateral view, showing the condition of the specimen at the time of collection and observation. A large laceration was observed on the torso, between the pectoral fins and the dorsal fin. A second laceration, of similar size, was also observed on the right side of the specimen, in the same location on the torso. The specimen also exhibited severe bruising on a large portion of the left side of the torso (05/16/2023).

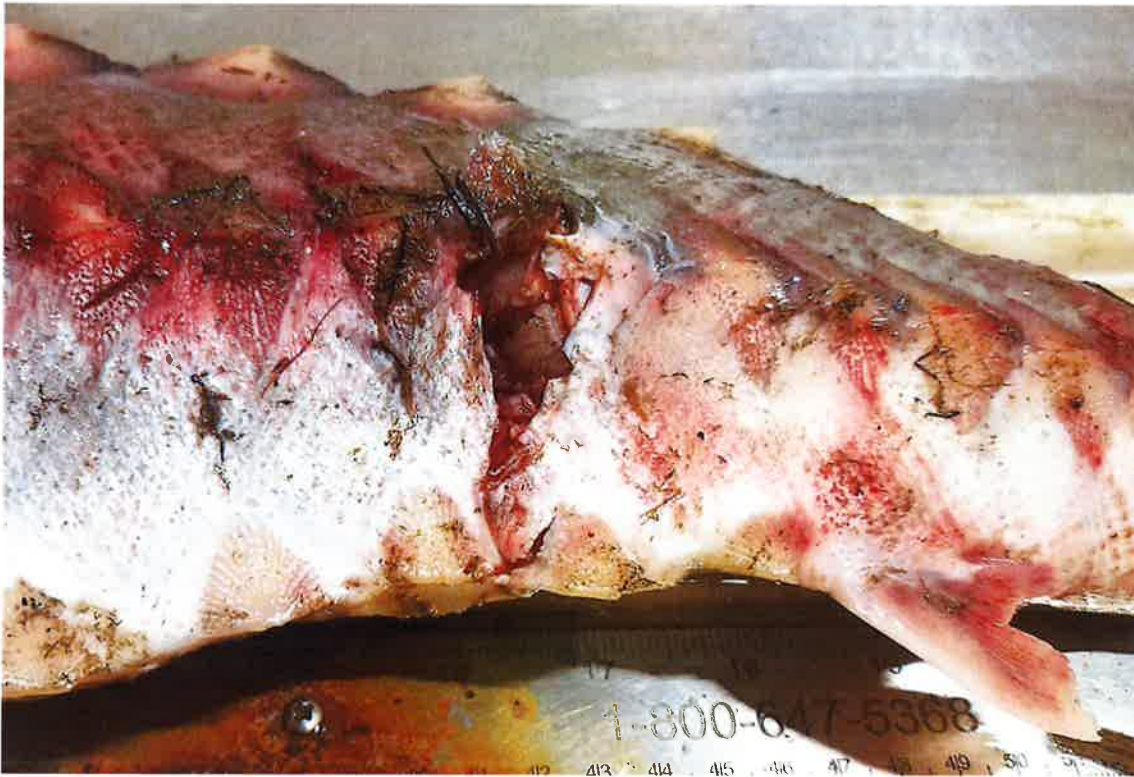
A close-up of the deep laceration on the left side of the torso (05/16/2023) .

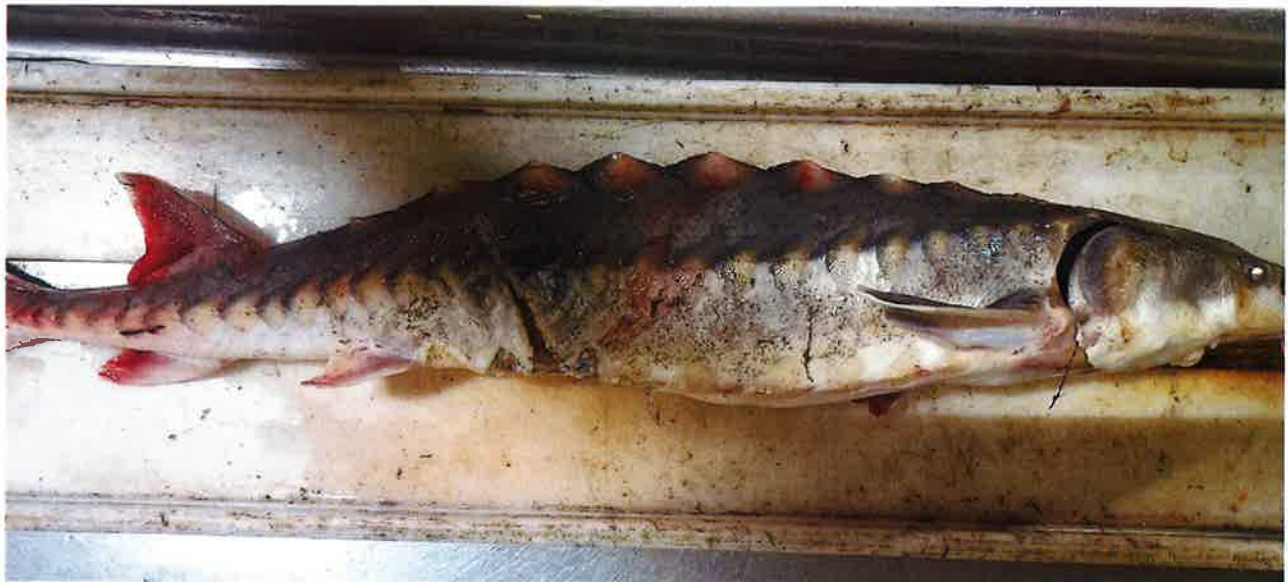
A right, dorsolateral view showing a second laceration located anterior to the pelvic fin, and corresponding with the laceration on the left side of the torso (05/16/2023).

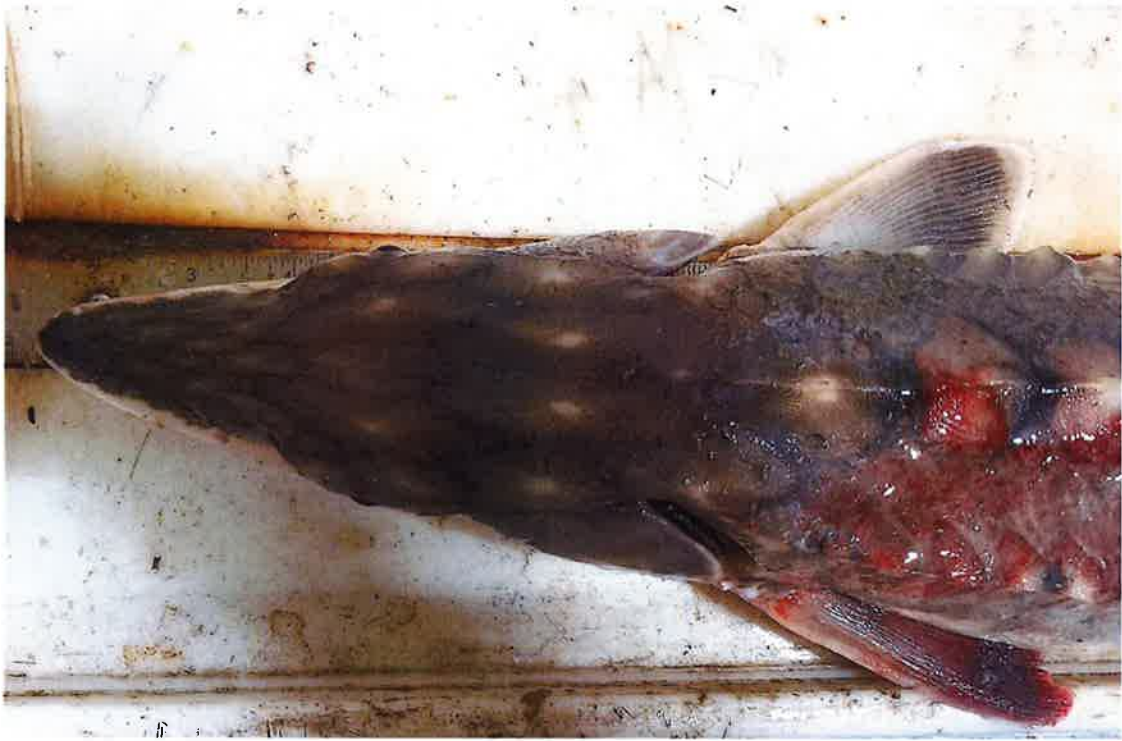
A dorsal view of the head, showing the characteristic elongated rostrum. Severe bruising is evident on the torso, posterior to the head (05/16/2023).
