EA-23-040 Predecisional Enforcement Conference NRC Region II Atlanta, Georgia

June 21, 2023

Annular Organic Waste Tank and Ventilation System Overview

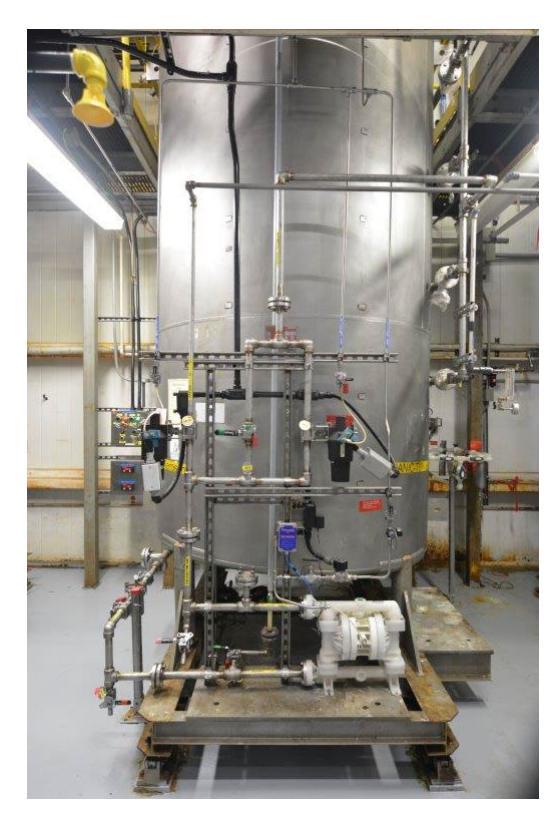
Front View – Floor Level

- The Annular Organic Waste Tank is a favorable geometry, ~800 liter, tank used for storage of organic waste solution generated from the Recovery Extraction process.
- The tank is utilized as interim storage prior to the transfer of Organic Waste Solution back into Recovery for further processing ("washing") – uranium extraction.
- The NCS posting limits incoming concentration to $\leq 10 \text{ g U}^{235}$ / liter.

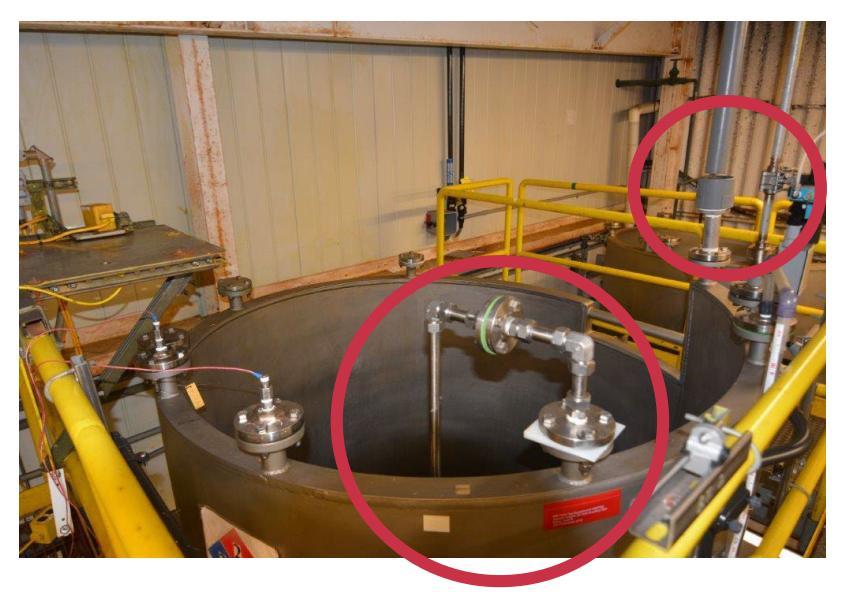
Top View – Mezzanine Level

Overflow

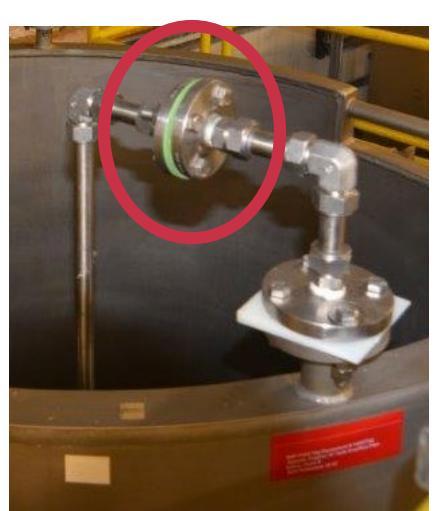
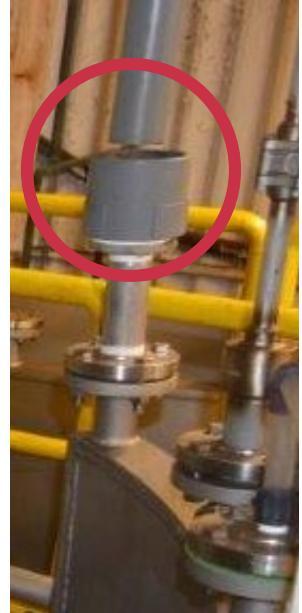
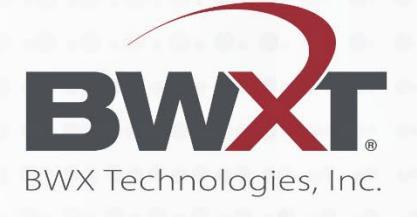
- NCS personnel identified the Overflow & Ventilation Air Gap IROFS as degraded. The IROFS did not fully prevent solution from entering the ventilation system.

- Corrective Action Initialed.
- NCS Safety Concern Analysis was completed, documenting the conditions and analyzing the associated Safety Analysis Report (SAR) Accident Scenario. Identified Actions prior to return-to-service included:
 - Verifying the Annular Organic Waste Tank Overflow Line is not partially clogged.
 - Change the configuration of the Annular Organic Waste Tank Air Gap.
- February 3 While disassembling and inspecting the Overflow Line, an intact rupture disk was identified.
- February 3 A report was made to the NRC Operations Center because the IROFS function of the Overflow could not be credited in the accident sequence. As documented in the Integrated Safety Analysis, the performance criteria of 10 CFR 70.61 were not maintained.

- o Plant:
 - Process was Shutdown and Tank Locked-Out. (Immediate Action)
 - Removed the Rupture Disk. (Immediate Action)
 - Redesign the air gap on the Annular Organic Waste Tank and incorporate in the field.
