VIRGINIA ELECTRIC AND POWER COMPANY NORTH ANNA POWER STATION UNIT 1 REQUEST FOR APPROVAL OF ALTERNATIVE REQUEST N1-I5-NDE-007 TO DEFER ADDITIONAL REQUIRED REACTOR COOLANT PUMP CASING INSPECTION

Excerpts from Engineering Evaluation ETE-NA-2024-0033, 1-RC-P-1A Casing Indication Evaluation

ETE-NA-2024-0033

CR1253801-Structural Deformation Identified on Pump Casing- 1-RC-P-1A

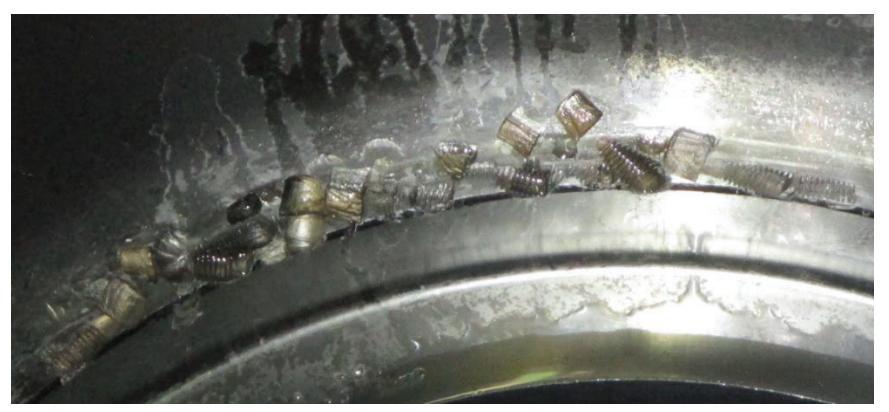
Figure 2- 1-RC-P-1A Casing Indications- Partial Plan View

As detailed in CR1253801 the casing VT-3 examination revealed multiple instances of structural deformation at the bottom of the casing near where the 'A' intermediate leg enters the pump. If looking downstream with the 'A' Cold Leg at 12:00, the area with the most significant impressions are at 9:00. The deformation appears to be impressions in the casing made by loose parts (i.e. bolts). The indications in question are shown below in Figures 2, 3, 4, and 5. The specific location of these indications is highlighted above in Figure 1 and is at the diffuser adapter to casing interface. By design, the diffuser adapter has a minimum diametral clearance of 0.050" and a maximum clearance of 0.060" to the casing wall. Based on a review of the as built drawing for 1-RC-P-1A (reference ETE-NA-2023-0031 Revision 1 Attachment 3), the clearance of the new pump to casing is estimated to be 0.048". This is tighter than the original design requirements which has no impact on the diffuser adapter function. The interior of the casing, including the areas where all of the indications were found, does not participate in a measurable way in the hydraulic performance of the pump. The only clearances that are important to hydraulic performance are the labyrinth clearance between the diffuser adapter and impeller at the discharge of the impeller.

There are several ~3-4 indications on the ID of the casing at the adapter interface. These indications do have potential to impact the adapter functionality by allowing flow around the impeller (or adapter due to opened clearances) and into the ID of the casing. As stated above, in 1982, 1-RC-P-1A was removed from its casing to support suction splitter plate removal. Upon removal of the pump assembly, it was identified that 7 of the 12 adapter cap screws had failed. From a review of LER 82-056 (Attachment 3), Westinghouse evaluated the condition and determined that even if all of the adapter socket head cap screws had failed, significant operation degradation of the reactor coolant pump would not have resulted. A loose adapter would initially drop loop flow about 0.2% which is much less than the existing flow margin of approximately 5% above core thermal design flow. In addition, the automatic low flow reactor trip would prevent operation below core thermal design flow. Based on a review of current 1-PT-27 trends, the total RCS flow rate on Unit 1 is 313,904.4 gpm which has considerable margin above the Technical Specification LCO 3.4.1 requirements of 295,000 gpm. This supports the fact that with the diffuser adapter in the dropped condition on 1-RC-P-1A, there is no impact on the pumps ability to adequately cool the core. Given that the impact of a loose diffuser adapter is an anticipated drop in flow

Note that the indications shown on the inner bore of the casing at the diffuser adapter interface (Figures 3,4, and 5 above) are believed to be induced during the maintenance evolution. Upon the retrieval attempt of the diffuser adapter, it was identified that the component was "stuck" and required mechanical methods to be removed from the case. This indicates that there was interference between the casing bore and the diffuser adapter, likely due to the small fragments of the failed cap screws becoming lodged within the clearance between the casing the diffuser adapter. Upon separation of the two parts, the forces applied caused small pieces of the casing to shear off which created these indications. This is supported by the visually rough surface of these indications as compared to the clear indications in the upper cavity induced by the fastener caps/threads. As such, the indications on the inner bore of the casing ID at the diffuser adapter interface are a result of the maintenance activity and are not service related/induced and there are no degradation mode concerns.

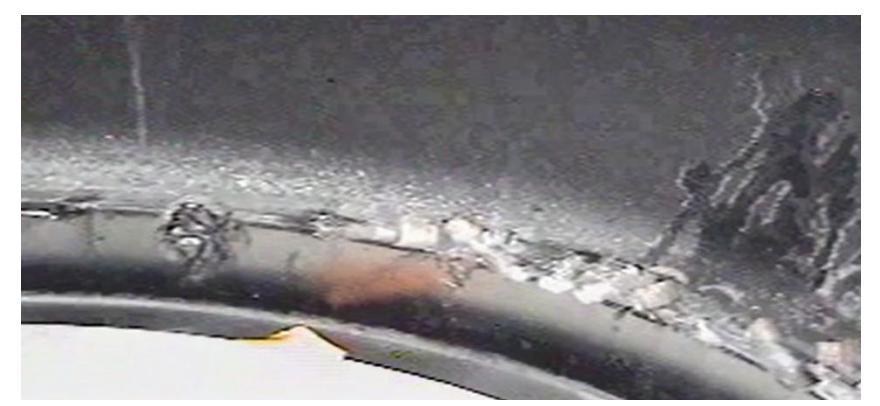
Figure 3- 1-RC-P-1A Casing Indications- Partial Elevation View

Based on visual inspections and overall dimensions of the cap screws the limiting depth of the indentations in the pump casing is conservatively estimated to be 1.125/2 = 0.5625", which exceeds the limiting flaw depth of 0.3" in the acceptance standards of ASME Section XI. Table IWB-3519.2-2 (Ref. 9 and 17). The noted degradation has effectively changed the surface profile locally in this area and it is considered the new casing surface in this area. Therefore, the evaluation considers the effects of this new surface profile on the ASME Class 1 Stress Report (EM-4771) along with potential impact of this new surface profile being created by partially pressing the bolting material into the surface of the pump casing. Based on provisions of IWB-3142.4, Acceptance by Analytical Evaluation, the surface degradation is evaluated considering that a crack like flaw may be present at or just below the surface of the more heavily deformed areas. For the current Licensing period the allowance for performing only visual examinations at North Anna is based on NRC approval of the Code Case N-481 evaluations performed by Westinghouse, as documented in LR-1017/LR-2017 (WCAP-15555), Reference 27, which is based on the generic industry analysis performed in WCAP-13045 (Reference 10). Based on a review of WCAP-13045 the global stress field in this area of the pump casing is relatively low compared to the postulated flaw locations evaluated (Ref. Figures 8-12, 8-13 and 8-14 of Ref. 10). During the event which resulted in the postulated plastic deformation at the pump casing surface the material at or just below the surface of the indentations would have been subject to out of plane tensile stress in the hoop and axial directions of the pump casing. Although no indications of actual surface cracking could be seen in the photos and video of the affected area, since the compressive stresses required to generate the observed surface profile would have exceeded the yield strength of the material it is conservatively postulated that the resulting out of plane tensile stresses in the surface and underlying material could have resulted in minor cracking at or just below the surface. Given that the surface indentations are limited in depth to 0.5625" or less it is considered reasonable to postulate that a maximum resulting flaw size during the postulated deformation of the subsurface material would not exceed approximately 50% of the depth of these local surface depressions, or 0.2813", given a typical extent of influence for localized loading effects. Thus, the maximum postulated initial flaw size of 0.3" used in the analysis performed in WCAP-13045, which has been approved by

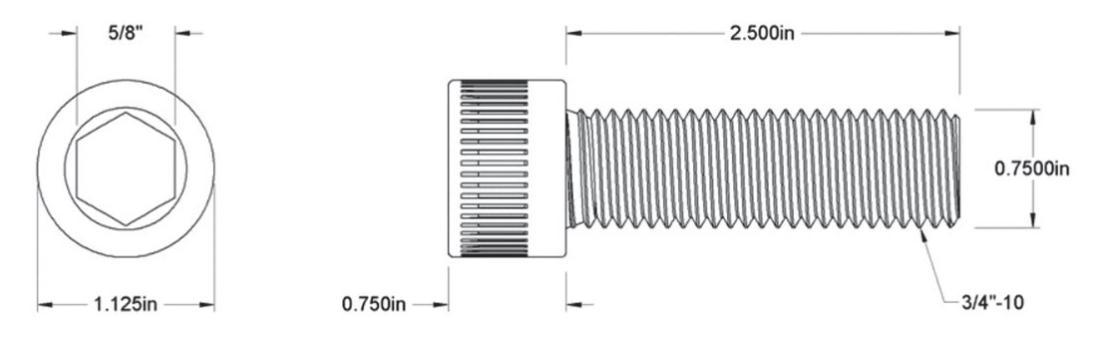
Note that the presence of multiple postulated cracks is considered. The worst case was judged to be two adjacent indentations from cap screw heads, aligned to form a single flaw of 0.3" depth and an estimated 1.5" length (1.5" = 0.75"x2), or (a/I) = 0.3/1.5 = 1/5 which is bounded by the aspect ratio of 6:1 assumed in the analysis performed in Ref. 10. Based on the majority of the areas of deformation being shallow compared to the worst-case assumption, no other combined flaws are postulated based on the proximity rules of IWA-3330-1, which would limit the need to consider indentations separated by more than half of the depth of the deepest adjacent indentation.

The dimensions of the cap screws are shown below for reference.

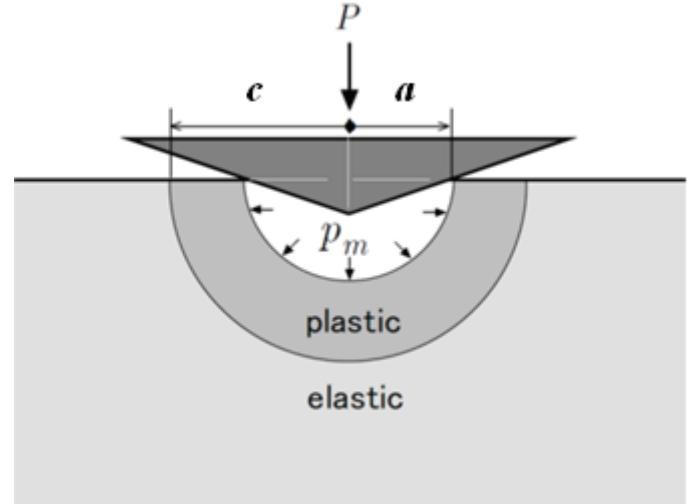
Figure 7- Cavity model of an elastoplastic indentation contact by a cone; the model comprises a hemispherical cavity of radius a with internal hydrostatic contact pressure $p_m = P/\pi a^2$. The cavity is surrounded by a plastic core with radius b embedded in an elastic half space [8].

The plastic zone (a < r < c) can be estimated by Johnson's cavity model (see Figure 7) [8], where a spherical core of radius *a*, representing the contact area, is assumed to be under hydrostatic pressure, p_m , as a result of the indentation load *P*. The elastic-plastic boundary of radius *c* as defined by the yield criteria is given by [9, 10]

where $\sigma_{x} = 30,000$ psi is the yield strength of the material, the contact radius a is set to a = 0.5625". With an estimated pressure of 25,000 psi, the estimated plastic zone depth is less than 0.1". When c is set to 0.8625" (0.5625" + 0.3"), the estimated hydrostatic pressure would be 45,000 psi, which exceeds the estimated load for the worst-case scenario. Therefore, a subsurface flaw as a result of indentation is bounded by the 0.3" initial flaw depth used in Reference 10.
