Status of Medical Events FY 2023

Daniel DiMarco

Medical Radiation Safety Team

April 8, 2024

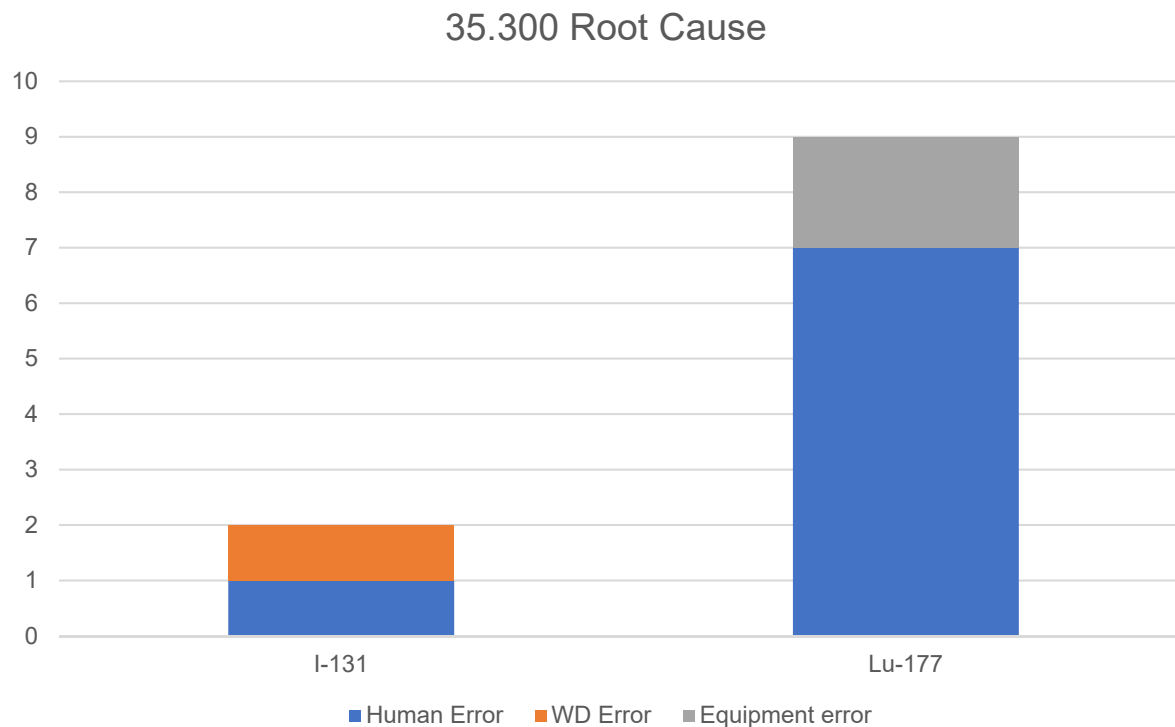
- 35.300
 - Primarily Lu-177 events, huma error underdoses
 - Mix-up Lutathera and Pluvicto, mix-ups on patients
 - Supply chain issues for delivery equipment

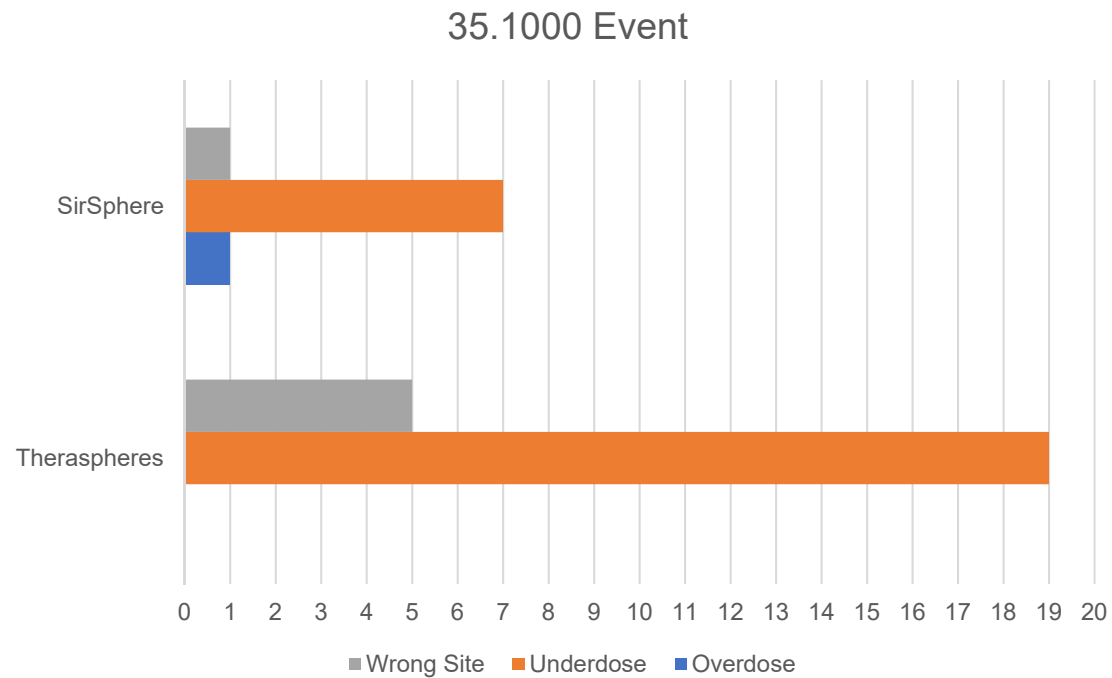
- 35.1000
 - Primarily Y-90 Theraspheres, primarily underdoses
 - Collaboration with manufacturers
 - Possible complications with catheter supplements (anti-reflux cage, extension)
