PNNL-36836

# Nondestructive Evaluation of Electron Beam Welds

June 2024

Prepared for the U.S. Nuclear Regulatory Commission Office of Nuclear Regulatory Research Under Contract DE-AC05-76RL01830 Interagency Agreement: NRC-31310022S022

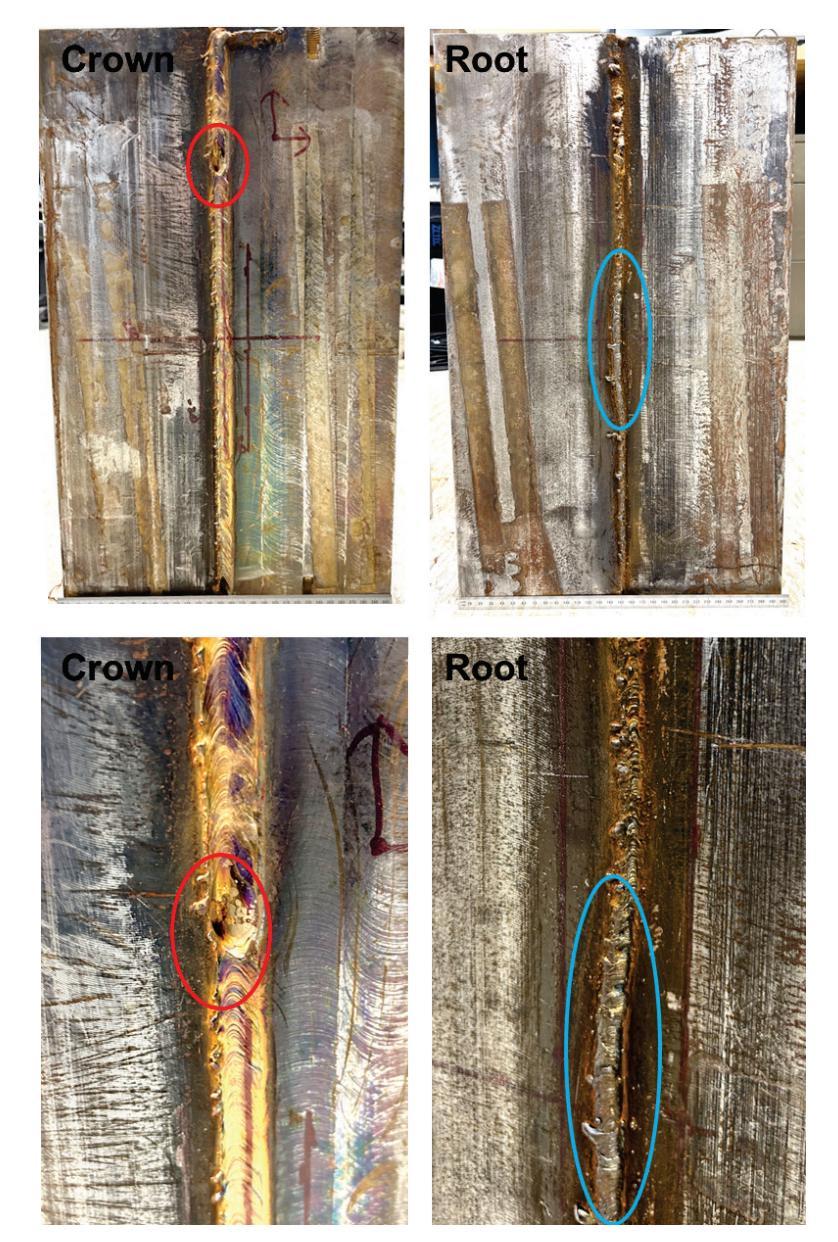
Block 2 was welded with the same parameters as block 1. The weld crown and root of block 2 are shown in figure 12. About midway through the weld, a partial through-wall LOF flaw was created by deflecting the electron beam with a magnetic field. A slight deviation in the weld root, visible in the photographs (blue circles), was indicative of the deflected beam. A through-wall keyhole defect was also present (red ovals). This defect was caused by a beam shutdown during welding.

Figure 12: Photographs of the block 2 weld crown and root. The top photographs are of the whole block face, and the bottom photographs are closeups. The keyhole defect is highlighted by the red ovals and a root deviation is indicated by the blue ovals.

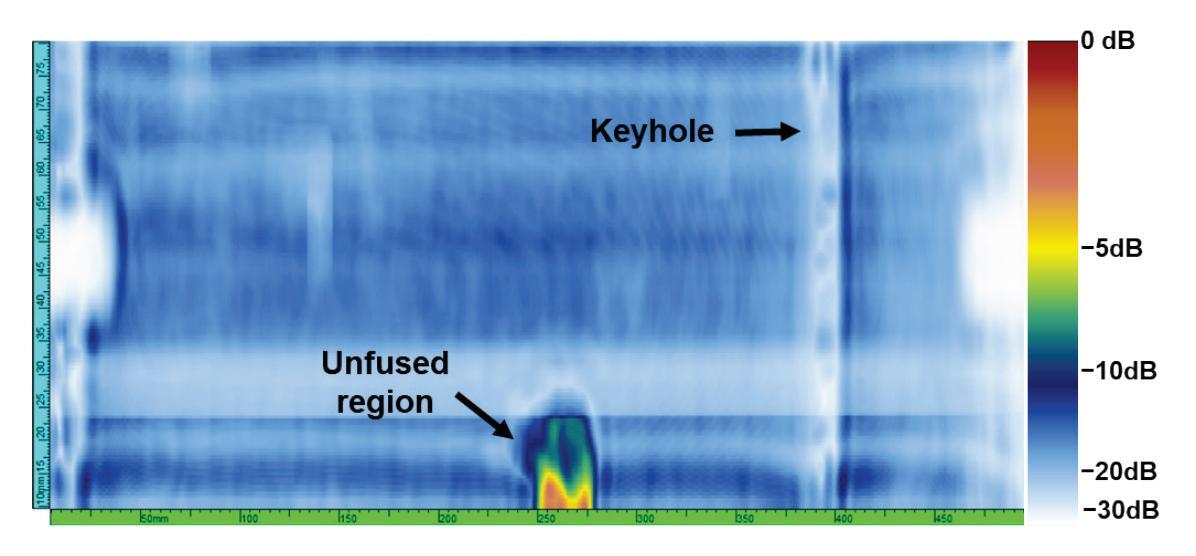
The 0° UT scan of block 2 is shown in figure 13. Overall, the UT signals were weak and relatively uniform, indicating a well-fused weld joint, except for the region where the electron beam was deflected and the weld joint was not fused. The keyhole defect was visible as a vertical stripe with weak signal because it scattered the sound instead of reflecting it back to the probe.

Figure 13: 0° UT scan of block 2. Overall, the UT signals were weak and relatively uniform except for the strong echo from the unfused region. Note that the horizontal scale is compressed with respect to the vertical scale to fit the image on the page.

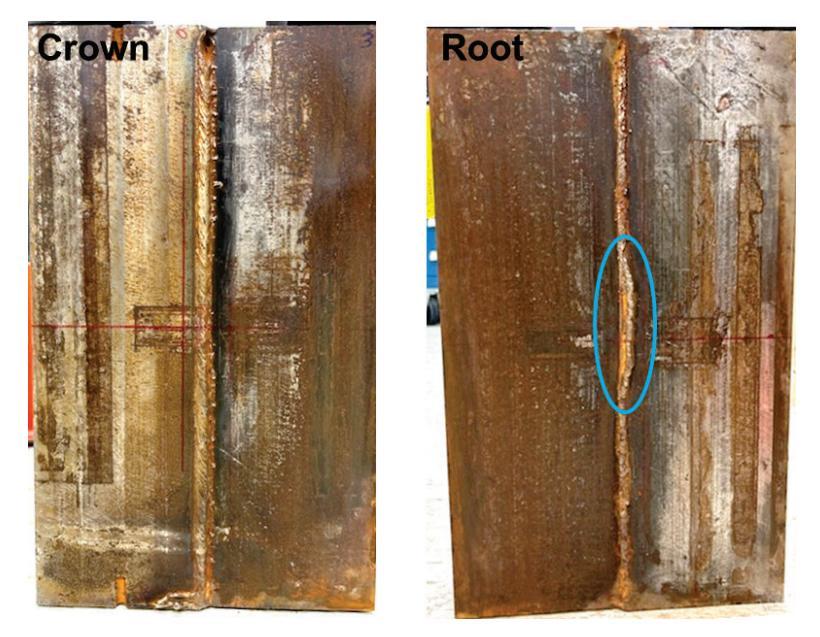
Block 3 was welded with the same parameters as blocks 1 and 2, but the beam was aligned to miss nearly the entire weld joint. Only a small region was fused; we could not visually discern the location of the fused region. A deviation was visible in the weld root (blue oval), but it was not indicative of the larger extent of the unfused region. Figure 14 shows block 3. Some rust buildup due to water couplant for ultrasonic scanning is visible in the figure.

Figure 14: Photographs of the block 3 weld crown and root. A deviation of the weld root is encircled in blue.

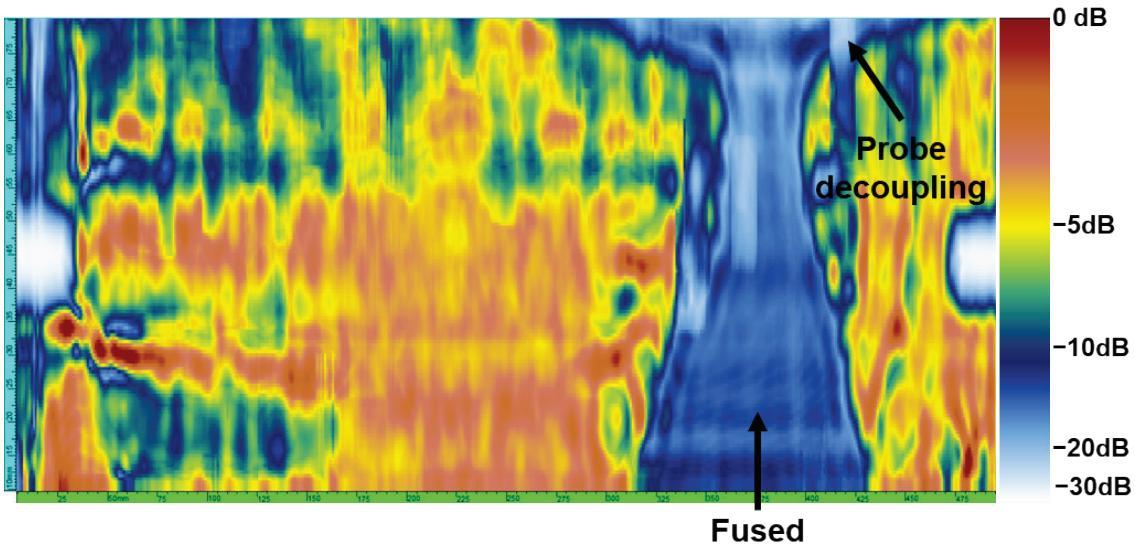
The 0° UT scan of block 3 is shown in figure 15. Overall, the UT signals were strong, indicating most of the weld joint was unfused. There are some signal variations from the unfused surface possibly suggesting that the block surface and/or joint line was not completely smooth. There is an hourglass-shaped region where the weld appears to be well fused.

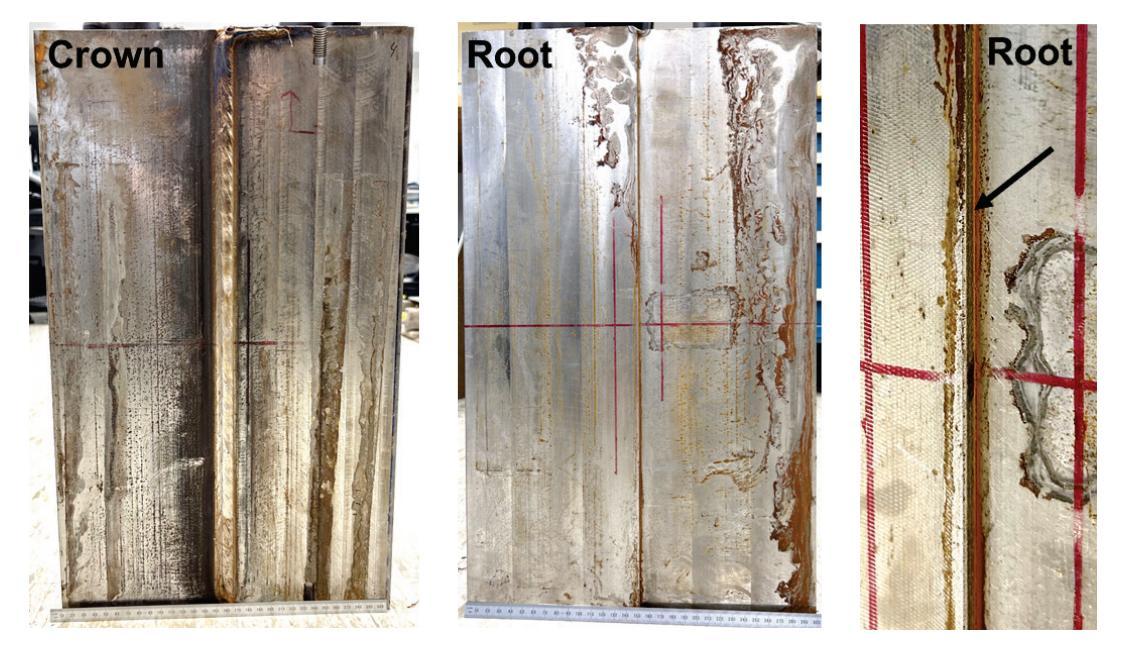
Block 4 was welded with the same parameters as the block 1, except the beam oscillation axes were reversed. In this case, the beam was oscillated by 1 mm along the weld direction and 3 mm perpendicular to the weld direction. Because the beam spent less time in the weld direction, the melt pool did not penetrate through the entire block thickness; the result was an LOP defect along the entire length of the block. Photographs of block 4 in figure 16 show the weld root was smooth and straight with no indications of the melting or splatter seen in the other blocks, evidence that the beam did not fully penetrate the block. The depth of the LOP defect cannot be discerned visually.

Figure 16: Photographs of the block 4 weld crown and root. The weld root appears smooth and straight. The closeup view of the root (rightmost image, black arrow) shows no melting or splatter, indicating that the electron beam did not penetrate the material.

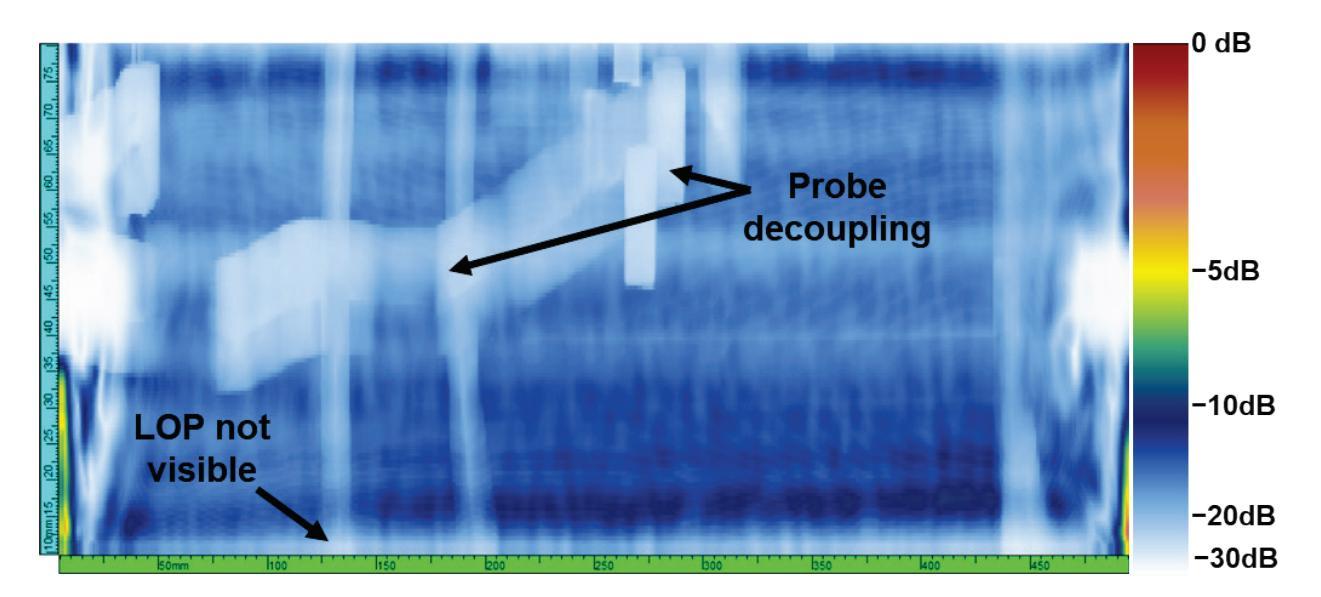
The 0° UT scan of block 4 is shown in figure 17. Overall, the UT signals were weak and relatively uniform, indicating a well-fused joint. There are some large regions with signal dropout due to probe decoupling. The LOP defect should appear as a strong echo near the bottom edge of the figure, but it was not visible. We conclude that the LOP defect was not deep enough to be detected and is therefore  $\leq 10$  mm deep.

Figure 17: 0° UT scan of block 4. Overall, the UT signals were weak and relatively uniform suggesting a well-fused joint. Some large regions of poor probe coupling were visible. The LOP defect was not visible since it was within the ~10 mm buffer zone. Note that the horizontal scale is compressed with respect to the vertical scale to fit the image on the page.

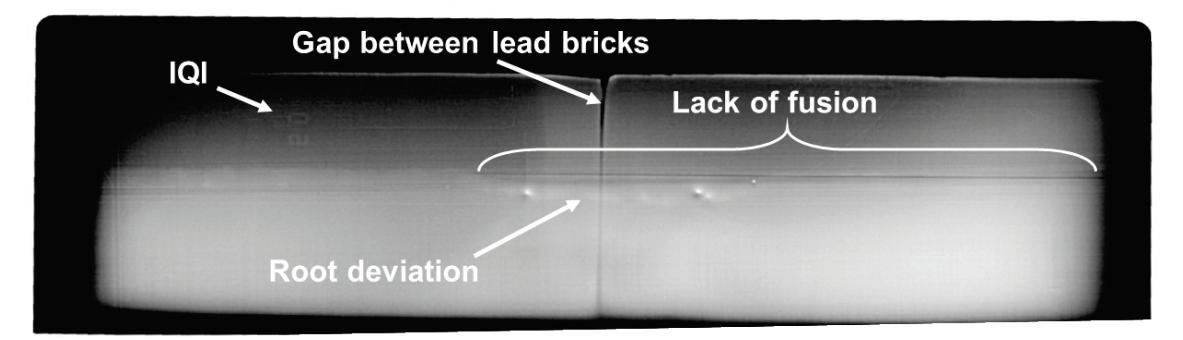
Figure 24 shows a radiograph from block 3, which had substantial LOF along most of the weld joint. A portion of the LOF defect was *potentially* visible as a straight line, but the depth or severity of the LOF was not apparent. The deviation in the weld root was also faintly visible, although it was seen more readily with the eye as in figure 14. The gap between the lead bricks was prominent from x-ray exposure through the back of the imaging plate, showing that x-ray backscatter was significant. The IQI number was barely visible, and none of the IQI holes were visible, nor were the IQI borders.

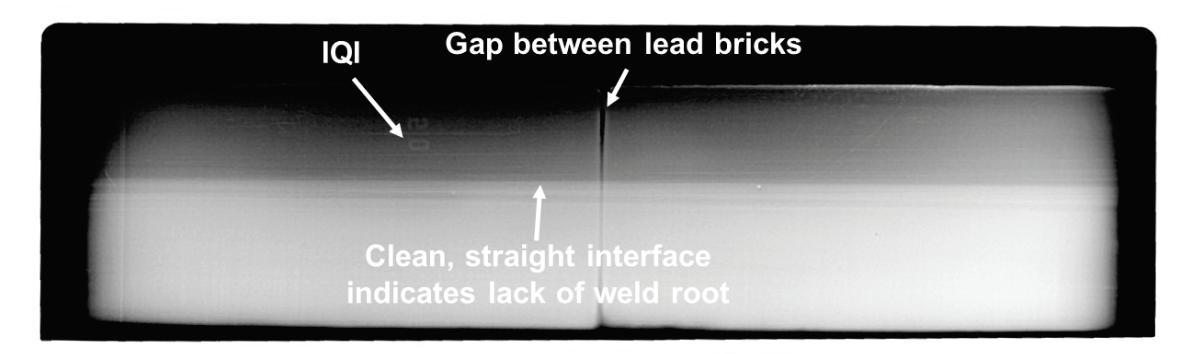
Figure 25: Radiographic image of block 4.

Figure 25 shows an example from block 4, which had an LOP defect along the entire length of the block. The LOP defect was apparent in the image as a straight line that would otherwise be obscured by the weld root. Naturally, a radiograph is not needed to see to lack of weld root, which was readily visible with the eye (see figure 16). The radiograph did not give any information about the depth of the LOP. The flaw opening dimension was too small to be visible, and radiographs taken at an angle to try to show the LOP depth would simply increase the metal path of the x-rays, further reducing exposure.

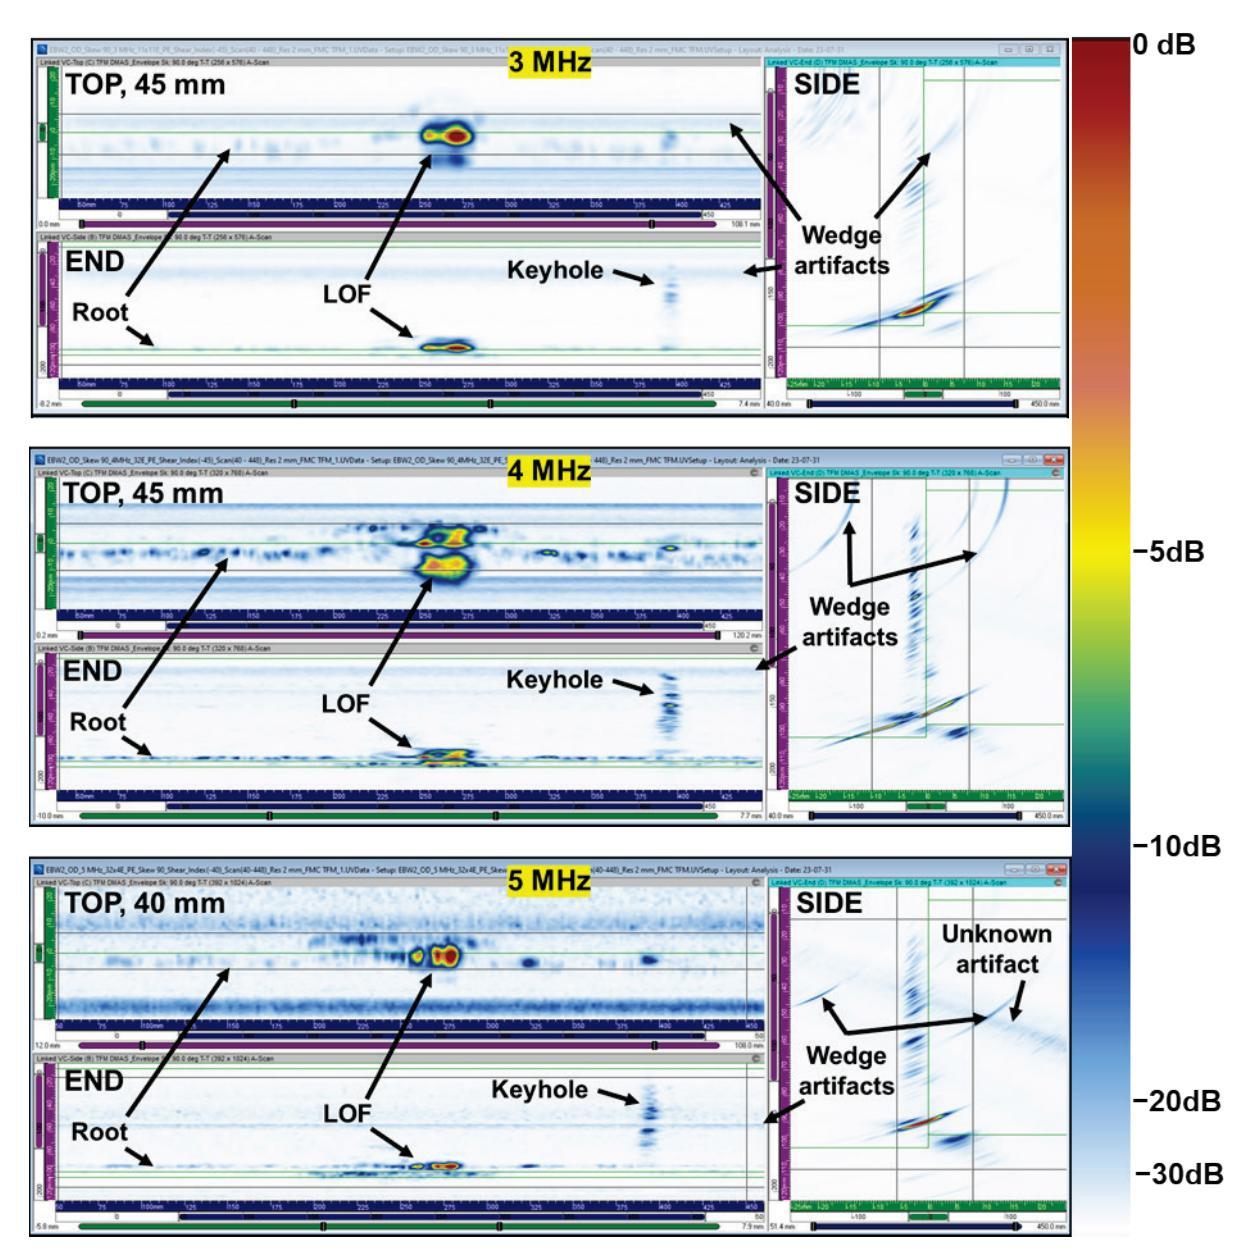
Figure 26: Example FMC scans of block 2 with the three different probes.

In the 3 MHz scan, the LOF defect was prominent, but the root and keyhole echoes were only faintly visible. Wedge artifacts were present but not obtrusive. The 4 MHz scan clearly showed the LOF defect, and the root and keyhole echoes were stronger and easily identifiable. The wedge artifacts were also stronger, but they mostly occurred outside the regions of interest and therefore did not interfere with data interpretation. The echoes in the 4 MHz scan appeared to be considerably "sharper" or better focused than those in the 3 MHz scan. The 5 MHz scan clearly shows the LOF and keyhole echoes, but the root echo was relatively weak. The echoes did not appear to be as sharp as those in the 4 MHz scan. The wedge artifacts were not obtrusive, but an additional unknown artifact was present in the 5 MHz scan. In the side view, this artifact permeated diagonally through the joint line resulting in the top and end views appearing to have noisy backgrounds. Overall, we judged that the 4 MHz probe provided the best results, so we focused on evaluating the 4 MHz scans for the remainder of this section.

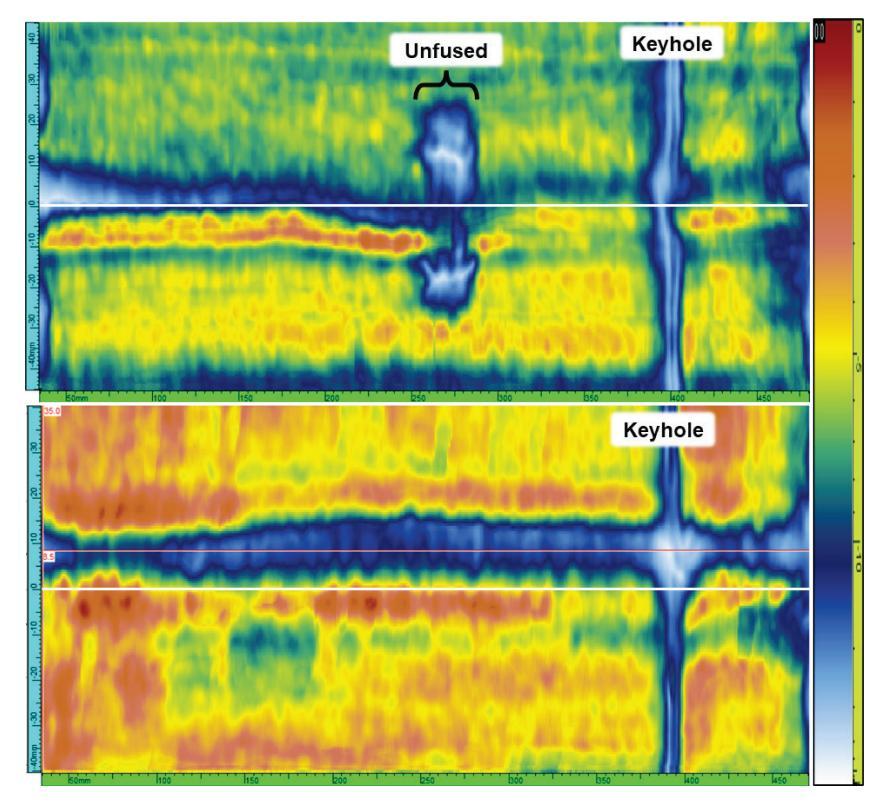
Figure 33: TOFD scans of block 2. Top: scan from the top of the block. Bottom: scan from the bottom of the block. The LOF and keyhole defects are labeled. The color scale indicates signal intensity with red being the highest.

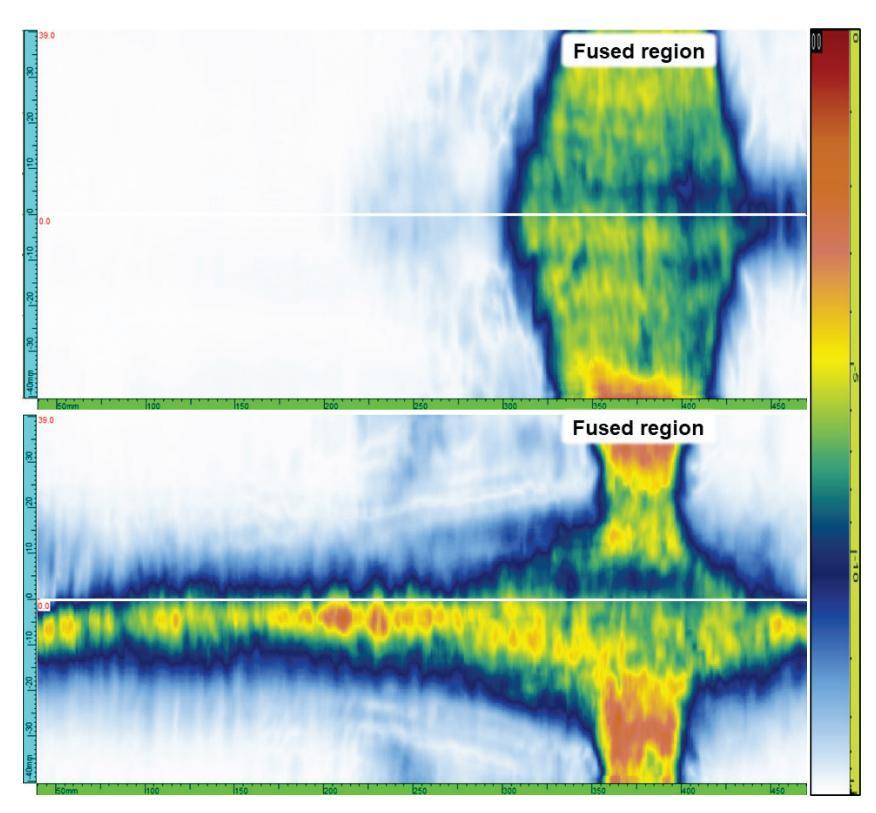
Figure 34: TOFD scans of block 3. Top: scan from the top of the block. Bottom: scan from the bottom of the block. The regions where fusion occurred are labeled. The color scale indicates signal intensity with red being the highest.

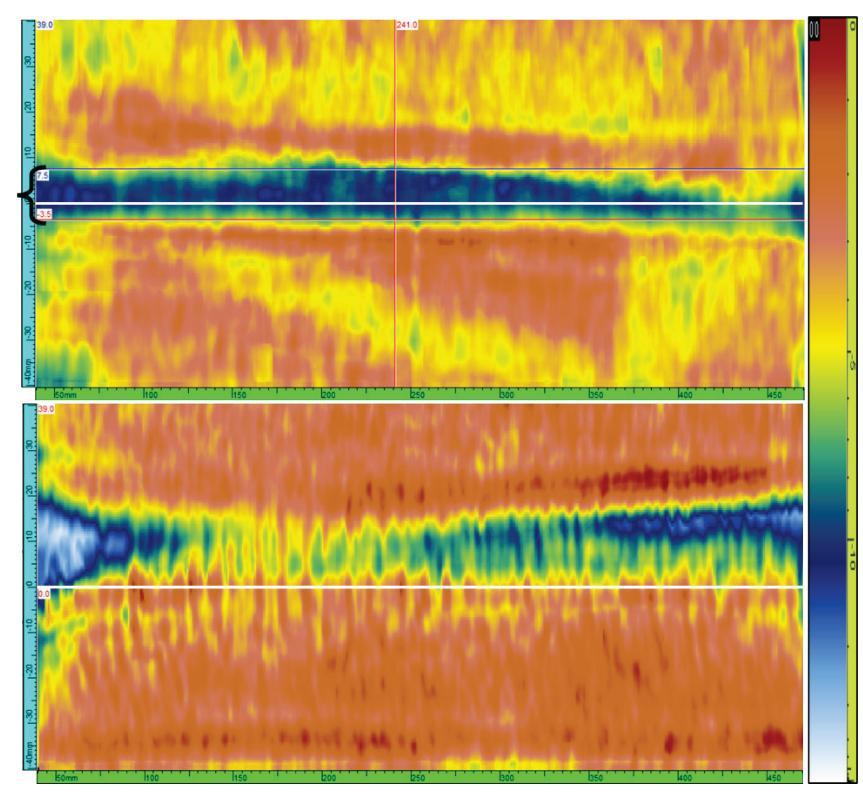
Figure 35: TOFD scans of block 4. Top: scan from the top of the block. Bottom: scan from the bottom of the block. The LOP defect is indicated in the top scan by the black bracket. The color scale indicates signal intensity with red being the highest.

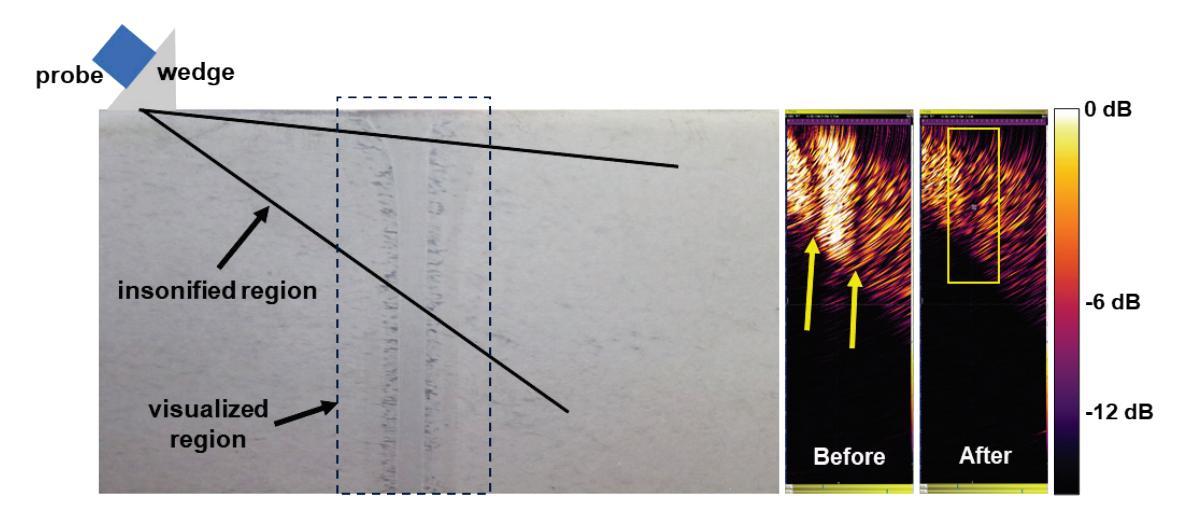
Figure 42: FMC results before and after heat treatment. The yellow arrows indicate shadows observed along the outline of the weld region. The yellow box indicates the joint line region.
