> Dresden Nuclear Power Station, Unit 2 Facility Operating License No. DPR-19 NRC Docket No. 50-237

Subject: Licensee Event Report 1999-005-00, "Unanticipated loss of Level in Reactor Cavity/Fuel Pool during Refueling Activities due to Open Electromatic Relief Valve"

Unanticipated Loss of Level in Reactor Cavity/Fuel Pool during Refueling Activities due to Open Electromatic Relief Valve.

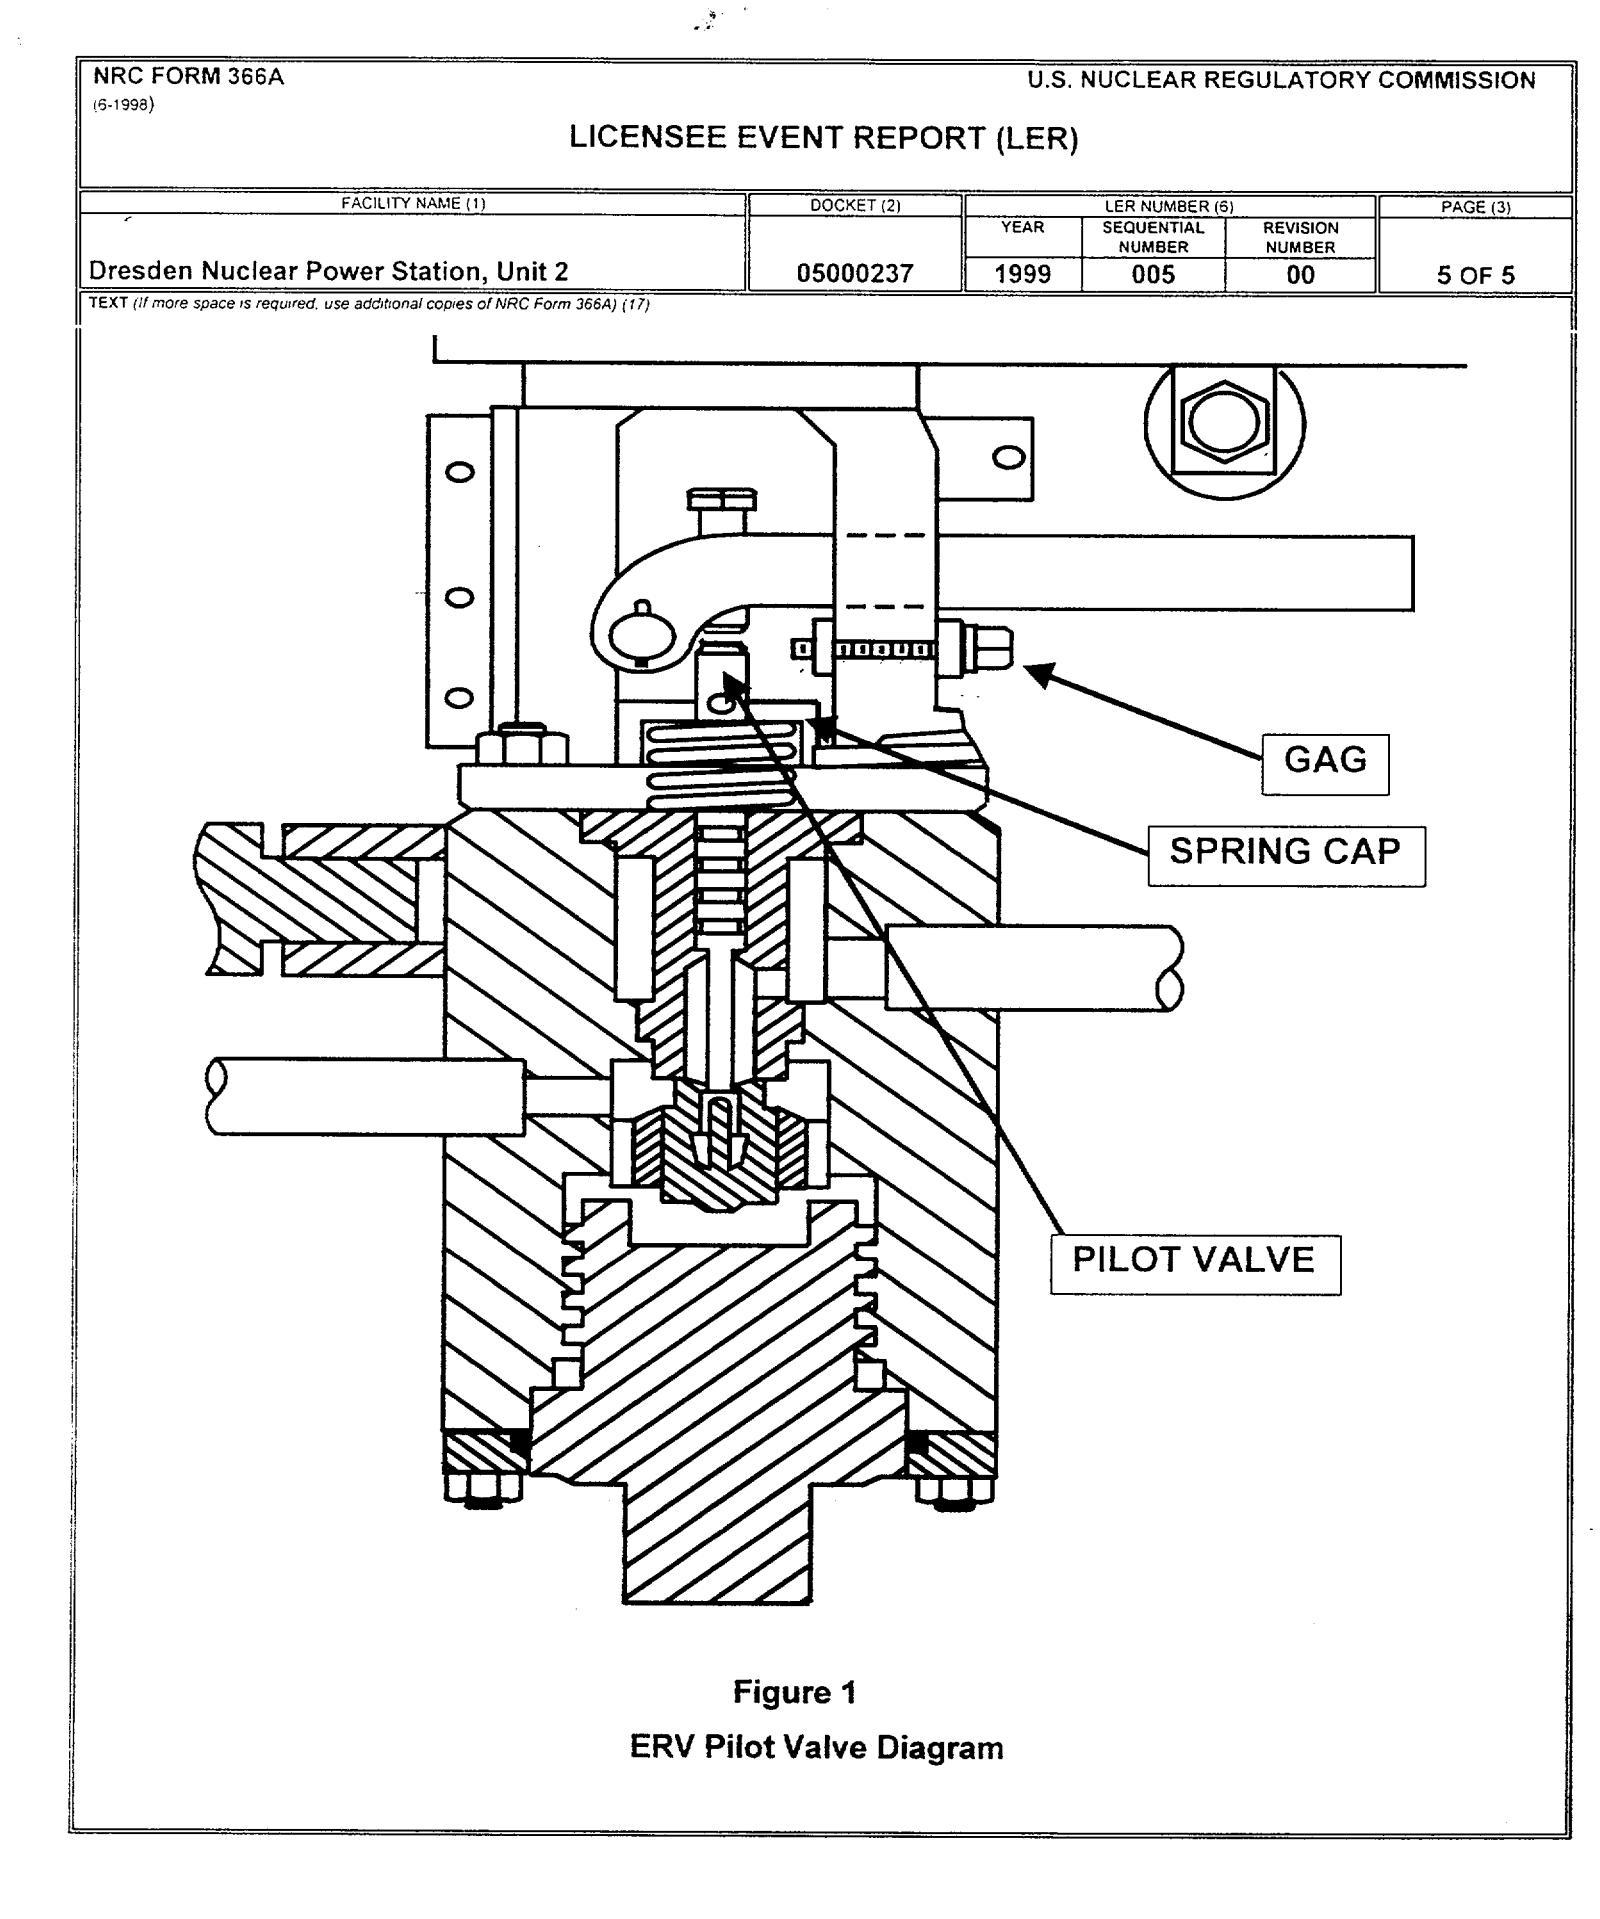
Based upon review of the maintenance work packages, the investigation concluded that the gagging device was in place when the "E" ERV was cycled. When cycled, the downward force of the solenoid plunger against the actuator arm was sufficient to force the gag downward (into its final resting position as found by the Outage Manager on October 19, 1999). This repositioning of the gagging device was sufficient to permit the actuator arm to contact the pilot stem, and permit successful completion of the position indication limit switch checks. When personnel entered the Drywell for troubleshooting during the draindown event, the "E" ERV was found to be open, and the ERV was subsequently closed. The Outage Manager did not reposition the gagging-device until after the "E" ERV was closed. This confirmed his visual observation that the gagging device was not hindering the movement of the pilot stem through contact with the pilot spring cover (see attached drawing).

Before the MSL "B" plug was pulled on October 19, 1999 at 1525 hours, MSL plugs "C" and "D" were pulled. Even though the MSLs are cross-tied just upstream of the inboard MSIVs, the crosstie-piping diameter is small and would preclude a rapid filling of the other MSLs. Once the MSL "B" plug was removed, the approximate 70 feet of cavity water head pressure seen at the ERV established an approximate 30 psi differential pressure across the ERV permitting the main seat to open. Agitation of the pilot valve permitted repositioning of the stem and allowed ERV closure.

The inadvertent opening of the ERV was caused by failure of the ERV pilot valve to reseat after being cycled for a post maintenance testing. The probable cause for the "E" ERV Pilot valve's failure to close appears to be either a mechanical defect or the intrusion of foreign material during pilot valve assembly. Following performance of a component failure analysis, a supplemental LER will be issued, incorporating any additional corrective actions.

- The "E" ERV pilot assembly was replaced. The station has quarantined the removed component for performance of a component failure analysis. (Complete)
- Following performance of a formal component failure analysis, a supplemental LER will be submitted including a review of the Post Maintenance Testing (PMT) process, system readiness and work request package control, incorporating any additional corrective actions.
- (ATI# 18034)
