NRC FORM 464 Part I U.S. NUCLEAR REGULATORY COMMISSION	FOIA/PA	RESPONSE NUMBER
(6-1998)	2000-0171	· 1
	2000-017 1	1
		PARTIAL

ALLEGATION SUMMARY

CONCERN ABOUT PUBLIC EXPOSURE TO DEPLETED URANIUM MUNITIONS

Depleted Uranium (DU) Penetrators Vieques Naval Target Range, Live Impact Area Vieques, Puerto Rico

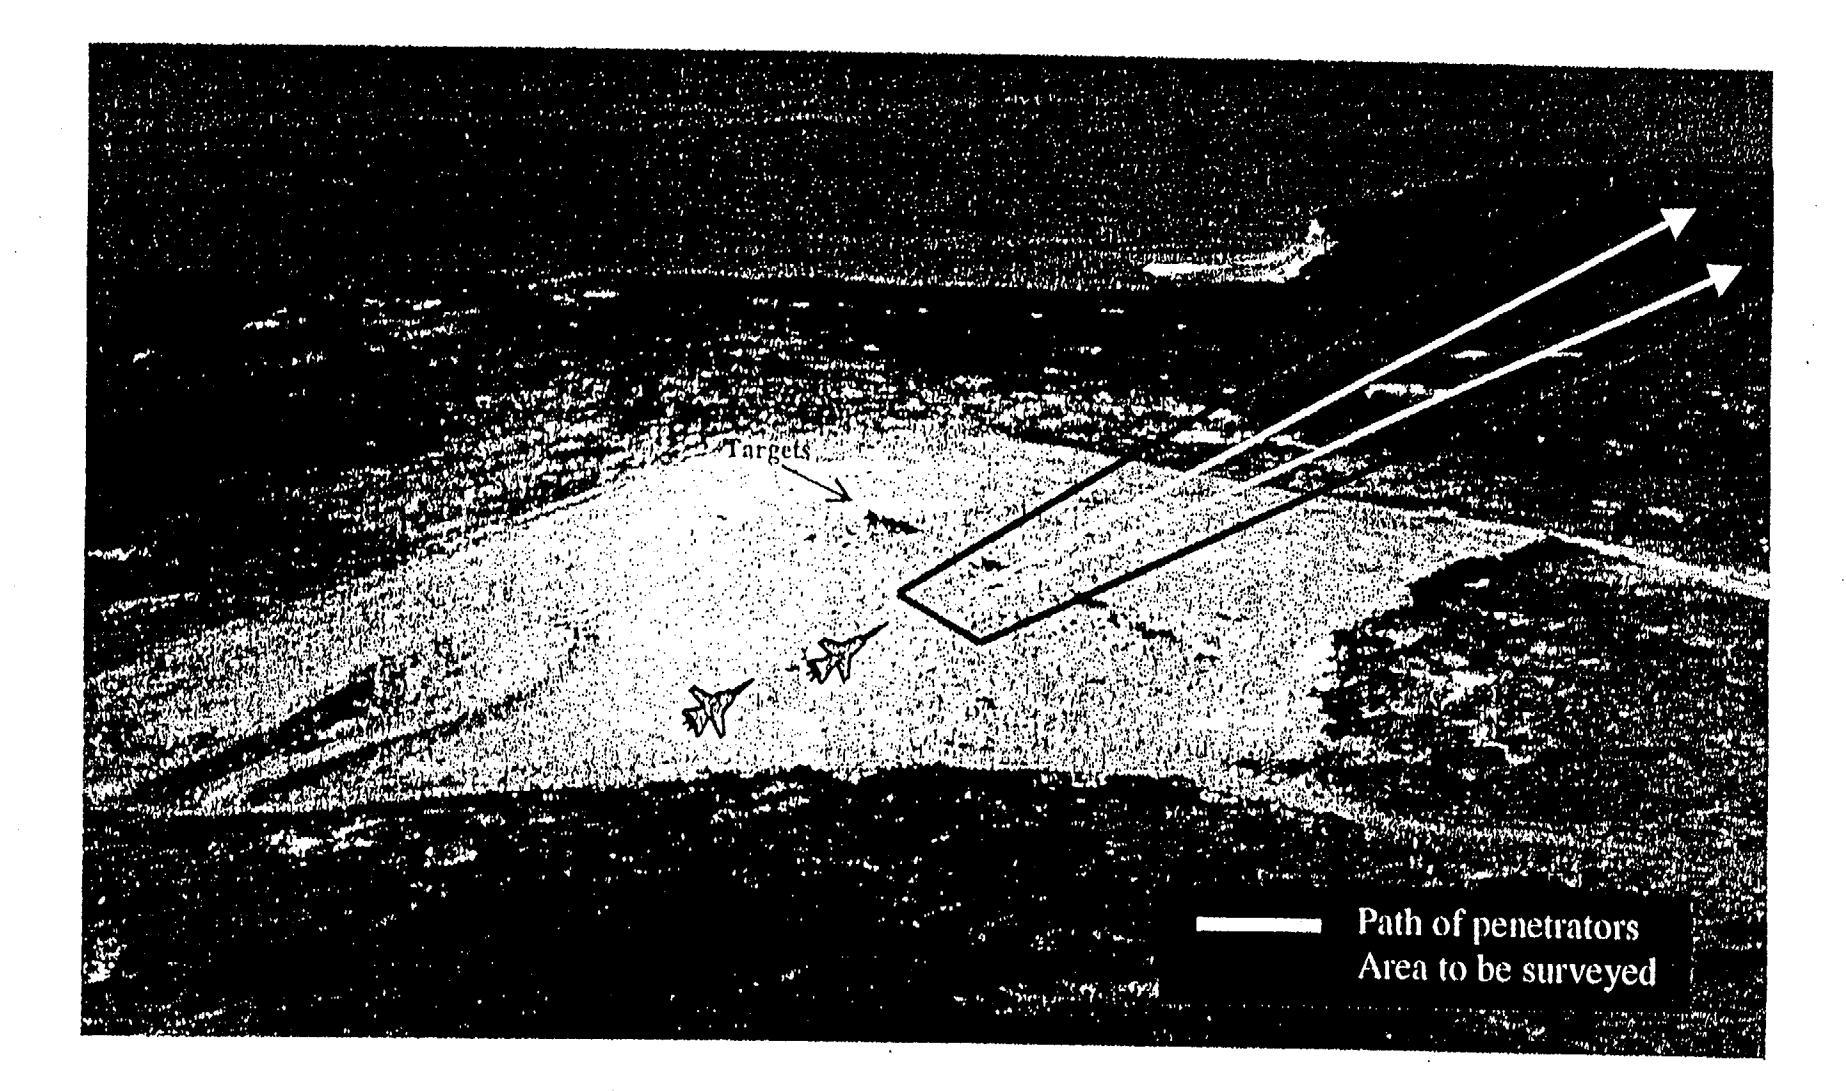
The team recovered a total of 57 DU penetrators, most of them completely intact. Due to the low trajectory of the Harriers, although several penetrators were located near the targets, the majority of penetrators were located north of the targets within the brush. Penetrators were located approximately 10 to 20 feet apart. About 20% of the penetrators recovered were located on the surface, the rest were buried in the soil at an average depth of 6-8 inches (see Figures 4). One penetrator was buried up to 18 inches in very loose soil. Only a few holes exhibited residual contamination after the penetrator was removed. In each of these cases, part of the penetrator had fractured into smaller pieces.

Figure 4. DU penetrators previously located on the North Convoy Site.

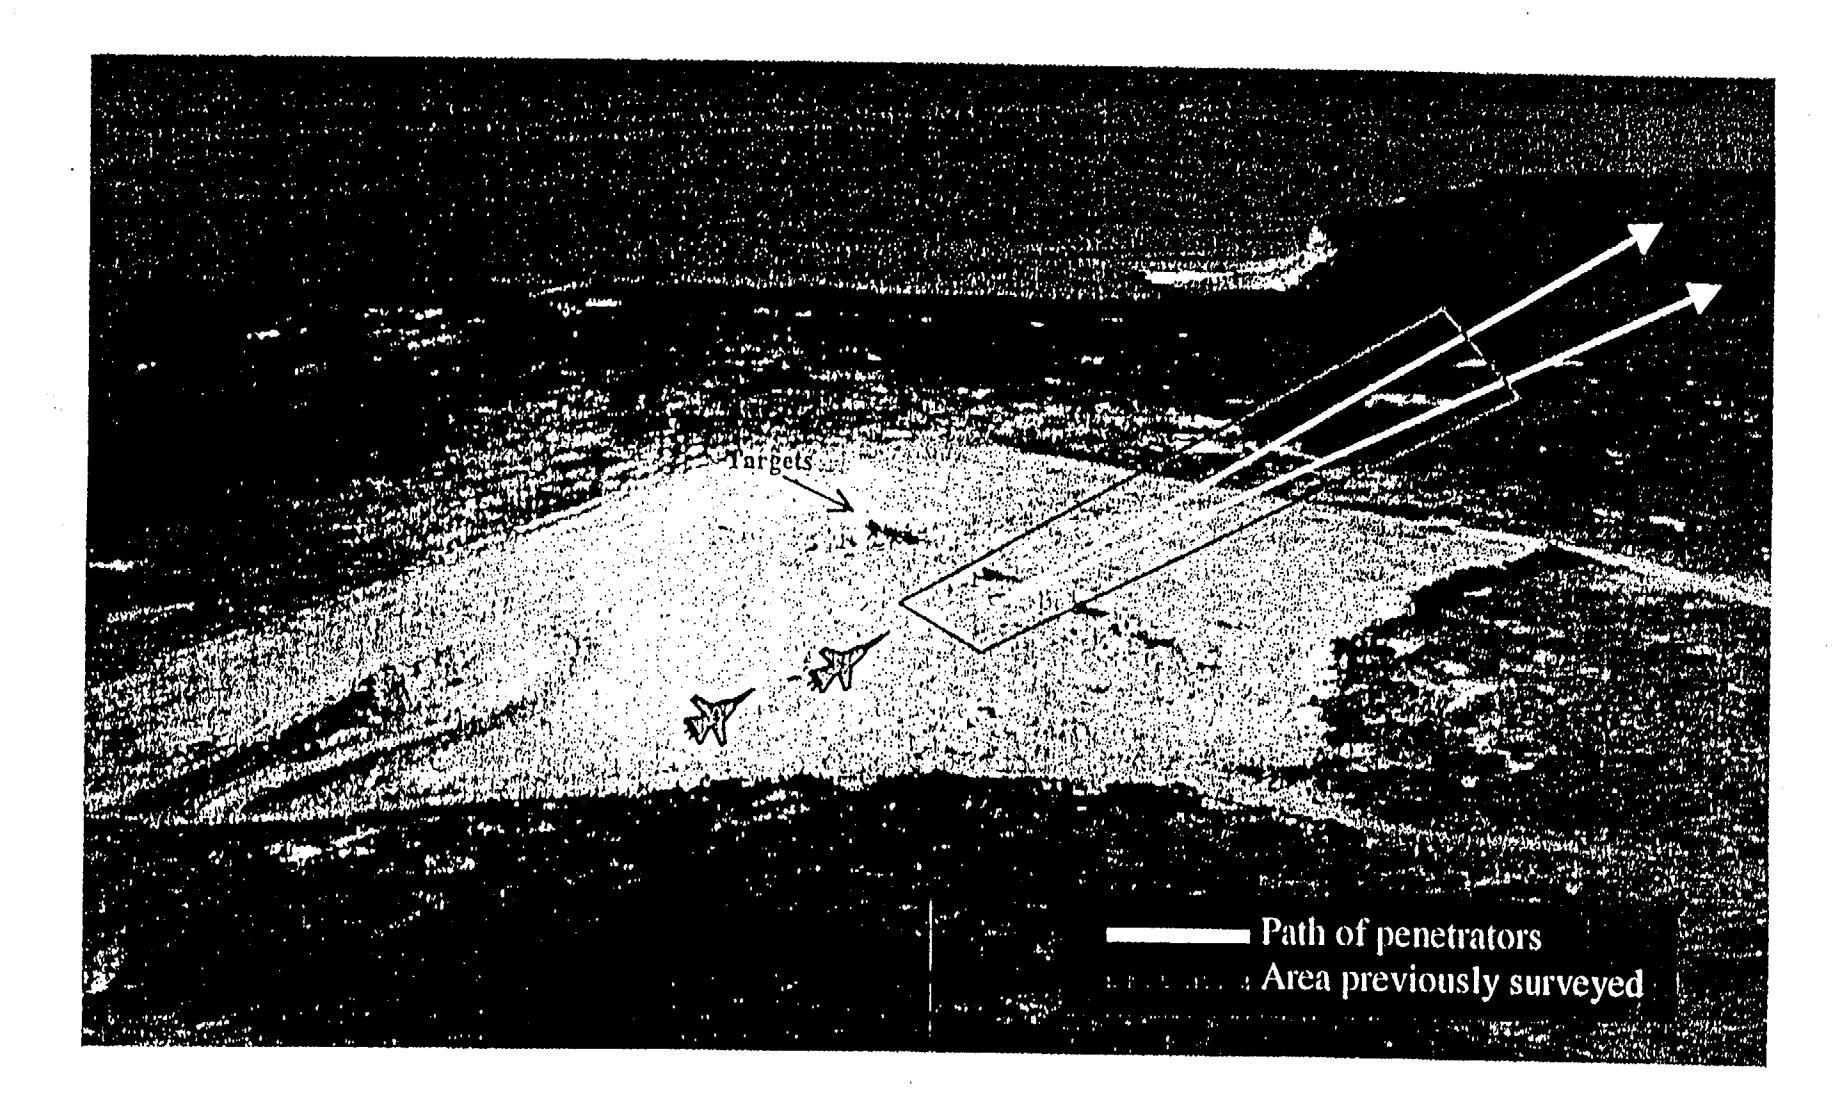
A radiological scan survey of the North Convoy Site, out to the perimeter of the brush, was conducted using a 2 inch by 2 inch sodium iodide detector following the recovery of all penetrators. No additional penetrators or residual contamination were noted as a result of the radiological survey. Due to the dense vegetation and the possibility of hidden unexploded ordnance (UXO), detailed surveys were limited to the immediate vicinity of the cleared area of the North Convoy Site.

Figure 5. Area of North Convoy Site Previously Surveyed.

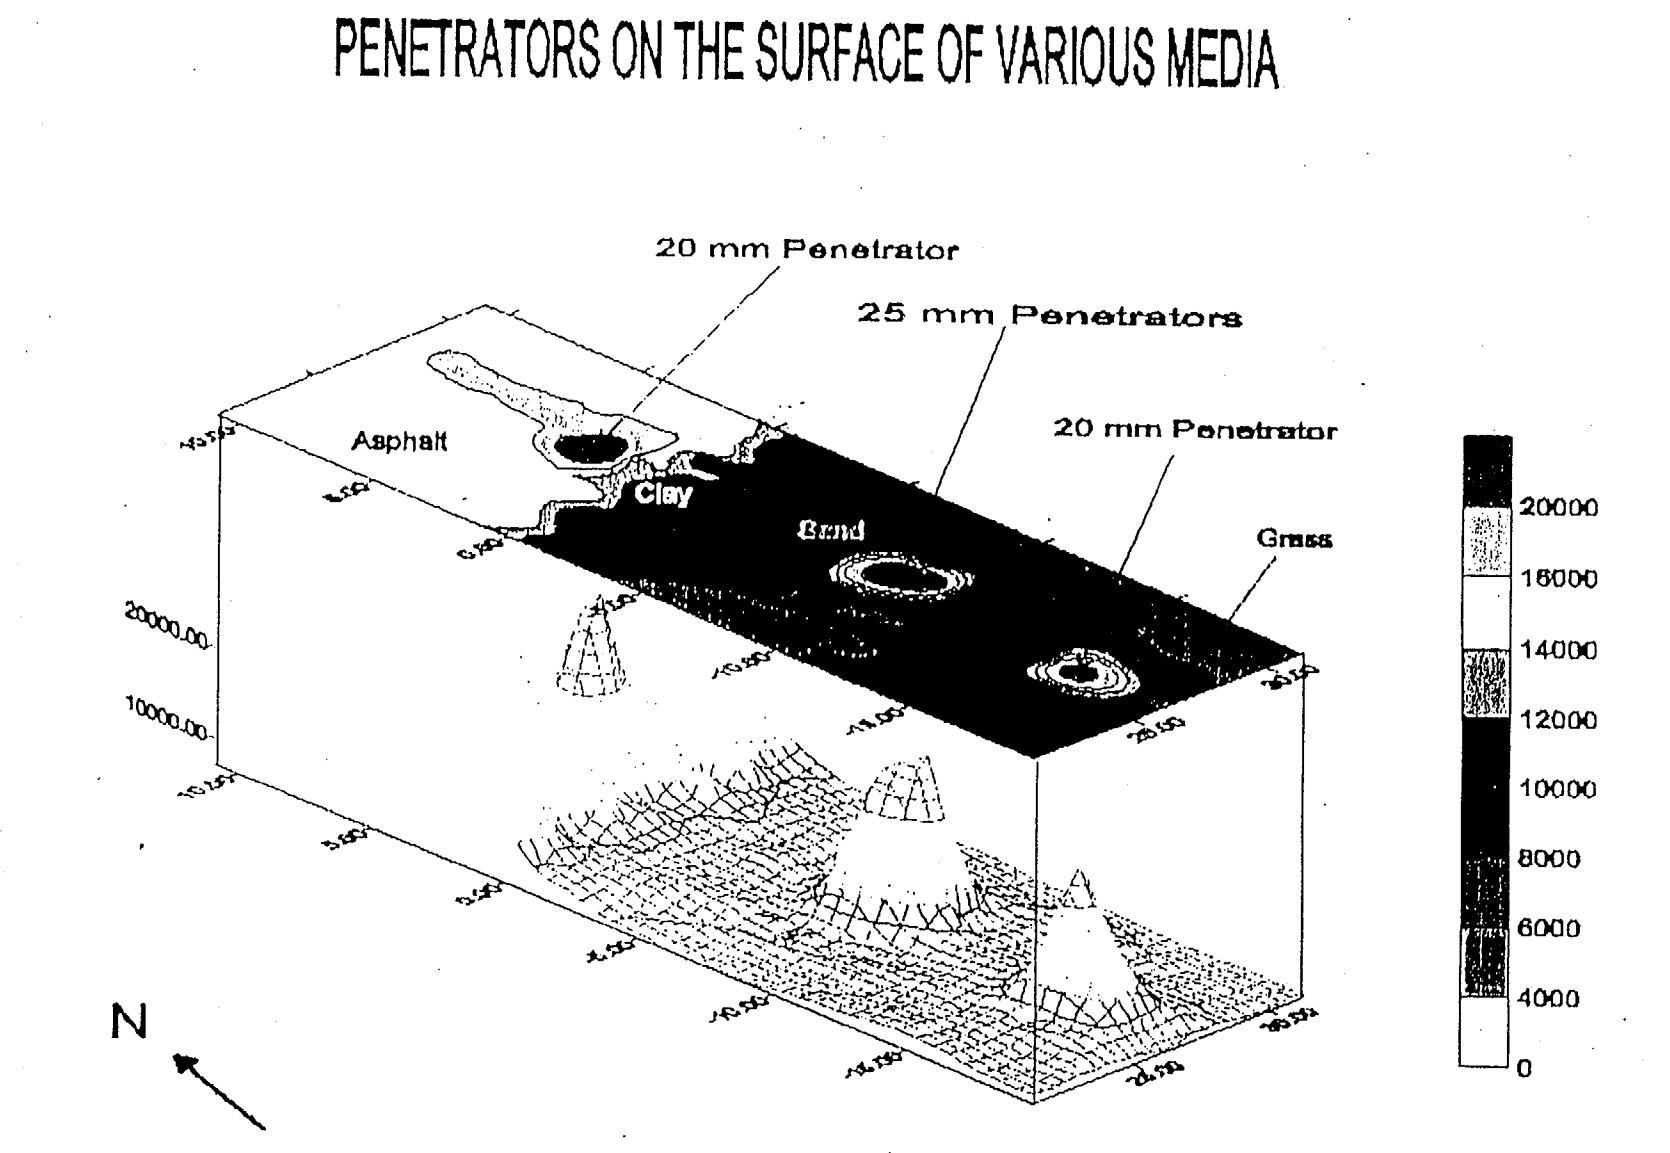
Figure 8. Stack Map Used to Analyze Scan Survey Data.
