NUREG/CR-5699
ORNL-6666/V1
Vol. 1

Aging and Service Wear of Control Rod Drive Mechanisms for BWR Nuclear Plants

Oak Ridge National Laboratory

Prepared for
U.S. Nuclear Regulatory Commission

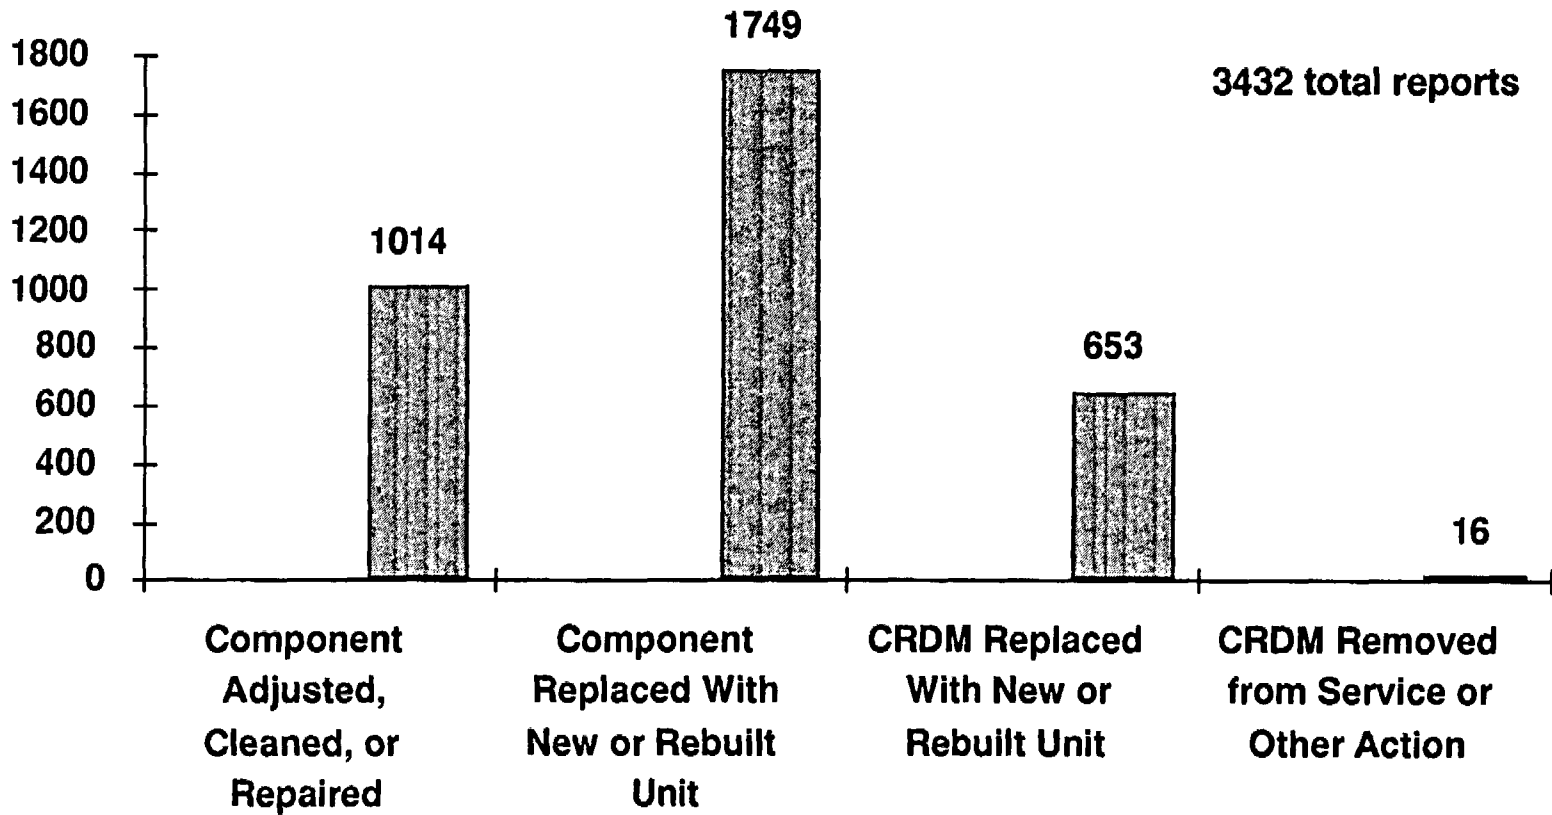
Figure 3.3 Comparison of utilities' corrective actions to reported CRD system failures.

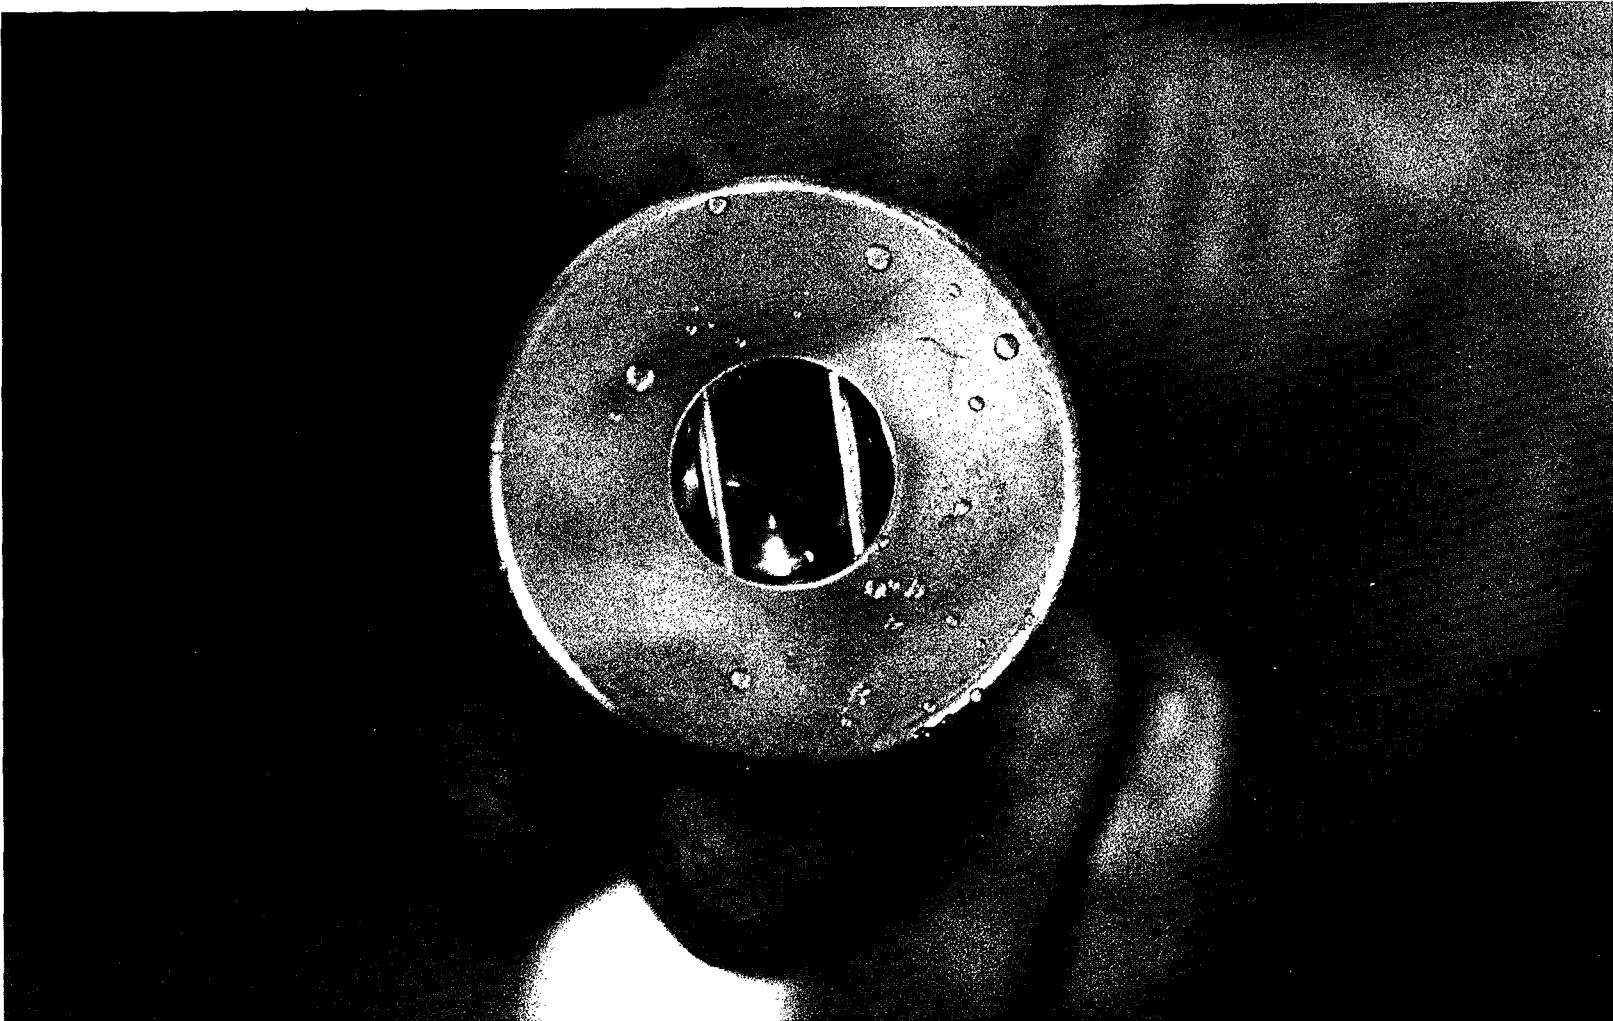
Figure 3.8 Spring clip mechanism on CRDM inner filter.

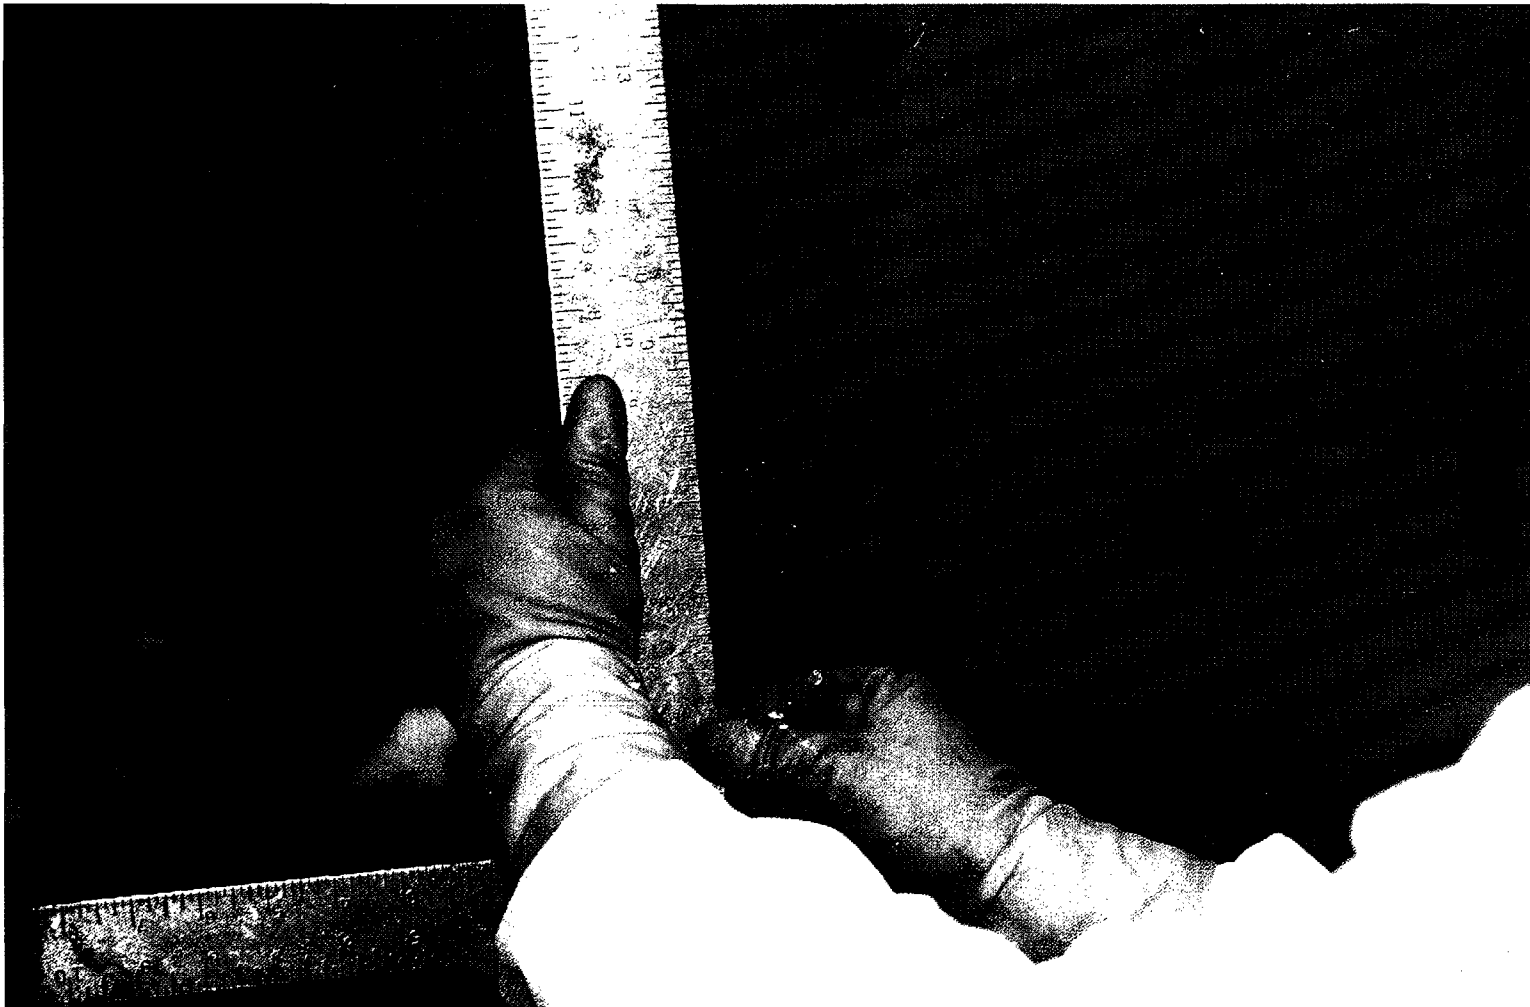
Figure 3.9 Bent CRDM uncoupling rod.

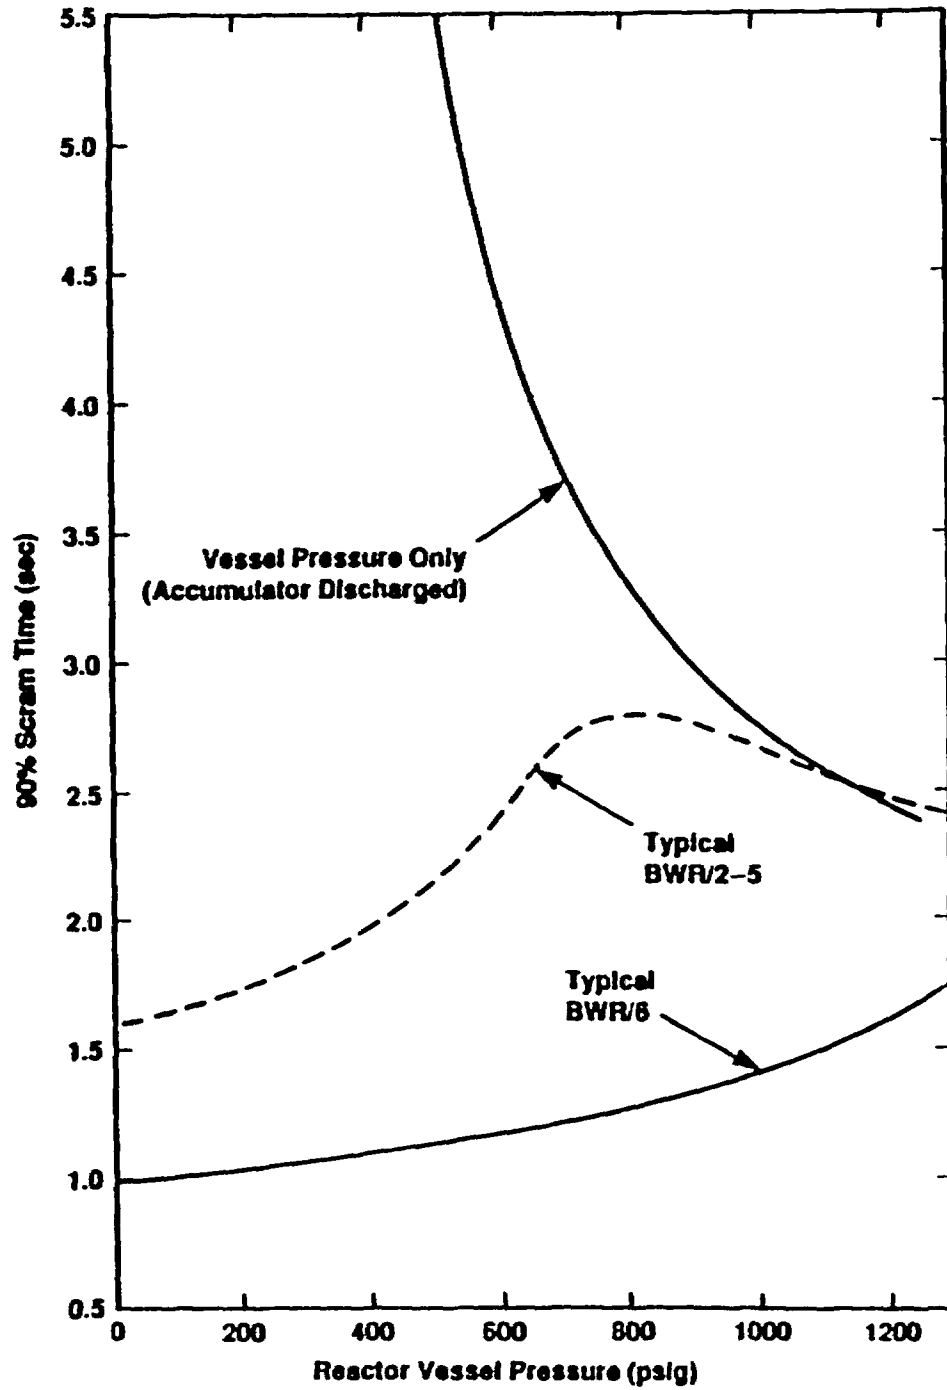
Figure 4.3 BWR CRDM scram times.

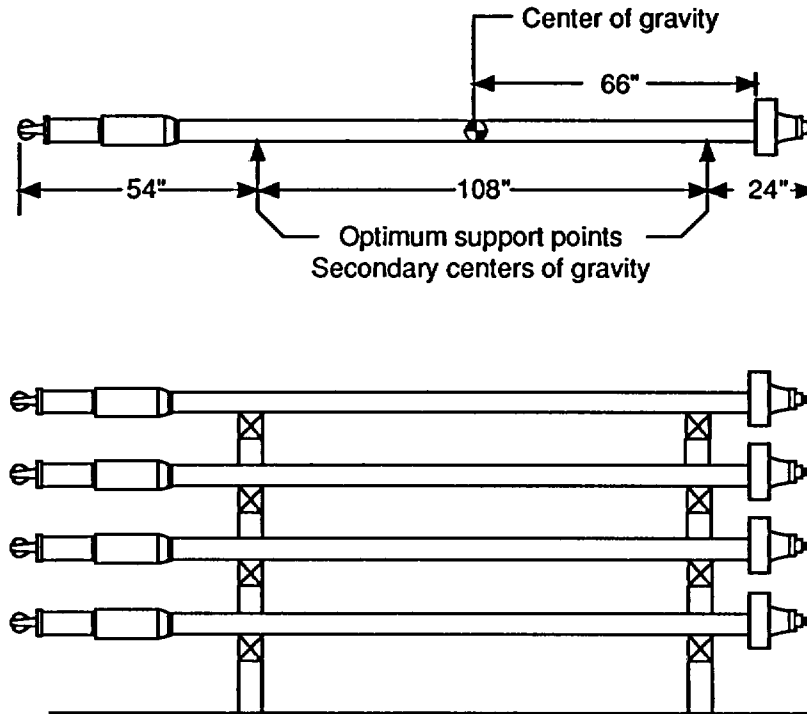
Figure 4.10 Optimum storage arrangement for CRDMs.¹⁹

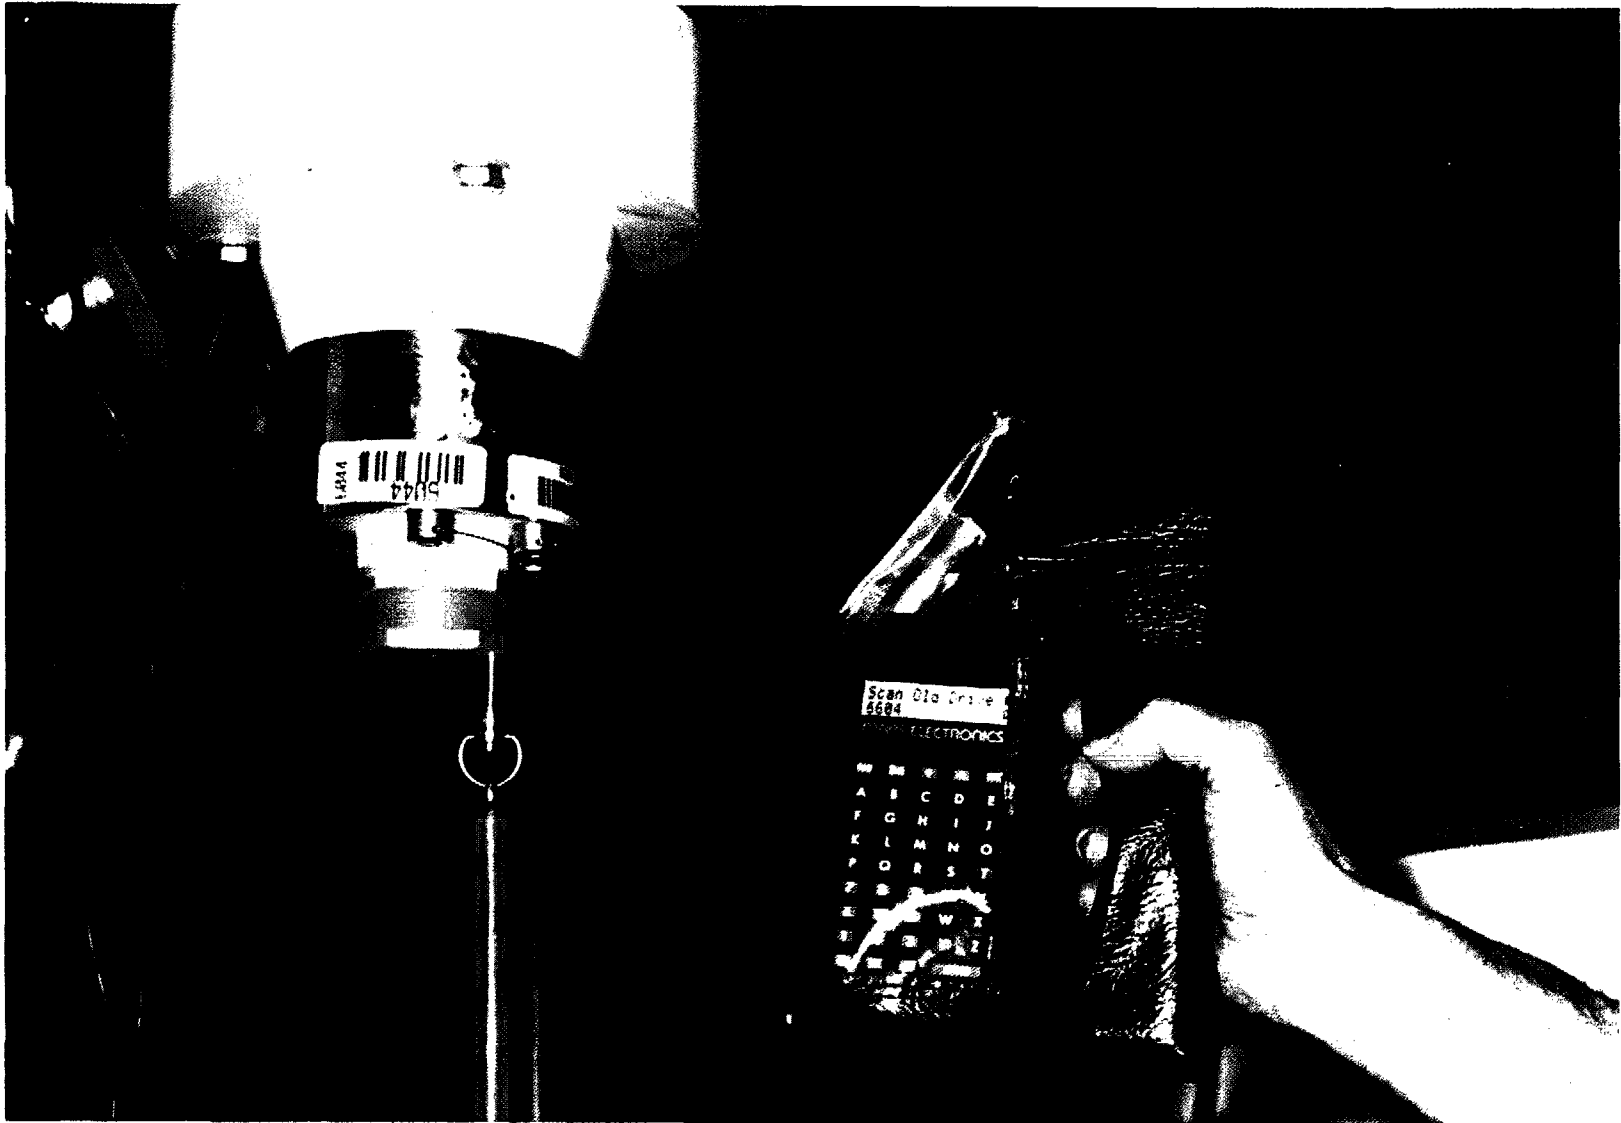
Figure 4.26 Barcode scanning system for quick identification of CRDMs.
