Traveller Safety Analysis Report**TABLE OF CONTENTS**

3 THERMAL EVALUATION

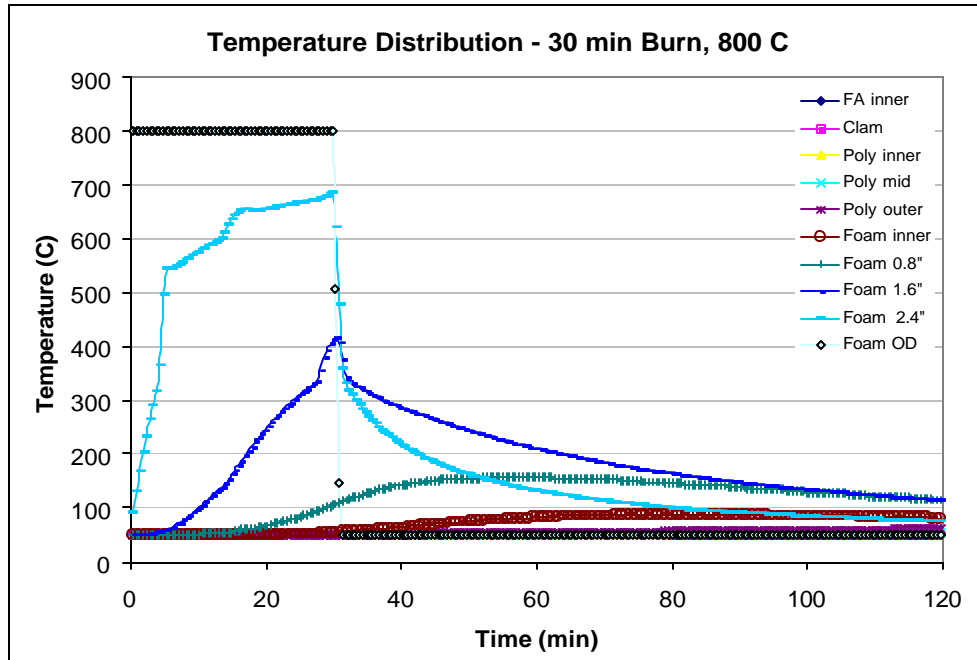
Figure 3-1 Calculated Radial Temperature Distribution for 30 Minute Fire (800°C)

The analysis results show that the outer skin of the package quickly rises to thermal equilibrium with the fire. The internal components heat up more slowly due to the insulation capability of the polyurethane foam between the inner and outer shell of the Outerpack. Fuel and Clamshell temperatures increase by approximately 50°C and are well within acceptable levels, see Figure 3-1 and Figure 3-2. This analysis is described in greater detail in appendix 3.6.1.

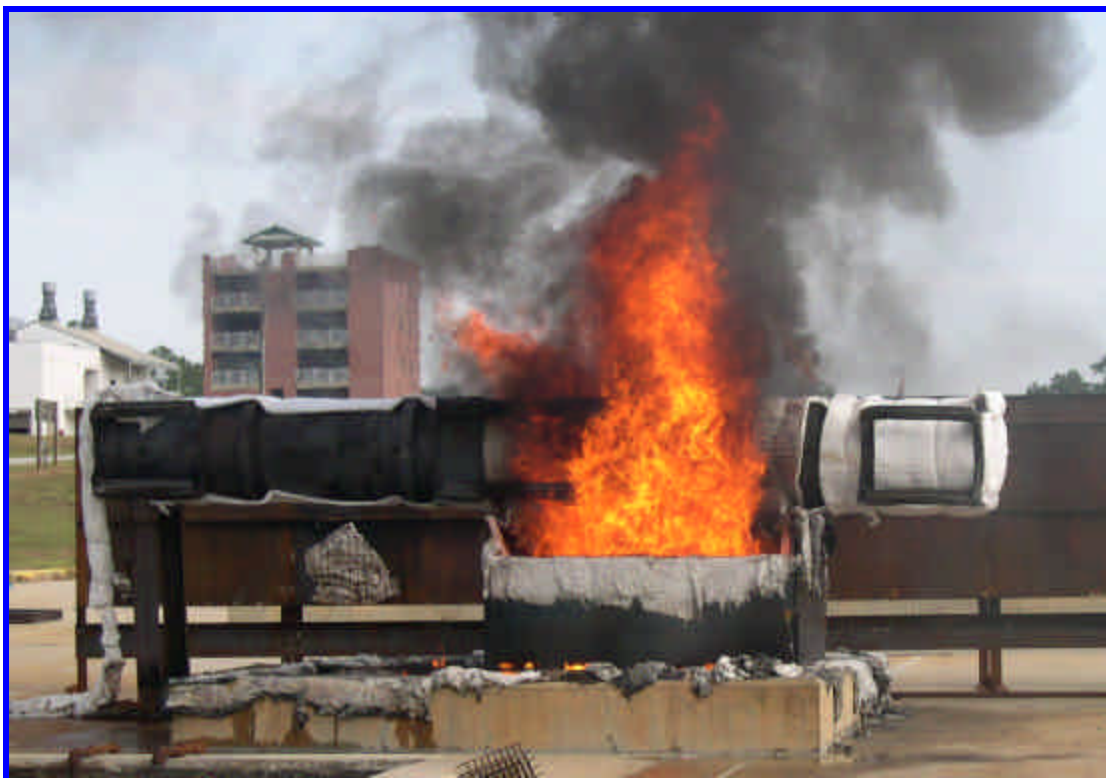
Figure 3-3 Seam Burn Test

The first burn was of the control section. During the 30 minute burn, internal temperatures rose within the test section throughout the test due to the gap deliberately left in the seam between Outerpack base and lid. Peak internal temperatures over 500°C were observed, Figure 3-3.

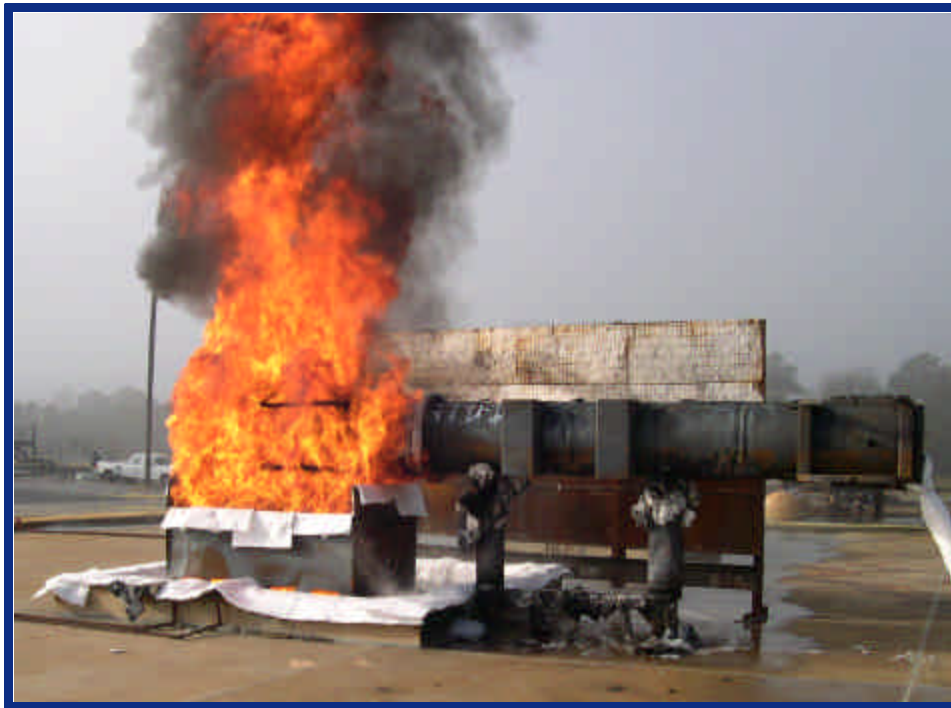
Figure 3-4 December 15, Impact Limiter Burn Test

package. The test unit was mounted over the small weir built for the seam burn tests and burned for 40 minutes, Figure 3-4. Because the ambient temperature dropped below freezing during the night, initial temperatures inside the package started the test at approximately 0°C. Temperatures within the impact limiter pillow climbed to between 70 and 95°C depending on location during and after the burn test. Temperatures within the Outerpack interior cavity varied from 50 to 320°C. The only temperature measurements above 200°C were at locations near the outside skin of the Outerpack and well away from the moderator or impact limiter pillow.

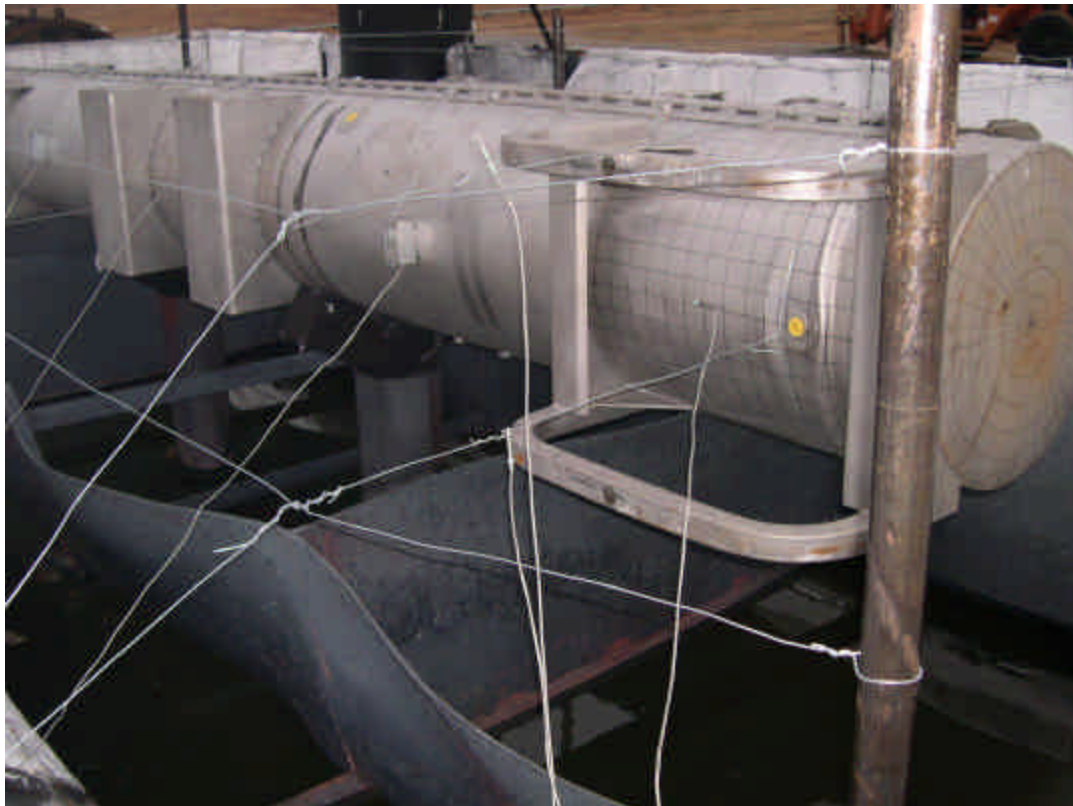
Figure 3-5 Pool Fire Test Facility

The testing was conducted on a calm day. To further minimize the impact of winds, the burn pool was surrounded with an insulated steel diffuser that extended to the top of the package and expanded the effective fire area. The maximum distance between the package and the diffuser was less than the 3 meters maximum proscribed distance, Figures 3-5 and 3-6.

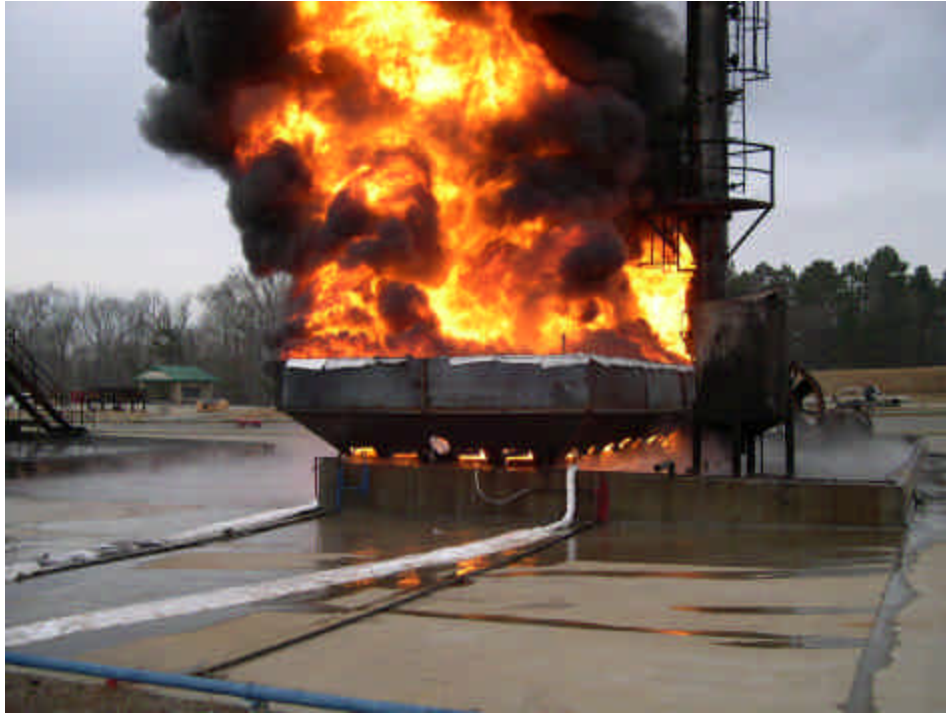
Figure 3-6 Traveller CTU During Pool Fire Test

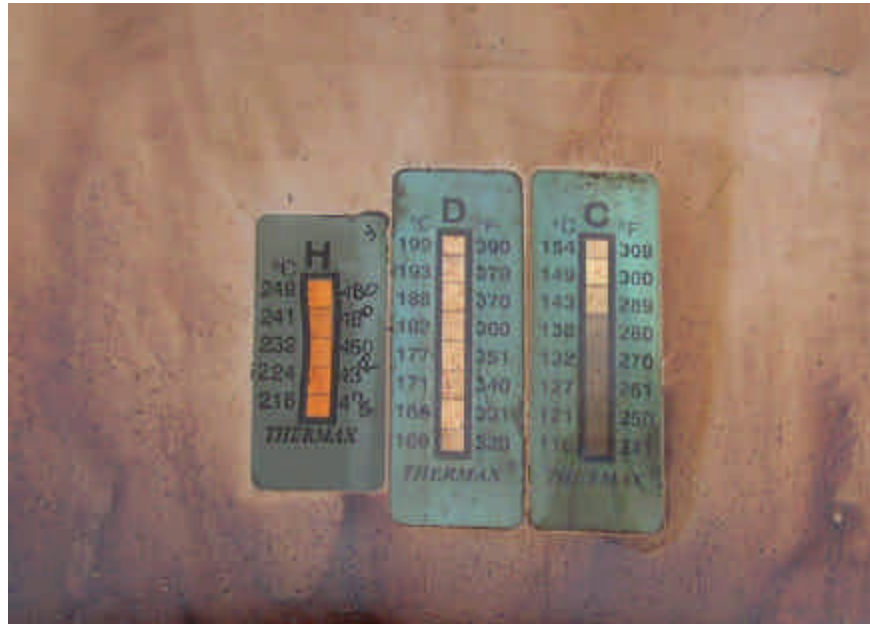
Figure 3-8 Temperature Strip Condition After CTU Burn Test

Temperatures were measured on the CTU Outerpack outer skin using six type K thermocouples, attached by screws. These thermocouples were located as shown in Figure 3-7 above. The 30 minute average temperature measured by these thermocouples was 904°C (1659°F). Temperatures inside the CTU Outerpack were measured using 13 sets of non-reversible temperature strips. One set on the inner stainless steel skin covering the Outerpack lid moderator was unreadable. All of the remaining temperature strips on the Outerpack lid recorded temperatures of 177°C (351°F) or below. Temperatures on the inside surface of the top and bottom impact limiters were 116 (241°F) and 149°C (300°F) respectively. Temperatures inside the Clamshell were below 104°C (219°F). An example of the temperature strip sets attached to the Outerpack lid moderator cover sheets is shown in Figure 3-8.

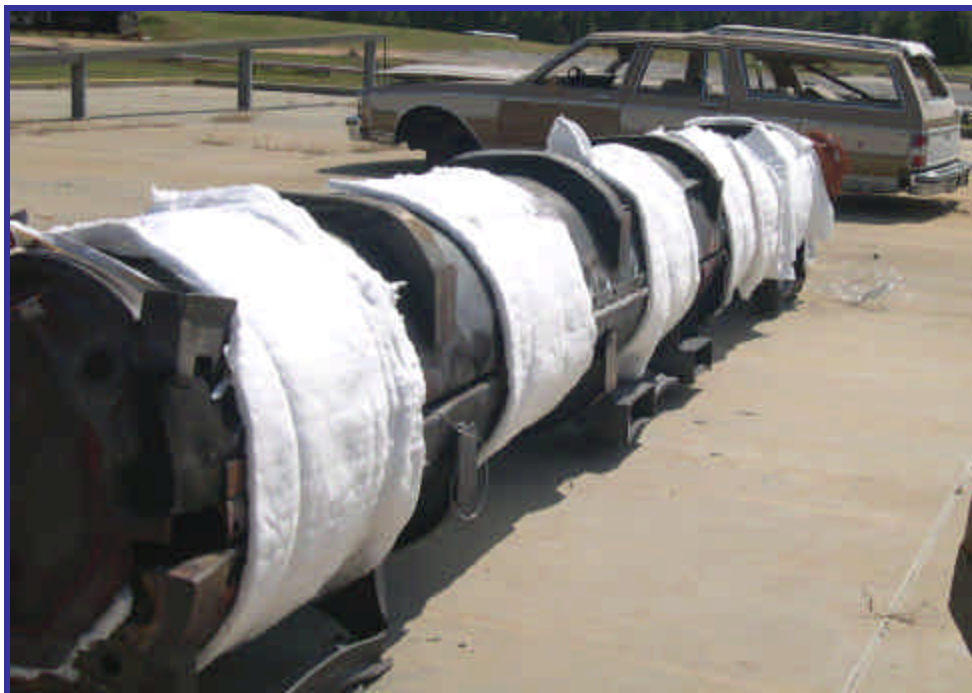
Figure 3-11 Package Exterior Wrapped with Ceramic Fiber Insulation

The test was performed as series of three burns, heating the reference or control section, the section with additional hinge to model a package with continuous hinges, and the section with stainless covering over the moderator respectively. The first burn lasted 30 minutes. The two subsequent burns lasting for 35 minutes. A small pool fire (approximately 30 x 80 inches) was be created under the region of the package to be tested, Figure 3-10. Each region was approximately 57 cm (22.4 inches) across separated from the adjacent test region by 61 cm (24 inches) of refractory *fiber felt* insulation. This insulation was stuffed between the Clamshell and the moderator to prevent air flow from the section being tested to other test regions within the prototype package. The test regions were selected based having intact moderator left from previous tests. The test section with stainless steel cover over the moderator was selected based on the minimum distortion of the inner Outerpack shell and moderator blocks. The outside of the package was insulated on the bottom and sides using at least 2.5 cm (one inch) of refractory fiber *felt* insulation. This insulation will extend at least 1.2 m (48 inches) from each end of the test region, Figure 3-11.

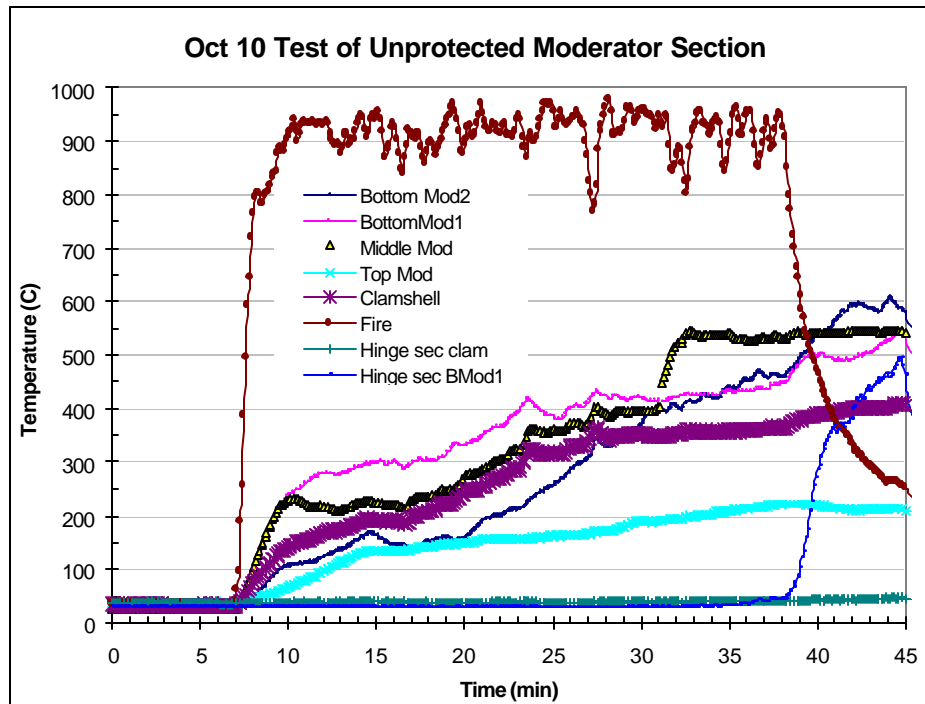
Figure 3-12 Measured Temperatures During Second Burn of the Control Section

The burn of the control section was then repeated on October 6. The new weir confined the fire to the test section and temperatures rose within the test section throughout the test, Figure 3-12. After the pool fire was extinguished, burning polyurethane was observed along the top seam of the package and at the bottom seam of the test section. This was extinguished after approximately 10 minutes and the package was opened. Significant moderator was lost.

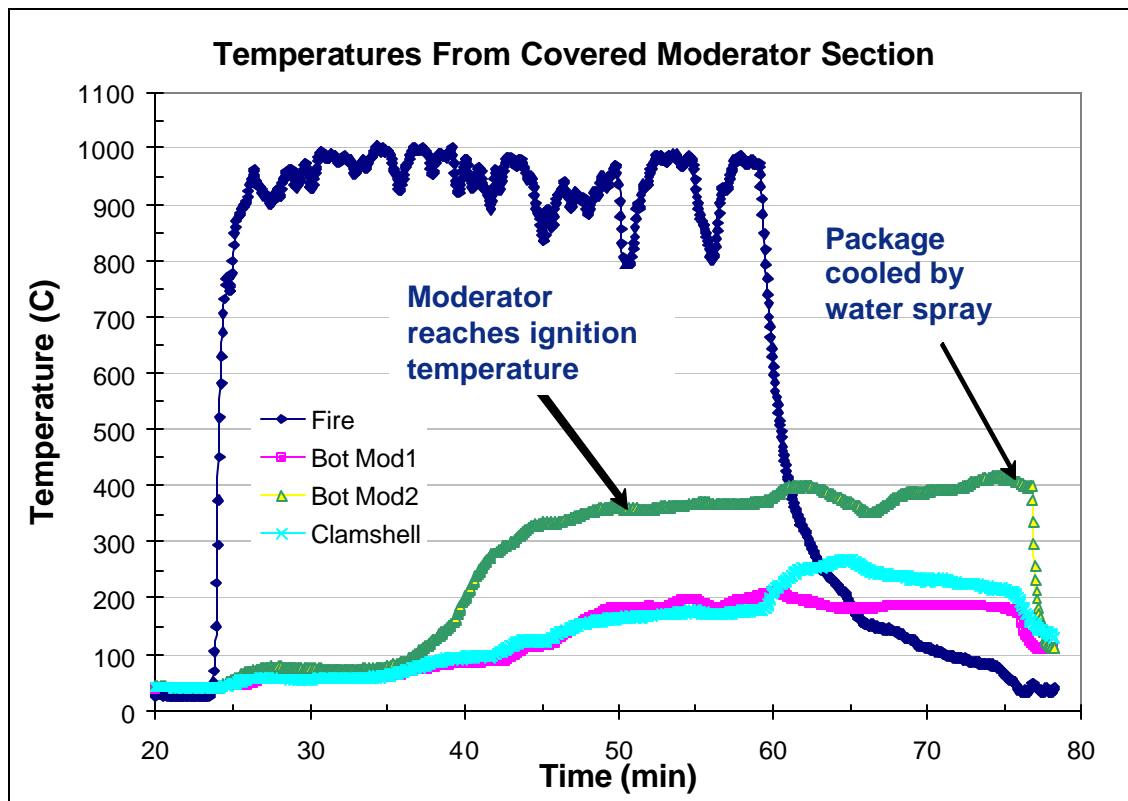
Figure 3-15 Interior Temperature Measurements During Test of Covered Moderator Section

The package was then moved on the test stand and positioned with the third test section, the covered moderator, over the burn weir. This section was burned for 35 minutes as well. The internal temperatures measured, Figure 3-15, show temperatures rose at a much higher rate than in the second test. This was expected because of the large gapes in the Outerpack seam (varying between 0.5 and 1.5 inches at the bottom seam), Figure 3-16. One thermocouple showed temperature at the bottom moderator blocks rose to above 350°C within 25 minutes after the start of the burn. After the pool fire was extinguished, some smoke was observed at the top Outerpack seam. This corresponded with an eventual rise in moderator temperature at one location after the external fire had been extinguished. After approximately 15 minutes, the package was cooled by water spray and removed from the burn pool. When opened, there was not initial sign of damage. After the stainless steel covering the moderator was removed, however, it was confirmed that small amounts of the moderator had burned.

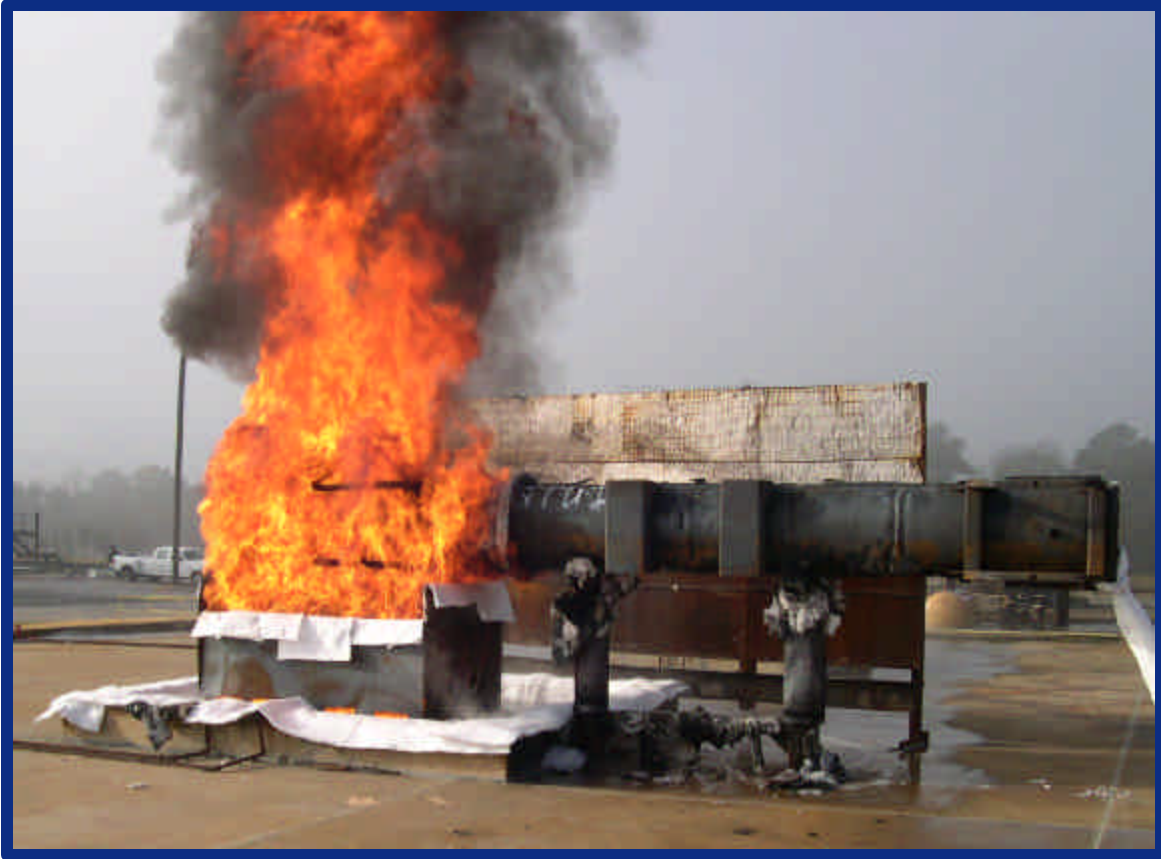
Figure 3-19 December 15, Impact Limiter Burn Test

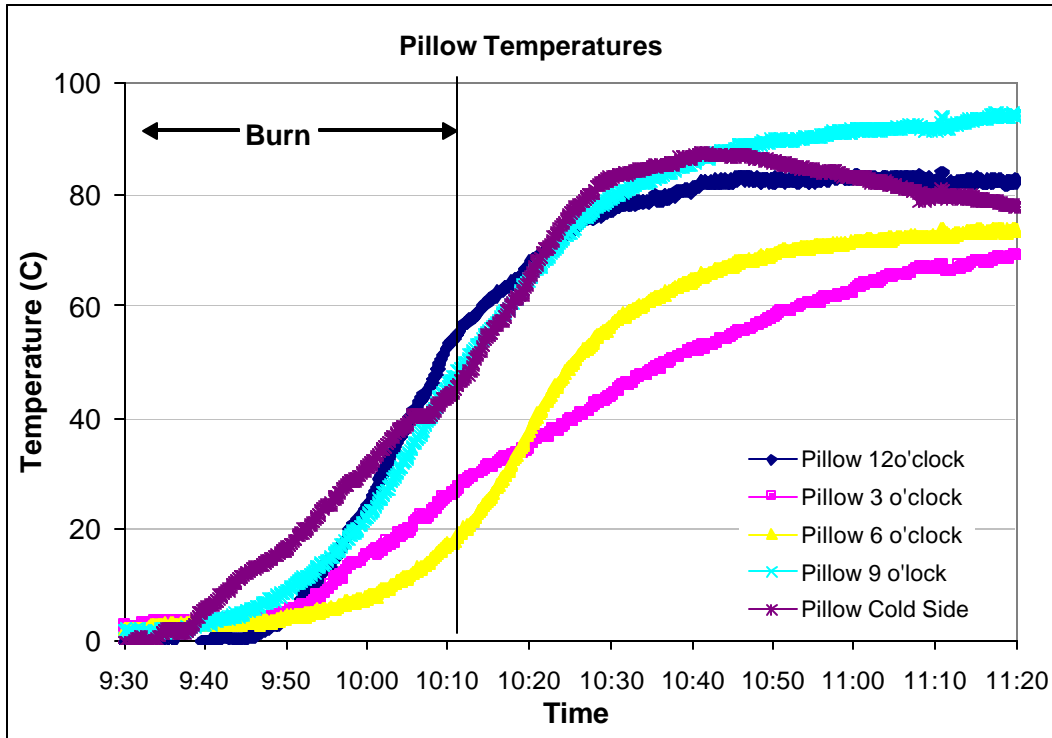
Figure 3-20 Impact Limiter Pillow Temperatures

temperatures inside the package started the test at approximately 0°C. Temperatures within the impact limiter pillow climbed to between 70 and 95°C depending on location during and after the burn test, Figure 3-20. Temperatures within the Outerpack interior cavity varied from 50 to 320°C, Figure 3-21.

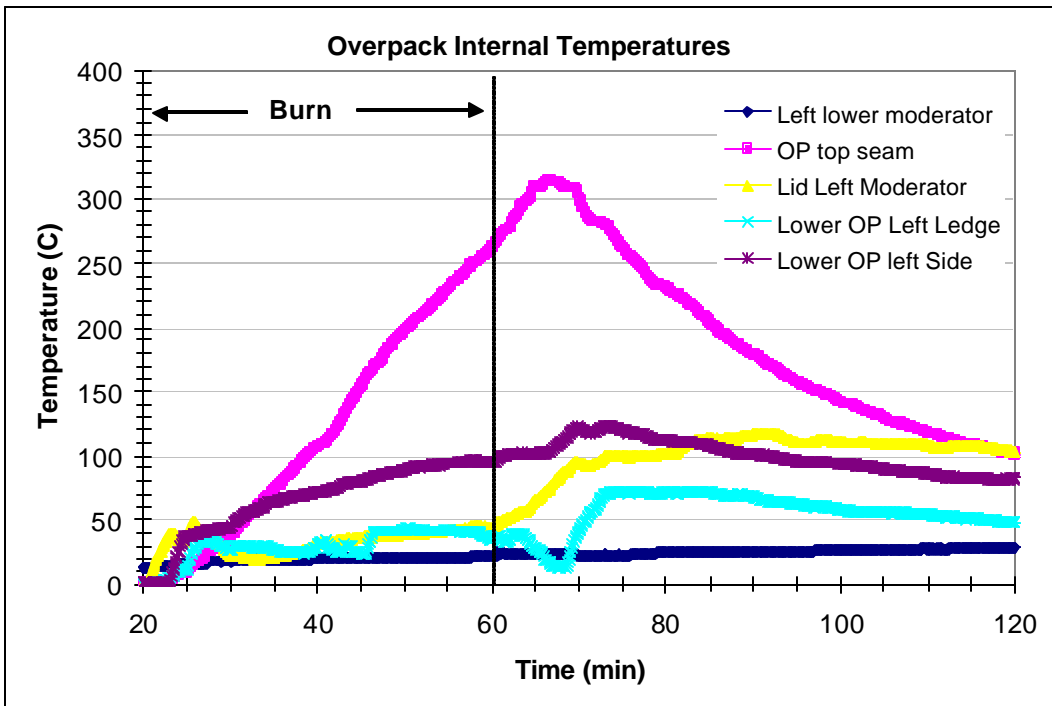
Figure 3-21 Internal Outerpack Skin Temperatures (December 15 Burn)

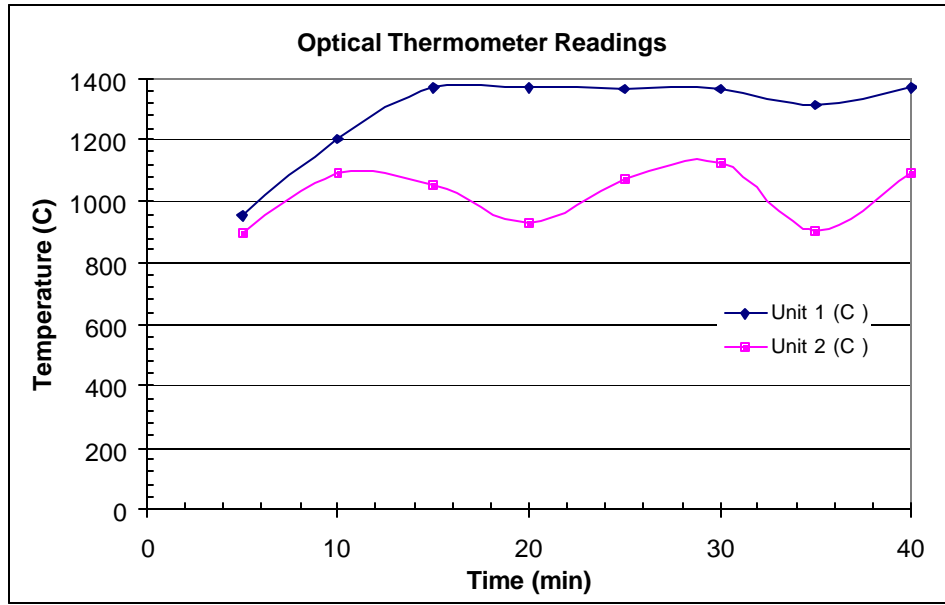
Figure 3-22 Flame Temperatures Measured by Optical Pyrometers

During this test, external temperatures were measured with two optical thermometers. Readings were taken every five minutes, Figure 3-22. After the test was completed, the Outerpack was opened. Other than a thin layer of soot lining the inside surfaces, there was no noticeable change in the Outerpack or Clamshell, Figure 3-23.

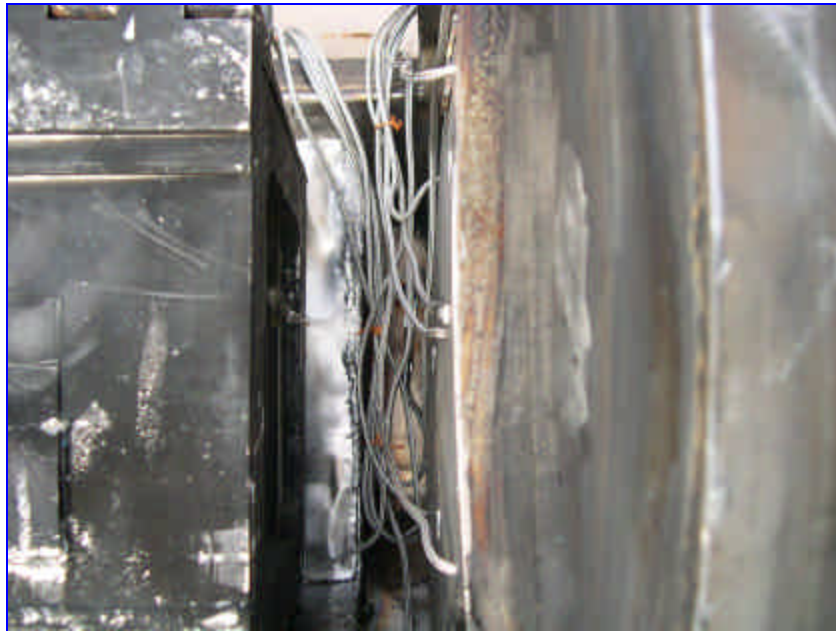
Figure 3-23 Outerpack Internals after December 15 Burn Test

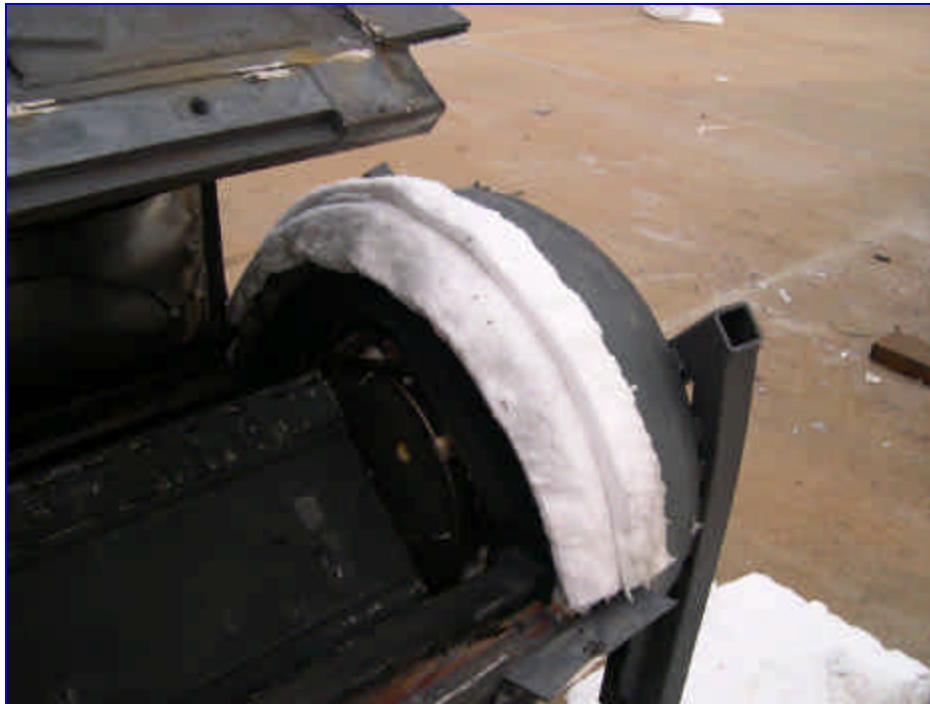
Figure 3-24 Kaowool Layers on Outerpack Bottom Impact Limiter

The relatively high temperature observed at the Outerpack top seam led to questions of heat transfer. Was hot gas entering past the lip on the Outerpack door, or was the temperatures the result of heat conduction through the metal of the impact limiter bulkhead. The impact limiter burn test was therefore repeated but with Kaowool insulation stuffed into the Outerpack upper seam to prevent hot gasses from entering the package from that location, Figure 3-24. This burn lasted for 30 minutes, Figure 3-25. This test was performed in the late afternoon, so the initial temperatures inside the package were higher than the previous day. Temperatures within the Outerpack interior cavity varied from 80 to 340°C, Figure 3-26. Temperatures within the impact limiter pillow climbed to between 70 and 95°C depending on location during and after the burn test, Figure 3-27. The Outerpack top seam temperature rose to the same levels with insulation stuffed into the seam, demonstrating that the primary heat transport mechanism in this region is conduction.

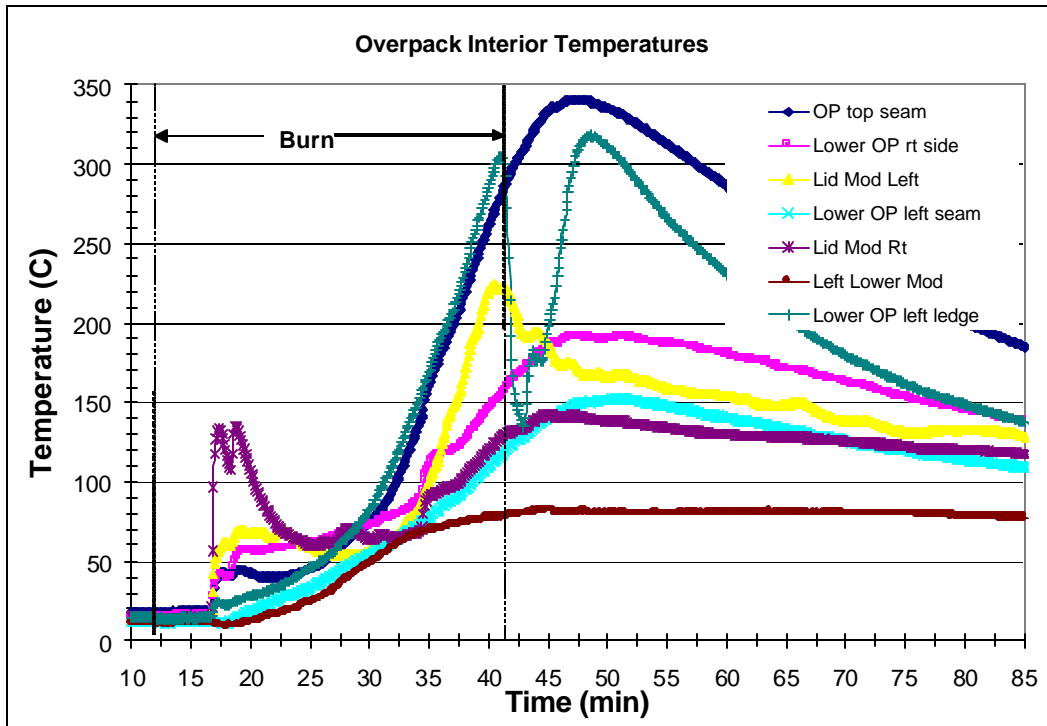
Figure 3-26 Internal Outerpack Skin Temperatures (December 16 Burn)

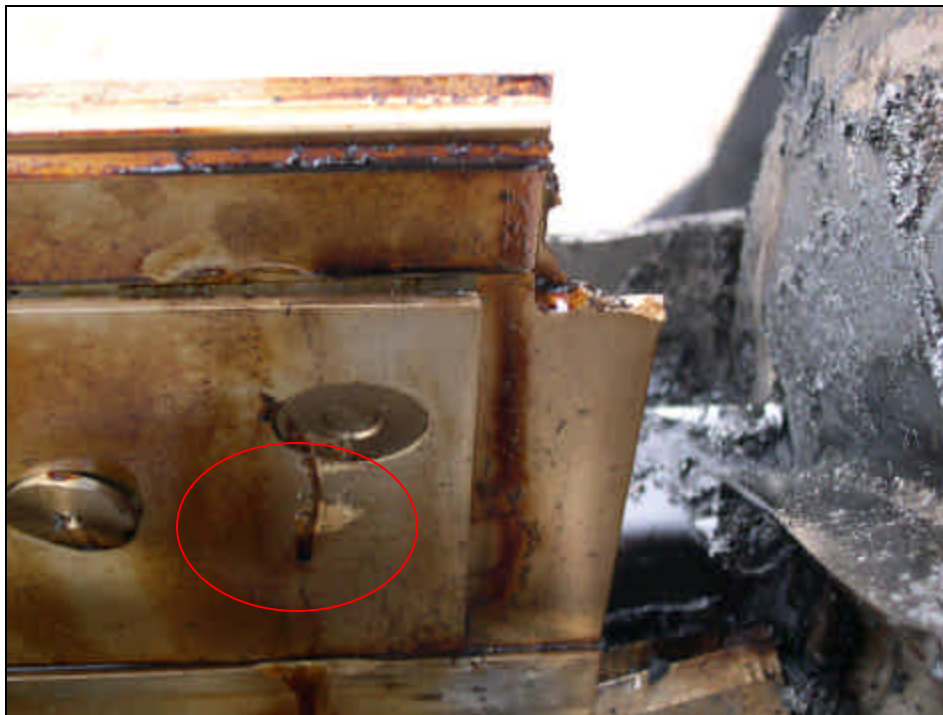
Figure 3-31 Brown Polyurethane Residue Inside Outerpack After Burn Test

After the pool fire was extinguished, the package was removed from the pool and allowed to cool. Small amounts of smoke were observed to be coming from the package seams. The package was opened and the interior was examined. Significant amounts of polyurethane intumescence residue were observed along the Outerpack seam. Figure 3-30, and brown tar from the polyurethane was observed inside the package, Figure 3-31. Internal temperature strips recorded peak temperatures under 150°C throughout the package with one possible exception. Approximately 2 m (6 ft) from the bottom of the package, one set of temperature strips was unreadable due to heating and urethane deposits. An examination of the fuel assembly and the moderator blocks showed no significant heat damage.

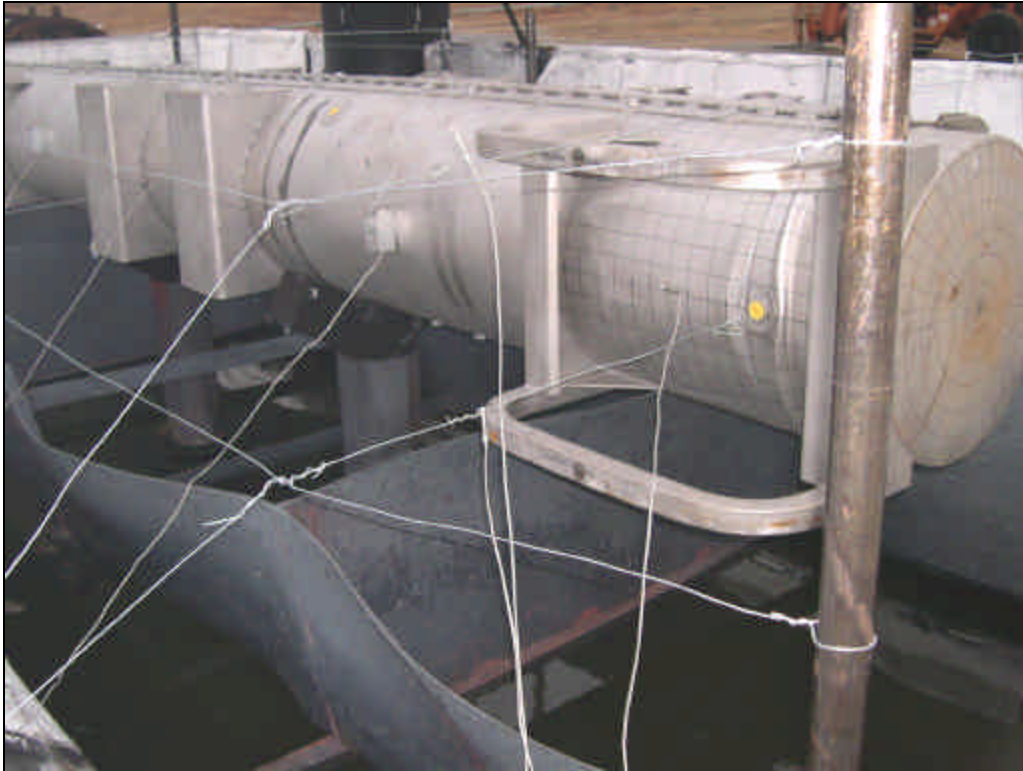
Figure 3-32 Test Stand for Fire Test

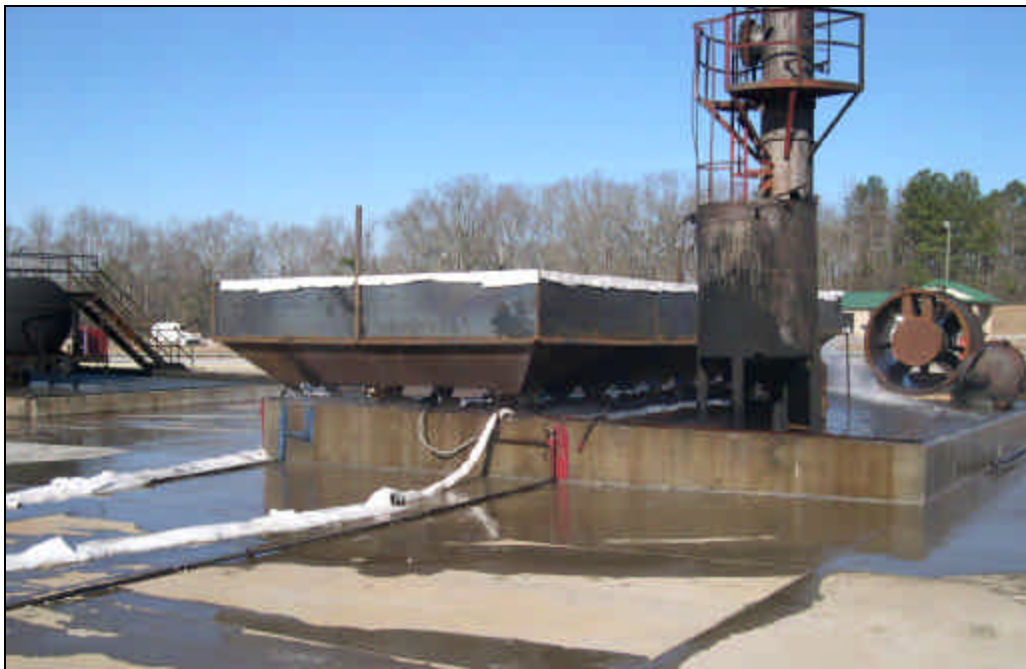
Figure 3-33 Test Setup with Steel Diffuser Plates

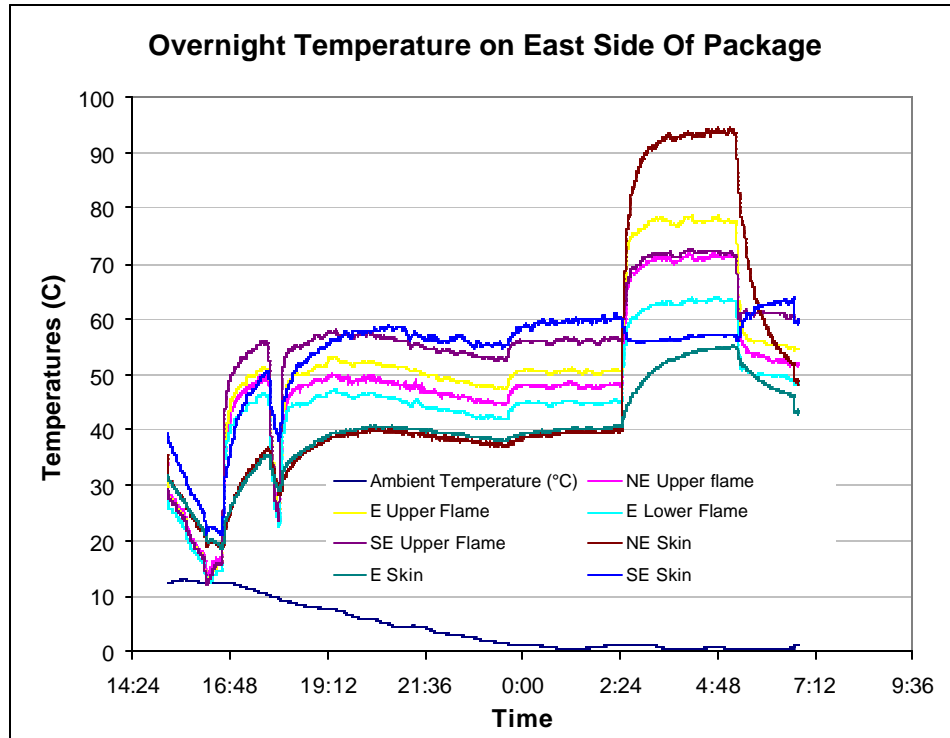
Figure 3-35 Overnight Temperatures on East Side of Test Article

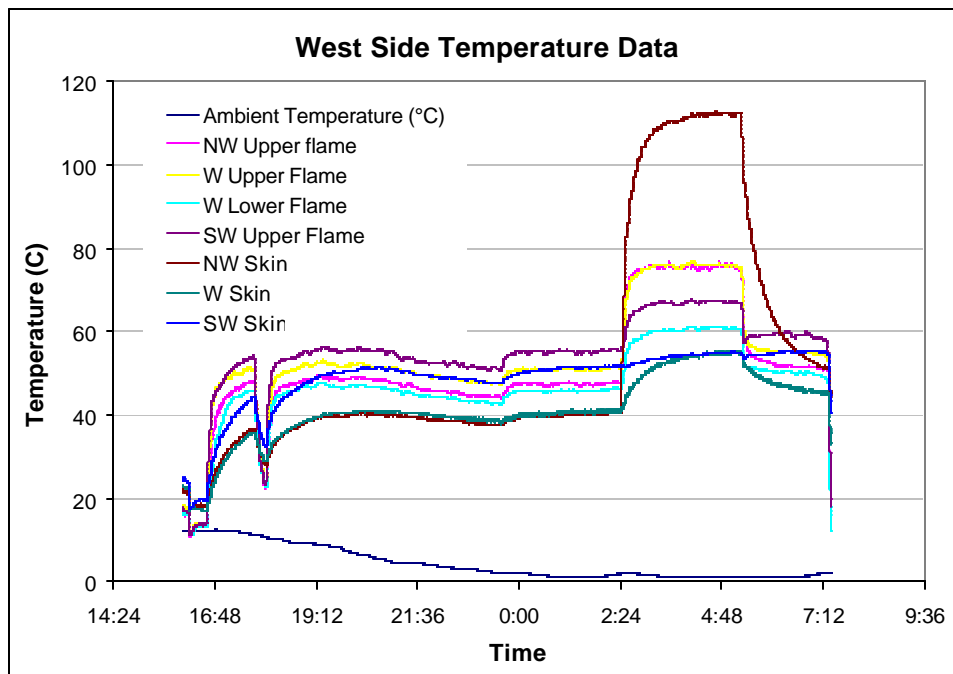
Figure 3-36 Overnight Temperatures on West Side of Test Article

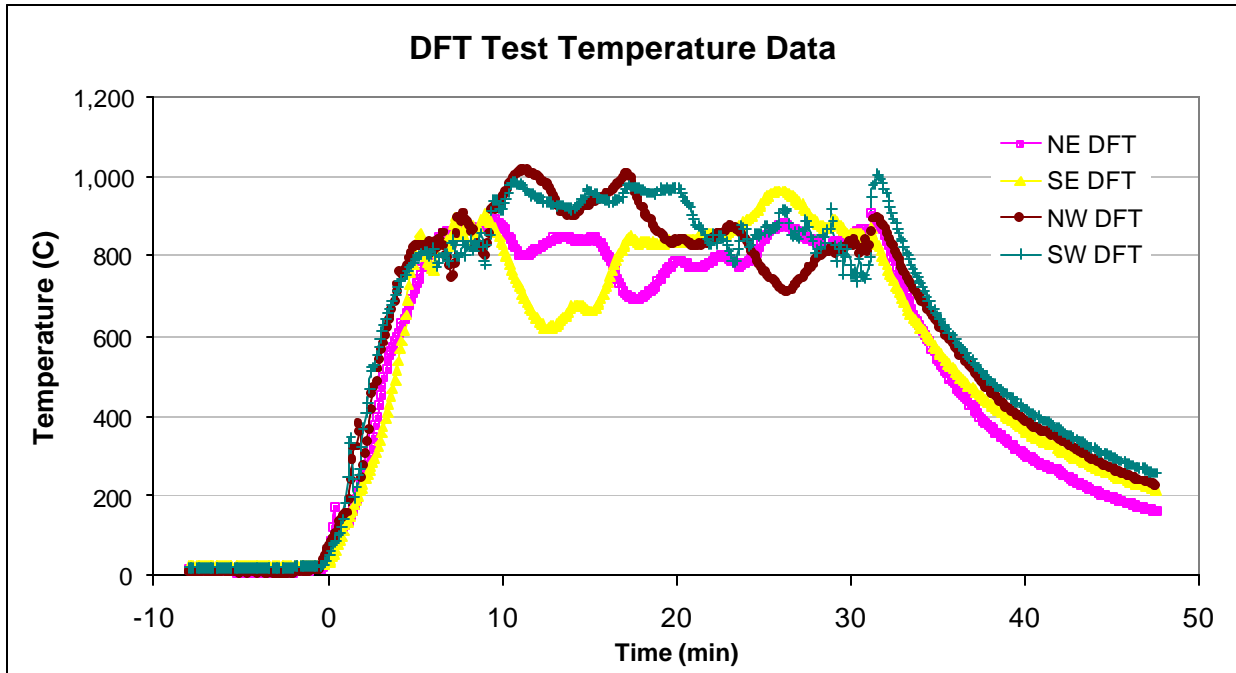
Figure 3-38 Data from Direction Flame Thermometers (DFTs)

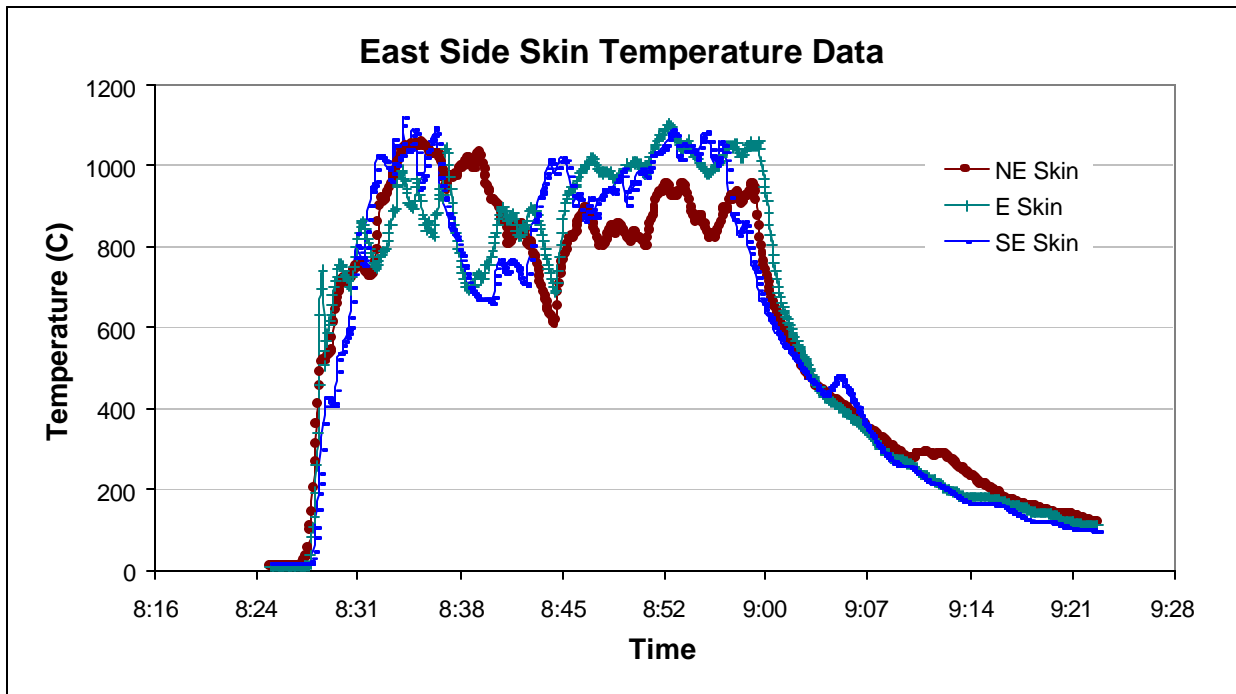
Figure 3-39 Skin Temperature Data from East Side of CTU

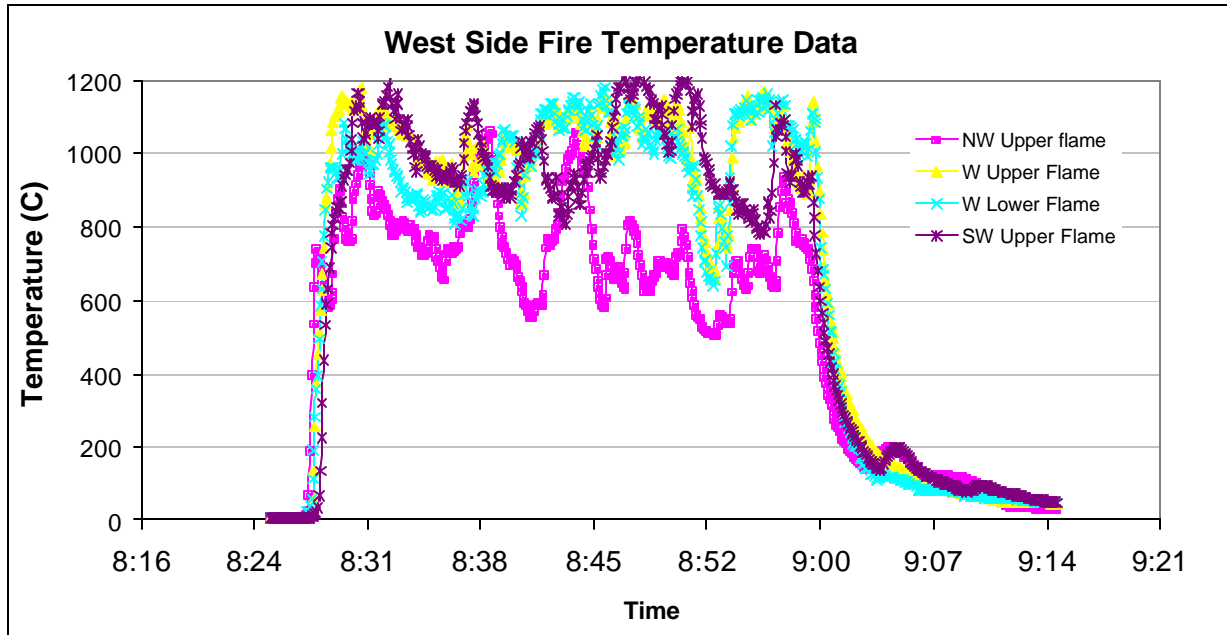
Figure 3-42 Fire Temperature Data from West Side of CTU

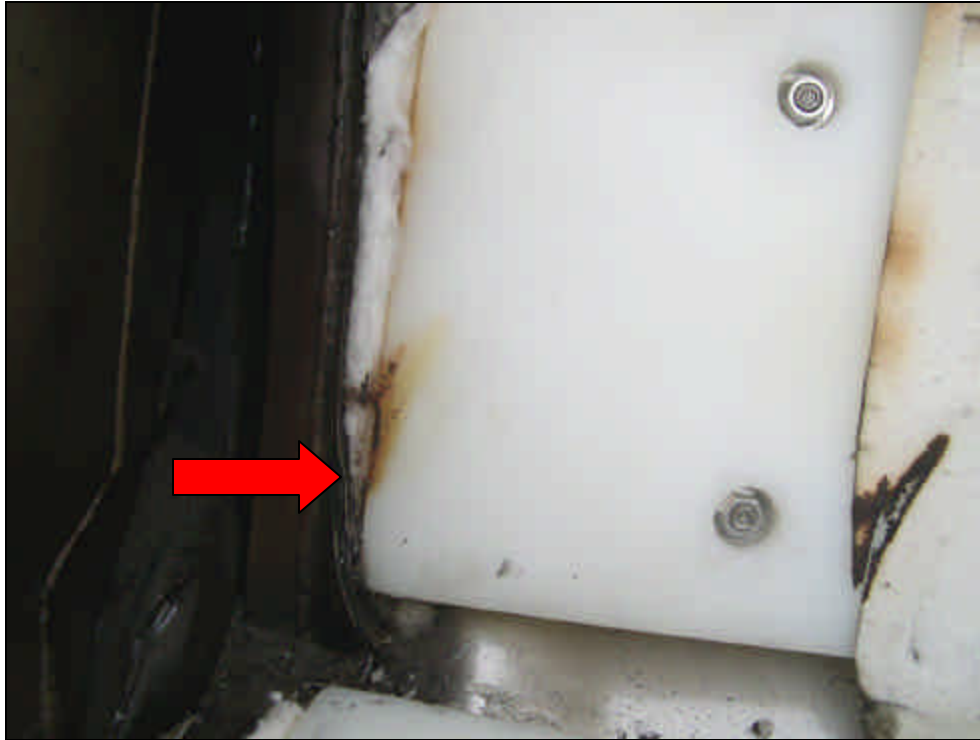
Figure 3-43 Location of Possible Combustion of Moderator

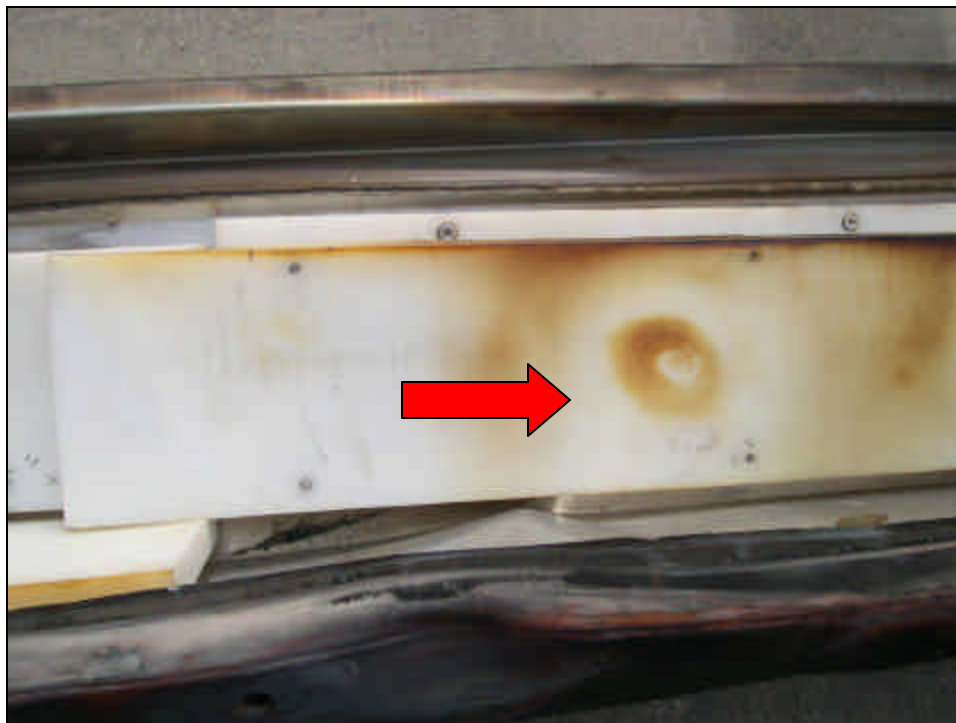
Figure 3-44 Localized Melt Spot in Lid Moderator Block

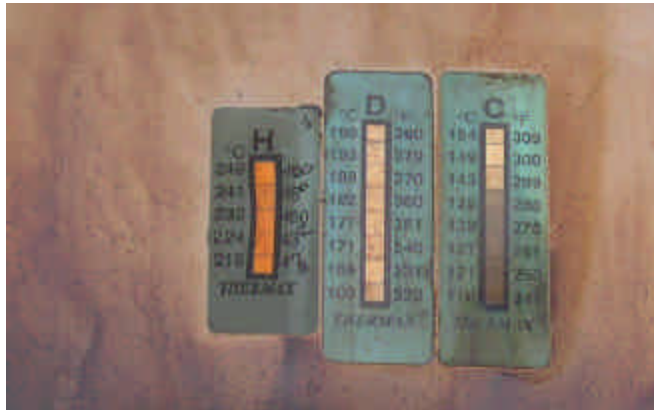
Figure 3-46 Temperature Strip Set After Fire Test
