## Enclosure 3

Pictures of CPSES/PCI Prototype Strainer Testing  
Tests 1 and 5

# CPSES Prototype Strainer

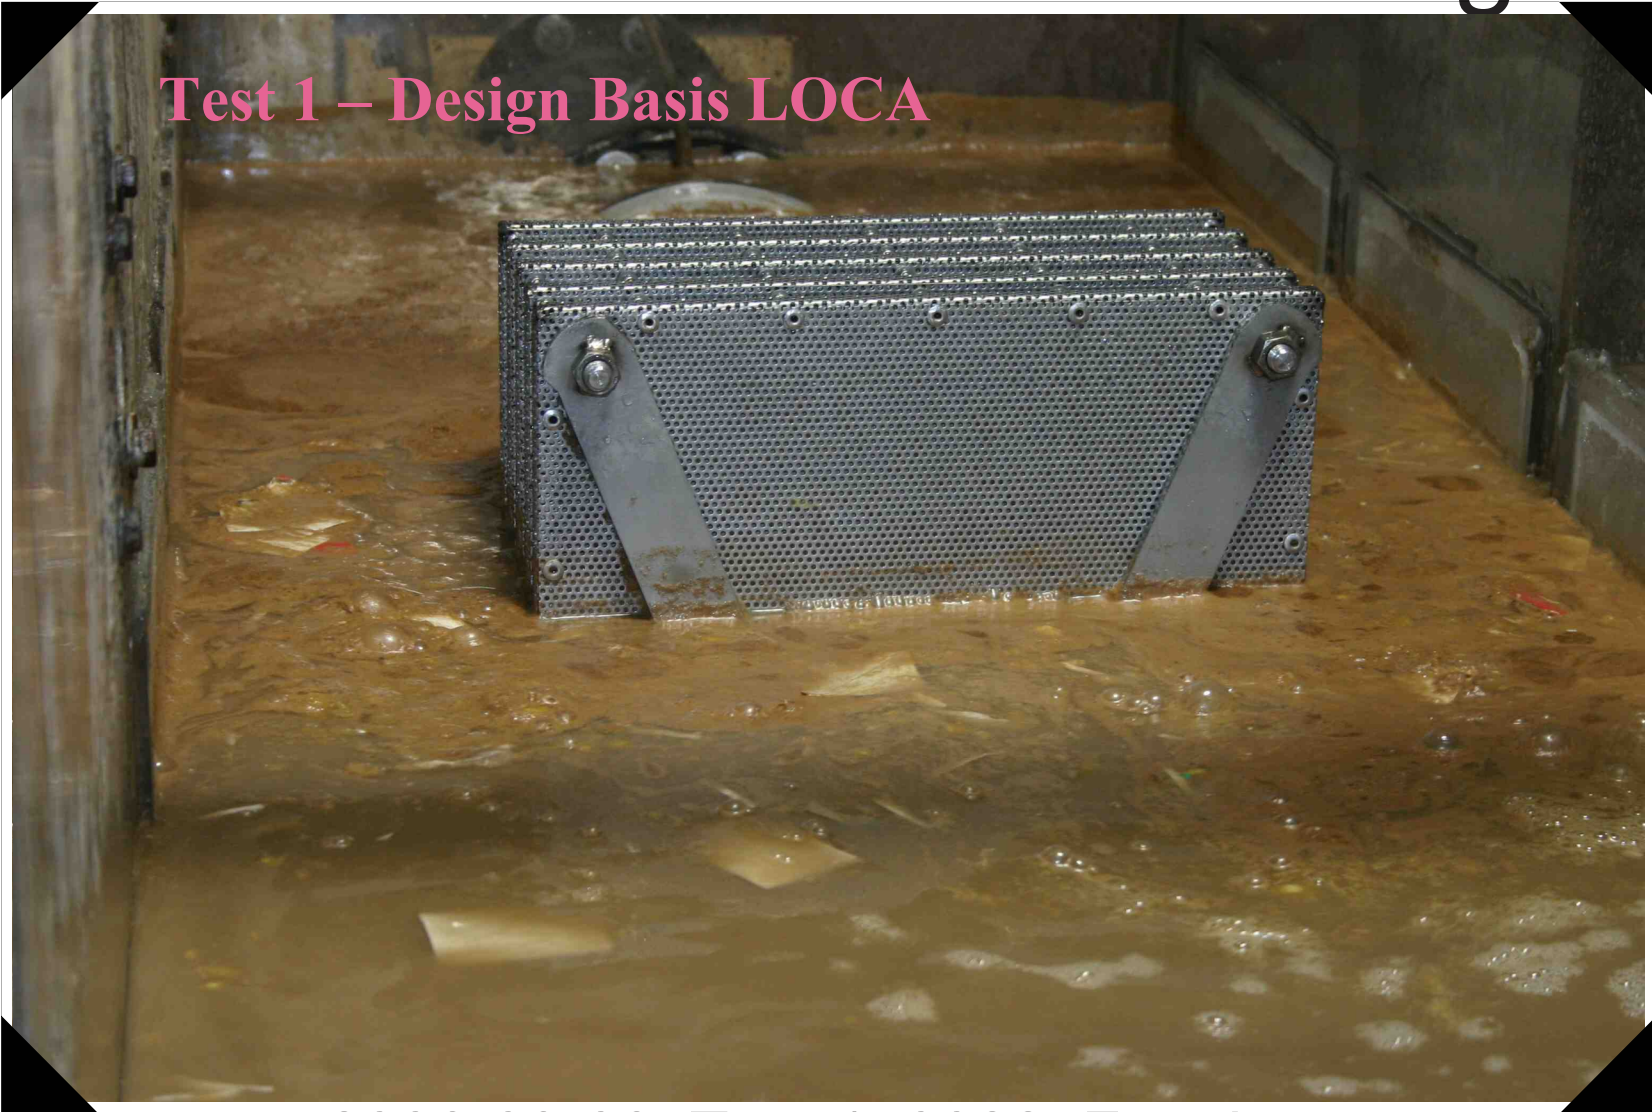
2006-03-08\_Test 1\_0022\_Flood up

Test 1 – Design Basis LOCA

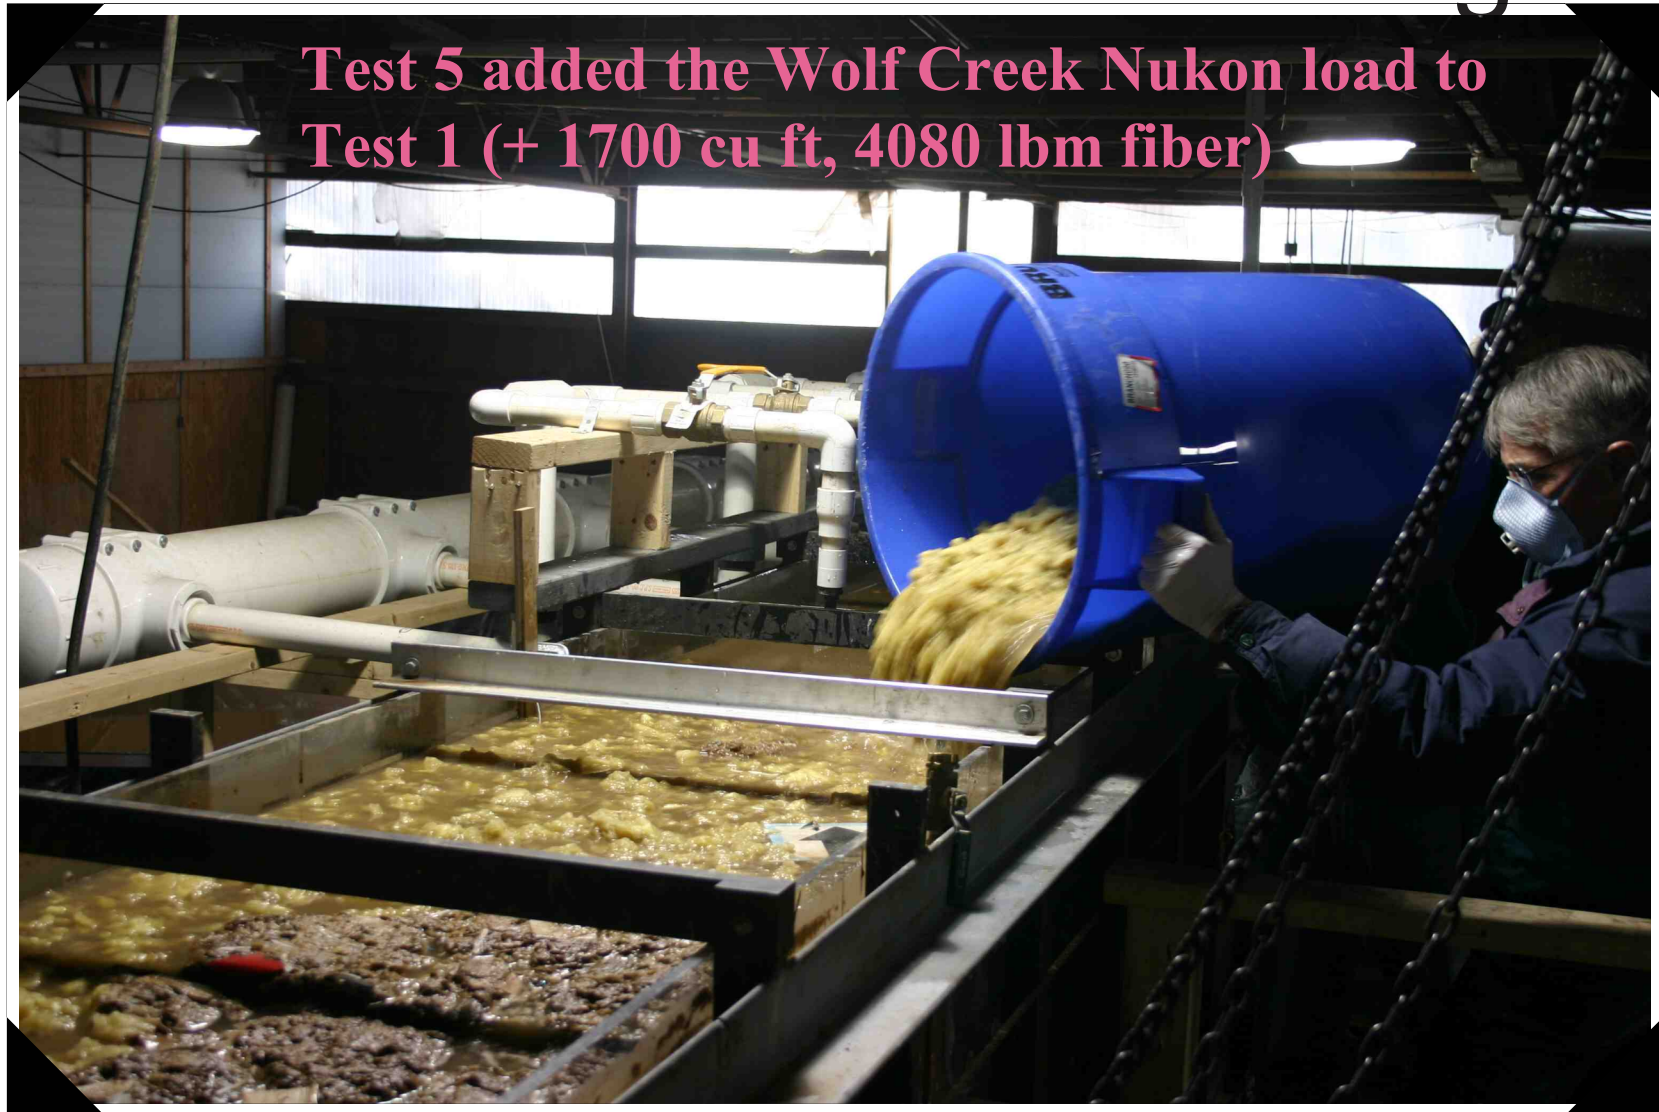
2006-03-08\_Test 5\_0003\_Adding Nukon to Test 1

Test 5 added the Wolf Creek Nukon load to  
Test 1 (+ 1700 cu ft, 4080 lbm fiber)

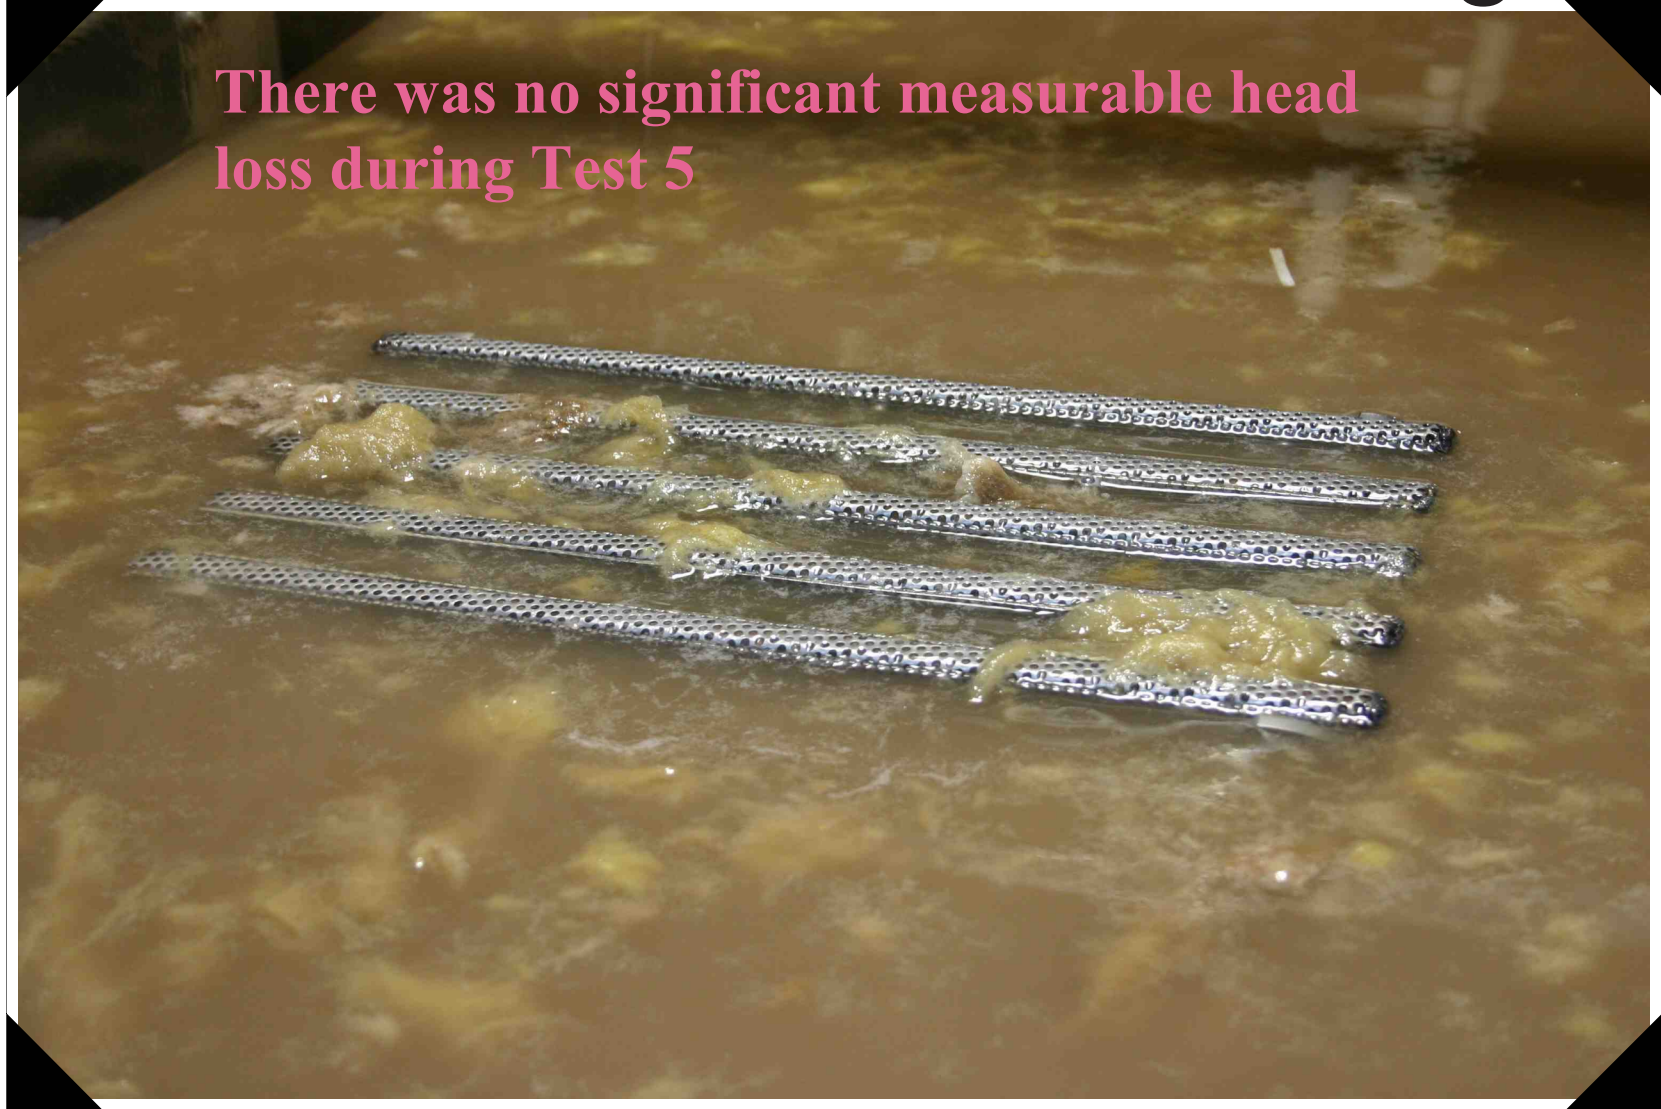
2006-03-08\_Test 5\_0012\_Draindown

There was no significant measurable head loss during Test 5

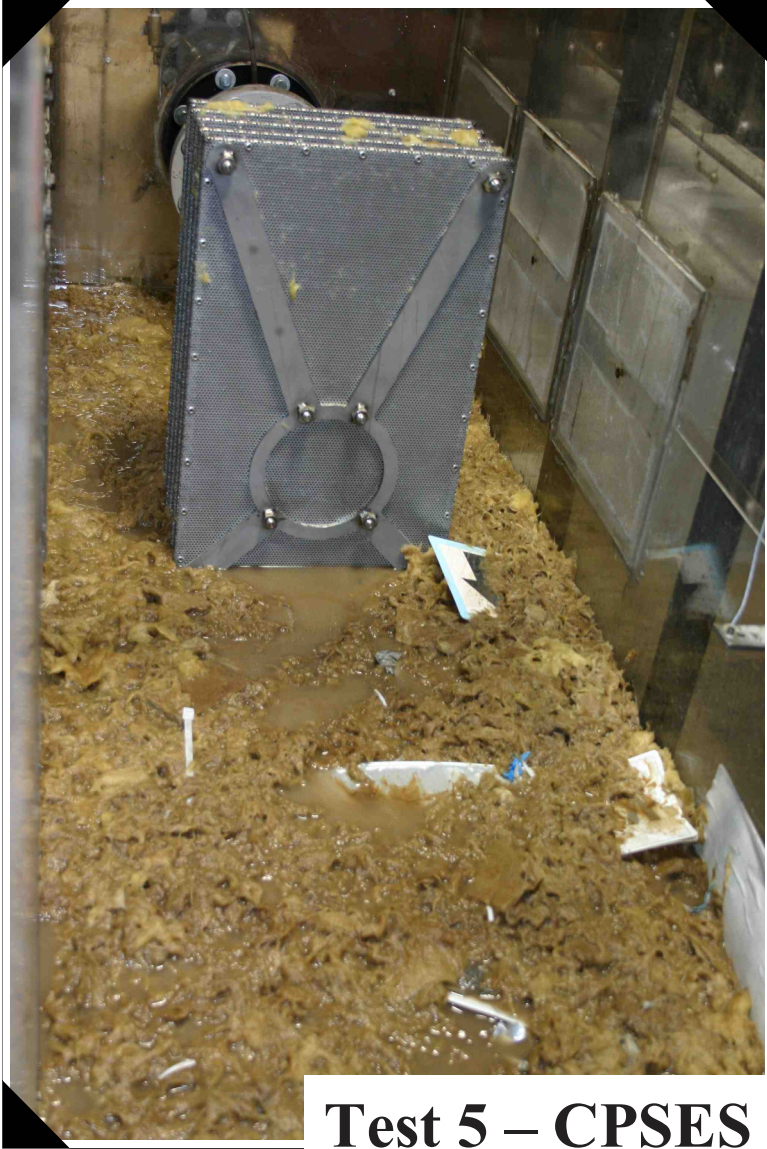
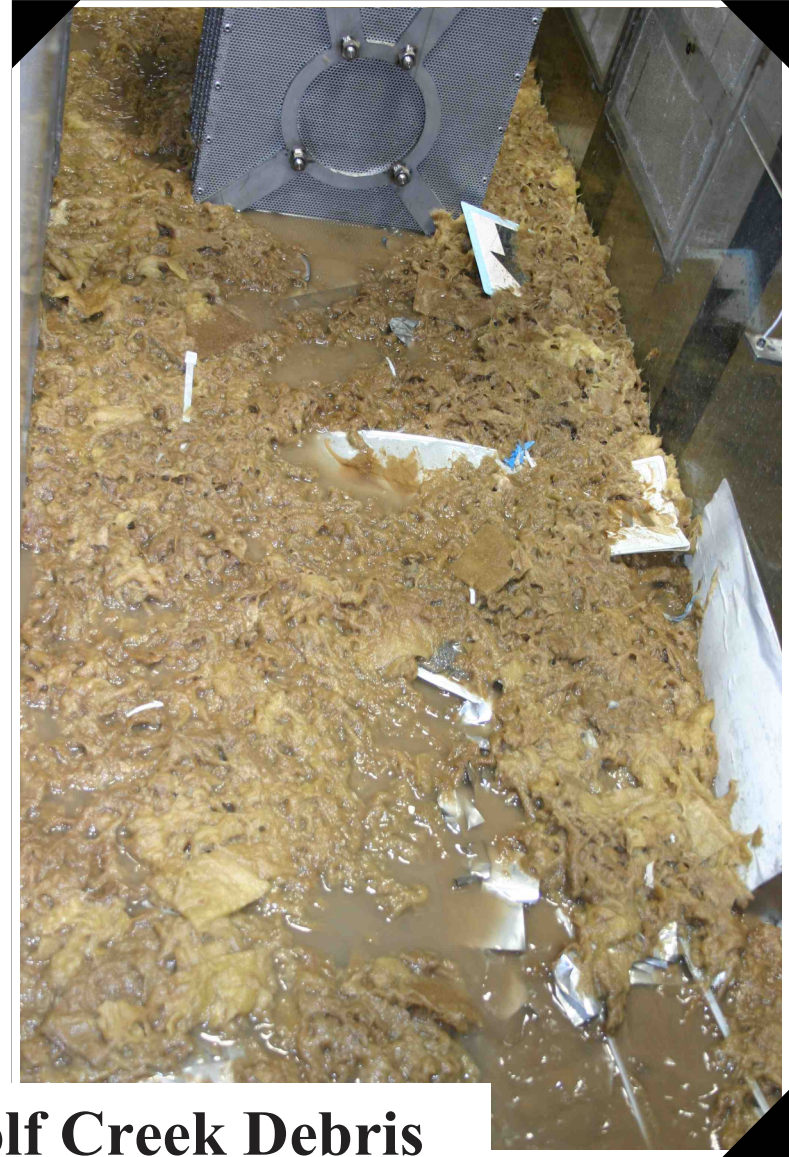
# Tests 1 & 5 Combined Debris

**Test 5 – CPSES + Wolf Creek Debris**
