4. The Davis-Besse March 2002 Event

4.2 March 2002 13RFO Discovery of Large Head Corrosion Cavity at CRDM Nozzle 3 and Minor Crevice Corrosion at CRDM Nozzle 2 in the RPV Head

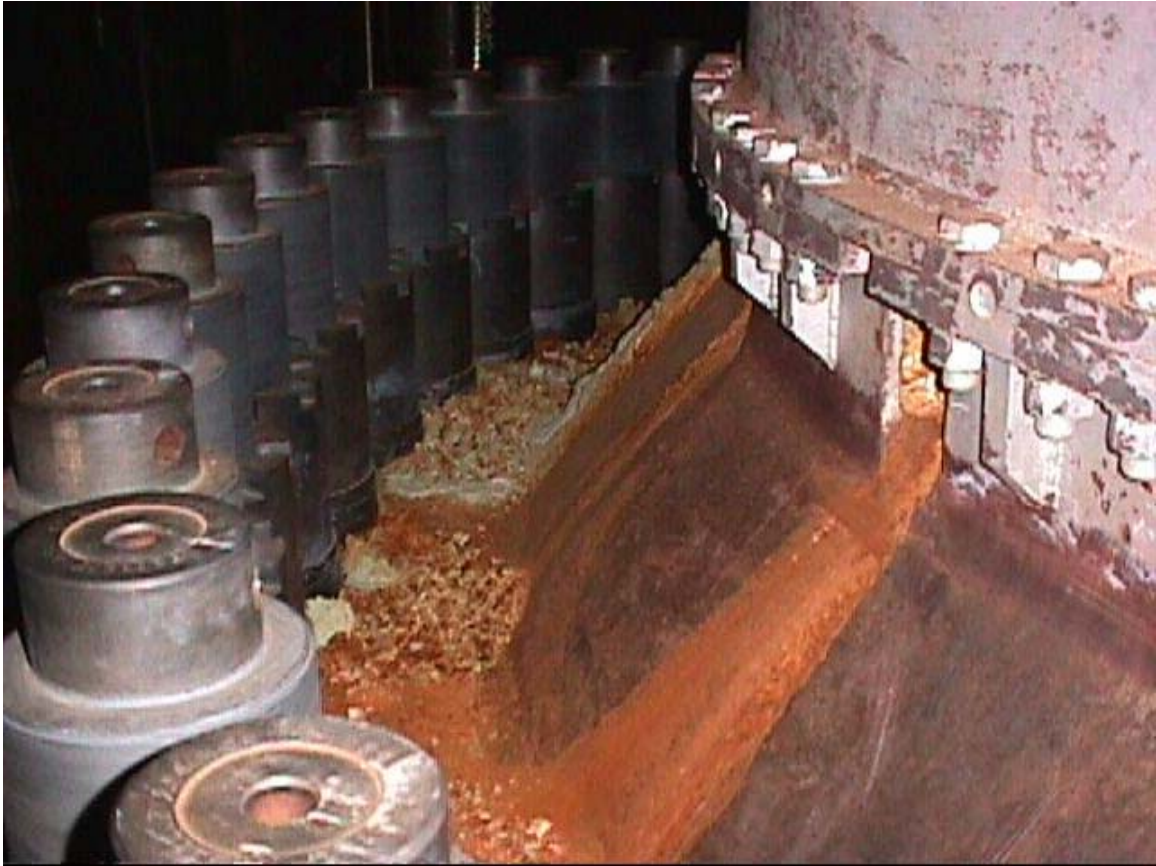
Figure 4.1 Boric acid and iron oxide flowing from mouse holes at 12RFO.⁵

The boron accumulation from the previous outage (12RFO) is shown in Figure 4.1.⁵ Video inspection of the RPV head during 13 RFO was completed on February 25, 2002. During this video inspection, “more boron than expected was found on the top of the head.” Video inspection of CRDM flanges performed on February 25-26, 2002, indicated no flange leaks. However, boric acid was encountered in the vicinity of Nozzle 3, which made the inspection of the underside of the flange difficult.⁶

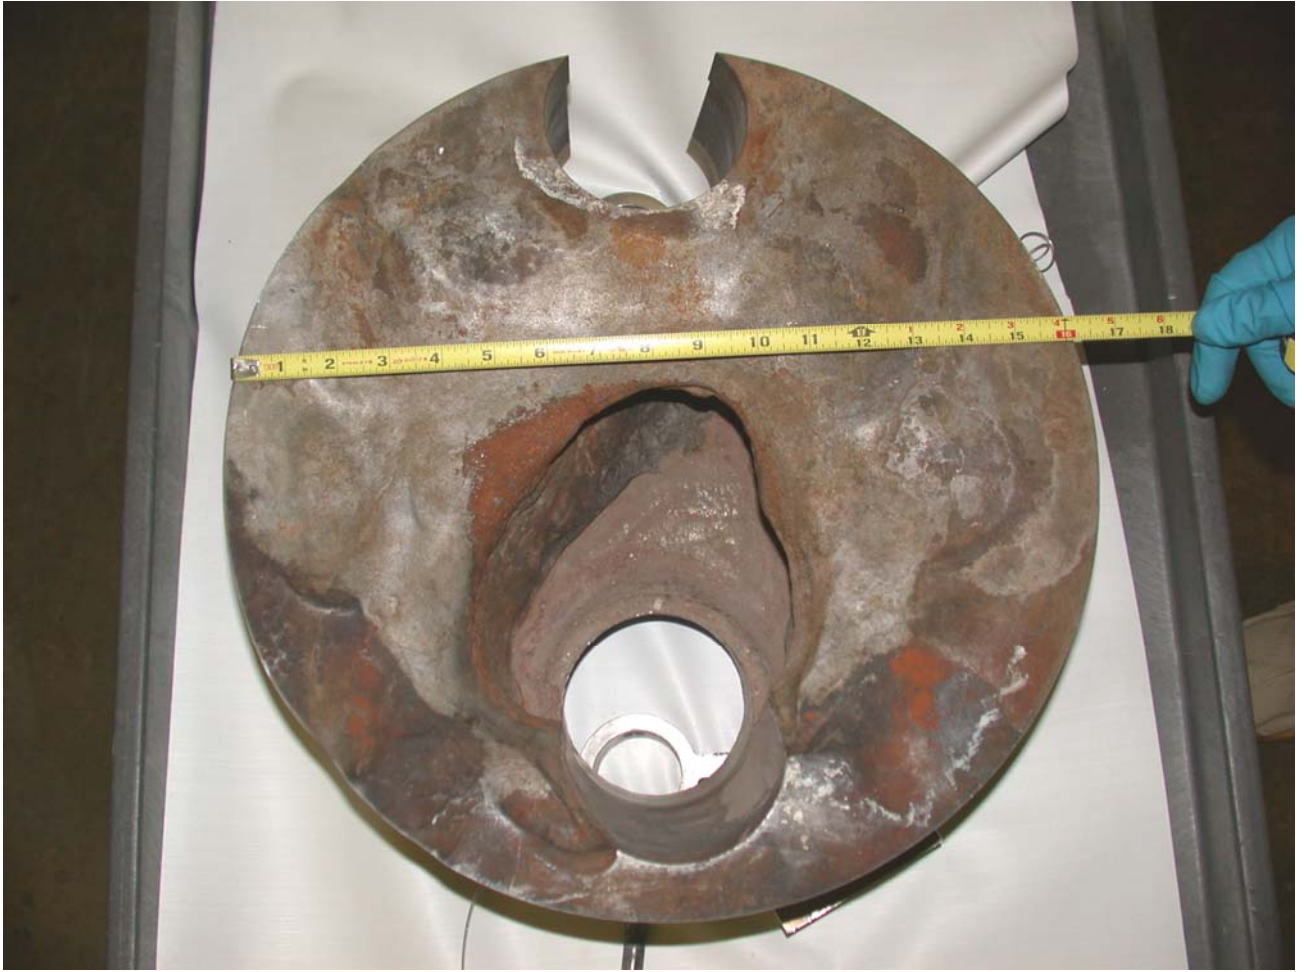
Figure 4.2 Davis-Besse RPV head wastage cavity found adjacent to Nozzle 3.¹²

Nozzle repairs were initiated following the identification of cracks in Nozzles 1, 2, 3, 5, and 47 that were detected by non-destructive examination in response to NRC Bulletin 2001-01. During the course of these repairs on March 5, 2002, an unexpected movement of the nozzle boring tool of approximately 15 degrees occurred.¹⁰ Evaluation of the bottom-up ultrasonic test data in the area of Nozzle 3 indicated significant, unexpected degradation of the reactor pressure vessel head pressure boundary.¹¹ Following the removal of Nozzle 3, a wastage cavity was discovered in the low-alloy steel RPV head on the down hill side of Nozzle 3 above the J-groove weld. The wastage cavity is shown in Figure 4.2.¹² The occurrence and the magnitude of the wastage of the RPV head was completely unanticipated. The relative location and size of the wastage cavity (with respect to the RPV head) is shown in Figure 4.3. This figure is a computer-generated image of the cavity on the RPV head.

The top portion of Nozzle 3 was removed and the RPV head was cleaned by hydrolasing. Subsequent video inspection of the wastage in the low-alloy steel near Nozzle 3 revealed material missing from the RPV head. The preliminary estimates of the dimensions of the cavity were that it was about 6-7 inches long and approximately 4-5 inches wide. The total volume of material removed is estimated to be about 200 cubic inches (approximately 3,000 cubic cm). These estimates are based on measurements taken from the dental mold images in the BWXT Services, Inc. report.¹³

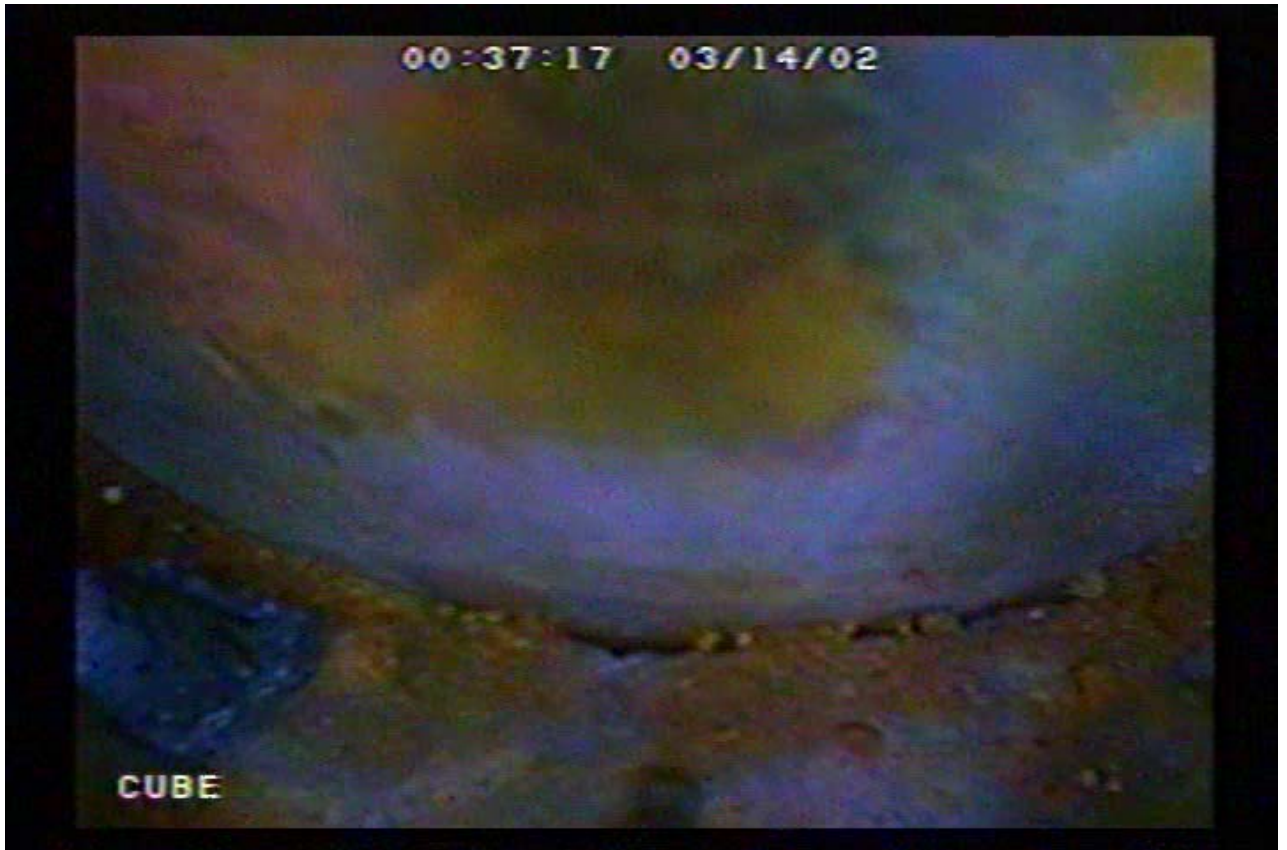
Figure 4.4 Crevice identified by inspection of Nozzle 2 with a hand-held video camera following the removal of a section of mirror insulation.¹⁴

A small area of wastage (annulus enlargement) was observed via video inspection of the RPV head near Nozzle 2. The crevice associated with this wastage is shown in Figure 4.4. This annulus enlargement, which was relatively minor, was found using hand-held video inspection techniques that were undertaken through access holes cut through the mirror insulation above the RPV head. Using a boroscope, subsequent video inspection of the interior of the small wastage area adjacent to Nozzle 2 was completed on March 9, 2002.¹⁴ This video inspection showed that a majority of the material removal occurred below the surface of the RPV head and was not readily observable by video inspection of the top of the RPV head. This observation is significant and will be addressed in detail in subsequent Sections 9 and 10 of this report.

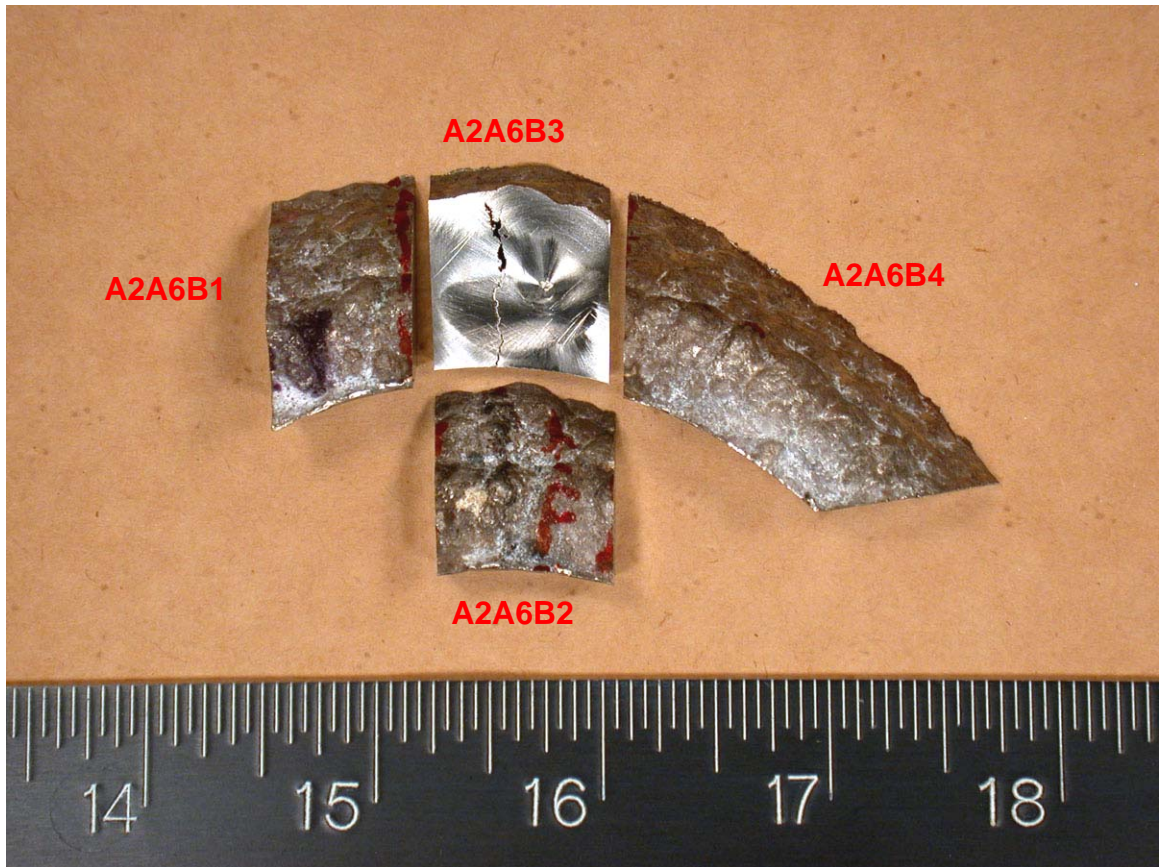
Figure 4.6 J-groove weld with the 10-degree crack showing crack and flow channel.¹⁶

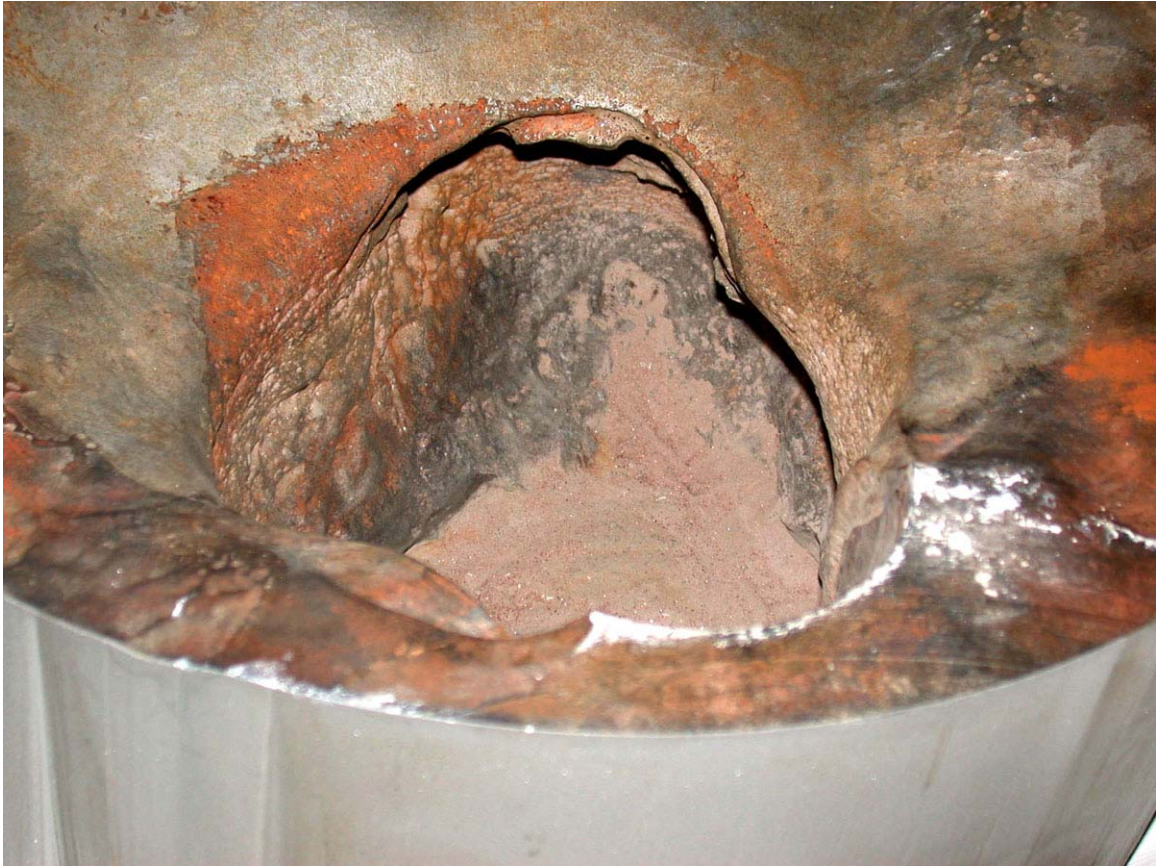
Figure 4.7 Surface morphology of the Davis-Besse RPV head wastage cavity looking toward the nose of the cavity (~10-degree).¹⁷

Detailed examination of the wastage cavity was also completed as part of the BWXT Services analyses. Some of the most significant indications of various material removal mechanisms that resulted in the formation of the wastage cavity are found in the images of the cavity (Figures 4.5, 4.6, and 4.7).¹⁷⁻¹⁹ These images show the surface morphologies at the final stage of cavity formation. These morphologies suggest a range of material removal mechanisms that range from mechanical removal (flow impingement) and flow-enhanced corrosion (corrosion/erosion) to general boric acid corrosion and molten metaboric acid corrosion. These mechanisms will be discussed in detail in subsequent sections (Sections 9 & 10) of this report.

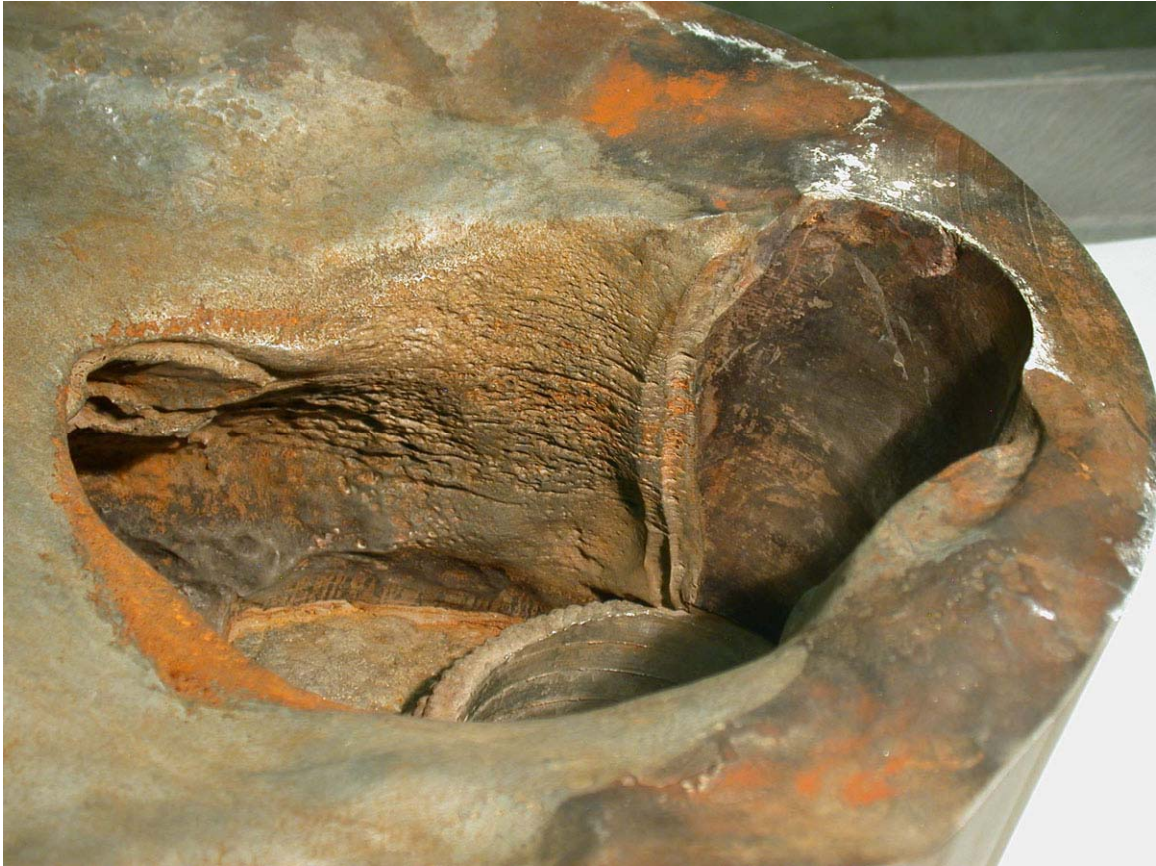
Figure 4.8 Surface morphology of the Davis-Besse RPV head wastage cavity looking toward the 90-degree side.¹⁸

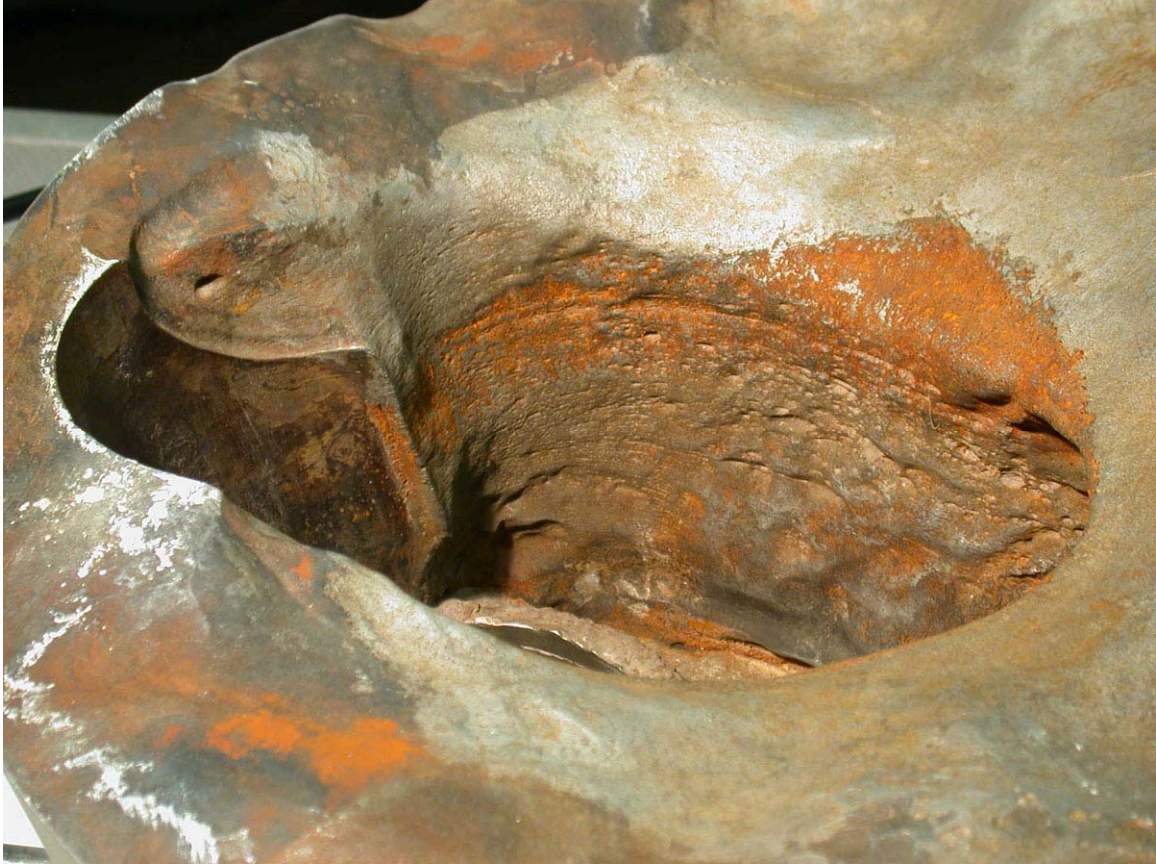
Figure 4.9 Surface morphology of the Davis-Besse RPV head wastage cavity looking toward the 270-degree side.¹⁹
