9. CFD Modeling of Fluid Flow in CRDM Nozzle and Weld Cracks and through Annulus

In this section, we describe the results of the detailed computational fluid dynamics (CFD) modeling effort that we undertook to develop a better understanding and definition of the thermal hydraulic conditions in the CRDM nozzle annulus and developing wastage cavity at both CRDM Nozzles 2 and 3.

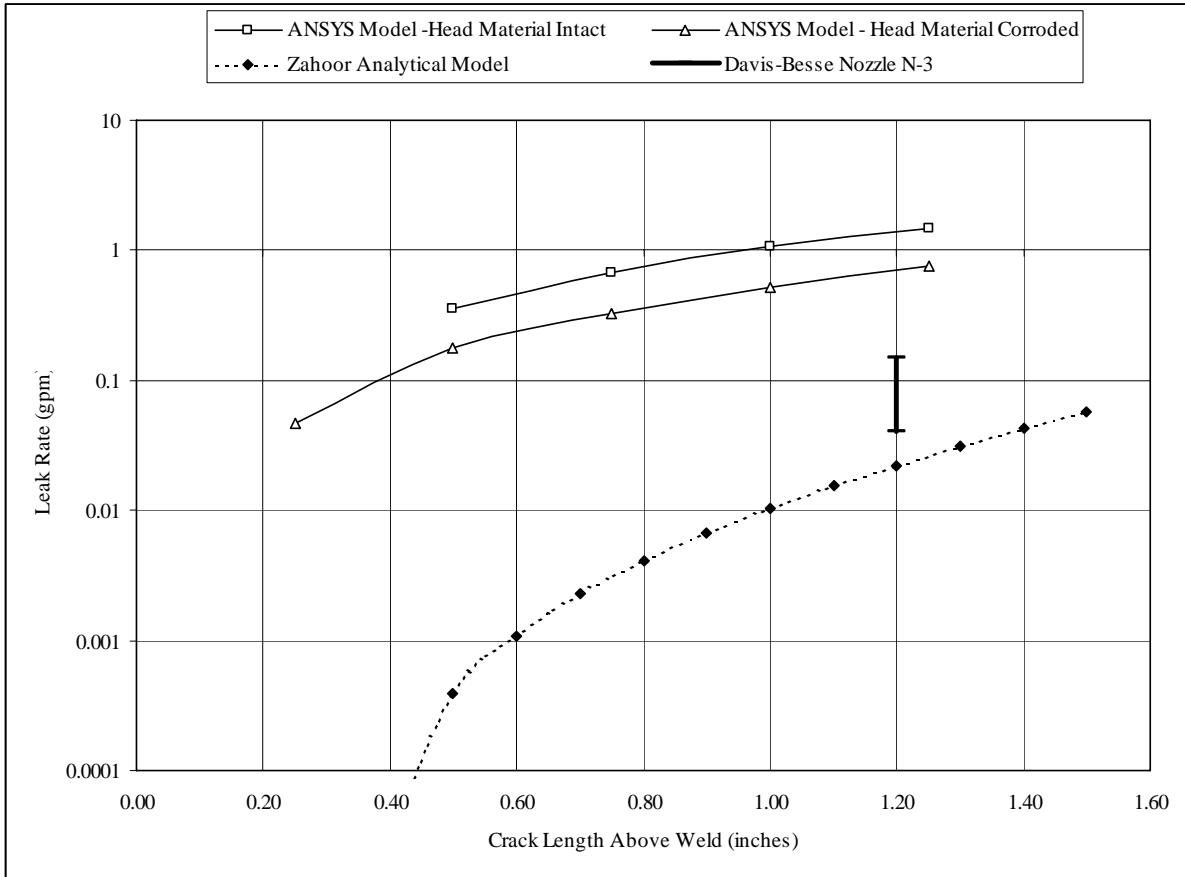
Figure 9.3 Calculated Leak Rate vs. Crack Length Above the J-Groove Weld as Calculated by Dominion Engineering, Inc.^{1,2}

Before we could begin the CFD modeling of the environmental conditions present in the annulus and wastage cavity at a cracked CRDM nozzle, we need to establish the relationship between PWSCC crack length and crack leak rate. Our initial effort to evaluate the leak rate from CRDM nozzle PWSCC cracks began with a review of the calculations completed by Dominion Engineering, Inc., shown in Figure 9.3.^{6,7}

These results, which show calculated leak rates for crack lengths ranging up to 1.6 inches, were based upon available data obtained for fluid leakage through thin-walled steam generator tubes. Based upon these results, the Root Cause Report attempted to compare the leak rates from the CRDM nozzle cracks identified by UT examination of Nozzles 2 and 3. The FENOC Root Cause Report noted:⁸

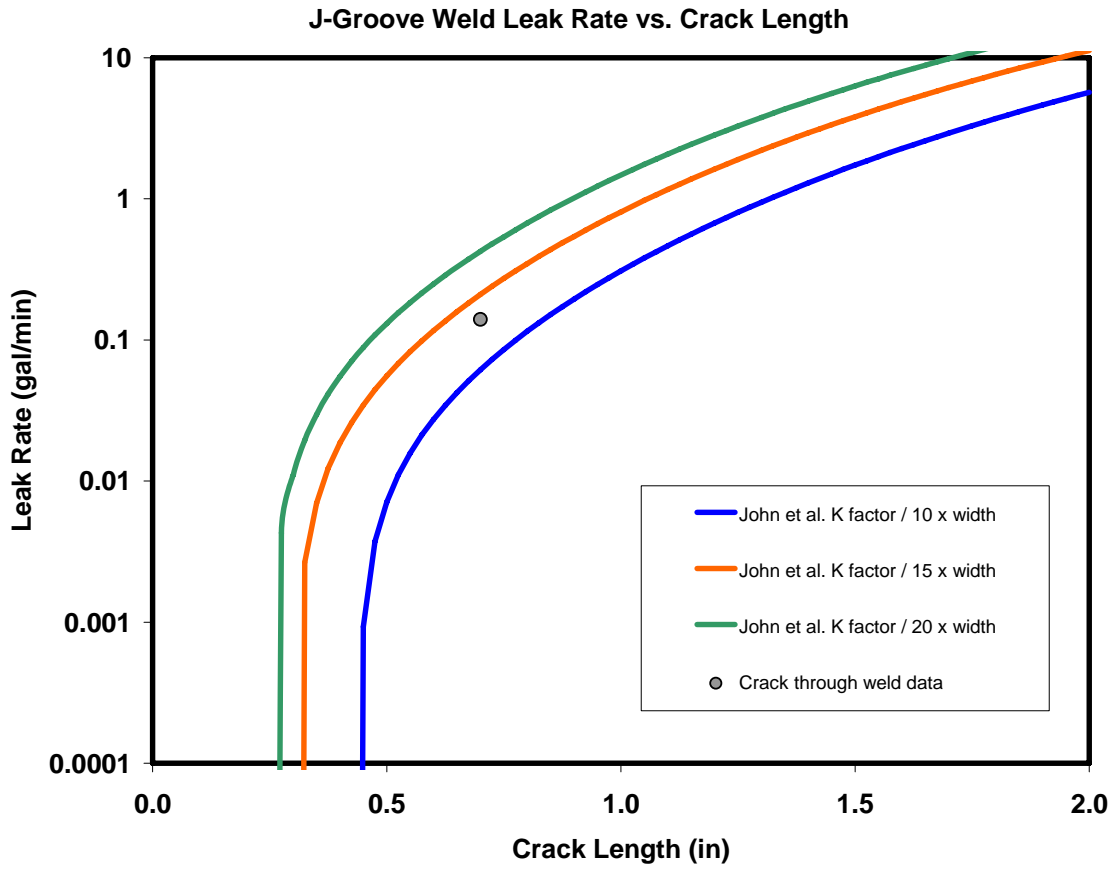
Figure 9.7 Calculated leak rate vs. crack length for a J-groove weld crack with crack widths that are 10 times, 15 times, and 20 times wider than typical PWSCC nozzle cracks.

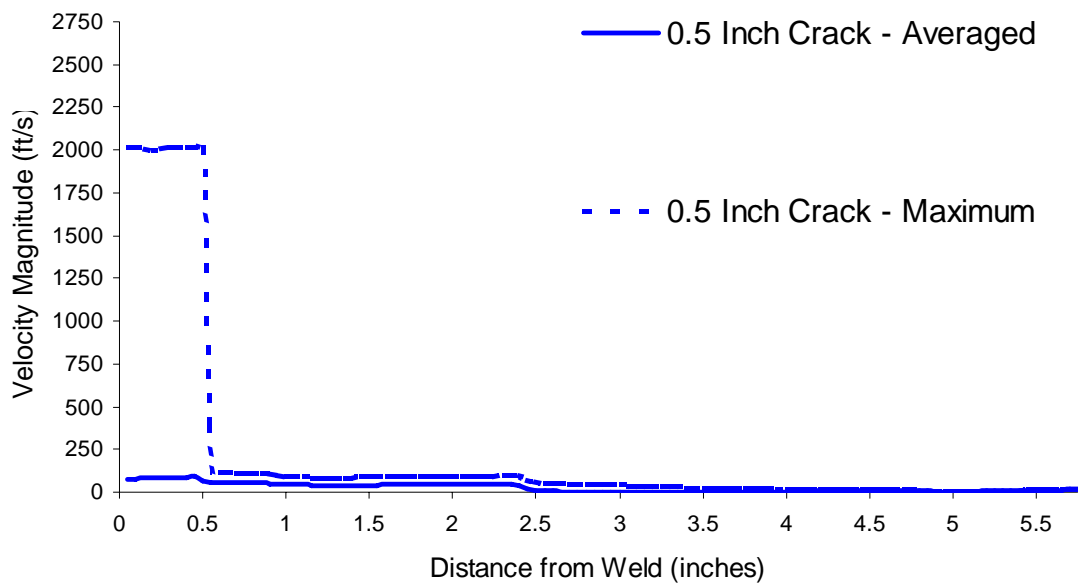
Figure 9.8 Case 1: Maximum and average fluid velocity magnitude within wastage as a function of distance to the J-groove weld for a 0.5-inch crack with a leak rate of 0.001 gpm.

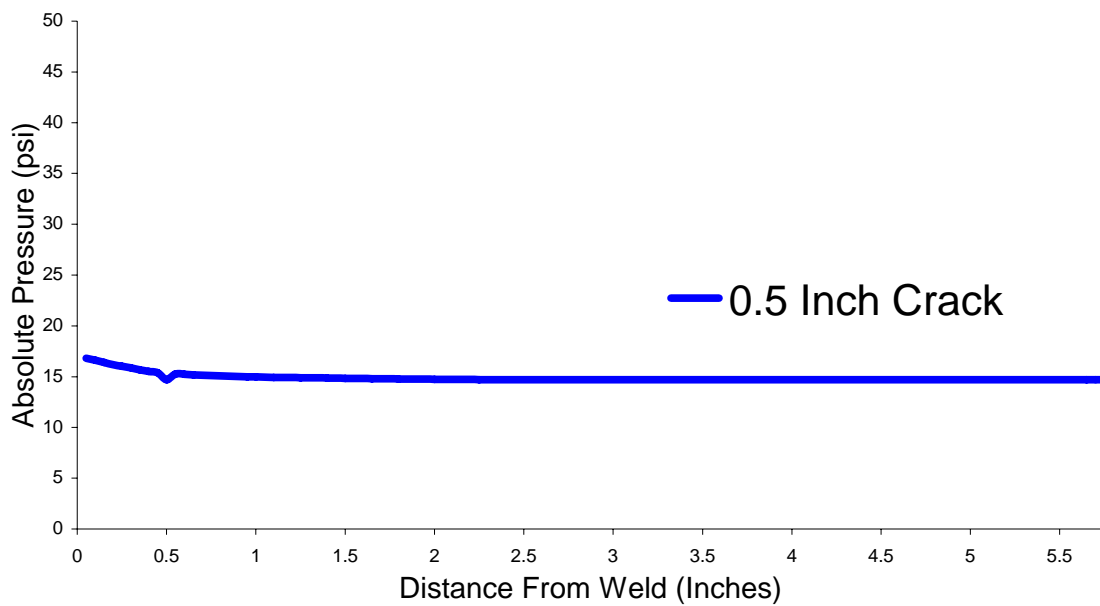
Figure 9.9 Case 1: Average fluid pressure within wastage as a function of distance to the J-groove weld for a 0.5-inch crack with a leak rate of 0.001 gpm.

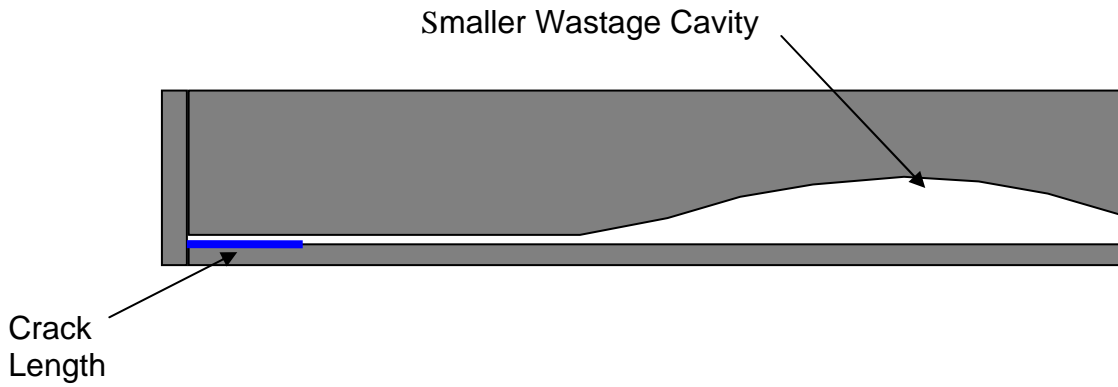
Figure 9.10 Case 1: Average wall temperature within wastage as a function of distance to the J-groove weld for a 0.5-inch crack with a leak rate of 0.001 gpm.

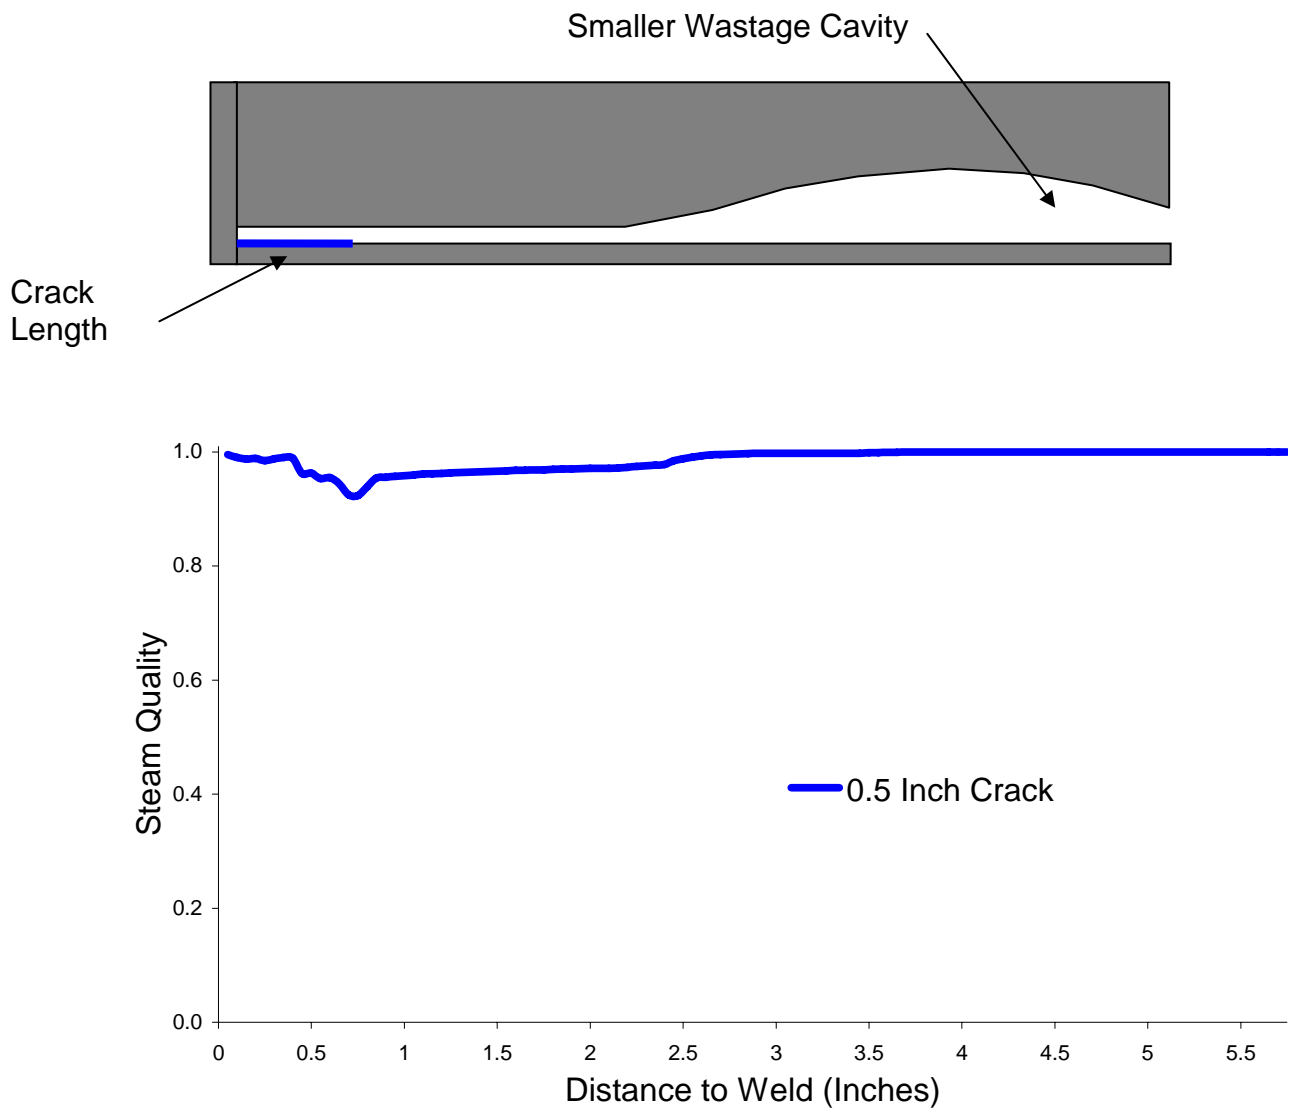
Figure 9.11 Case 1: Average steam quality within wastage as a function of distance to the J-groove weld for a 0.5-inch crack with a leak rate of 0.001 gpm.

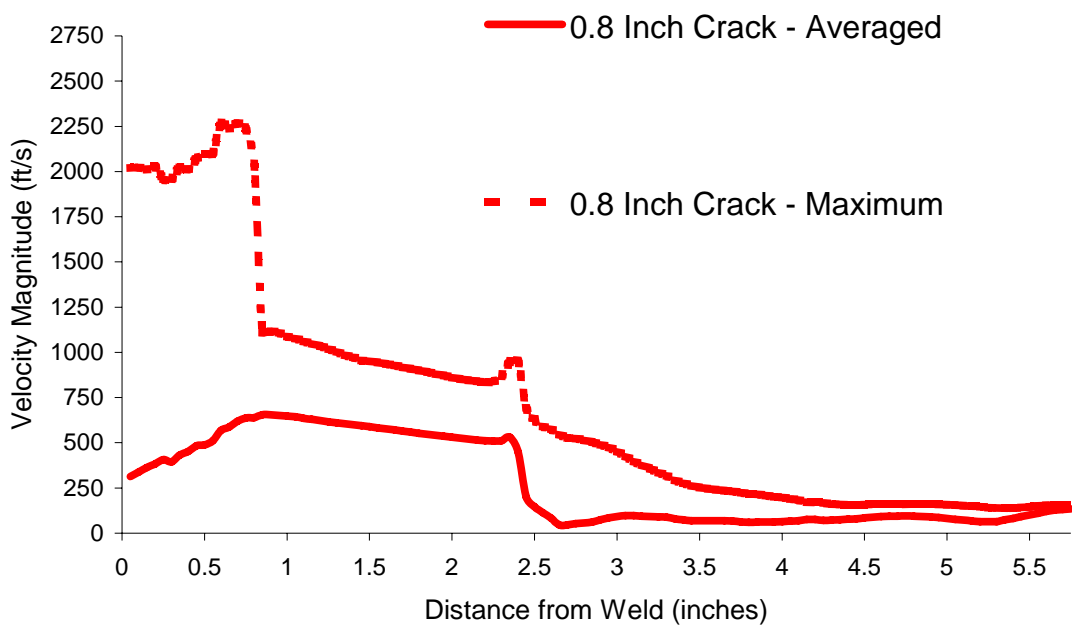
Figure 9.12 Case 2: Maximum and average fluid velocity magnitude within wastage as a function of distance from the J-groove weld for a 0.8-inch crack with a leak rate of 0.01 gpm.

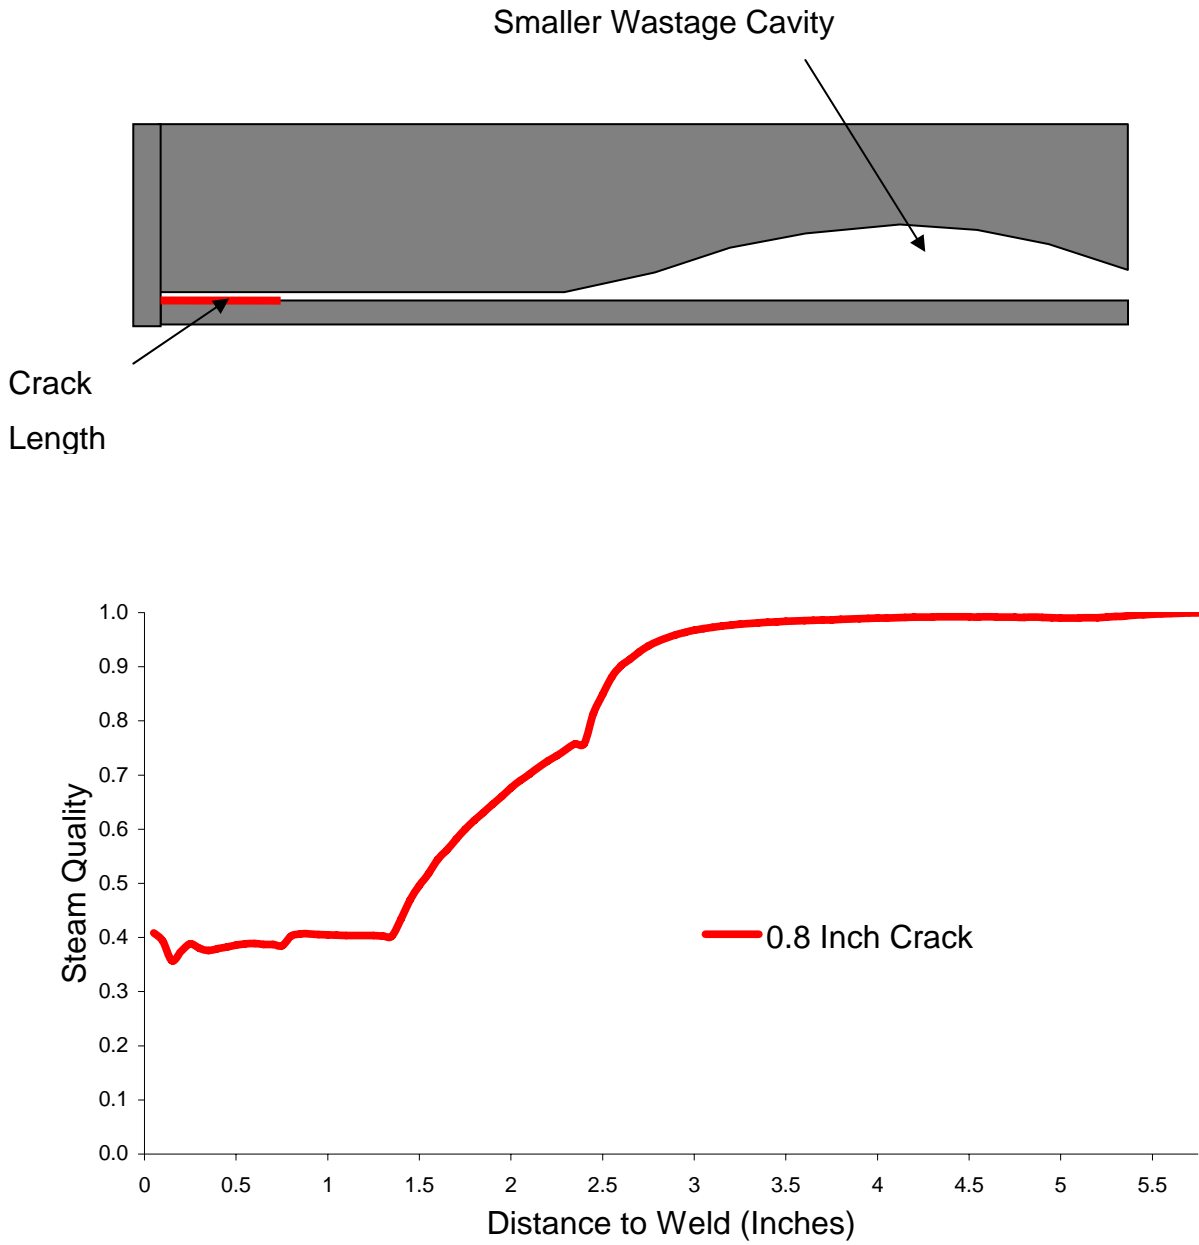
Figure 9.15 Case 2: Average steam quality within wastage as a function of distance to the J-groove weld for a 0.8-inch crack with a leak rate of 0.01 gpm.

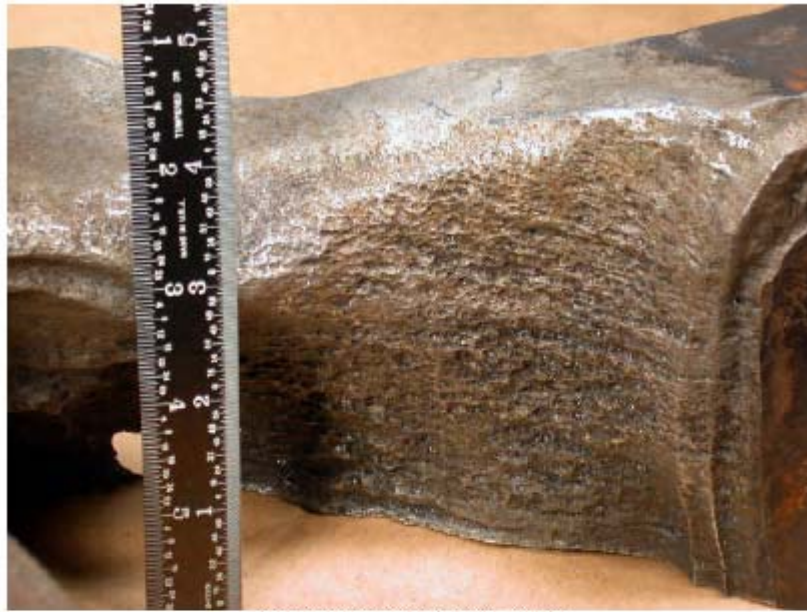
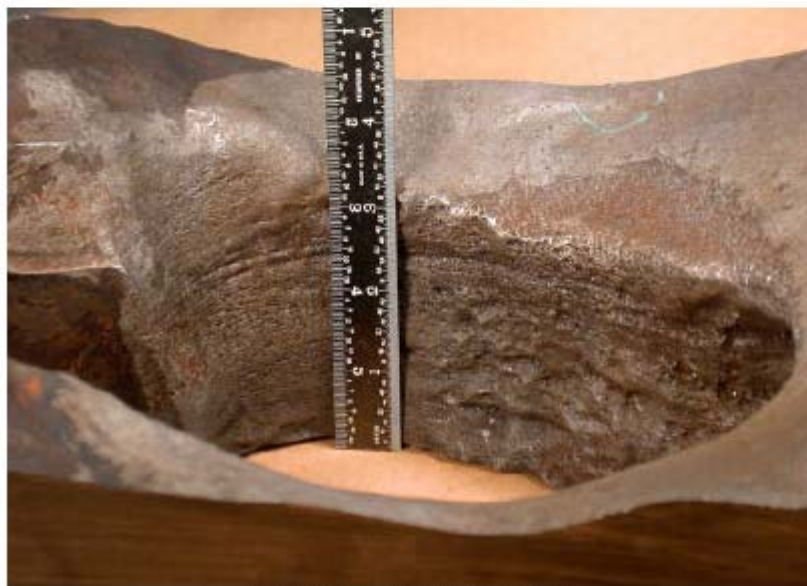
Figure 9.24 Wastage Cavity Sidewalls Viewed at Low Magnification Looking Toward 90° and 270°. ¹⁴

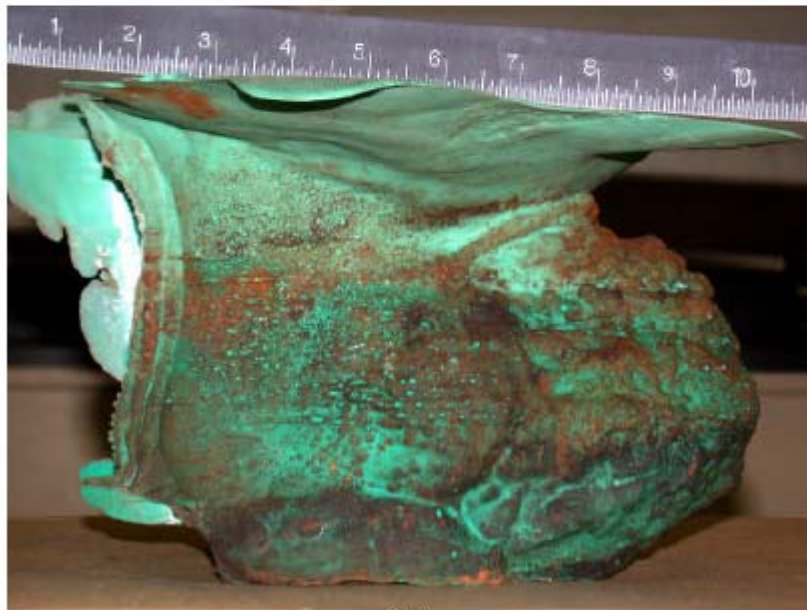
Figure 9.25(a) Dental Mold of Wastage Cavity Looking Towards 0° and 90°. ¹⁵

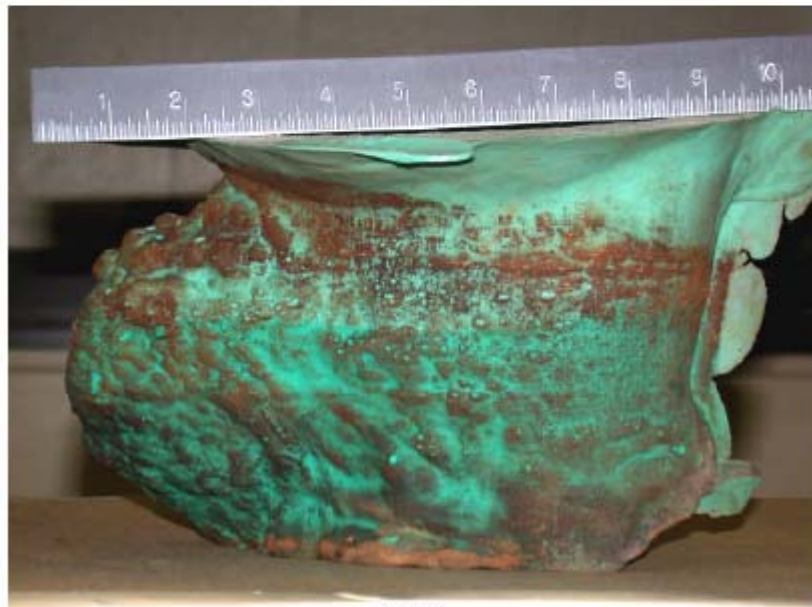
Figure 9.25(b) Dental Mold of Wastage Cavity Looking Towards 180° and 270°. ¹⁶

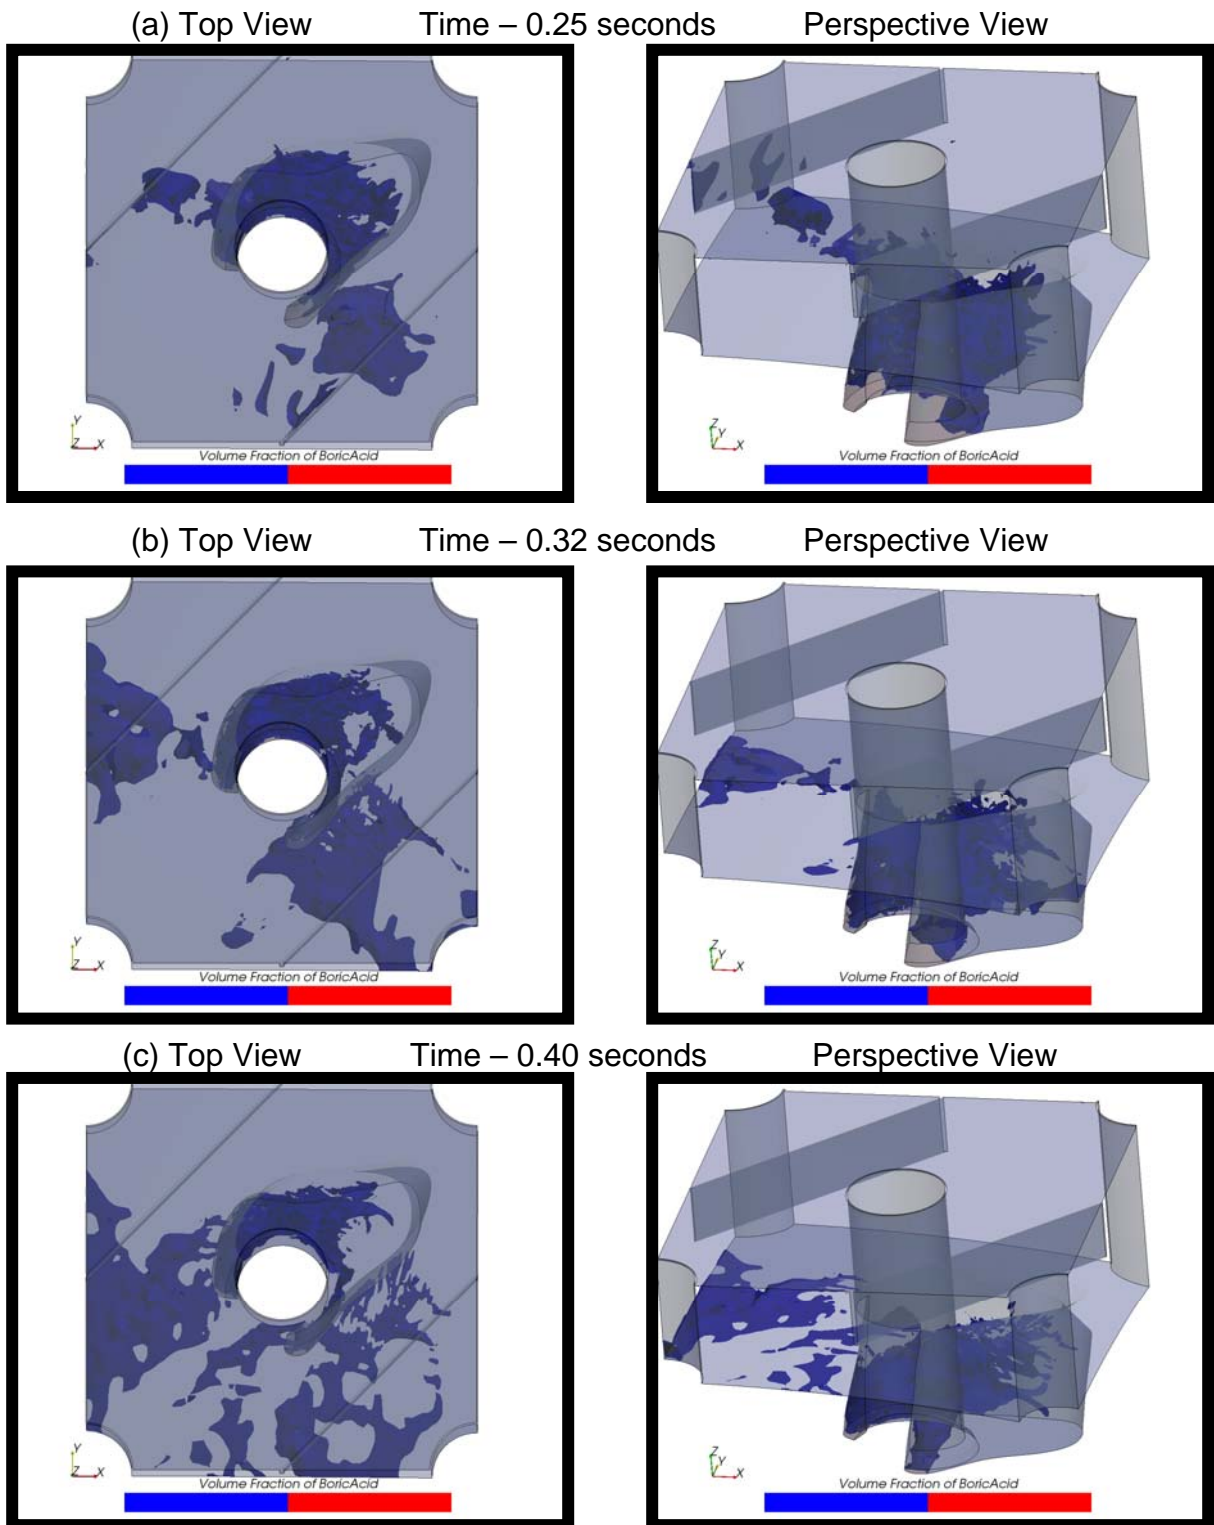
Figure 9.29 Transient analysis results for final wastage cavity filled with boric acid solution for time steps from 0.25 seconds to 0.40 seconds.
