NUREG/CR-6933  
PNNL-16292

**Assessment of Crack Detection in  
Heavy-Walled Cast Stainless  
Steel Piping Welds Using  
Advanced Low-Frequency  
Ultrasonic Methods**

**Pacific Northwest National Laboratory**

**U.S. Nuclear Regulatory Commission  
Office of Nuclear Regulatory Research  
Washington, DC 20555-0001**

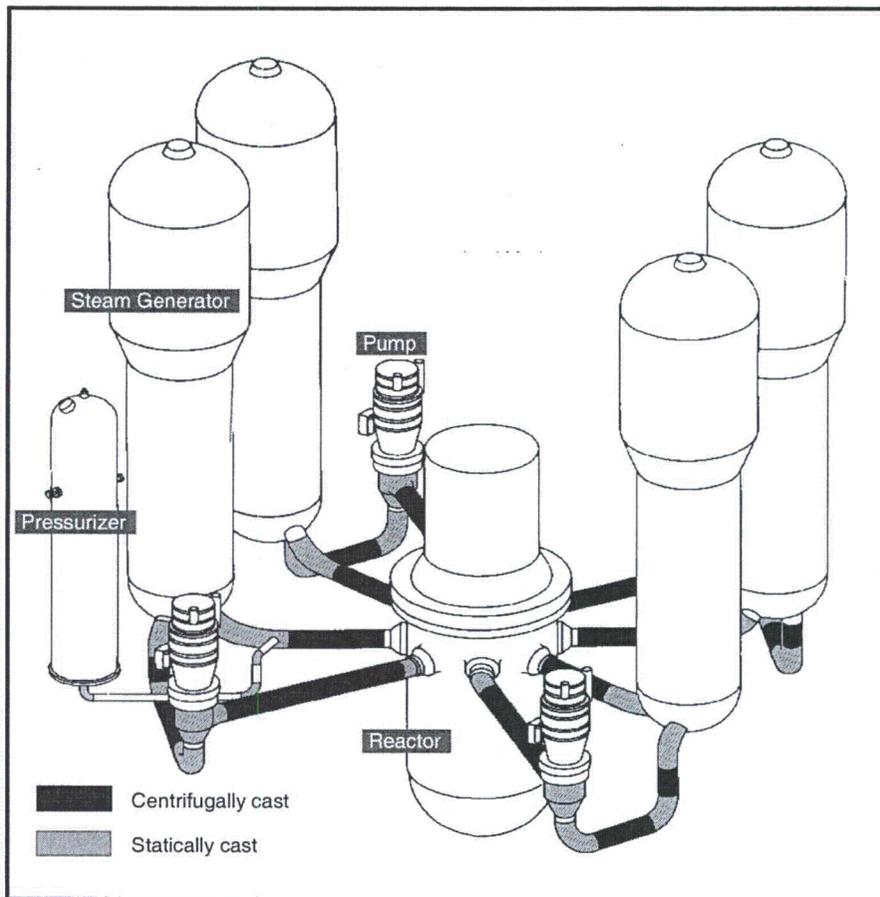
**Figure 2.1 Cast Stainless Steel Material in Primary Coolant System for Westinghouse-Designed Pressurized Water Reactor Four-Loop Plant (based on Westinghouse diagrams; illustration courtesy of A. Chockie, Chockie Group International, Inc.)**

The relatively low cost and high corrosion resistance of cast stainless steel (CSS) have resulted in extensive use of this material in the primary coolant piping systems of Westinghouse-designed pressurized water reactors (PWRs). Alloying elements and casting processes used in the fabrication of CSS materials are responsible for its corrosion resistance and strength but also create complex and coarse-grained microstructures. Figure 2.1 illustrates the general location of key CSS components in the primary coolant loop of a Westinghouse-designed PWR.

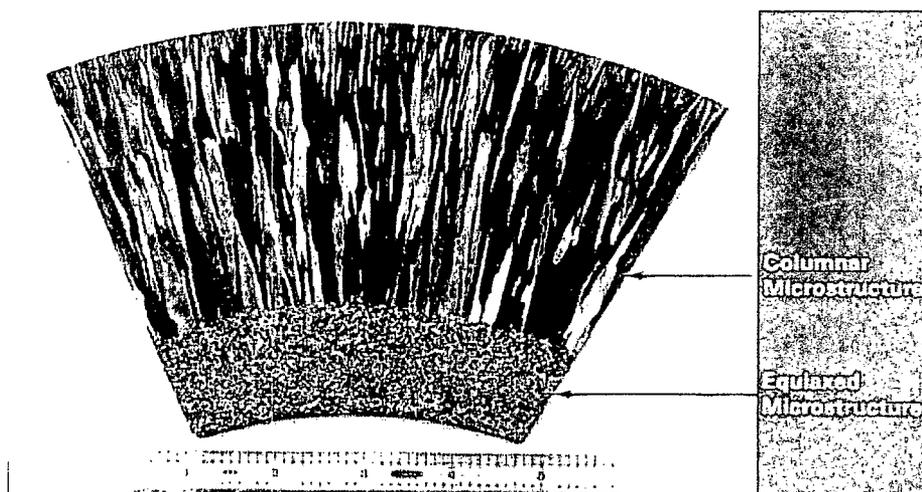
**Figure 2.2 Specially Fabricated Sample Illustrating Both Columnar (Dendritic) and Equiaxed Microstructures in Centrifugally Cast Stainless Steel**

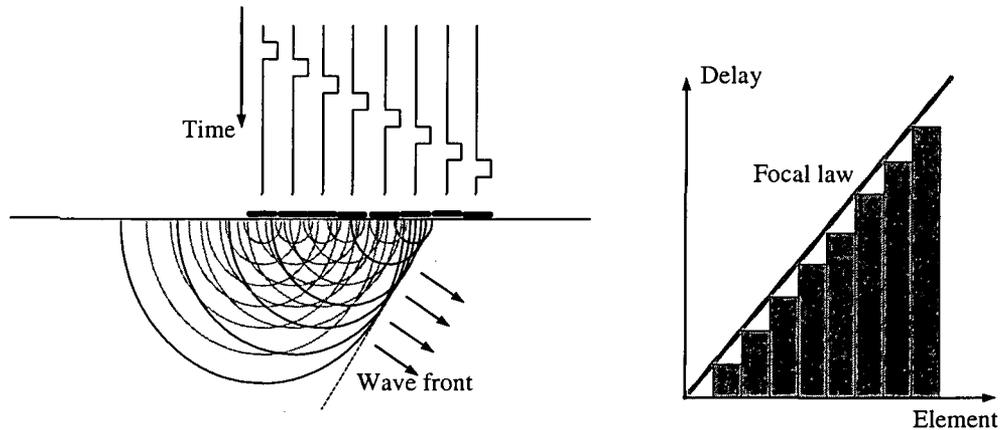
**Figure 2.4 Beam Forming Using a Phased Array (courtesy R/D Tech, Inc.)**

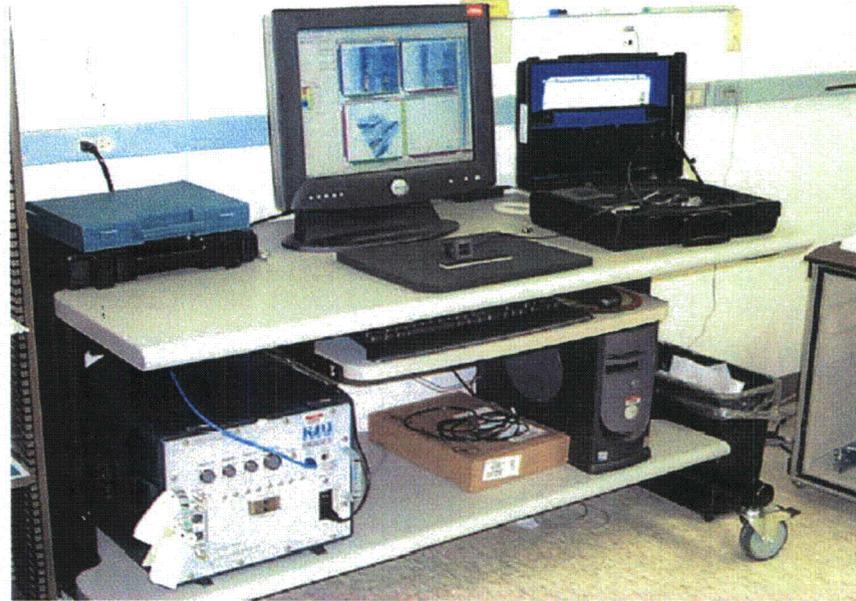
**Figure 2.5 Typical Phased Array System Components**

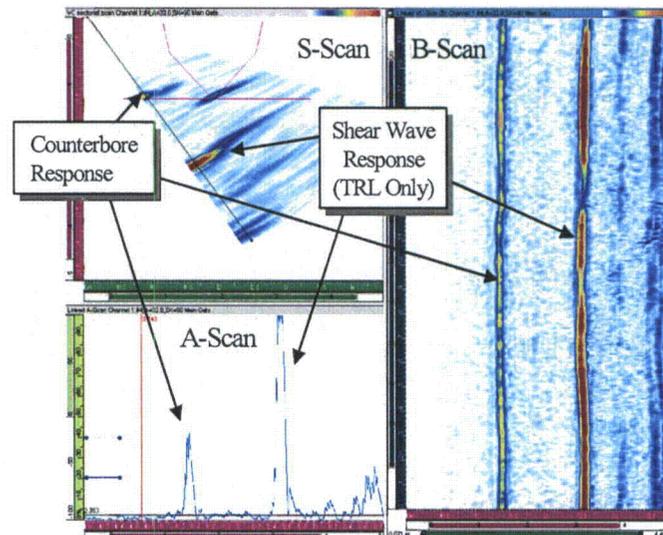
**Figure 2.6 Typical Analysis Images Used for Phased Array Inspection**

For the TomoView® and UltraVision® PA software used during these trials, the B-scan image is a projection of the sound field through the component, oriented as if looking along the direction of sound propagation, displaying a circumferential cross section of the weld (shown in the right pane of the analysis screen in Figure 2.6). The S-scan (shown in the upper left pane of the analysis screen), or sector view, provides a projection of the sound fields (from initial to final angle being used, i.e., 30° to 60° for the TRL arrays). The black line in the S-scan shows which angle is currently selected. Finally, the A-scan (lower left pane of analysis screen) represents the electronic responses for reflectors based on x-y axes of time and amplitude, respectively. A typical composite analysis screen showing the scan images described above is included as Figure 2.6.

between the various features in a specimen. In Figure 2.6, the system is displaying the results for an inspection angle of  $35^\circ$ , which shows reflections from the counterbore of a pipe. When a higher angle is displayed, shown by  $53^\circ$  in Figure 2.7, other features such as weld root become visible, and for this example, when one displays  $65^\circ$  data (Figure 2.8), targeted flaws become visible. This angular

The images presented in Figures 2.6 through 2.8 are shown to provide the reader with the general concept of how phased array data analyses may be performed. Typical data sets from wrought stainless steel piping welds are presented in these images for ease of discrimination between geometrical, metallurgical, and flaw responses. However, data on the CSS materials is much more challenging due to the nature of the grain structure and the need to use a low frequency for ultrasound penetration. The image in Figure 2.9 shows actual phased array data acquired during this CSS research.

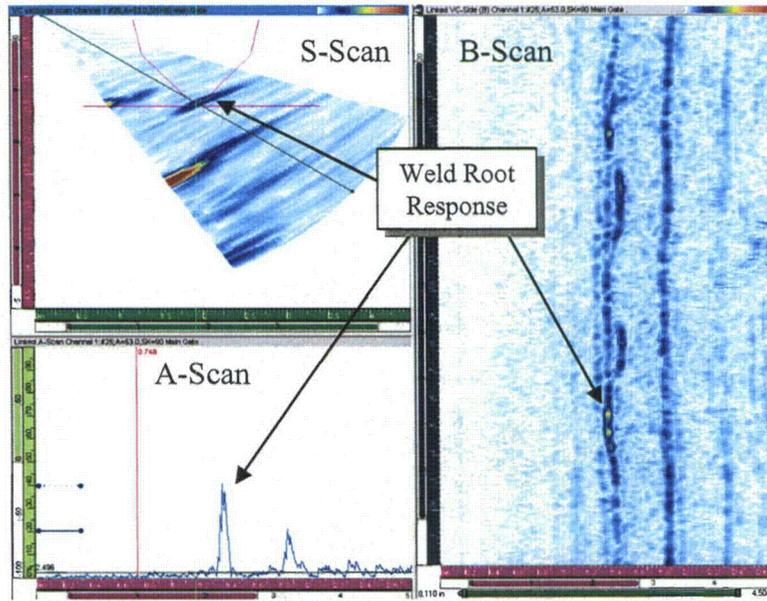
**Figure 2.7 Typical Analysis Screen with Mid-Range Angle ( $53^\circ$ ) Selected, Showing Weld Root with TRL Array**

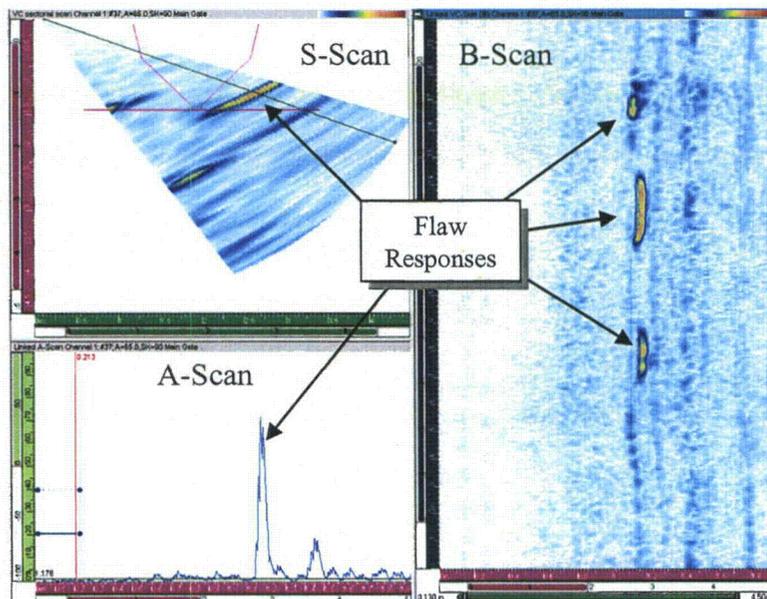
**Figure 2.8 Typical Analysis Screen with High Angle ( $65^\circ$ ) Selected, Showing Flaws with TRL Array**

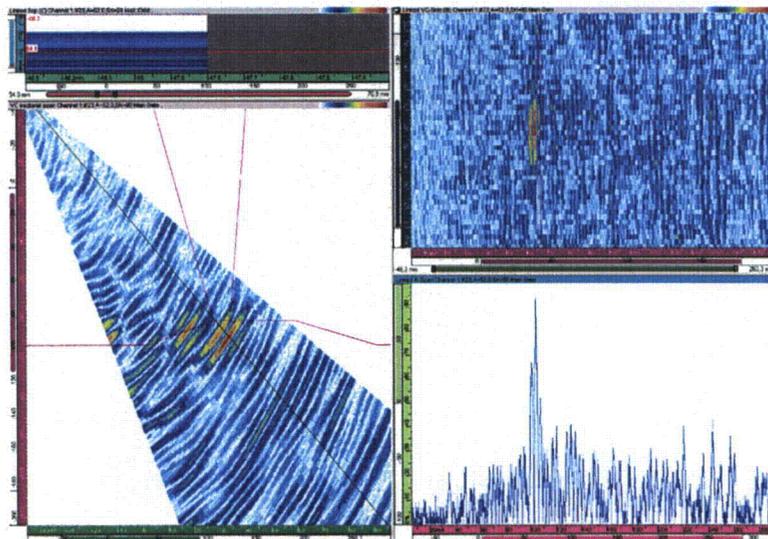
**Figure 2.9 Low-Frequency (500-kHz) Data Acquired from CCSS Side of Specimen in Current Study**

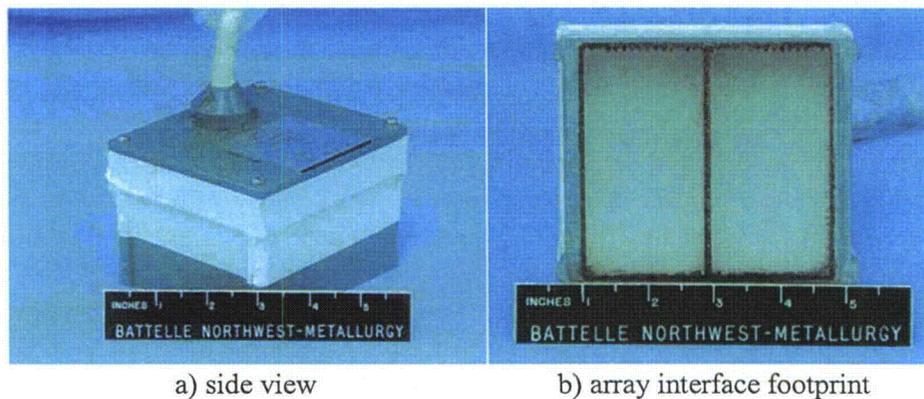
Figure 3.1 500-kHz Prototype Phased Array

Photographs of the first-generation 500-kHz array are shown as Figure 3.1. As can be seen, the prototype has a very large footprint because of the active aperture length needed for sound field focusing, the radiating area of each element required for beam steering in the 500-kHz domain, and an integral wedge to enable steered beams up to 70° in stainless steel. The plastic housing and insulating materials also contributed to this large overall footprint. The specifications for this array are shown in Table 3.1.

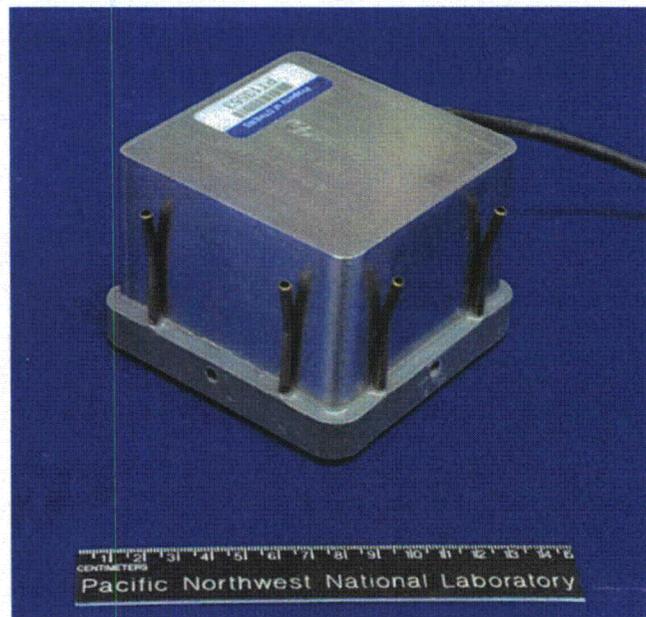
**Figure 3.2 Improved Design 500-kHz Phased Array Probe**

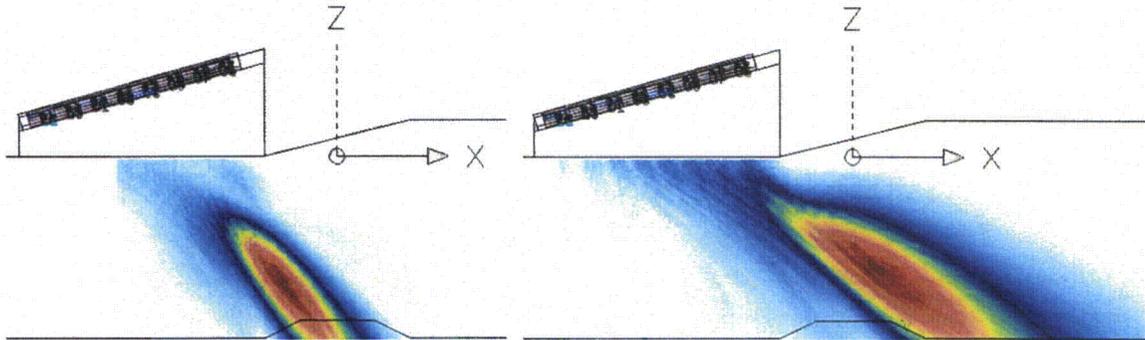
**Figure 3.3 Side View of Sound Profile Generated by 500-kHz Probe with Focal Laws Set To Provide Angle of  $45^\circ$  (left) and  $60^\circ$  (right)**

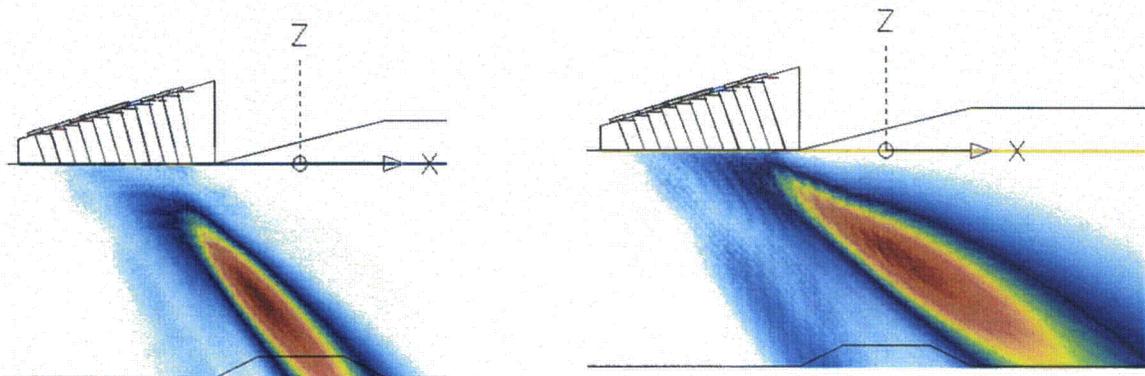
**Figure 3.4 Side View of Sound Profile Generated by 750-kHz Probe with Focal Laws Set To Provide Angle of  $45^\circ$  (left) and  $60^\circ$  (right)**

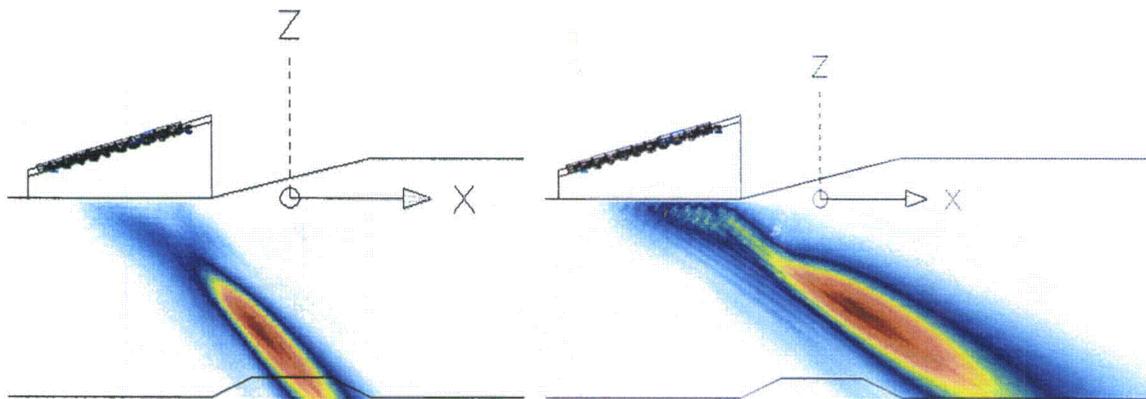
**Figure 3.5** Side View of Sound Profile Generated by 1.0-MHz Probe with Focal Laws Set To Provide Angle of 45° (left) and 60° (right)

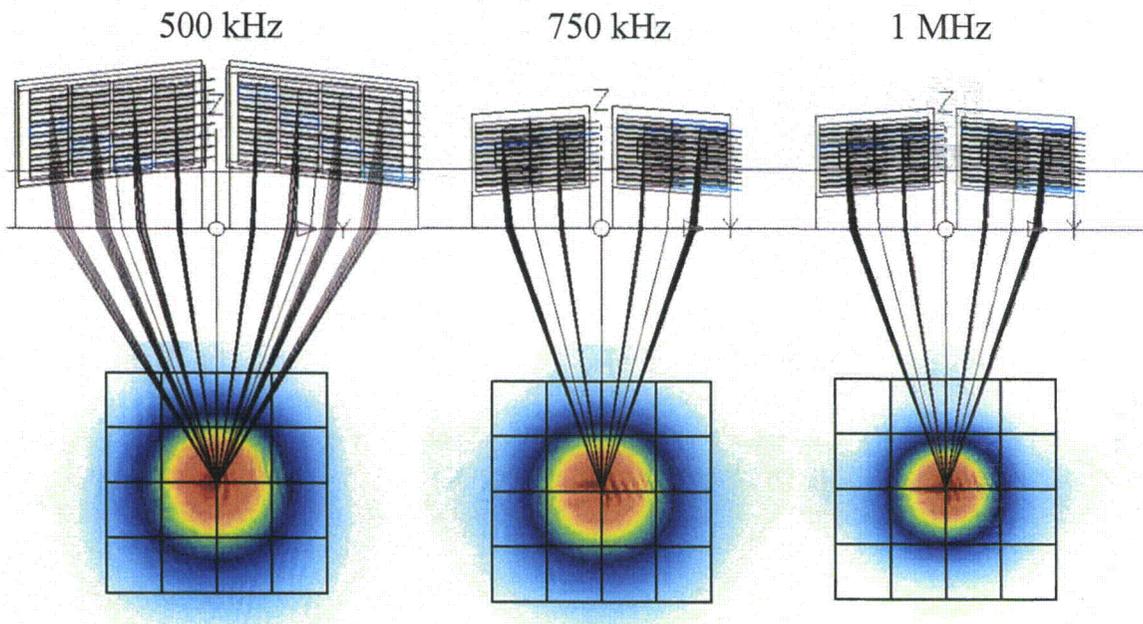
**Figure 3.6** View of Sound Profile Generated by 500-kHz, 750-kHz, and 1.0-MHz Array Probes with Focal Laws Set To Provide Angle of 45°. The grid spacing is 12.7 mm (0.5 in.), and the view is from behind the transducer looking in the direction of sound propagation.

The width of the beam is important for determining the resolution capability of the phased array systems. Figure 3.6 depicts beam sizes for the three arrays used in this study. Theoretical simulations for the 500-kHz array show a primary beam diameter of approximately 20 mm (0.79 in.). The 750-kHz array exhibits a slightly narrower beam, with a diameter of 17 mm (0.67 in.), and the 1.0-MHz array has a theoretical beam width of 14 mm (0.55 in.).

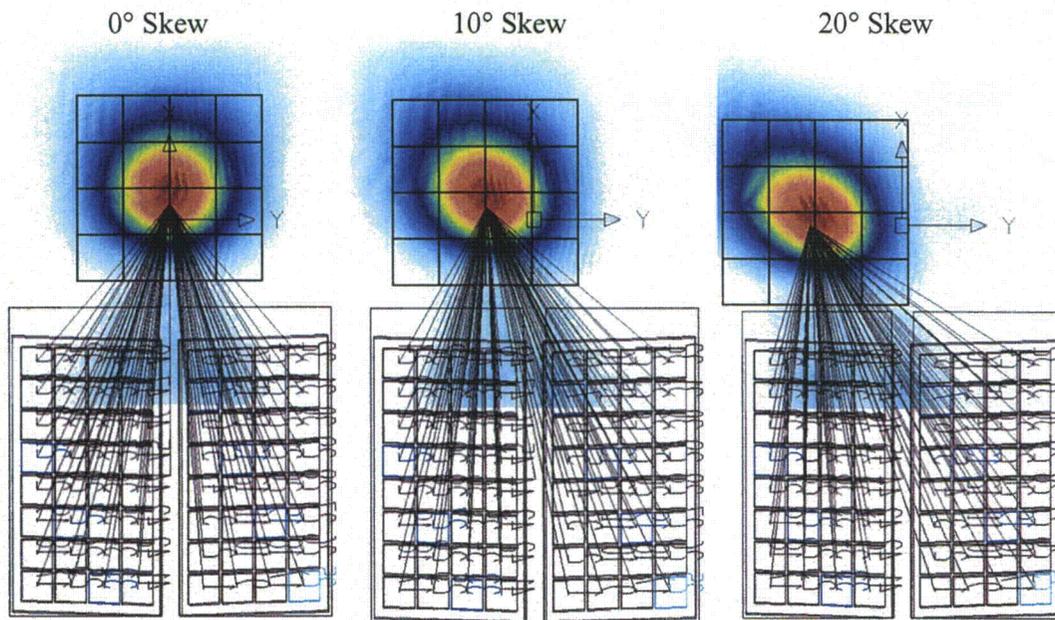
**Figure 3.7 Skewing Capabilities of 4 × 8 matrix 500-kHz Probe. The grid spacing is 12.7 mm (0.5 in.).**

the sound field of the 500-kHz probe when skewed from 0° to 10° and 20°. Although some elongation of the field is exhibited, the primary beam is not radically changed.

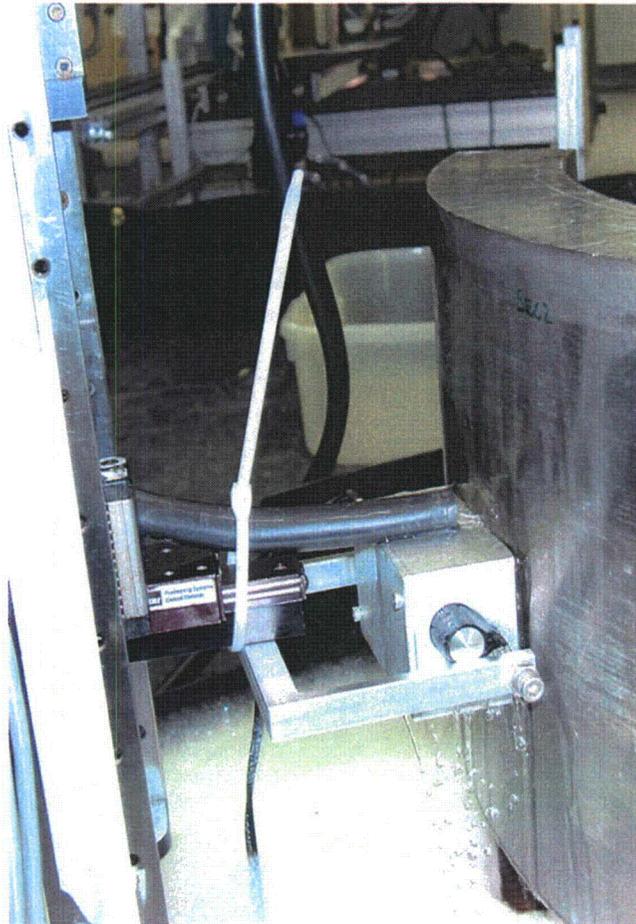
**Figure 3.8 Variable-Angle Low-Frequency/SAFT Probe Shown on Westinghouse Piping Segment**

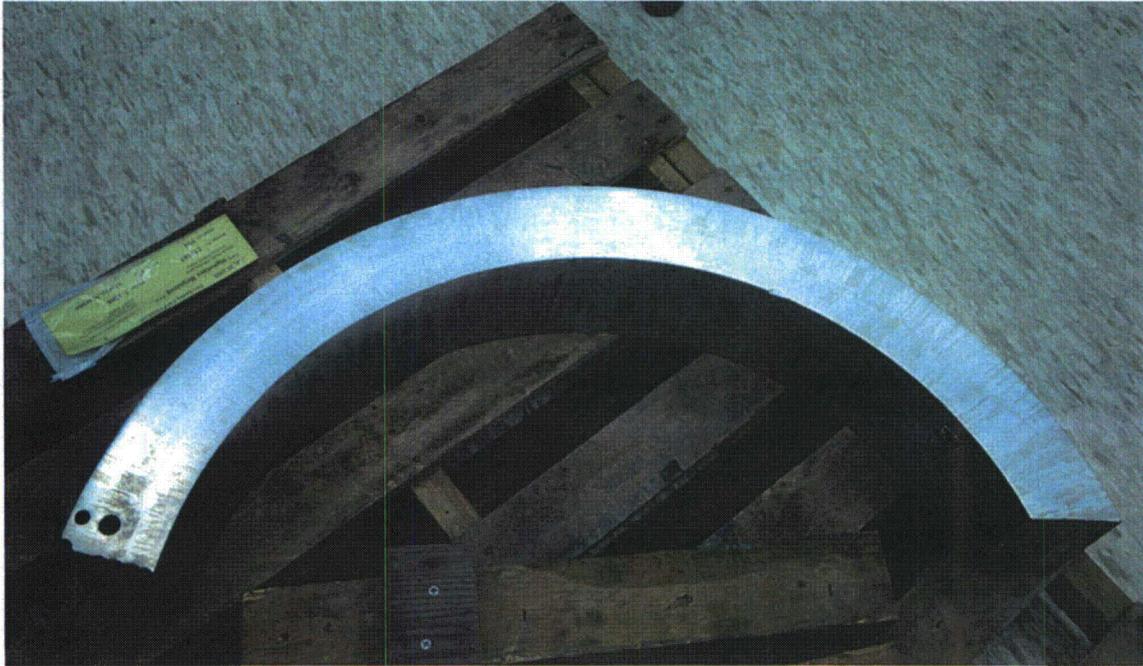
**Figure 4.1 Centrifugally Cast Stainless Steel Piping Segment Loaned by IHI Southwest Technologies, Inc.**

The oldest vintage, or initial CCSS piping fabricated (from early to mid 1960s), is thought to be similar to the IHI Southwest Technologies piping segment, which is 15.24 cm (6 in.) in axial extent by 127 cm (50 in.) in circumferential extent. The segment has an 8.4-cm (3.3-in.) wall thickness and is approximately 91 cm (36 in.) in outside diameter. It consists of coarse-grained, mixed, and banded microstructure and had some surface defects, sawcuts, and notches machined into the specimen but no fabricated or implanted cracks. A photograph of the IHI Southwest Technologies segment is shown in Figure 4.1. This material contains a wide range of grain sizes and structures, with significant layering, as can be seen in Figure 4.2. Note the variation of grain types as a function of circumferential location. This metallurgical configuration represents the most challenging microstructure for ultrasonic examination

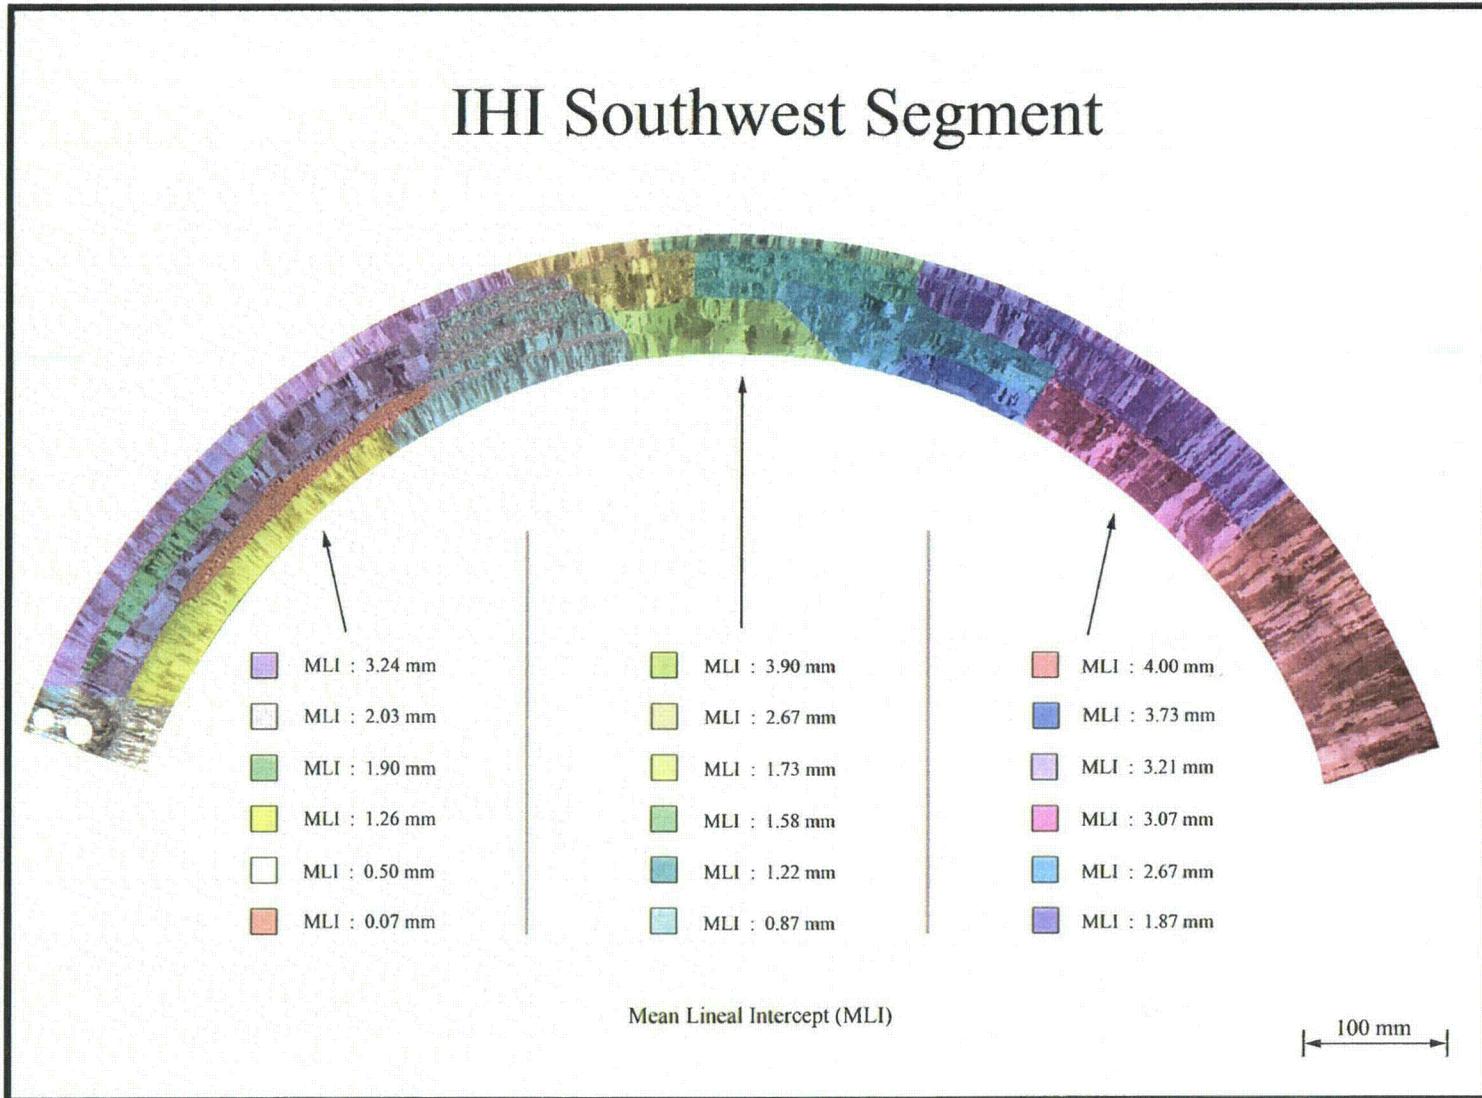
Figure 4.2 False-Color Map Depicting Variation of Grains in CCSS Piping from IHI Southwest Technologies, Inc.

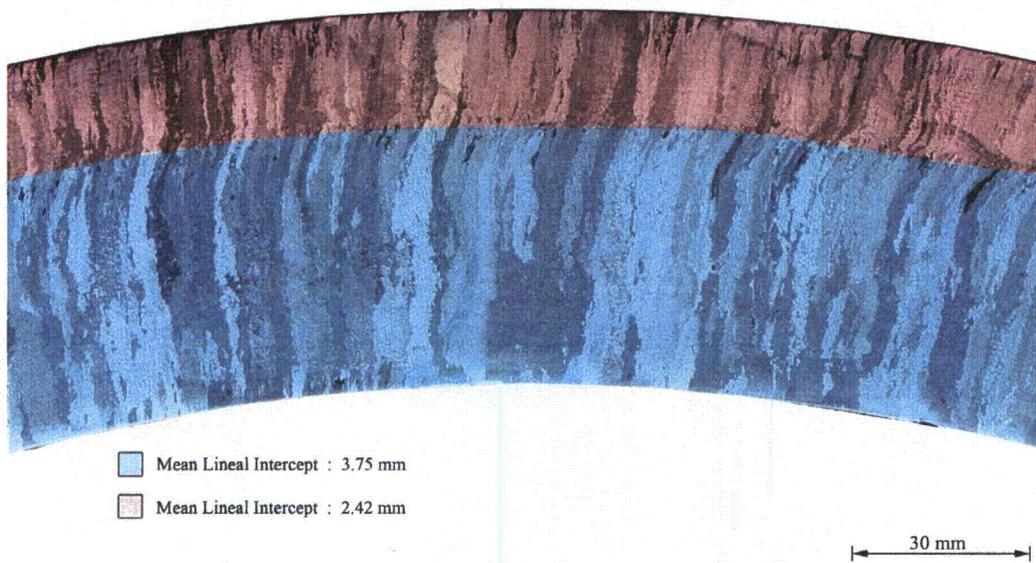
**Figure 4.3** Portion of CCSS Piping Specimen from Westinghouse, Inc., Showing Dendritic Grain Structure Observed to be Consistent Throughout Circumference

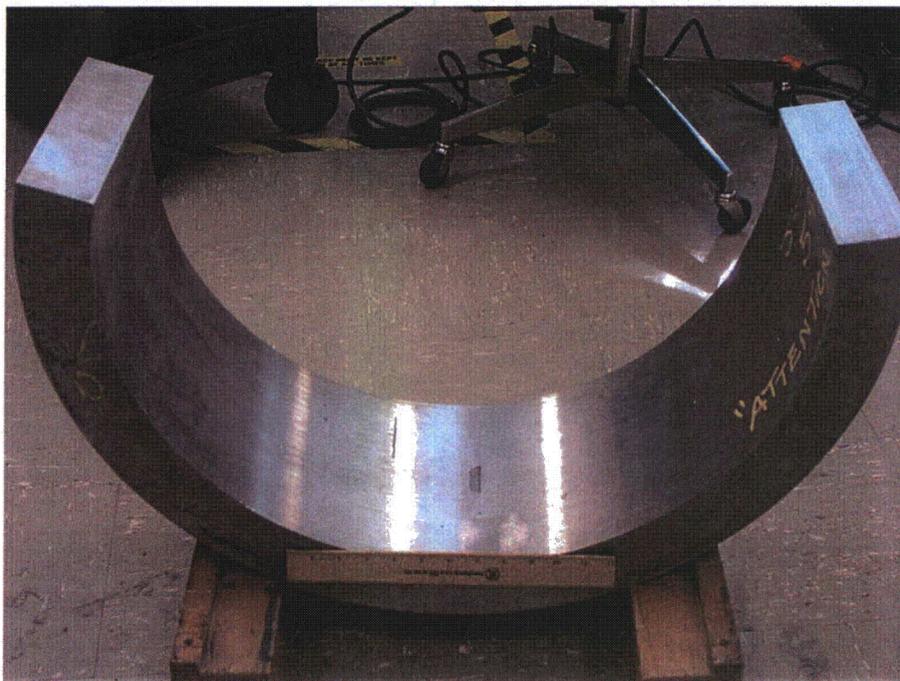
**Figure 4.4** Westinghouse, Inc. CCSS Piping Segment on Loan to PNNL

The next class, or intermediate vintage, of CCSS microstructures is represented by the piping segment on loan from Westinghouse, Inc. This segment is believed to have been fabricated in the late 1960s to mid-1970s and, although the microstructure is still very challenging to examine, shows consistent grain orientation and size throughout the circumference, which may indicate the casting process was becoming more refined. The Westinghouse segment is 25.4 cm (10 in.) in axial extent by 130 cm (51 in.) in circumferential length, with a 6.4-cm (2.5-in.) wall thickness and an approximately 71-cm (28-in.) outside diameter. This segment exhibits a coarse-grained, dendritic (columnar) microstructure with a banding condition evident as well. Figure 4.3 shows a portion of the circumferentially consistent microstructure of the Westinghouse segment. The specimen contains some minor surface defects, sawcuts, and small notches machined into the surface but no fabricated or implanted cracks. This segment was also polished, etched, and photographed; then a lineal intercept method applied to determine the grain sizes shown in Figure 4.3. A photograph of the Westinghouse segment is shown in Figure 4.4.

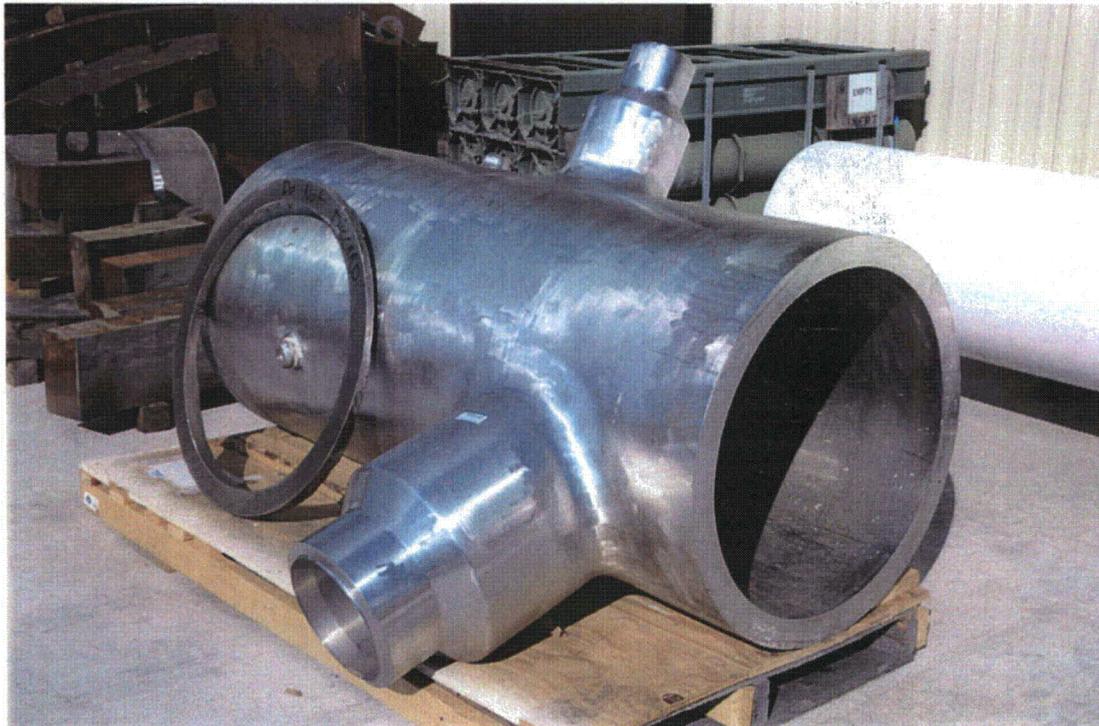
**Figure 4.5 Large Blank Spool Piece on Late-Vintage CCSS Piping from Cancelled Spanish Plant on Loan to PNNL by EPRI**

The most recently fabricated CCSS base material was loaned to PNNL by EPRI and was extracted from a cancelled nuclear power plant in Spain. The large blank spool piece (see Figure 4.5) has consistent fine-grained CCSS microstructure. The piece is 1.86 m (6.1 ft) in length, with a 6.35-cm (2.5-in.) wall thickness and an outside diameter of 86.4 cm (34.0 in.). A ring at one end of the spool piece was cut off, polished, and chemically etched to obtain digital photographs of the material structure. Figure 4.6 depicts a region of the polished and chemically etched ring, which shows the relatively fine (for CCSS) equiaxed microstructure and approximate grain size, present over the entire circumference of the segment. Again, the grain size determination was performed by the lineal intercept method as described previously. This type of microstructure is believed to represent the latest class of CCSS piping installed in primary coolant systems of later vintage Westinghouse-designed plants (circa mid-1970s through mid-1980s). Of all CCSS piping examined in this study, this microstructure is believed to be the least challenging to ultrasonic testing. This premise is to be tested in forthcoming studies.

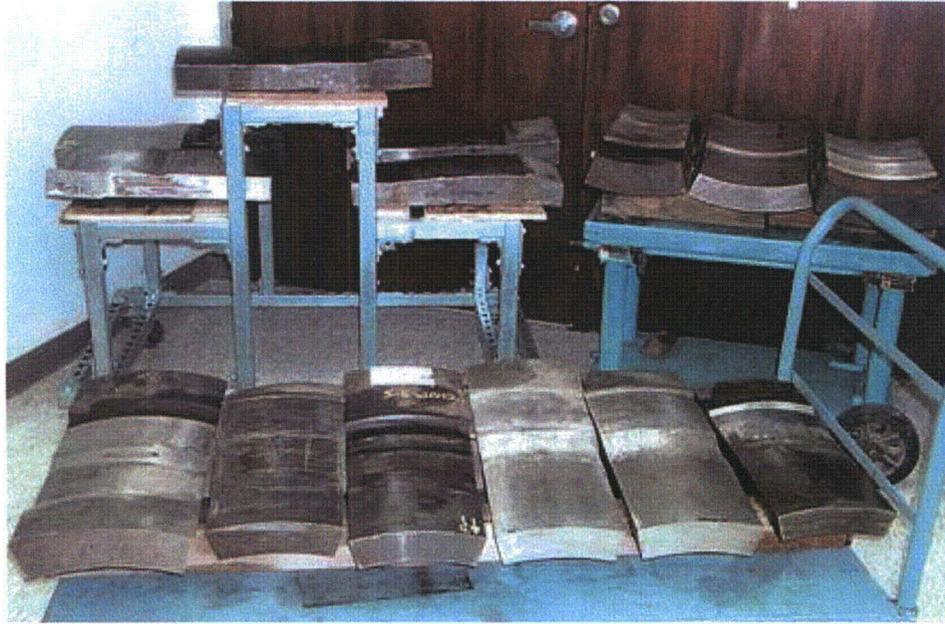
**Figure 4.7 Westinghouse Owners Group Specimens Showing Varied Inside and Outside Surface Geometries Typical of Field-Installed Components**

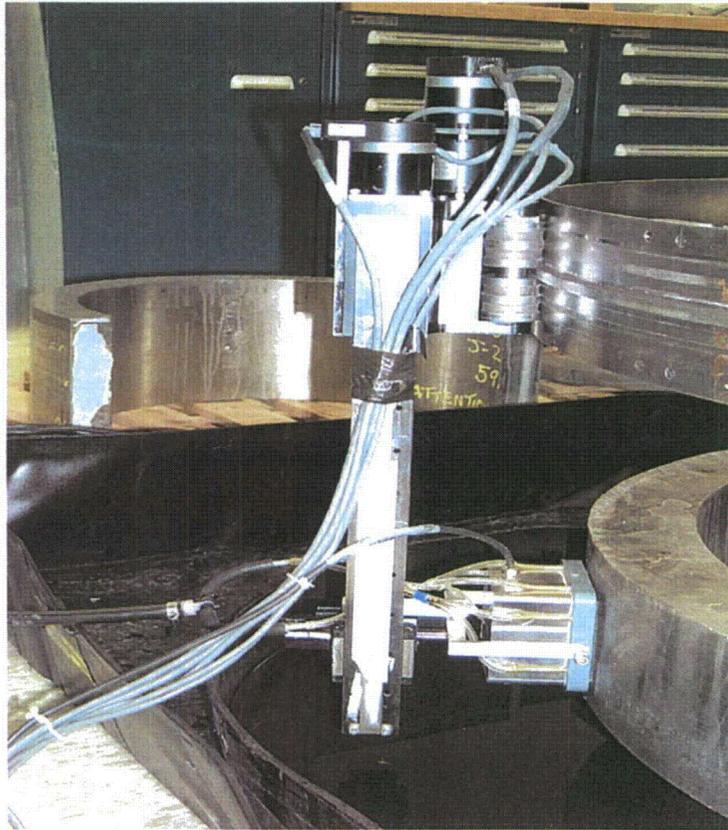
**Figure 5.1** Laboratory Setup for Phased Array Data Acquisition on the IHI-SW Vintage Piping Segment

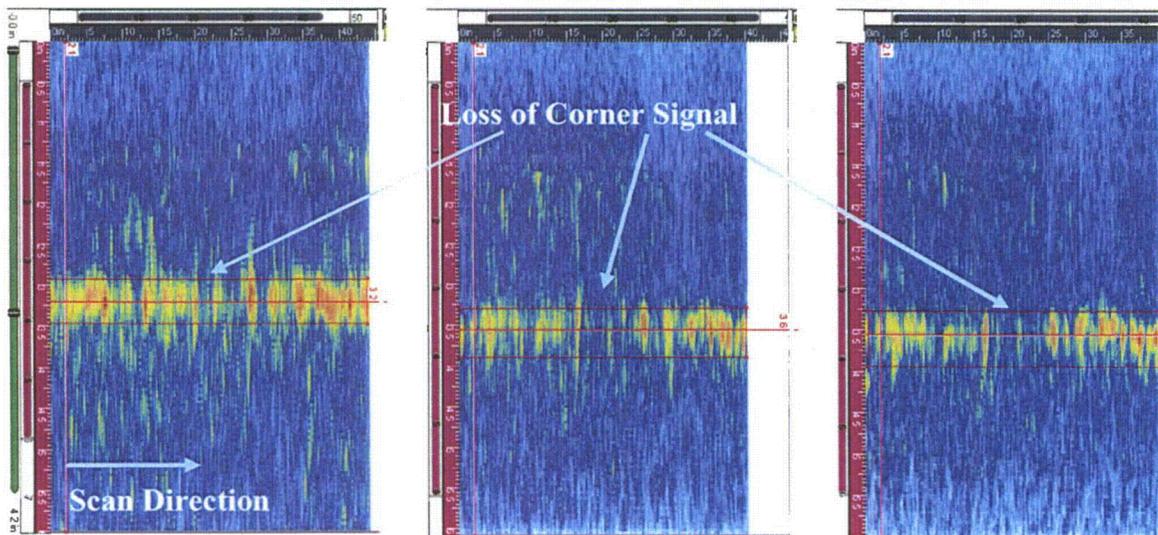
**Figure 5.2** Merged B-Scan Views of IHI-SW Segment Corner Signal at 500 kHz (left), 750 kHz (center), and 1.0 MHz (right). Scan length is 112 cm (49 in.), 102 cm (40 in.), and 98 cm (39 in.), respectively.

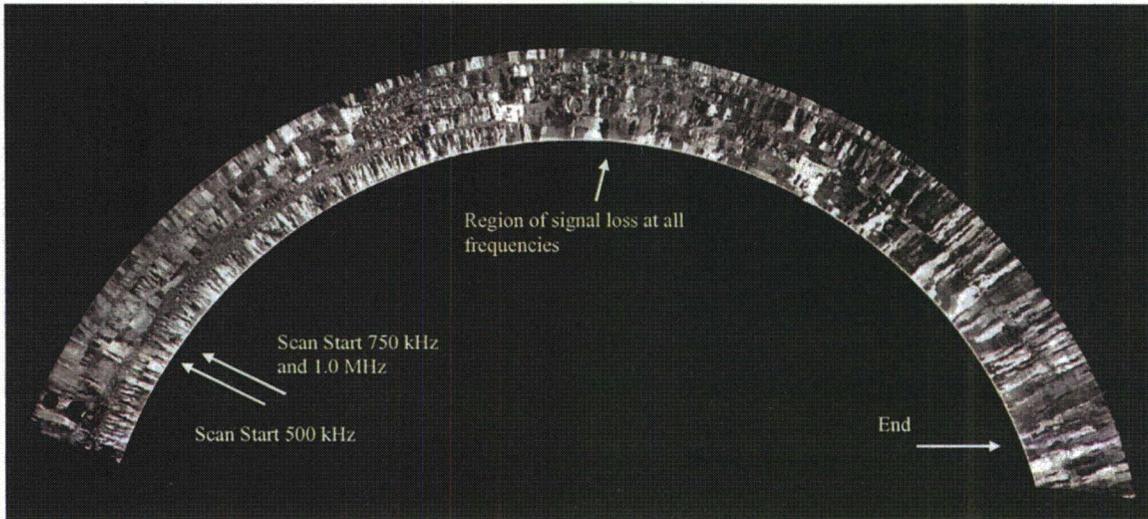
**Figure 5.3 Polished and Etched Surface of IHI-SW Segment. Shown are the phased-array scan start and end as well as the approximate region of corner signal loss noted in the 750-kHz and 1.0-MHz scans.**

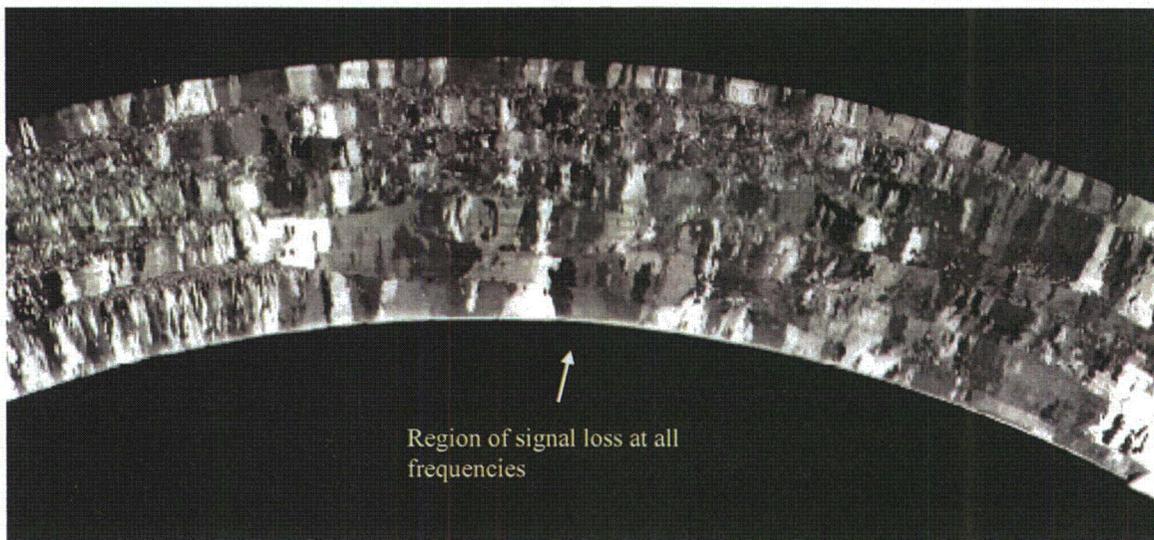
**Figure 5.4 Blowup of the Region of Signal Loss**

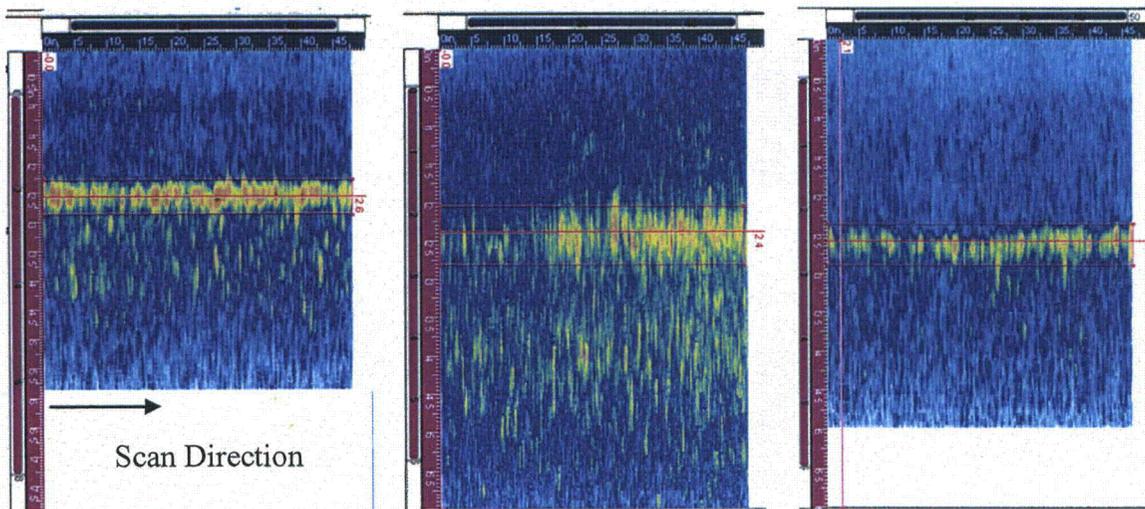
**Figure 5.5** Merged B-Scan Views of Westinghouse Segment Corner Signal at 500 kHz (left), 750 kHz (center), and 1.0 MHz (right). Scan length is 121 cm (48 in.), 120 cm (47 in.), and 118 cm (46 in.), respectively.

The Westinghouse polished and etched surface appears more columnar throughout the segment, with both the 500-kHz and 1.0-MHz data giving a fairly consistent response. At 750 kHz, the corner signal is not present at the start of the scan, and the data appear much noisier.

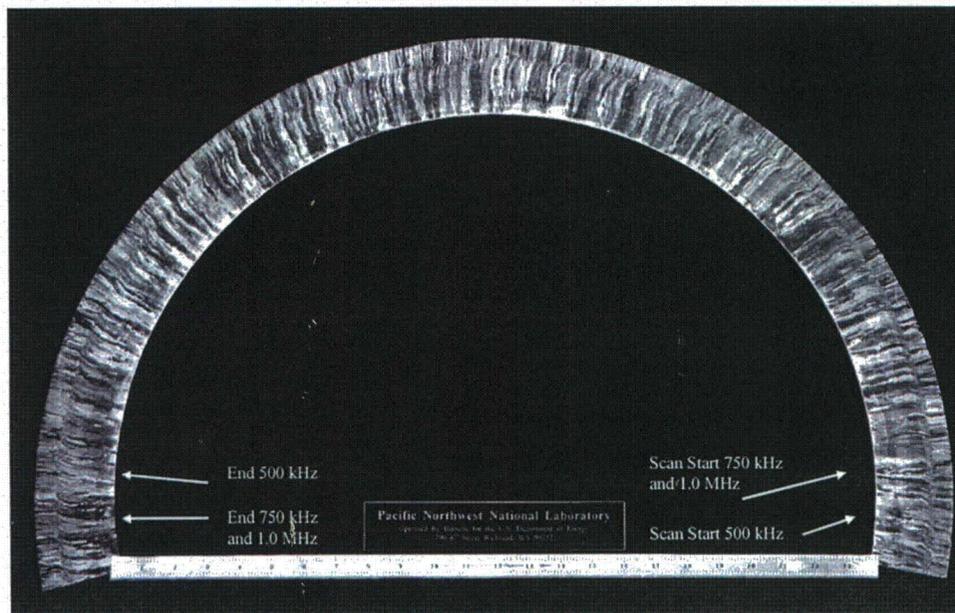
**Figure 5.6** Polished and Etched Surface of Westinghouse Segment. Scan start and end points are shown for the 500-kHz, 705-kHz and 1.0-MHz scans.

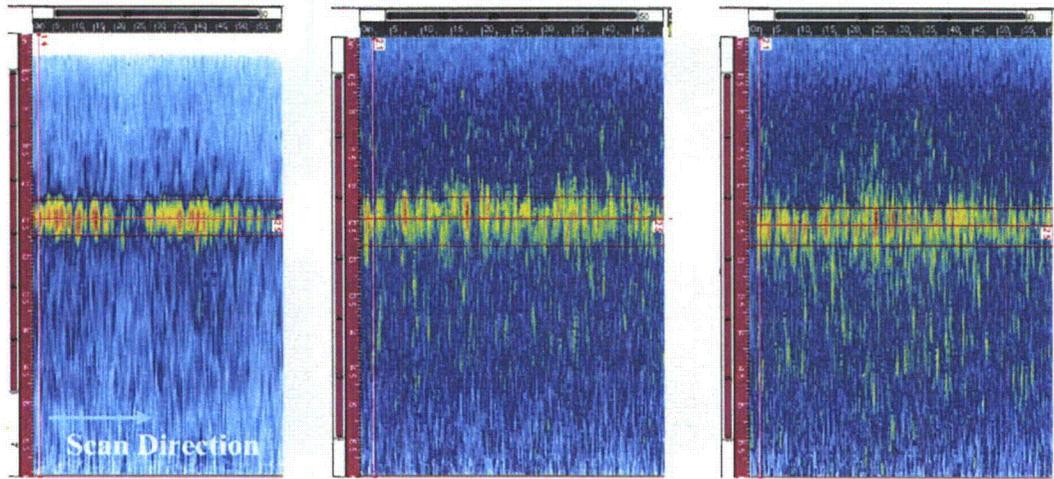
Figure 5.7 Merged B-Scan Views of EPRI Segment Corner Signal at 500 kHz (left), 750 kHz (center) and 1.0 MHz (right). Scan length is 127 cm (50 in.), 155cm (61 in.), and 155 cm (61 in.), respectively.

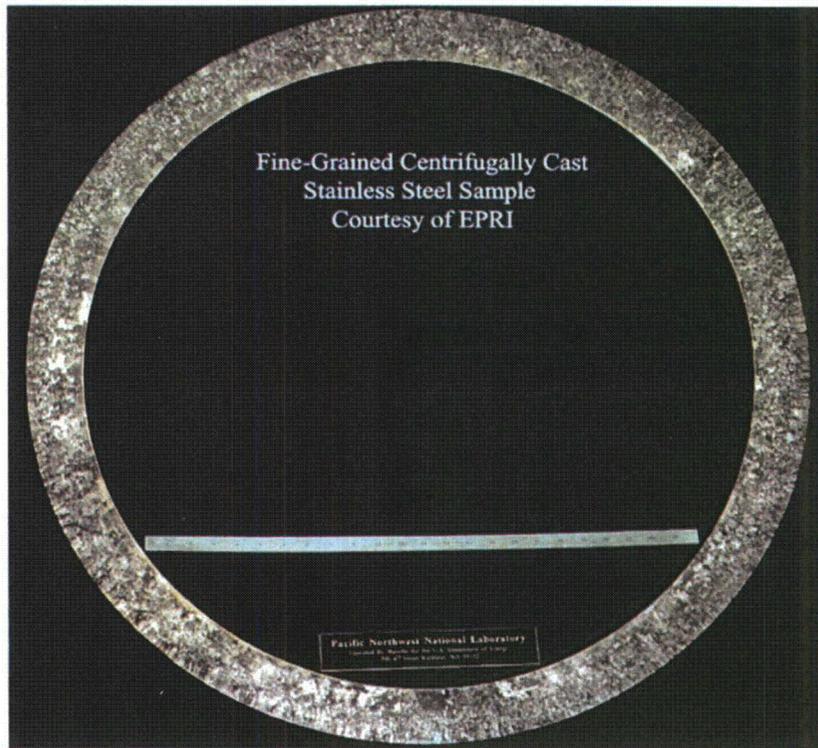
Figure 5.8 Polished and Etched Surface of EPRI Segment

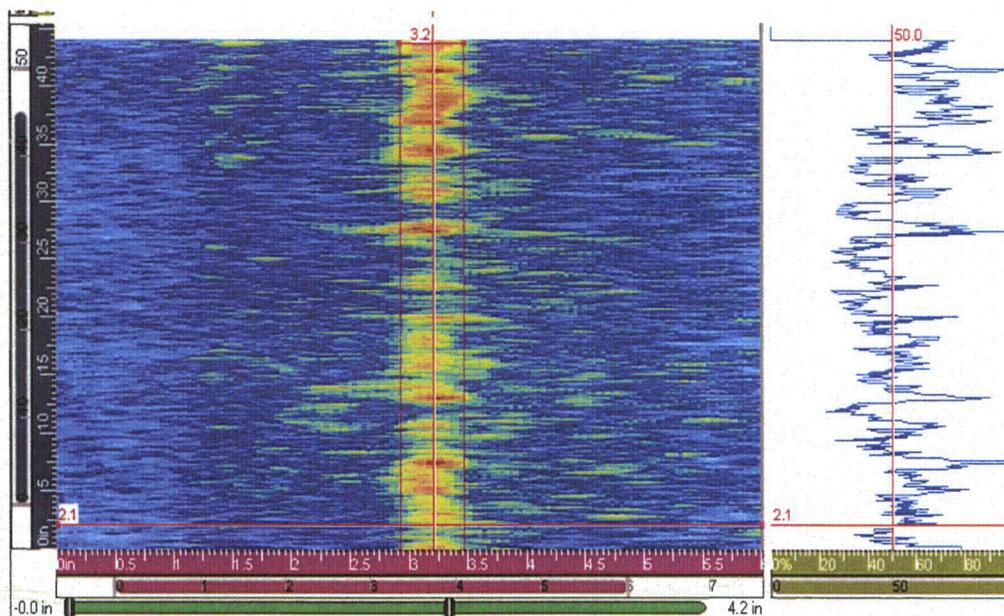
**Figure 5.9 Merged B-Scan Image of IHI-SW Segment Corner Response at 500 kHz. Shown are echo-dynamics and amplitude contour mapping.**

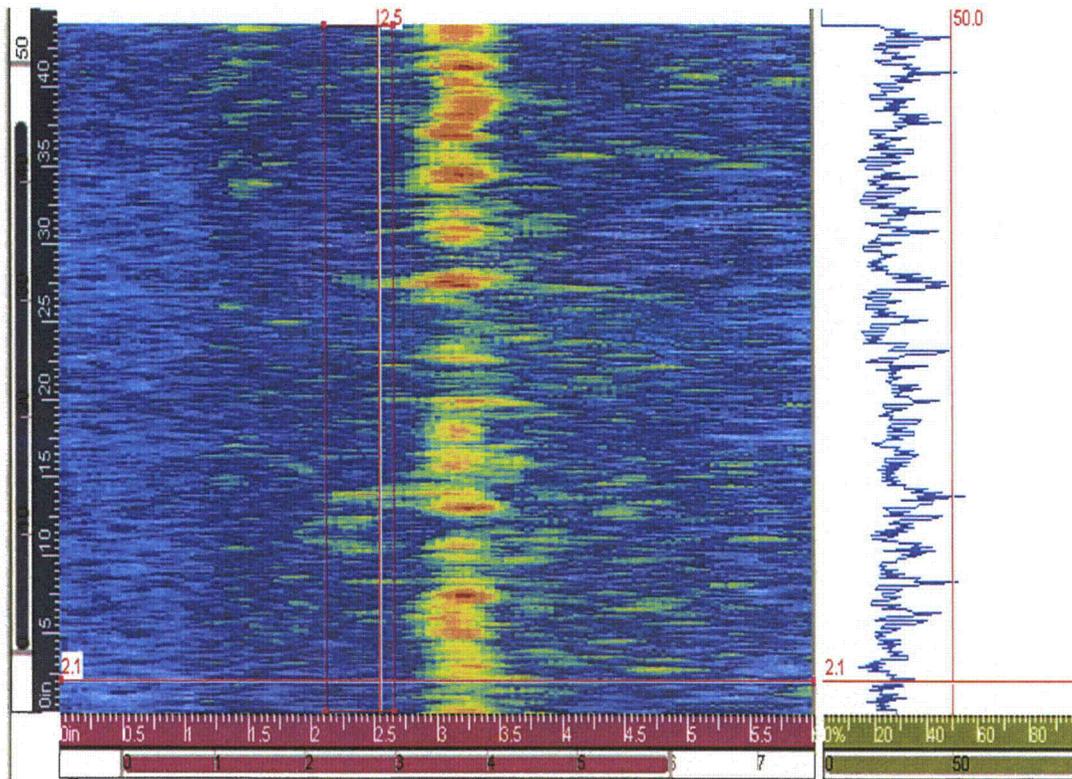
**Figure 5.10 Merged B-Scan Image of IHI-Southwest Segment Noise Response at 500 kHz. Shown are echo-dynamics and amplitude contour mapping.**

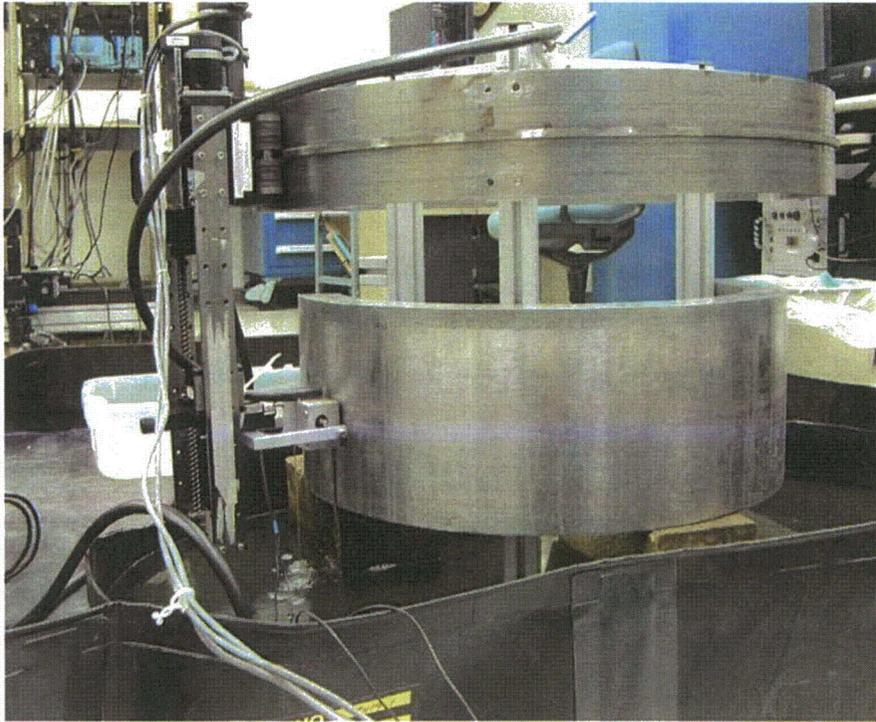
**Figure 5.11 Low-Frequency Scan Apparatus for Westinghouse and IHI-Southwest Segments**
