NUREG/CR-6933  
PNNL-16292

**Assessment of Crack Detection in  
Heavy-Walled Cast Stainless  
Steel Piping Welds Using  
Advanced Low-Frequency  
Ultrasonic Methods**

**Pacific Northwest National Laboratory**

**U.S. Nuclear Regulatory Commission  
Office of Nuclear Regulatory Research  
Washington, DC 20555-0001**

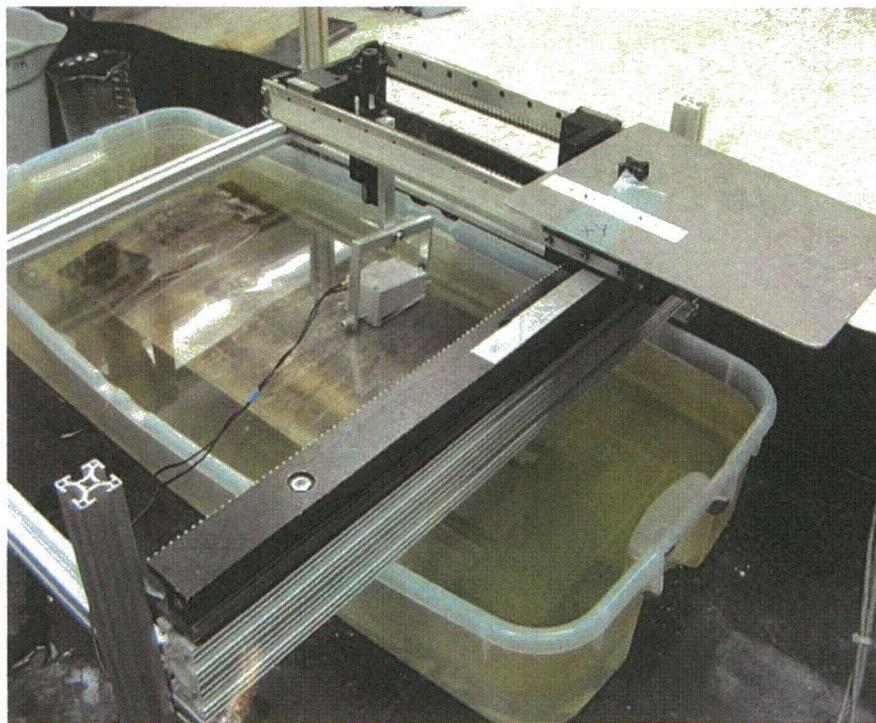
**Figure 5.12 Low-Frequency Scan Apparatus for WOG Specimens**

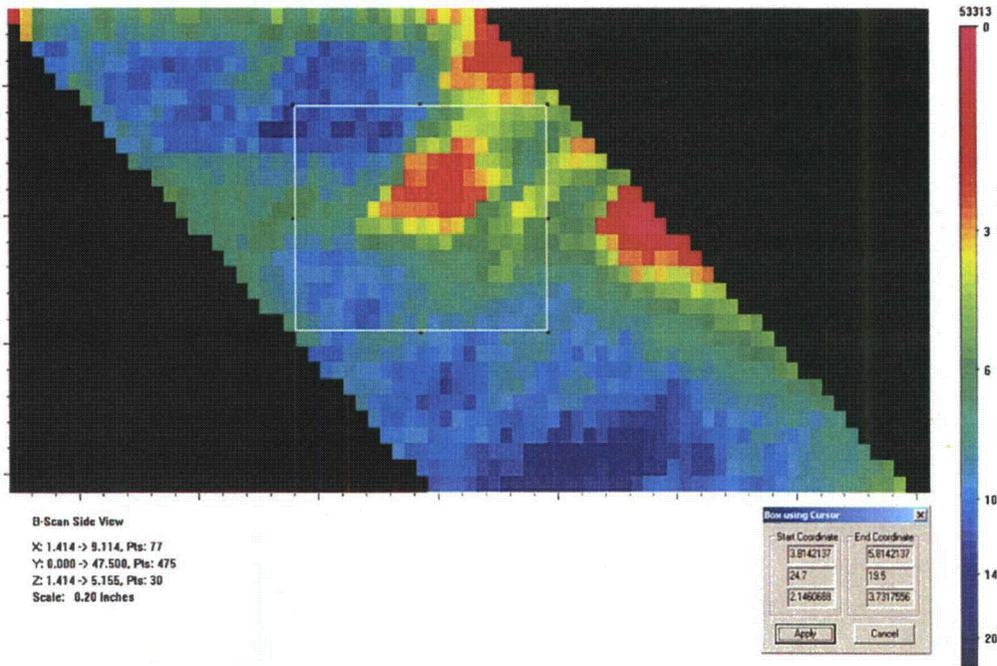
**Figure 5.13 Corner Trap Selected Area Outlined in White Box Shown in B-Scan Side View (25.4 mm = 1.0 in.)**

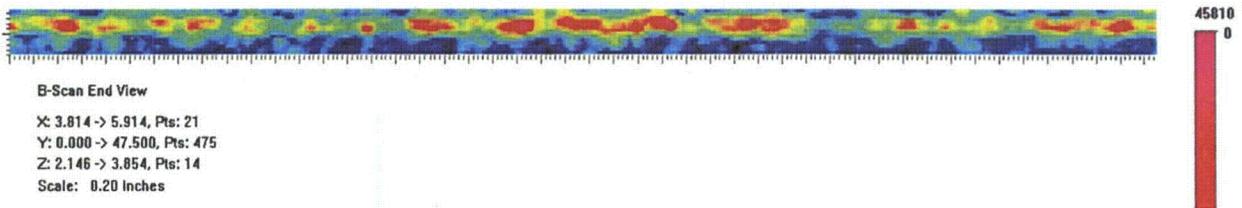
**Figure 5.14 B-Scan End View of Corner Trap Selected in B-Scan Side View (25.4 mm = 1.0 in.)**

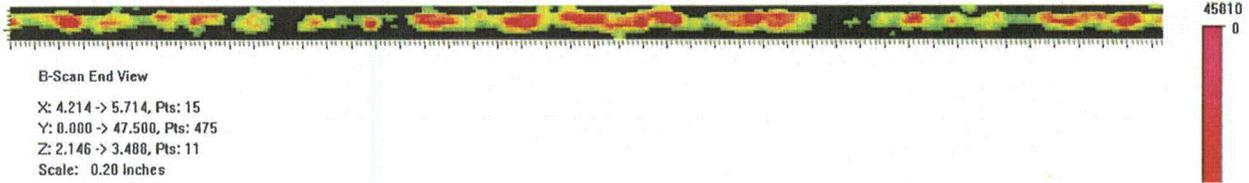
**Figure 5.15 Results of 6-dB Clip Used in B-Scan End View (25.4 mm = 1.0 in.)**

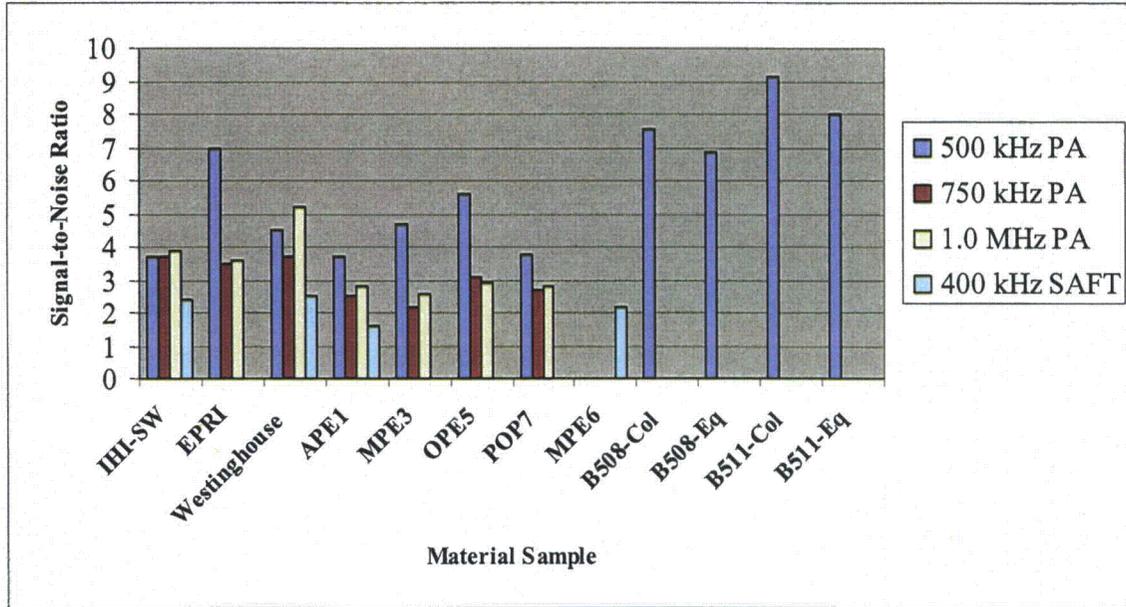
**Figure 5.16 Signal-to-Noise Values for CCSS Base Material As Determined from Examining Specimen End (Corner-Trap Response)**

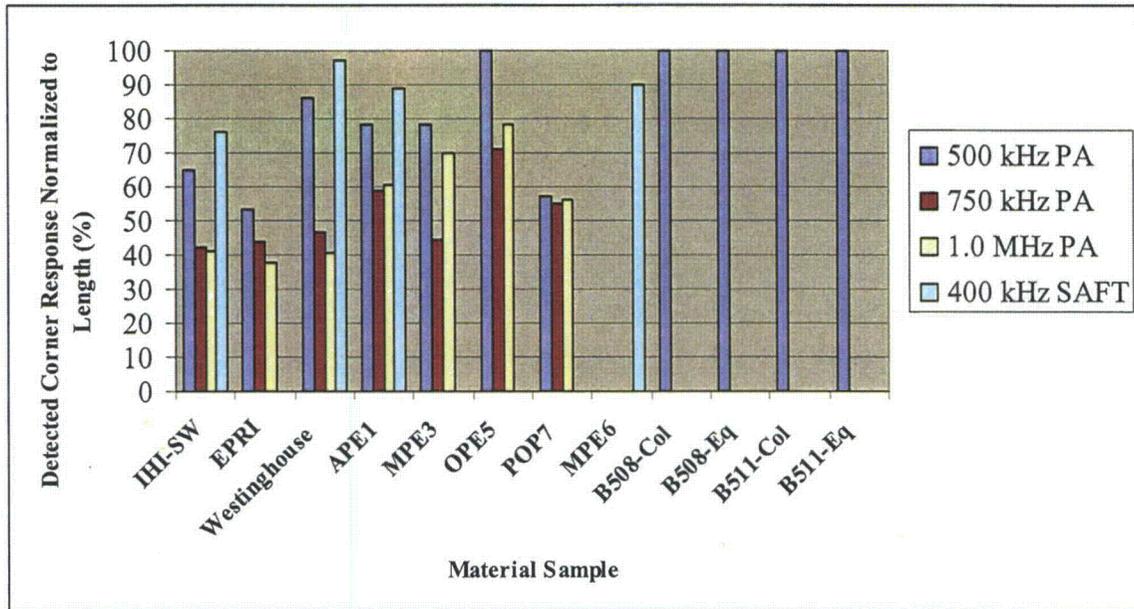
Figure 5.17 Detected Corner Response Values for Base Material As Determined from Inspecting End of CCSS Specimens

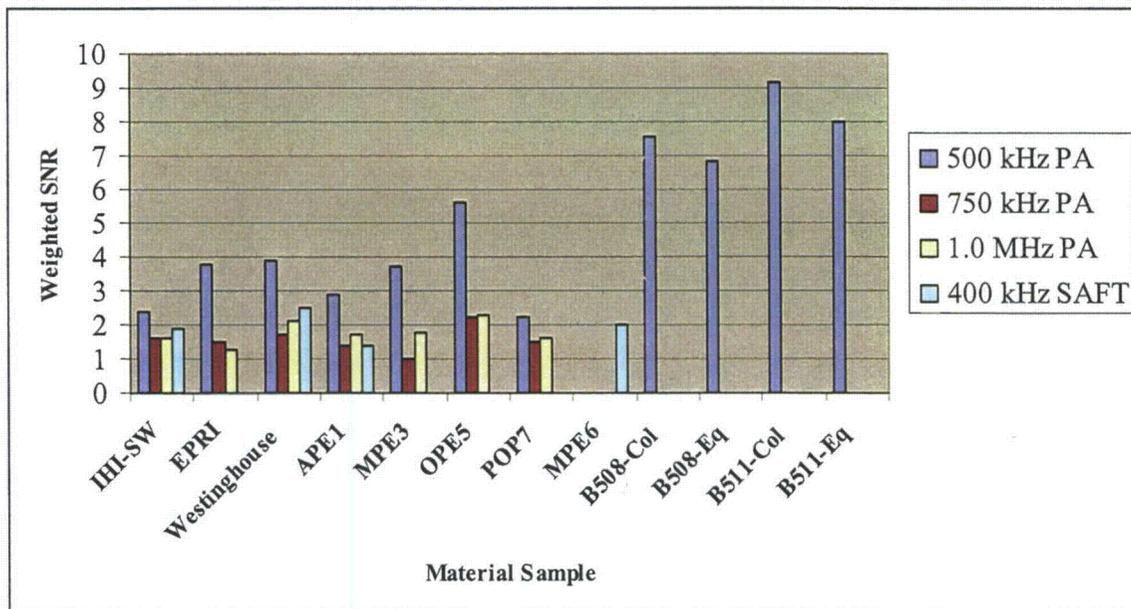
Figure 5.18 Weighted Signal-to-Noise Ratio for Base CCSS Specimens. The ratio has been weighted by the corresponding corner signal detection factor.

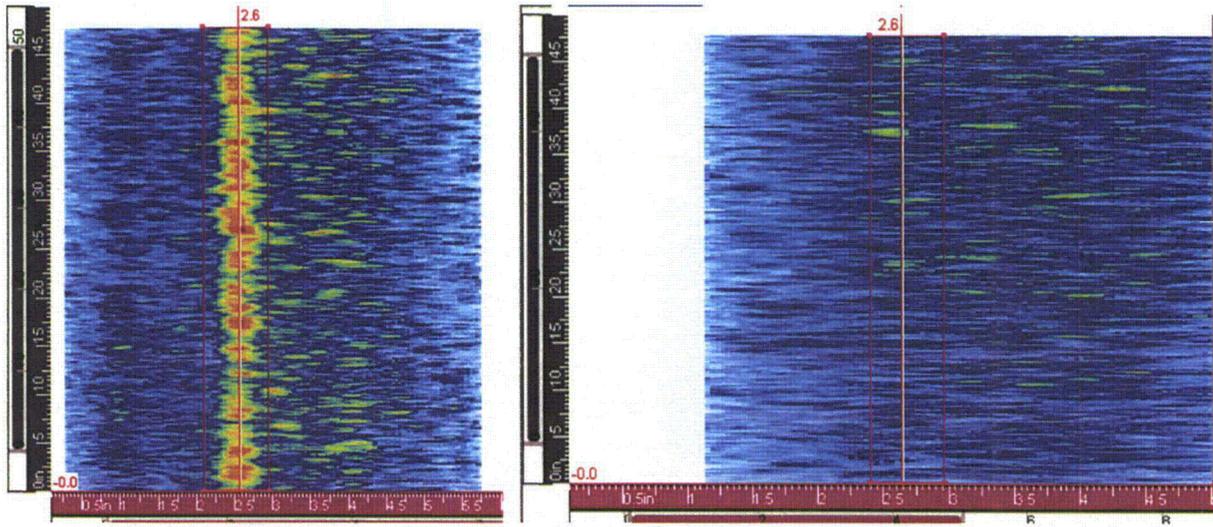
**Figure 5.19 CCSS Material Noise Scans.** The corner response from the Westinghouse piping segment is shown on the left; baseline noise with no geometrical reflectors is shown on the right. Scan length was 127 cm (50 in.) at 500 kHz.

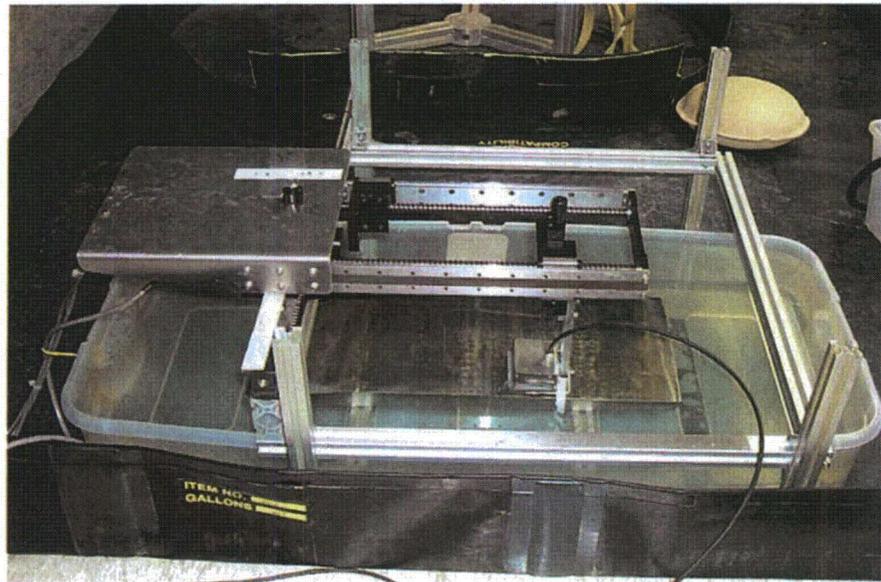
**Figure 6.1 Laboratory Setup for Phased Array Data Acquisition on Westinghouse Owners Group Specimens**

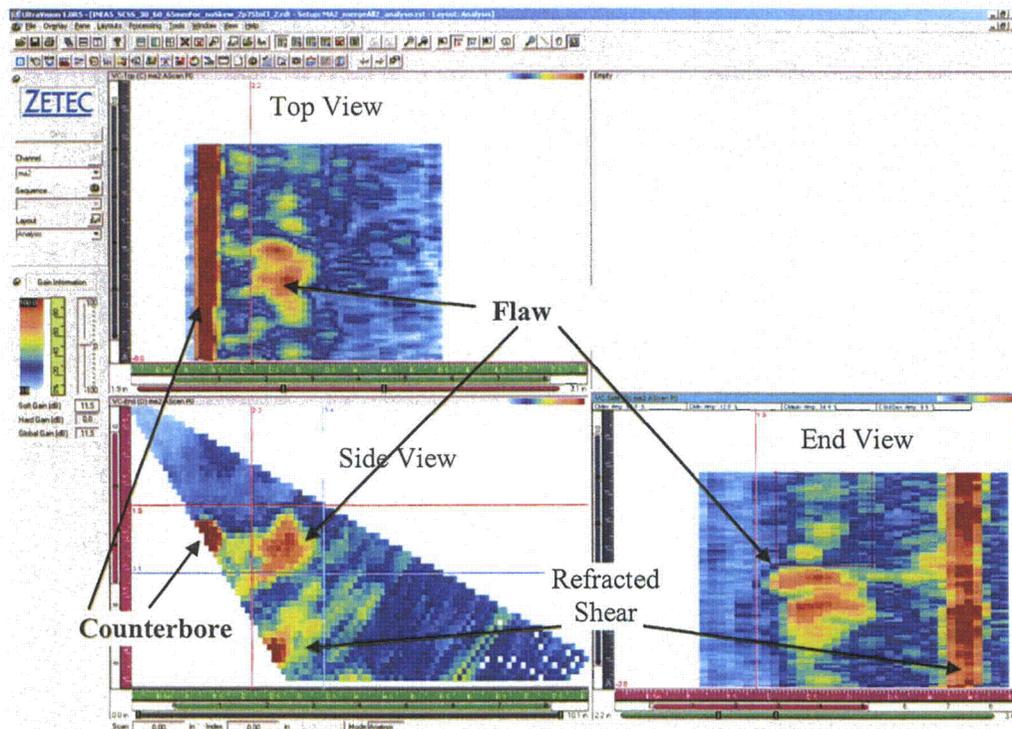
Figure 6.2 Merged Data File Showing Top, End, and Side Views for Longitudinal Inspection Mode

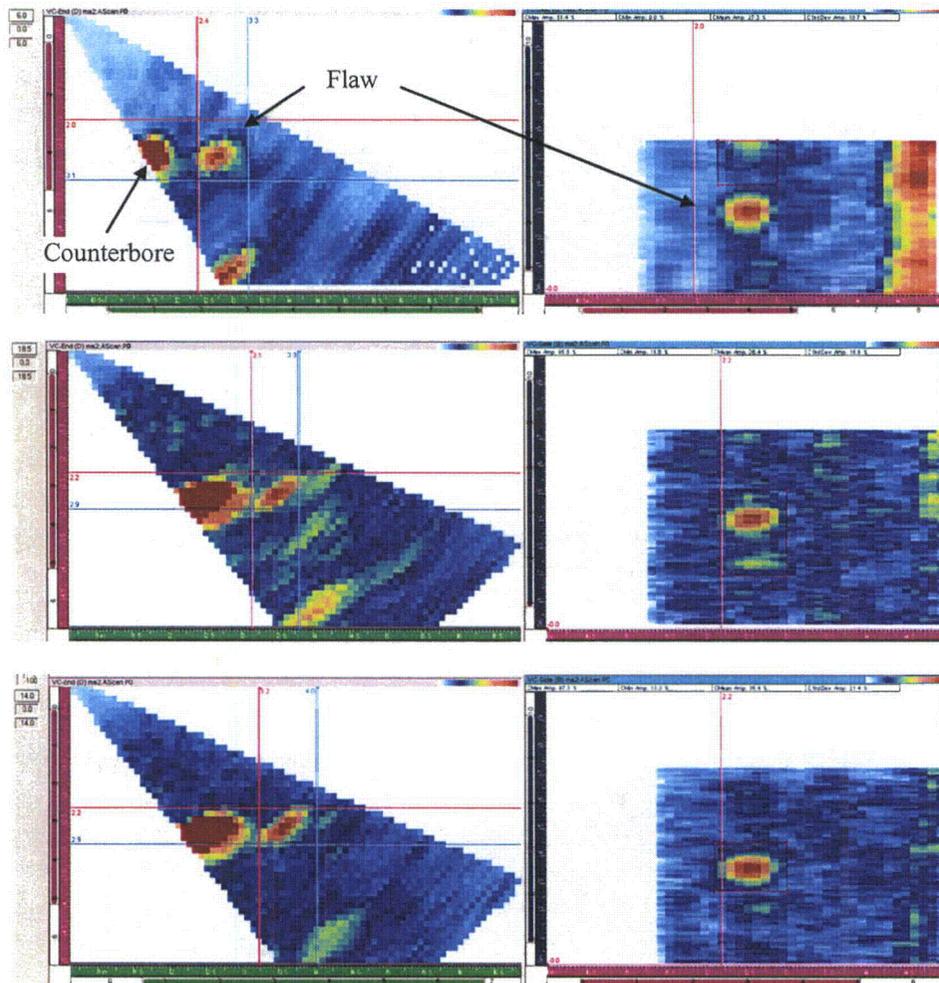
**Figure 6.3 MPE3 SCSS Merged Data at 500 kHz, 750 kHz, and 1.0 MHz, Top to Bottom. The flaw is detected at all three frequencies.**

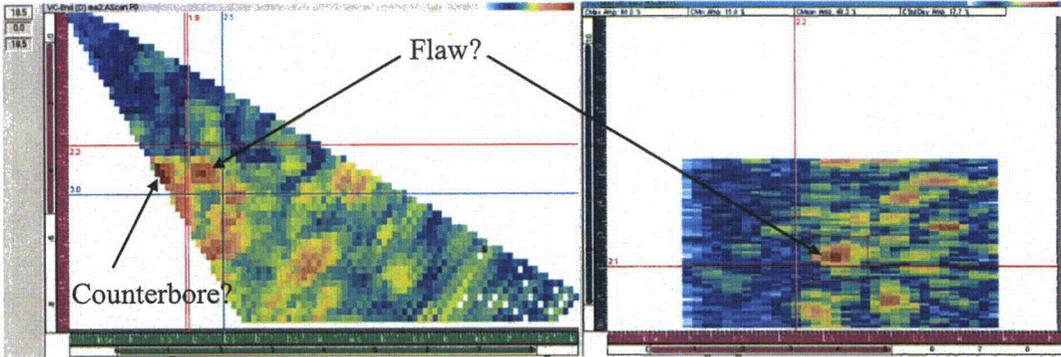
**Figure 6.4 Thermal Fatigue Crack in ONP-3-5 As Viewed from CCSS Side at 500 kHz Judged To Be Marginally Detected**

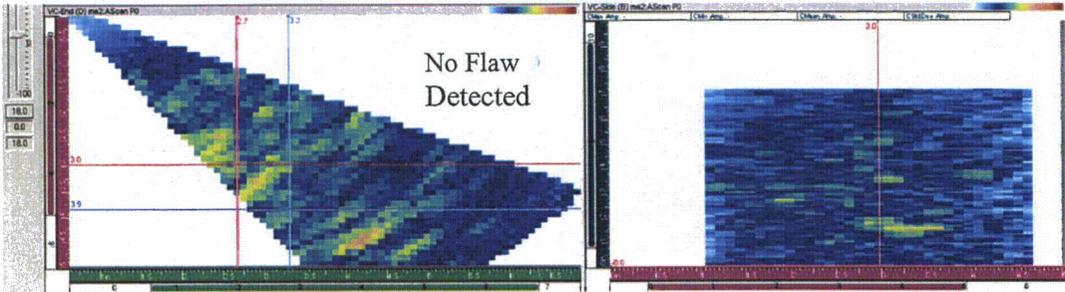
**Figure 6.5 Mechanical Fatigue Crack in Specimen MPE-3 As Viewed from CCSS Side at 1.0 MHz Judged To Be Not Detected**

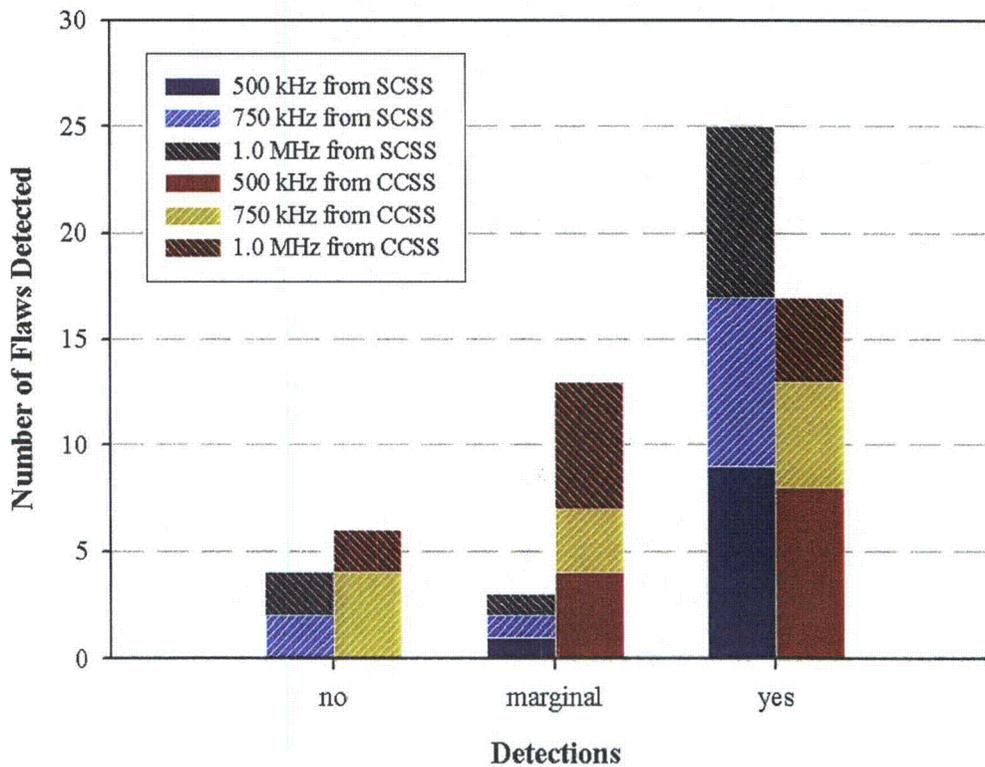
**Figure 6.6 WOG Crack Detections As a Function of Insonification Side of Weld**

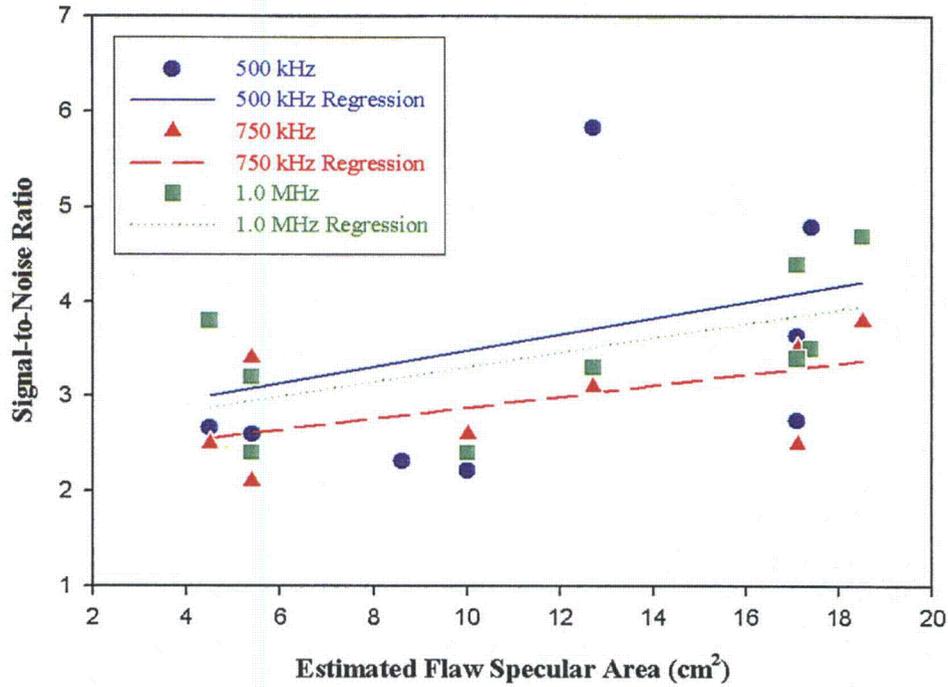
Figure 6.7 Regression Analyses of Detected Flaws Observed from SCSS Side of Welds in WOG Specimens

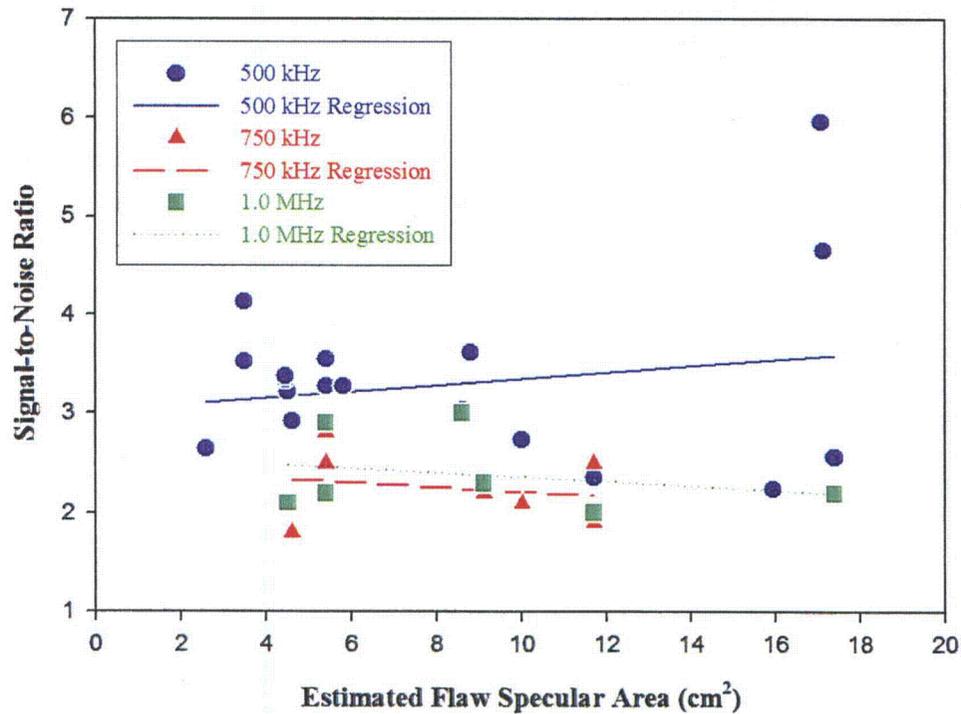
Figure 6.8 Regression Analyses of Detected Flaws Observed from CCSS Side of Welds in WOG and PNNL Specimens

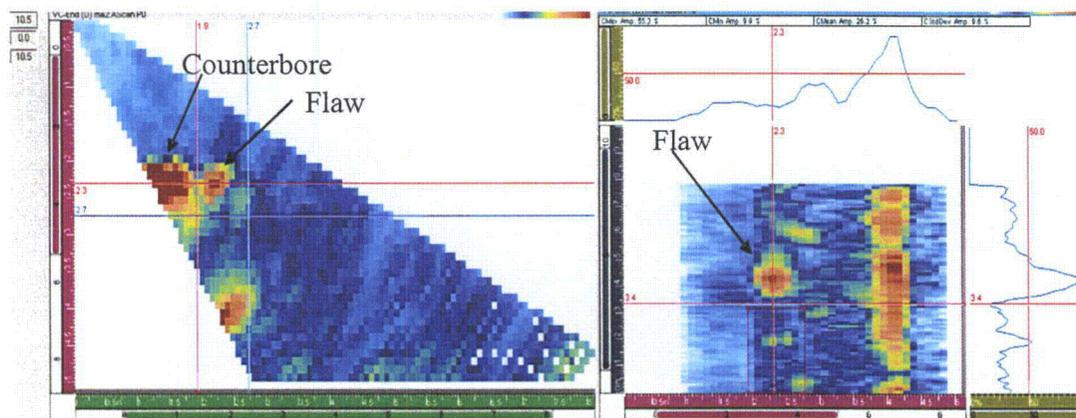
Figure 6.9 Flaw Length Sizing Method As Shown on WOG Specimen OPE-2

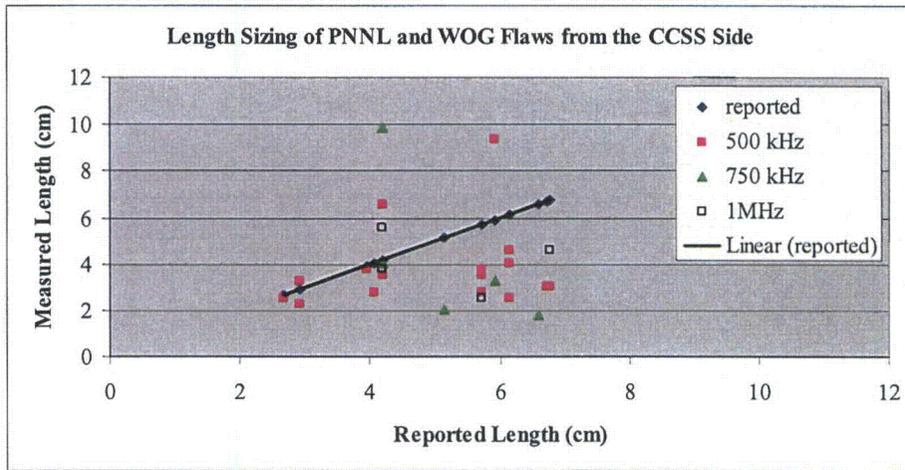
Figure 6.10 Length Sizing Results on Detected WOG and PNNL Flaws Using 6-dB Amplitude Drop as Inspected from CCSS Side of Weld

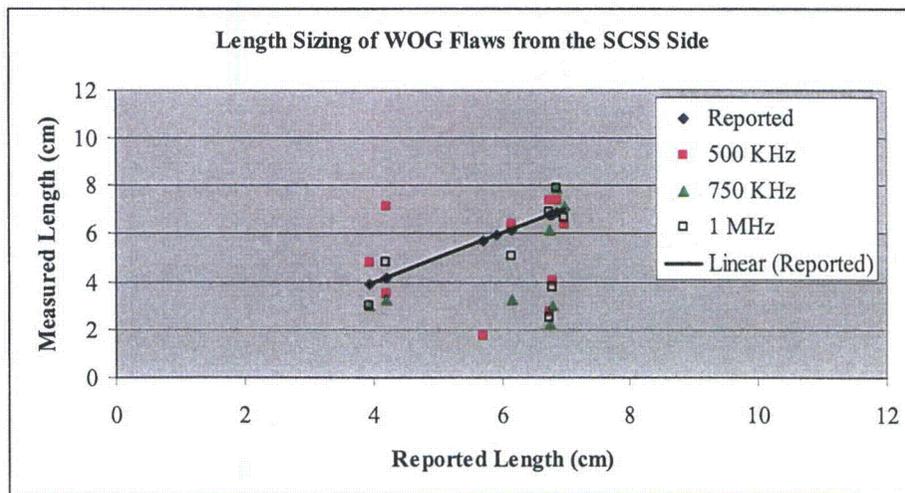
Figure 6.11 Length Sizing Results on Detected WOG Flaws Using 6-dB Amplitude Drop as Inspected from SCSS Side of Weld

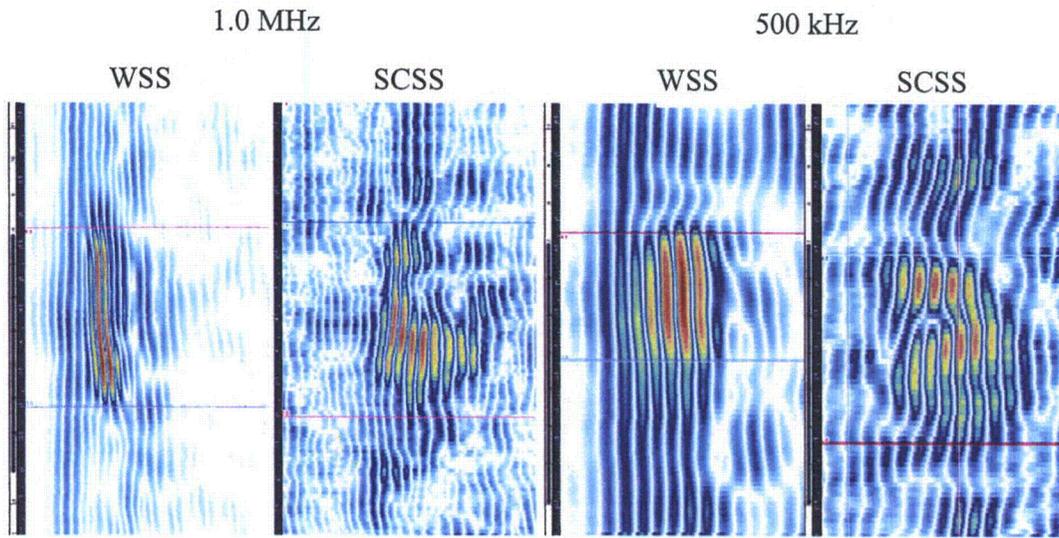
**Figure 6.12 Images for Comparing Length-Sizing Capabilities at 1.0 MHz and 500 kHz in Fine-Grained Stainless Versus Cast Material**
