# **NRC Perspectives on Potential Chemical Effects in Boiling Water Reactors**

**Boiling Water Reactor Owners Group**

**June 5, 2008**

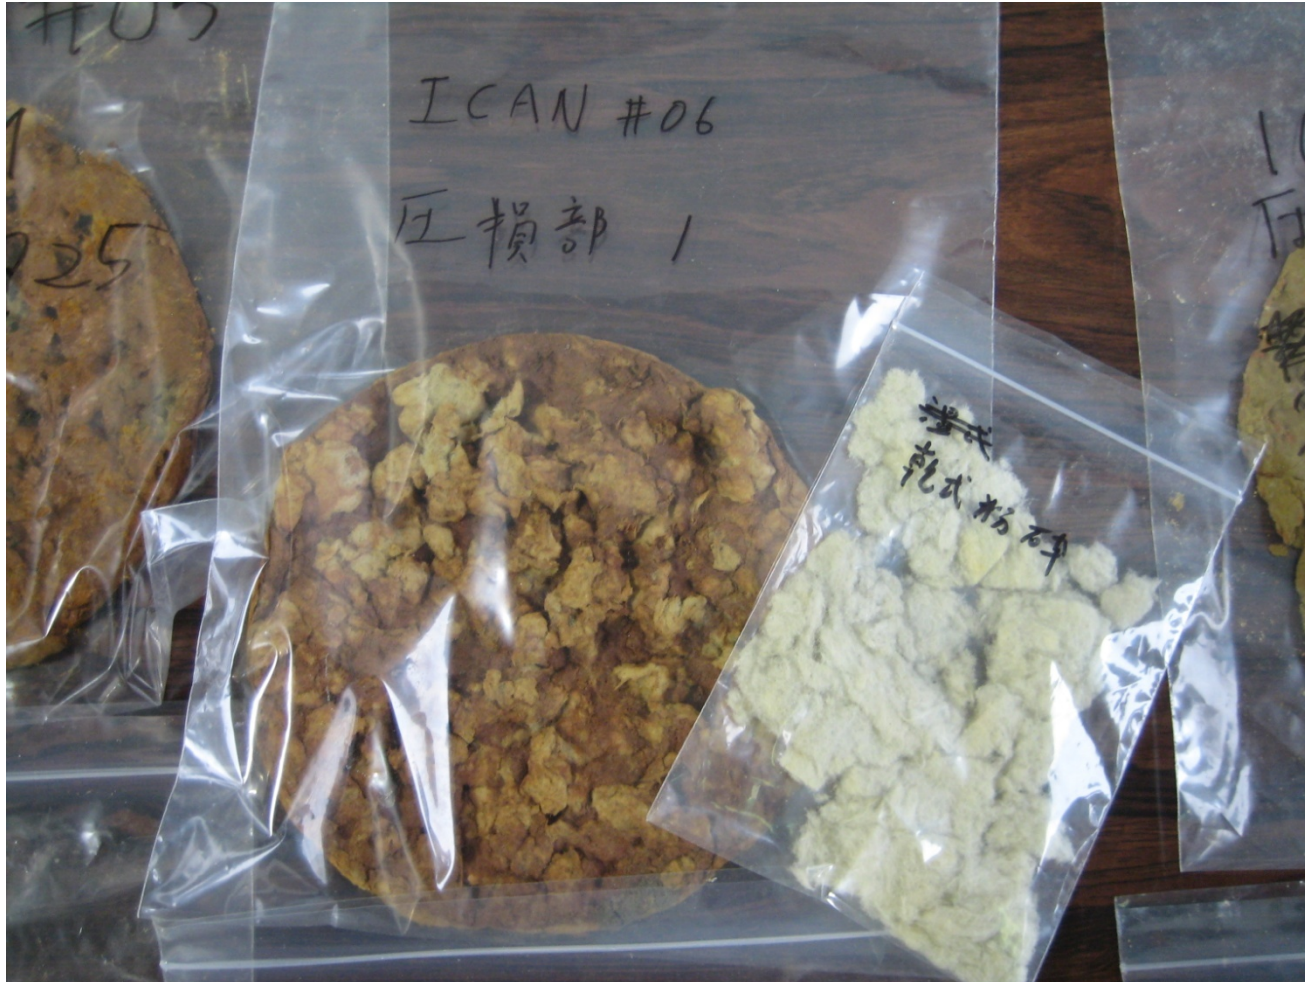
## Post Test Debris Bed for ICAN #6

- Most tests related to a PWR environment
- One test was dedicated to a representative Japanese BWR environment (ICAN #6)
- Significant weight loss occurred in iron coupons
- Iron oxide particulate was evident in the test tank and on the filtering bed of coarse fibrous debris
- When the test fluid was passed through a bed of finely prepared fiber, significant head loss increase occurred

- Not the type of colloidal chemical precipitates found in some PWR environments
- Particulate corrosion products such as iron oxide may be an additional source of debris that could significantly affect head loss
- Corrosion products formed post-LOCA may or may not be bounded by the head loss testing that was previously performed for US BWRs, which considered iron oxide formed during normal operating cycle
