NRC Information Meeting

Neutron Absorbing Material Technology

February 27, 2009
Washington DC

***NRC Information Meeting
Neutron Absorber Materials
In-Service Performance of Boraflex***

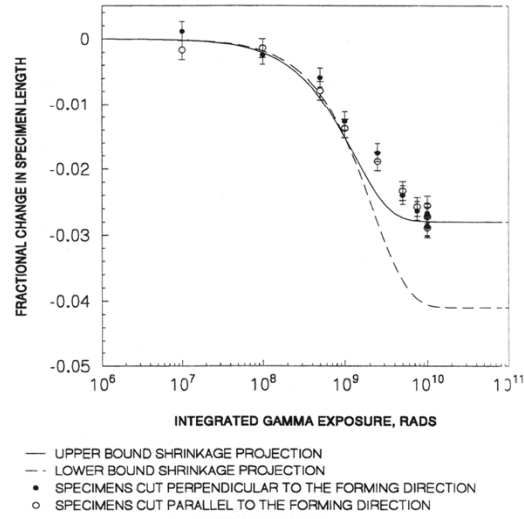
Cross-Linking Induced Shrinkage of Boraflex

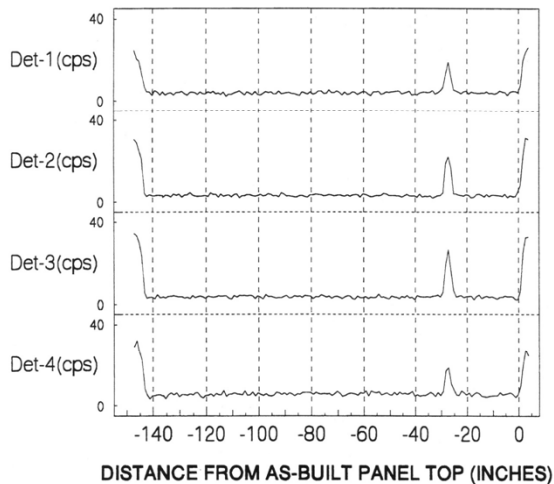
BADGER Detector Outputs

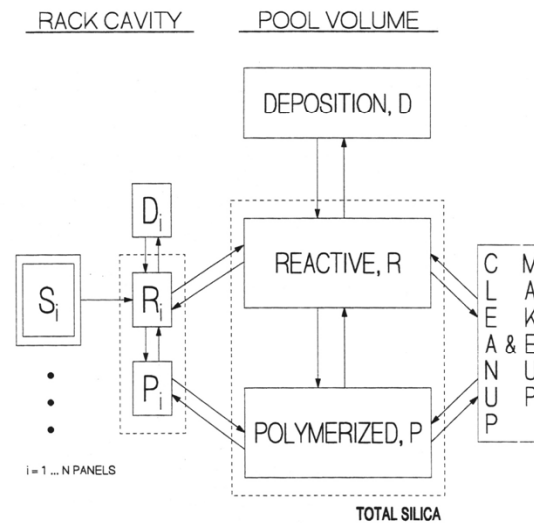
Kinetics of Silica Transport in a Spent Fuel Pool

- Mass balance of one decomposition product (soluble silica) of degrading Boraflex from rack cavities containing Boraflex to bulk pool volume
- Mass balance is based on first principles
- Very large Windows® based program - keeps track of B_4C loss from all panels of Boraflex in a pool (as many as 8000 in some cases)

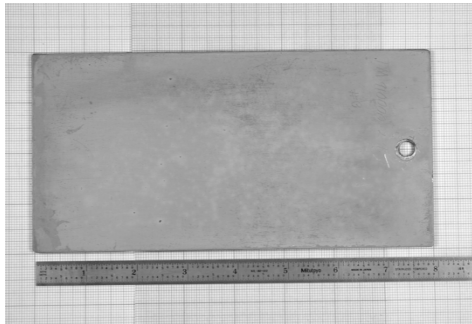
PWR Coupon

BORAL® Surveillance Coupons Generalized Corrosion

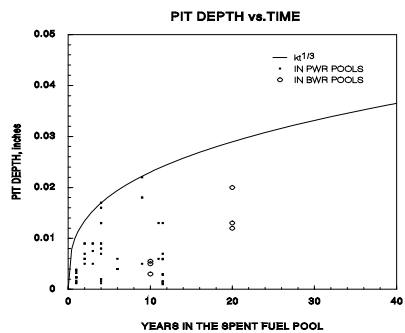
PITTING CORROSION ON BORAL COUPONS

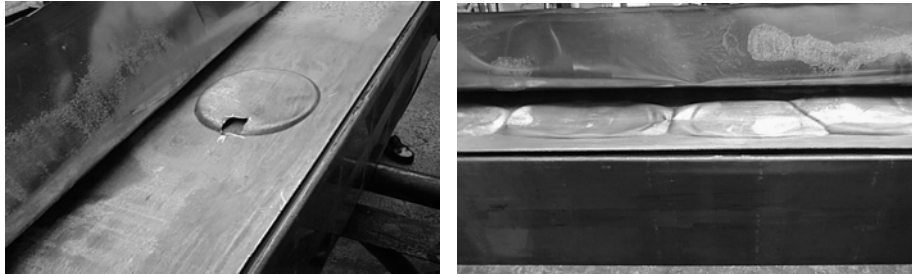
BORAL® **Clad Blistering - Dry Storage**

- Full size canister in Spain subject to simulated canister flooding followed by vacuum drying conditions (heating and evacuation)
- Cells of basket drag tested before and after test
- Some interference noted after testing
- Destructive examination of basket

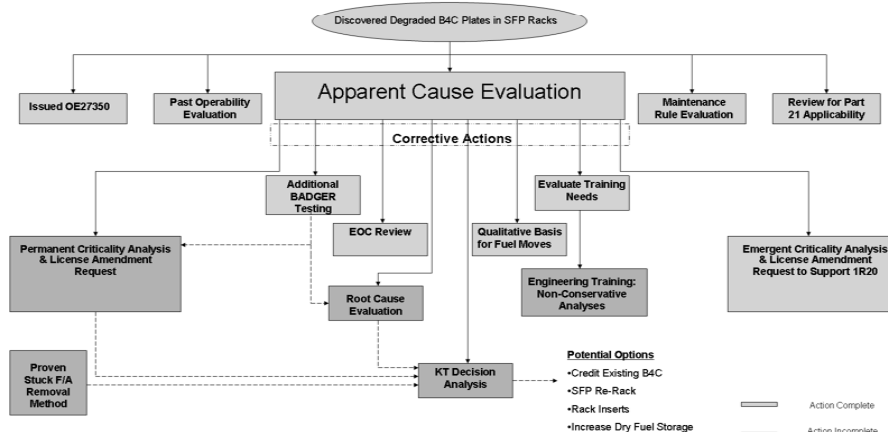
Palisades SFP Rack Degradation
