Seismic Damage Information (the 77th Release)  
(As of 14:30 April 6th, 2011)

## Seismic Damage Information (the 80th Release)

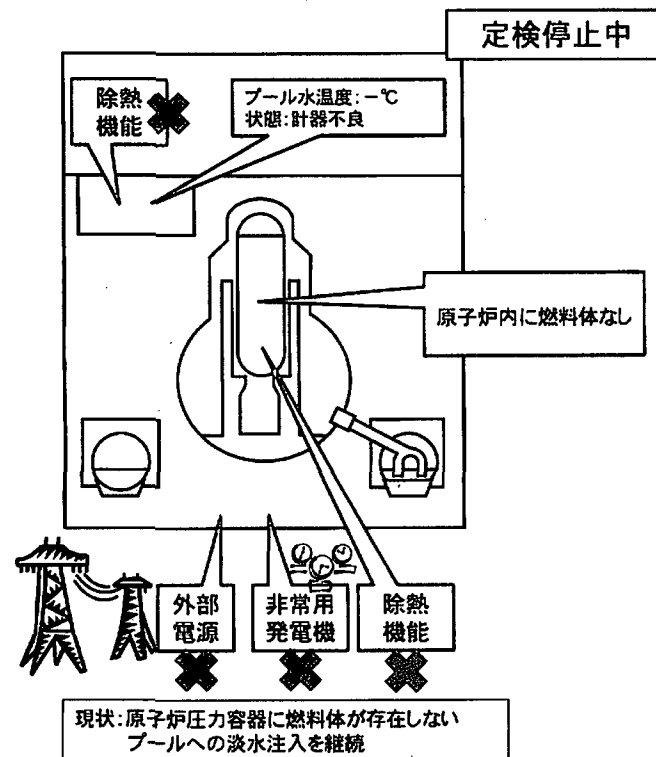
# 福島第一原子力発電所4号機の状況 (4月2日 23:00現在)

- ### 発生後の主要なできごと
- 地震発生時、定期検査により停止中
- 14日04:08 使用済燃料プール温度84℃
  - 15日06:14 4Fの壁が一部破損の確認
  - 15日09:38 3階部分で火災(12:25鎮火)
  - 16日05:45 4号機で火災。事業者によると現場での火は確認できず(06:15)
  - 20日08:21~9:40 自衛隊による使用済燃料プール(SFP)への放水
  - 20日18:30頃 ~ 19:46 自衛隊によるSFPへの放水
  - 21日06:37~08:41 自衛隊によるSFPへの放水
  - 21日15:00頃 パワーセンターまでのケーブル敷設完了
  - 22日10:35 パワーセンター受電
  - 22日17:17~20:32 コンクリートポンプ車による放水
  - 23日10:00~13:02 コンクリートポンプ車による放水
  - 24日14:36~17:30 コンクリートポンプ車による放水
  - 25日06:05~10:20 使用済燃料プール冷却系(FPC)からSFPに海水を注入
  - 25日19:05~22:07 コンクリートポンプ車による放水
  - 27日16:55~19:25 コンクリートポンプ車による放水
  - 29日11:50 中央制御室の照明復帰
  - 30日14:04~18:33 コンクリートポンプ車による放水(淡水)
  - 1日8:28~14:14 コンクリートポンプ車による放水(淡水)

現状:原子炉圧力容器に燃料体が存在しない  
プールへの淡水注入を継続

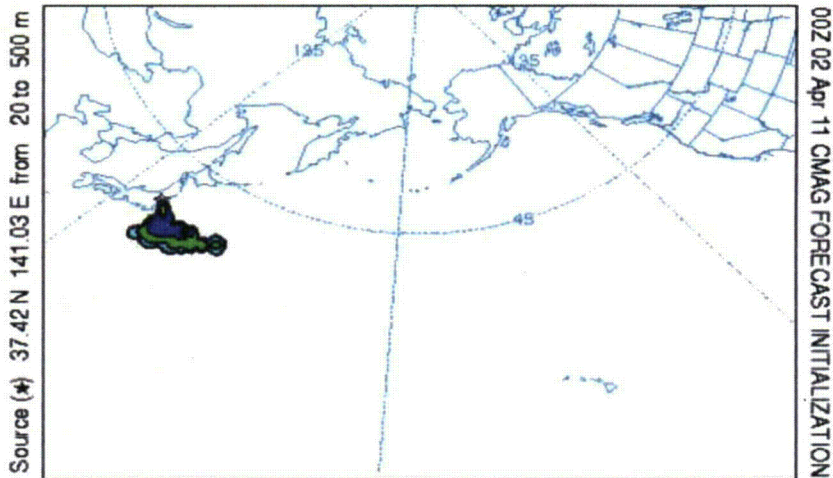
Integrated from 12z 02 Apr to 12z 03 Apr (UTC)

I131 Release Started at 12Z 02 Apr (UTC)

Location: Fukushima, Daiichi (37.4209 141.0329)  
Meteorology: GT213  
Emission: 1 Bq of I131 over 72 hr  
Distribution: Uniform between 20 m - 500 m agl  
Deposition: Wet and Dry (0.1 cm/s)  
Notes: Contours may change from map to map  
Results based on default values

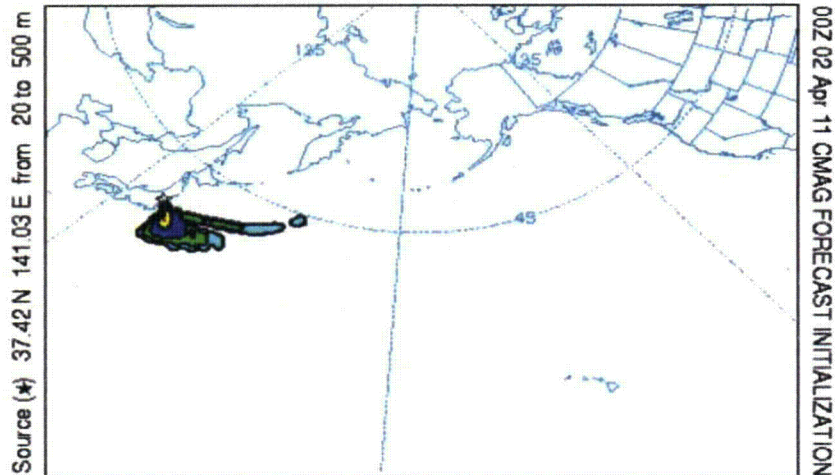
Deposition at Ground-Level (Bq/m<sup>2</sup>)  
Integrated from 12z 02 Apr to 12z 03 Apr (UTC)  
I131 Release Started at 12Z 02 Apr (UTC)

1.0E-12 1.0E-13 1.0E-14 1.0E-15 3.3E-12 Maximum at square

Location: Fukushima, Daiichi (37.4209 141.0329)  
Meteorology: GT213  
Emission: 1 Bq of I131 over 72 hr  
Distribution: Uniform between 20 m - 500 m agl  
Deposition: Wet and Dry (0.1 cm/s)  
Notes: Contours may change from map to map  
Results based on default values

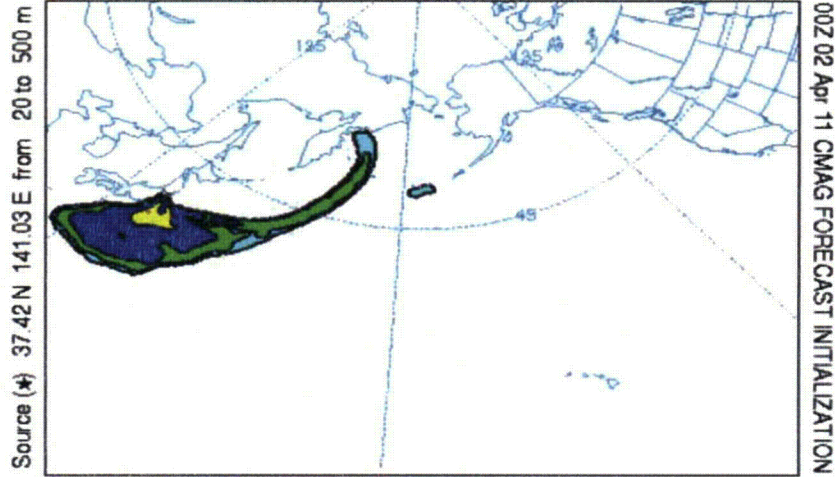
Deposition at Ground-Level (Bq/m<sup>2</sup>)  
Integrated from 12z 02 Apr to 12z 05 Apr (UTC)  
I131 Release Started at 12Z 02 Apr (UTC)

1.0E-12 1.0E-14 1.0E-16 1.0E-18 5.9E-12 Maximum at square

Location: Fukushima, Daiichi (37.4209 141.0329)  
Meteorology: GT213  
Emission: 1 Bq of I131 over 72 hr  
Distribution: Uniform between 20 m - 500 m agl  
Deposition: Wet and Dry (0.1 cm/s)  
Notes: Contours may change from map to map  
Results based on default values

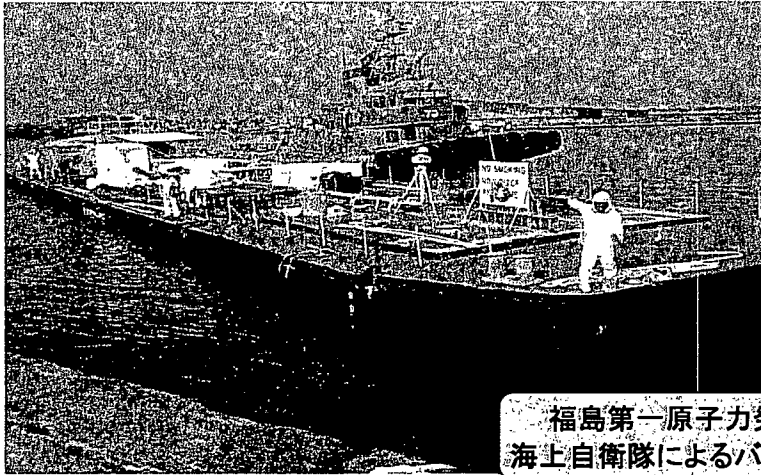
福島第一原子力発電所 物揚場岸壁  
海上自衛隊によるバージ船の接岸作業

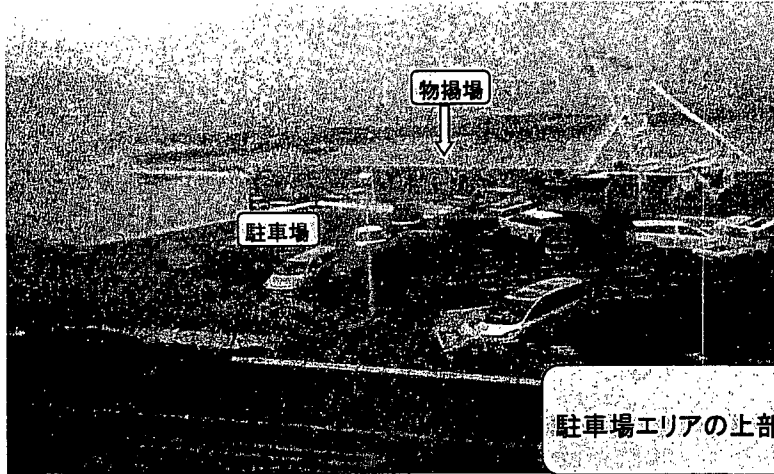
4

駐車場エリアの上部から物揚場を目視
