| Equipment ID No.: _1AP71E | <u></u> |
|---|---|
| Equipment Description: DIV I 480V MCC 135X-1 | |
| Project: LaSalle 1 SWEL | |

| Seismic Walkdown Checklist (SWC) | Status: Y N U |

| Seismic Walkdown Checklist (SWC) | Status: Y N U |
|---|---|
| Equipment Description: DIV I 480V MCC 135X-3 | |

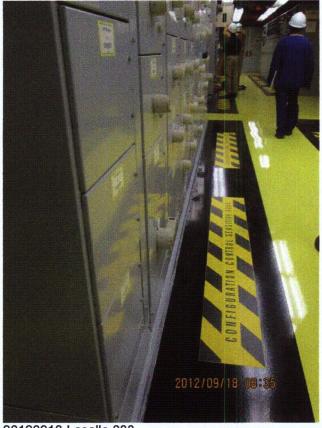
20120918-Lasalle 032

| Seismic Walkdown Checklist (SWC) | Status: Y N U |
|--|---|
| Small clearance between 72E and 73E cabinets. Both cabinets are long and stiff in the direction of this small clearance. Both cabinets are of the same type and manufacturer. Therefore, sufficient out-of-phase deflection during a seismic event to cause the 2 cabinets to impact one another is judged to not be credible. | |

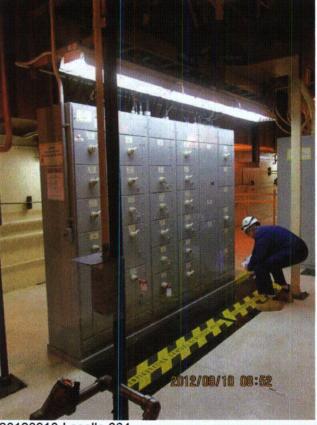
20120910-Lasalle 004

| Seismic Walkdown Checklist (SWC) | |
|---|---|
| Minor shrinkage cracking in floor judged to be acceptable. | |

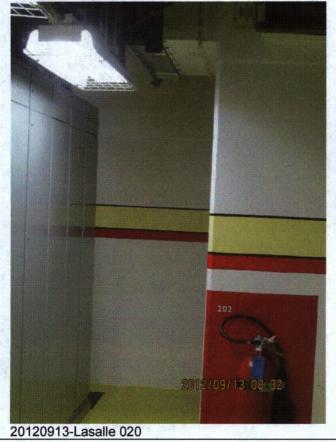
20120913-Lasalle 019

| Seismic Walkdown Checklist (SWC) | Status: Y N U |
|--|---|
| Bolted to adjacent MCC 1AP80E at top. Small gap between MCCs judged to be acceptable. | · · · |
