FIGURE 28 Multiple Polure Building Showing Survey and Soil Sampling Locations

SUMMARY AND RECOMMENDATIONS

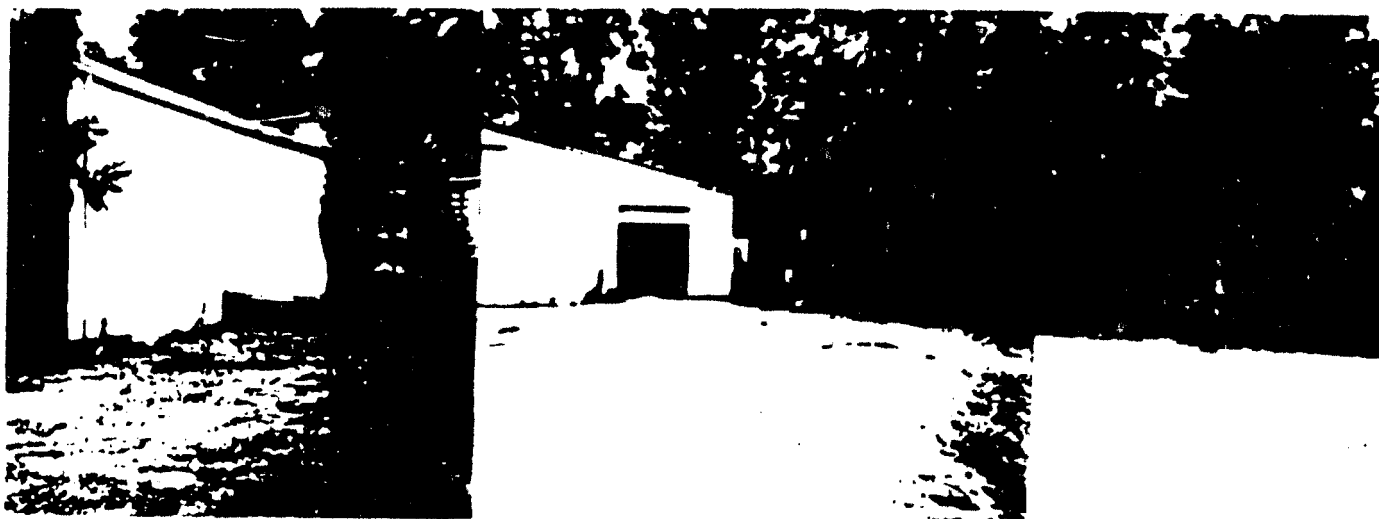
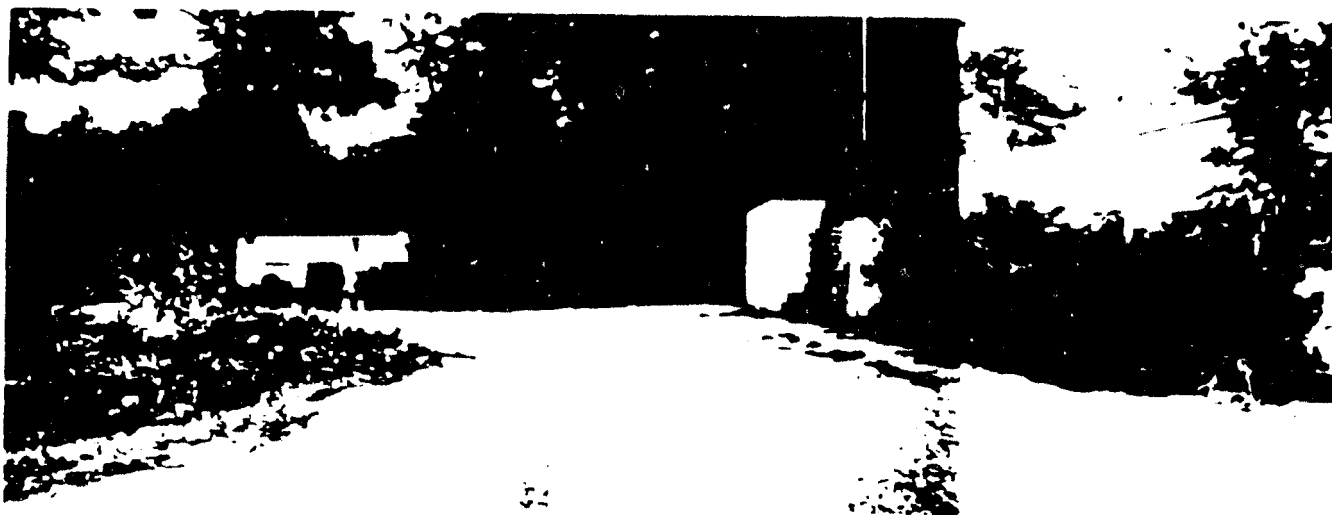
Figure 2.2. Views of Area A.

(A) East facing view of wooded and paved area south of the plutonium storage facility.

(B) North facing view of paved area west of the plutonium storage facility and south of the engineering building.

The Nuclear Lake Site is a 1137 acre parcel that, in addition to the 53 acre lake, contains a number of structures: an access road, parking lots, buildings, land, and utilities (Figure 2.1). The site is heavily wooded and public access is restricted. A view of the area (Area A) over which the first of the two land based GPR surveys of Phase I was conducted is presented in Figure 2.2. Area A includes the wooded and paved area south of the plutonium facility and west of the waste disposal building, the paved parking lot area west of the plutonium facility and south of the engineering building, the wooded area north of the plutonium facility, and the grassy area west of the engineering building. A leaching field with subsurface piping is believed to be beneath the area west of the waste disposal building (per conversation with the ORAU on-site representative). Elevation remains fairly constant over this area.

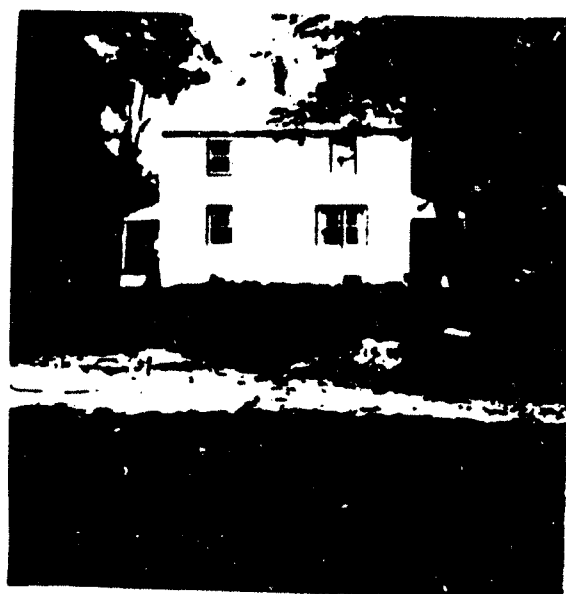
Figure 2.3. View of Area B. Pictured are the gravel driveway and grassy area south of the remote assembly building.

A view of the area (Area B) over which the second of the two land based GPR surveys of Phase I was conducted is presented in Figure 2.3. Area B consists of a grassy area and gravel driveway south of the remote assembly building. A septic system associated with the remote assembly building is known to exist beneath this area (per conversation with the ORAU on-site representative). Elevation over this area increases from the gravel driveway to the base of the remote assembly building.

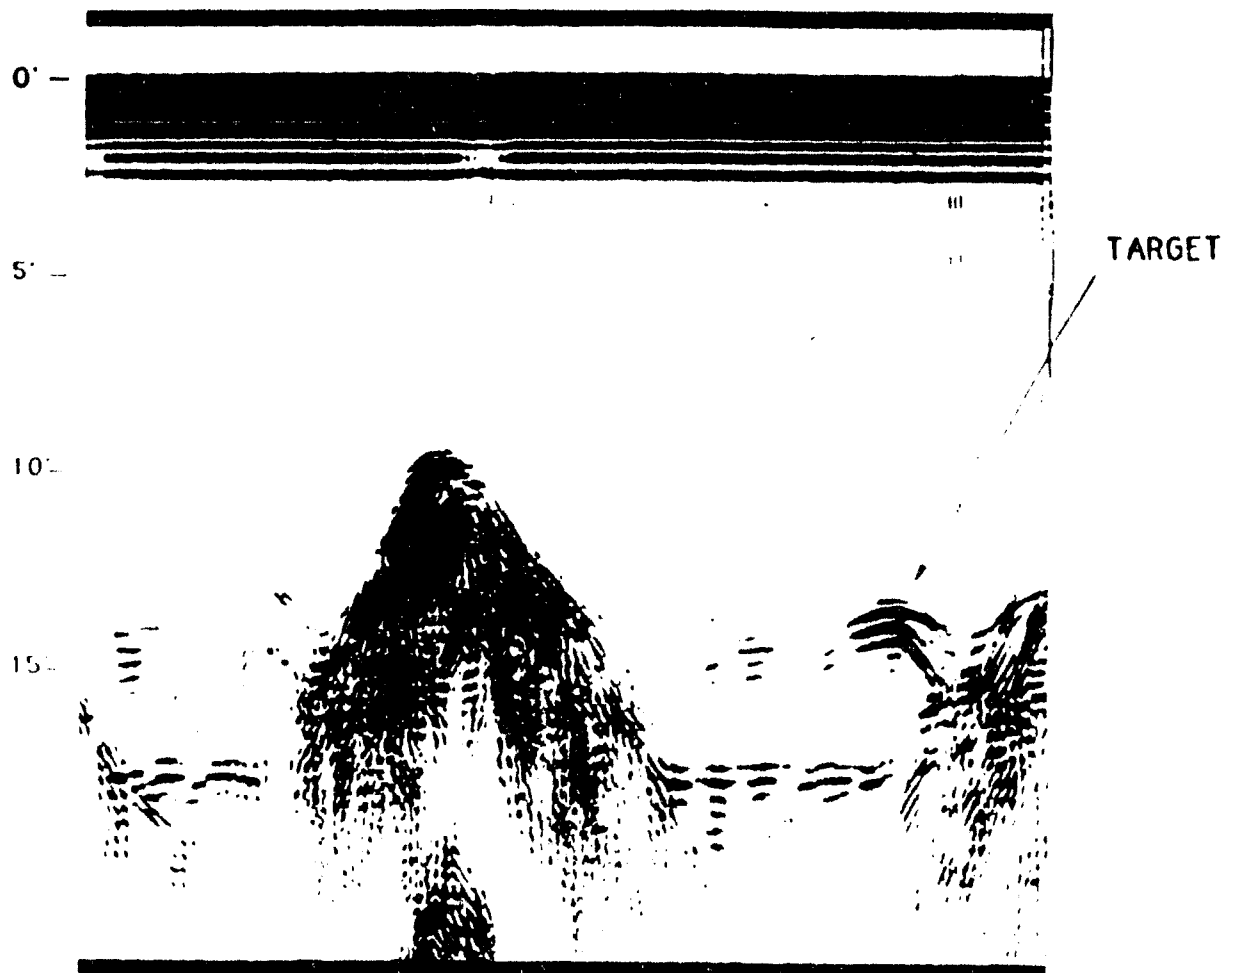
Approximate depth to Metal reflector
on lake bottom 13'

Figure 4.3.3. Radar profile taken over a reflective target at a known depth of 13 feet.

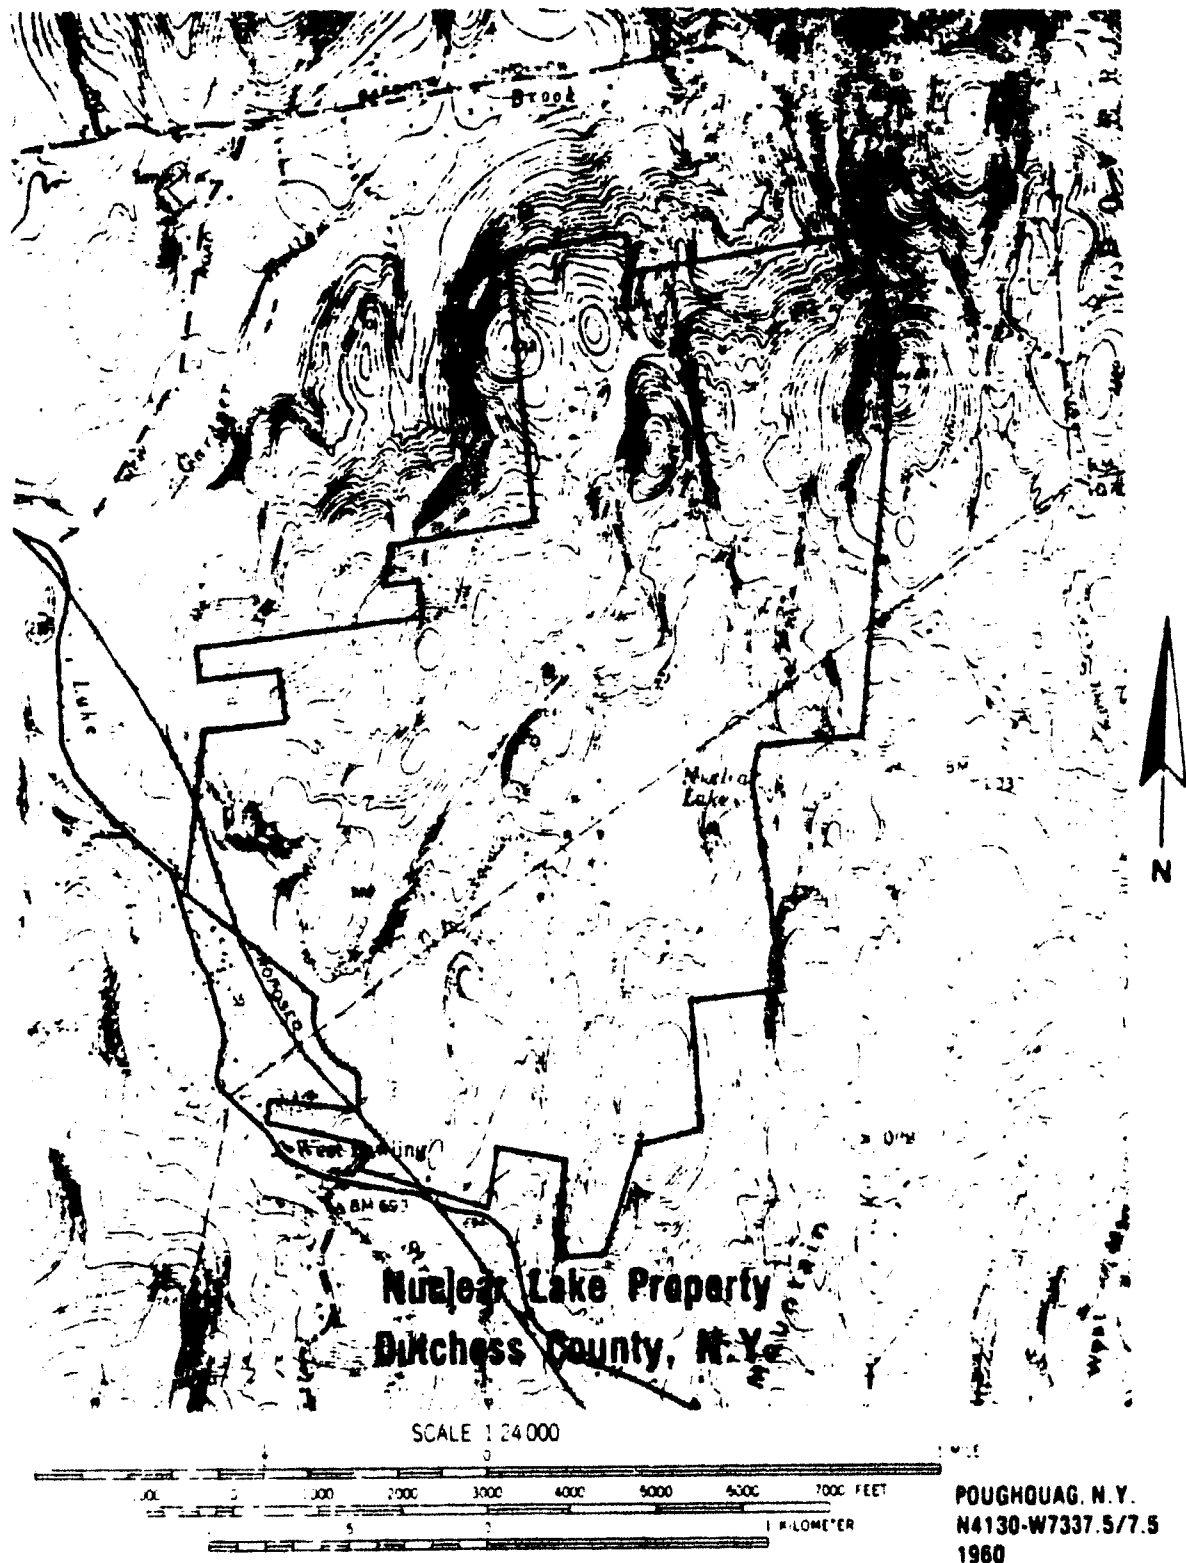
Figure II-1 - A segment of the 1960 USGS Topographic map Poughquag Quadrangle showing elevation and slope data for the Nuclear Property. Superimposed is the boundary of the Nuclear Lake Property owned by the National Park Service.

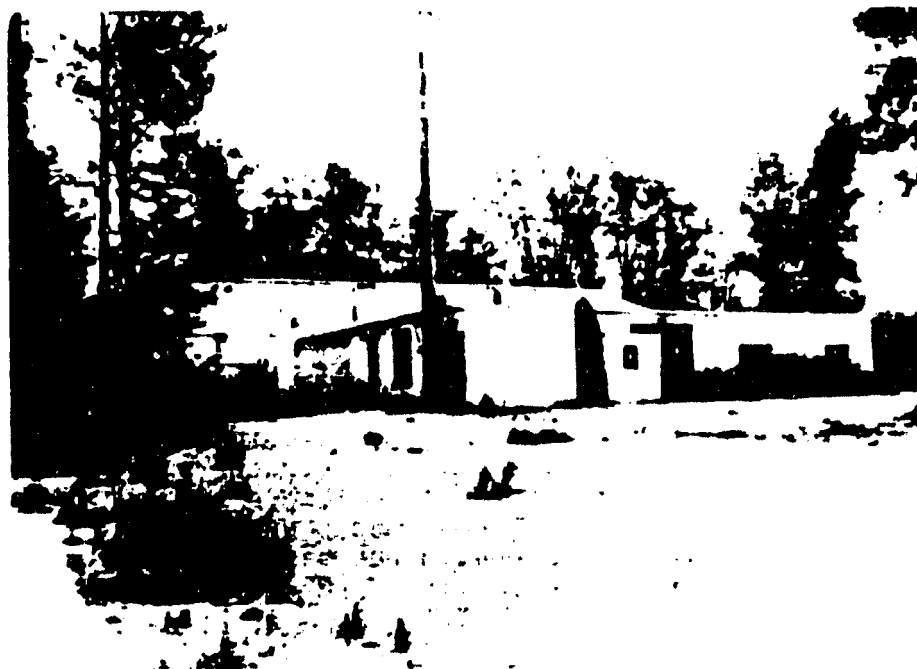
Figure III-4 - The Plutonium Facility (1981 Photo)

The building is located close to the west edge of the lake, north of the Waste Storage Building and east of the Engineering Building. It was one of the initial "testing and experimental labs" constructed in 1956 (7, 11, 12). Between 1966 and 1971, portions of the building were removed and other sections added. The present structure contains 8800 square feet. It is partially one story and partially 1½ stories, made of concrete block with two additions on the south side.

Several plans for alterations were reviewed between 1963 and 1966. During 1967, the detached Gas House on the northwest corner was removed and replaced by a 24' by 36' concrete block addition to the main structure. At the same time a 30' by 50' concrete block addition was constructed on the southwest corner. This required reconstruction of the sub-surface sewage disposal system (13, 14). Plans for this system were approved by the Dutchess County Department of Health in February 1967. It was constructed on the south side of the building, by June 1967, and included a 900 gallon tank and a leach field 5-7' deep (15, 16). After 1970, a 28' by 32' metal addition was constructed on the southeast corner of the facility.

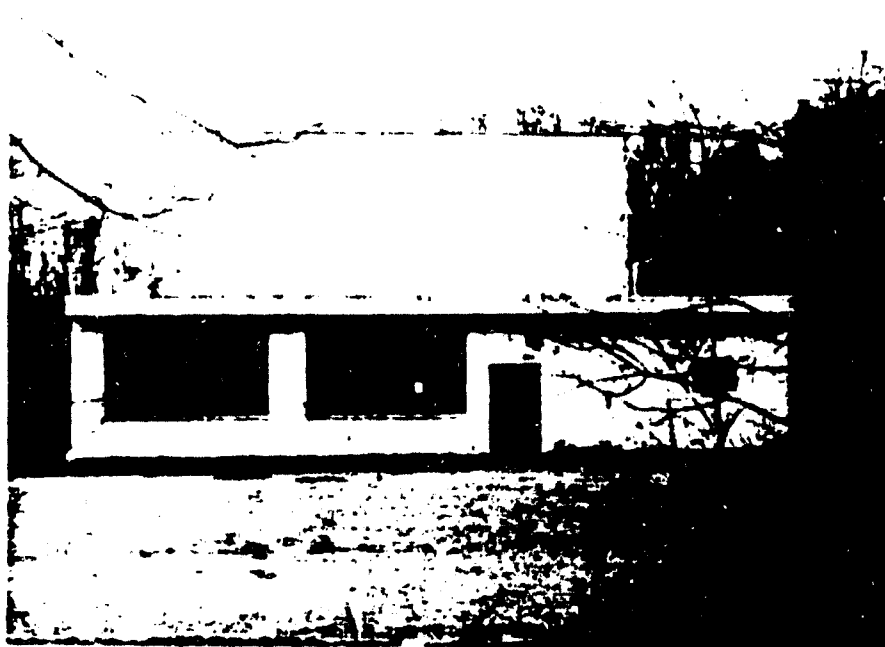
Figure III-6 - Critical Facility (1981 Photo)

This 6000 square foot building is located on the edge of the complex, approximately 400 feet west of the Plutonium Facility. It has a separate parking area on the west side and the other sides of the building are surrounded by an 8 foot chain link radiation exclusion fence designed to keep people and animals from wandering too close to the building during operation. A large wetland system is adjacent on the southwest.

Construction began in 1956 and there have been no apparent exterior additions. The building was constructed of "structural steel with non-load-bearing masonry walls". The west end of the building consisted of the 25' by 60' by 38' high reactor room. It had provisions for two reactor locations and had two concrete pits in the floor. These measured 10' by 20' by 10' deep and 8' in diameter by 8' deep, and both were constructed without drains. A 4 foot thick poured concrete shield wall separated the reactor room from the other parts of the building. The remainder of the building is one story concrete block. Both sections have flat reinforced roofs (24, 34).

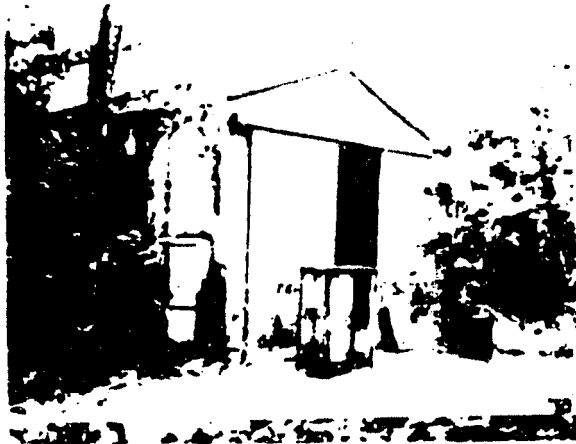
Outside the Multiple Failure Building - Barrels containing trash and debris, a metal safe (cut open) and miscellaneous objects, still remain (see Figure V-5). Also, four barrels connected to the building by a system of pipes are buried in the ground behind the building (see Figure V-6).

Figure V-5 Materials outside the Multiple Failure Building

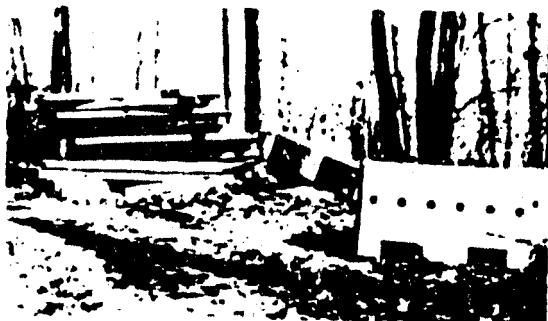
Area North of Multiple Failure Building - Twentysix concrete slabs (6' X 12' X 6'), two concrete slabs (6' X 4' X 1') (see Figure V-8) and ten large concrete blocks (4' X 5' X 2') containing holes (4' to 6' diameter) (see Figure V-9) have been placed here.

Figure V-8 Concrete Slabs north of the Multiple Failure Building

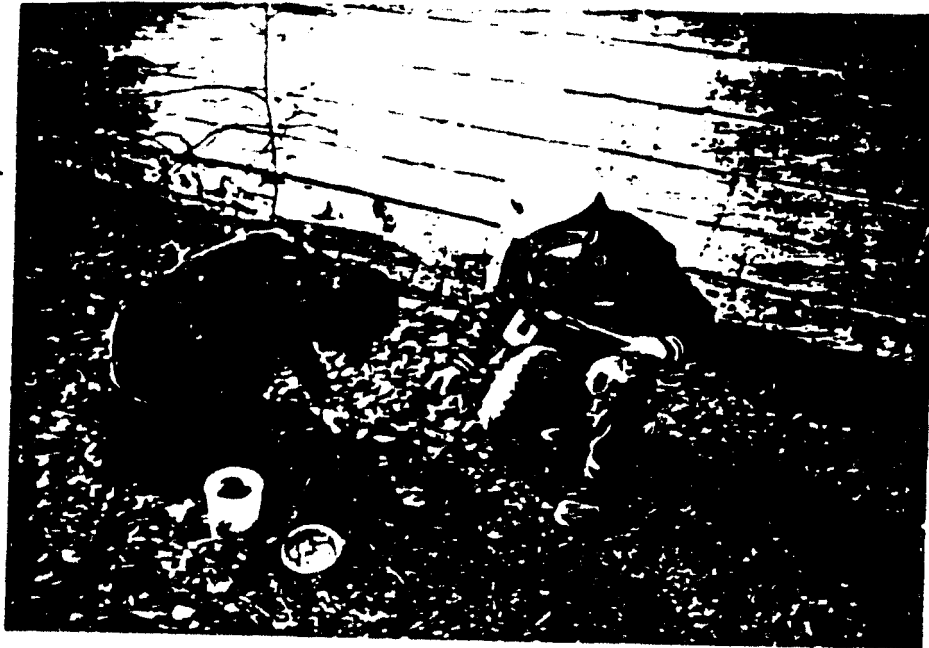
Soil Sampling At Plutonium Building

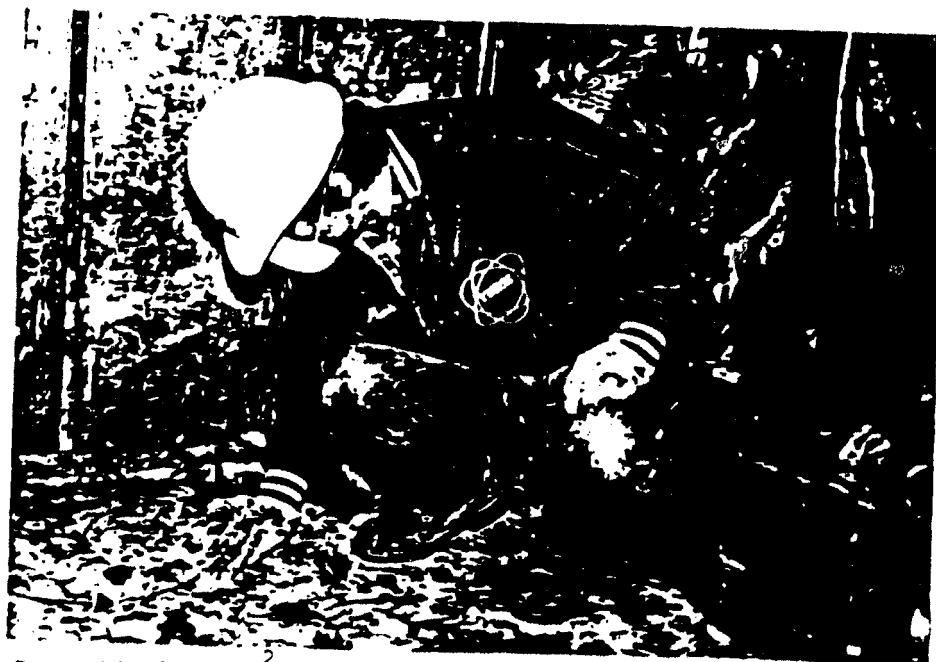
Removable 100 cm.² Swipe in Waste Building
