LIMITS TO CREVICE CONCENTRATION PROCESSES

Allen Baum

Presentation to:

EPRI/Argonne Crevice Workshop

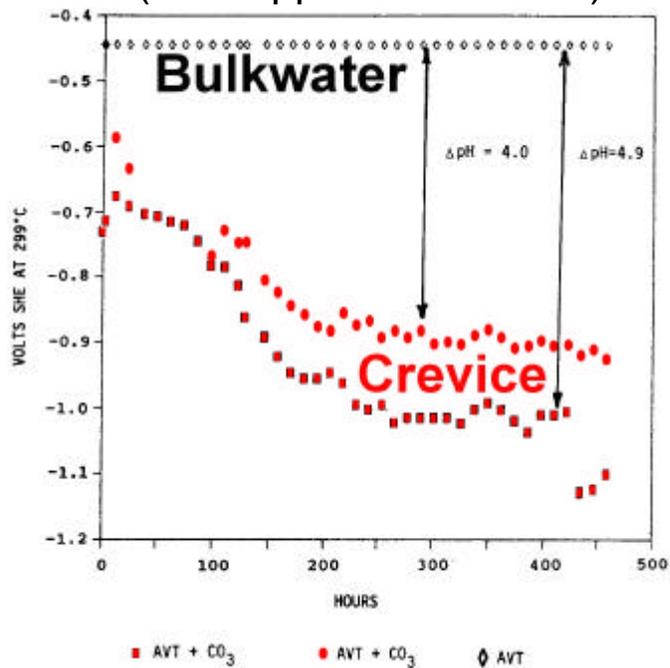
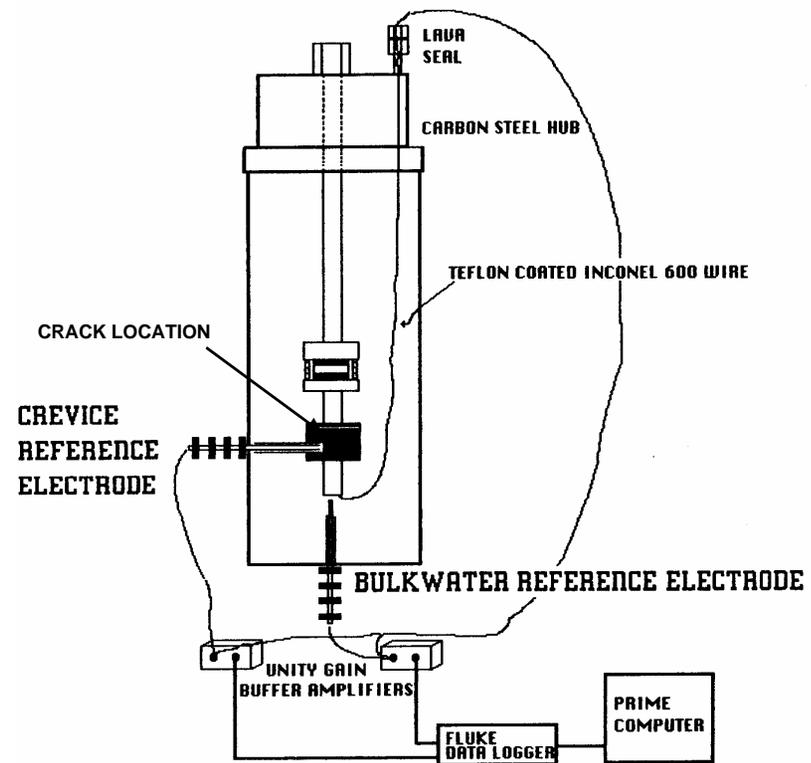
Westinghouse Heat Transfer Electrode (HTE) Measured Change in Crevice ECP

0.3 ppm Sodium Carbonate
 (~ 500 ppb Na⁺ in boiler)

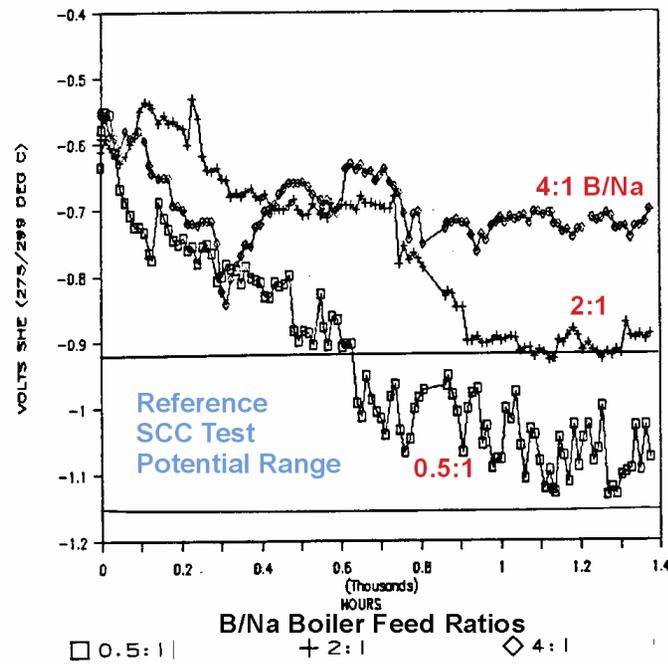
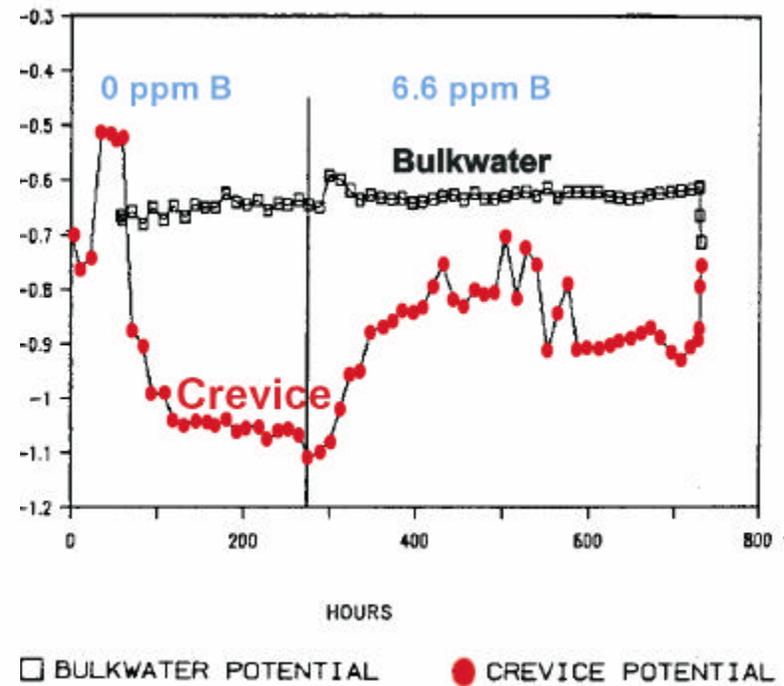
HTE Testing Found Strong Effect of Boric Acid

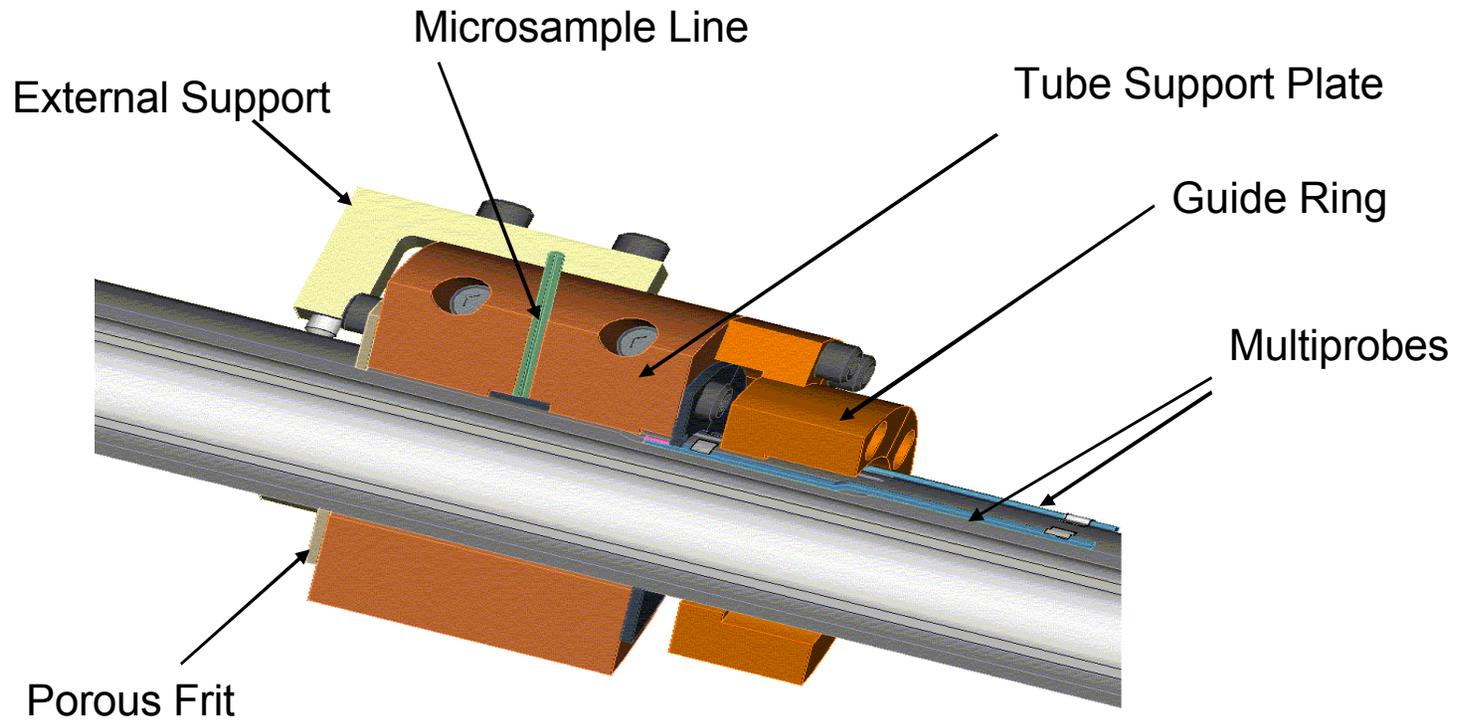
Cross-section of Instrumented Test Piece

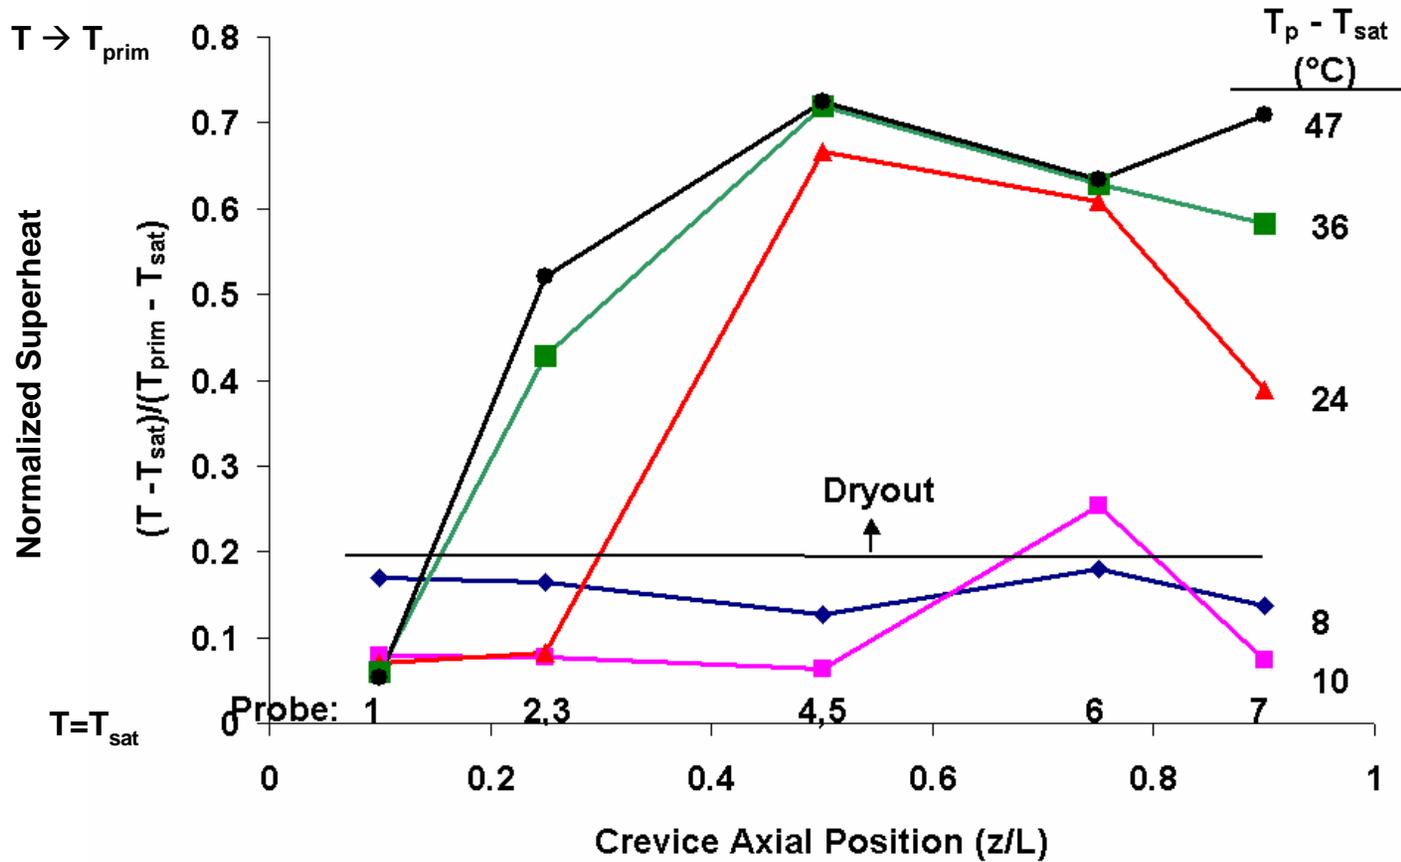
Dryout Initiated at About 10°C ΔT

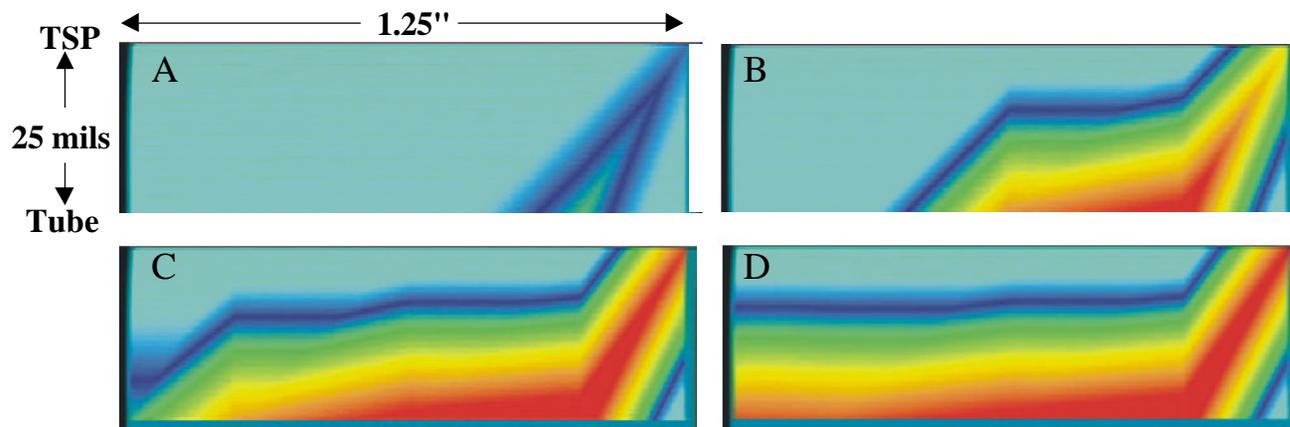
Impedance Response of 300 ppb Cl⁻ as Seawater Showed Local Concentration at Tube Surface

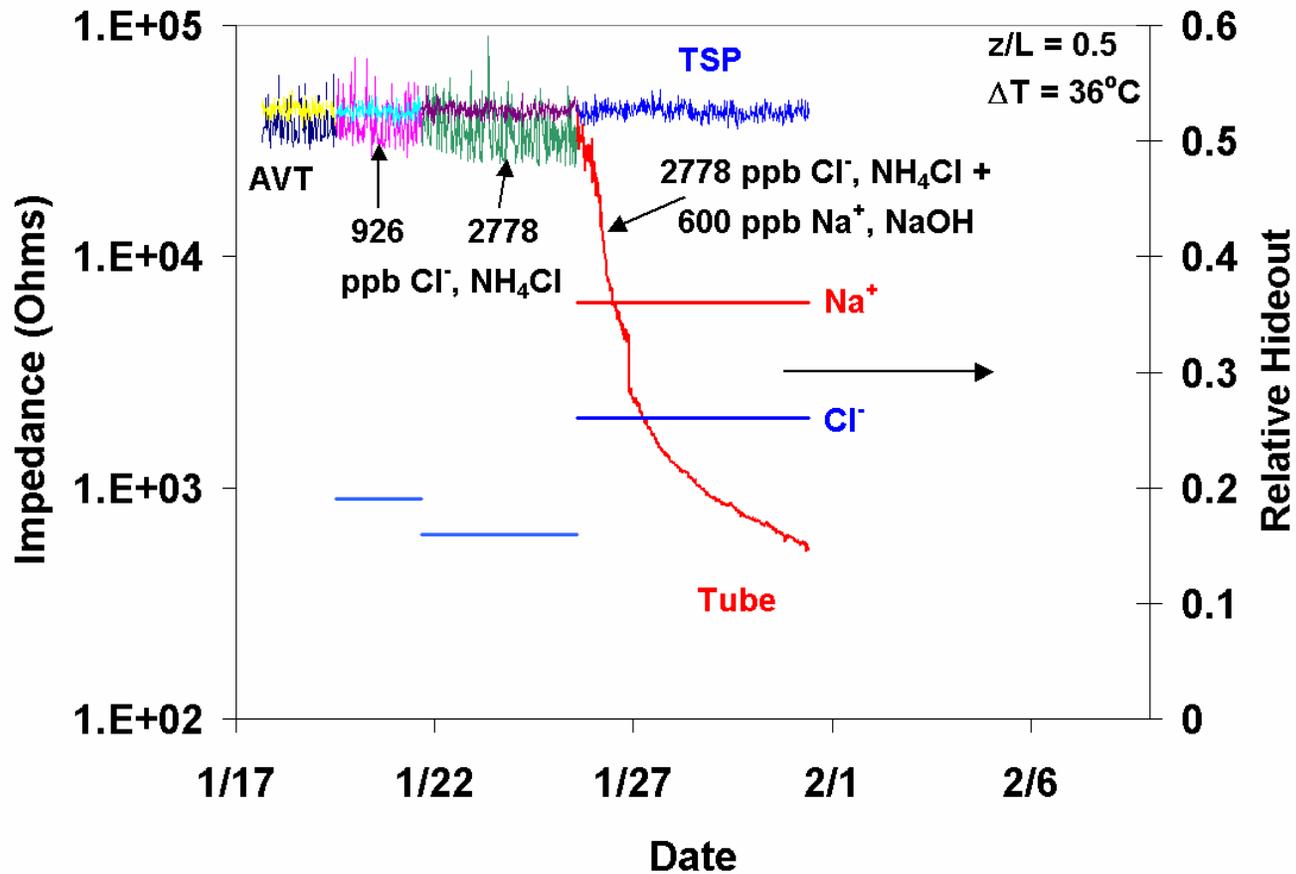
Chloride Concentration Limited Both by Volatility and Adsorptivity

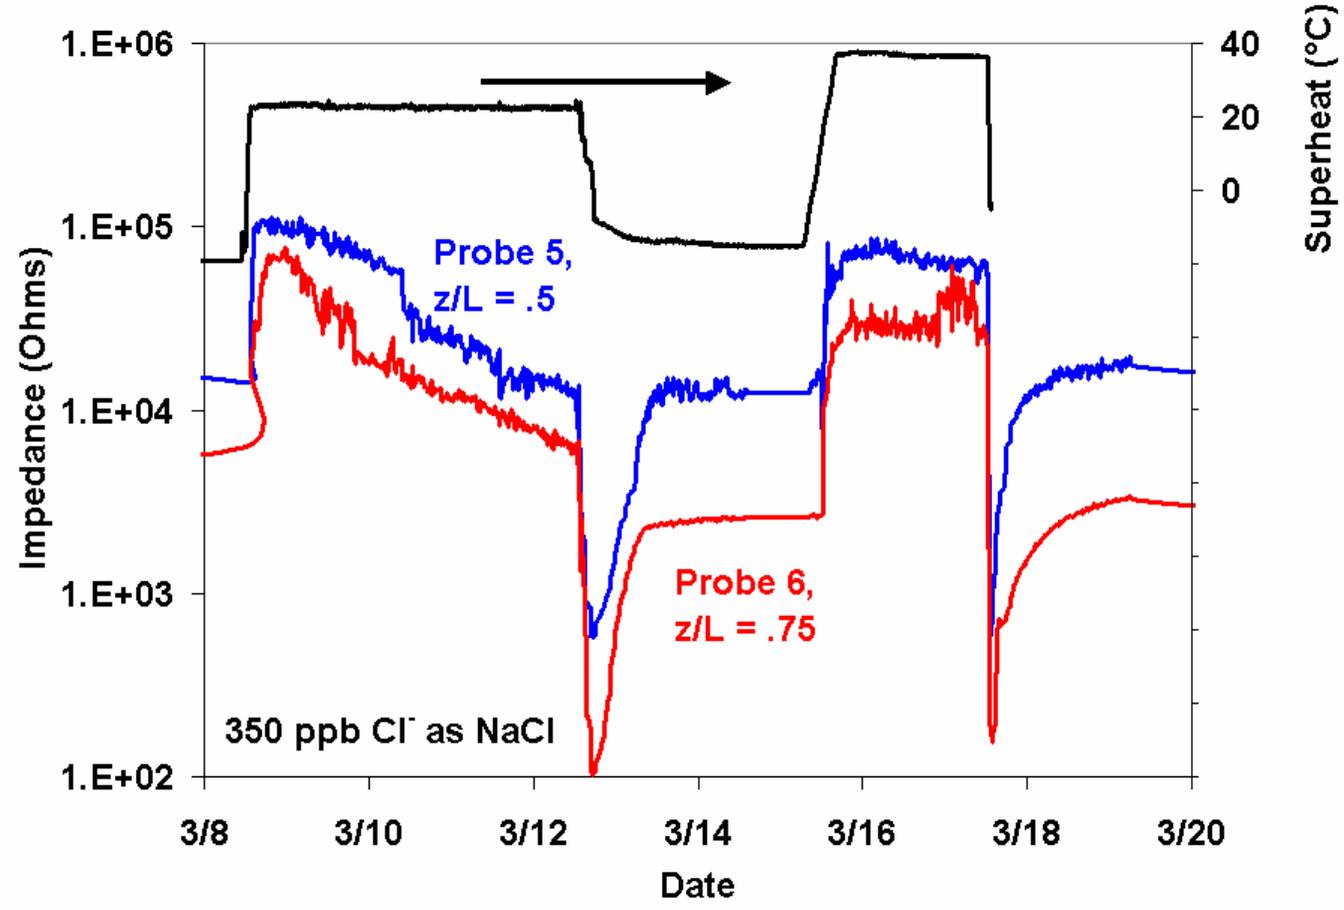
NaCl Precipitated at Highest Superheats

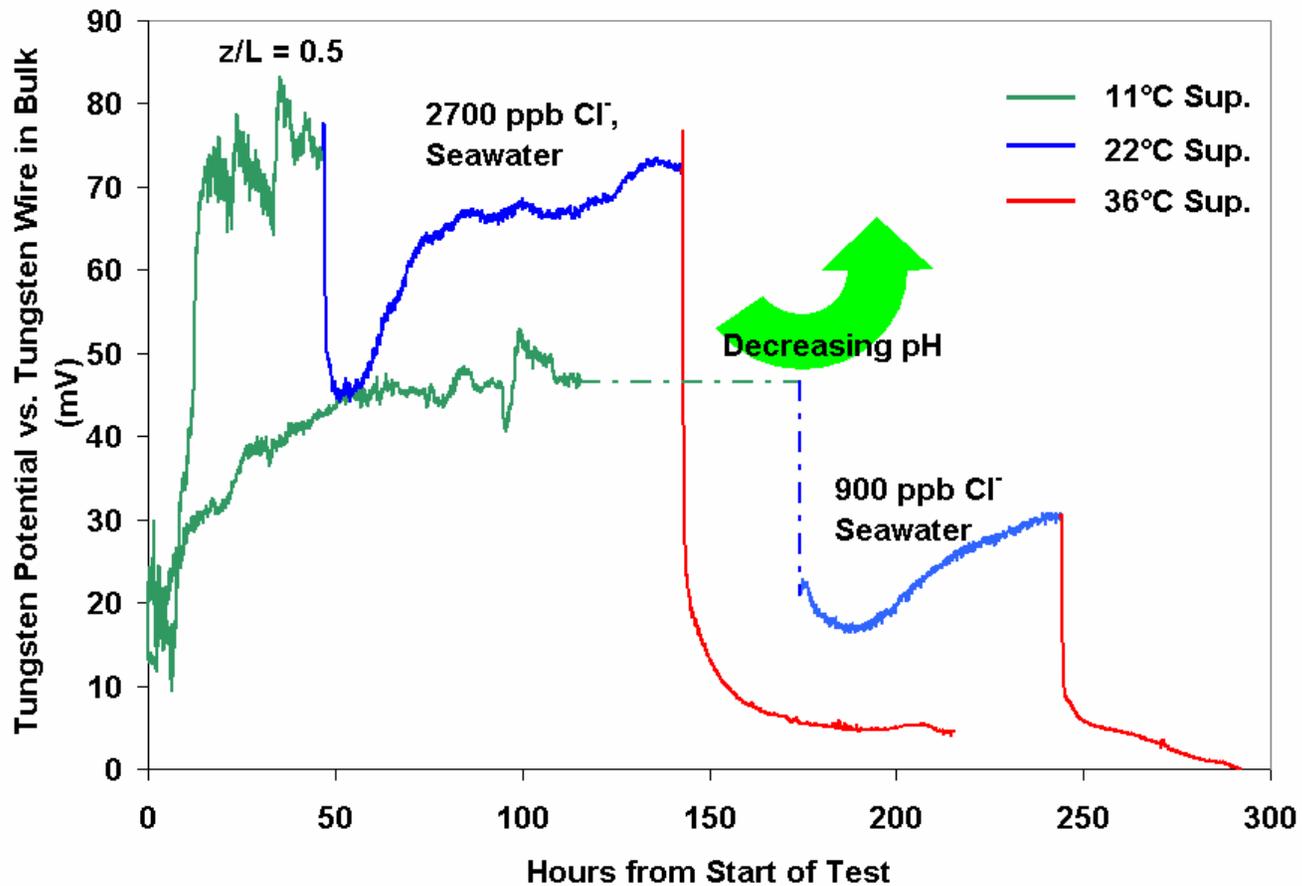
Seawater Concentrate Lost Acidity with Increasing Superheat

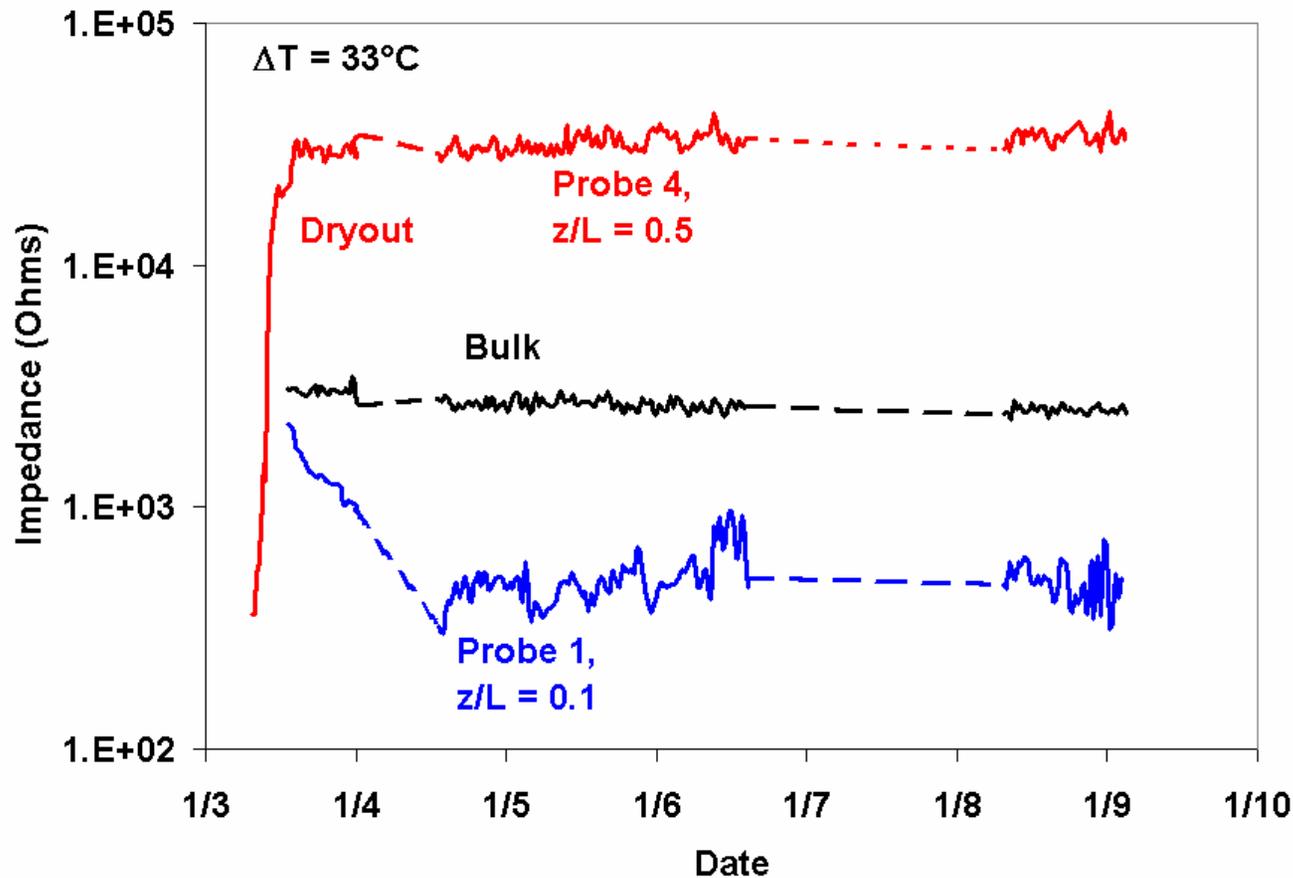
Sodium Phosphate, Indicative of Less Soluble Salts, Precipitated in Crevice Interior

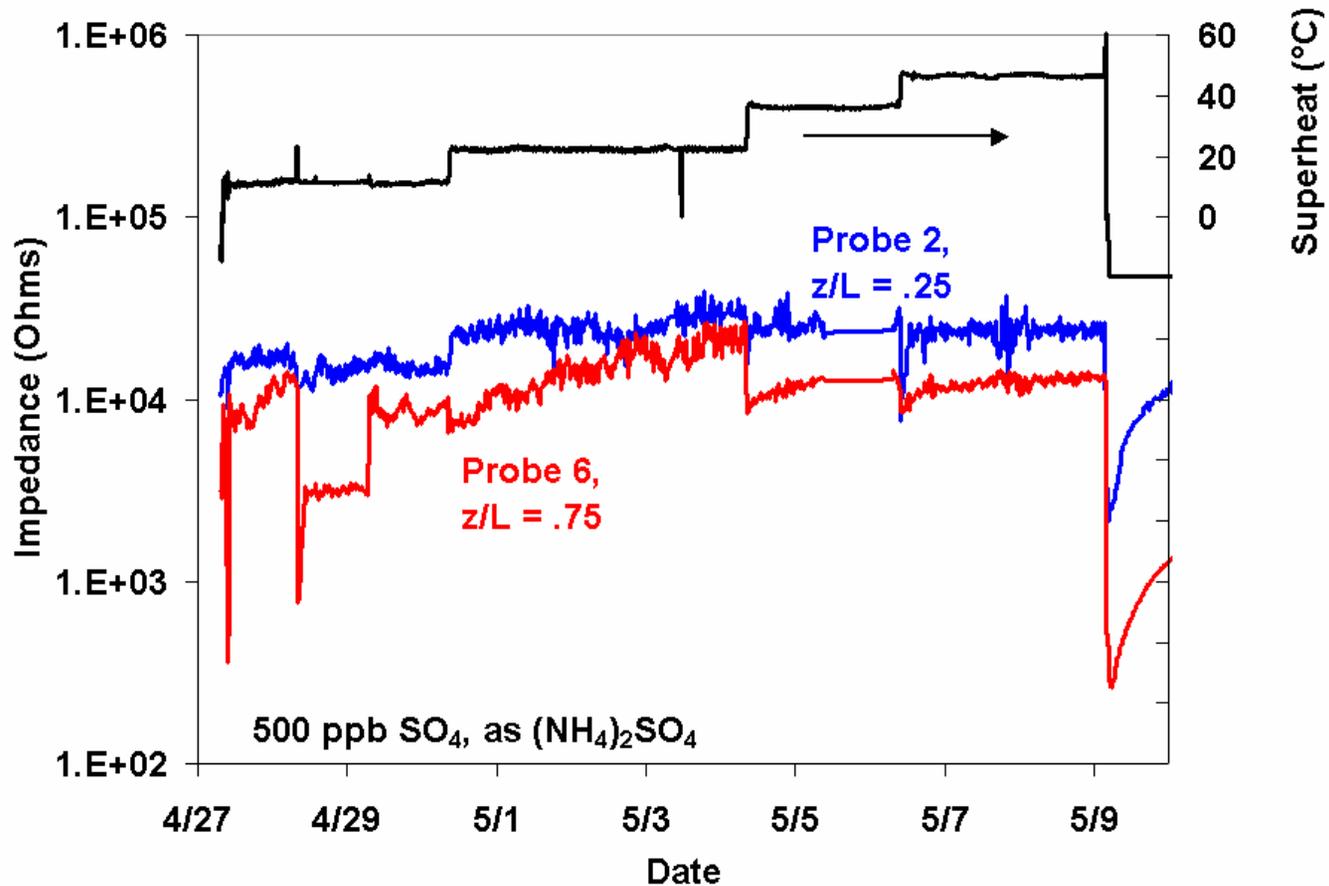
Ammonium Sulfate Testing Produced Little Impedance (or pH) Response, Indicative of Solute Adsorption

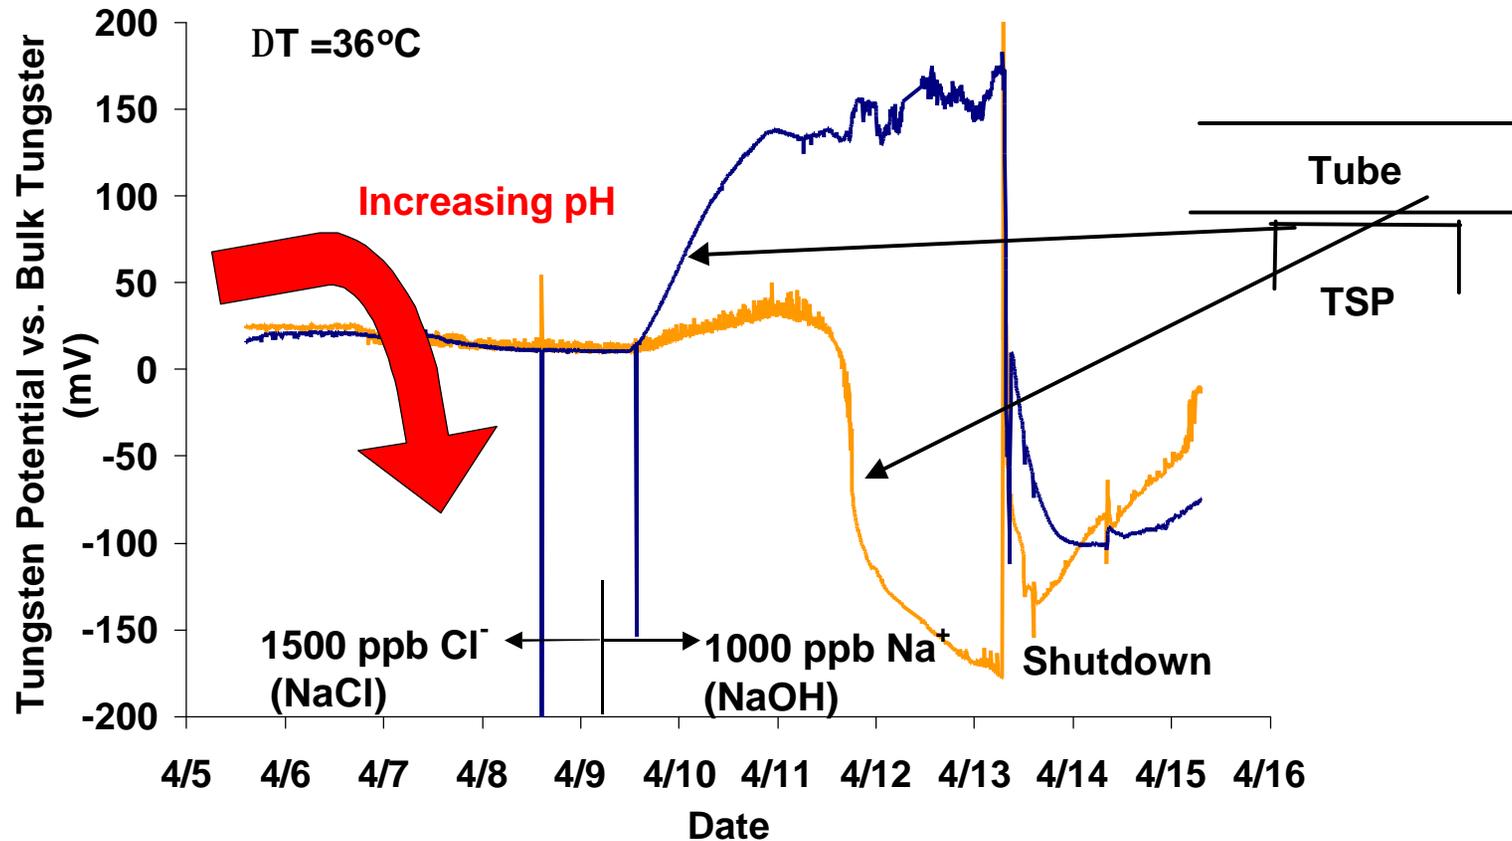
Large Radial pH Gradients in Caustic Test may have Resulted from Chloride Desorption

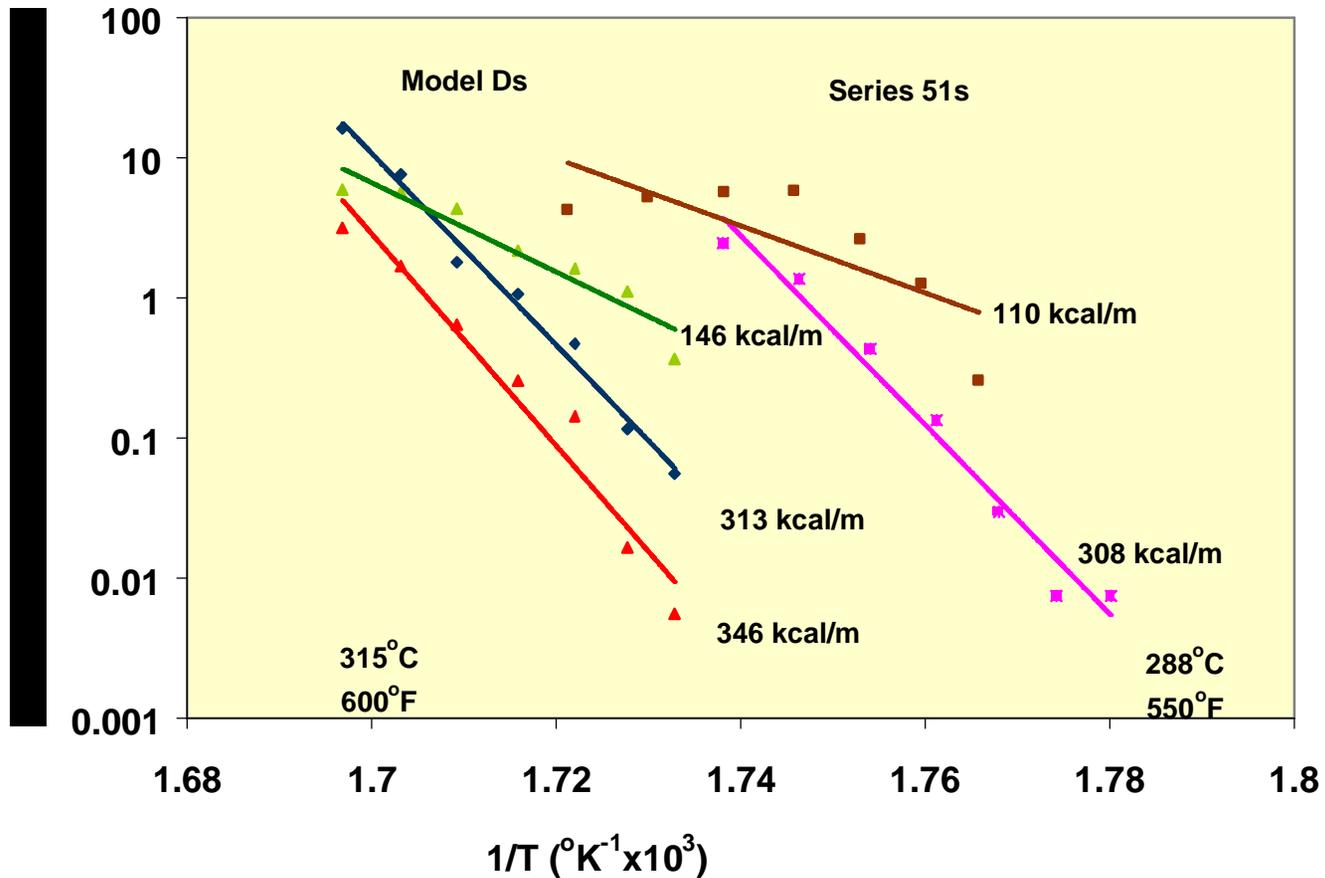
Progressive Loss of Other Species is Consistent with High SG ODSCC Activation Energies

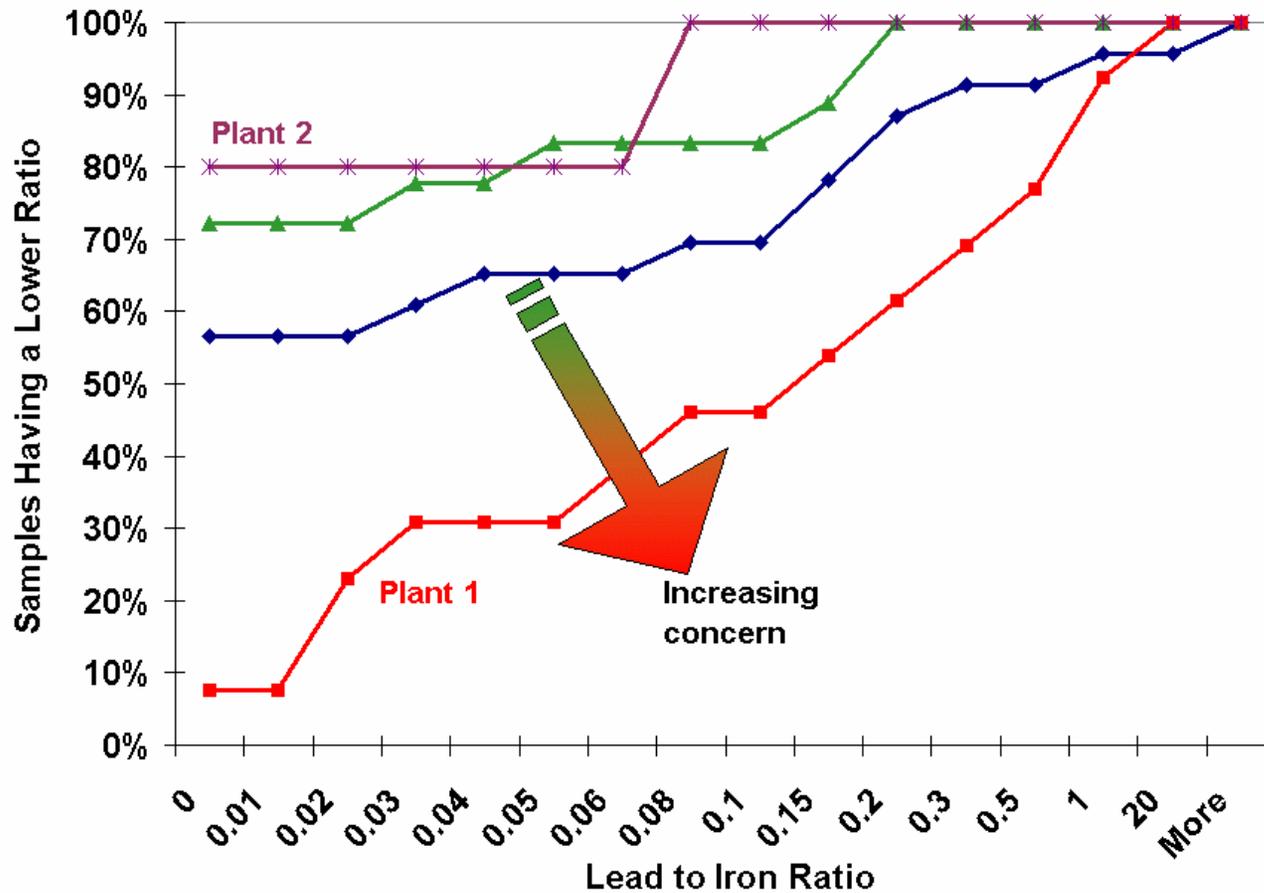
Cumulative Histograms Provide Convenient Means for Comparing Lead Content Identified in Tube Exams

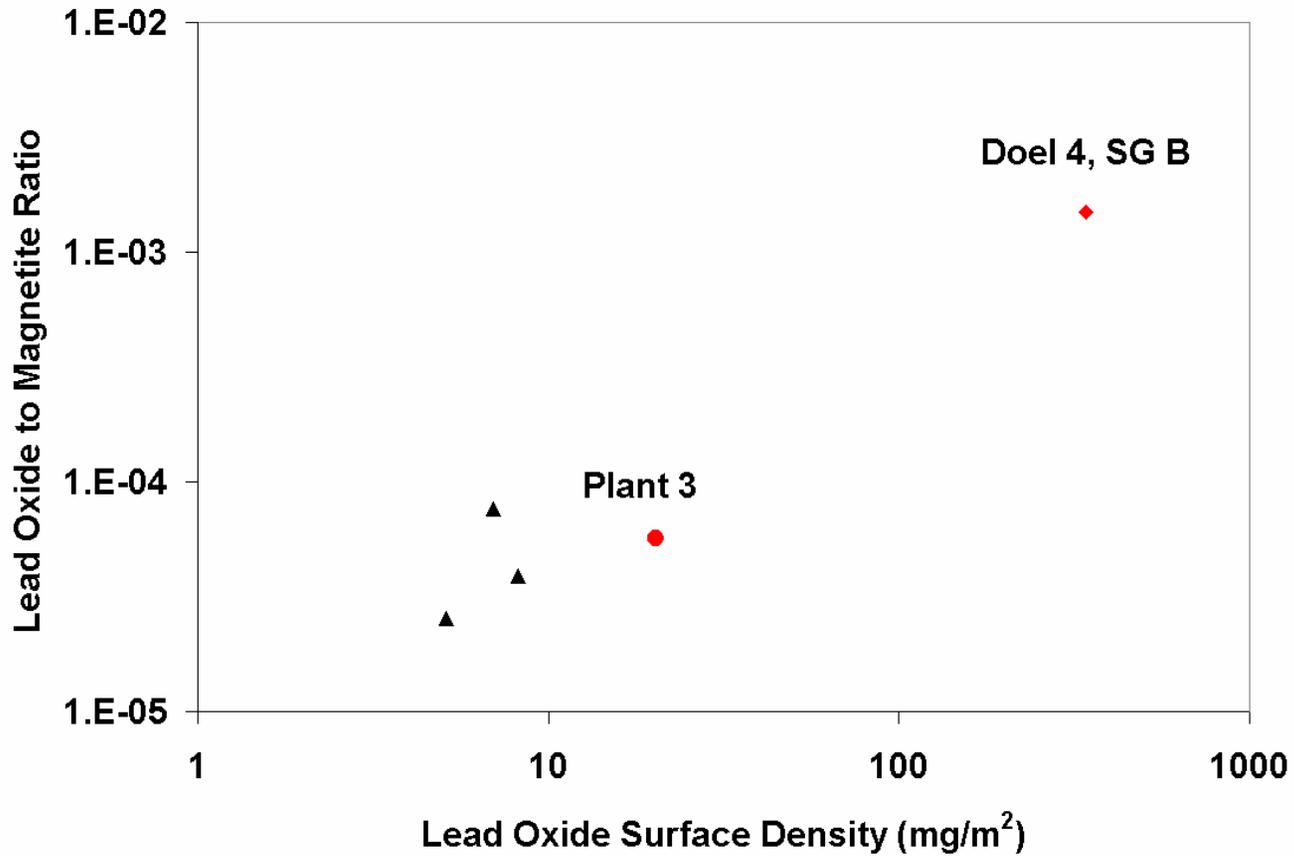
Two Measures for Comparing Lead Removed by Chemical Cleaning

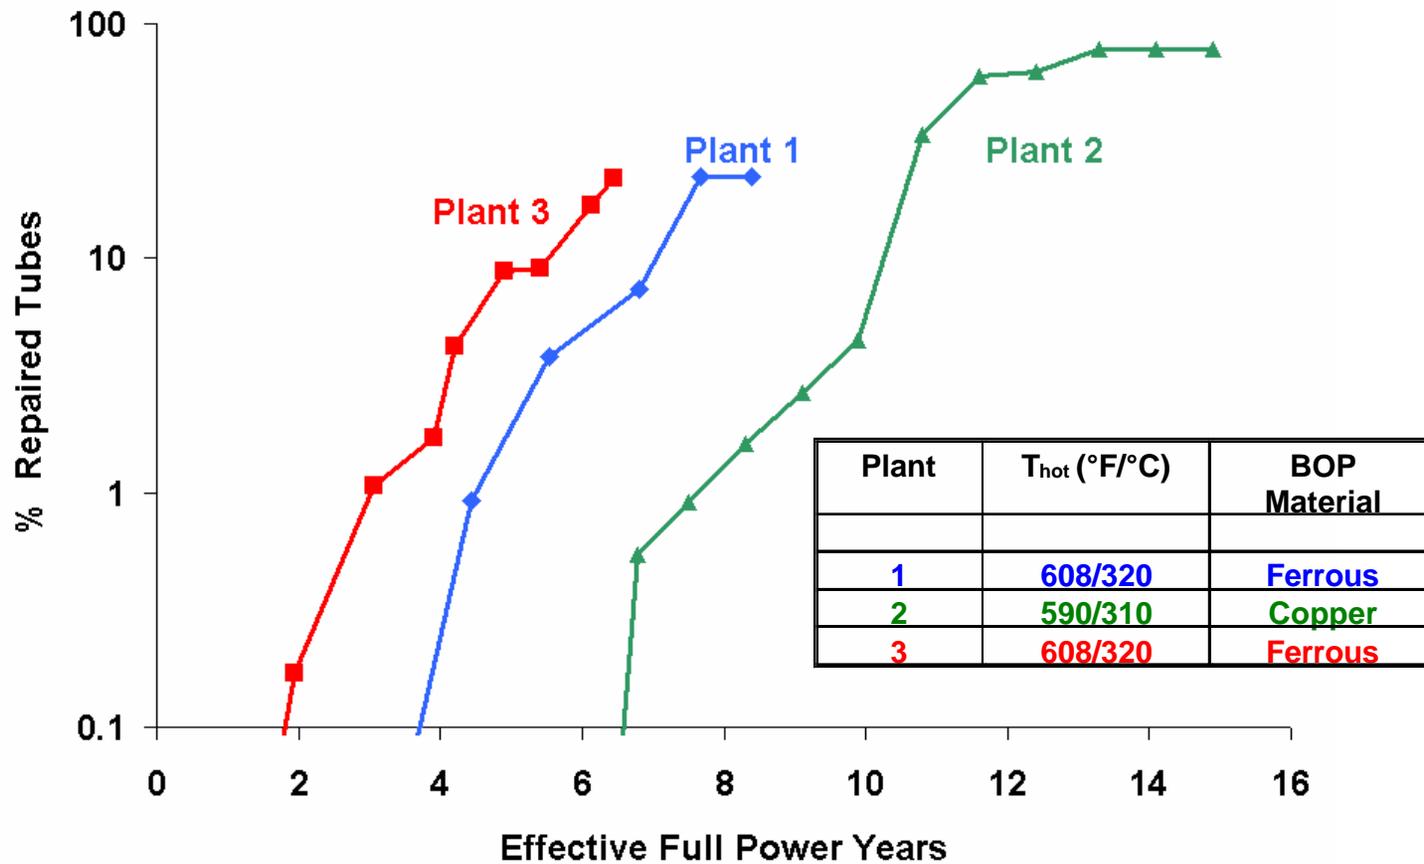
All Three Plants Experienced Extensive SCC in Crevice Interior

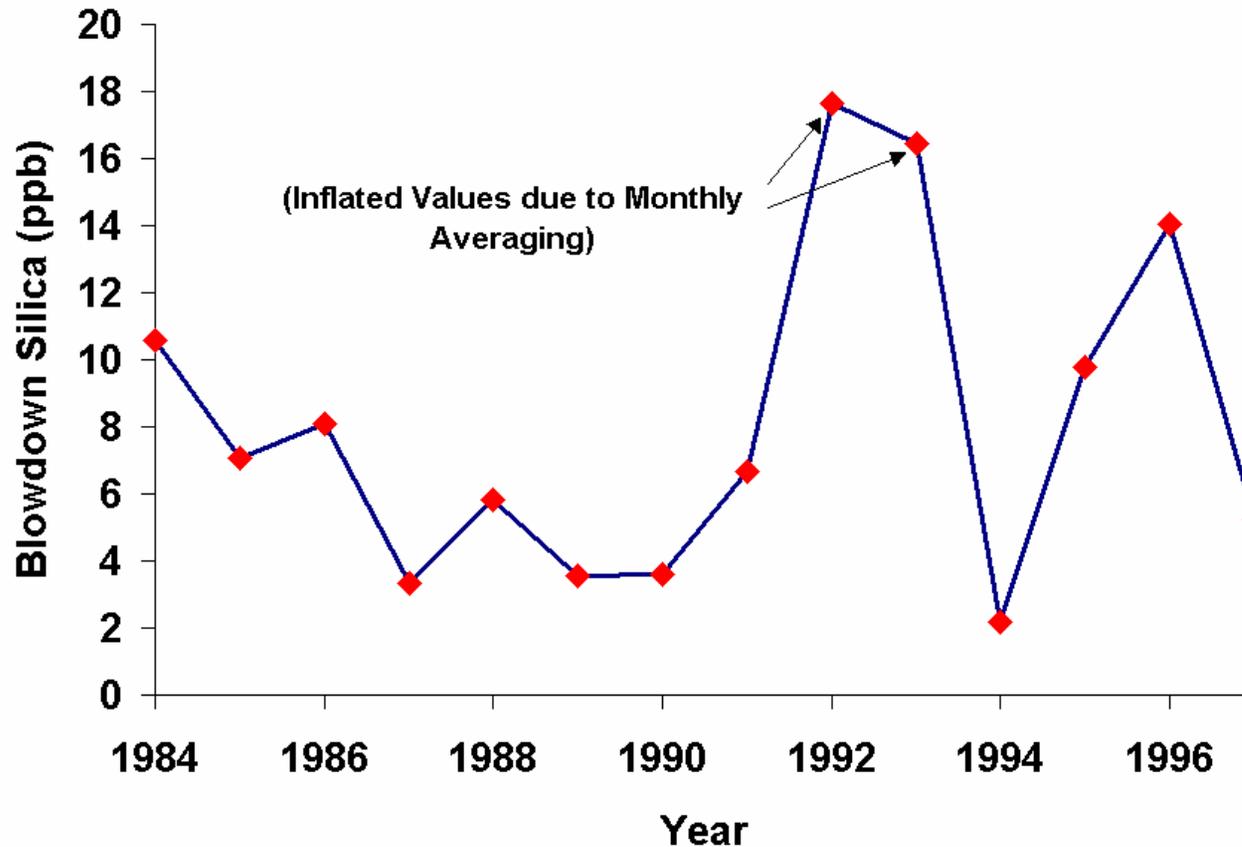
Plant 2, with Low Lead to Iron Ratio in Crevice, Operated with Exceptionally Low Blowdown Silica

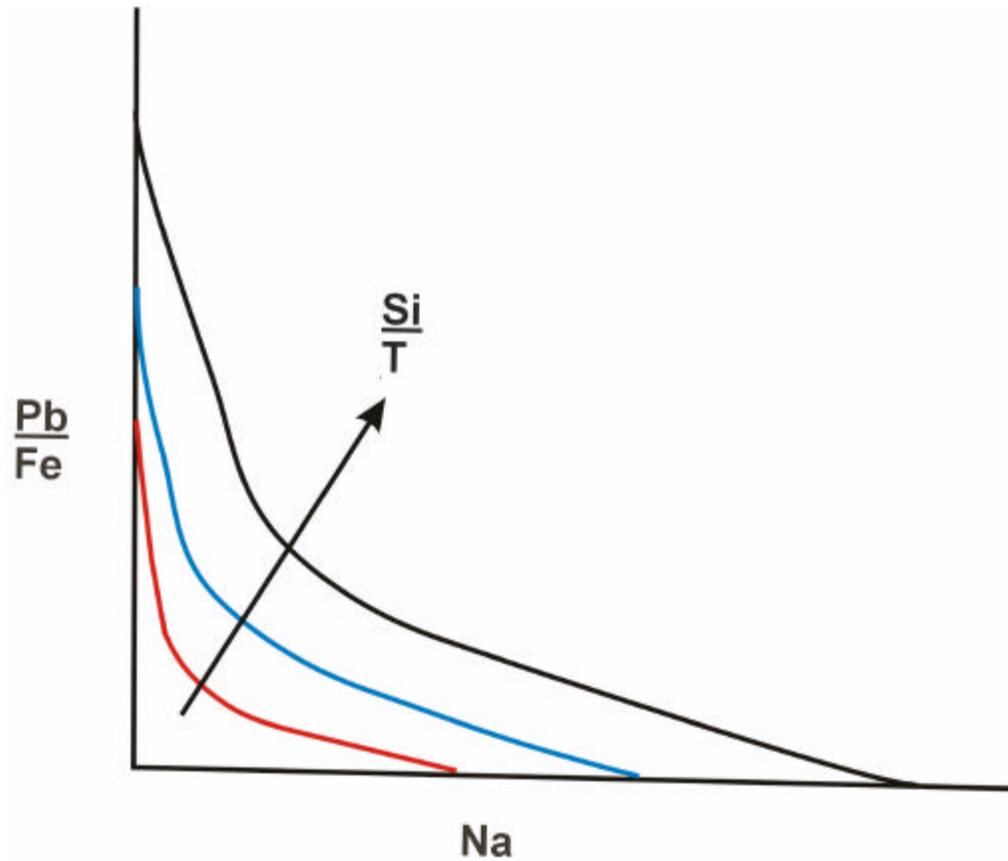
First Order ODSCC Variables Show Plane Having Equal Corrosion

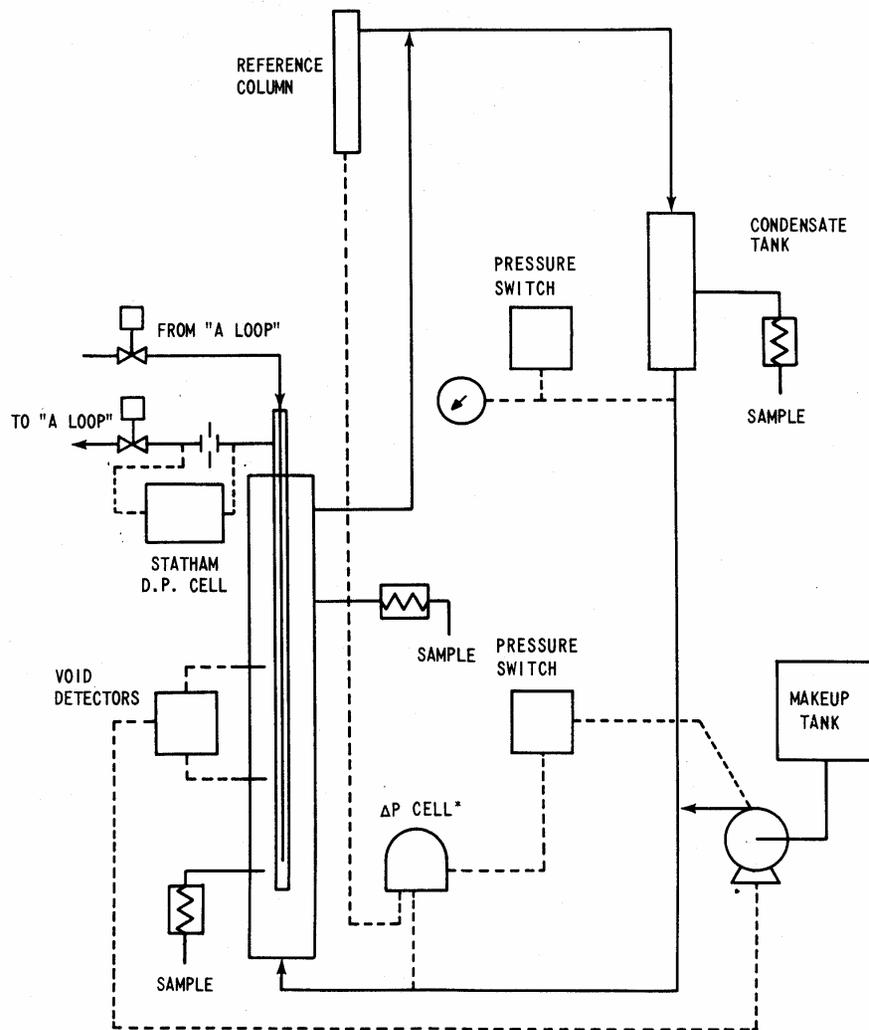
Figure 3-1. Schematic Diagram of Forest Hills Model Boiler System

**Westinghouse
Model Boiler
System (from
WCAP-10273)**

- General Approach (see Figures 1-3)
 - Use realistic or somewhat elevated primary and secondary temperatures and heat fluxes
 - Use realistic primary coolant chemistry
 - Use AVT chemistry plus selected additive(s)
 - Use realistic tubes, crevices
 - Add sludges of various compositions (often oxidizing)
 - Often use sludge cups and porous frits to hold sludge in place
 - Often use periodic power and pressure cycling to introduce solutions into crevices

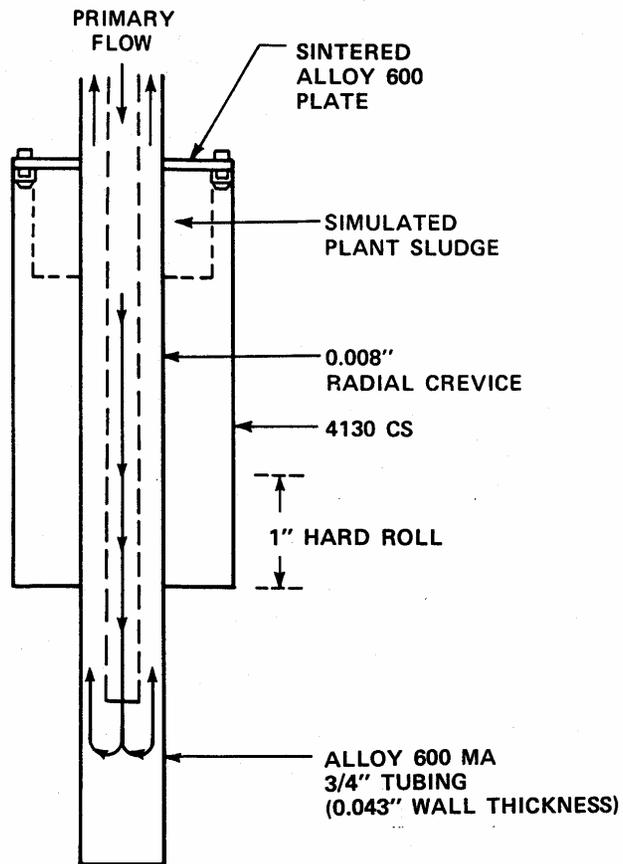
Figure 3-2. Schematic Diagram of Tubesheet Simulant

**Tube Sheet
 Simulant (from
 WCAP-10273)**

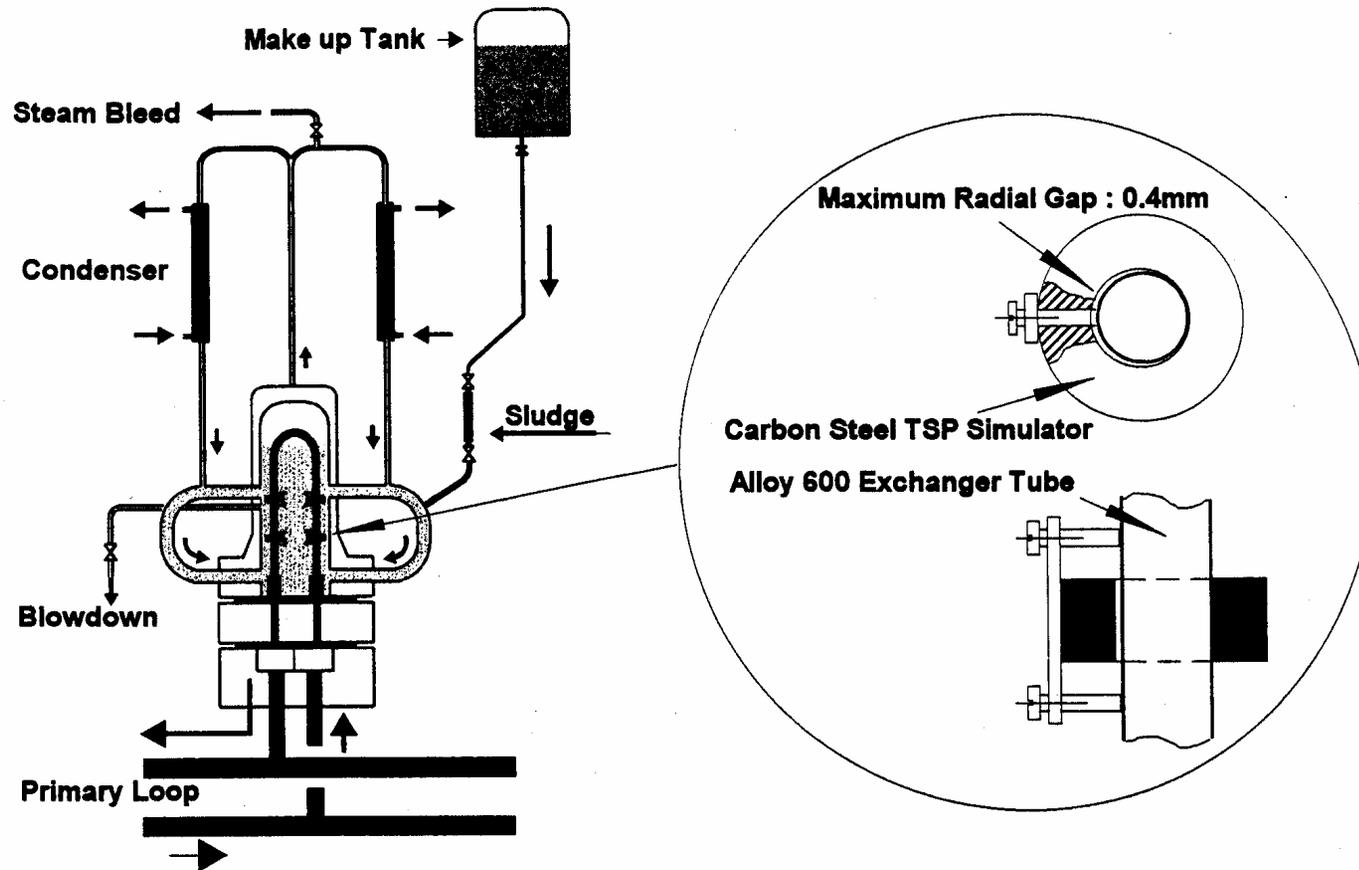
CEA's AJAX MB (from Daret, 1997)

Figure 1. Schematic flow sheet of an AJAX model boiler, with a close view of a simulated tube-tube support plate intersection

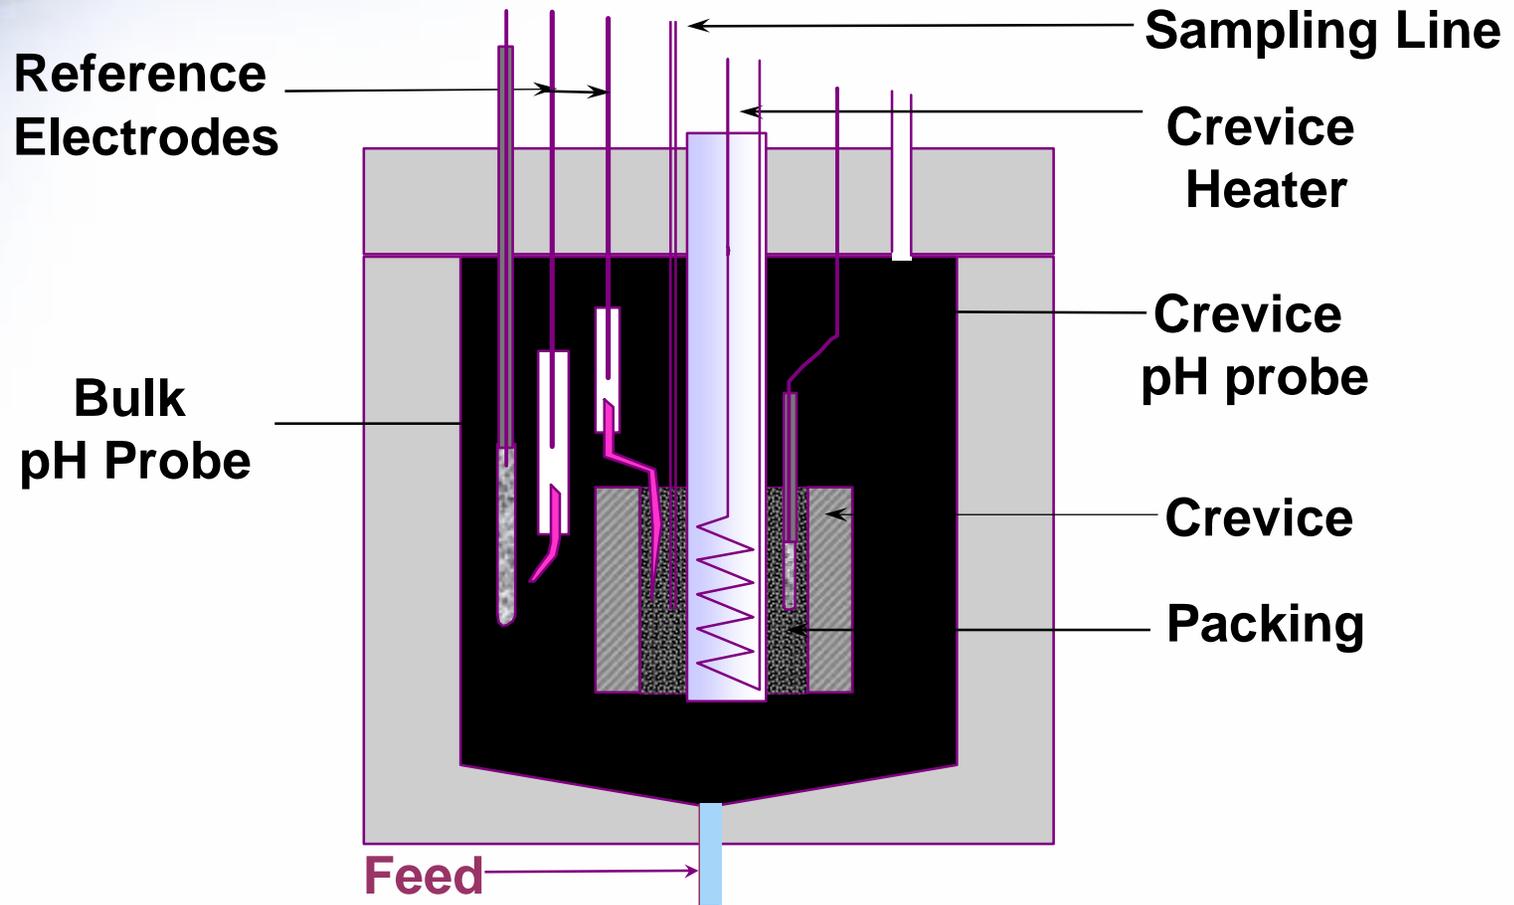
Replenished Autoclave System
