LIMITS TO CREVICE CONCENTRATION PROCESSES

Allen Baum

Presentation to:

EPRI/Argonne Crevice Workshop

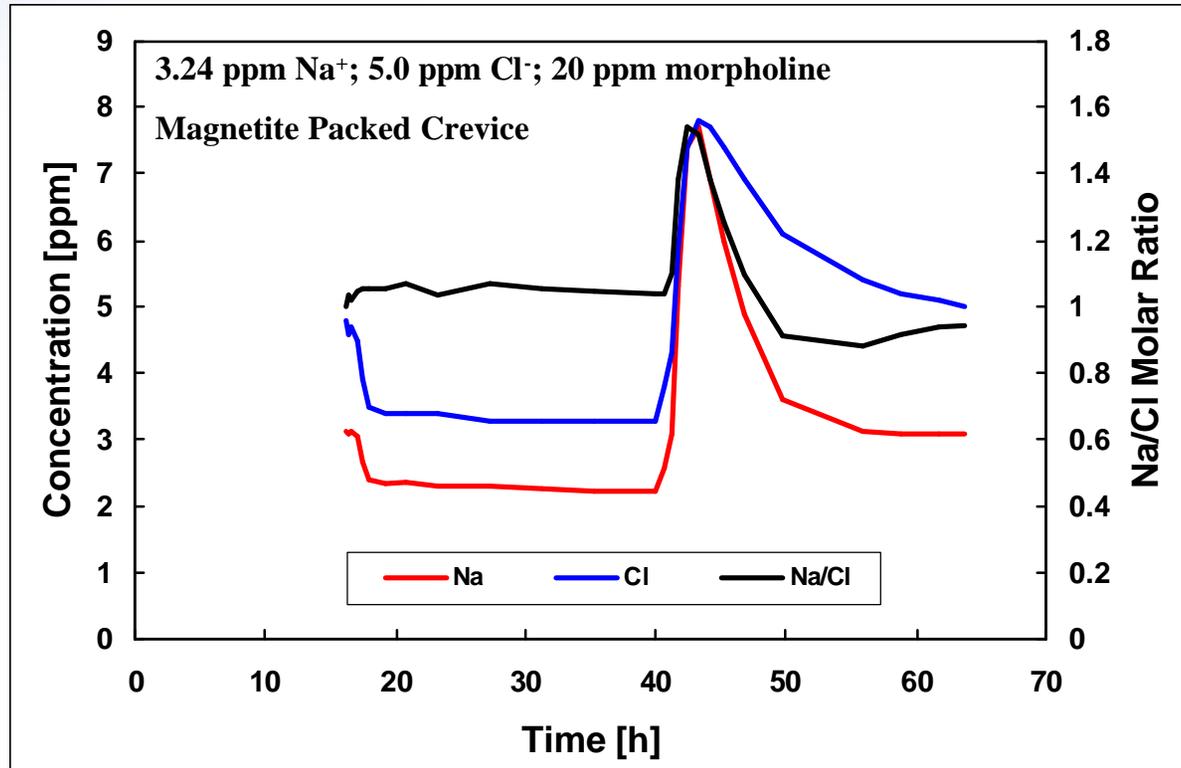
Typical Hideout/Hideout Return Profile

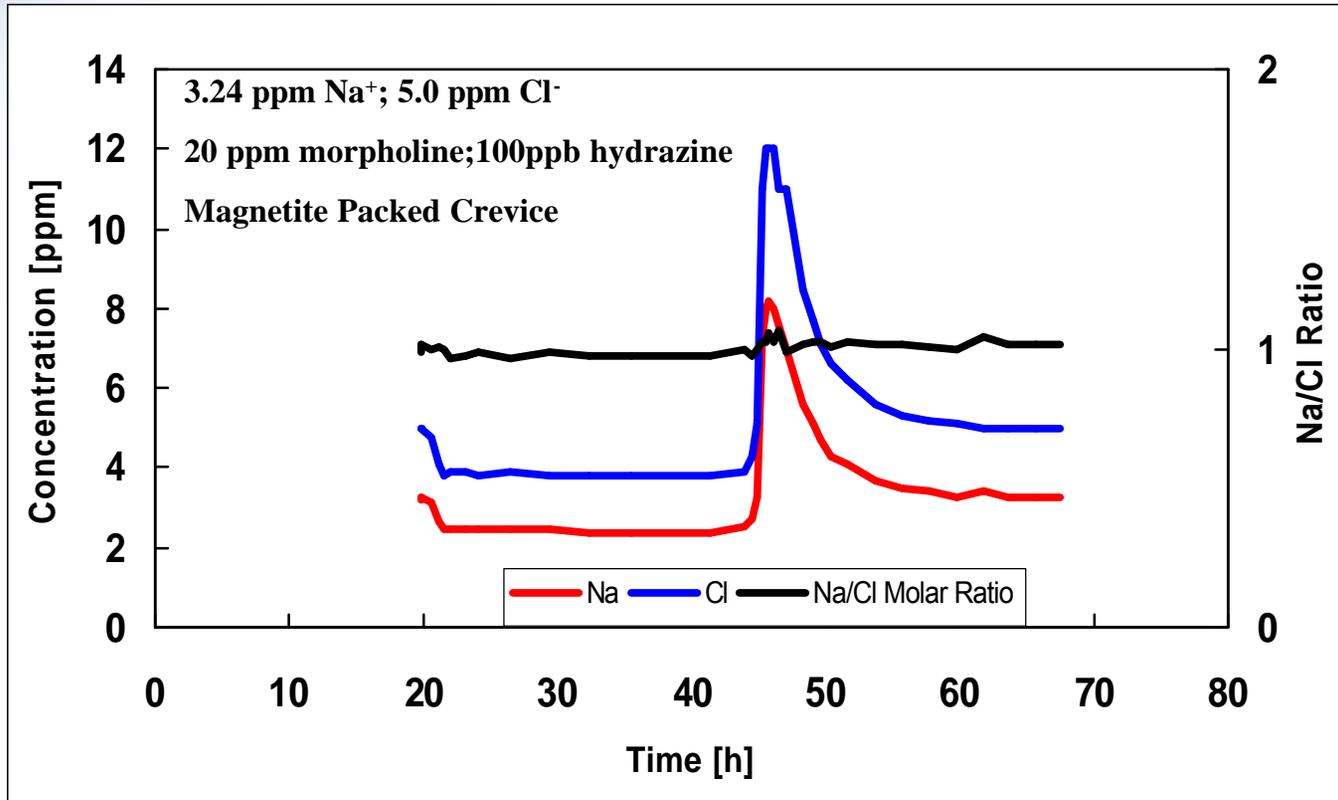
Hideout Return Profile w/ Hydrazine

•De-Aerated Conditions ↻ non-oxidizing

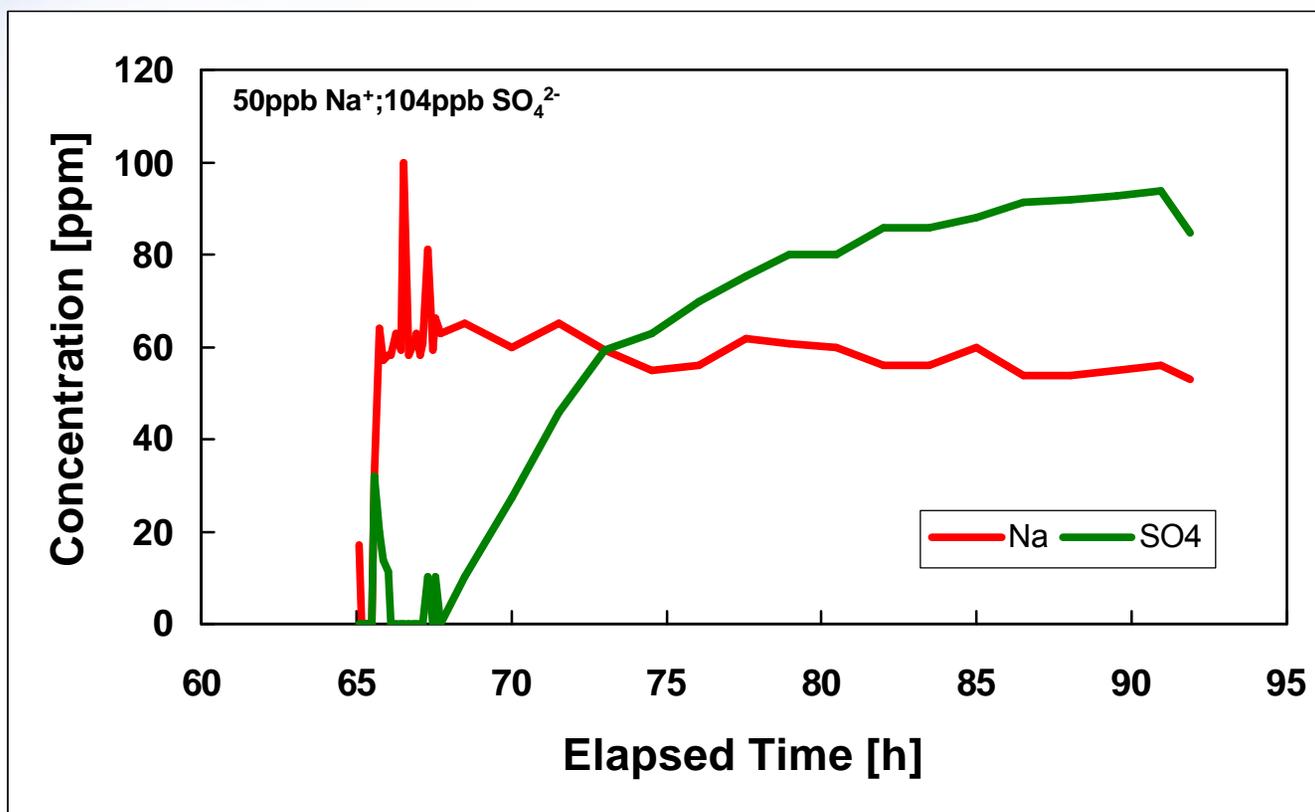
Sulphate Adsorption on Magnetite

•Solution pumped through a magnetite column (270°C)

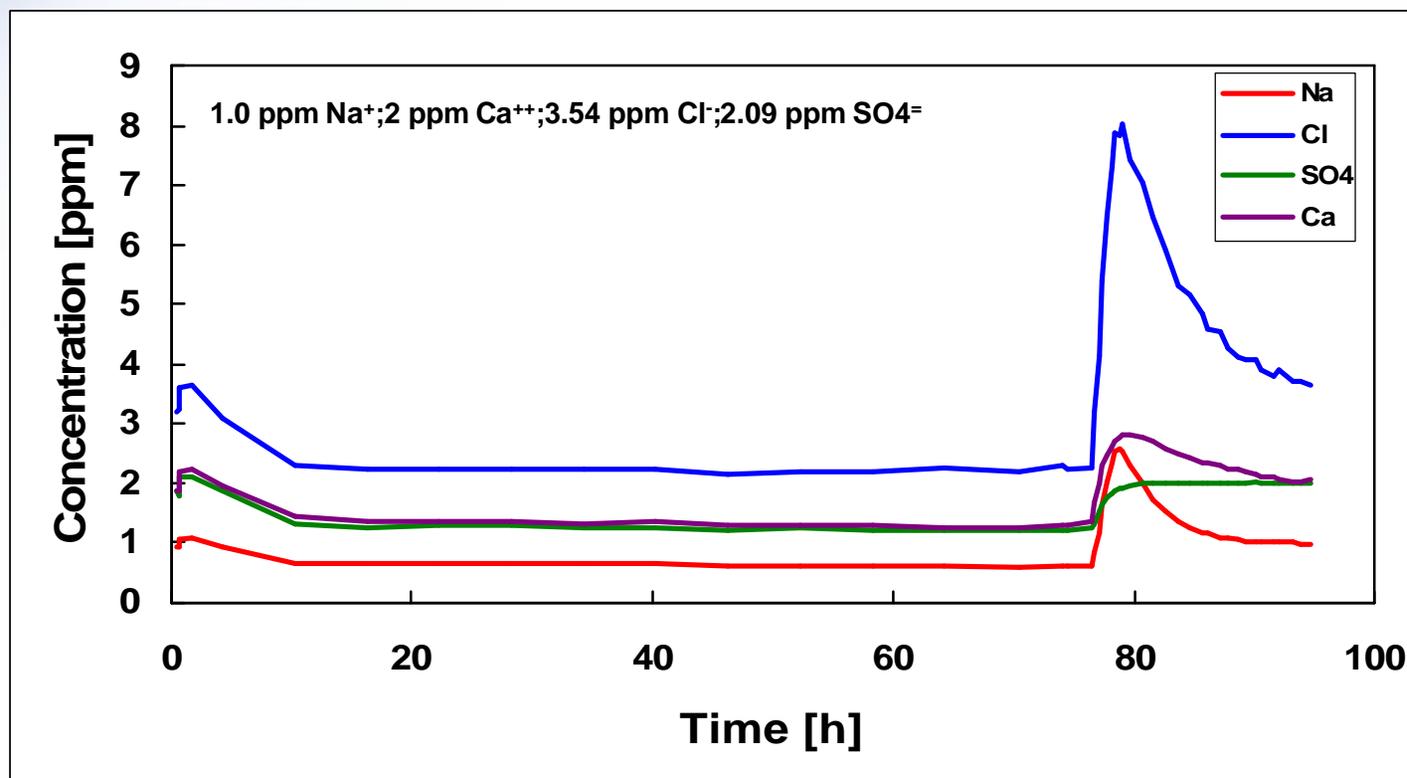
Hideout/Return of Complex Solutes

• Indicates incomplete return of Ca²⁺ and SO₄²⁻

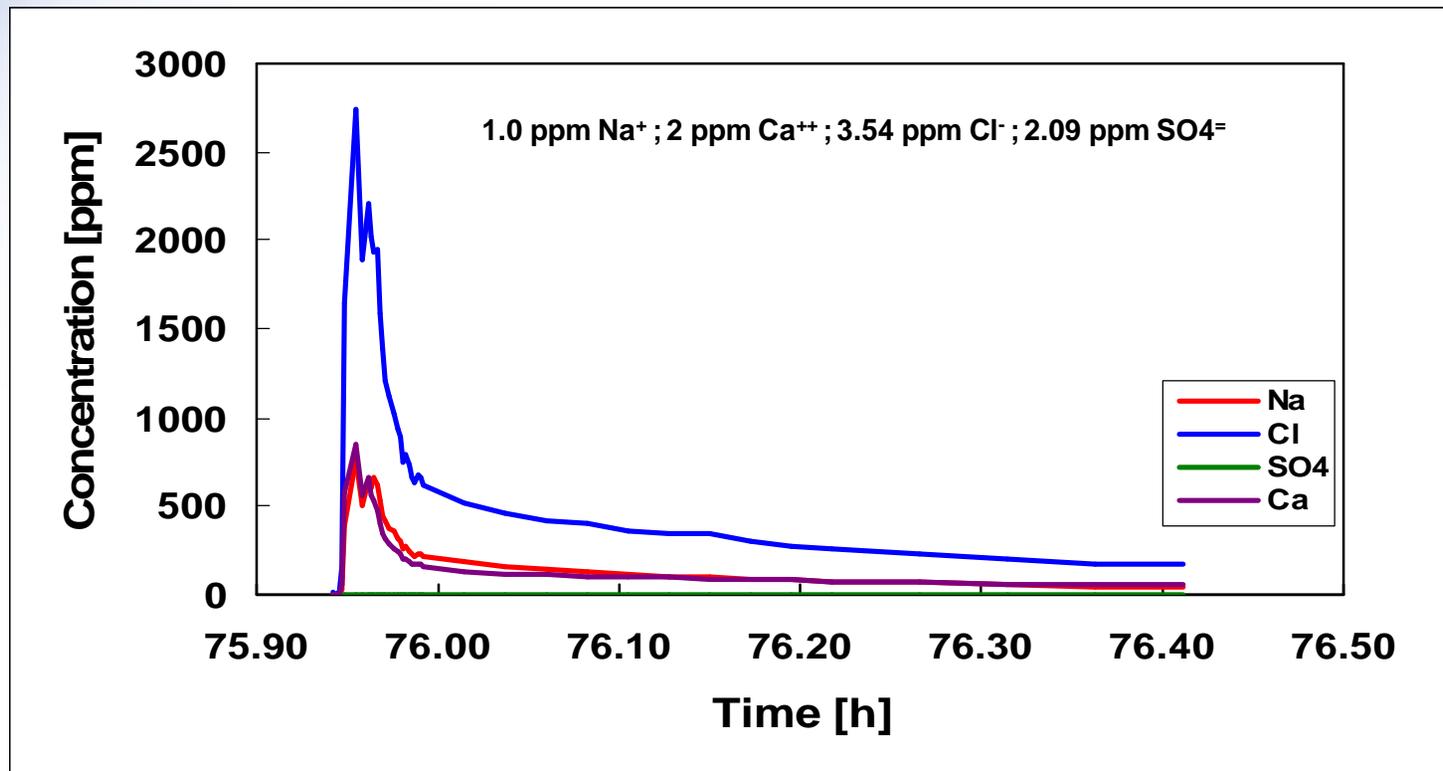
Crevice Sampling

• Lower than expected concentrations of SO₄²⁻ and Ca²⁺

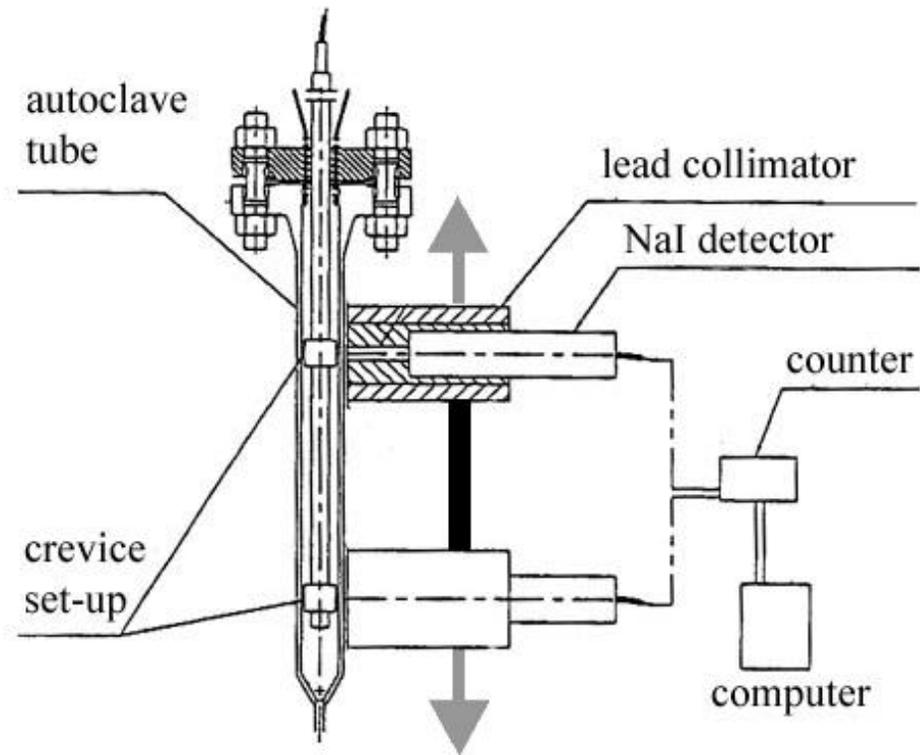
Autoclave setup

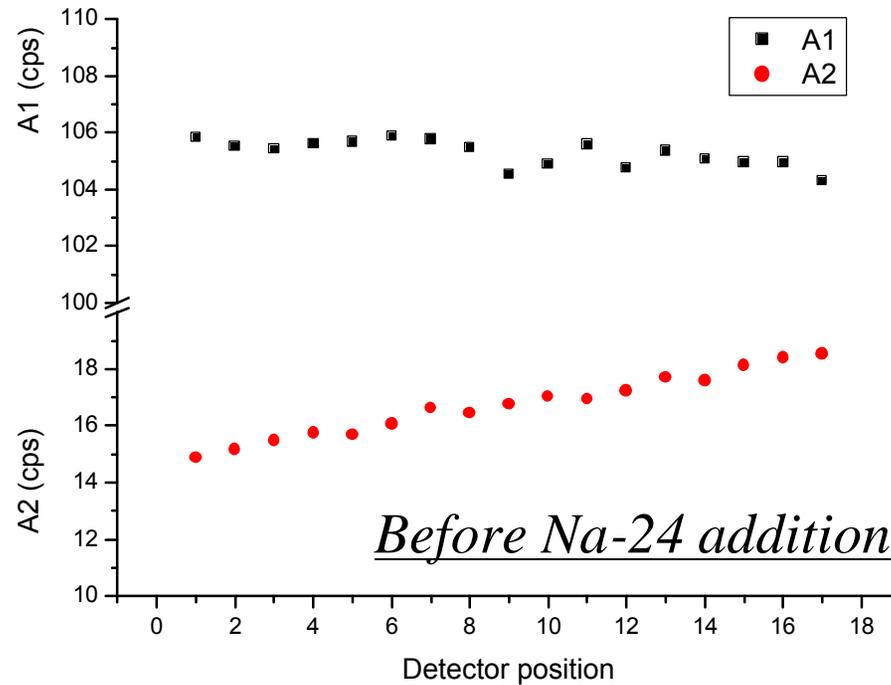
Activity of as-received Ringhals TSP sample

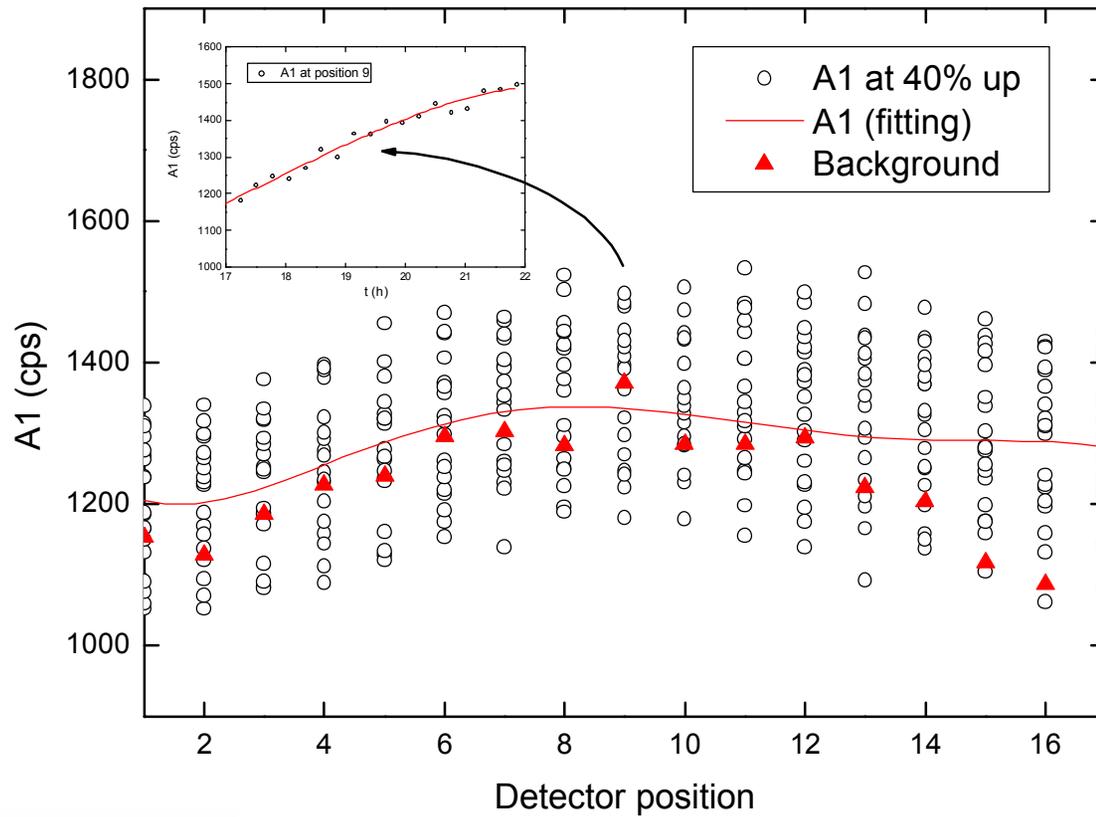
Activity build-up in the crevice

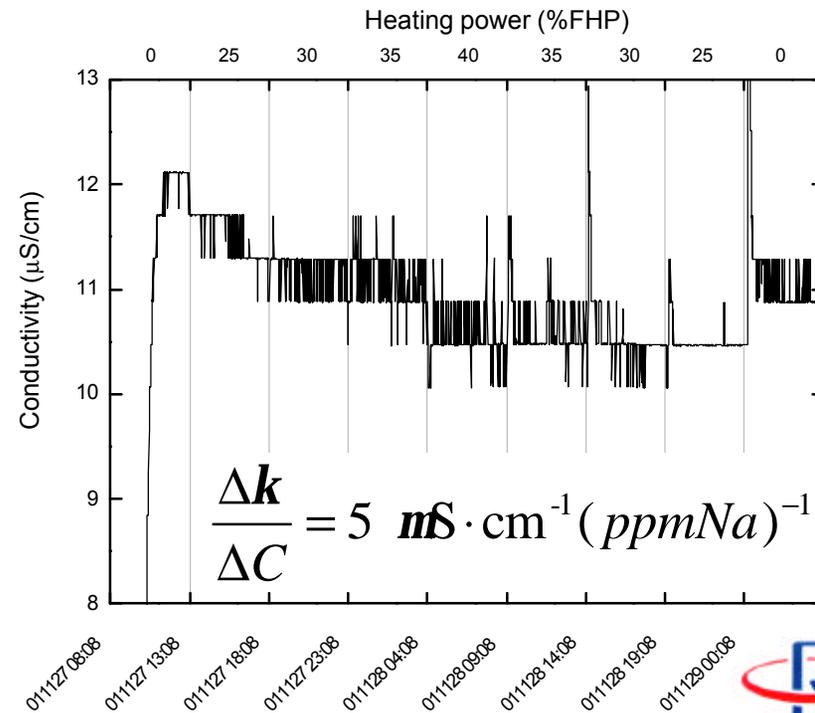
Water conductivity change during hideout and return

- It decreases with increasing heating
- It increases when the heating is off.

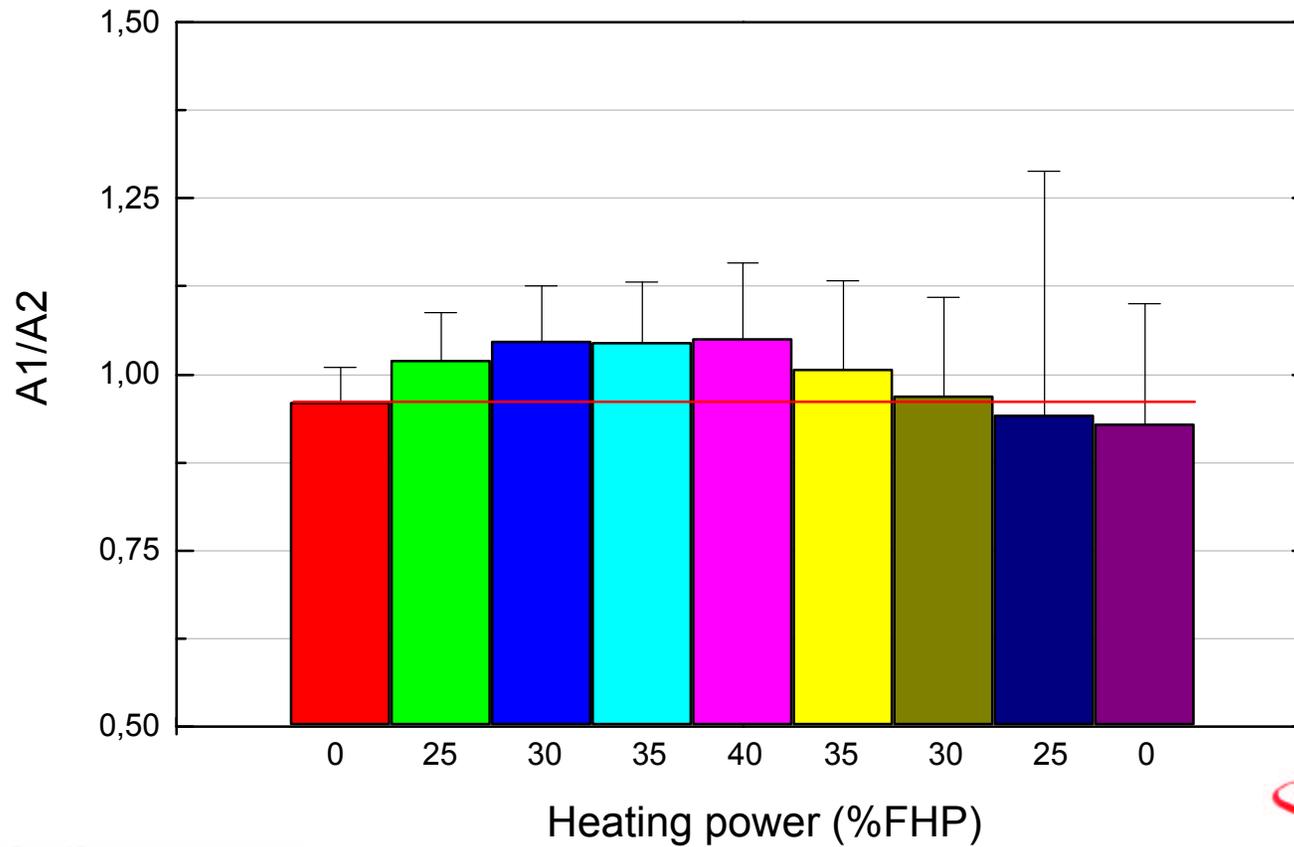
Dummy crevice test

- There is a slight activity buildup around the dummy crevice when heated (the amount is negligibly small)
- At the upper mouth location, there is a slightly increased activity (the amount is negligibly small)

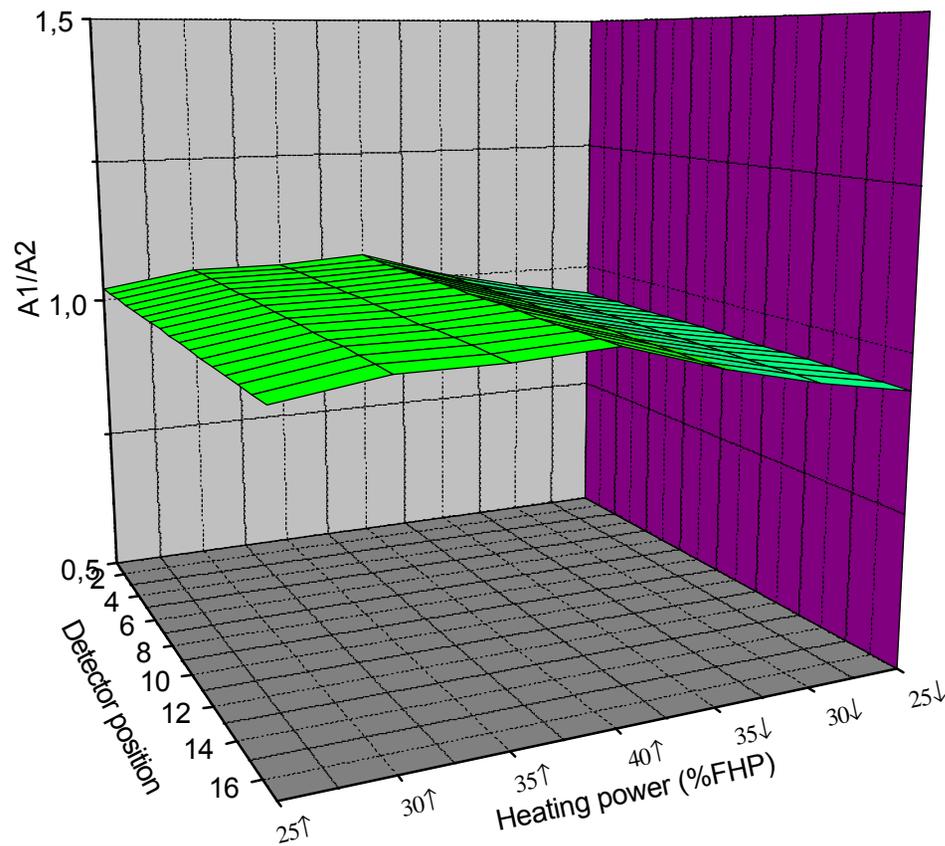
Axial profile of the activity ratio

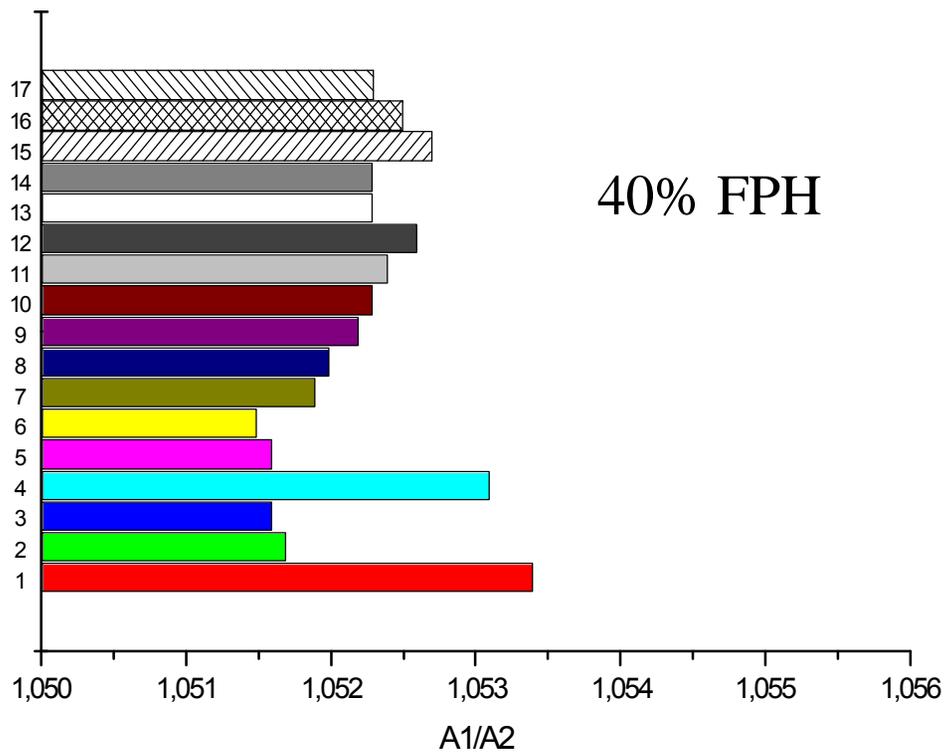
Axial profile of the activity ratio

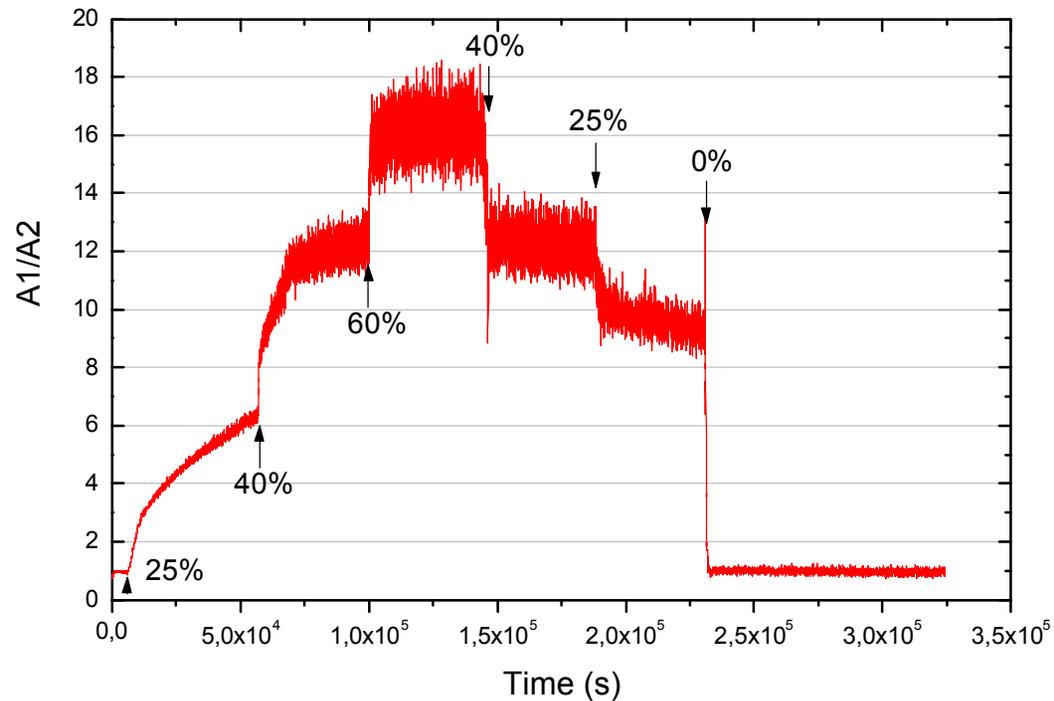
Hideout and return of a metal-net filled TSP crevice

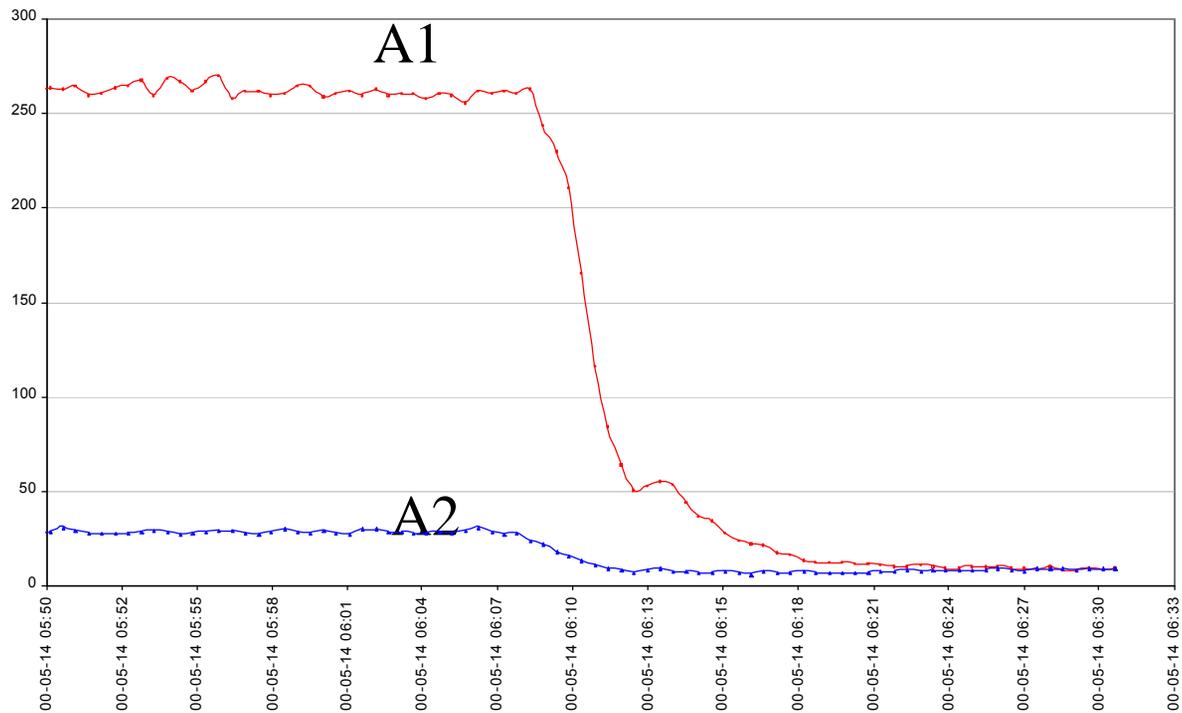
Rapid return at zero power

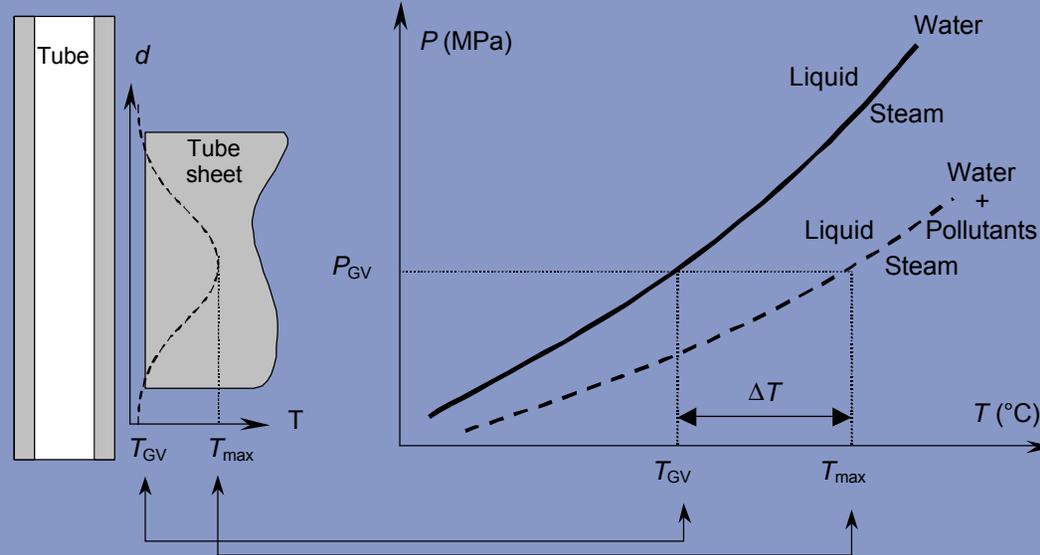
Liquid/vapor equilibrium in crevices

In S.G., a concentrated liquid phase is stable when its vapour pressure is equal to the secondary pressure.

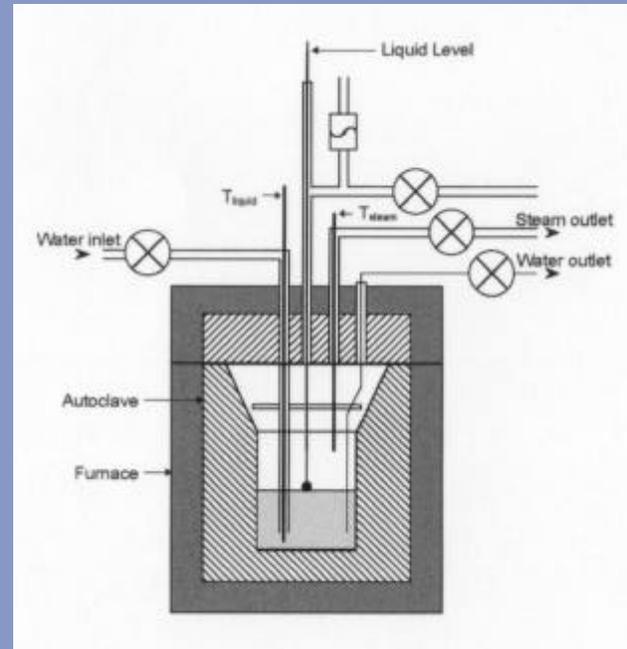
EVA facility

- Device made to study isochoric and isotherm concentration processes by evaporation of an homogeneous aqueous solution in pseudo-equilibrium conditions with its vapour phase
 - Constant liquid phase volume
 - Maximum temperature: 320°C
 - Feed flow rate: 30g.h⁻¹
 - Maximum pressure: 15 MPa

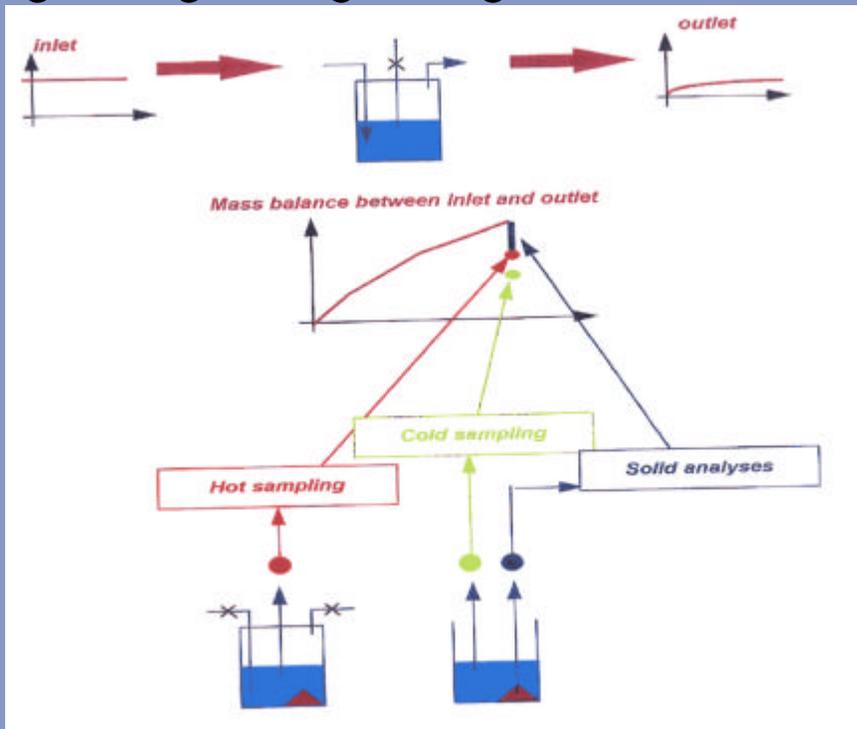
Test methodology

- 1- Inlet and outlet analyses
- 2- Mass balance calculations
- 3- Sampling at the end of
 1. Hot liquid phase (or a hideout return phase)
 2. Cold liquid phase
 3. Solid phases

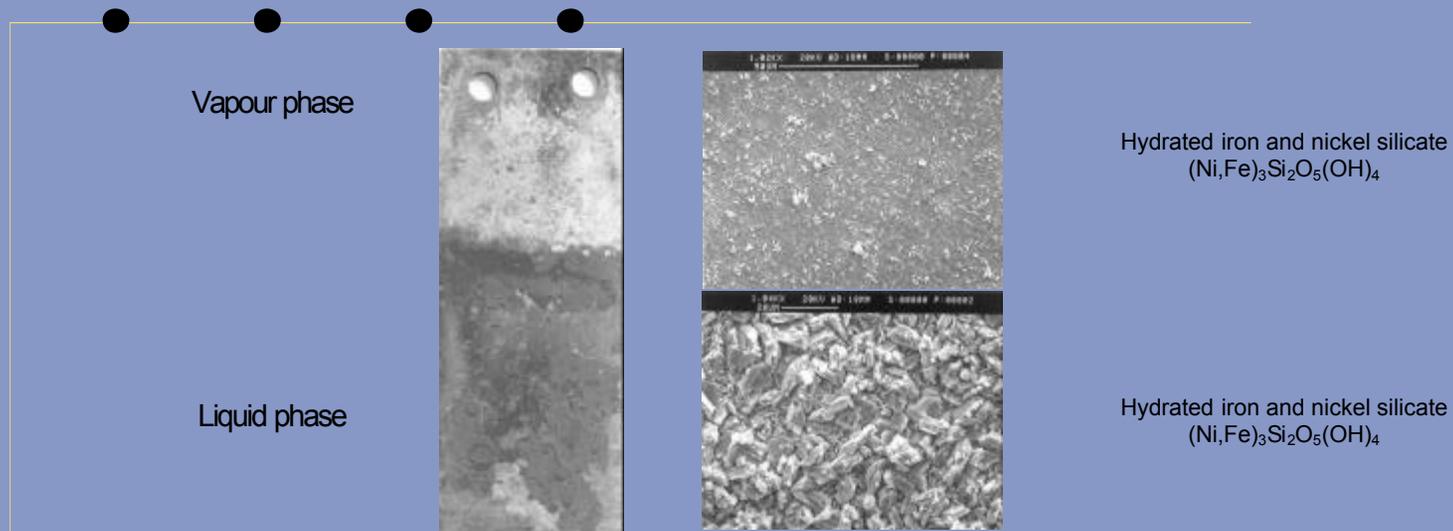
NaOH results (3): after test examinations

View of the alloy 600 coupon exposed during the caustic tests in EVA device

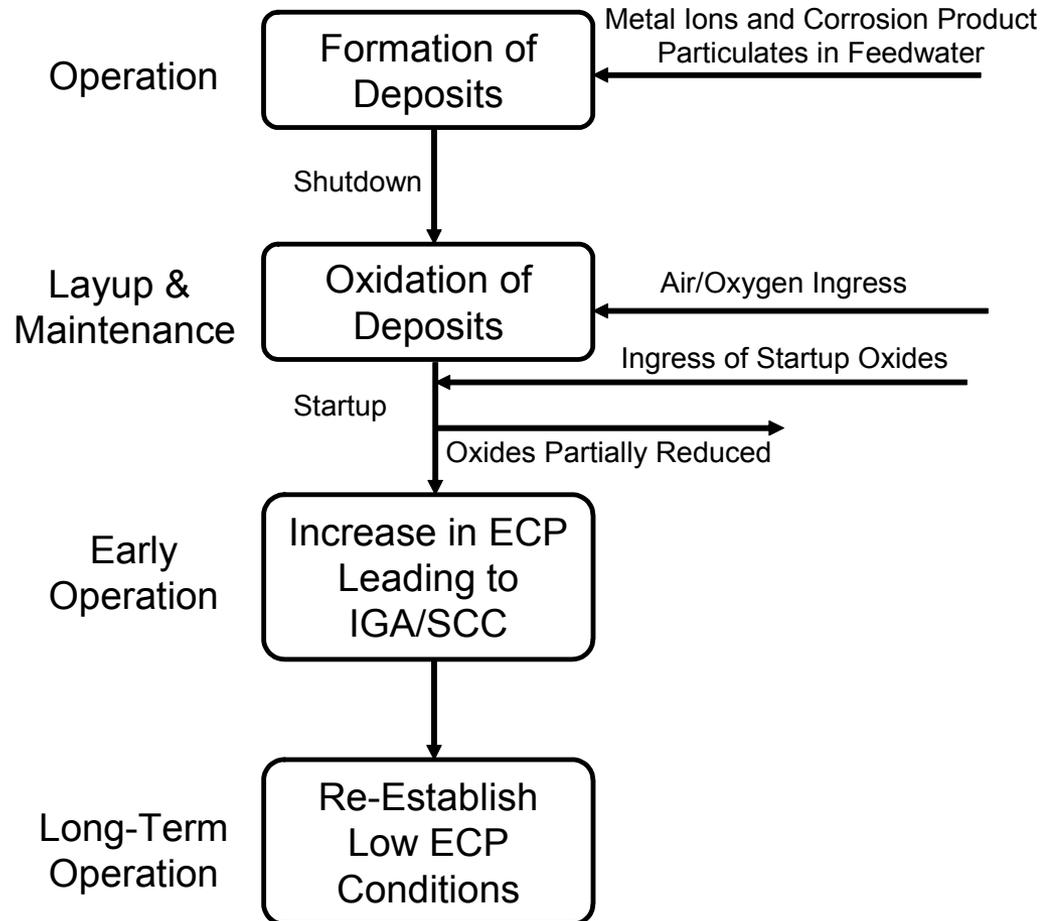
Startup Oxide Theory

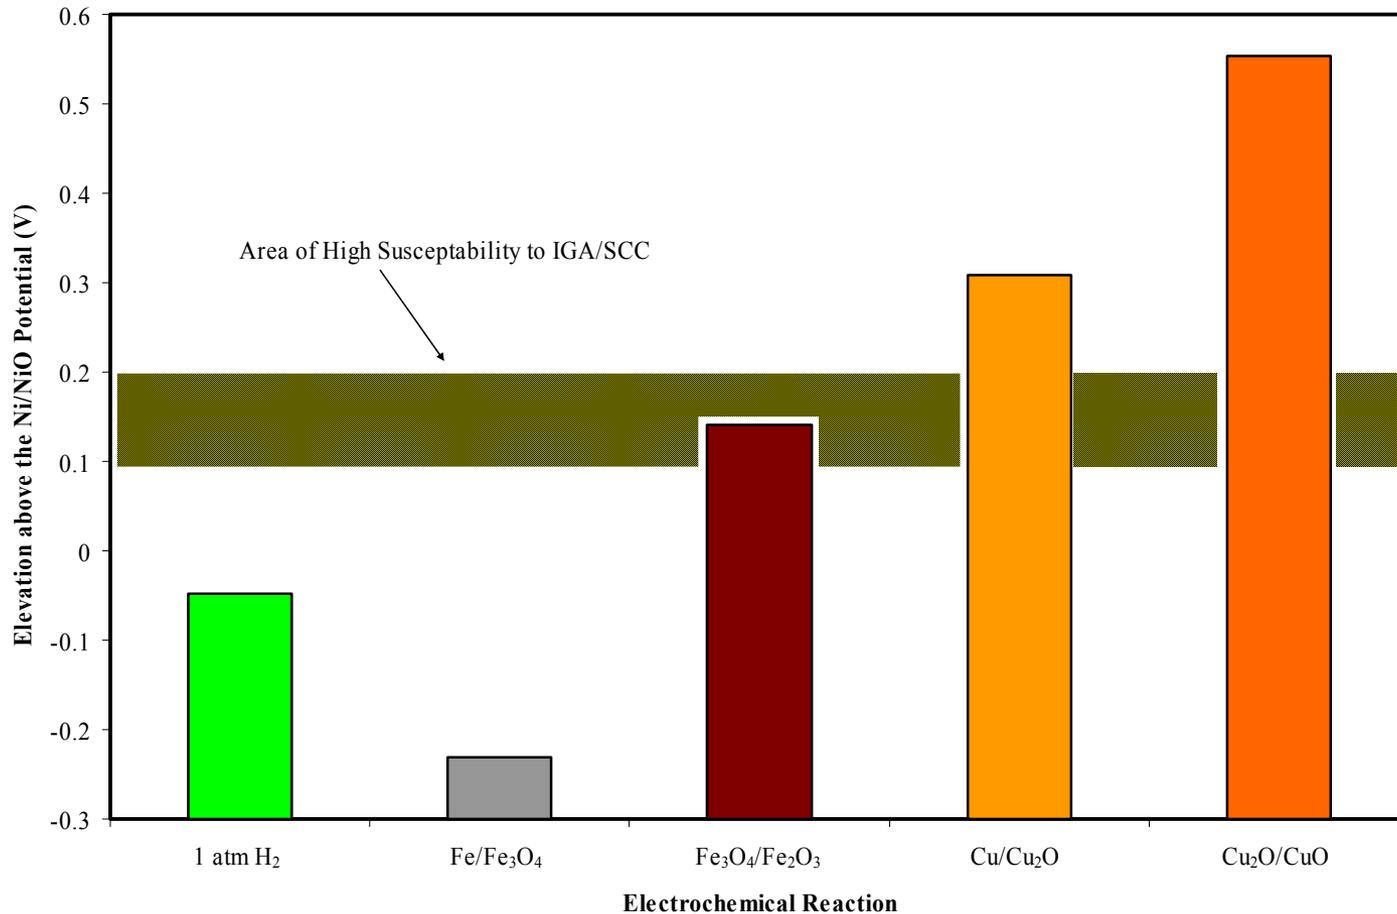
Electrochemical Potentials of Deposit Constituents

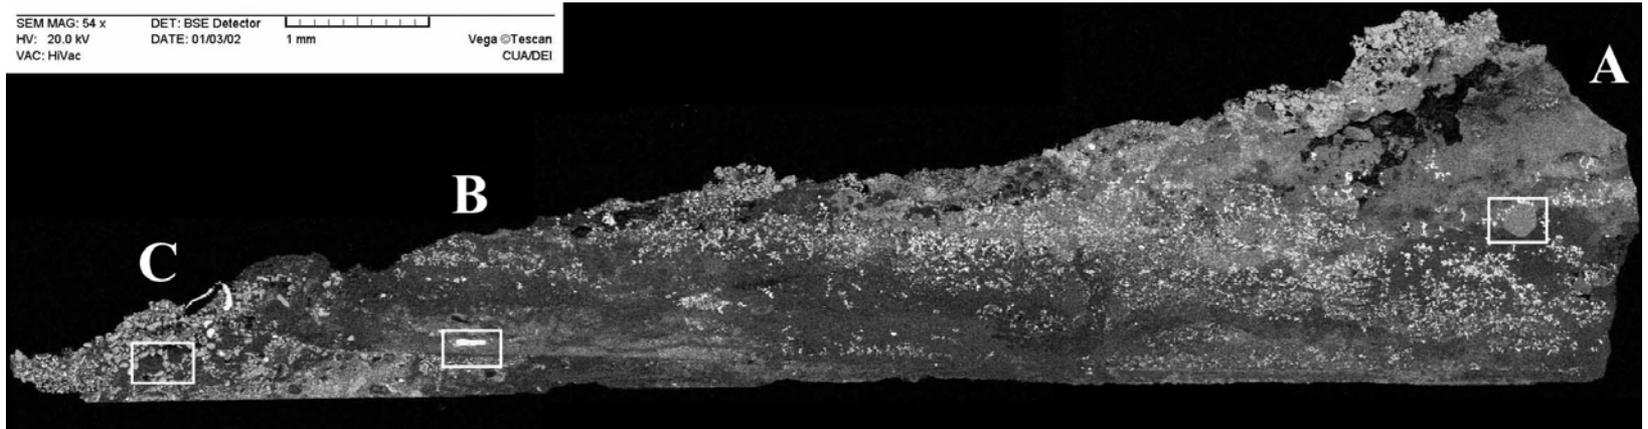
“Typical” Collar

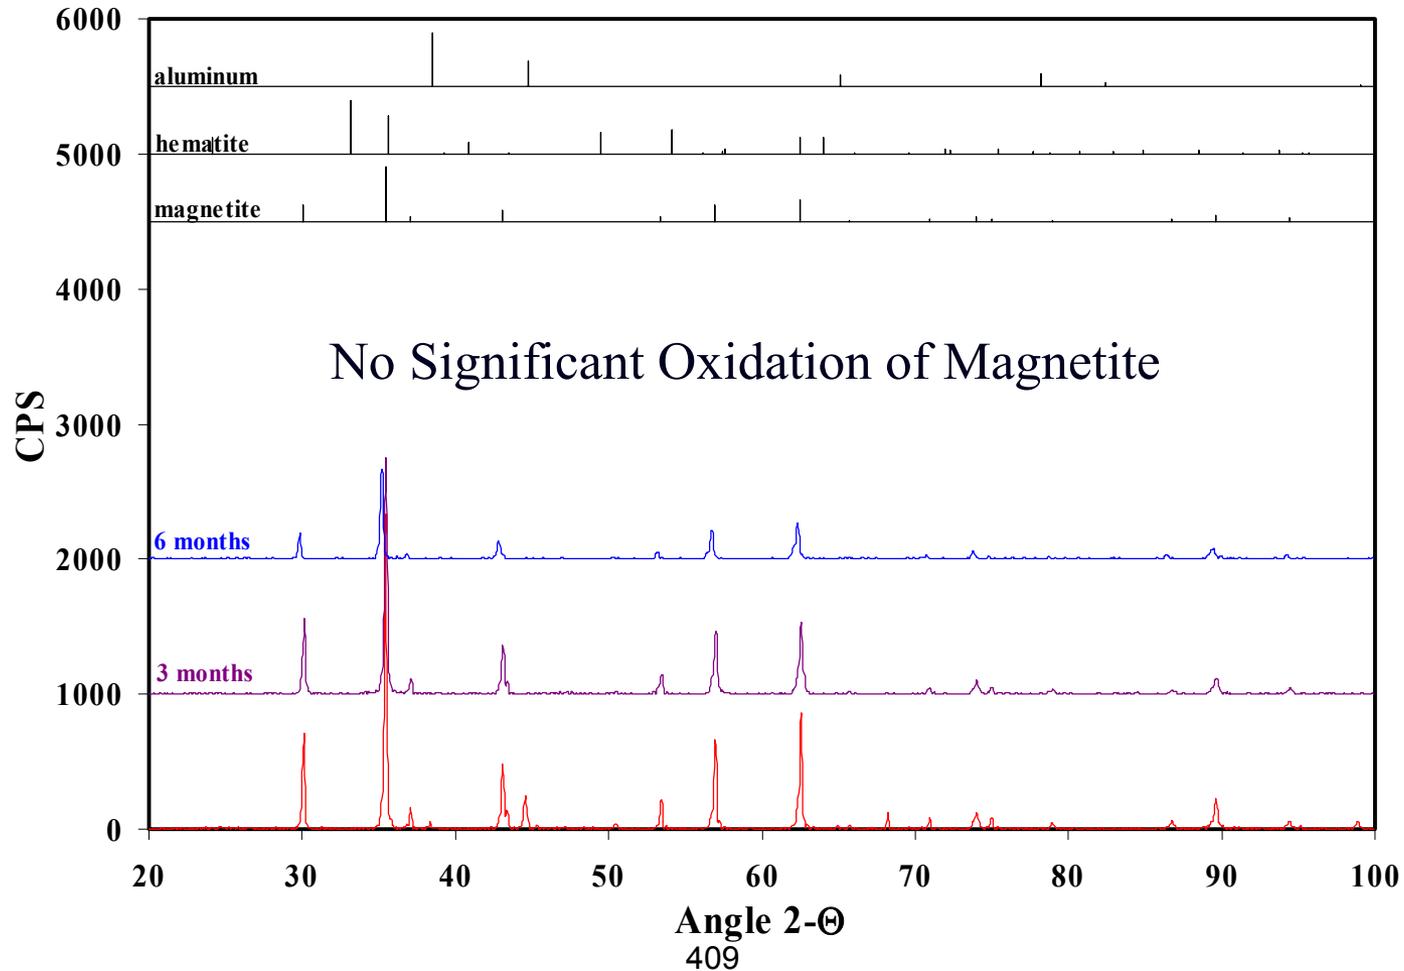
Magnetite—Pellet Experiment Results

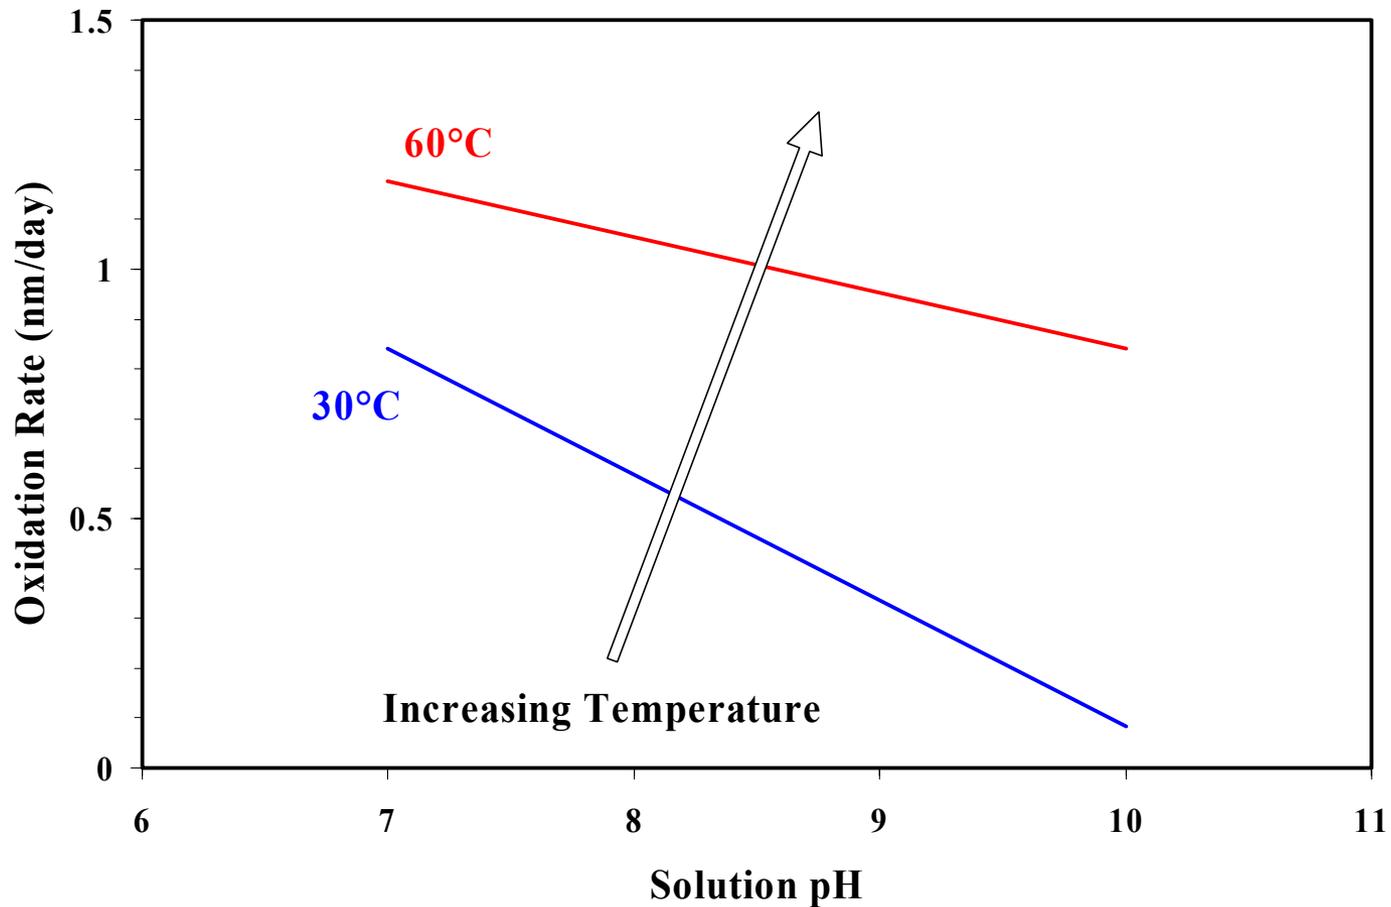
Copper—Aqueous Oxidation

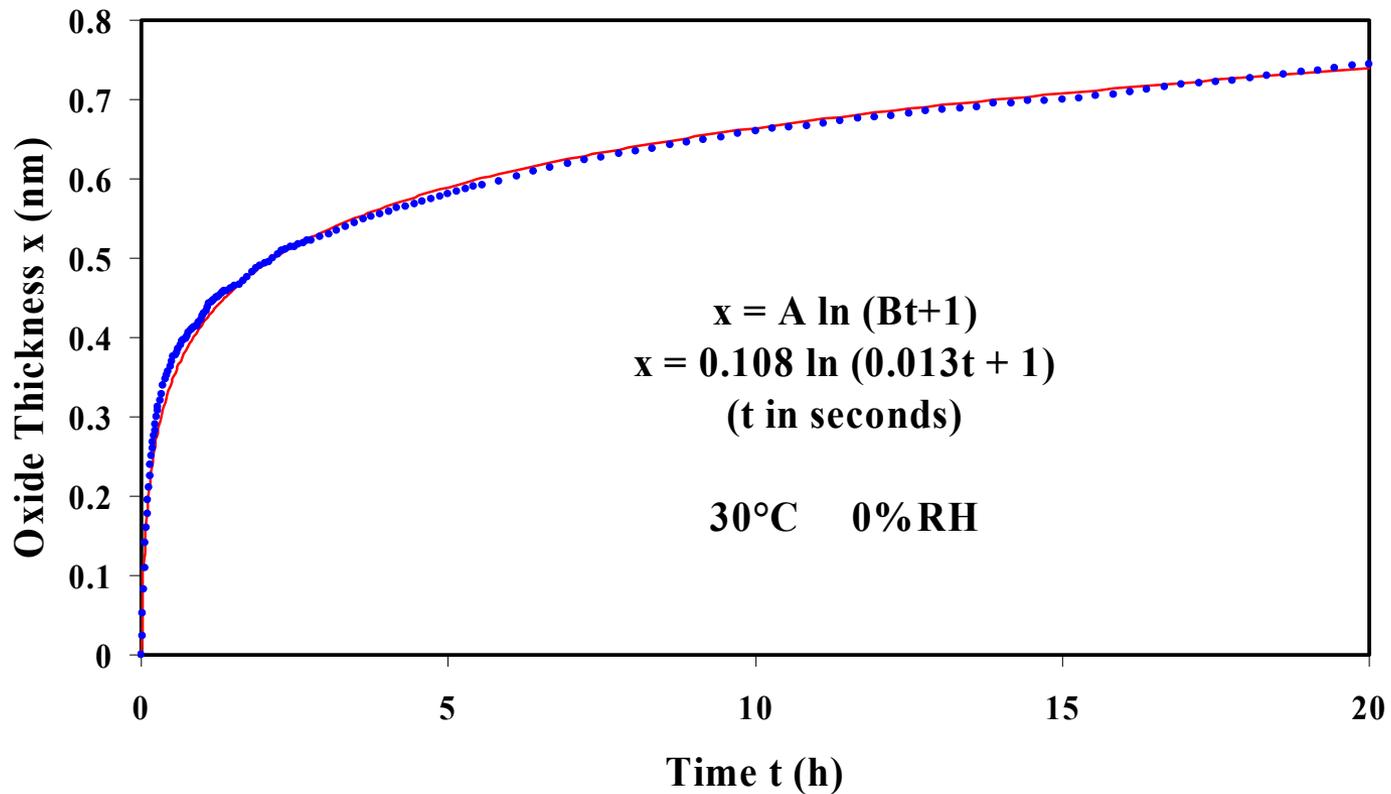
Copper—Atmospheric Oxidation

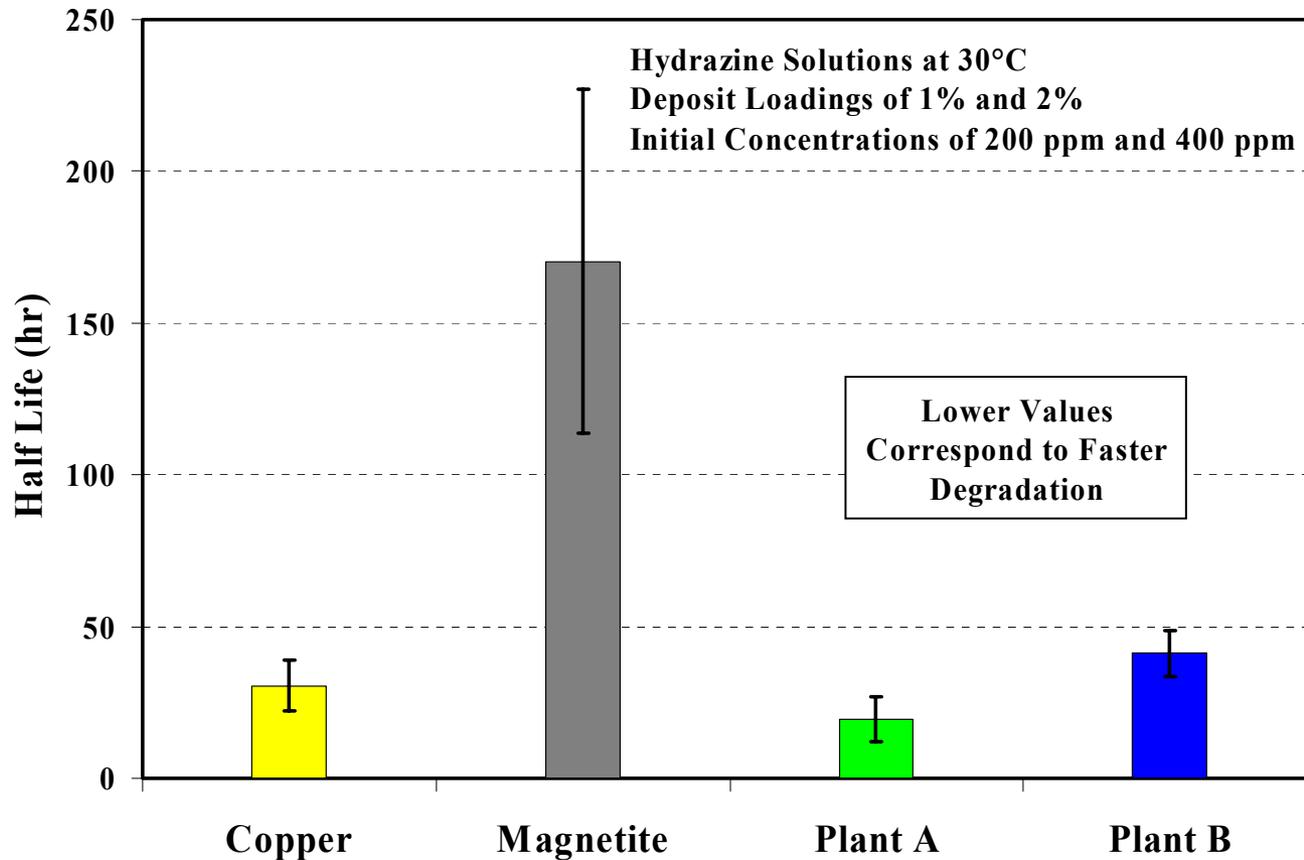
Hydrazine and SG Deposits
