LIMITS TO CREVICE CONCENTRATION PROCESSES

Allen Baum

Presentation to:

EPRI/Argonne Crevice Workshop

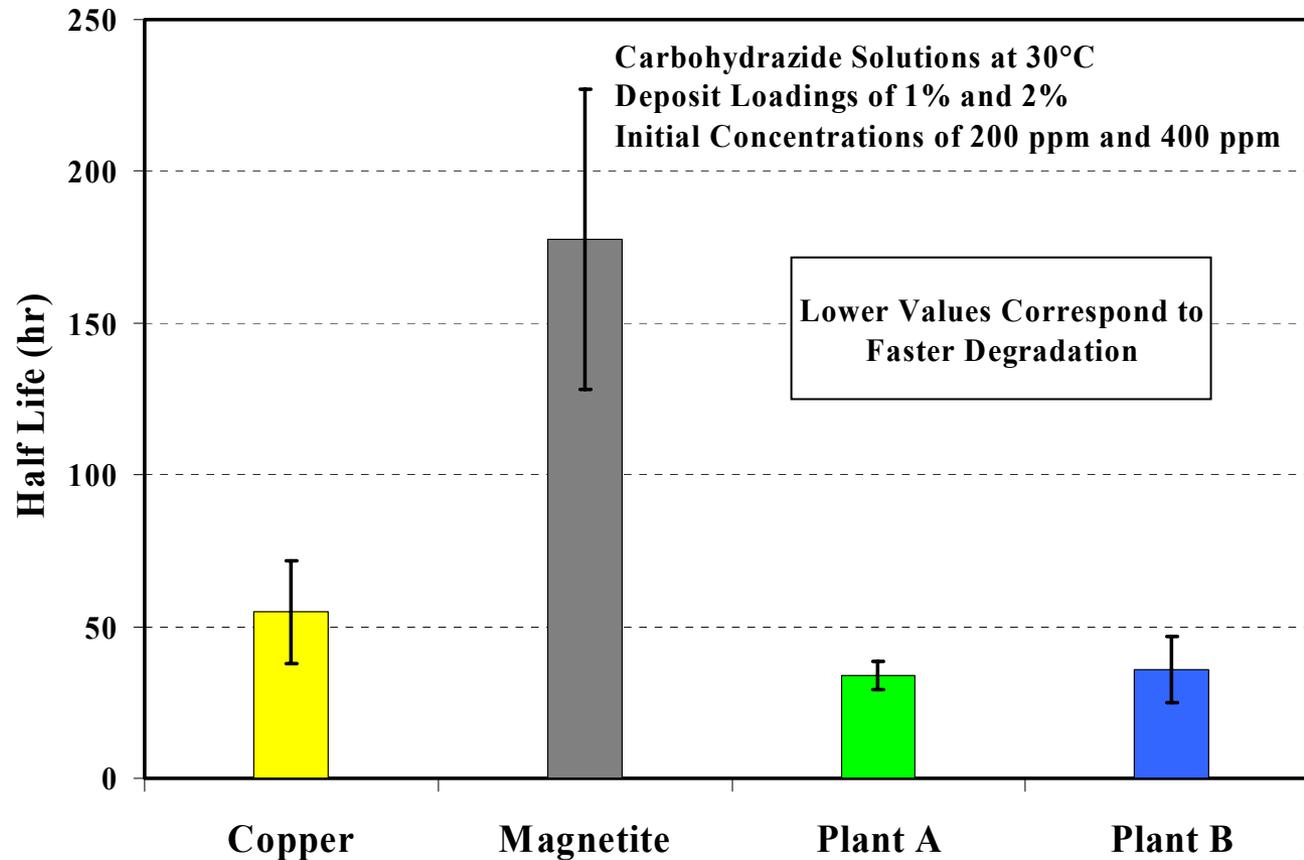
Carbohydrazide and SG Deposits

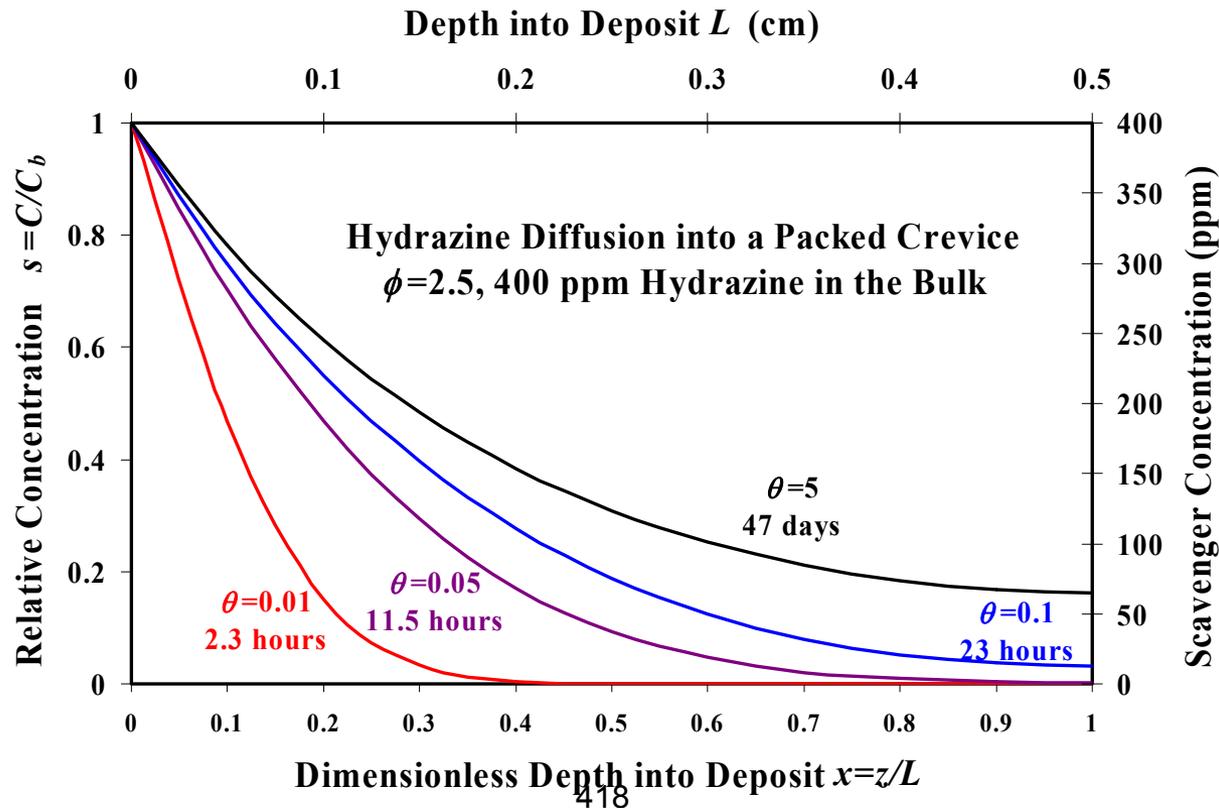
Diffusion/Reaction Modeling

$$\phi = L \sqrt{\frac{k_d}{D_{eff}}}$$

$$\theta = \frac{t}{\Theta} = \frac{t}{\frac{L^2}{D_{eff}}}$$

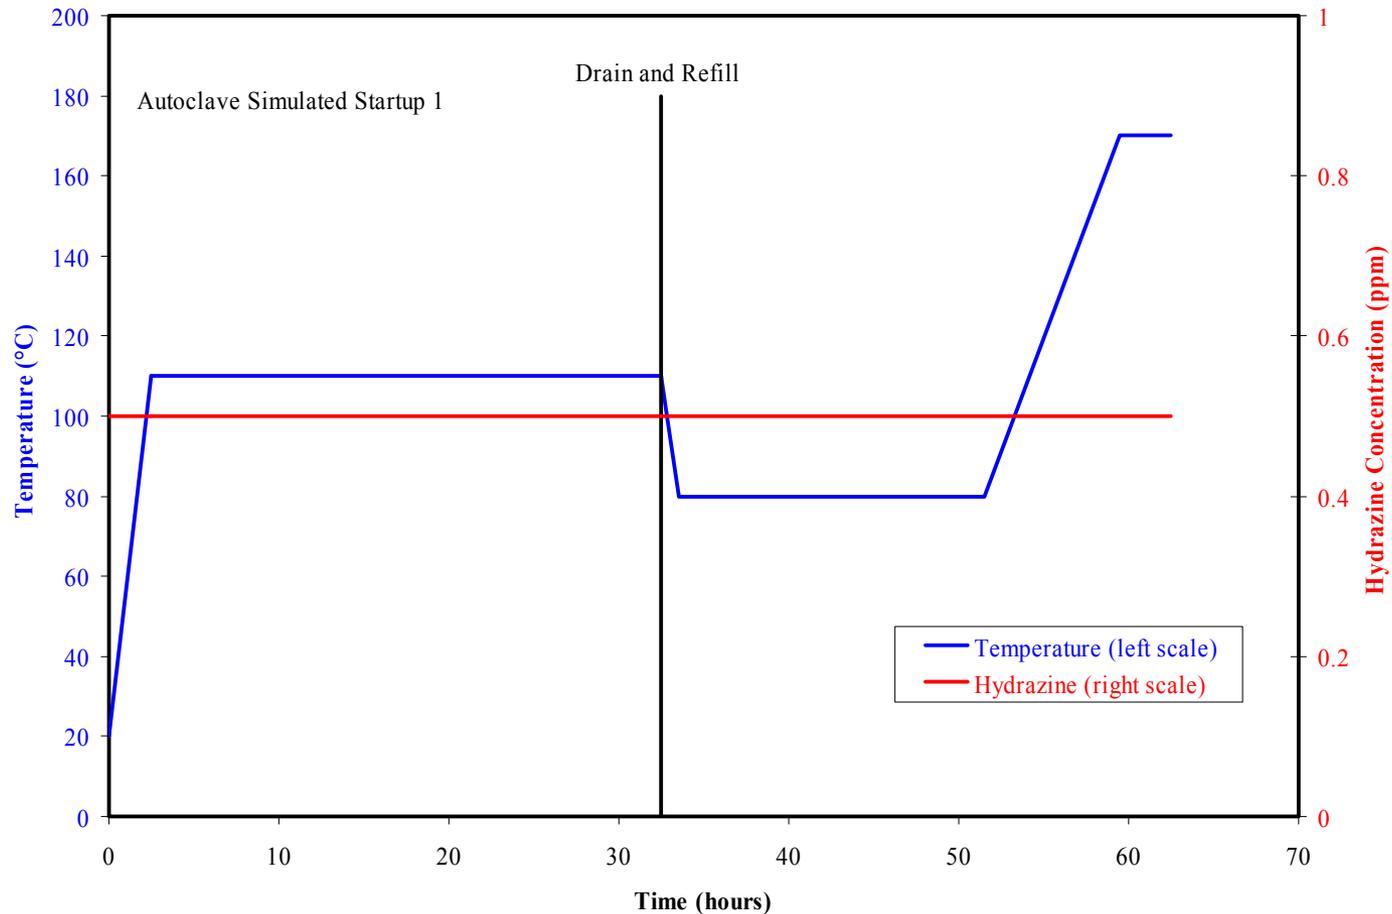
Simulated Startup Sequences—Test 1

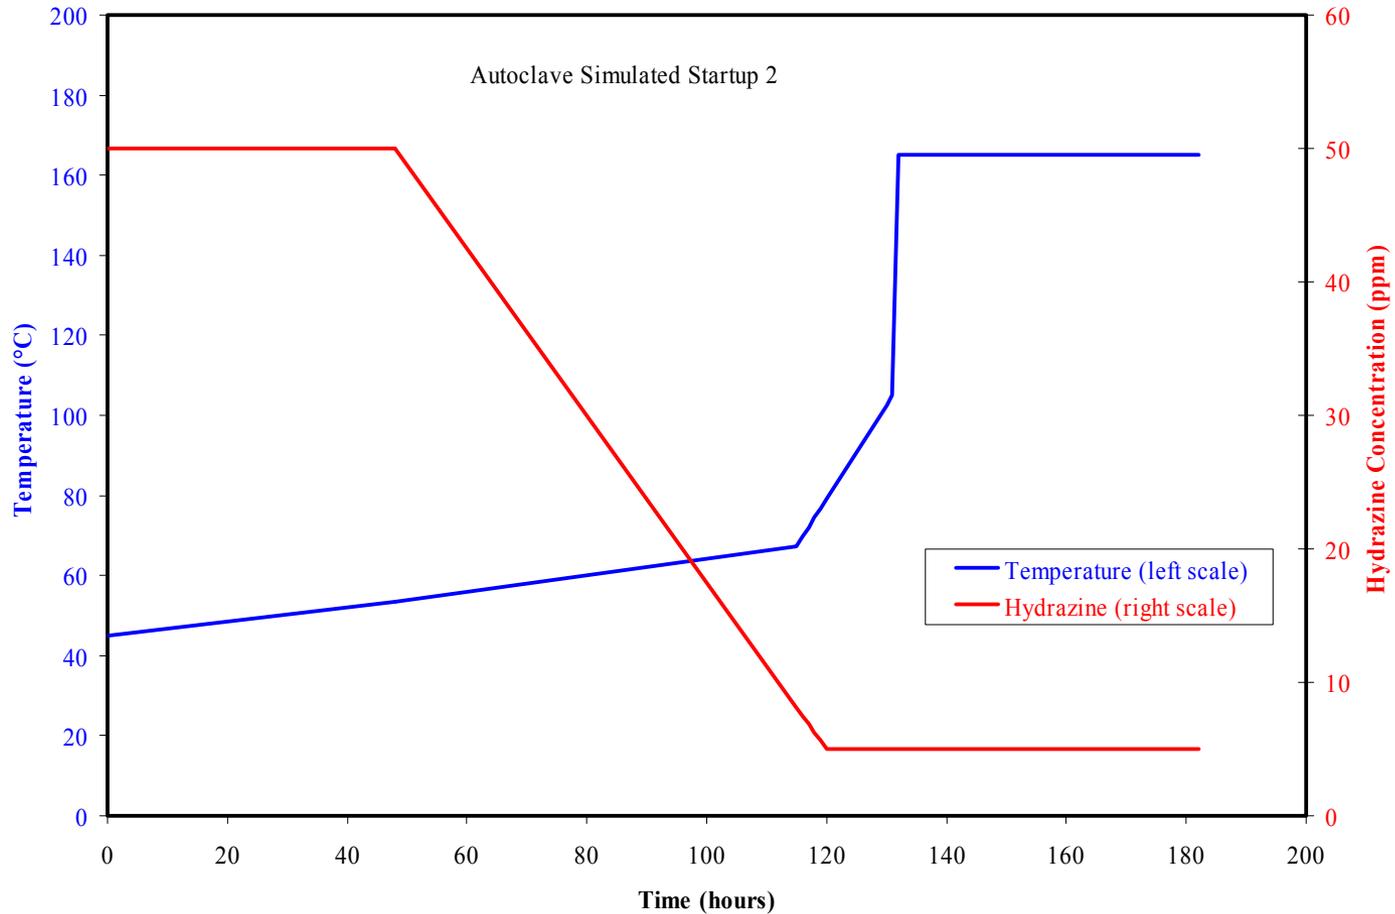
Simulated Startup Sequences—Test 2

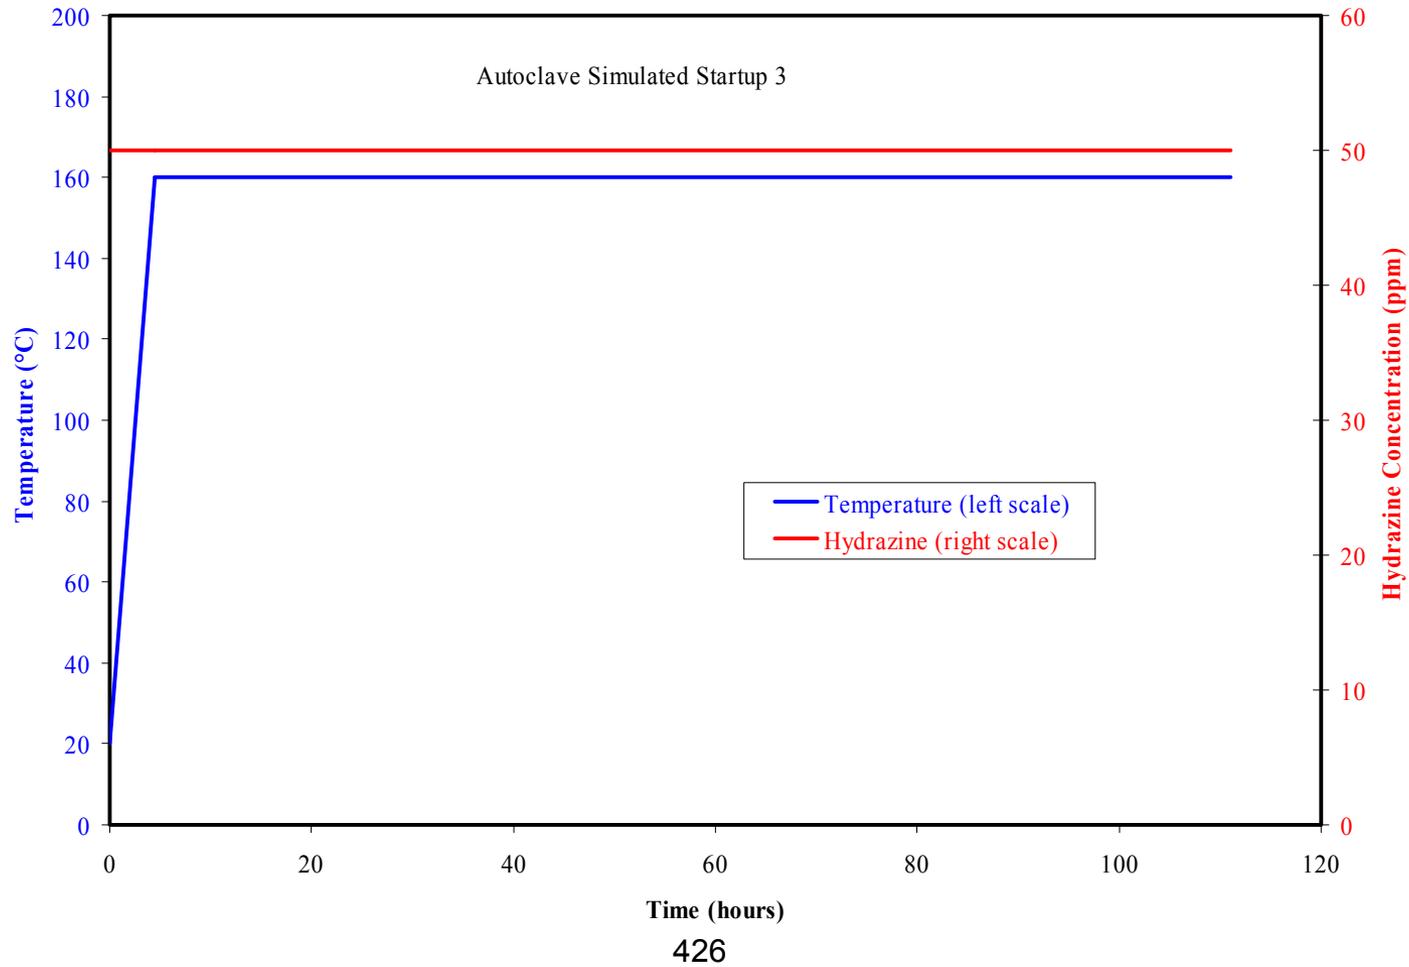
Simulated Startup Sequences—Test 3

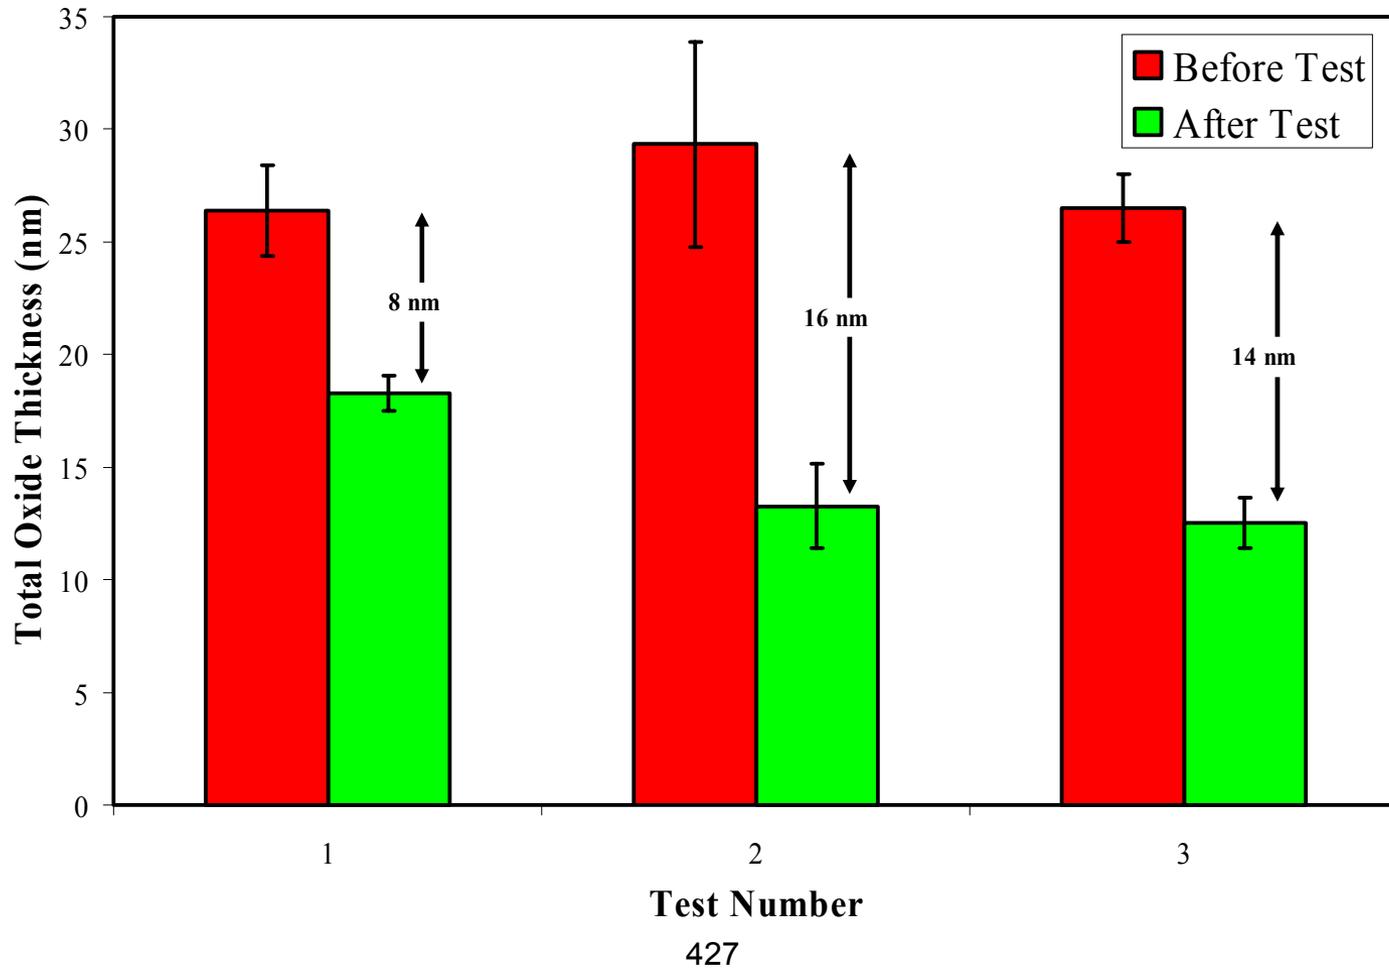
Simulated Startup Tests—Results

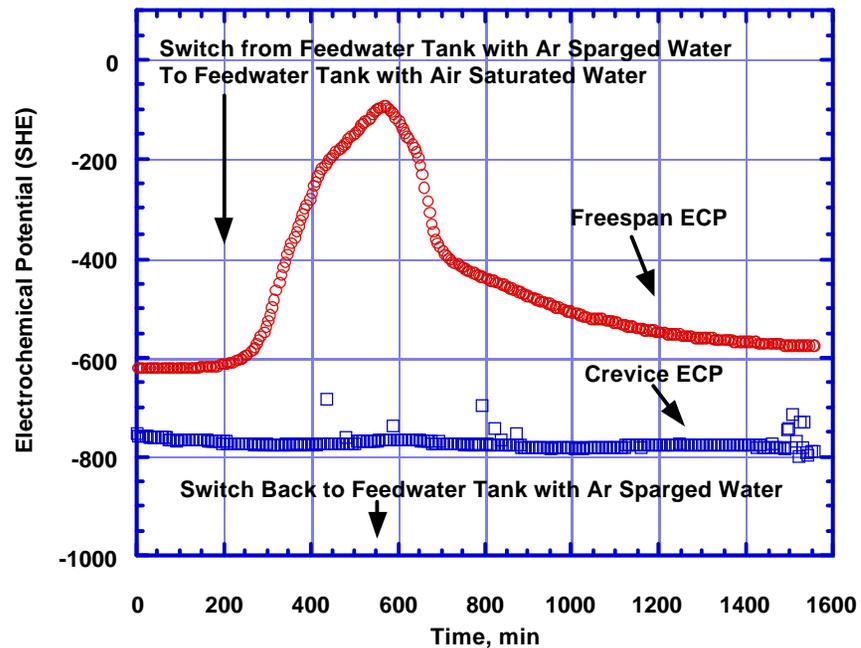
Does Dissolved Oxygen in the Feedwater Change the Crevice ECP Under Heat Transfer Conditions?

40 ppm NaOH
Bulk Temperature 275°C
Average Crevice Temperature 315°C
Crevice Packed with Magnetite
Flow Rate 15 cc/min

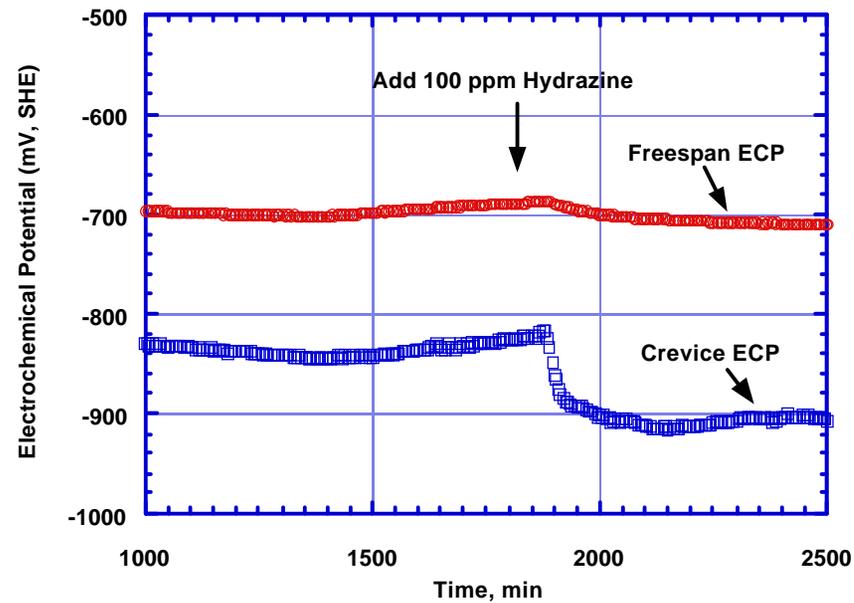
Does Hydrazine Change the Crevice ECP Under Heat Transfer Conditions?

40 ppm NaOH
Bulk Temperature 275°C
Average Crevice Temperature 315°C
Crevice Packed with Magnetite
Flow Rate 15 cc/min
Ar Sparged Feedwater

$$E = -1216 + 120\text{pOH} - 60 \log a\text{N}_2\text{H}_4 + 60\log \text{PN}_2$$

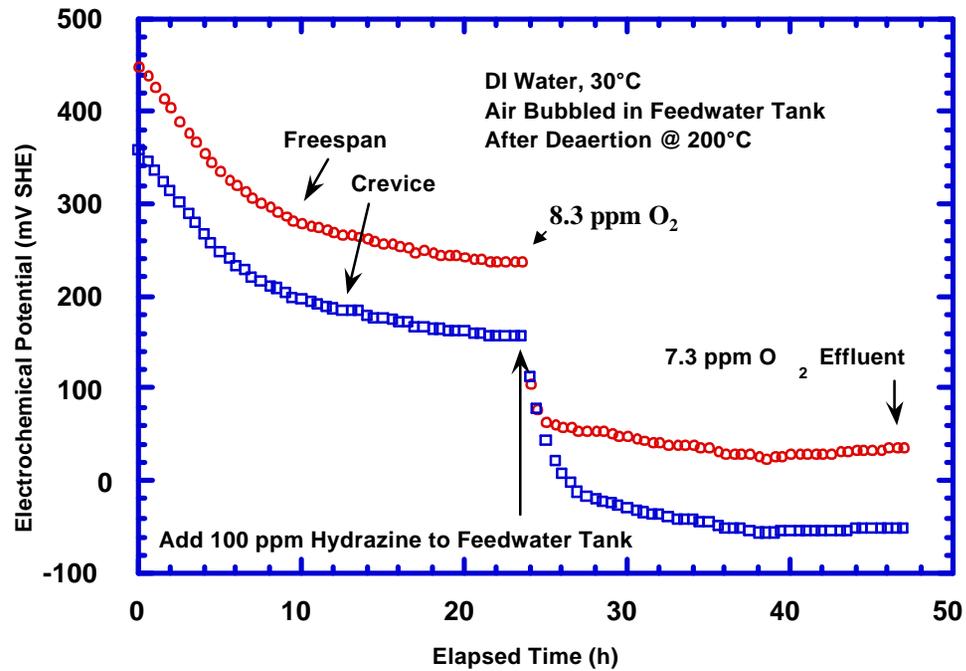
Effect of Hydrazine Addition to Air Saturated DI Water

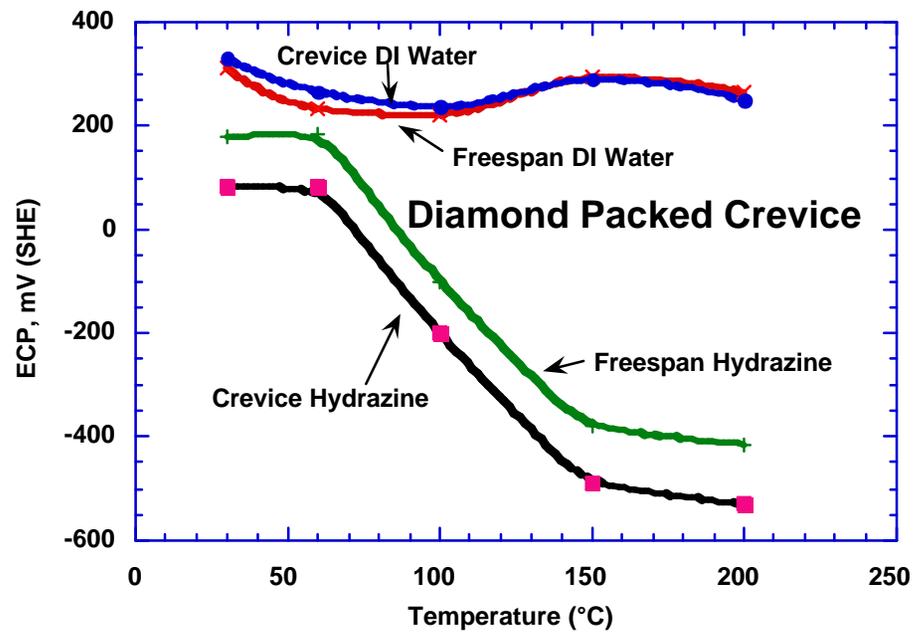
Effect of Hydrazine Addition to Air Saturated DI Water
