# Results From Pressure and Leak-Rate Testing of Laboratory-Degraded Steam Generator Tubes

Argonne National Laboratory

U.S. Nuclear Regulatory Commission  
Office of Nuclear Regulatory Research  
Washington, DC 20555-0001

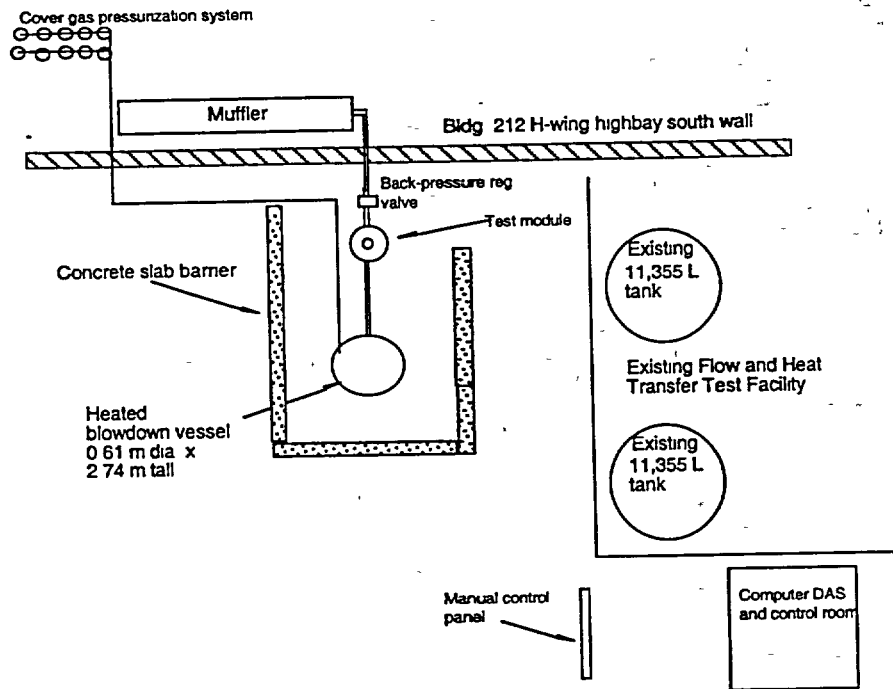
Figure 3. Floor layout of Pressure and Leak-Rate Test Facility.

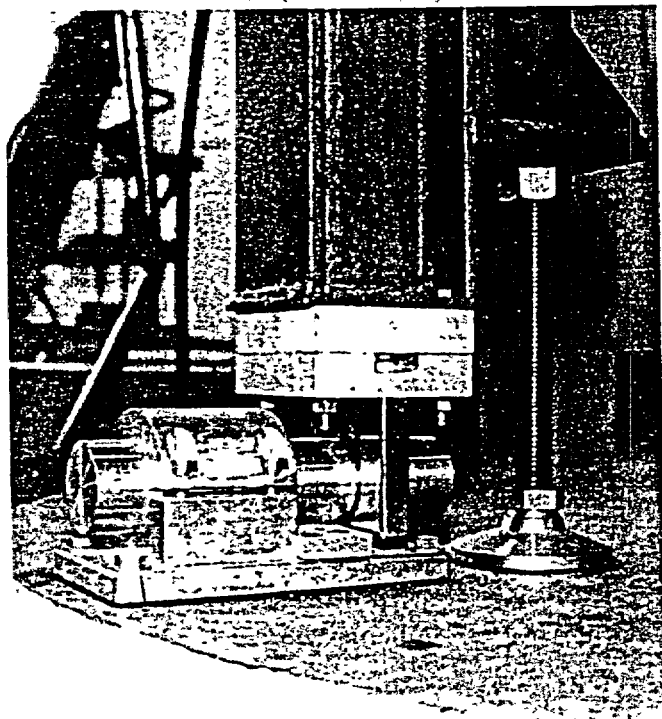
Figure 11.  
Blowdown vessel leg lead cell (one  
of three).

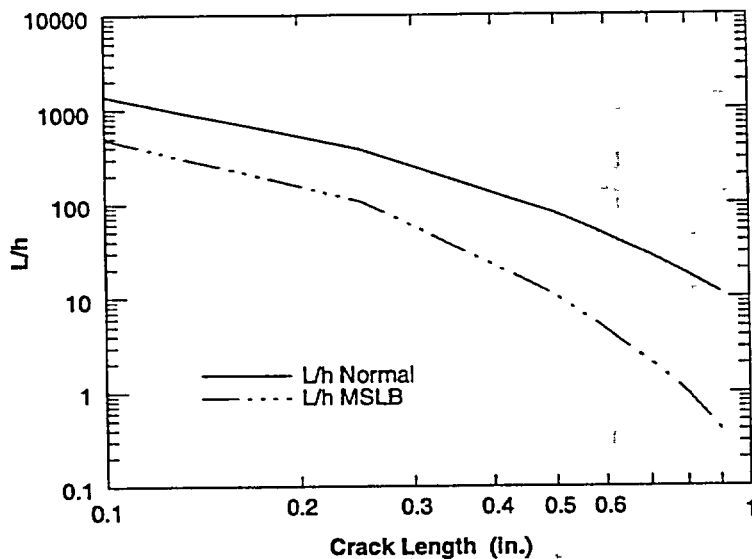
Figure 18. Variation of the ratio of flow path length to the crack opening width with crack length for normal operating and main steam line break (MSLB) conditions.

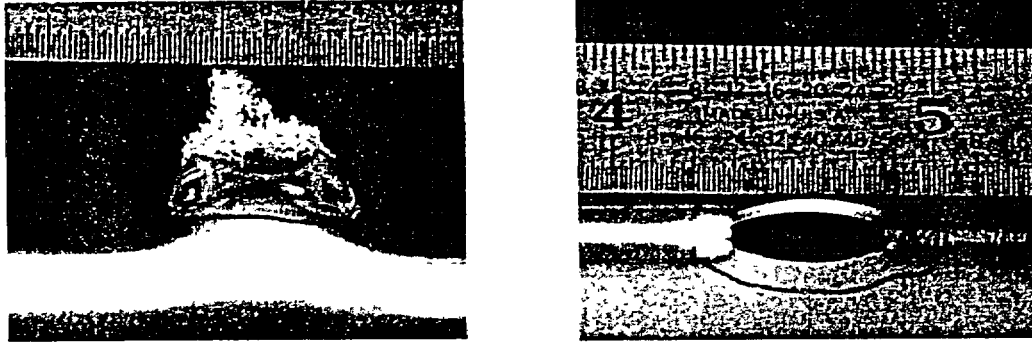
Figure 35. Side (left) and top (right) views of Tube OM102 with a 12.7-mm (0.5-in.)-long 100% TW EDM axial notch. Specimen was tested with a 2.4-mm (3/32-in.)-thick hard bladder at a pressurization rate of 13.8 MPa/s (2000 psi/s).

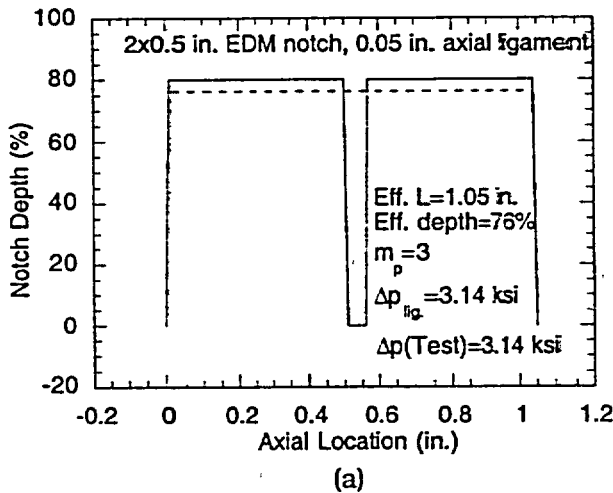
Figure 87. (a) Equivalent rectangular crack approach applied to calculate ligament rupture pressure of a specimen with two axial part-throughwall notches with a 1.27-mm (0.05-in.) axial ligament and (b) comparison of axial ligament (Type 2) with circumferential ligament (Type 4) geometry.

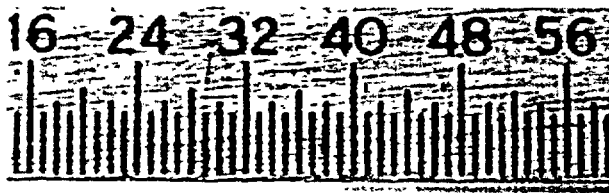
Figure 96.  
 Pretest dye-penetrant digital image of Westinghouse Tube W2-10 cracked using doped steam.

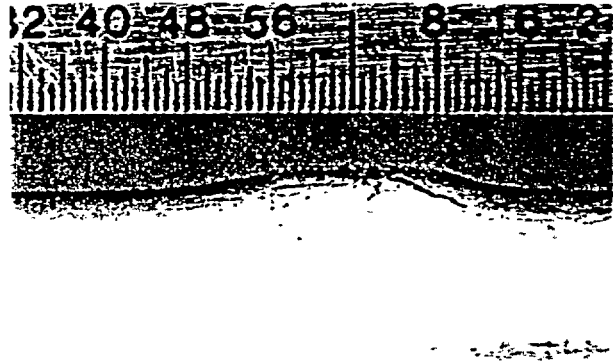
Figure 100. Side view of tube shown in Fig. 99.
