# **Overpressurization Test of a 1:4-Scale Prestressed Concrete Containment Vessel Model**

**Sandia National Laboratories**

**U.S. Nuclear Regulatory Commission  
Office of Nuclear Regulatory Research  
Washington, DC 20555-0001**

**Nuclear Power Engineering Corporation  
Tokyo 105, Japan**

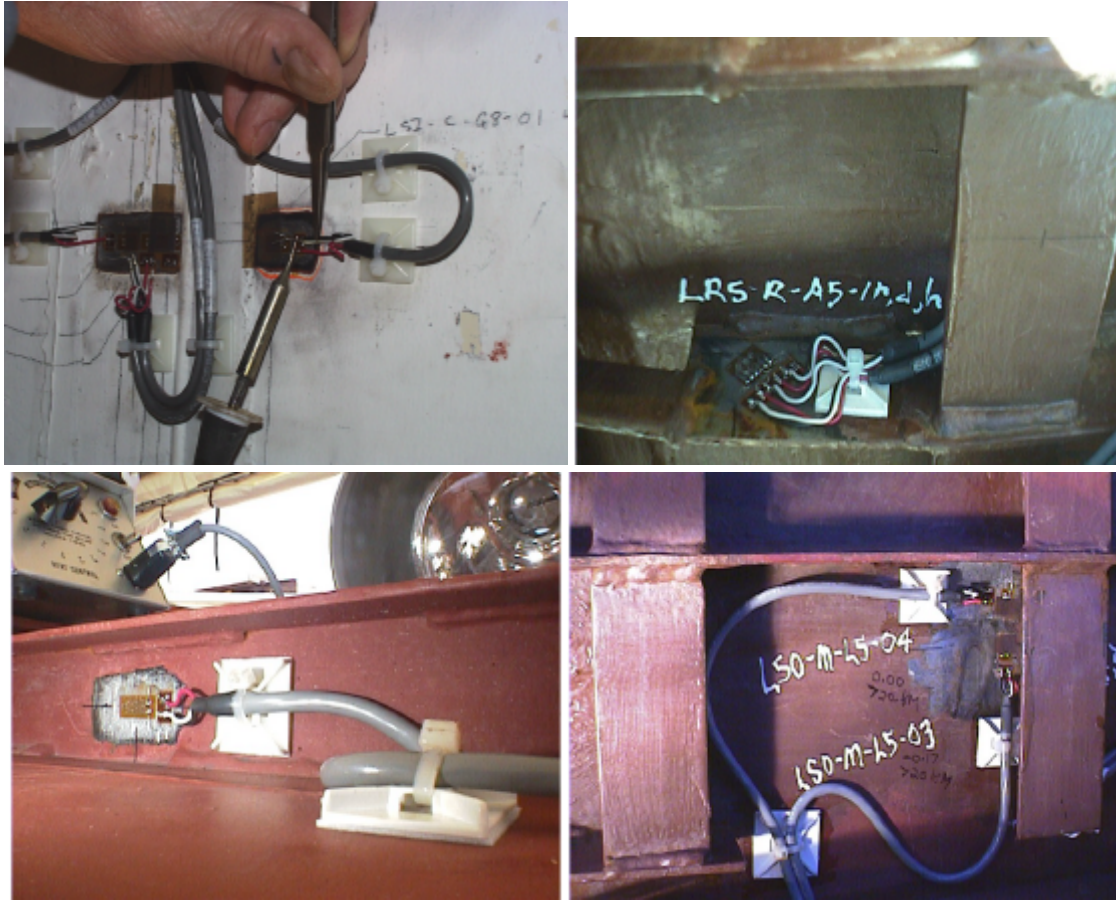
**Figure 3.11 Liner and Liner Anchor Strain Gages**

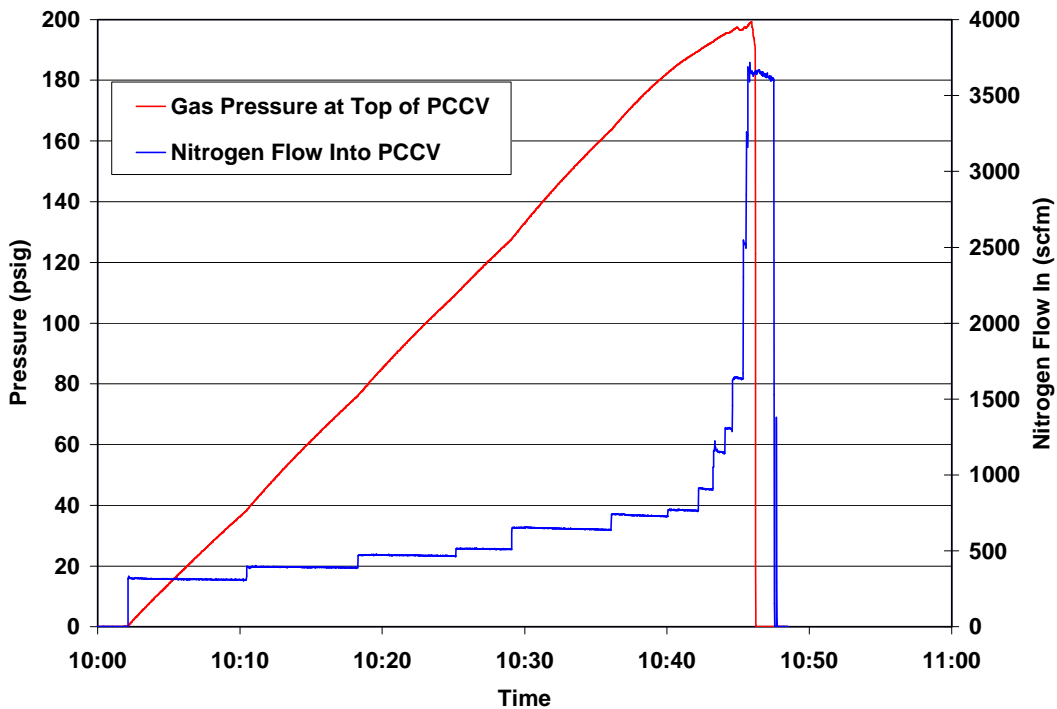
**Figure 5.33 SFMT Pressurization System Data**

The rate of pressurization decreased and the nitrogen flow rate was increased to maintain the pressurization rate. The gas pressure and flow rates are shown in Figure 5.33. The water surface inside the model, viewed through the internal video camera, was dropping slowly, but it was unclear if this was due to leakage or radial expansion of the vessel.

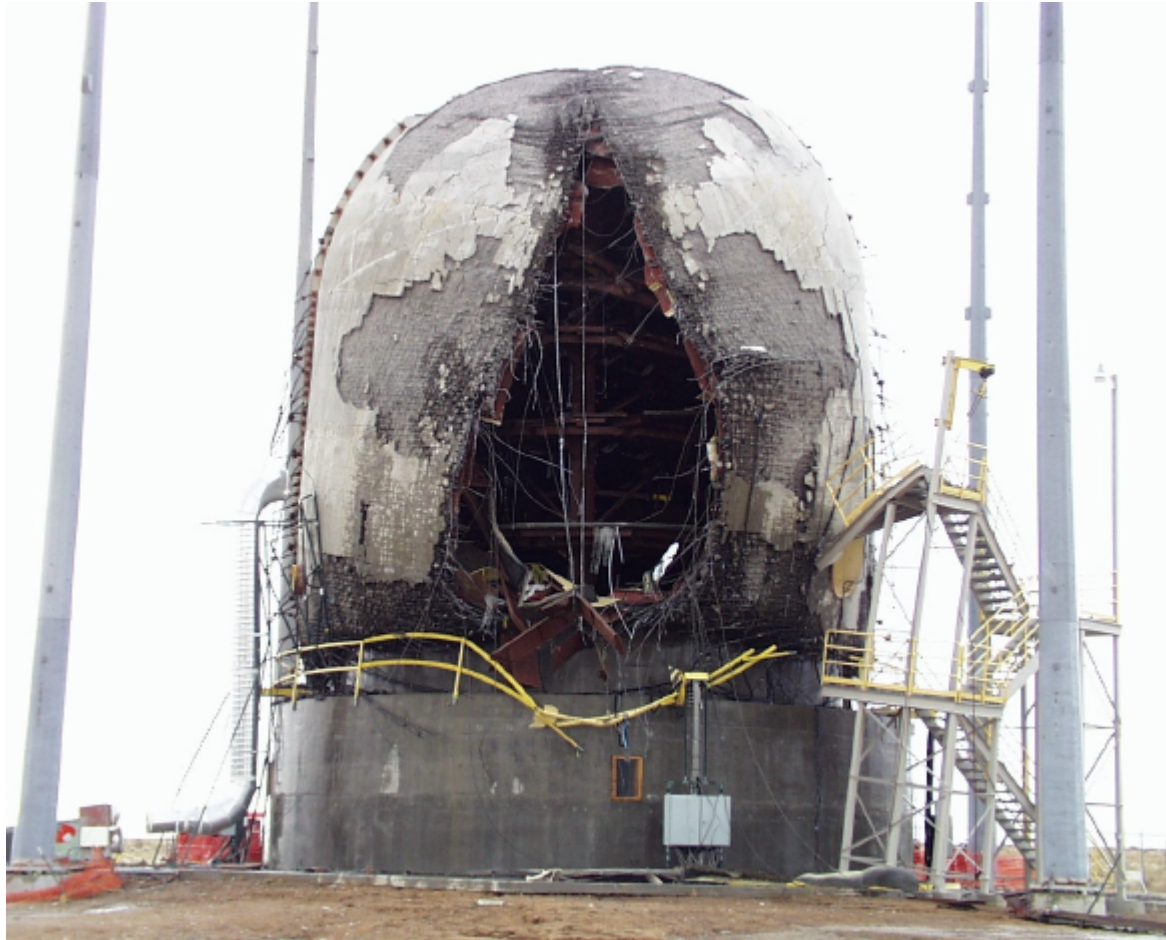
**Figure 5.35 PCCV Model after the SFMT**

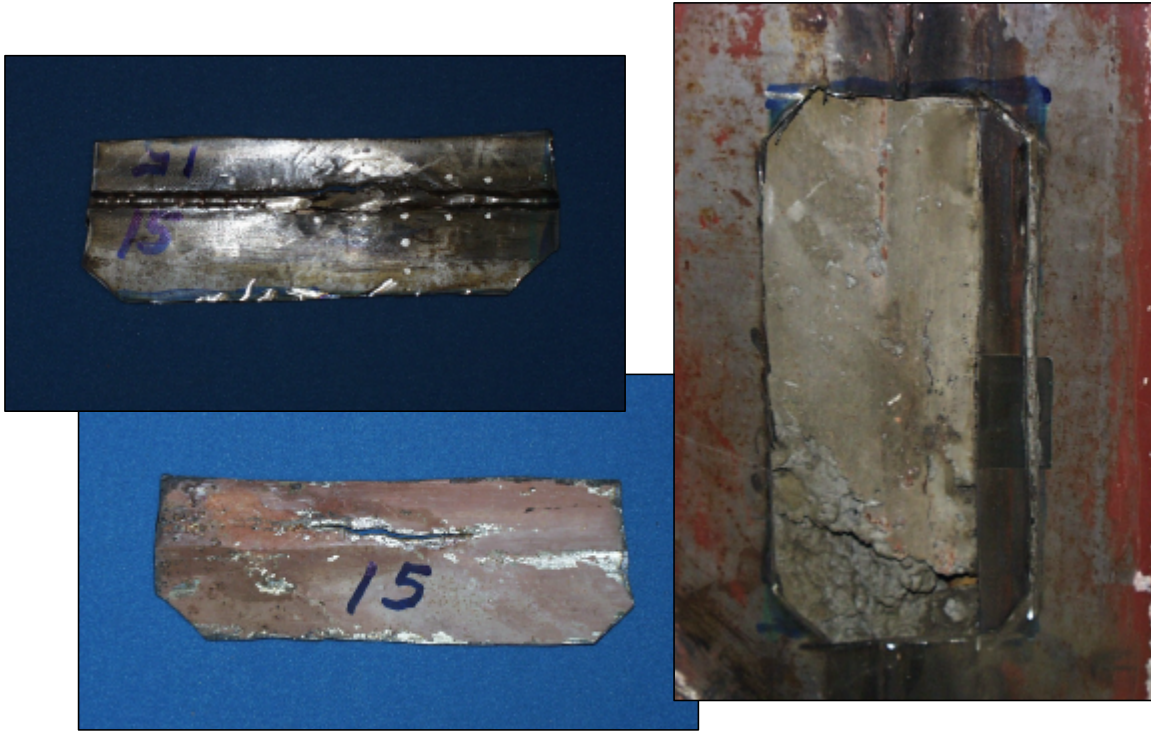
**Figure 5.88 Liner Specimen at Tear #15**
