LA-UR-04-1227

# **GSI-191: Experimental Studies of Loss-of-Coolant-Accident-Generated Debris Accumulation and Head Loss with Emphasis on the Effects of Calcium Silicate Insulation**

Manuscript Completed: April 2004  
Date Published: April 2004

Prepared for the  
Division of Engineering Technology  
Office of Nuclear Regulatory Research  
US Nuclear Regulatory Commission  
Washington, D.C. 20555-0001

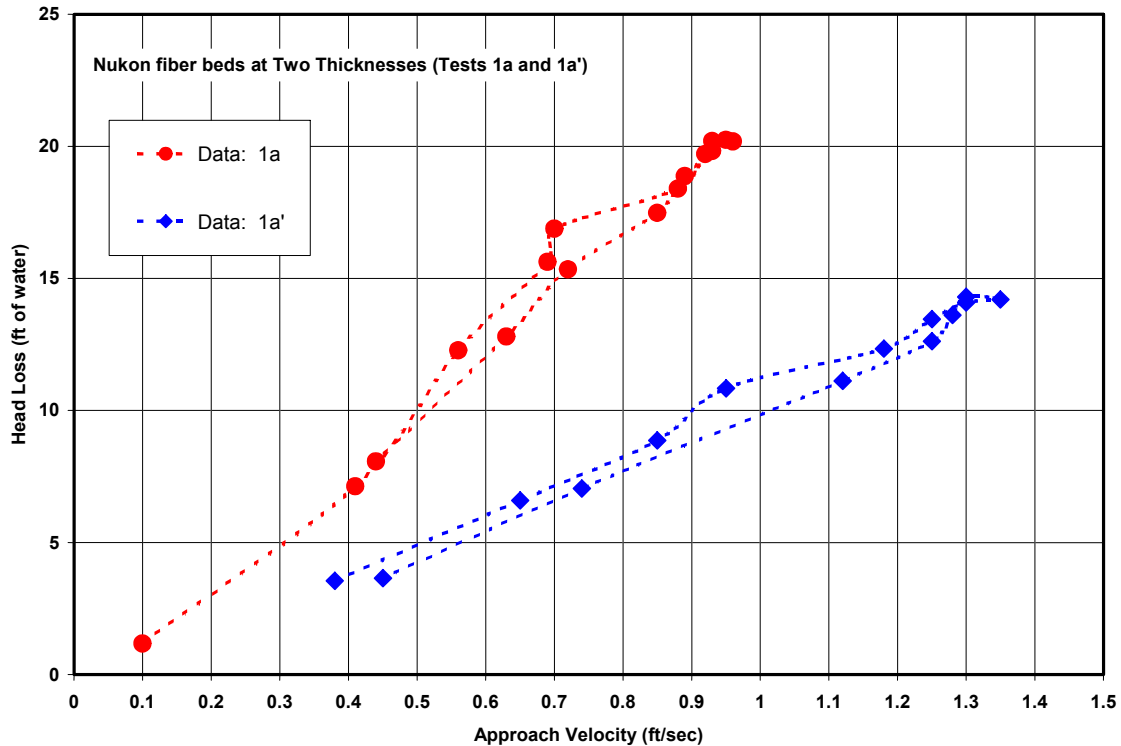
Figure 3.6. Measured fiber bed head loss at two thicknesses (72°F).

To further qualify the UNM facility, Test 1a was repeated as Test 1a' with roughly half the amount of fiber, reducing the theoretical bed thickness from ~1.72 to 0.86 in. The test data for Tests 1a and 1a' are compared in Figure 3.6, and the dashed lines in the figure indicate the order in which the data were taken, i.e., the data taken as the velocity were incrementally increased vs. when the velocity was incrementally decreased. The decreasing curves for both tests were somewhat higher than the increasing curves. This behavior is the typical compression hysteresis behavior, i.e., the bed does not expand as readily as it was compressed by the flow.

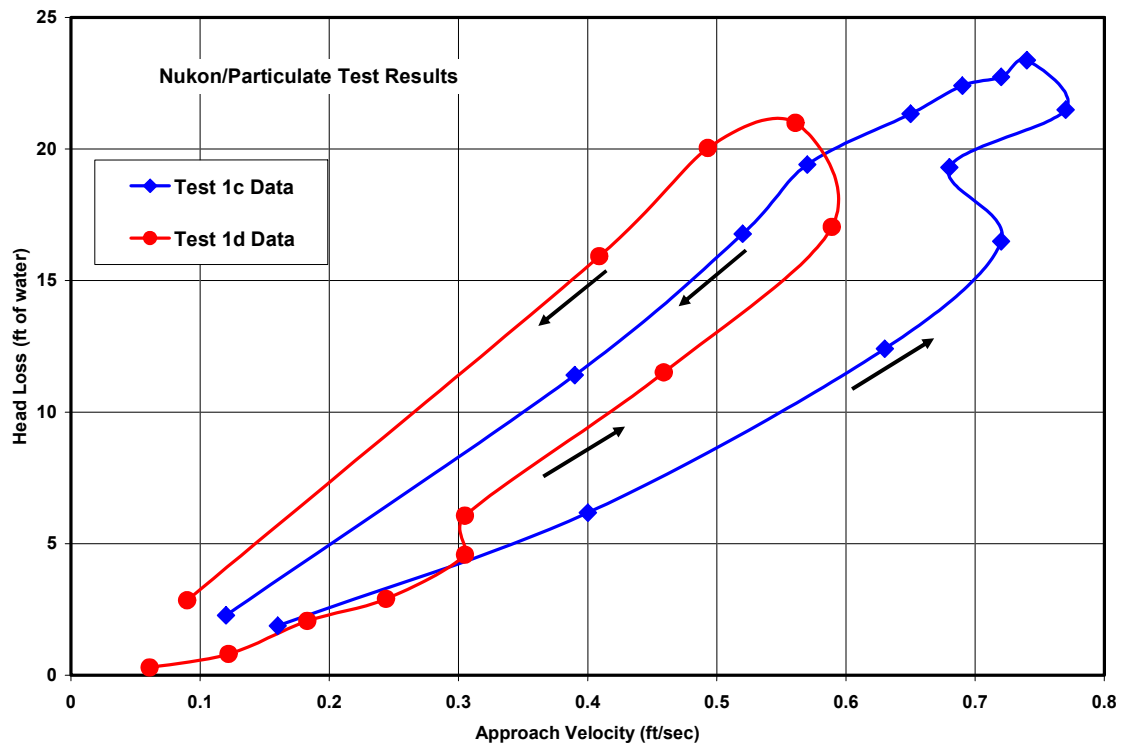
**Figure 3.7. Measured head loss for NUKON™ fiber bed with particulate for two fiber bed thicknesses.**

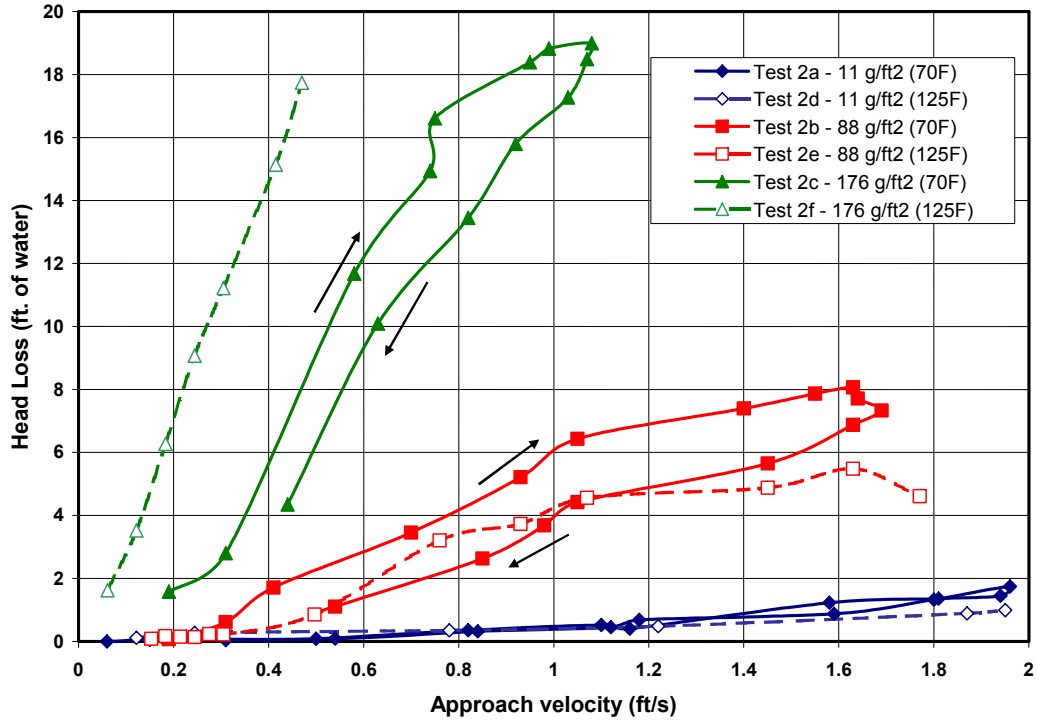
Figure 3.8. Head-loss measurements for three different quantities of CalSil at two different water temperatures.

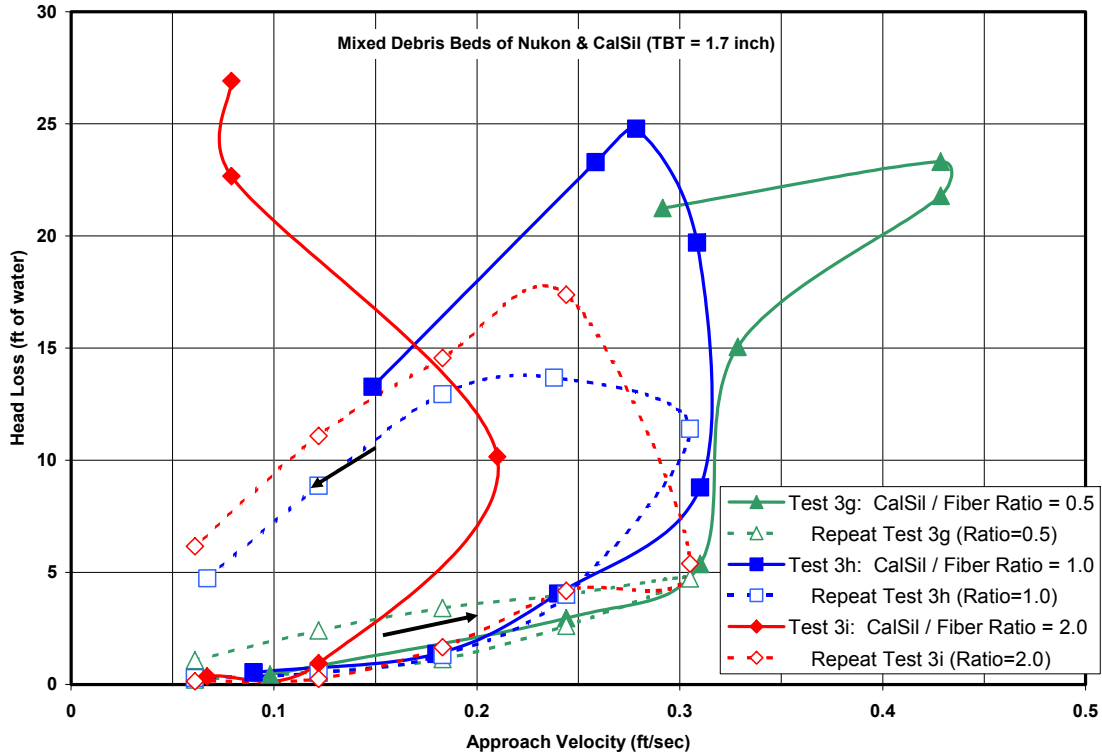
Figure 3.12. Head-loss measurements for CalSil/fiber debris mixtures: Tests 3g, 3h, and 3i.

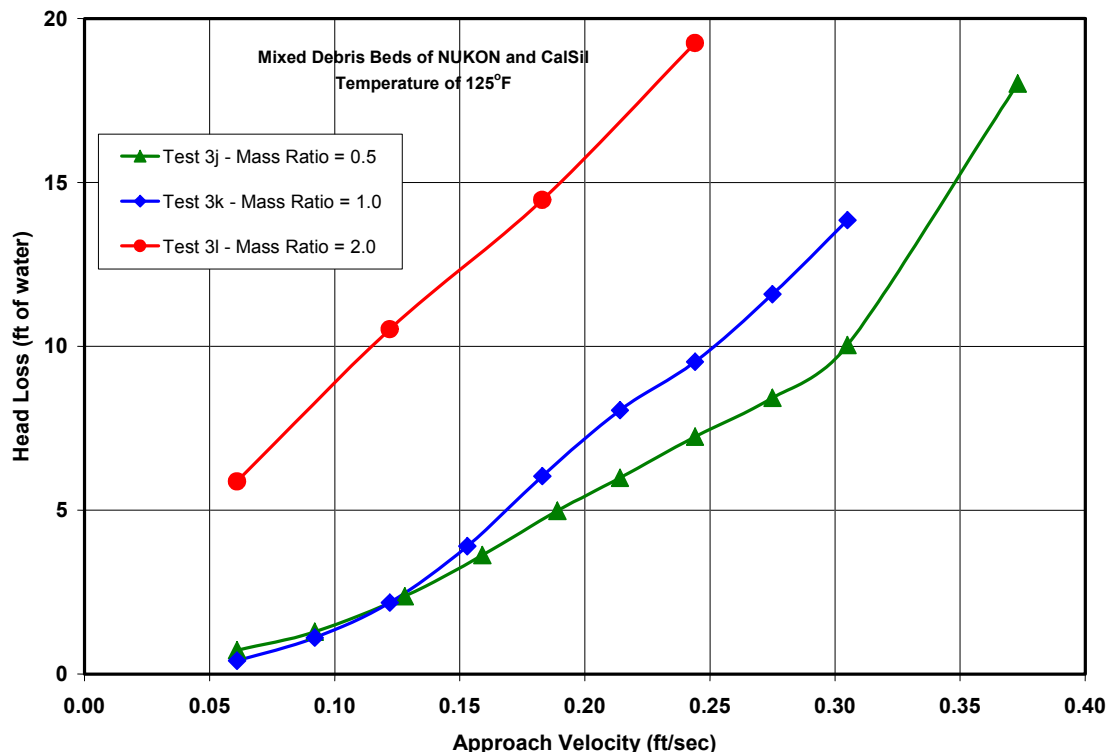
Figure 3.14. Head-loss measurements for CalSil/fiber debris mixtures: Tests 3j, 3k, and 3l.

Tests 3j through 3l were conducted using water heated to a nominal temperature of 125°F to examine the effect of water temperature on head loss. The temperature affected the head loss in two ways. First, the water viscosity decreases with temperature, thereby also decreasing the head loss. Second, the dissolution or disintegration of CalSil is enhanced by temperature, which was clearly demonstrated during the separate-effect debris characterization tests [Rao, 2002a]. Therefore, it should be expected that the lumps of CalSil will more readily disintegrate in the higher temperature test and subsequently form a more uniform bed. A comparison of the data from these tests is shown in Figure 3.14.

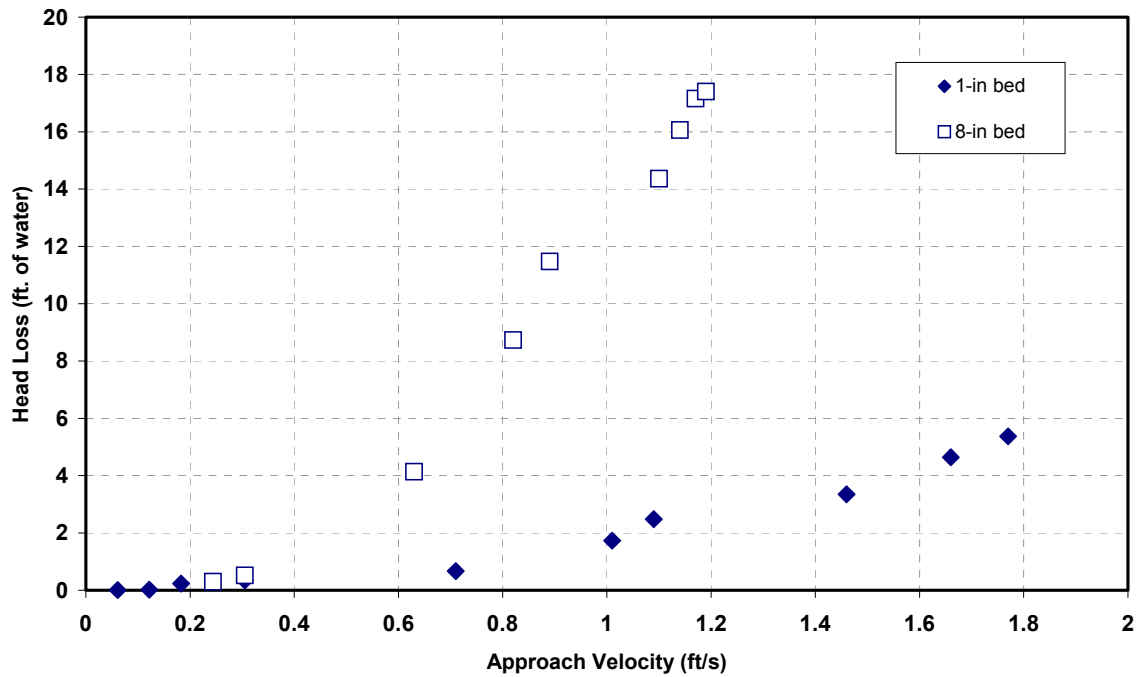
**Figure 3.21. Stainless-steel RMI foil head-loss data.**

Tests 5a and 5b establish a baseline of head-loss data for crumpled stainless-steel RMI foil. The baseline data allow the incremental effects of CalSil to be examined in Tests 5c through 5g; the latter are described in Section 3.2.5. The baseline data were collected for debris beds with an uncompressed thickness of 1 in. (Test 5a) and 8 in. (Test 5b.) Photographs of the two baseline debris beds are shown in Figure 3.20 (before testing). Head-loss measurements are shown in Figure 3.21.

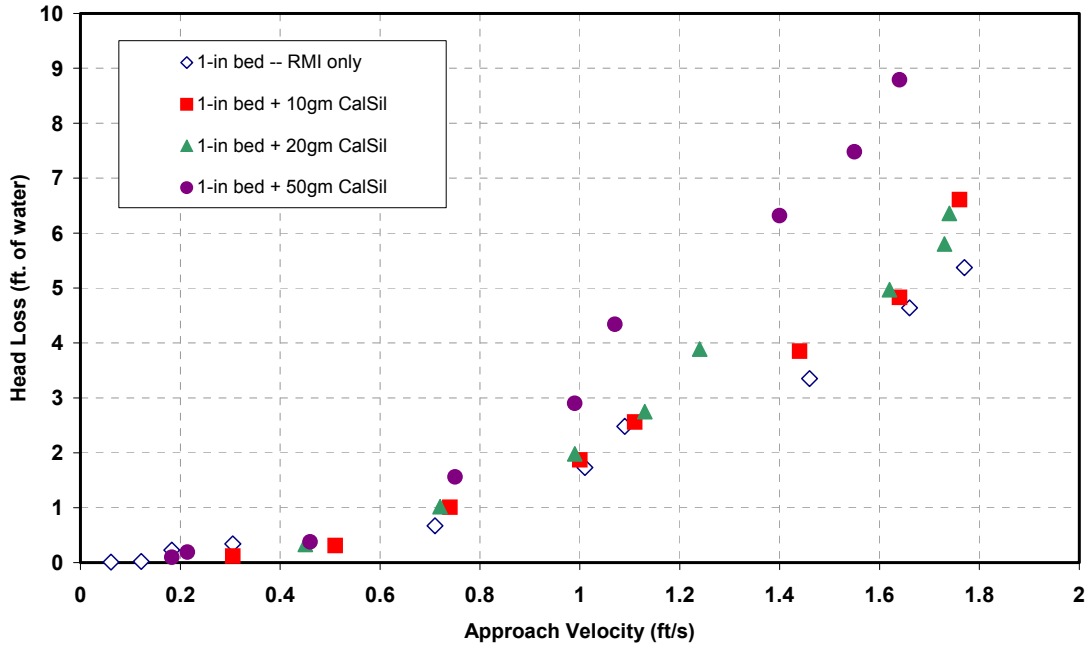
**Figure 3.22. Incremental head loss due to the addition of CalSil to a 1-in. stainless-steel RMI debris bed.**

Tests 5c through 5g examined the incremental effects of CalSil on the head loss generated by 1-in. and 8-in. beds of stainless-steel RMI debris. Results for the 1-in. RMI debris bed are shown in Figure 3.22; results for the 8-in. RMI debris bed are shown in Figure 3.23.

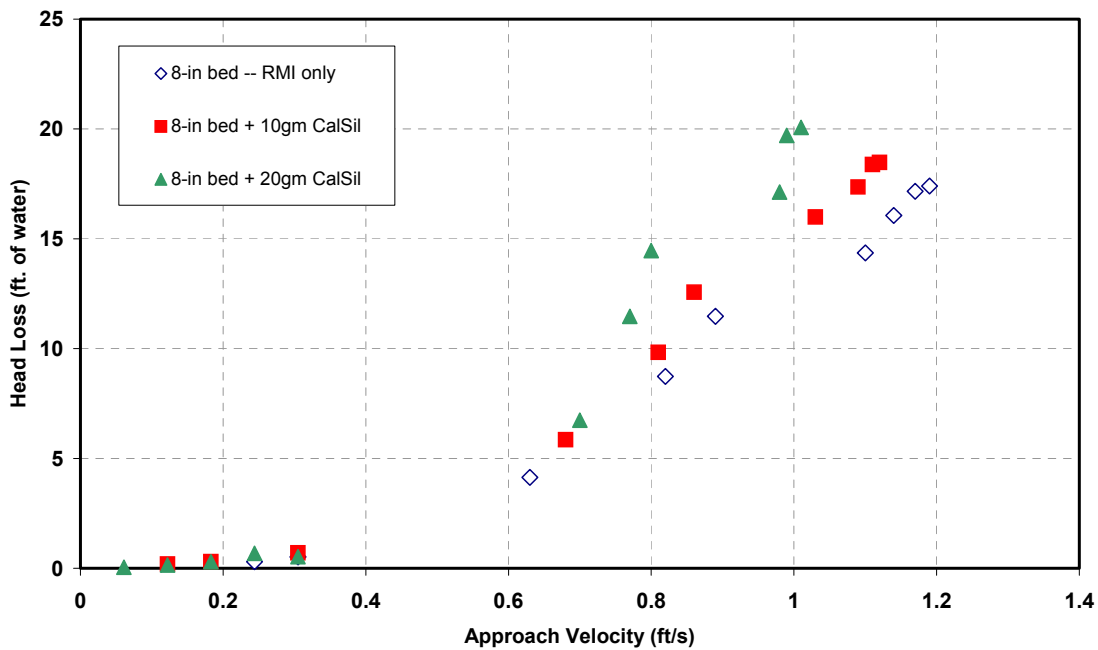
**Figure 3.23. Incremental head loss due to the addition of CalSil to an 8-in. stainless-steel RMI debris bed.**

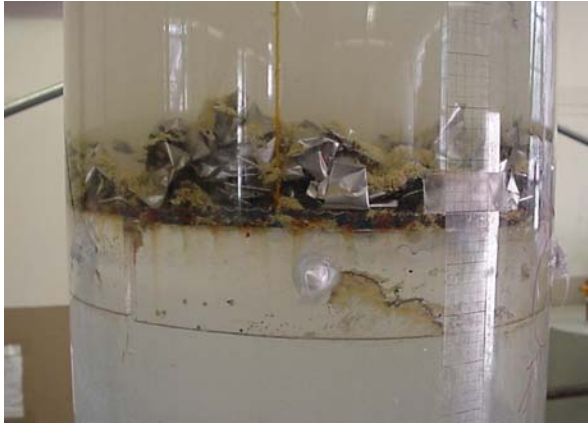
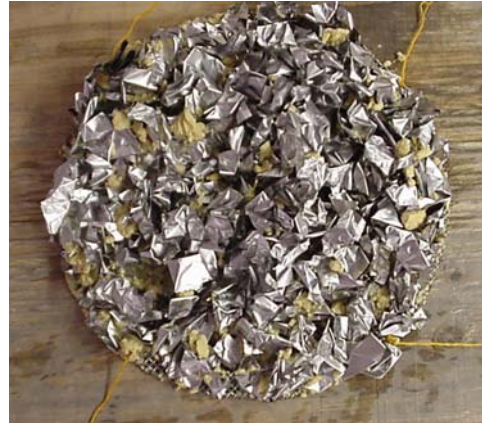
**Figure 3.24. CalSil/RMI debris mixture in a typical 1-in. debris bed.**

The distribution of CalSil within the RMI debris bed appeared to be nearly uniform in tests at each bed thickness. Photographs of typical post-test debris mixtures are shown in Figures 3.24 and 3.25 for the 1-in. and 8-in. beds, respectively.

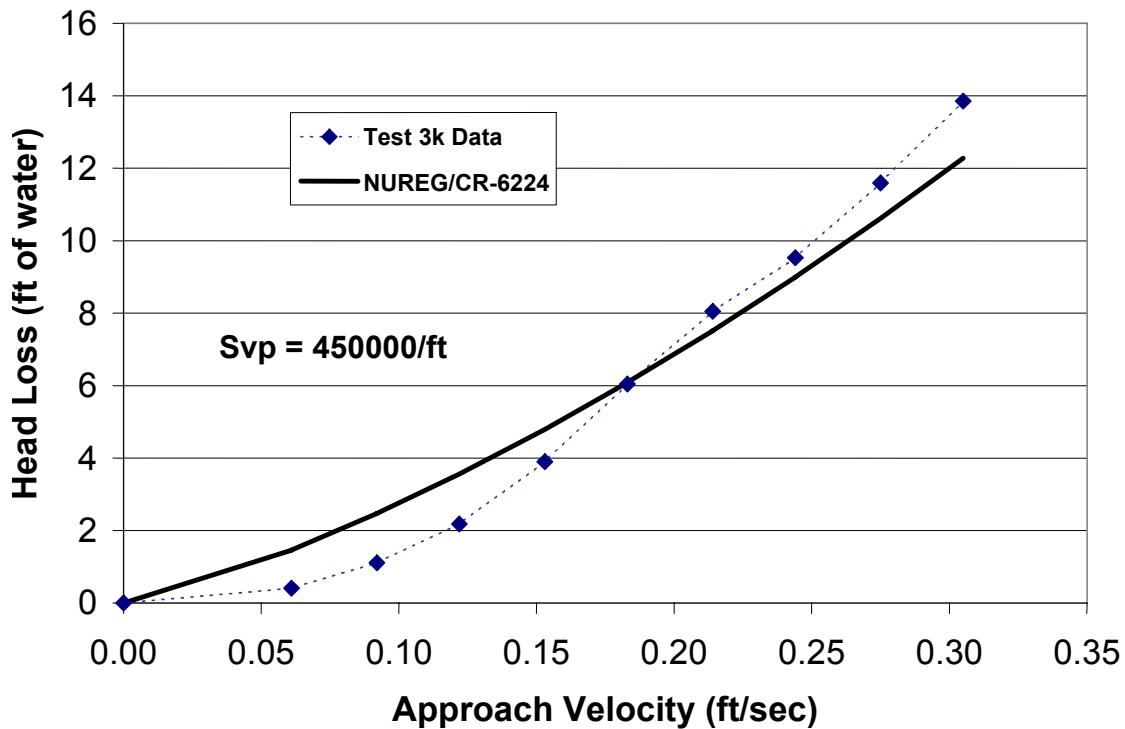
Figure 4.5. Comparison of Test 3k with NUREG/CR-6224 correlation.

Test 3k Test 3k was conducted using heated water, nominally at 125°F, 58 g of NUKON™, and an equal mass of CalSil. In applying the NUREG/CR-6224 correlation, NUKON™ properties were applied to the fibrous debris bed and CalSil properties were applied to the particulate. Note that the very fine fibers within the CalSil insulation were treated as particulate, not as fibrous debris. The solid density of 186 lbm/ft<sup>3</sup> was assumed for both fiber and particulate in CalSil. For Test 3k, the CalSil specific surface area was adjusted until the correlation reasonably well predicted the test results. The data from Test 3k are compared with the correlation in Figure 4.5.

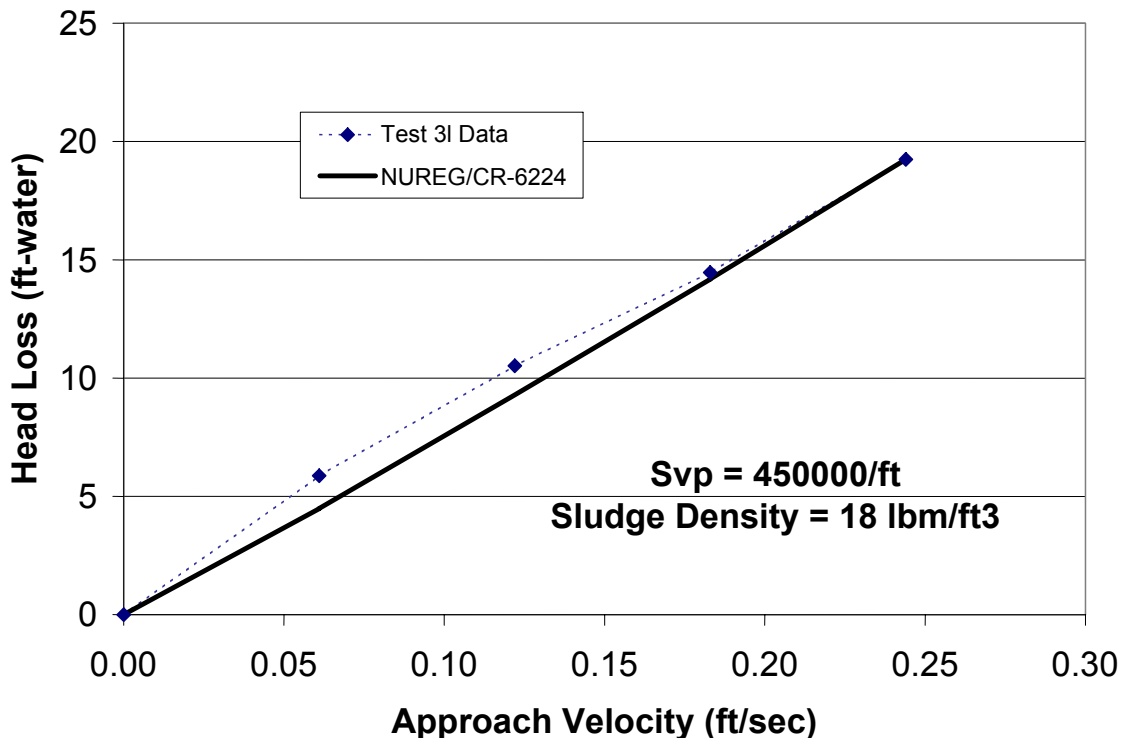
Figure 4.6. Comparison of Test 3l with NUREG/CR-6224 correlation.

Test 3l Test 3l was conducted using heated water, nominally at 125°F, 58 g of NUKON™, and 116 g of CalSil. The application of the NUREG/CR-6224 correlation to Test 3l data was similar to that of Test 3k, except that in Test 3l, the bed compression was limited by the sludge density. Using the specific surface area determined from Test 3k data, the sludge density for CalSil was adjusted until the correlation reasonably well predicted Test 3l and that density turned out to be 18 lbm/ft<sup>3</sup>. The as-fabricated density for CalSil was estimated at 14.5 lbm/ft<sup>3</sup>, so this sludge density represents a compression of ~25% more than the as-fabricated density. Data from Test 3l are compared with the correlation in Figure 4.6, and a photo of the debris bed is shown in Figure 4.7. This debris bed did not have any apparent holes or uncovered screen, but the nonuniform thickness likely resulted in a lower head loss than if the bed were completely uniform.

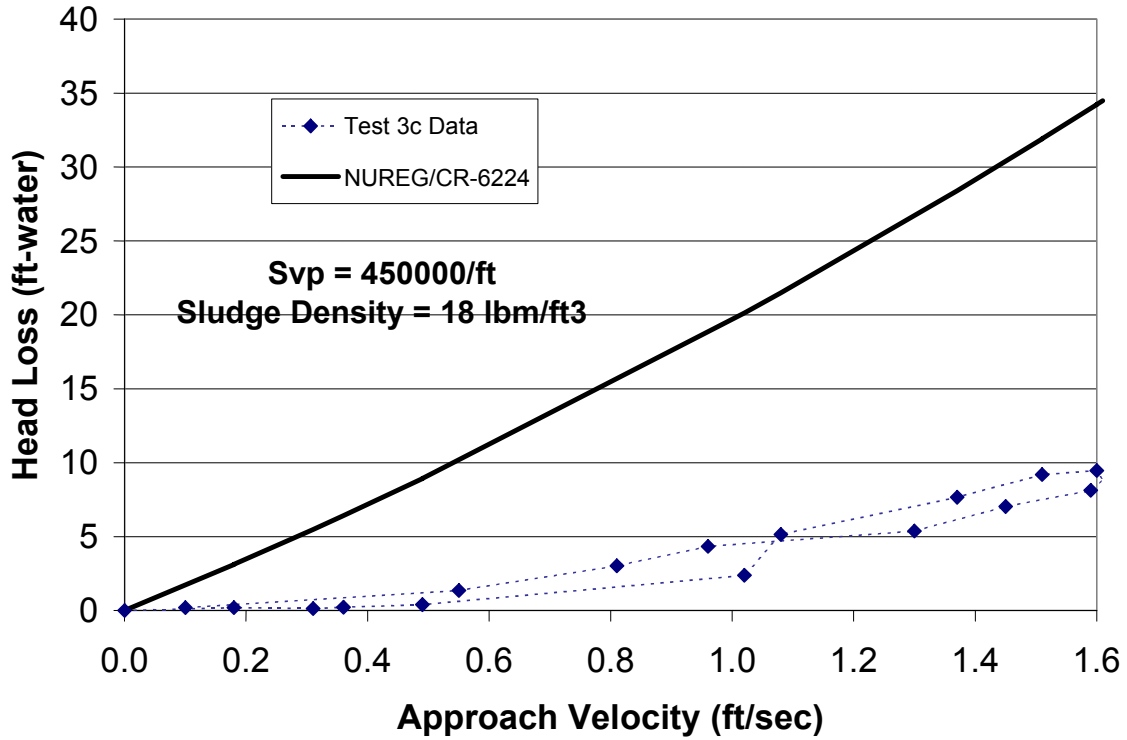
Figure 4.10. Comparison of Test 3c with NUREG/CR-6224 correlation.

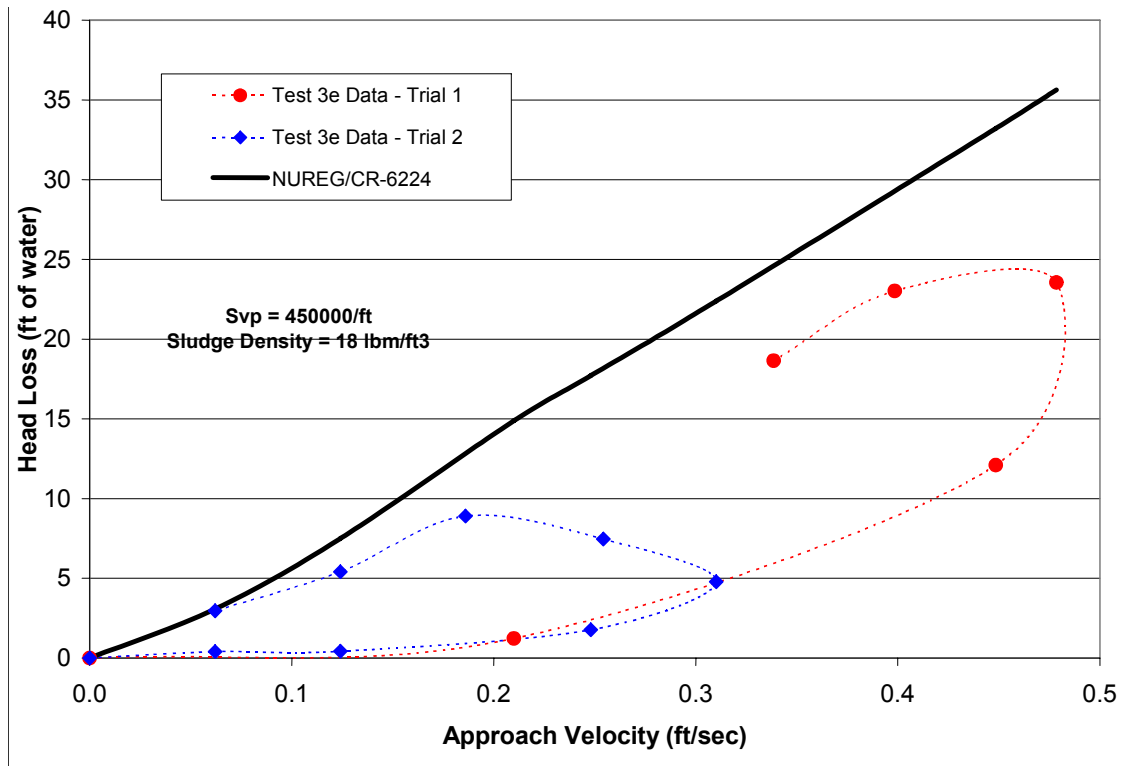
Figure 4.11. Comparison of Test 3e with NUREG/CR-6224 correlation.

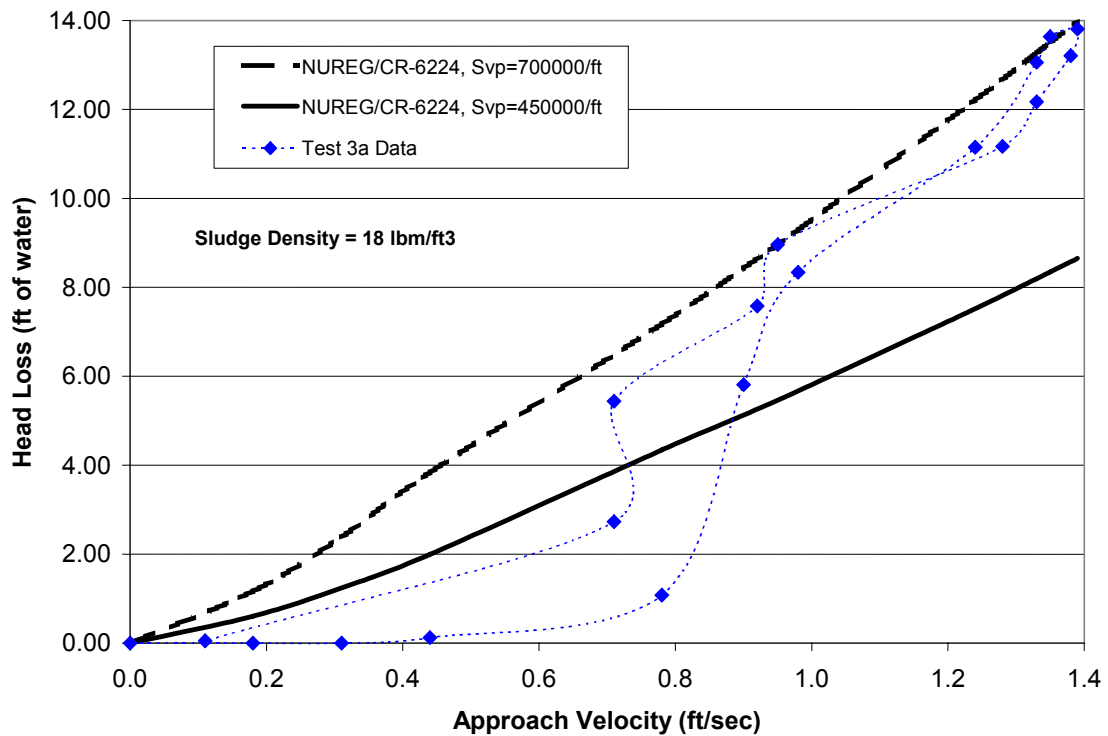
Figure 4.16. Comparison of Test 3a with NUREG/CR-6224 correlation.

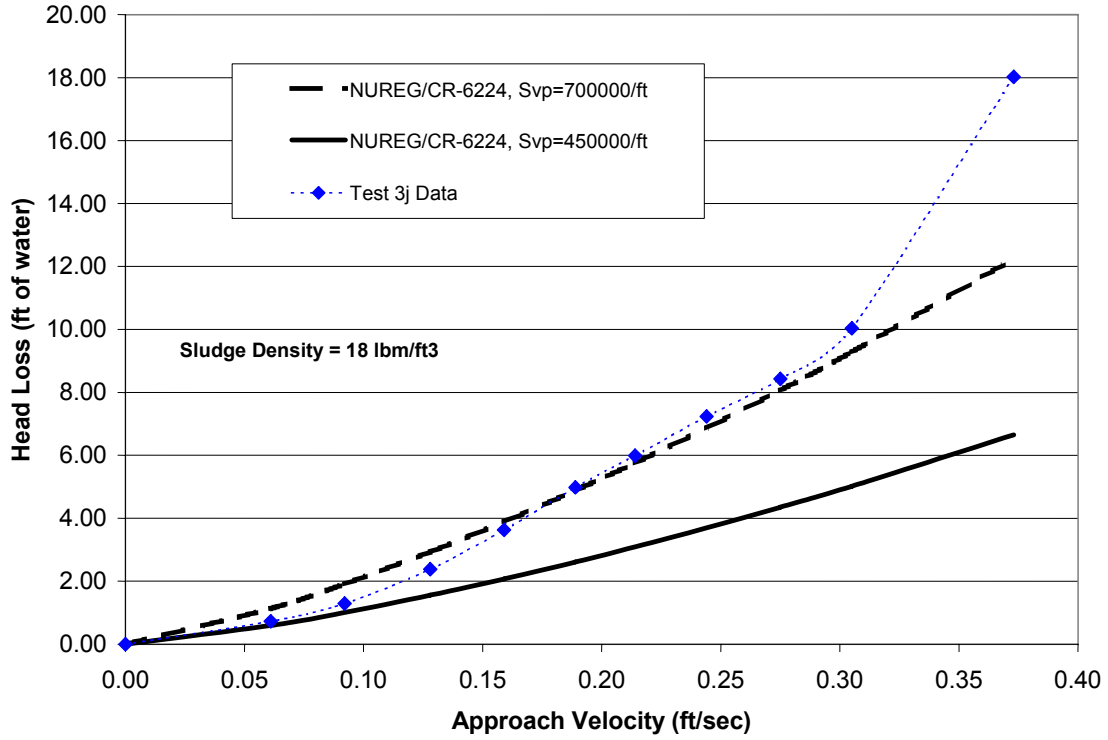
Figure 4.17. Comparison of Test 3j with NUREG/CR-6224 correlation.

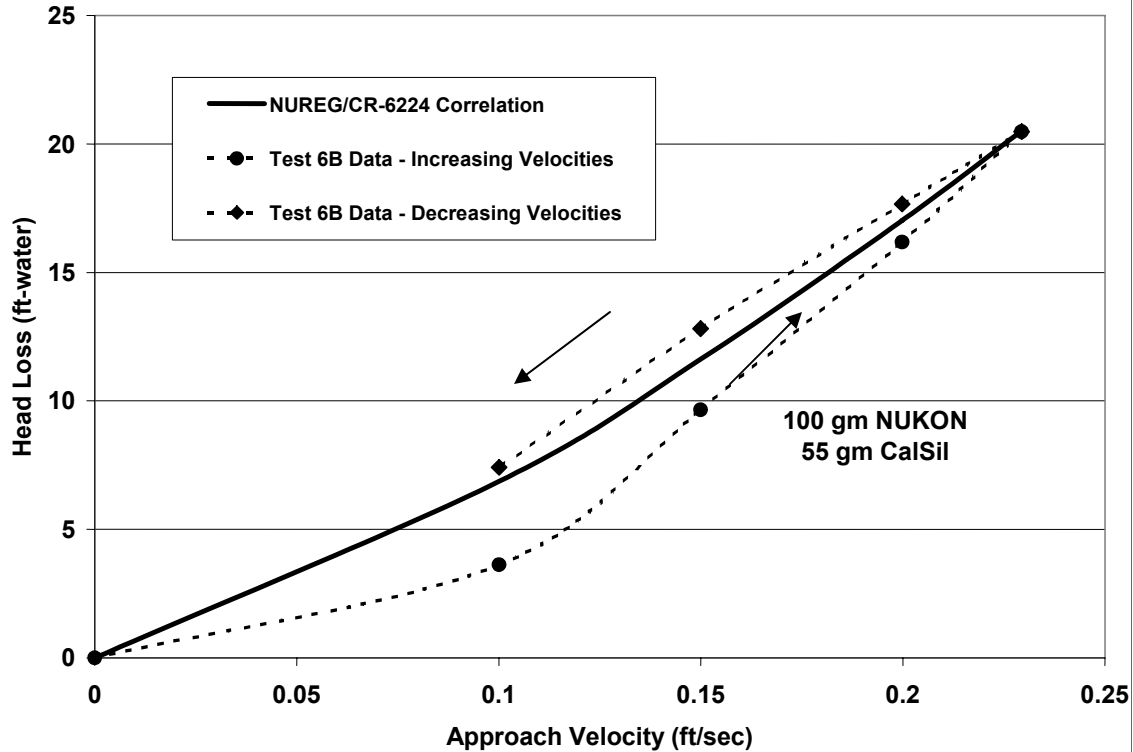
Figure 5.5. Comparison of NUREG/CR-6224 correlation with Test 6B head-loss data.

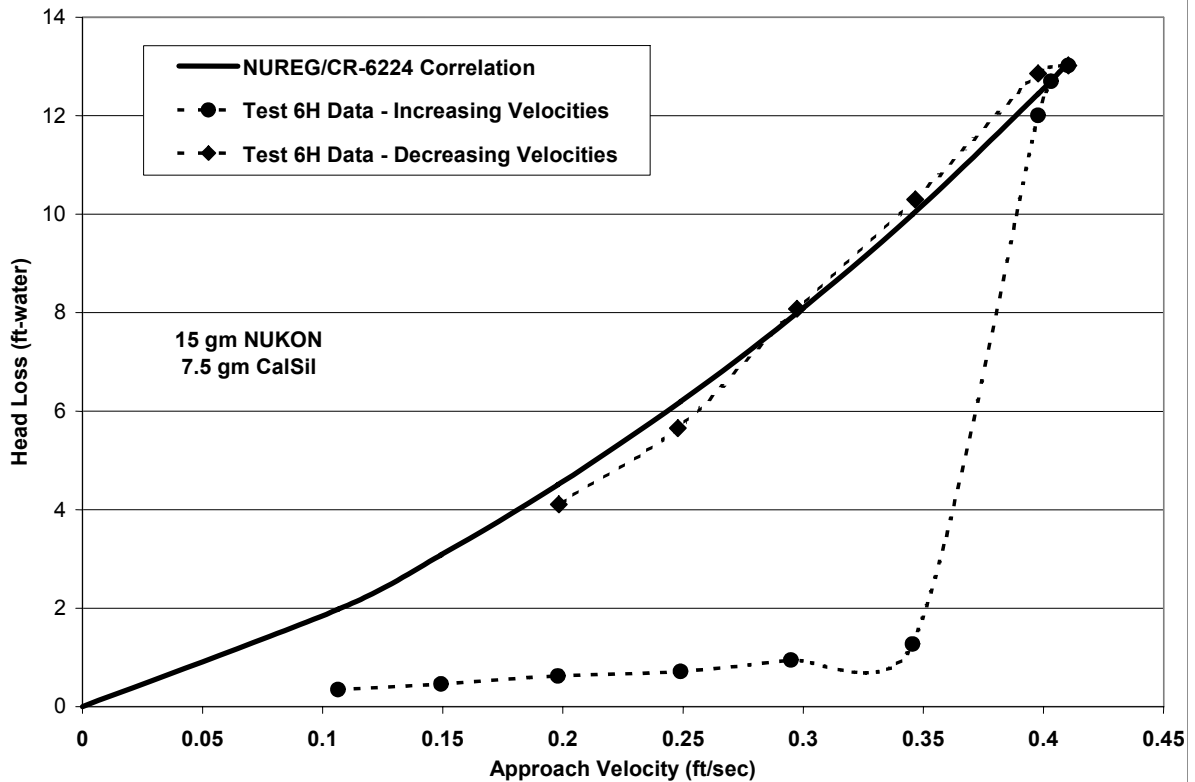
Figure 5.13. Comparison of NUREG/CR-6224 correlation with Test 6H head-loss data.

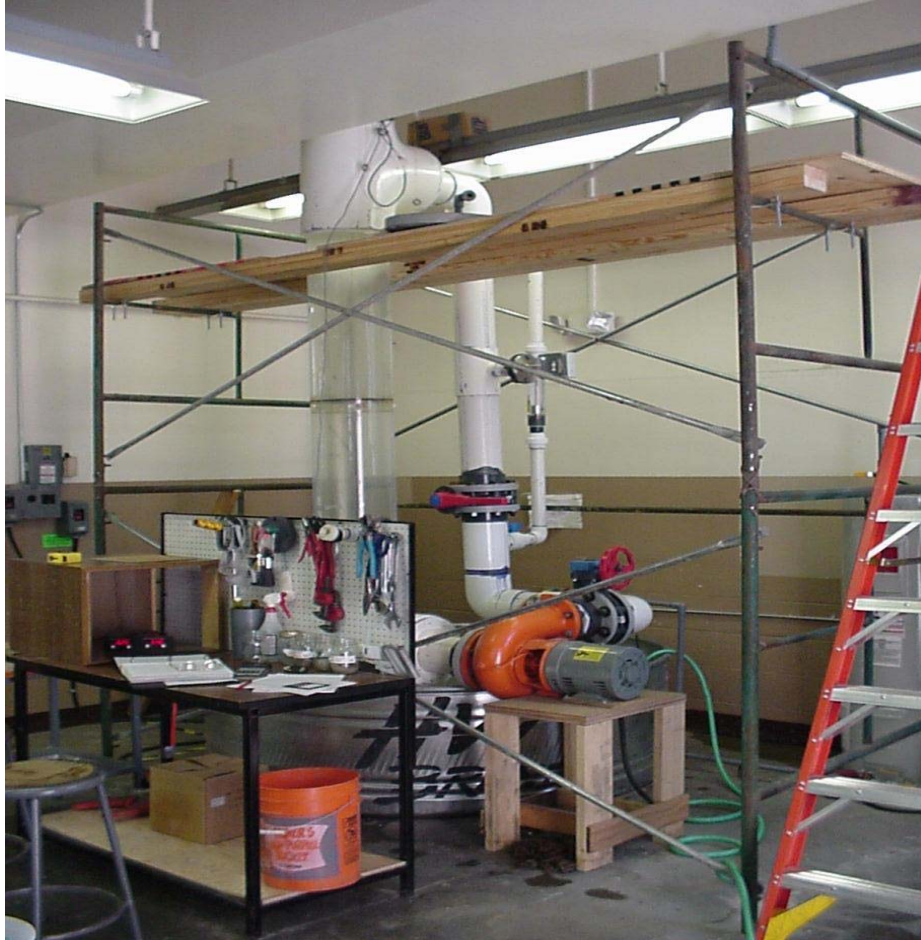
**Figure A.8. UNM closed-loop head-loss test facility.**

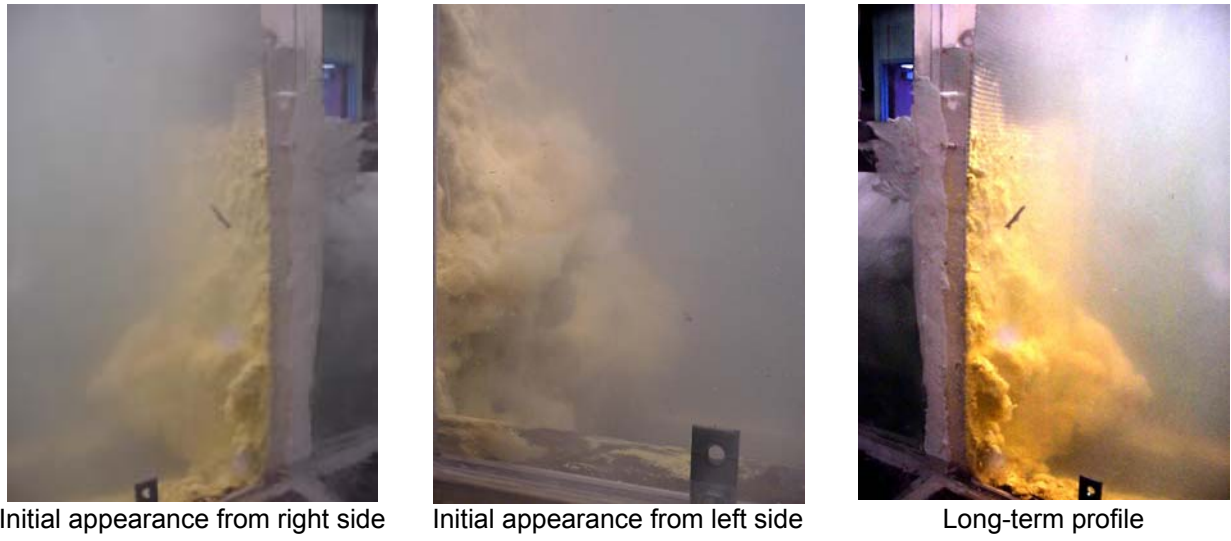
**Figure B.1:** The debris did not cover the entire width of the screen and left ~2 in. of space relatively open on one side, in addition to the 3 in. of opening at the top.

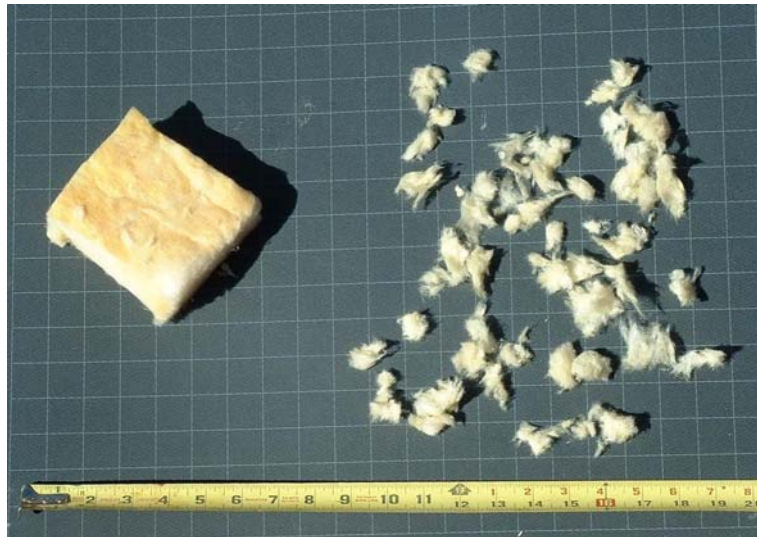
**Figure C.1. NUKON™ fiber debris samples.**

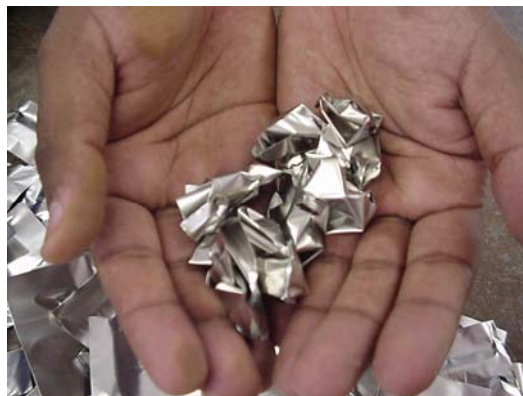
**Figure C.5. Stainless-steel RMI debris used in experiments.**
