# Proceedings of the Conference on Vessel Penetration Inspection, Crack Growth and Repair

Held at  
Gaithersburg Marriott at Washington Center  
Gaithersburg, MD  
September 29 – October 2, 2003

U.S. Nuclear Regulatory Commission  
Office of Nuclear Regulatory Research  
Washington, DC 20555-0001

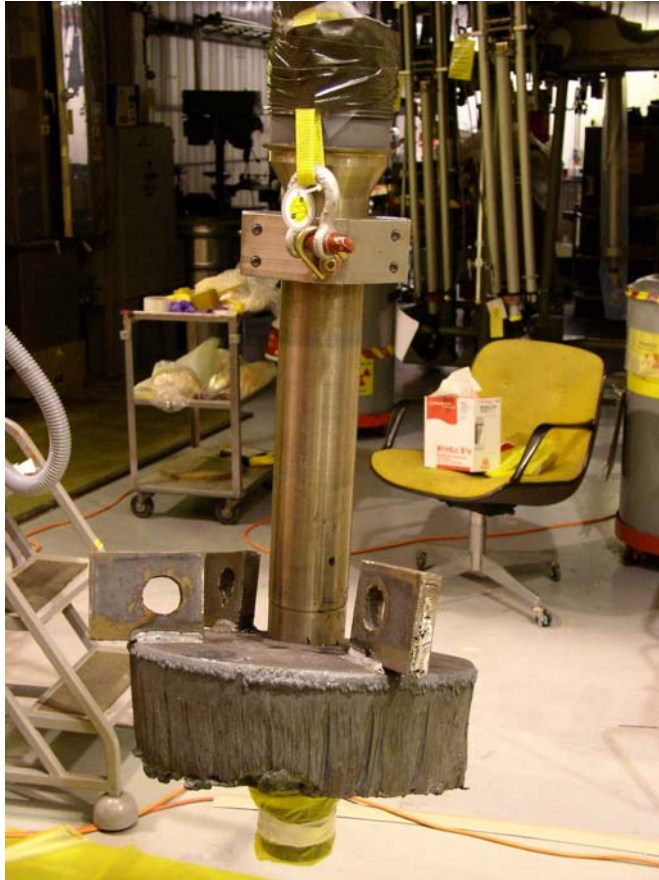
**Figure 3. North Anna 2 CRDM that has been decontaminated and is ready for moving to a stand for NDE inspections.**

Figure 3 shows a CRDM that has been decontaminated and is being readied for transit to a stand where it will reside during NDE inspections. Four CRDMs will be inspected by the commercial NDE vendors. The really fantastic opportunity that the North Anna 2 CRDMs offer is realistic NDE studies on service induced PWSCC coupled with flaw validation. This will allow us to fully understand how effective the NDE is in detecting PWSCC at all of the locations found in these samples. For the first time, we will also know what was found and what was not found. In addition we will for the first time understand how accurate the NDE techniques are in sizing the PWSCC.

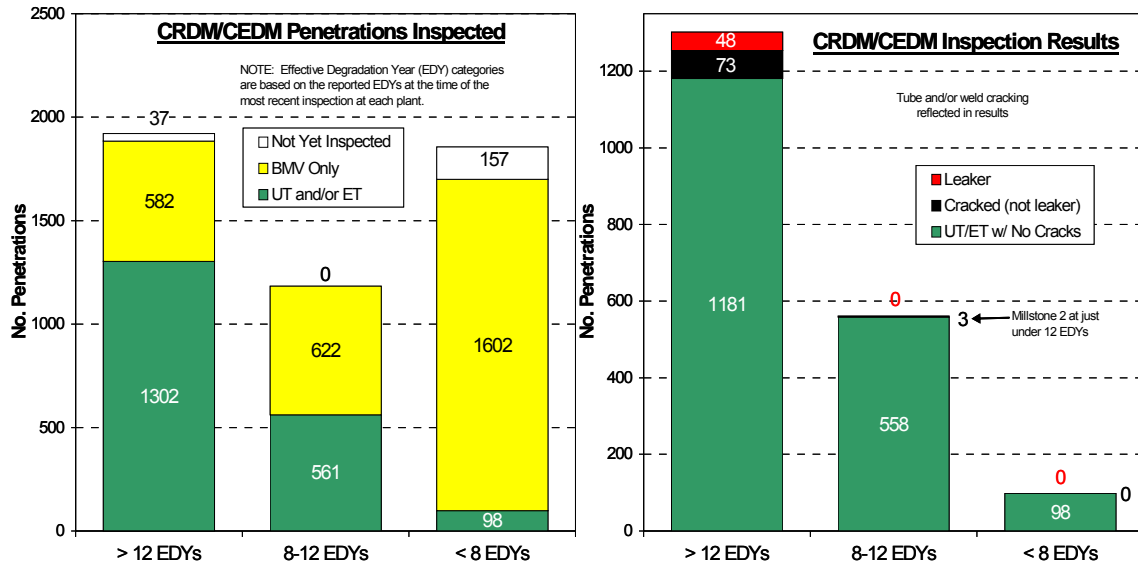
Figure 6  
RPV Head Inspection Statistics – by EDY Group

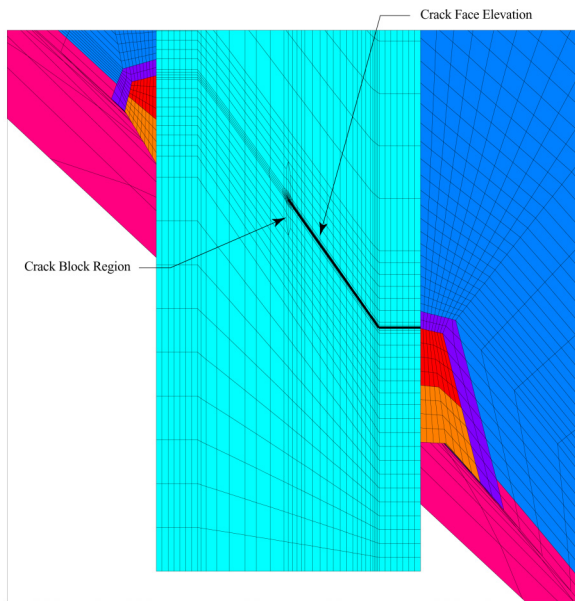
**Example of Operating Stress Perpendicular to Circ Crack Plane**

**180° Downhill-Centered Crack**

**Crack Mesh Detail**

Figure 4  
Example Fracture Mechanics Model for Nozzle Circumferential Cracks

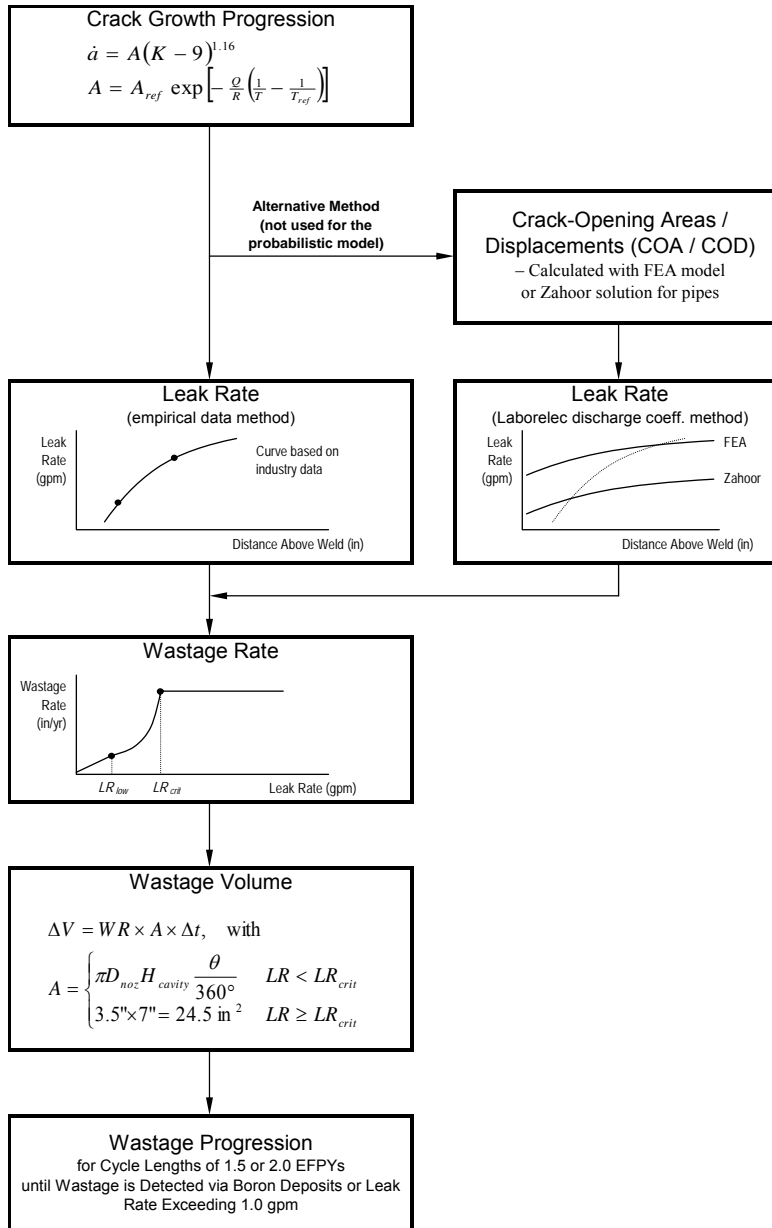
Figure 11  
Probabilistic Model for Boric Acid Wastage (MRP-75)
