Section 3:  
Session 2: Continued Plant Operation

# Background and Technical Basis: Evaluation of Upper Head Penetration Flaws in the ASME Code

Warren Bamford, Westinghouse Electric  
and  
Guy DeBoo, Exelon

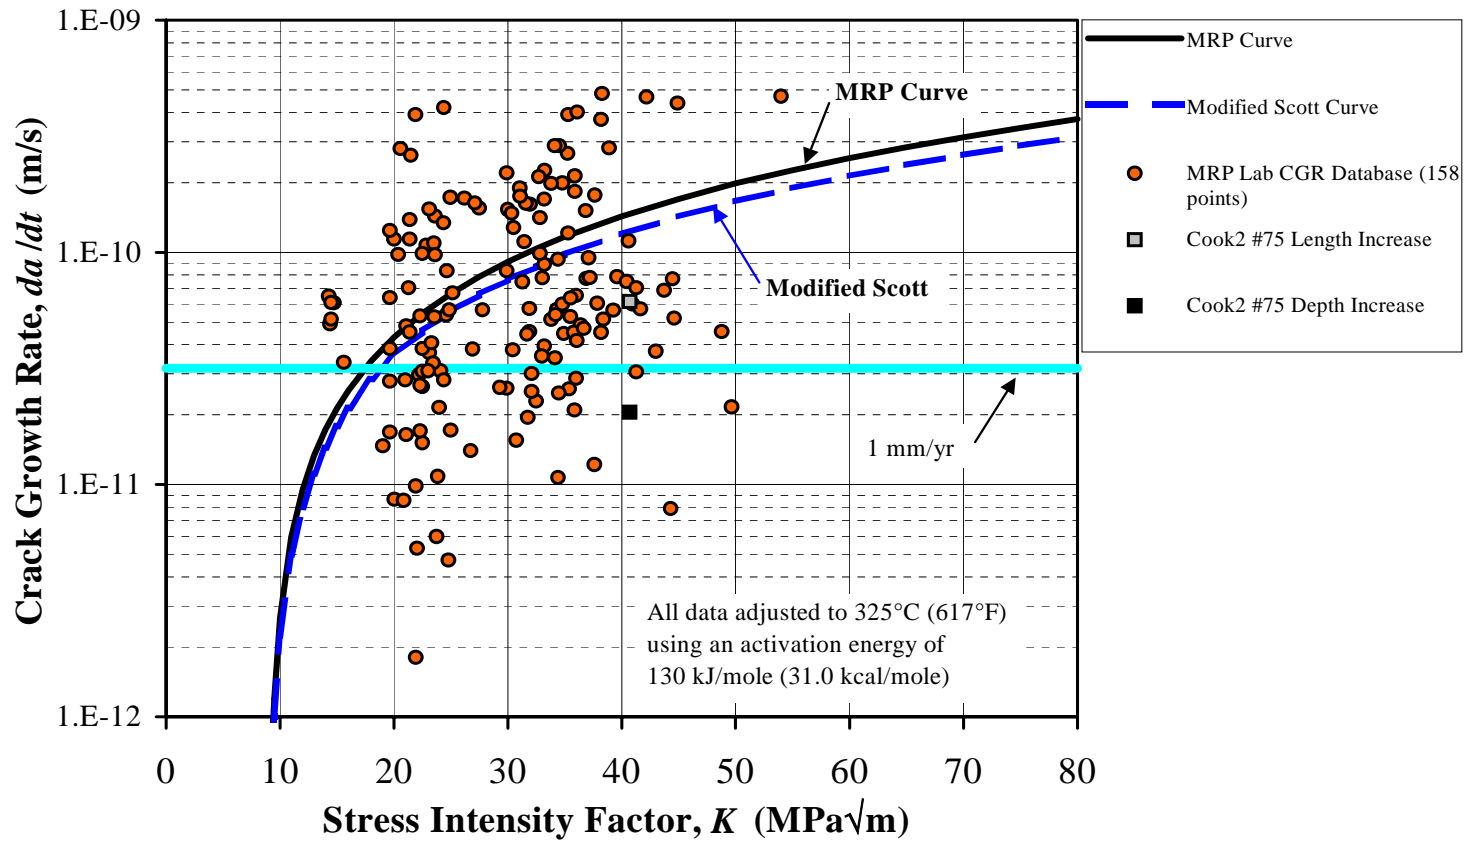
# Stress Corrosion Crack Growth

- Use EPRI MRP-55 Rev.A report as basis for growth model: Alloy 600 Base Metal
- Goal is a “Best Estimate” Prediction
- Model is higher than the mean, so it is conservative
- Additional conservations added in acceptance criteria

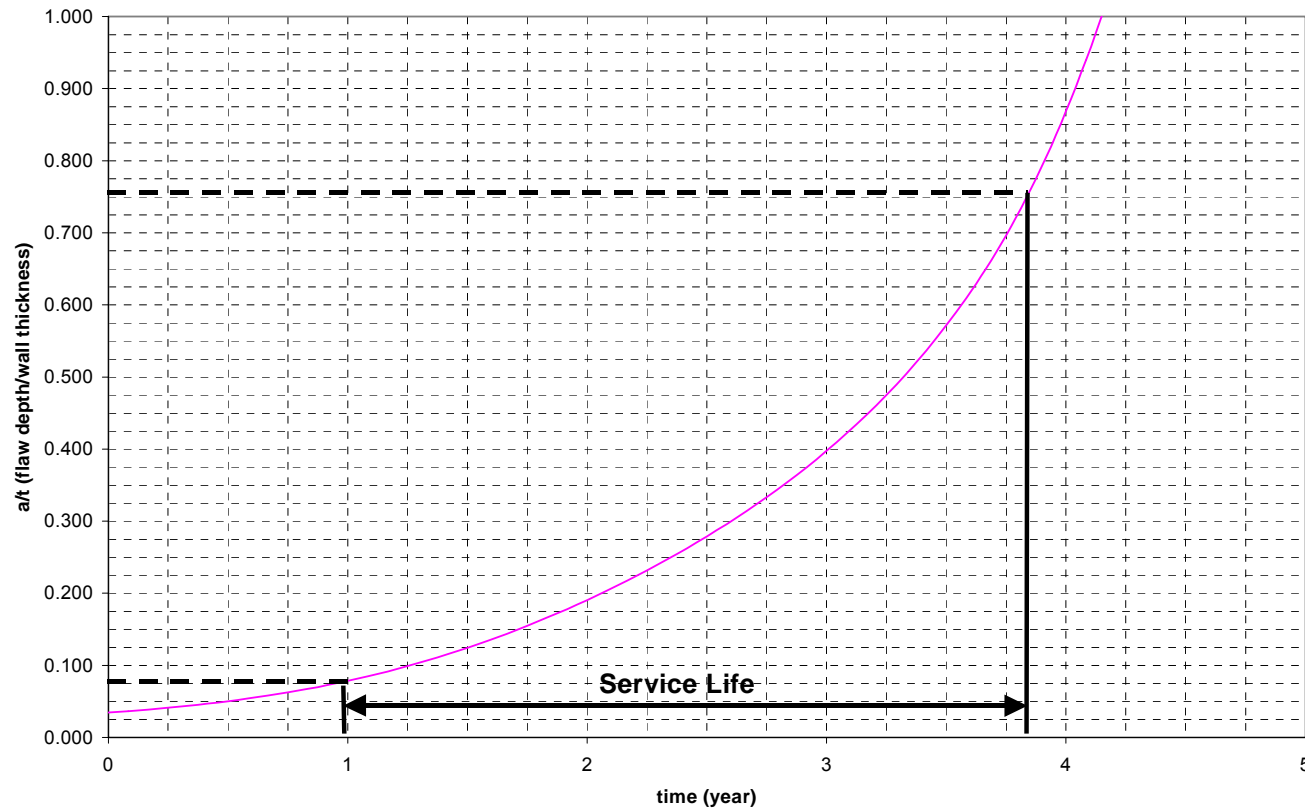
# Example Application

Orientation	Vertical Location	Circumferential Location	Length	Depth
Axial-ID	At Weld	Uphill	0.283" (7.2mm)	0.047" (1.2mm)

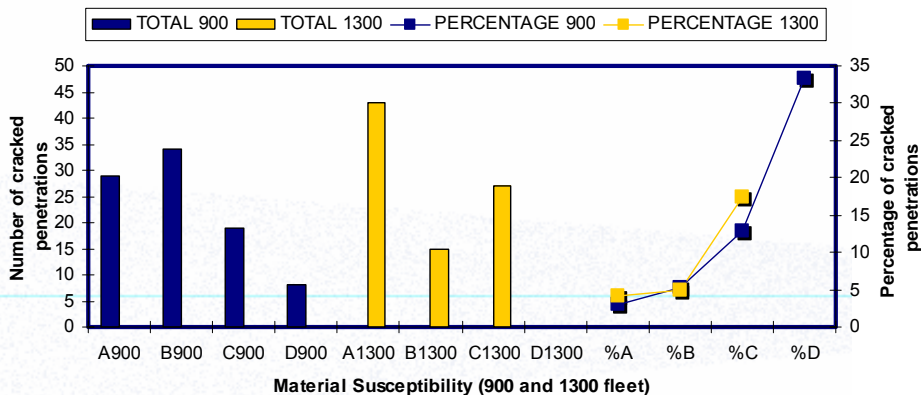
- ❑ Importance of the set up angle of the penetration,
- ❑ High angle = high stress level
- ❑ Importance of the susceptibility of materials to PWSCC

- ❑ Ranking in 4 classes show a clear effect of the material susceptibility

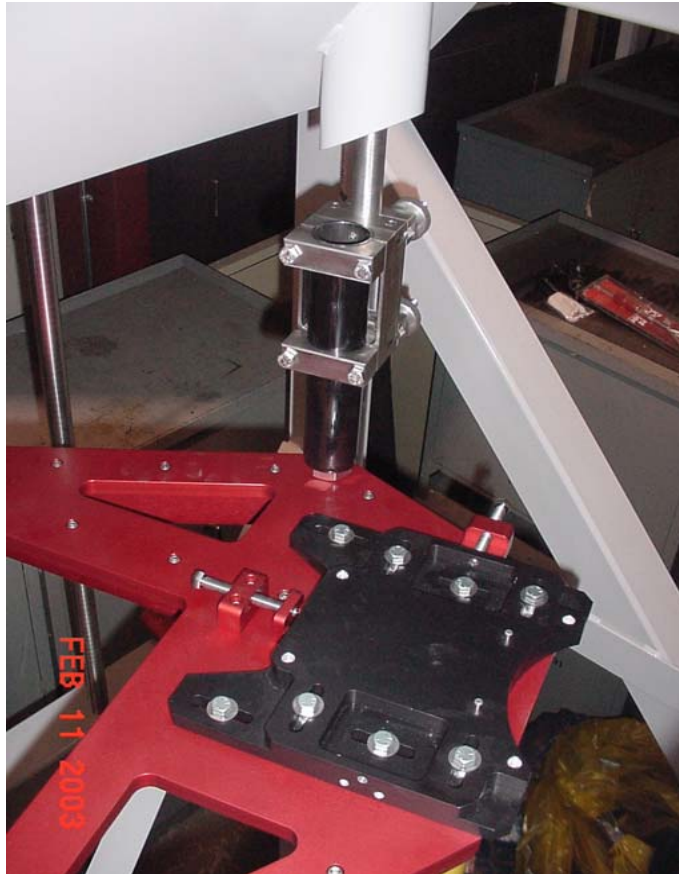
## Mechanical Plug

- > **Common Features**
  - ◆ **Redundant seals constructed from rad-tolerant material**
  - ◆ **Mechanically actuated to seal on nozzle surface (I.D. or O.D.)**
  - ◆ **Provides shielding (external or internal)**
    - **Rad-streaming concern after nozzle contents have been drained for below-vessel repair work**
- > **Option to remove I.D. Nozzle Plug from below vessel using freeze seals**

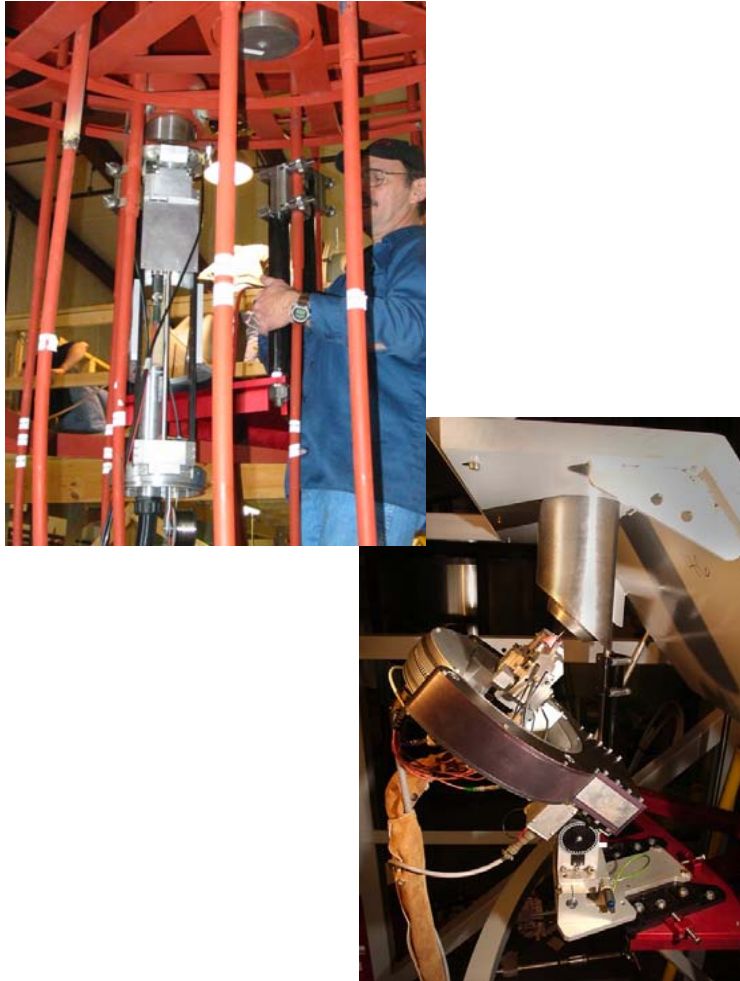
# BMI Nozzle Repair – Step 2

- > Deposit Alloy 52 weld pad
- > Grind suitable for NDE
- > Dimensionally inspect

- > *Field-hardened, proven design*
- > *R- $\Theta$  motion control with AVC*
- > *Machine vision of work point from remote operator's console*
- > *Two-axis wire steer*
- > *Water-cooled torch*
- > *Scaled, digital read-out (DRO) of both R (inches) and  $\Theta$  (degrees) axes*
- > *Pivot mount for adjustment to RV head tangent angle*

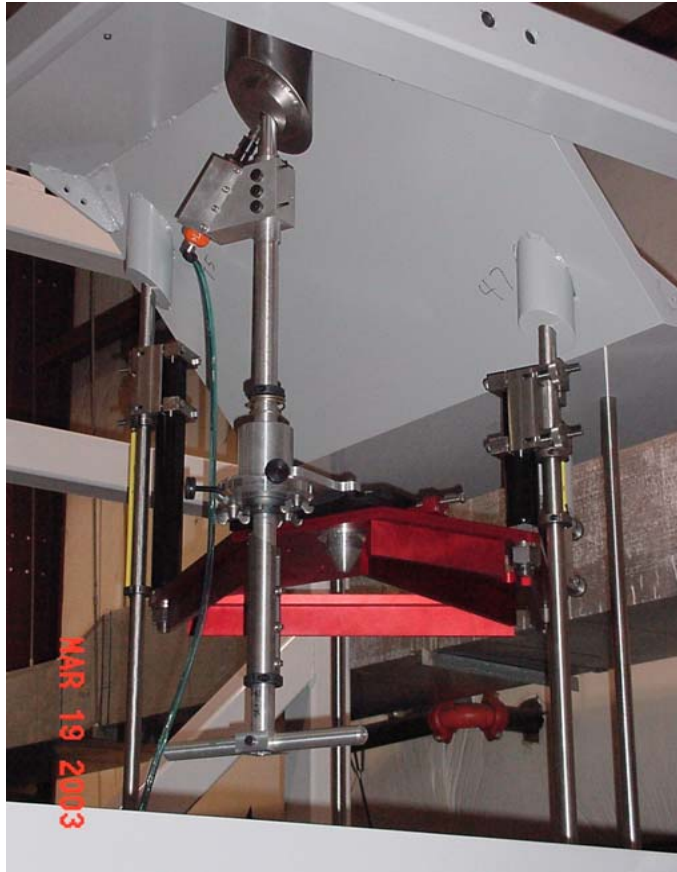
## J-Prep Tool

- > **Proven reliable design used previously on pressurizer nozzles**
- > **Lightweight, one-man installation**
- > **Custom cam for each nozzle location to grind appropriate angle of J-prep**
- > **Features a debris collection device with vacuum attachment to collect grinding flakes**
- > **J-Prep tool can be used as-is for using a specific set of burrs and cams**

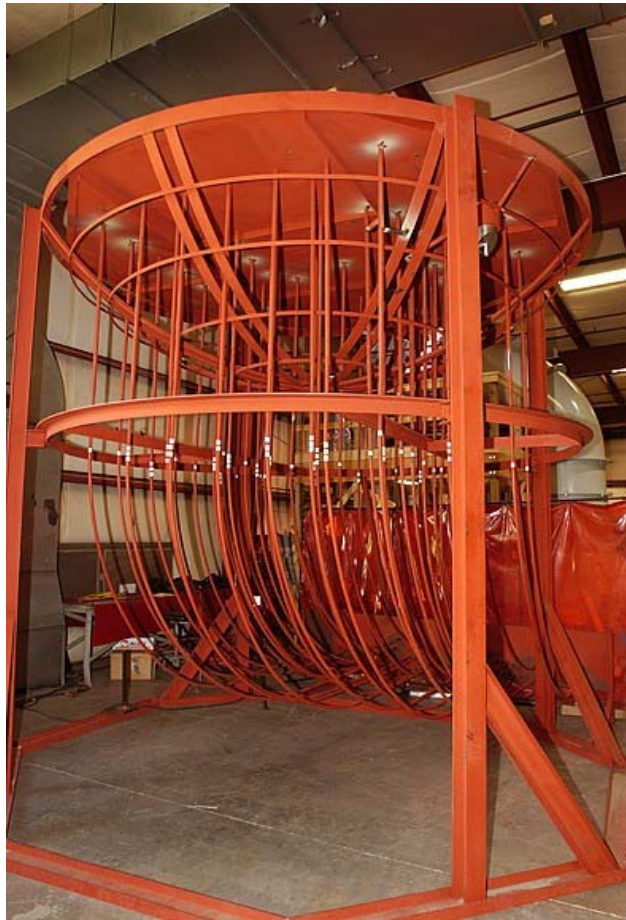
## ***RV Lower Head Mockup***

- > Originally designed for B&W Plant configuration, modified for Westinghouse design***
- > Includes features to hold removable coupons so that multiple repair trials can be performed at each location***
- > Used for machining and welding tool qualification and crew training***
