Section 6:  
Session 5: Mitigation of Nickel-base Alloy Degradation  
and Foreign Experience

## Belgian activities on alloys 600 and 182 issues

# *Conference on Vessel Head Penetration Inspection, Cracking and Repairs*

# Activities on Alloy 600 Cracking of PWRs in Japan

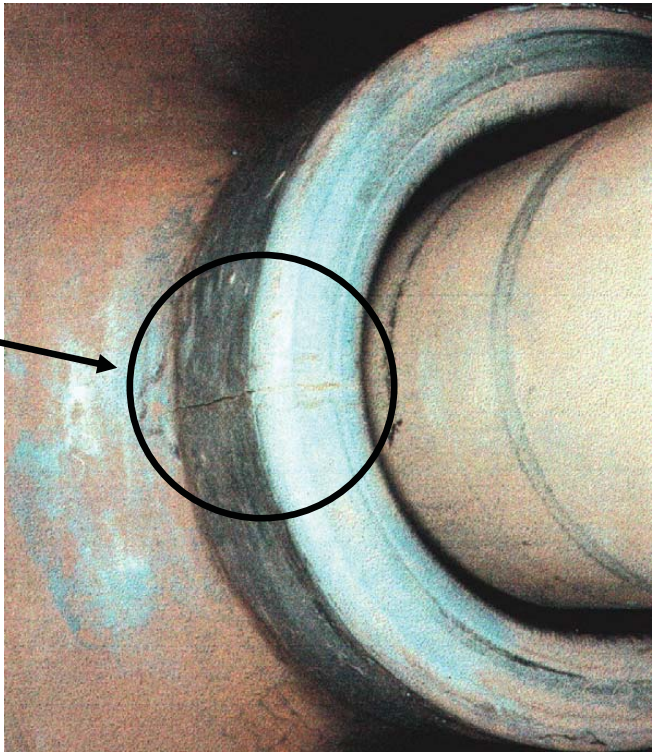
# Tihange 1 RPV head – Cracking in 03/1998

Long axial through-wall crack below weld

Operation justified for one additional cycle (17 months) before replacement

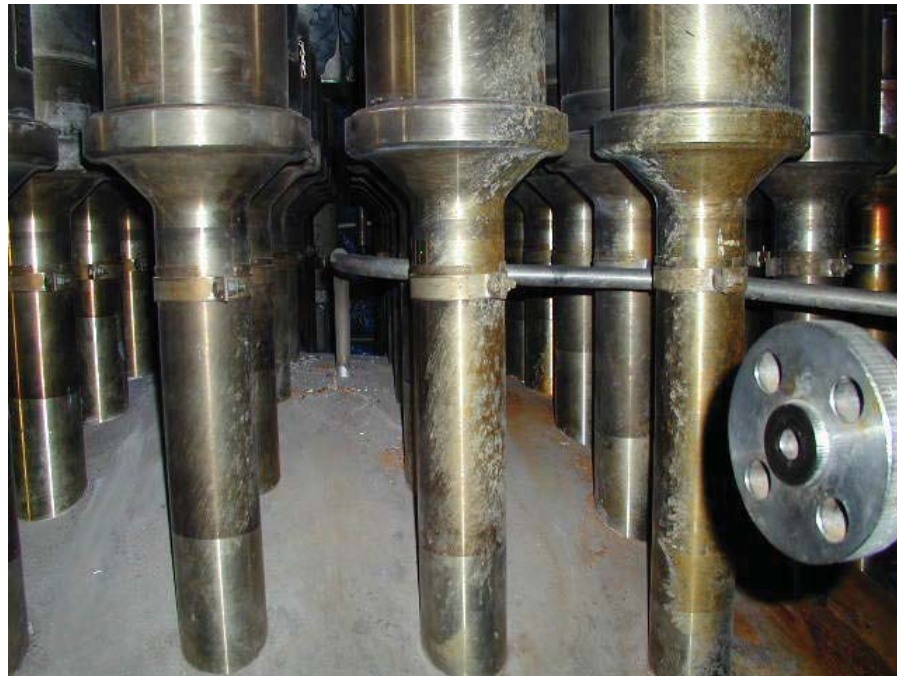
“Clean” heads with locally  
some rusty streaks and  
boric acid traces,  
attributed to canopy seals  
leaks

No evidence of RPV head  
corrosion

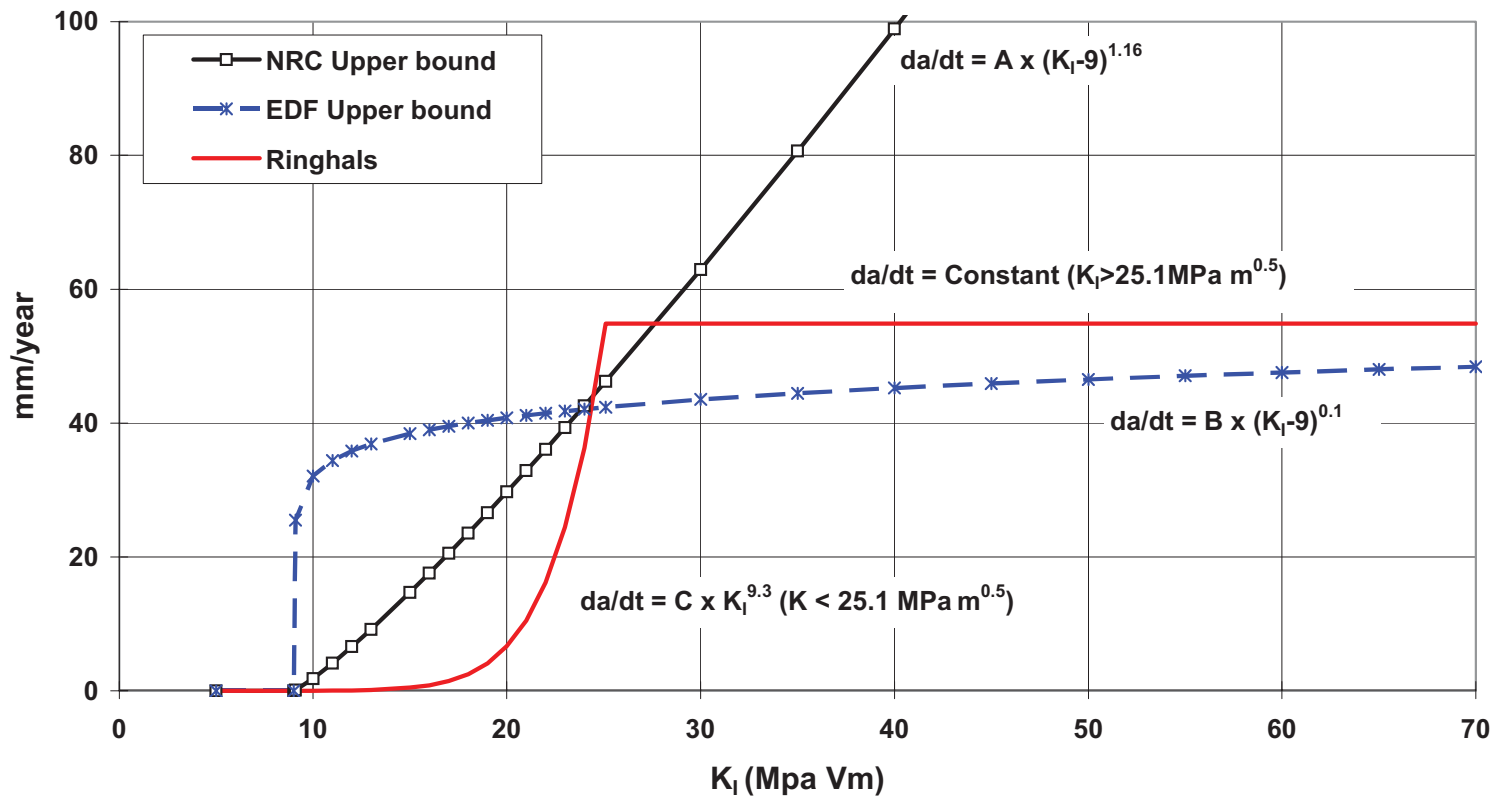
### Crack growth rates - Inconel 182 at 345°C (Arrhenius with Q=130 kJ/mole)

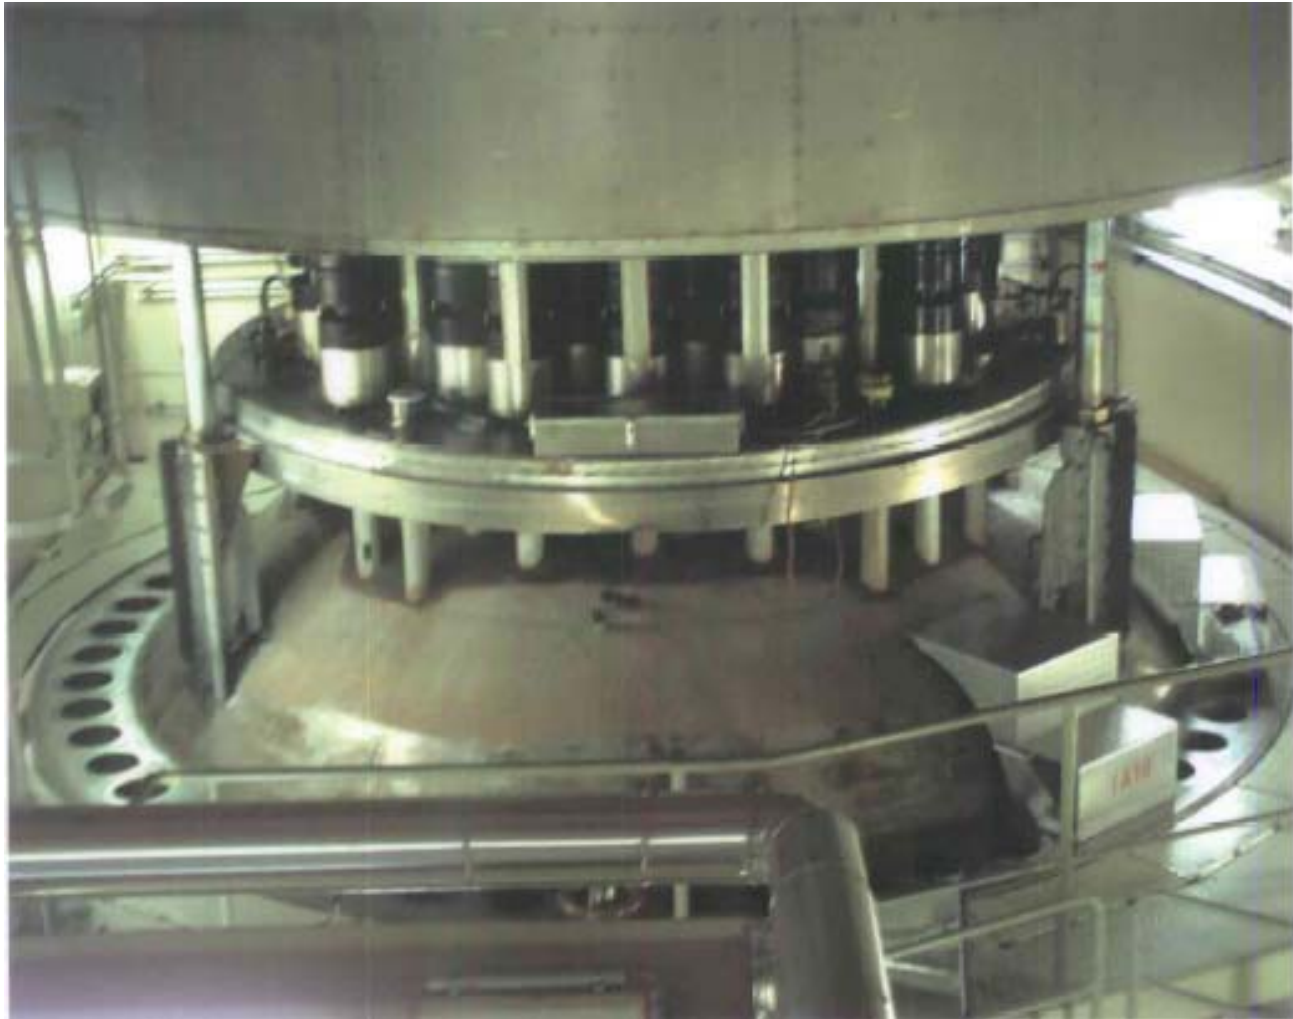
## *RPV Head after Removal from the Vessel*

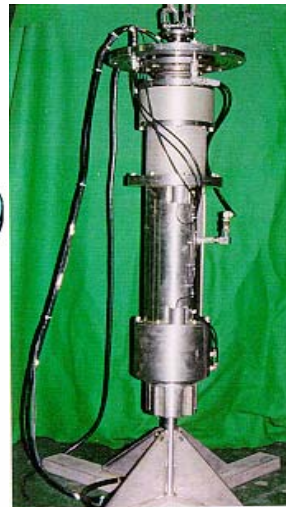
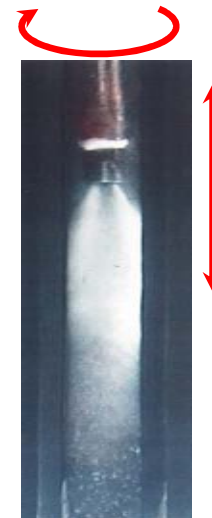
**WJP equipment**

**State of WJP  
in small diameter pipe**

- **Based on recent PWSCC assessment, BMI nozzles are suspected to have cracking and mitigation measurement is recommended.**
- **ECT and water jet peening (WJP) technology for BMI nozzles have been developed by MHI as mitigation measurement in accordance with PWSCC assessment.**

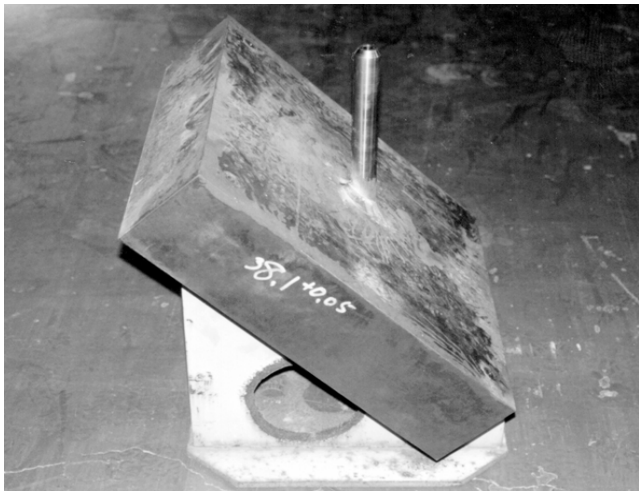
## Improvement of Residual Stress by WJP Technology

Mock-up of BMI

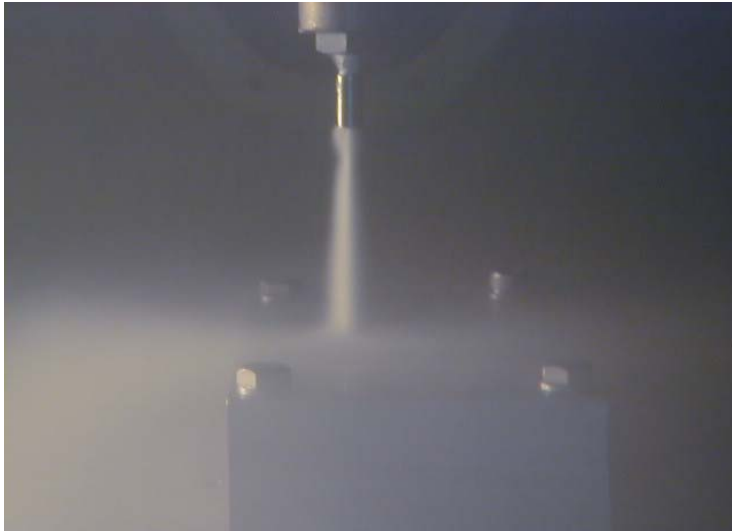
## Concept of WJP for Hot Leg Nozzle

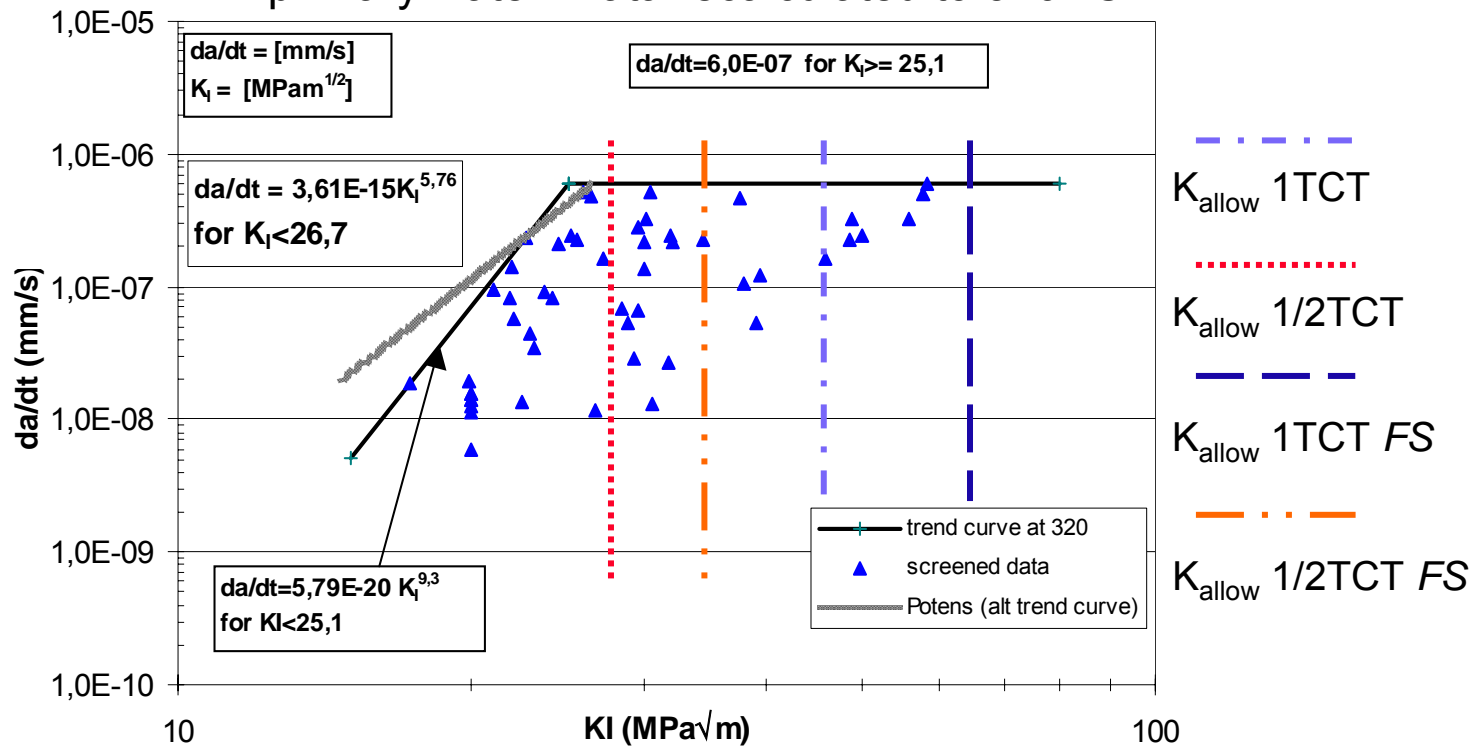
Screened data and bounding curves for Alloy 182 crack growth in PWR primary water. Data recalculated to 320 °C

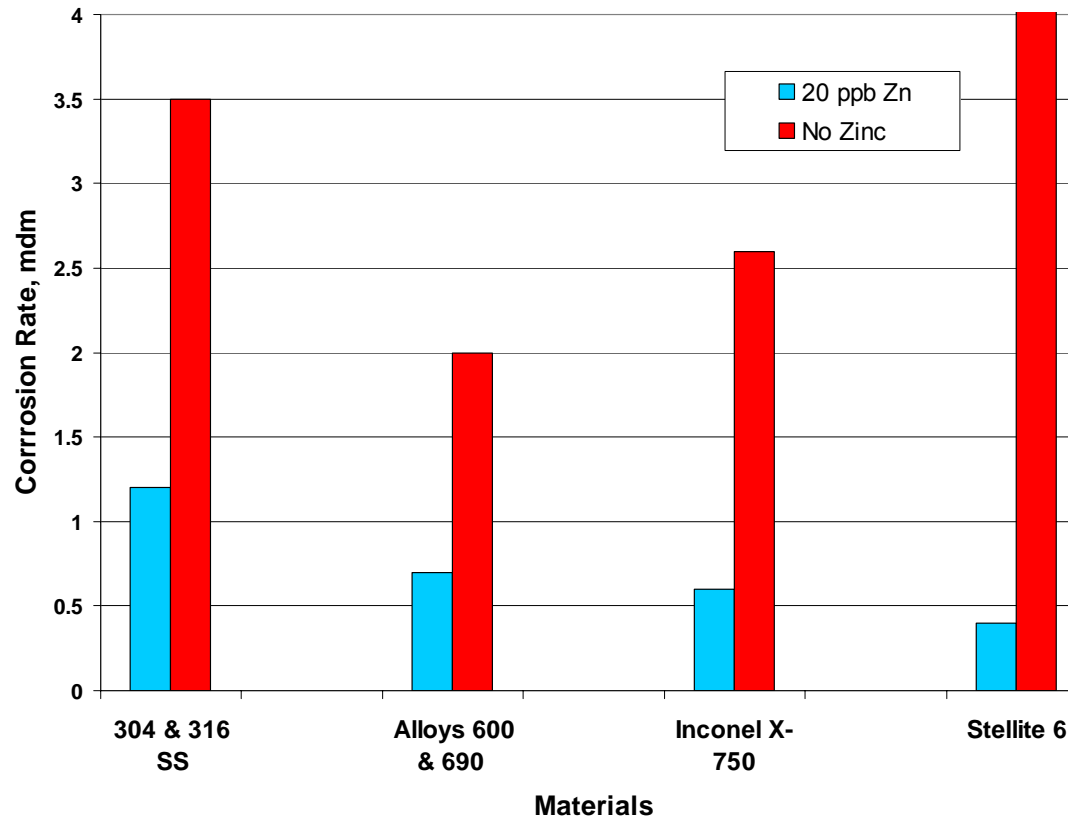
Corrosion Rate at 3.5 Months for Various Alloys

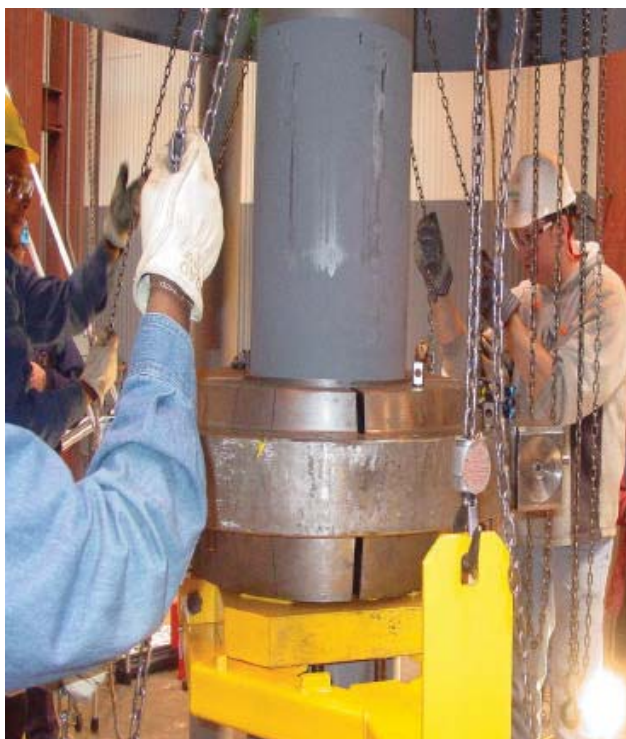
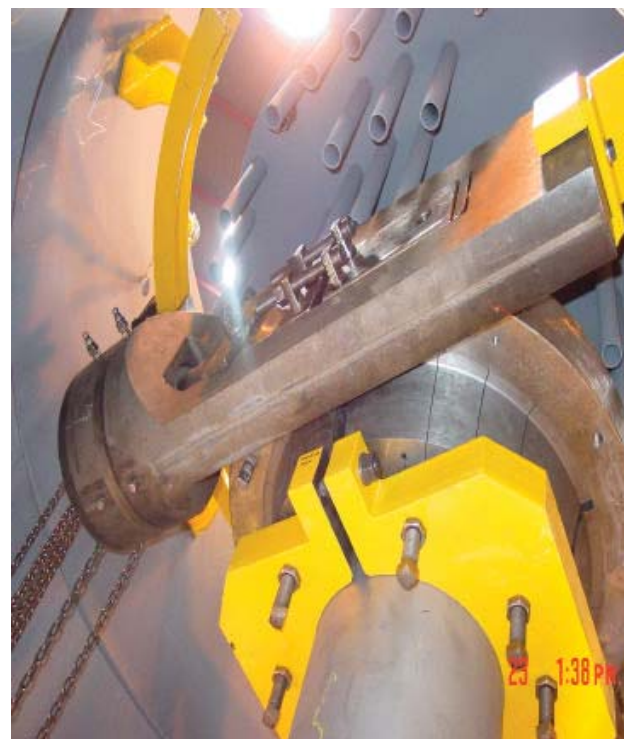
1105

# PRESURIZER SURGE NOZZLE MOCK-UP FOR TIHANGE 2

Pressurizer Surge Nozzle Mock-up for Tihange 2

- Tihange 2 MSIP qualification program demonstrated that the MSIP process was very effective in generating compression at the weld location
- Demonstrated that the MSIP process works well in thick-walled PWR applications
- Demonstrated that the post-MSIP OD profiles are acceptable for in-service inspections
- MSIP can be an effective part of a proactive Alloy 600 mitigation program

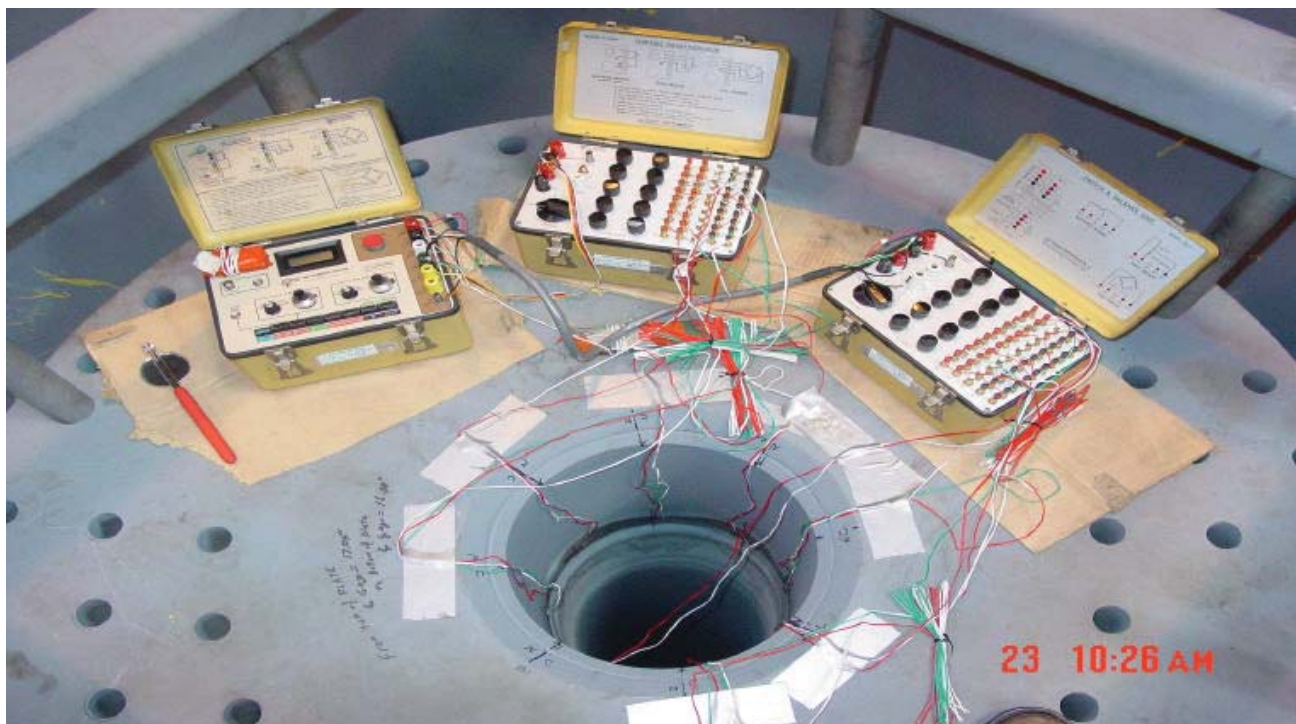
1108

# ILLUSTRATION OF INSTALLED STRAIN GAUGES AND STRAIN MEASURING INSTRUMENTATION AT GIRARD SITE PRIOR TO MSIP LOAD TEST

Illustration of the Installed Strain Gauges and the Strain Measuring Instrumentation at the Girard Site, Prior to MSIP Load Test
