NUREG/CR-6173
SAND94-1795

A Summary of the Fire Testing Program at the German HDR Test Facility

Prepared by
S. P. Nowlen

Sandia National Laboratories
Operated by
Sandia Corporation

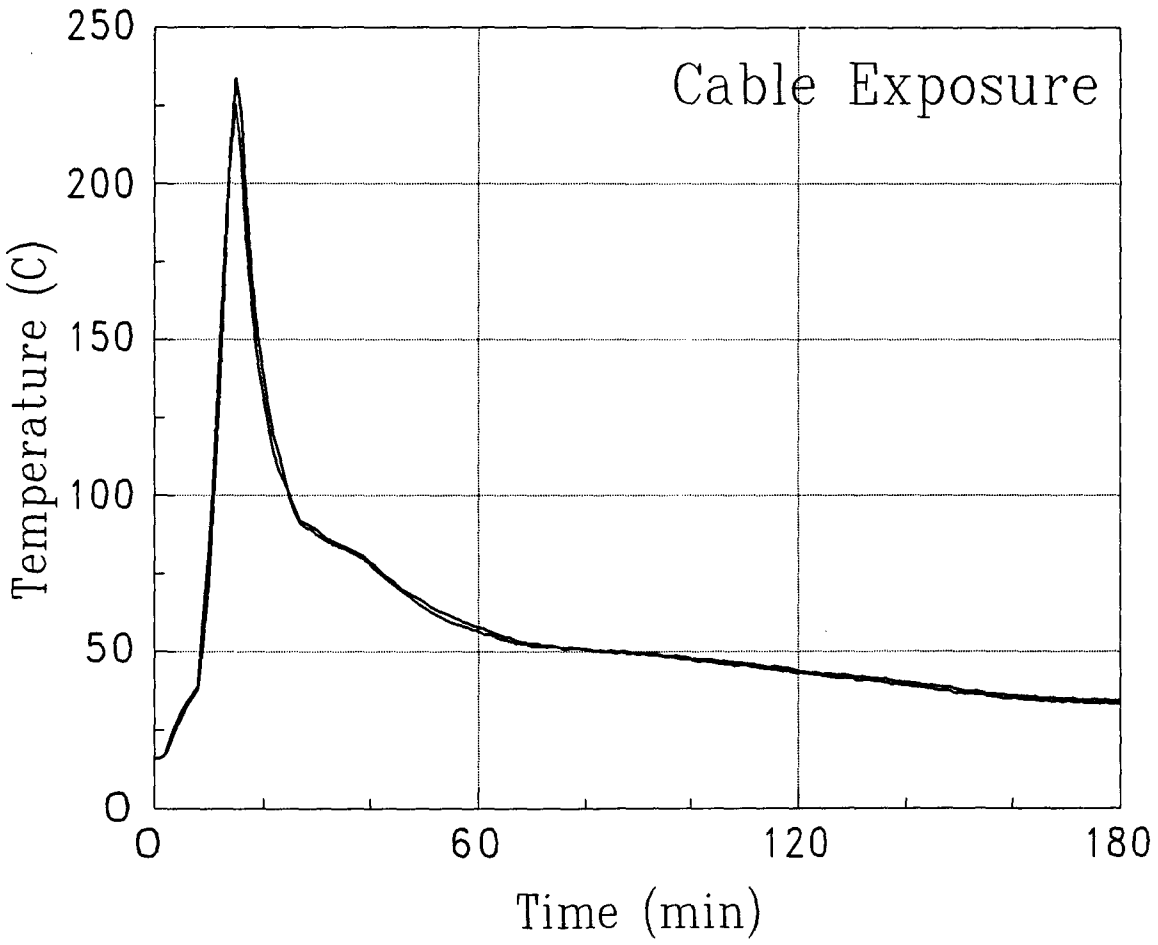
Figure A.1, Temperature Exposure History at the Location of the Sandia Cable Samples During Test E42.2

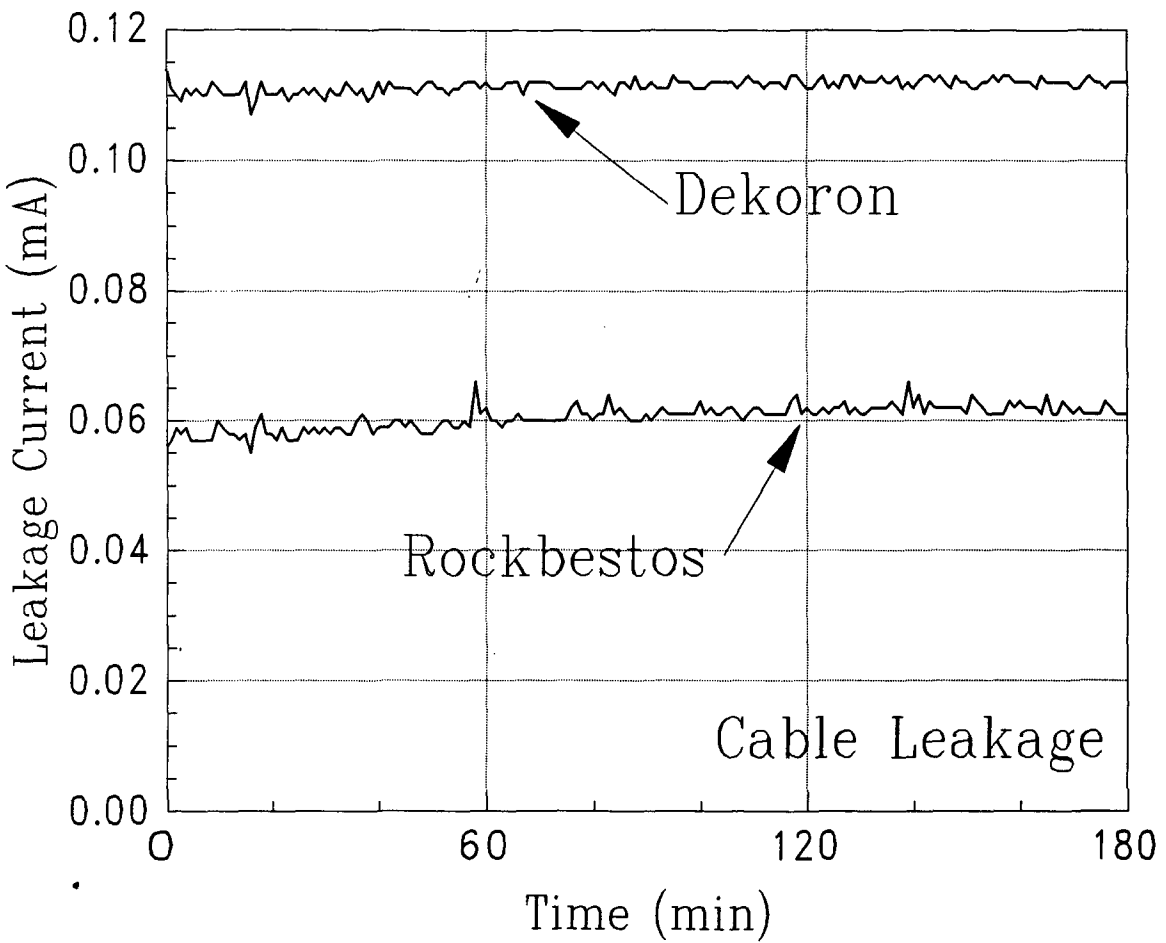
Figure A.2, Cable Performance Data, Leakage Current, for the Sandia Cable Samples During Test E42.2

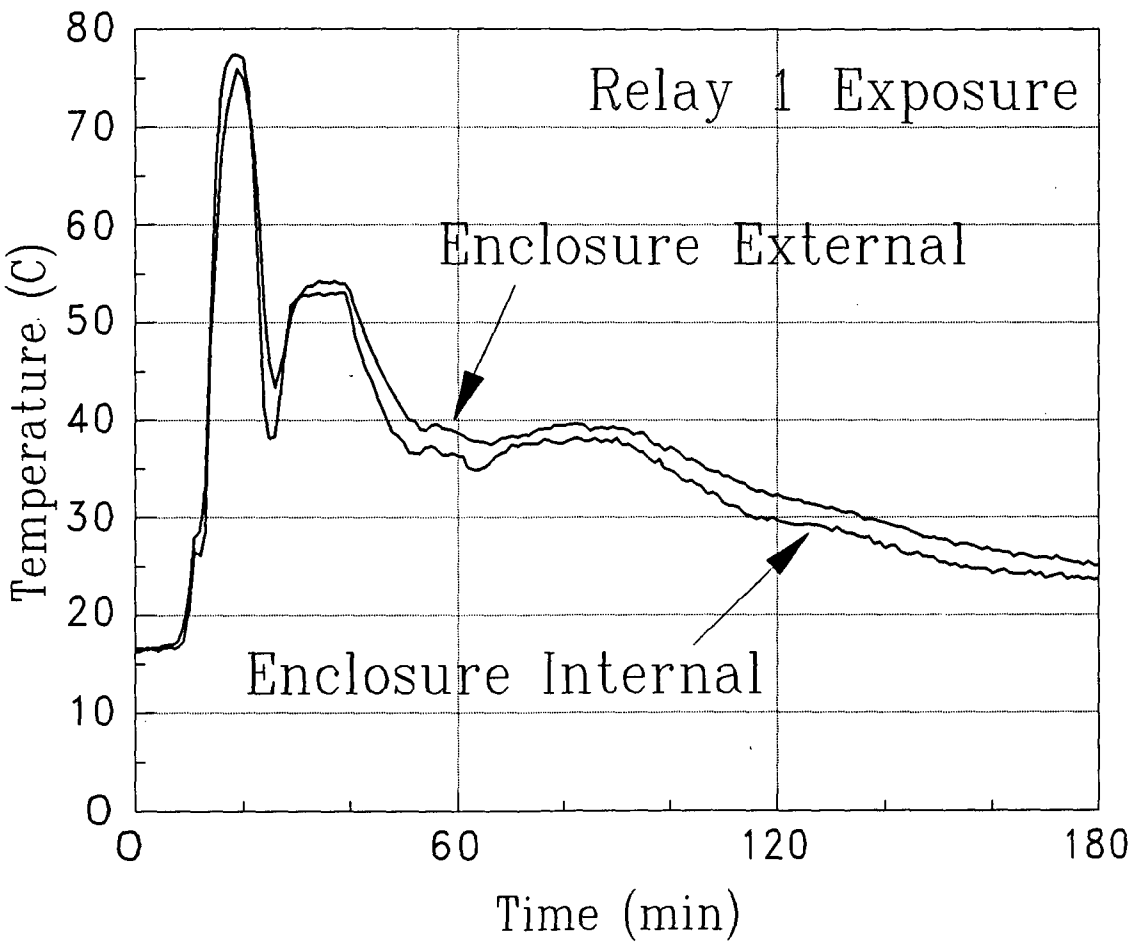
Figure A.3, Temperature Exposure History at the Outer Room
Relay Location During Test E42.2

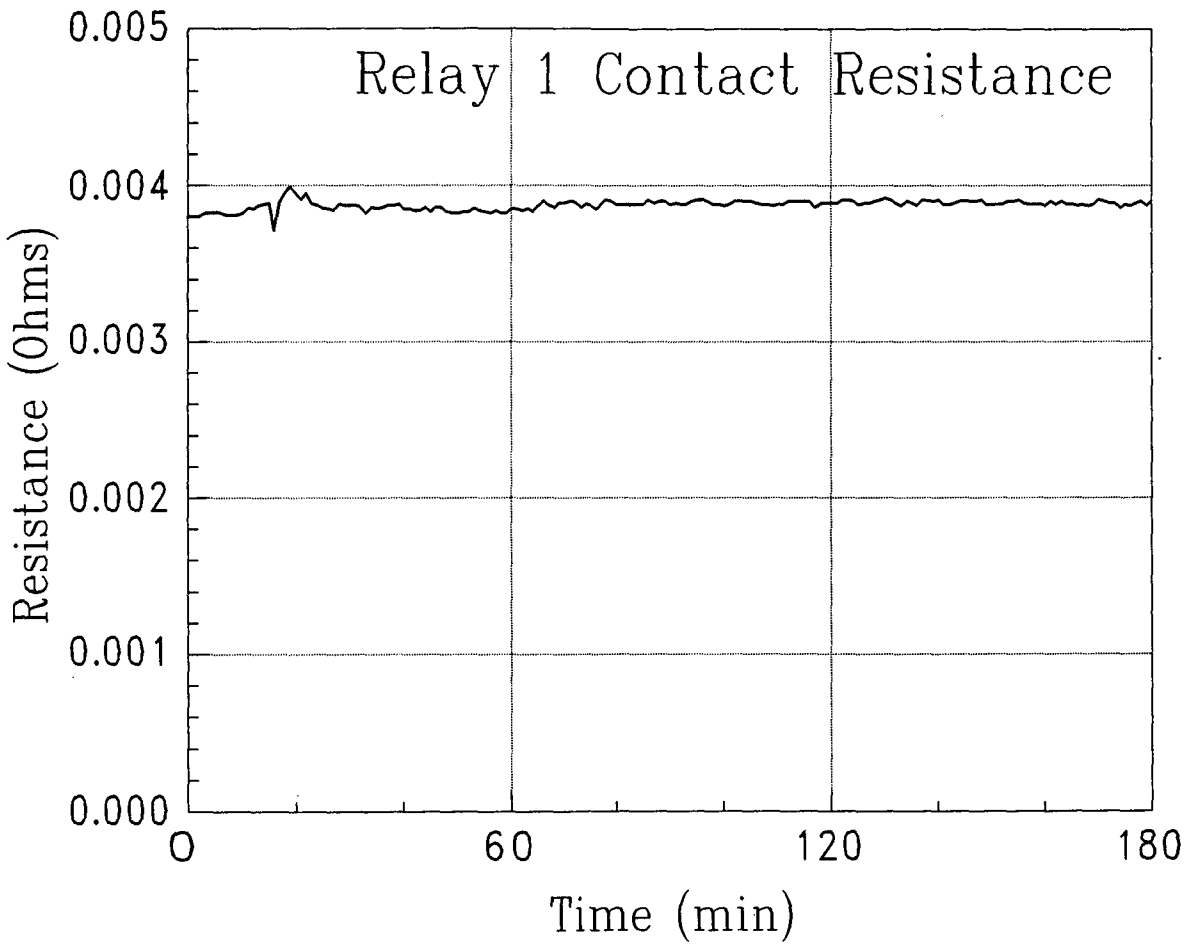
Figure A.5, Outer Room Relay Contact Resistance
Data Gathered During Test E42.2

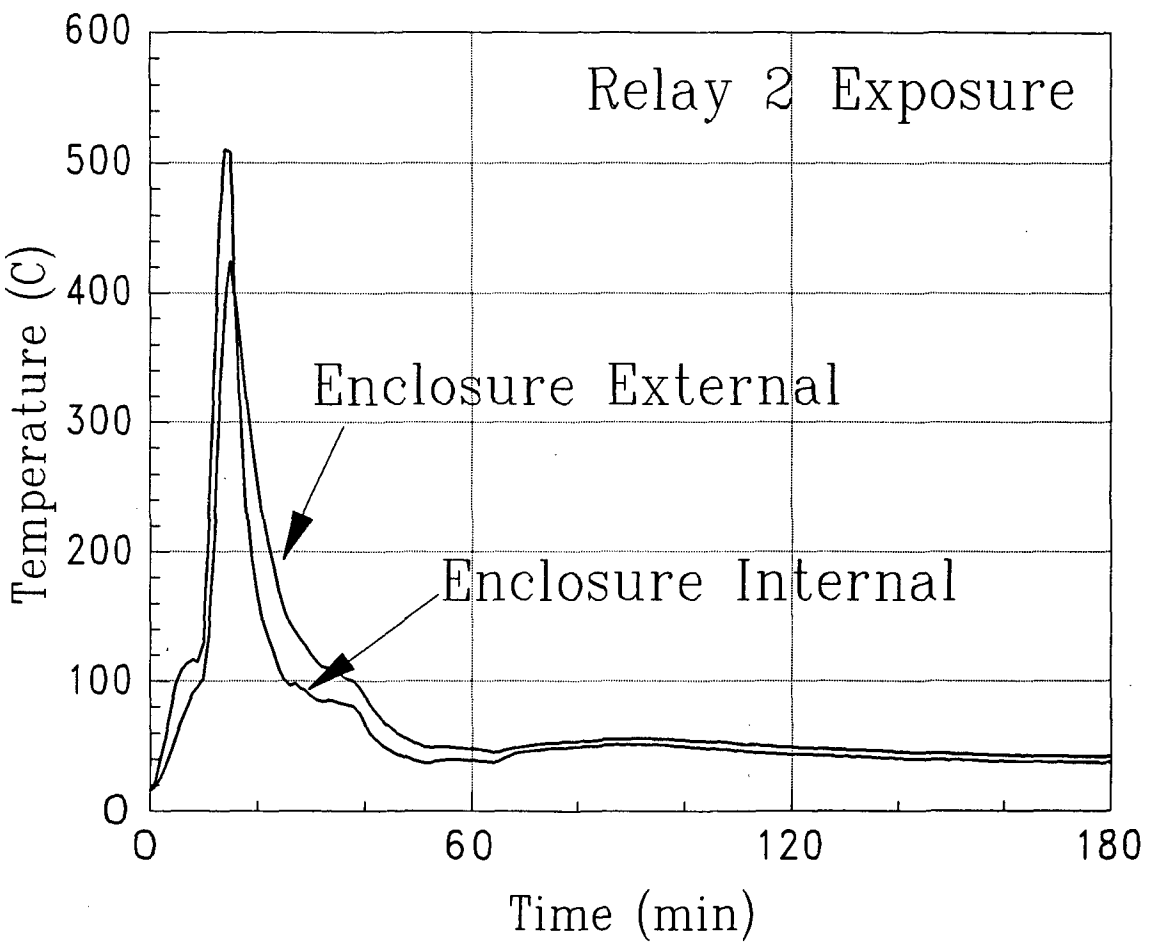
Figure A.6, Temperature Exposure History at the Fire Room
Relay Location During Test E42.2

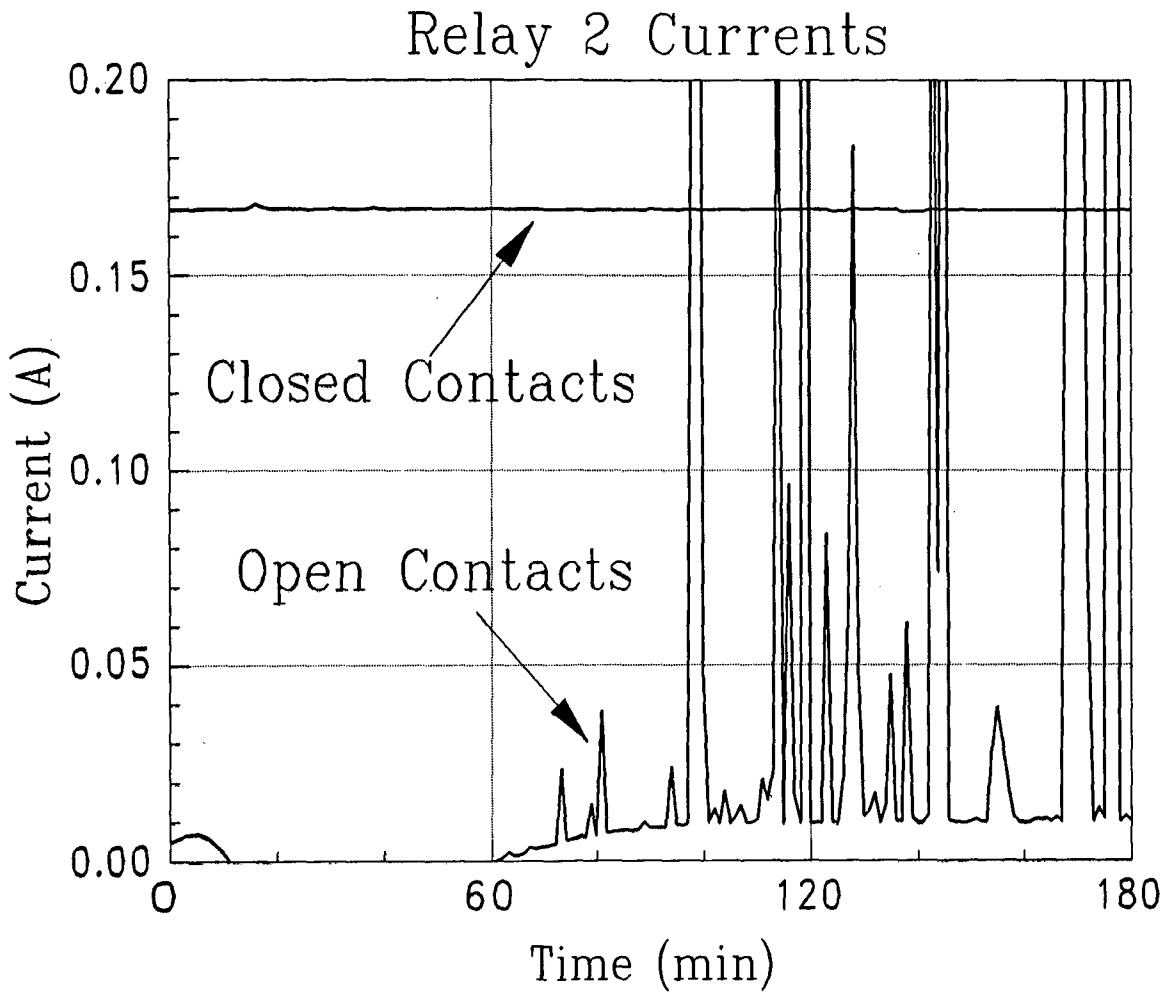
Figure A.7, Relay Switching Performance Data for the Fire Room Relay During Test E42.2
