Crack Growth Rates in a PWR Environment of Nickel Alloys from the Davis-Besse and V.C. Summer Power Plants

Argonne National Laboratory

**U.S. Nuclear Regulatory Commission
Office of Nuclear Regulatory Research
Washington, DC 20555-0001**

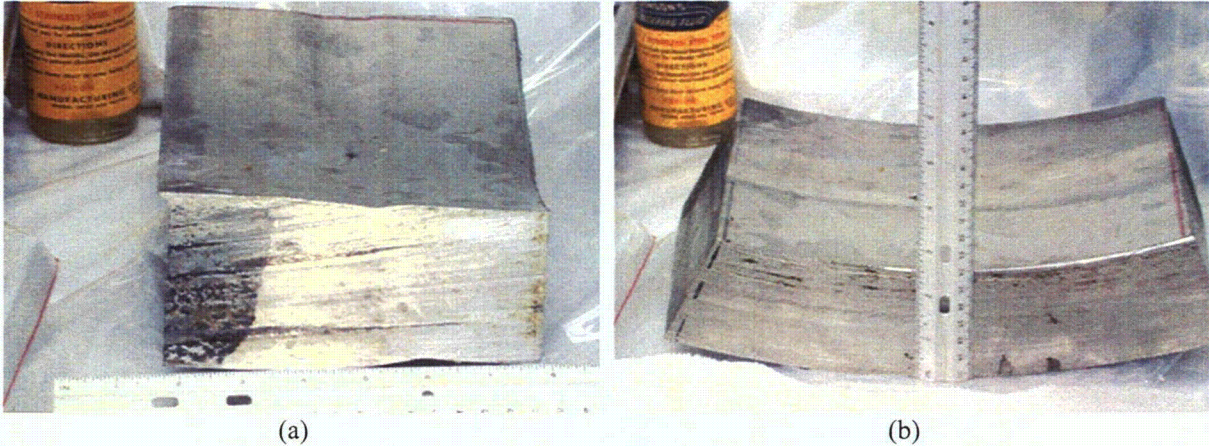
Figure 3. Photographs of the V.C. Summer spool piece.

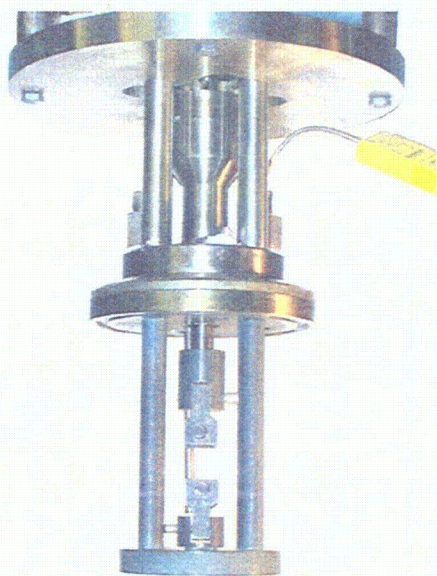
Figure 14.
Photograph of the specimen load train for the 1-liter autoclave.

The 1/4-T or 1/2-T CT specimen is mounted in the clevises with Inconel pins (Fig. 14). The two sets of clevises are at 90° opposition, forming a pair of universal joints. The specimen and clevises are kept electrically insulated from the load train by using oxidized Zircaloy pins and mica washers to connect the clevises to the rest of the load train. The crack length is monitored by reversed-current DC

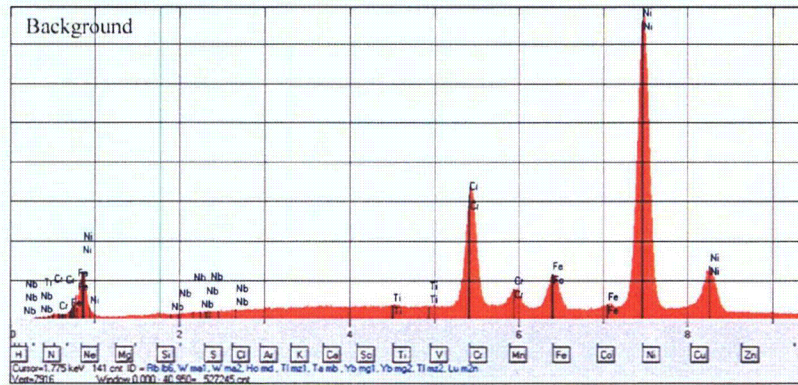
Figure 21. X-ray spectra obtained from (a) Alloy 600 bulk and (b) a Ti-rich matrix precipitate.

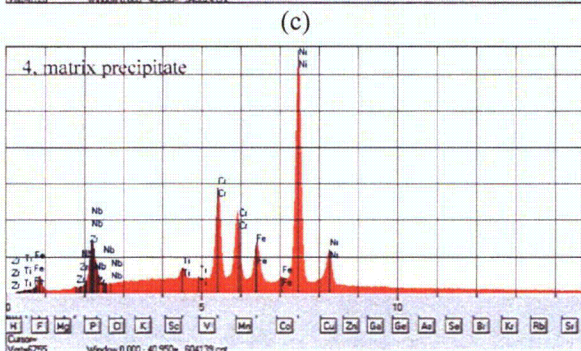
Figure 25. (a) Micrograph showing the locations where x-ray spectra were collected and spectra from (b) background, (c) matrix precipitate, (d) grain boundary precipitate, (e) another matrix precipitate, and (f) background at the completion of this series of analyses.

and IG precipitates (c, d). Energy dispersive x-ray analyses were performed to investigate the nature of the precipitates in the weld alloy. The scanning electron microscope (SEM) micrograph in Fig. 25a shows the locations where X-ray spectra were collected. The graphs in Fig. 25 show the resulting spectra from background (positions 1 and 5, Figs. 25b and f), matrix precipitates (positions 2 and 4, Figs. 25c and e), and grain boundary precipitates (position 3, Fig. 25d). The resulting compositions are summarized in Table 7. The results indicate that matrix precipitates are Nb- or Si-rich, and that the grain boundary precipitates are Nb-rich.
