Non-destructive and Failure Evaluation of Tubing from a Retired Steam Generator

Argonne National Laboratory

**U.S. Nuclear Regulatory Commission
Office of Nuclear Regulatory Research
Washington, DC 20555-0001**

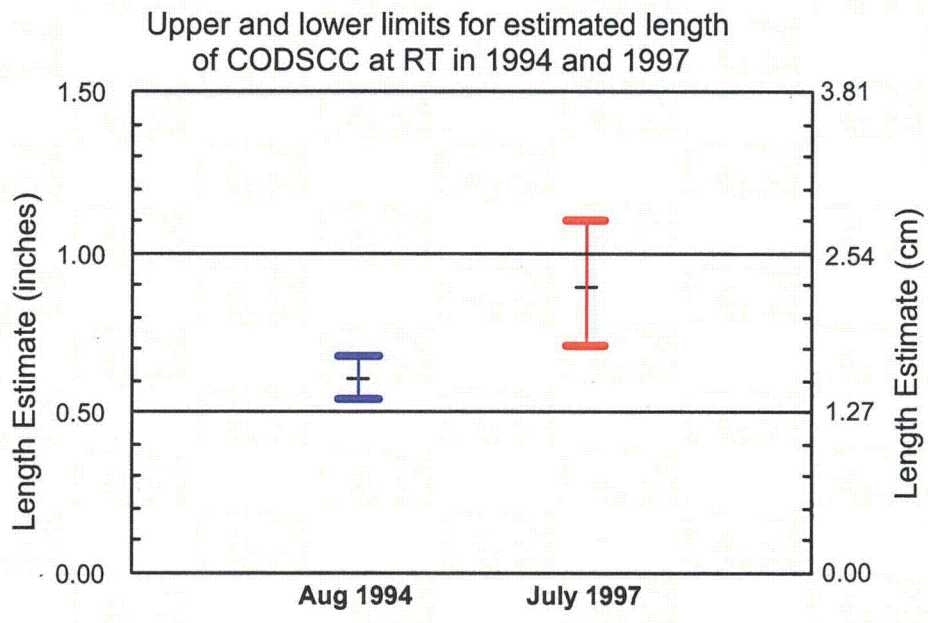
Figure 2.5 Graph showing estimated length with range of uncertainty for circumferential outer diameter stress corrosion crack (CODSCC) at top of tube sheet in tube R39-C46 of retired steam generator before (August 1994) and after (July 1997) unplugging. The data suggest growth of the SCC during the time tube 39-46 was plugged.

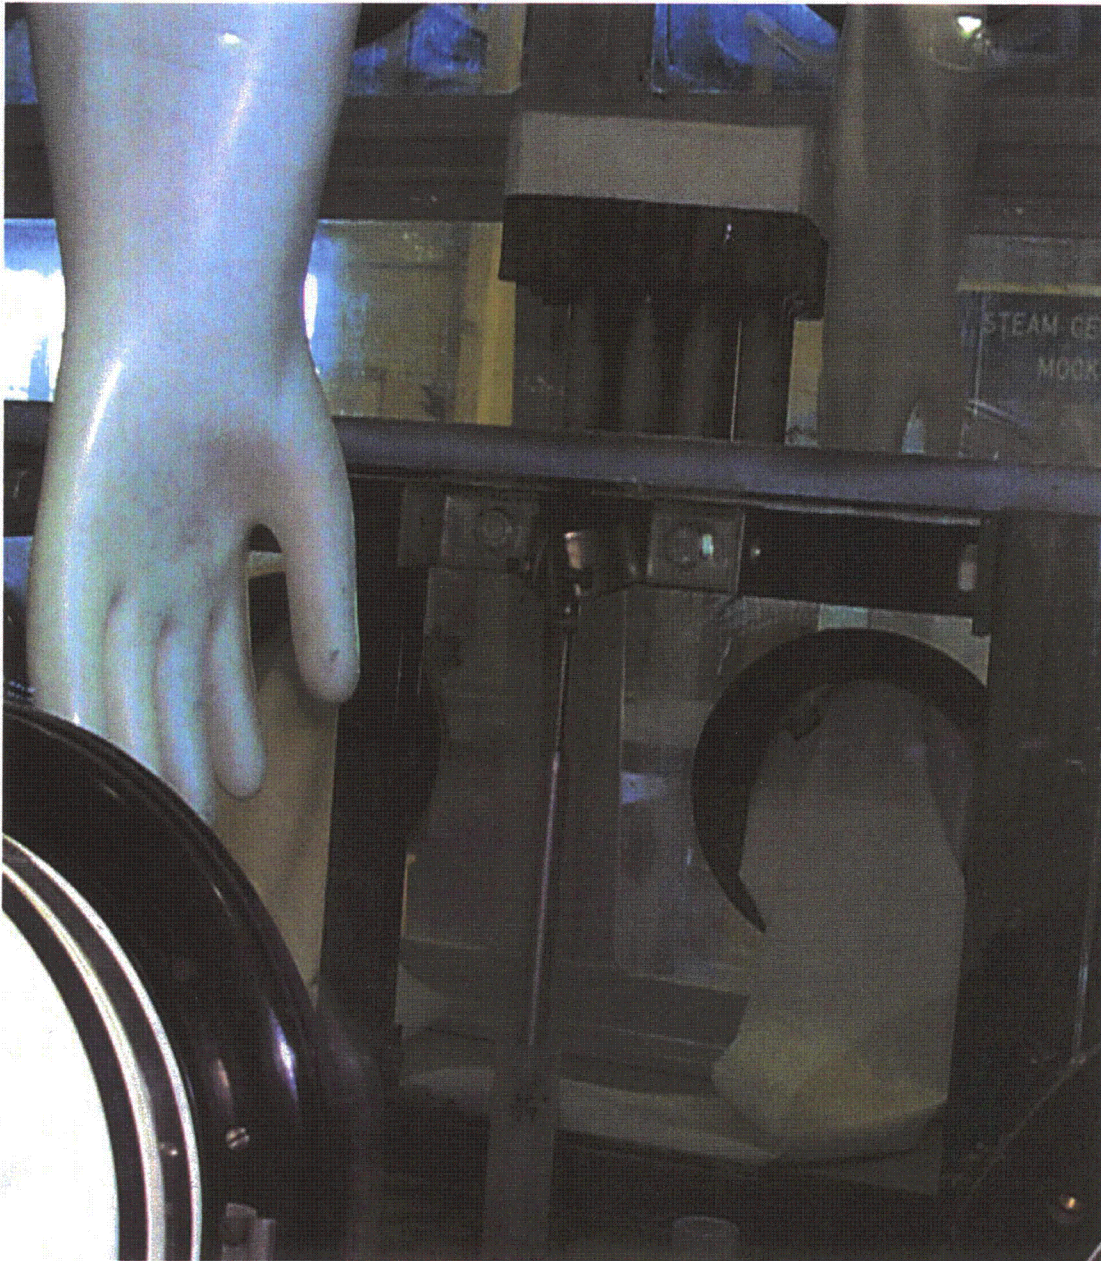
Figure 3.2 Photograph of section of the retired SG tube sheet placed in the Argonne NDE Glove Box. The tube sheet section (seen at top center of photo) contains 12 tubes and is ready for eddy current examination. Each tube extends 7.5 cm above and below the roll transition. The eddy current probe enters the tube from below.

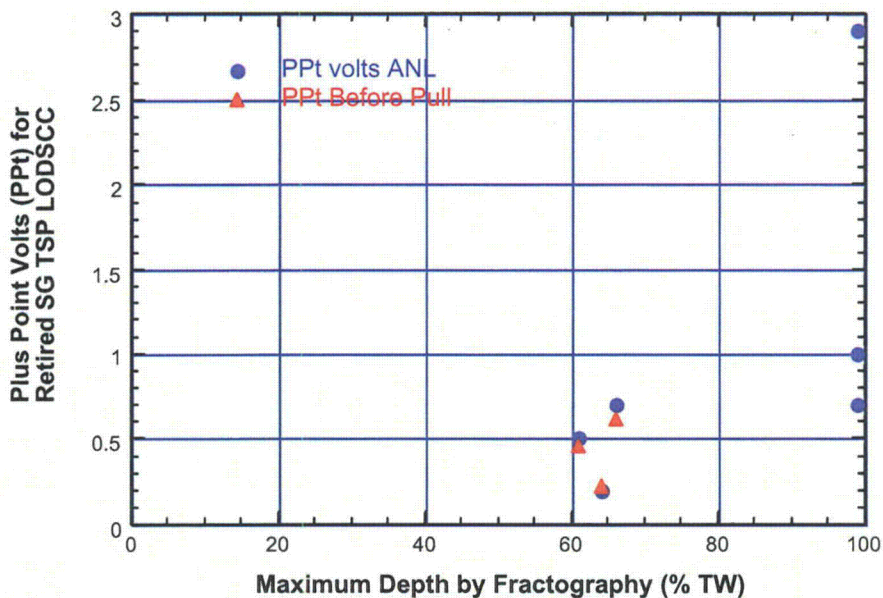
Figure 3.3 Graph of EC Plus Point (PpT) volts vs. maximum depth determined at Argonne by fractography for axial ODSCC at TSP intersection in retired steam generator. The two ODSCC at 100% TW at 1.0 and 0.7 V leaked at 5.2 ksi (36 MPa) and 7.1 ksi (49 MPa), respectively (+Point data before pulling is not available).

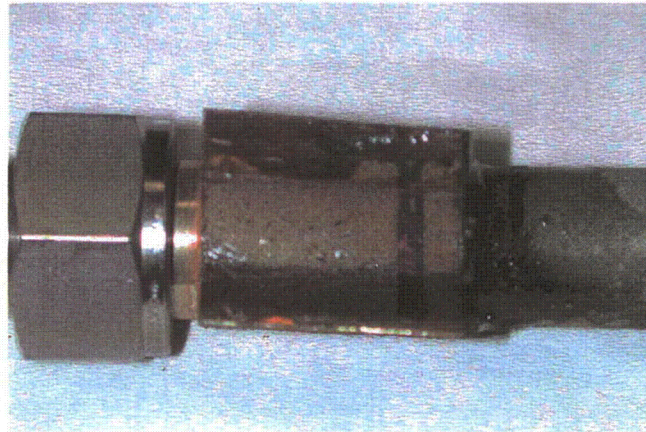
Figure 3.5 Photograph of Alloy 600, 19.1-mm (3/4-in.) diameter, test section #8 from retired steam generator after pressure testing. Some tube sheet material remains around the tube after reducing its size for pressure testing. Fittings to carry out the pressure test are attached to the ends of the tube. The top of the TS is on the right side of the photograph at the end of the tube.

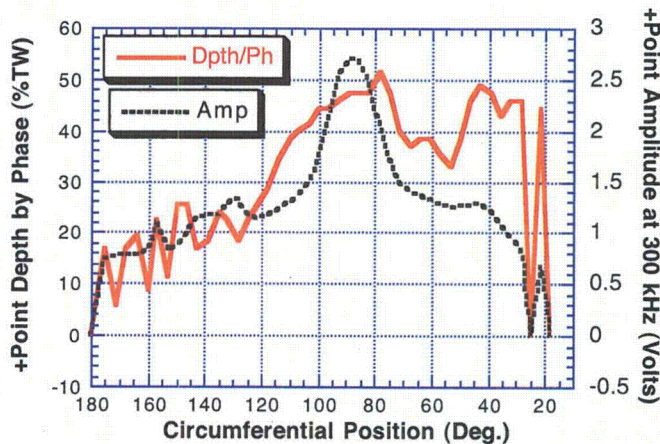
RTZ CODSCC before pressure testing

Figure 3.6 EC +Point profiles of CODSCC in RTZ with 50% TW depth (tube #6). The 1994 call was SCI with 0.73 V from a pancake coil. The 1997 +Point maximum signal was 1.54 V. The 2002 +Point maximum signal was 2.46 V. EC cross sections of this CODSCC were taken from standard +Point c-scans at 300 kHz. Pressure testing to 51.7 MPa (7.5 ksi) resulted in an increase in the extent of the crack (223° to 281°) and an increase in +Point voltage (2.46 to 2.97 V). A leak appeared at 35.2 MPa (5.1 ksi).

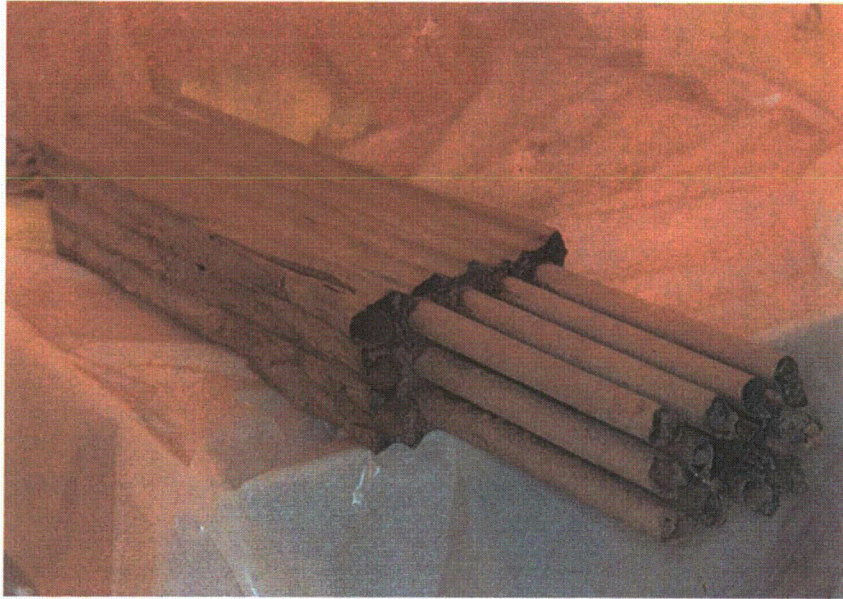
Figure 3.16 Tube sheet section TS1 removed from steam generator D (SGD) (4x3 array of 19-mm (3/4-in.) tubes).

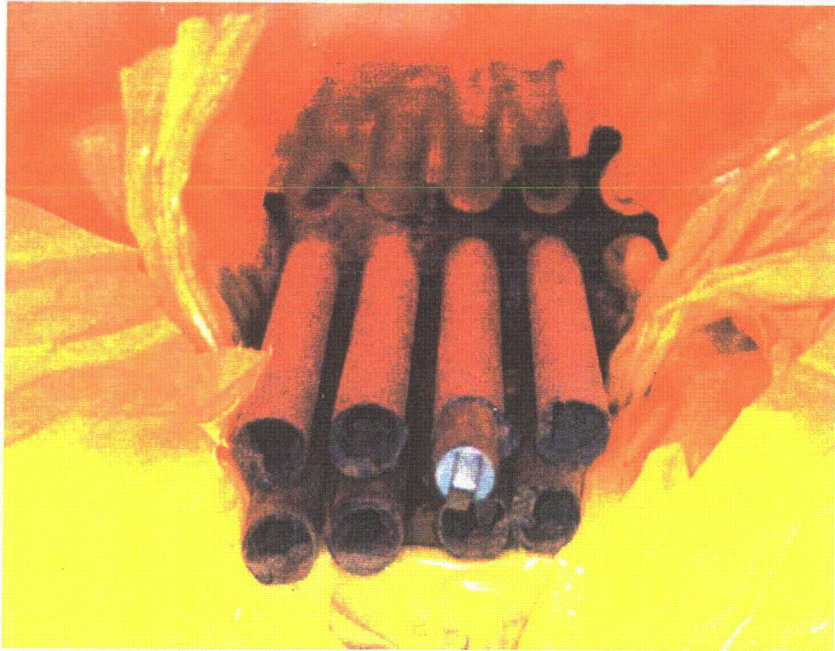
Figure 3.17 Tube sheet section TS2 removed from SGD (4x2 array of 19-mm (3/4-in.) diameter tubes).

tubing consisting of a 4 x 3 array is shown in Figure 3.16. A TS section consisting of a 4 x 2 array (not evaluated yet) is shown in Figure 3.17. Sections of the TSP from steam generator B (SGB) are shown in Figs. 3.18 and 3.19, though none of the SCCs in SGB have been evaluated.

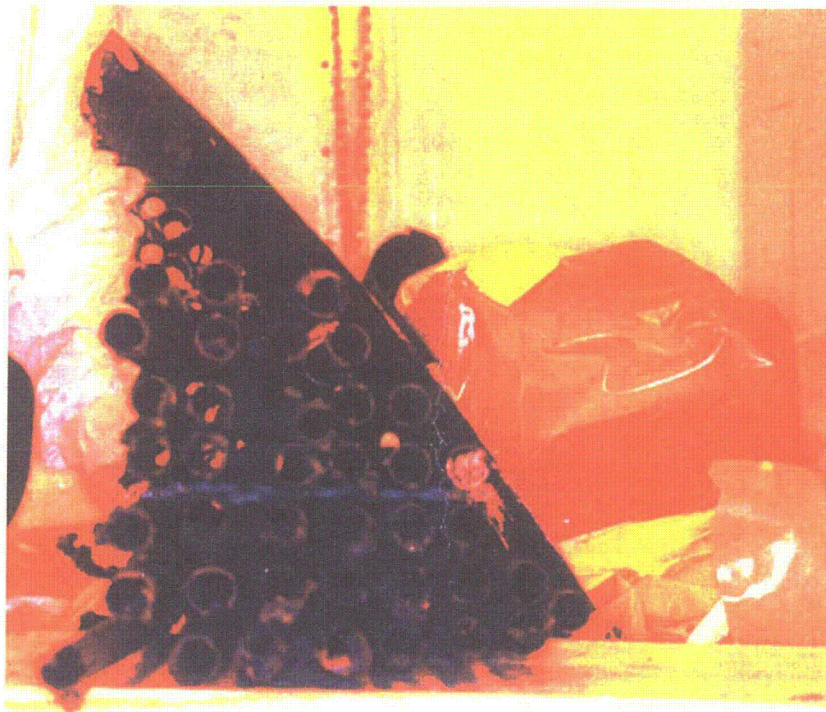
R35C14 BANDED REFERENCE,
VIEW FROM TUBESHEET

Figure 3.19 Tube support plate section TSP2 removed from SGB.

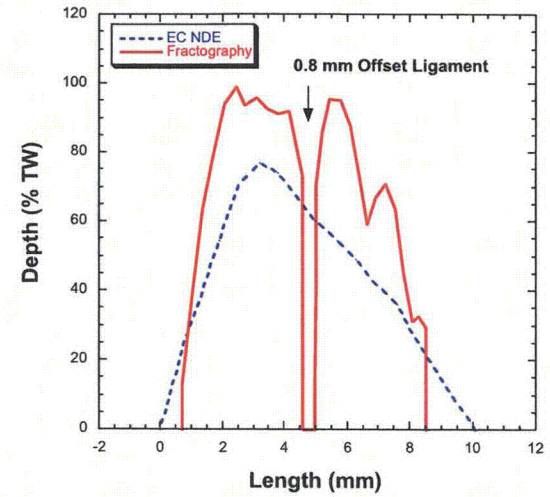
Figure 3.20 Comparison of fractography profile and NDE for axial ODSCC in 19-mm (3/4-in.) diameter tube specimen 4-43-2 (SGD). Area with the darker contrast represents the crack face. The complex character and ligament are the cause of the slight undersizing (NDE, blue dotted curve; fractography, red smooth curve) of the eddy current profiles. The arrow in graph indicates a 0.8-mm offset.

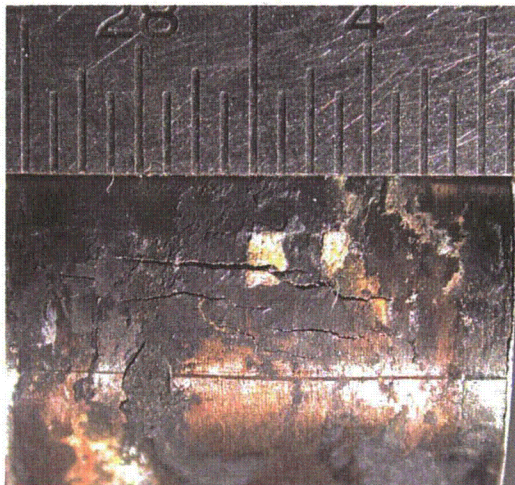
Figure 3.21 Comparison of fractography profile and NDE for axial ODSCC in 19-mm (3/4-in.) diameter tube specimen 5-51-2. The complex character is the cause of the undersizing (NDE, blue dotted curve; fractography, red smooth curve) of the eddy current profiles.

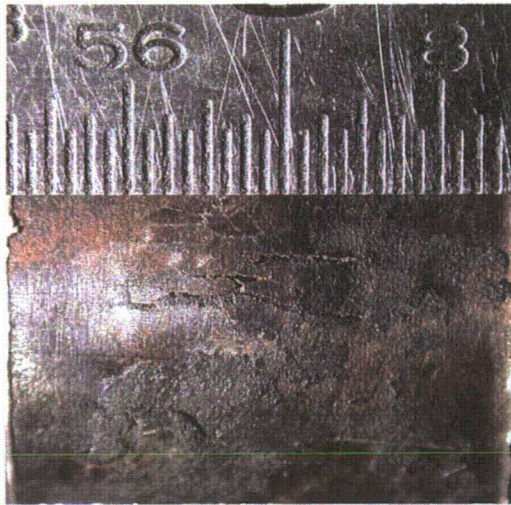
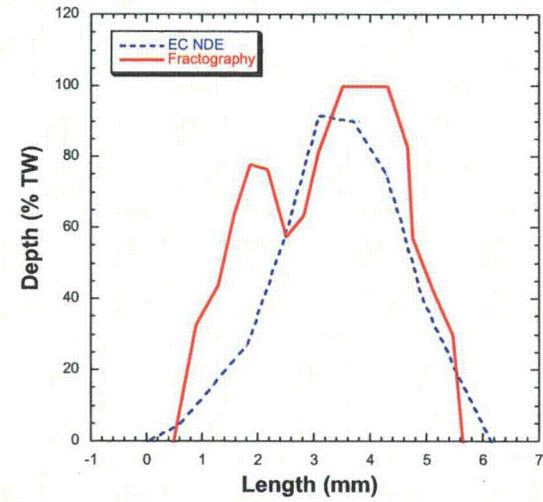
Figure 3.22 Comparison of fractography profile and NDE for axial ODSCC in 19-mm (3/4-in.) diameter tube specimen 7-24-3. The fractography shows that two cracks have merged together. The NDE (blue dotted curve) and fractography (red smooth curve) are in good agreement.

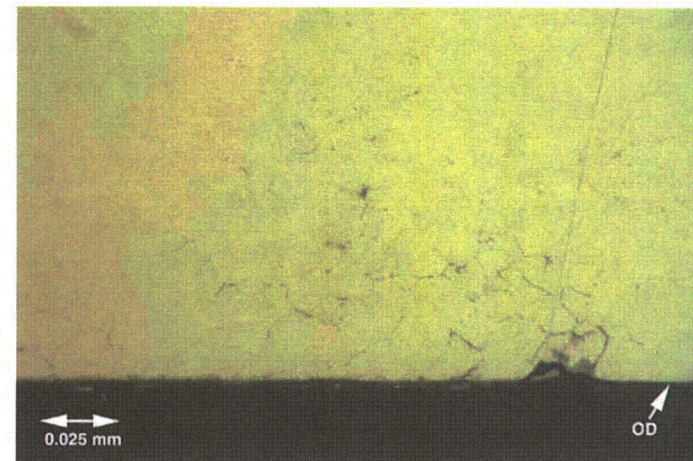
Figure 3.28 (a) IGA/IGSCC on OD at cross section perpendicular to tube axis in R39 C45 (ANL No. 8) at 0.5 mm (0.02 in.) below TTS. (b) Higher magnification view of the IGA/IGSCC on OD shown in (a).

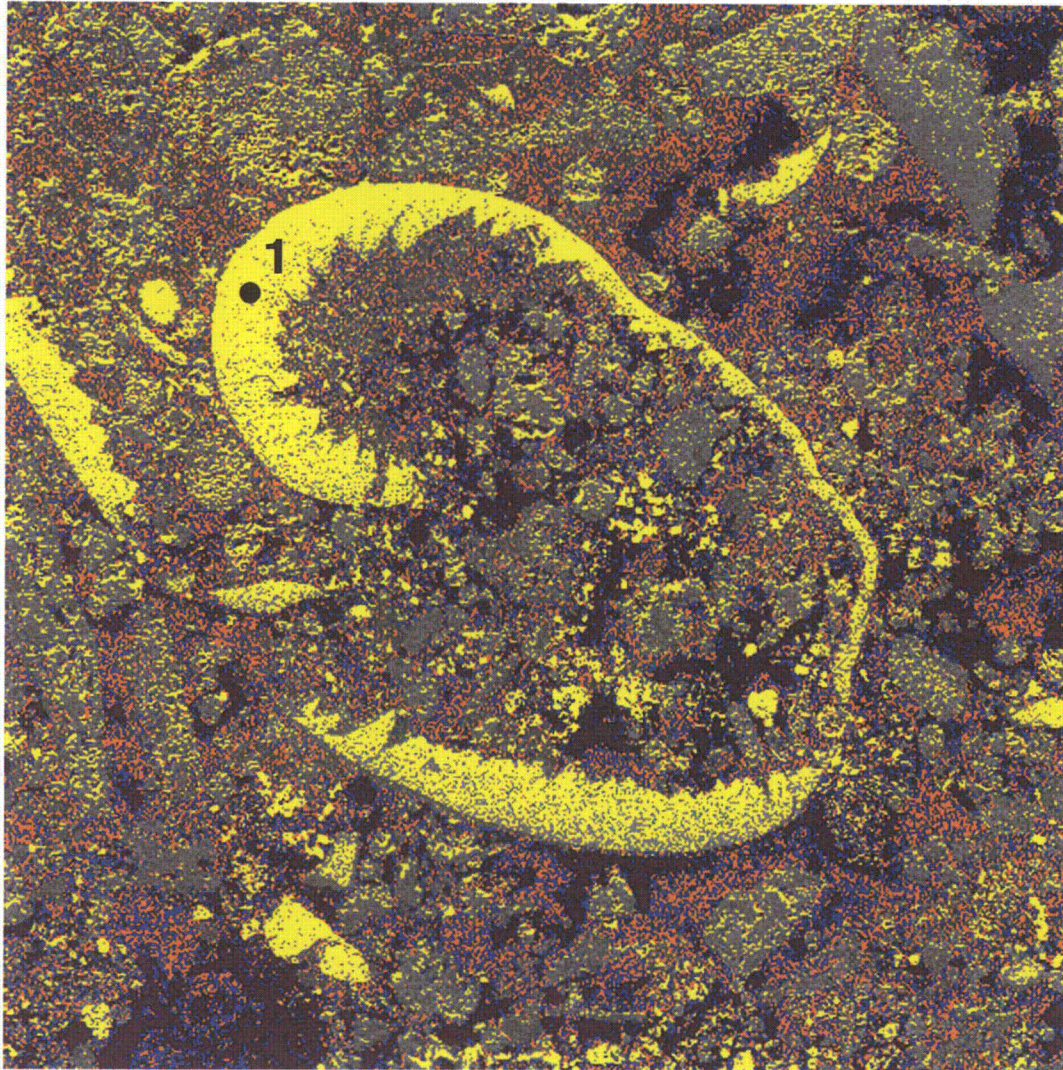
Figure 3.34
SEM image of cross section parallel to tube
axis near maximum EC signals in deposit.
Sample R39 C45 (ANL 8) at 100X. EDS
analysis showed Fe 69.3, Cr 20.0, and Ni
10.7 (in wt. %).

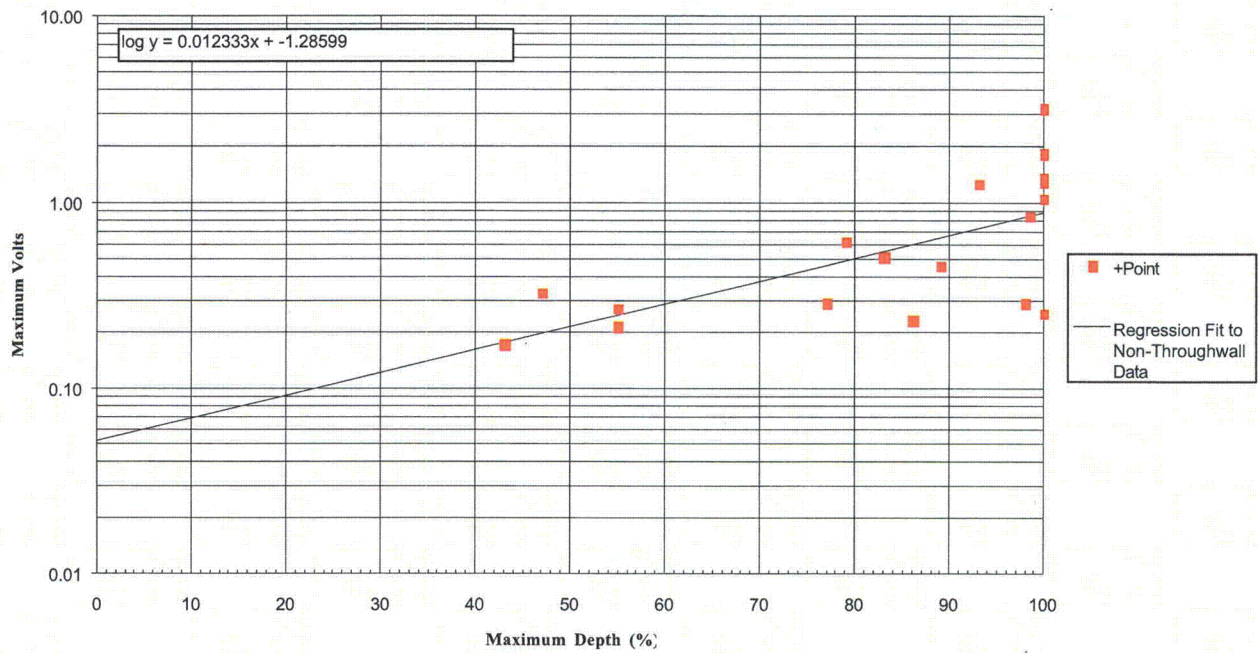
Figure 5.1 Maximum voltage vs. depth from +Point measurements in hard-roll expansions. Reproduced from Figure G-14b contained in Appendix G of EPRI Report TR-107 197-P2 [1]. Used by permission of EPRI.

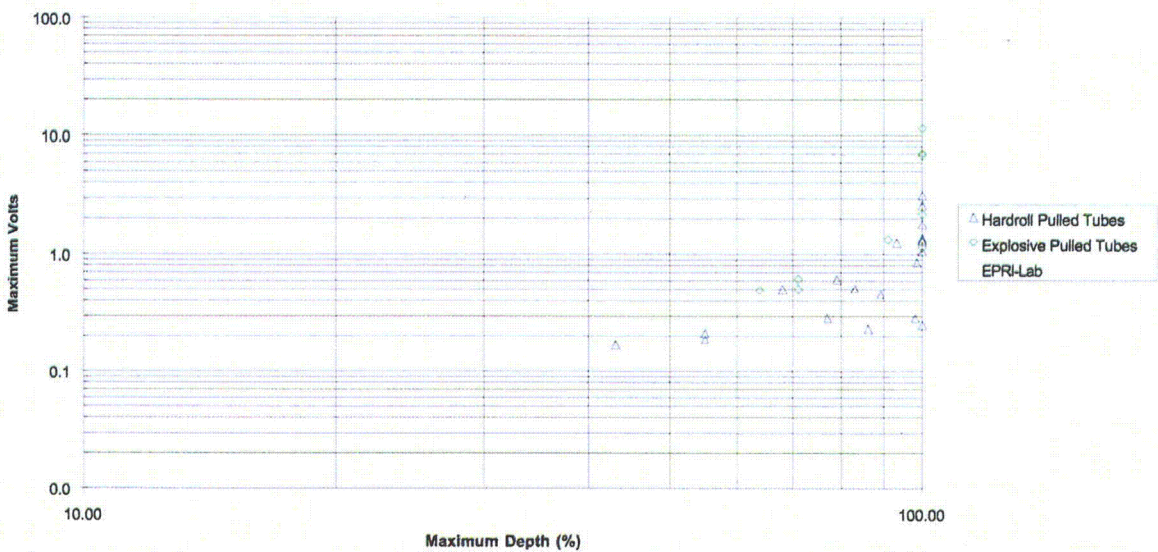
Figure 5.2 Maximum voltage vs. depth for OD indications in hard-roll pulled tubes and explosive pulled tubes. Reproduced from Figure G-15a contained in Appendix G of EPRI Report TR-107 197-P2 [1]. Used by permission of EPRI.

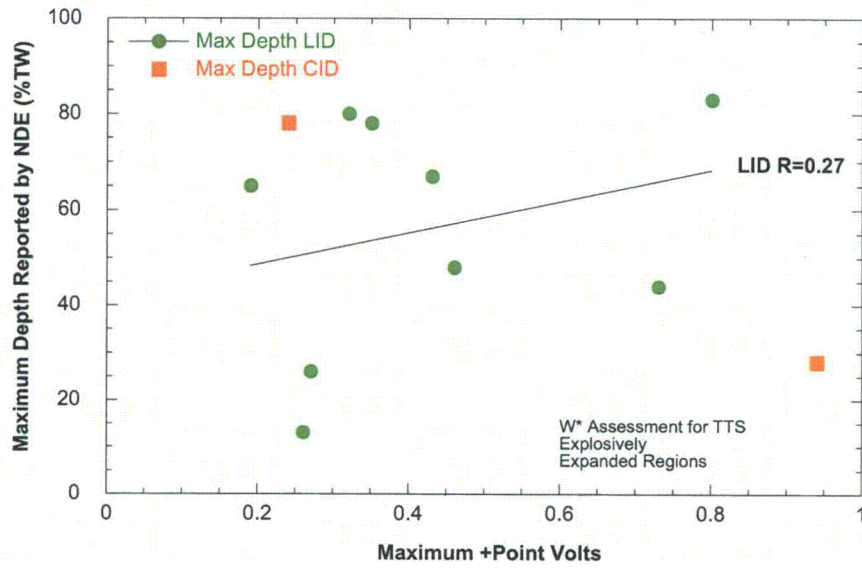
Figure 5.5 Maximum depth of axial IDSCC (dots) as reported by NDE (phase analysis) vs. +Point maximum voltage. The data were extracted from a TVA August 2005 report on a W* inspection assessment at Sequoyah.

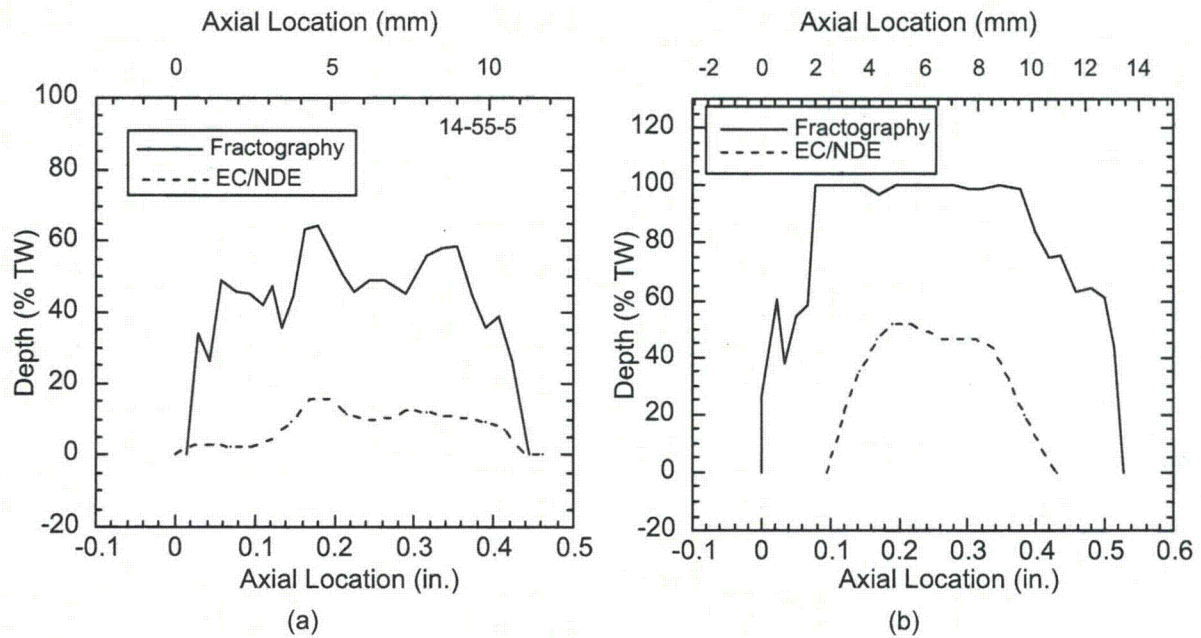
Figure 6.3 Crack depth profiles by EC/NDE and fractography of tube (a) 14-55-5 and (b) 39-57-2.

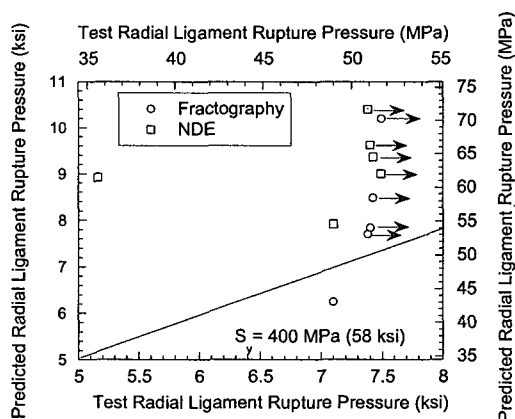
Figure 6.6
Observed vs. predicted radial ligament rupture pressures based on fractography and EC/NDE. Right arrows indicate no leakage during tests. The squares are for predictions based on NDE profiles before the test. The circles are for predicted rupture pressures based on fractography after the test.

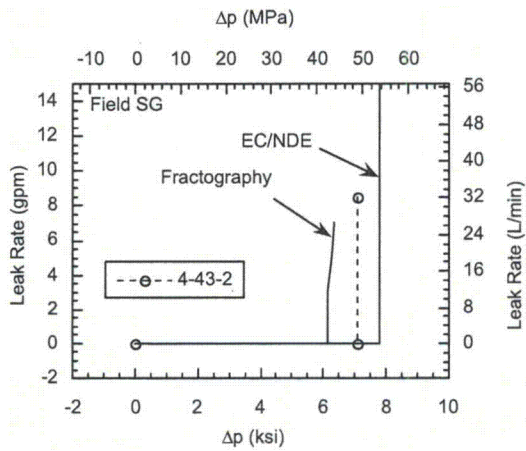
Figure 6.7
Observed variation of leak rate with pressure for Test 4-43-2 and the predicted leak rate variations based on crack profiles determined from EC/NDE (before testing) and fractography (after testing).

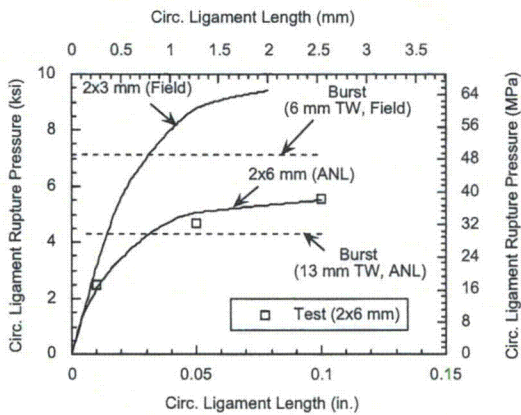
Figure 6.9
Predicted vs. observed circumferential ligament pressures for tests conducted at ANL on 2 x 6 mm axial throughwall cracks separated by a circumferential ligament of various lengths. Also shown are the predicted circumferential ligament rupture pressures for 2 x 3 mm cracks using the same predictive model but modified to account for the flow stress difference between the ANL tubes and the field tubes.

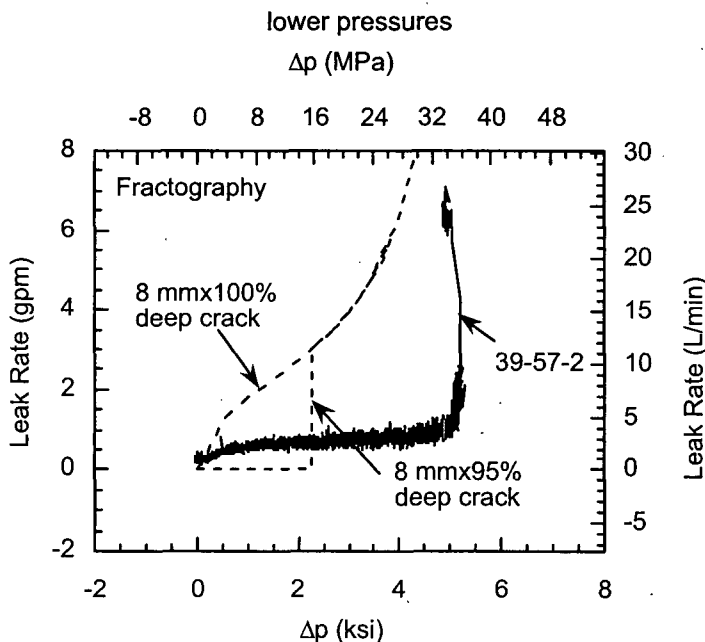
Figure 6.10
Observed and predicted leak rate vs. pressure plots for specimen C39-R57. The noisy signal suggests leakage at low pressure but no leakage at the was observed.

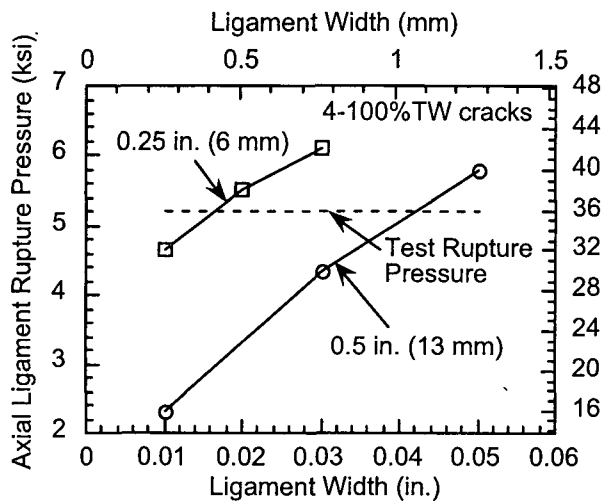
Figure 6.11
FEA (finite element analysis)—predicted axial ligament rupture pressures for 6- and 13-mm long 100% TW axial cracks separated by three axial ligaments with various ligament widths.

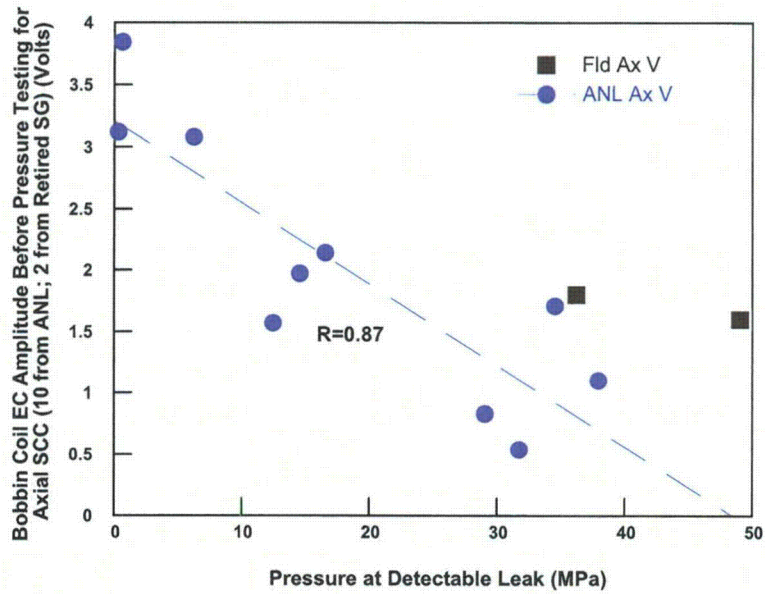
Figure 6.13 Graph of bobbin coil voltage before pressure testing for 10 axial ODSCCs grown at Argonne and 2 axial ODSCCs from the TSP of retired SGD versus the pressure at first observable leak. The linear fit correlation coefficient for the SCCs grown at Argonne under identical conditions is 0.87. In all cases samples were free of signal-distorting deposits.
