Joseph M. Farley Nuclear Plant
10 CFR 21 Report
AREVA Model MA-VR-350 4160 V Circuit Breakers

10 CFR 21 Report AREVA Model MA-VR-350 4160 V Circuit Breakers

Subject: Medium Voltage – Vacuum Replacement Circuit Breaker
Failure Notification

MV-VR Main Link Assembly Inspection Instructions

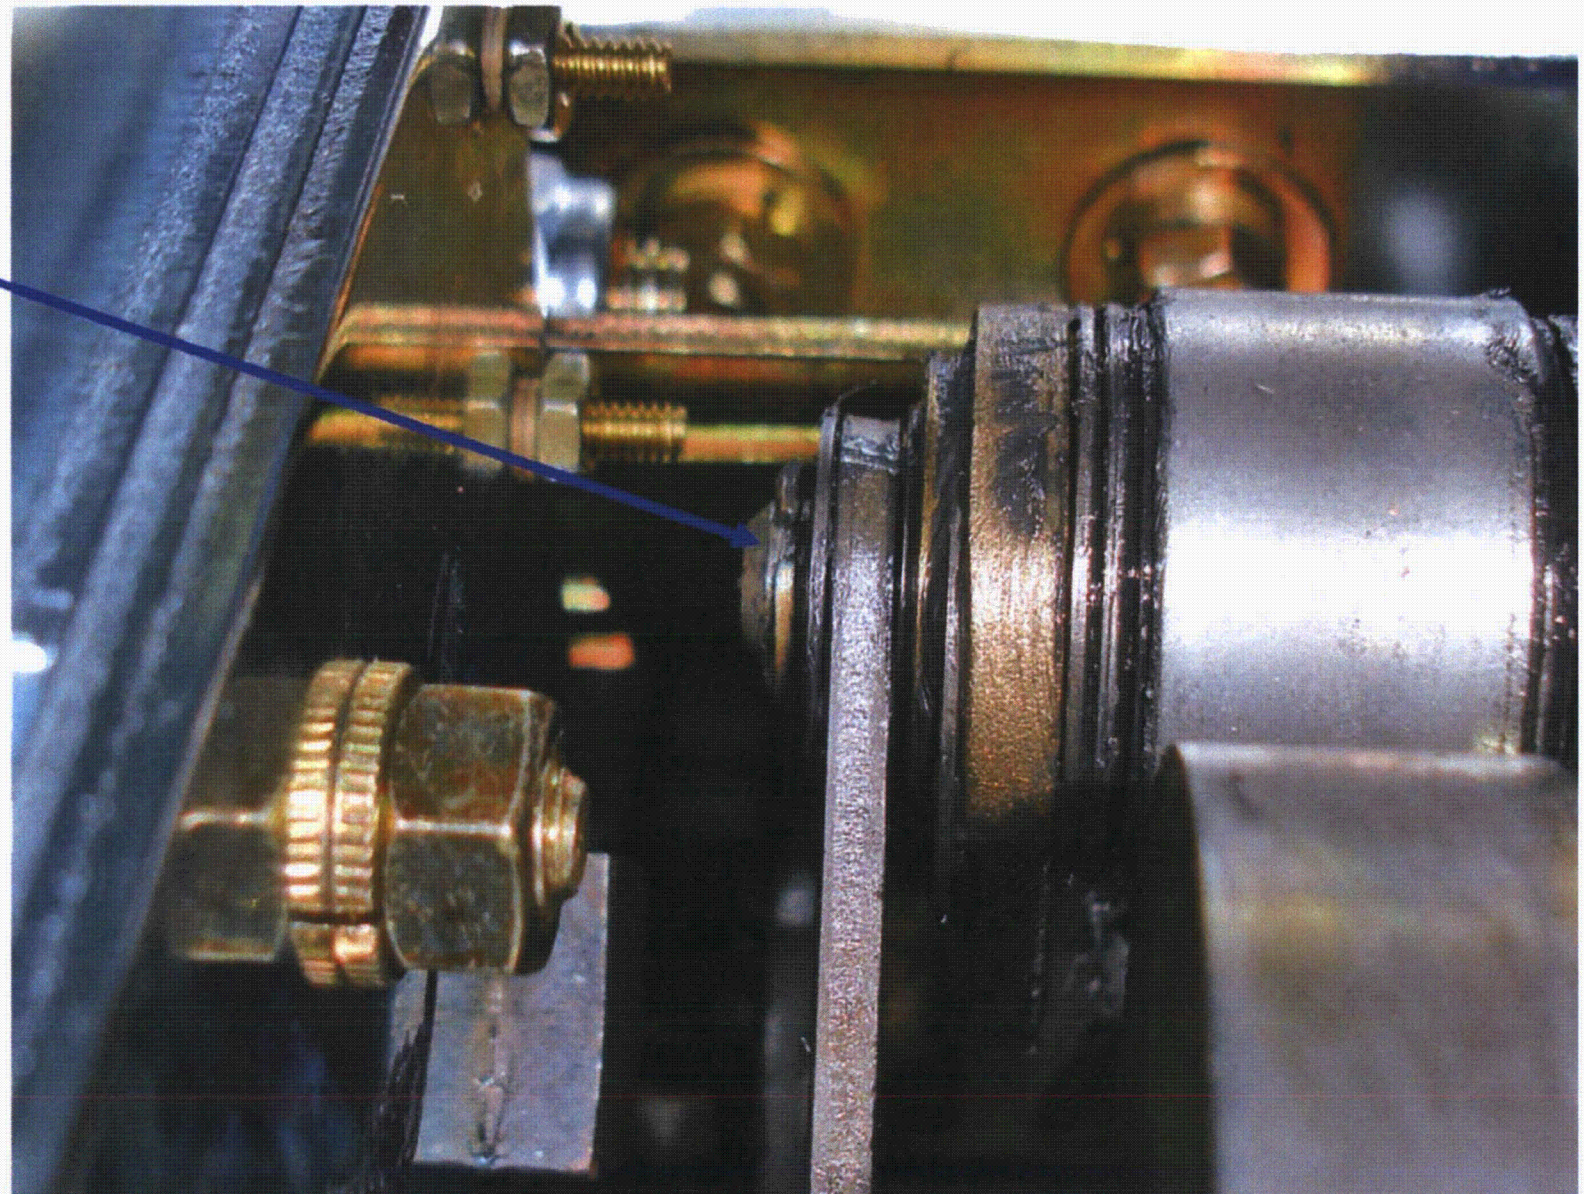
Photograph of a Main Link Assembly that was purposely assembled improperly for demonstration purposes. The retaining ring is not seated in the groove of the pin.

Illustration of "C" ring out of the groove

AREVA and the OEM recommend that an inspection to confirm that the retaining ring is fully seated in the groove of the Main Link Assembly pin is performed on all MV-VR equipment at the next regular maintenance interval.

1. Remove MV-VR breaker from cell.
2. Ensure MV-VR is in the “open” position.
3. Remove the front cover by completely removing the (4) 5/16-18 x 3/4” long hex head bolts that attach the front cover to the vacuum breaker element.
4. Look above the “Push To Open” clapper and behind the main mechanism shaft to locate the Main Link Assembly.
5. Remove excess grease with a dry rag to obtain a clear view of the retaining ring on the Main Link Assembly.
6. If needed, use a mirror and properly placed lighting to visually verify that the retaining ring is fully seated in the groove of the Main Link Assembly pin. Observe that no aspect of the inner diameter of retaining ring side facing the end of the Main Link Assembly pin is visible outside the pin groove.
7. See attached photo and drawings for example.
