**Technical Letter Report on
Evaluation of Head Loss by Products of
Aluminum Alloy Corrosion**

August 11, 2008

C. B. Bahn, K. E. Kasza, W. J. Shack, and K. Natesan

Argonne National Laboratory

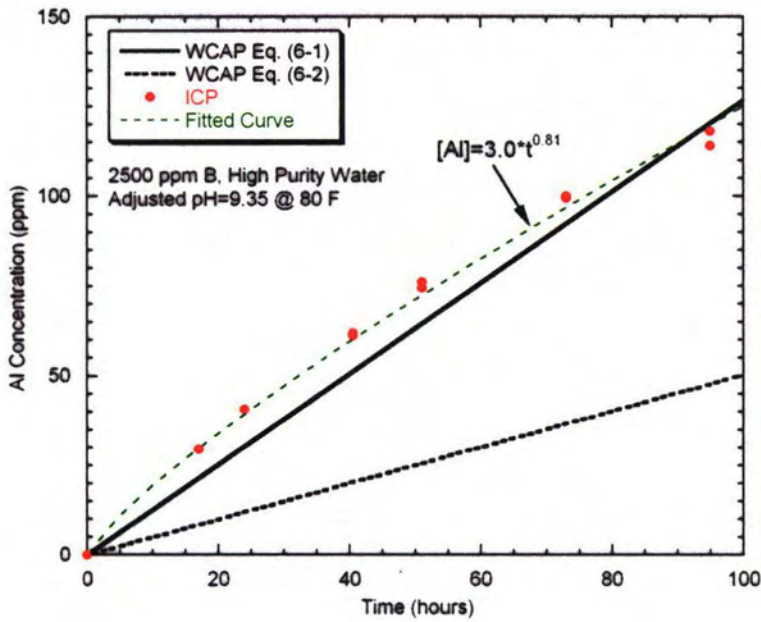
Figure 3. Dissolved Al concentration in the loop by ICP analysis as a function of total exposure time compared with the predicted Al corrosion rates by Westinghouse. The curve labeled 6-1 uses the values for the coefficients determined by ANL rather than the values given in the WCAP

Figure 3 shows the variation of the dissolved Al concentration with exposure time in the loop, as determined by ICP analyses of the solution samples. As shown in Figure 3, the observed corrosion rate of the 6061 Al alloy is similar to that predicted by the Al release rate equation (6-1) proposed in Ref. 4;

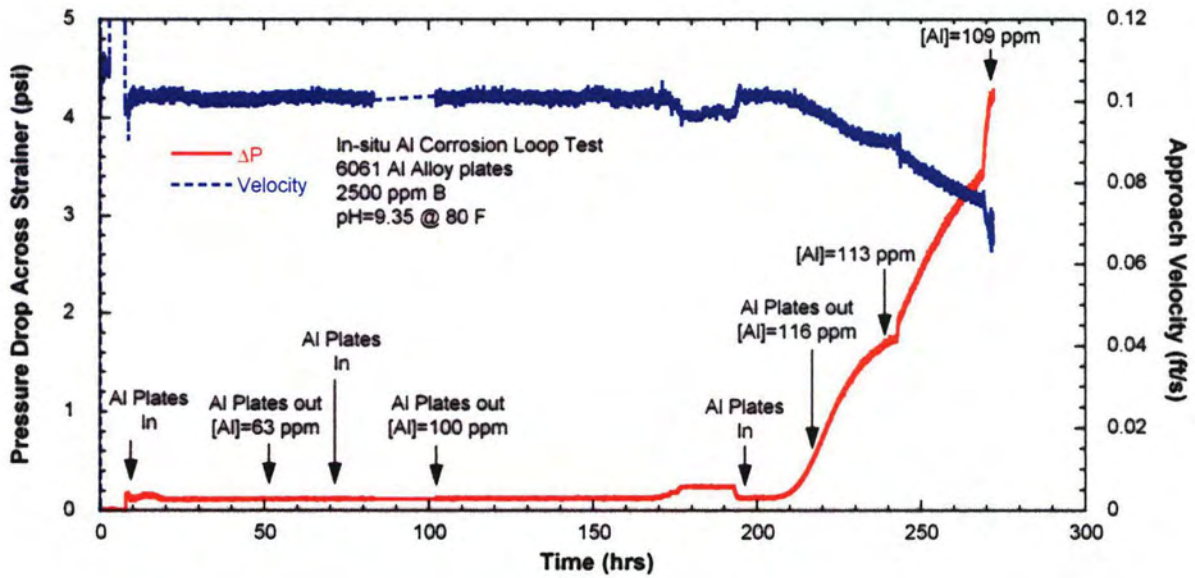
Figure 4. Pressure drop and screen approach velocity time history in a loop test using 6061 Al plates with 2500 ppm B and the initial pH=9.35 @ 80 F.

showed the dissolved Al concentration at the end of the test was 109 ppm, as shown in Table 2. Thus, the increase in pressure drop of 2.7 psi as the temperature decreased was associated with a decrease of approximately 4 ppm in Al concentration. A solution sample taken at 80°F and filtered by a 20 nm filter gave an Al concentration of 31.7 ppm. As expected, Al hydroxide precipitation occurred at 80 F, and the precipitate size was bigger than 20 nm. Again, it should be noted that the approach velocity was not held constant, but allowed to drift downward to approximately 0.065 ft/s at the end of the test.

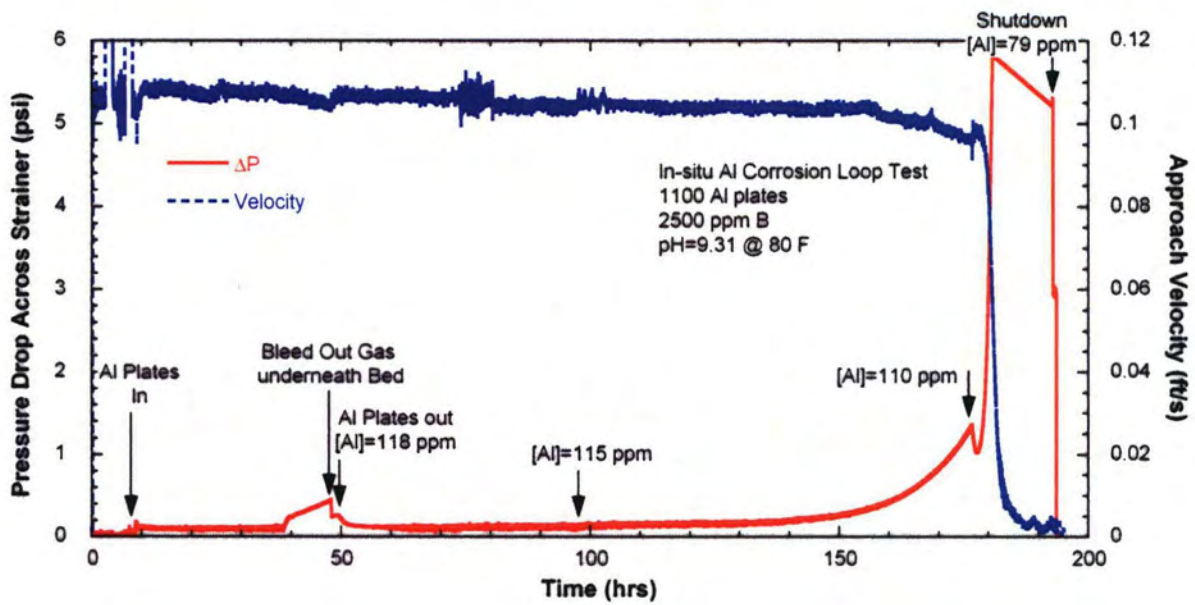
Figure 13. Pressure drop across a strainer and approach velocity time history in the 1100 Al loop test.

Figure 13 shows the pressure drop across the bed and the approach velocity as a function of time. Figure 14 shows the loop water temperature and the pressure drop as a function of time. During the period of the test between 40 and 48 hours, a linear increase of head loss was observed. About 3-in thick gas layer had developed underneath the NUKON bed during the period (an over night portion of the test). The sudden decrease of head loss at the test time of 48 hour was associated with opening a valve and bleeding the gas out.

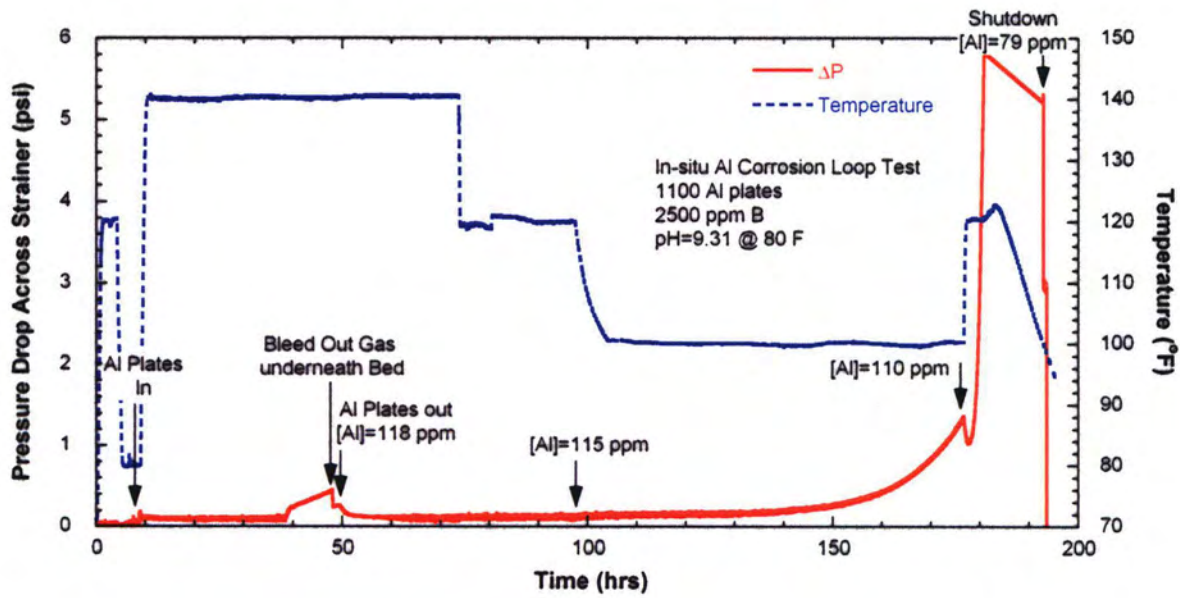
Figure 14. Pressure drop across the strainer and temperature time history in the 1100 Al loop test.

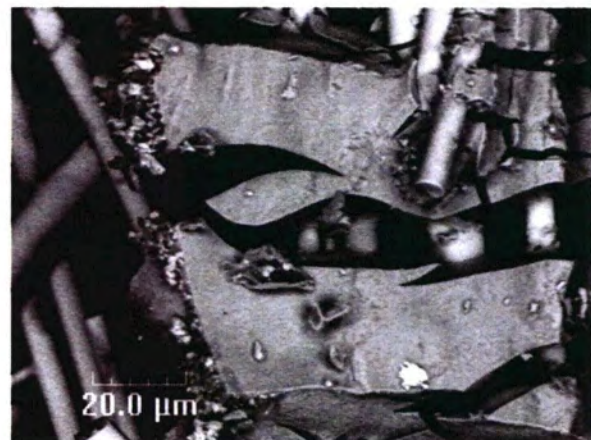
(a) Secondary electron image

(b) Back-scattered electron image

Figure 22. SEM micrographs for the bottom side of the NUKON bed after the 1100 Al corrosion loop test at a higher magnification than Figure 21 with (a) secondary electrons and (b) back-scattered electrons. The EDS spot analyses are presented in Figures A18-A21.

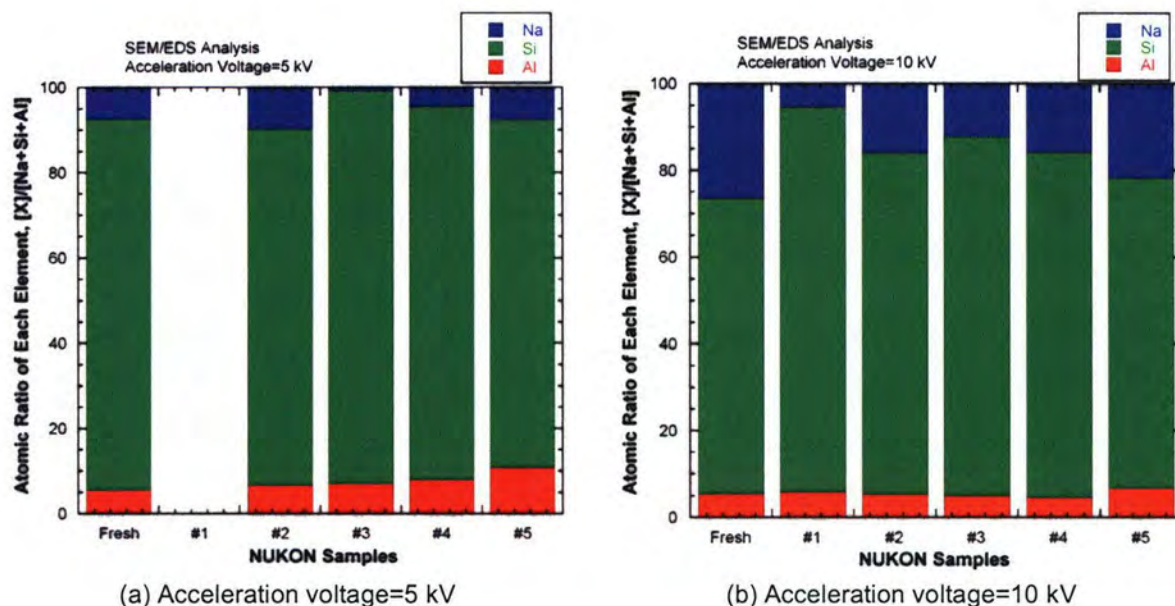
Figure 24. Atomic ratio between Na, Si, and Al on the fibers of NUKON patches as a function of acceleration voltage analyzed by SEM/EDS: (a) 5 kV and (b) 10 kV.

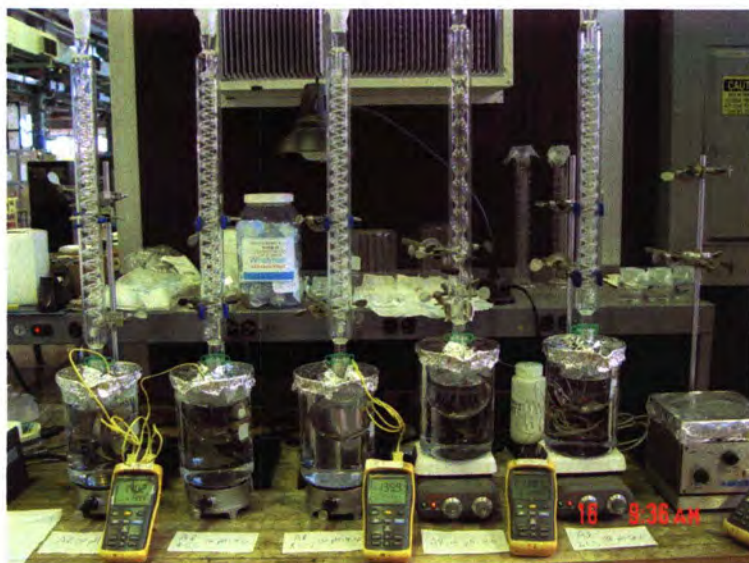
Figure 26. Bench top test setup for Al coupon corrosion tests at 140 F and with 2500 ppm B and the pH=9.4 or 8.0.

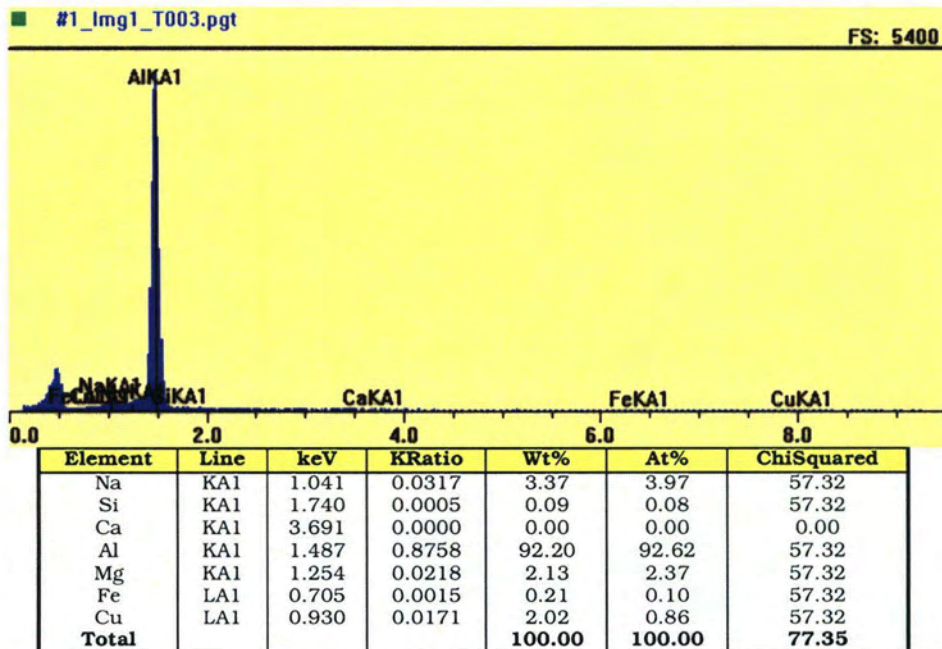
Figure A10. EDS spectrum for the spot "3" designated in Figure 18 (a) suggesting mainly Al hydroxide on the Al plate surface (acceleration voltage=10 kV).
