NUREG/CR-7113
PNNL-19353

An Assessment of Ultrasonic Techniques for Far-Side Examinations of Austenitic Stainless Steel Piping Welds

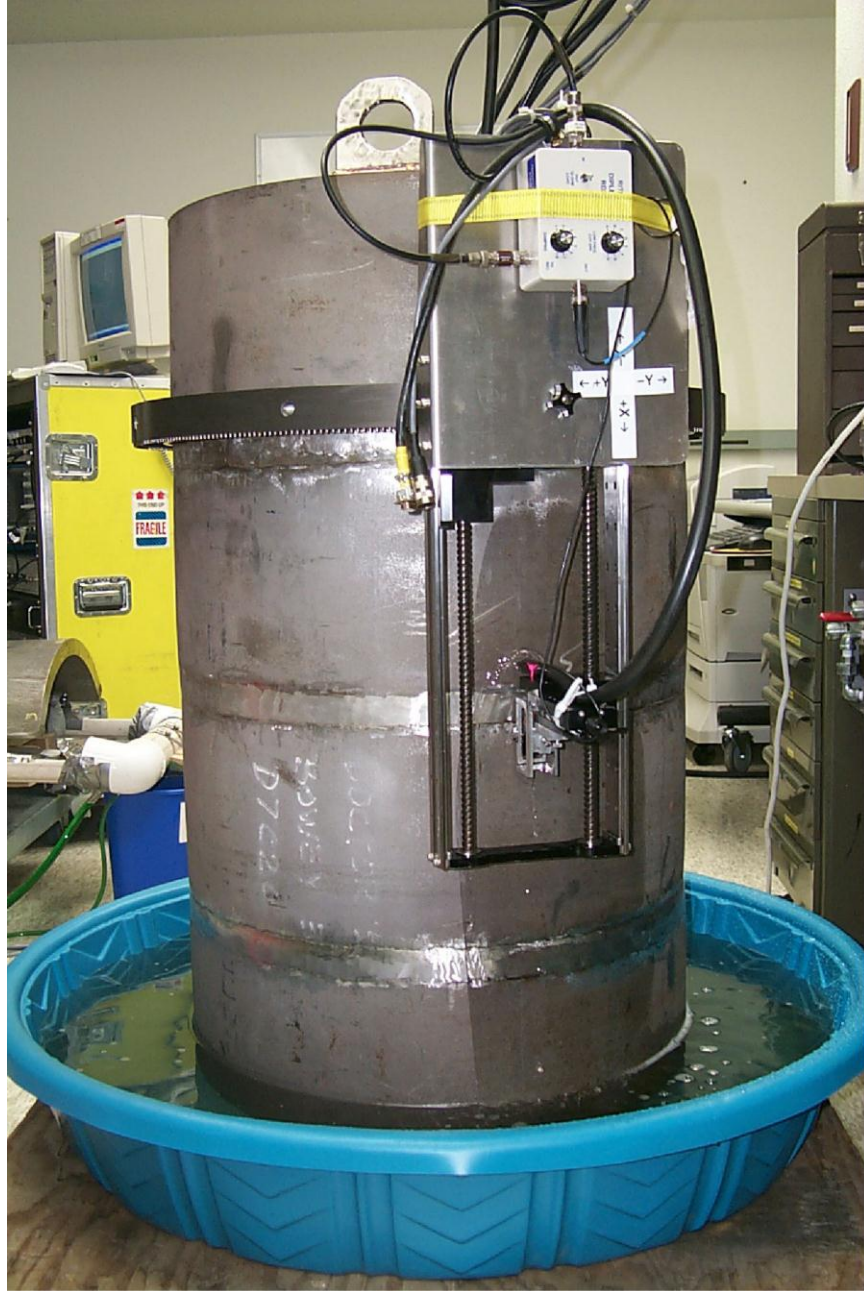
Figure 5.8 Experimental Set-up Showing Piping Specimen and Scanner

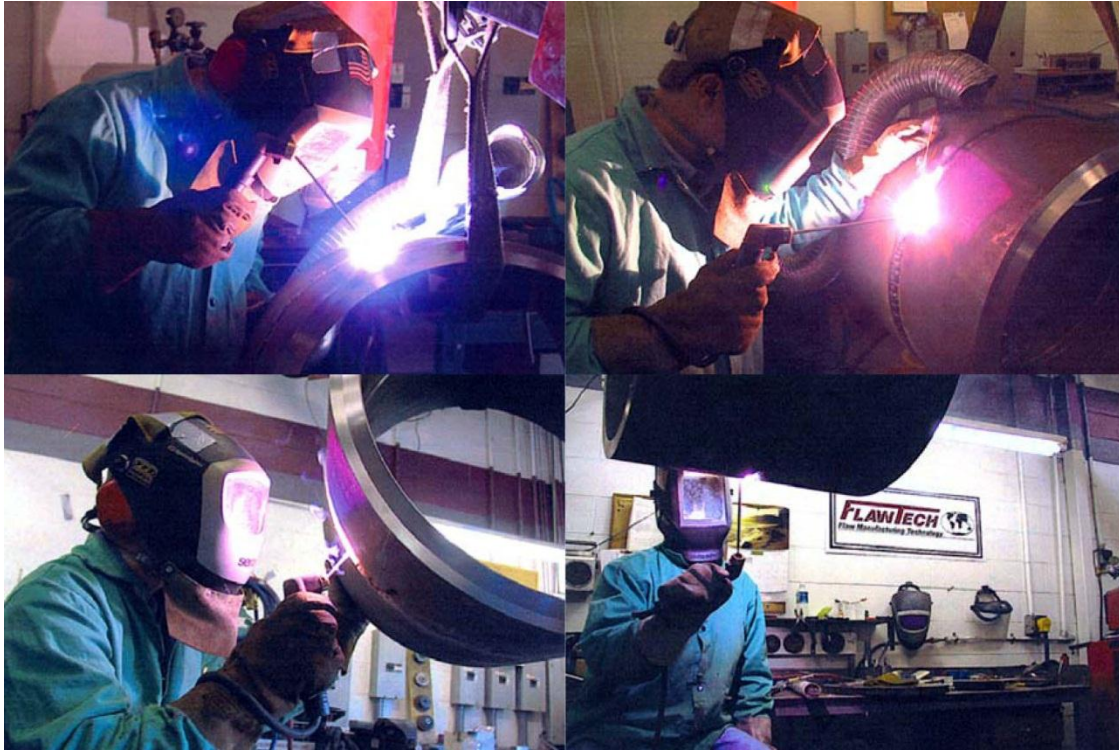
Figure 5.9 Field-like Welding on Horizontally Oriented Pipe Segments (photo courtesy of FlawTech Inc.)

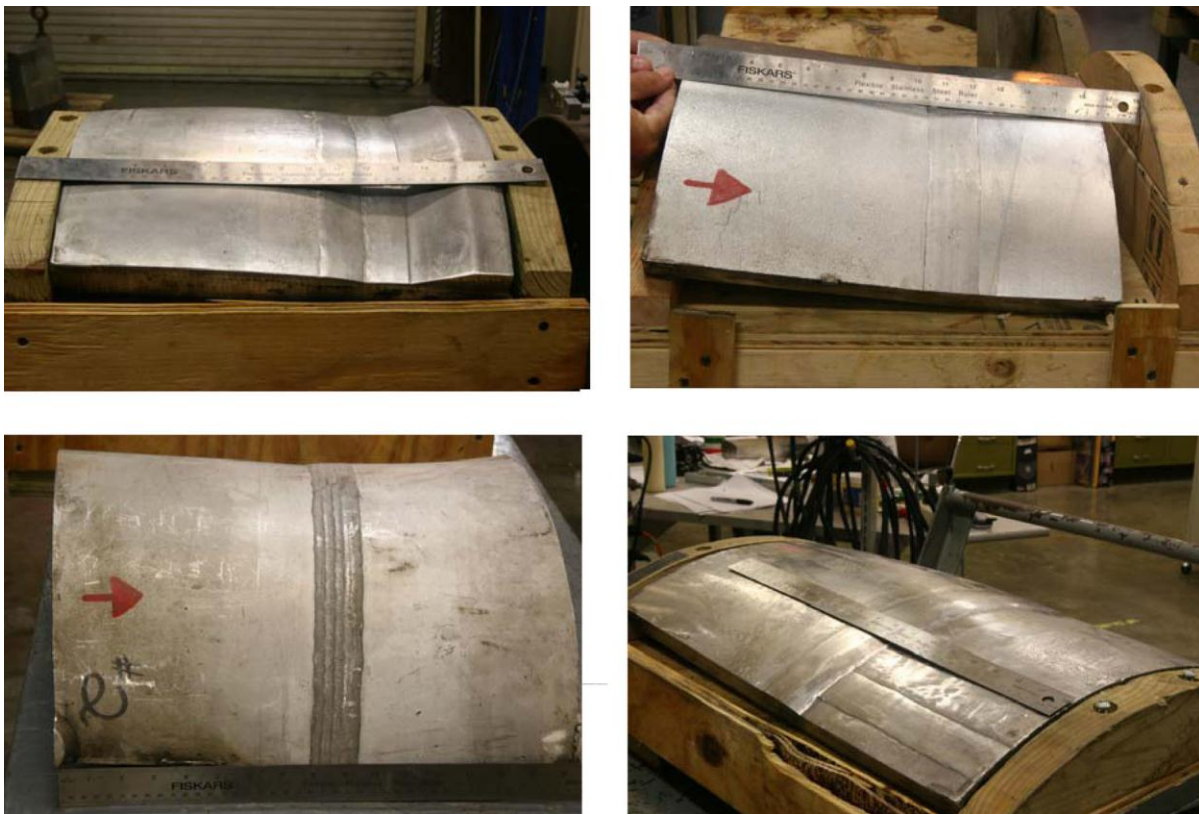
Figure 5.10 Examples of Specimens as Viewed from the Outer Surface

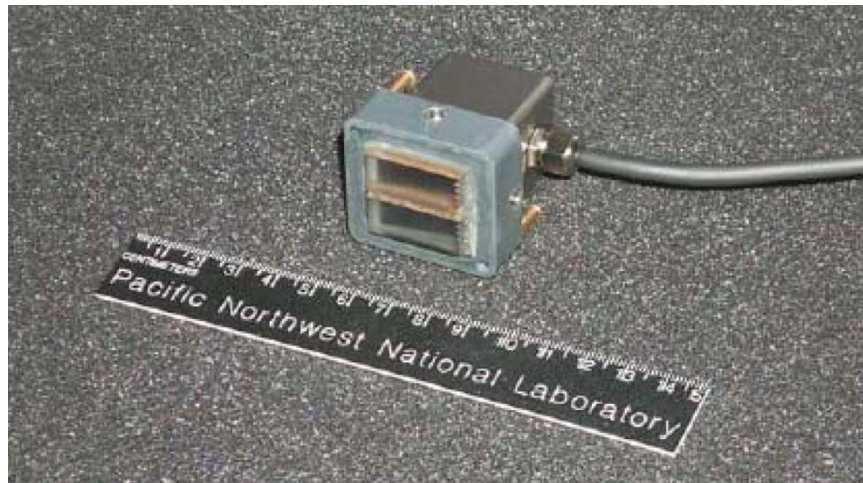
Figure 6.6 The 2.0 MHz TRL Phased-Array Probe

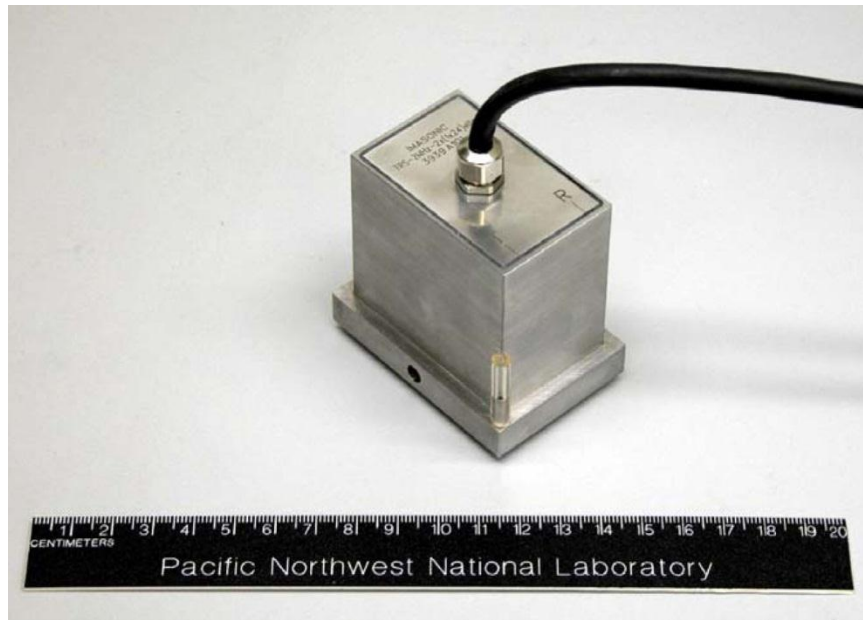
Figure 6.7 The 2.0 MHz TRS Phased-Array Probe

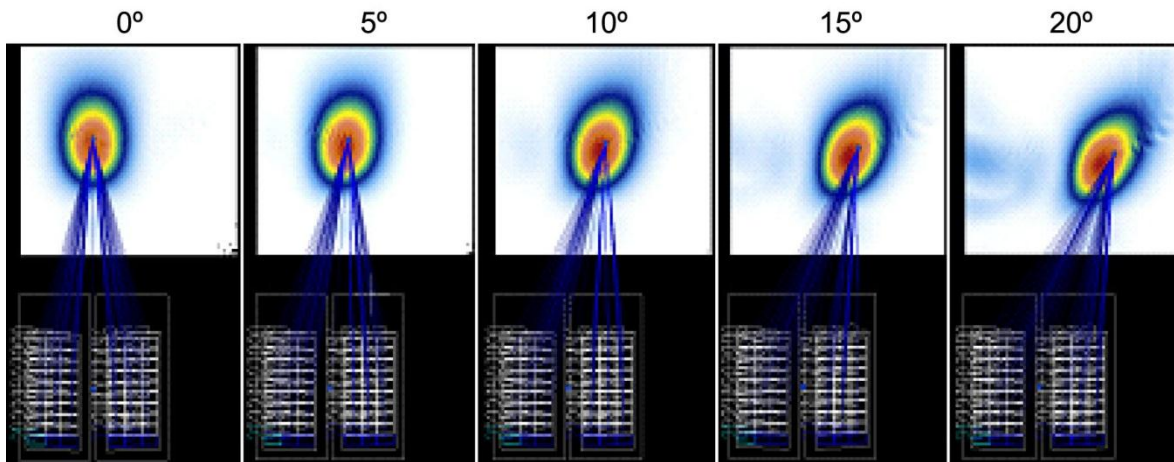
Figure 6.12 Beam Skewing Model for the 1.5-MHz TRL, 10 by 3 Element Probe

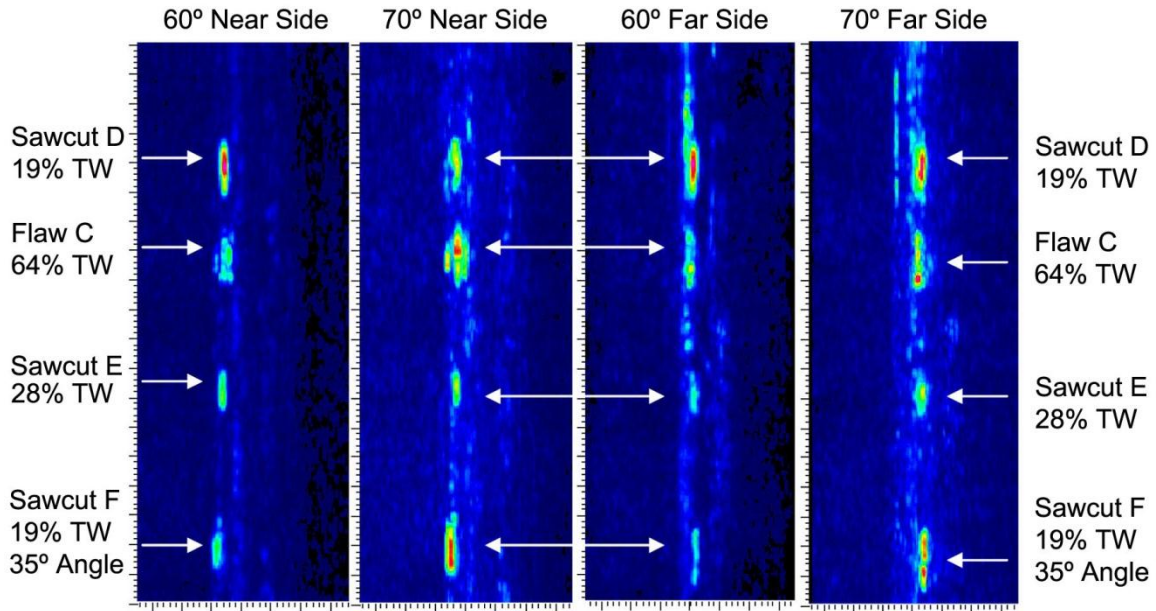
Figure 7.2 C-scan Views for Pipe Segment 2 from the Near and Far Side with the 1.5-MHz, 60° and 70° Conventional Shear-Wave Probes

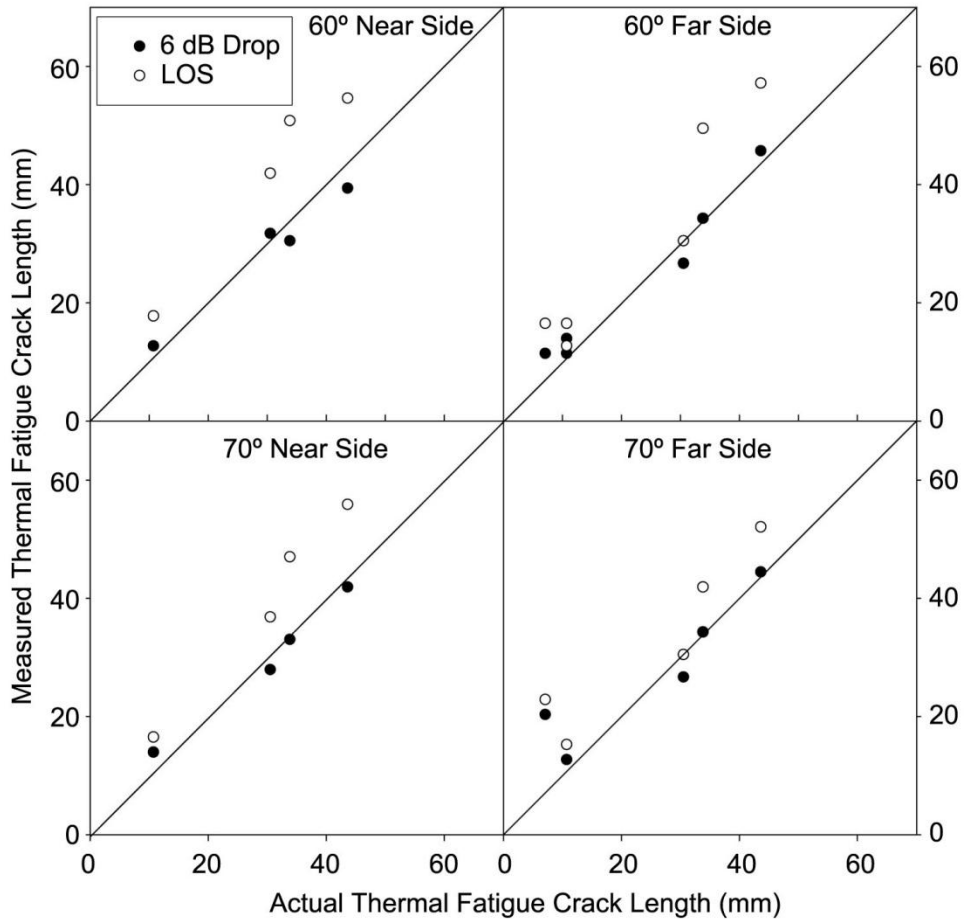
Figure 7.5 Thermal Fatigue Crack Lengths Measured Using the 6 dB Drop and Loss of Signal Techniques with the 1.5-MHz 60° and 70° Probes from the Near and Far Side of the Weld Versus the Actual Crack Lengths

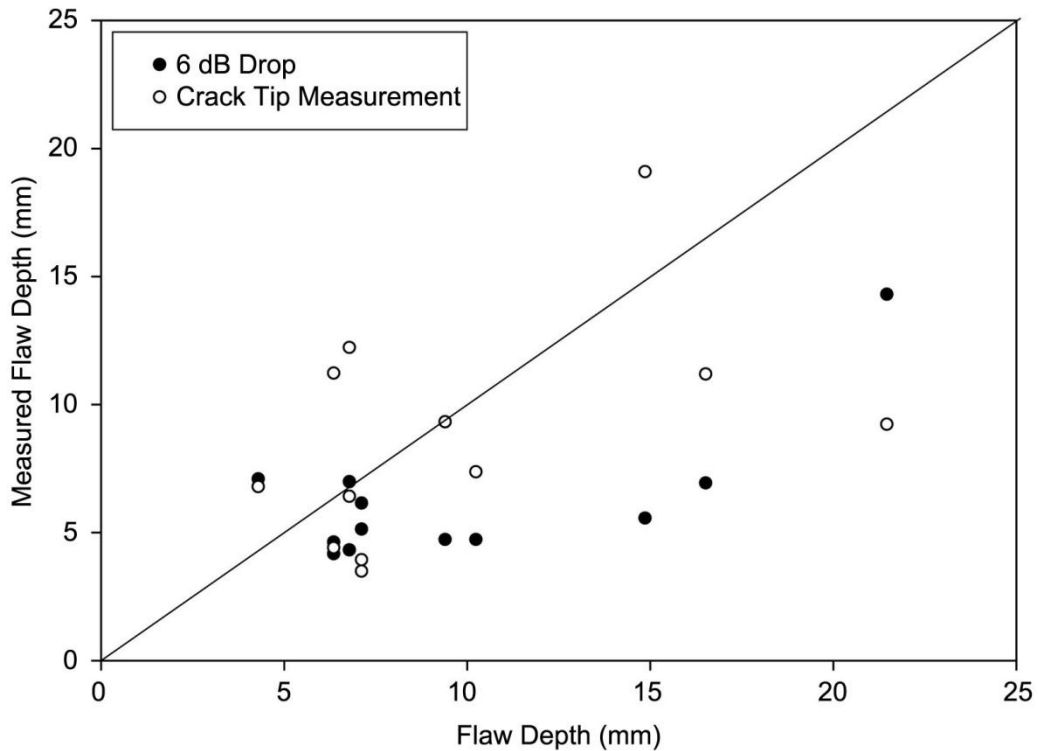
Figure 7.6 Sawcut and Crack Depths Measured Using the 6 dB Drop and Crack Tip Techniques with the 1.5-MHz 60° and 70° Probes from the Near and Far Side of the Weld Versus the Actual Sawcut and Crack Depths

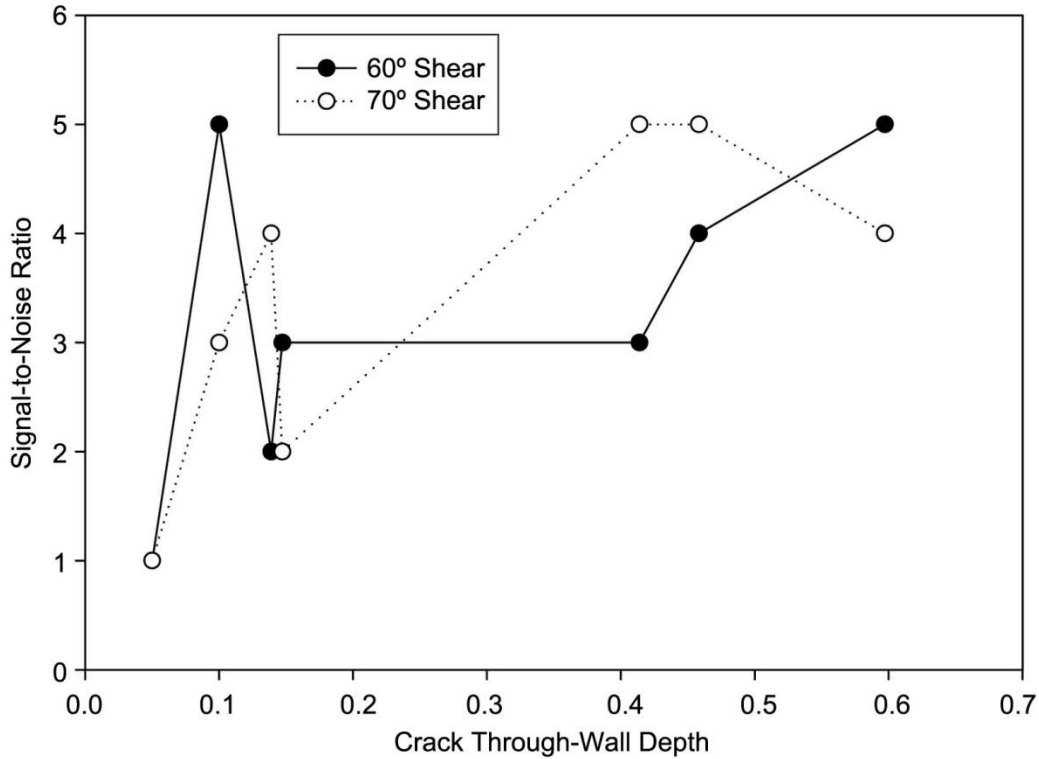
Figure 7.7 Signal-to-Noise Ratio Plotted Against the Crack Depth for the 60° and 70° Far-Side Scans

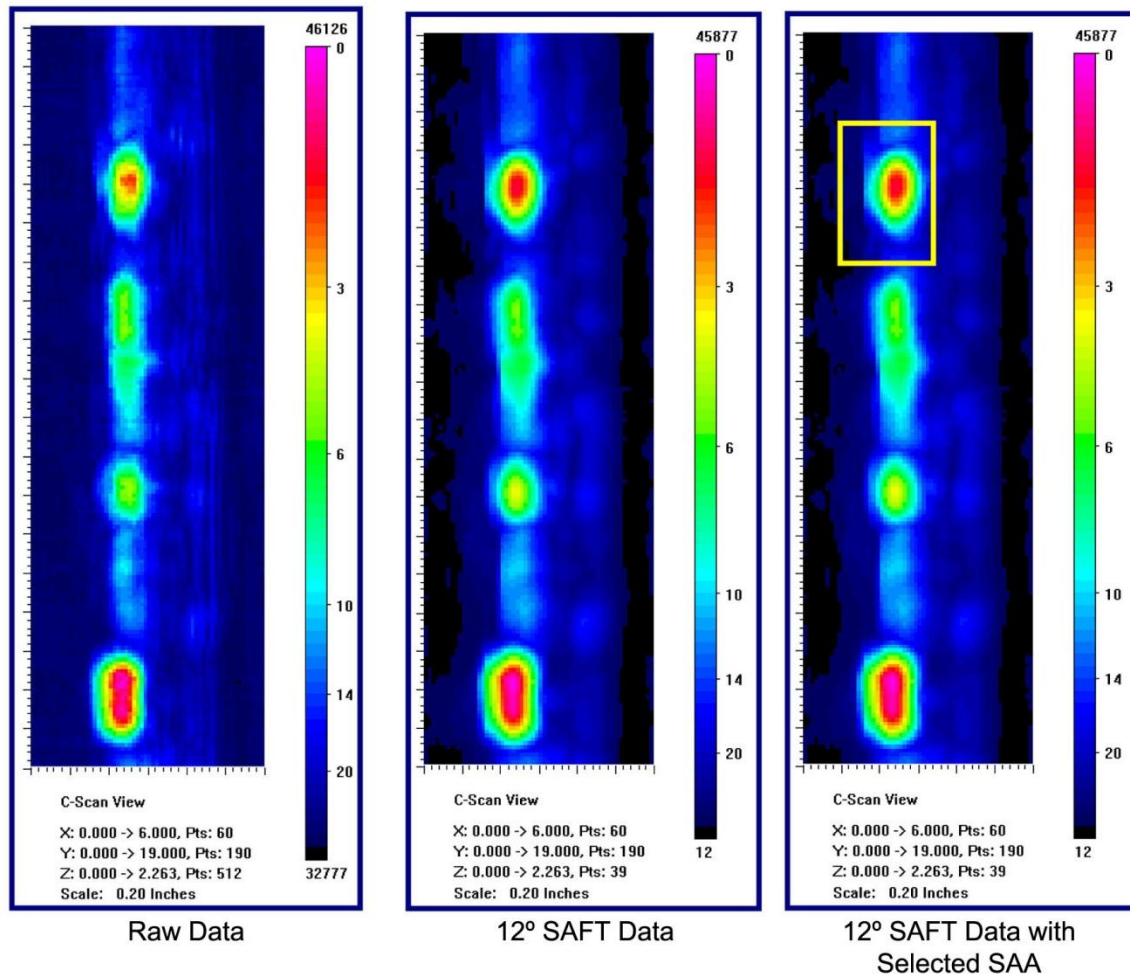
Figure 7.8 C-scan Analysis Process. From left to right, the unprocessed ultrasonic data in C-scan view. Next, the 12° SAFT-processed data in C-scan view. Finally, the processed C-scan view depicting an isolated SAA using the “box” feature embedded in the SAFT analysis menu.

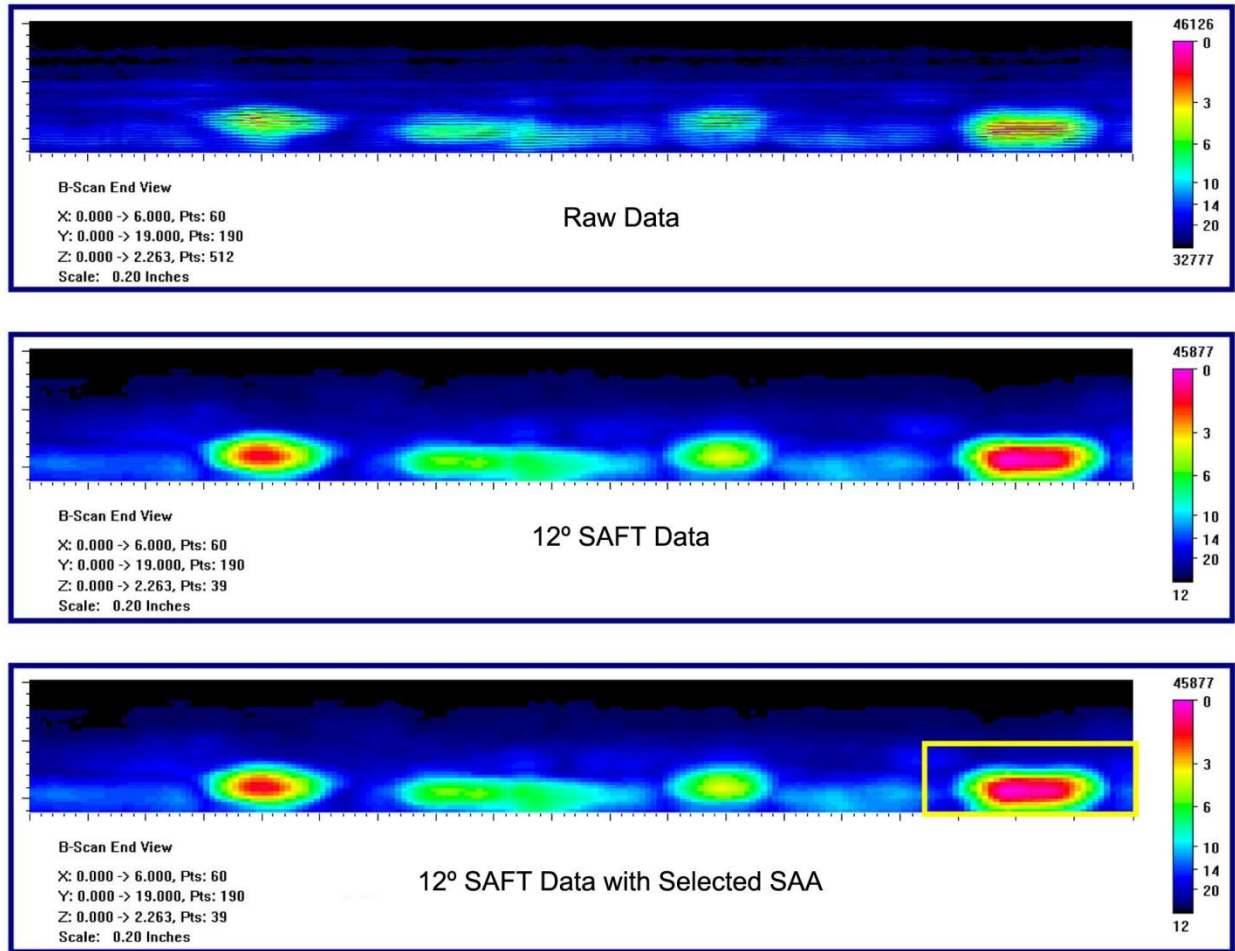
Figure 7.9 B-scan End-View Analysis. From top to bottom, the unprocessed ultrasonic data in B-scan end-view. Next, the 12° SAFT-processed data in B-scan end-view. Finally, the processed B-scan end-view depicting an isolated SAA using the “box” feature embedded in the SAFT analysis menus.

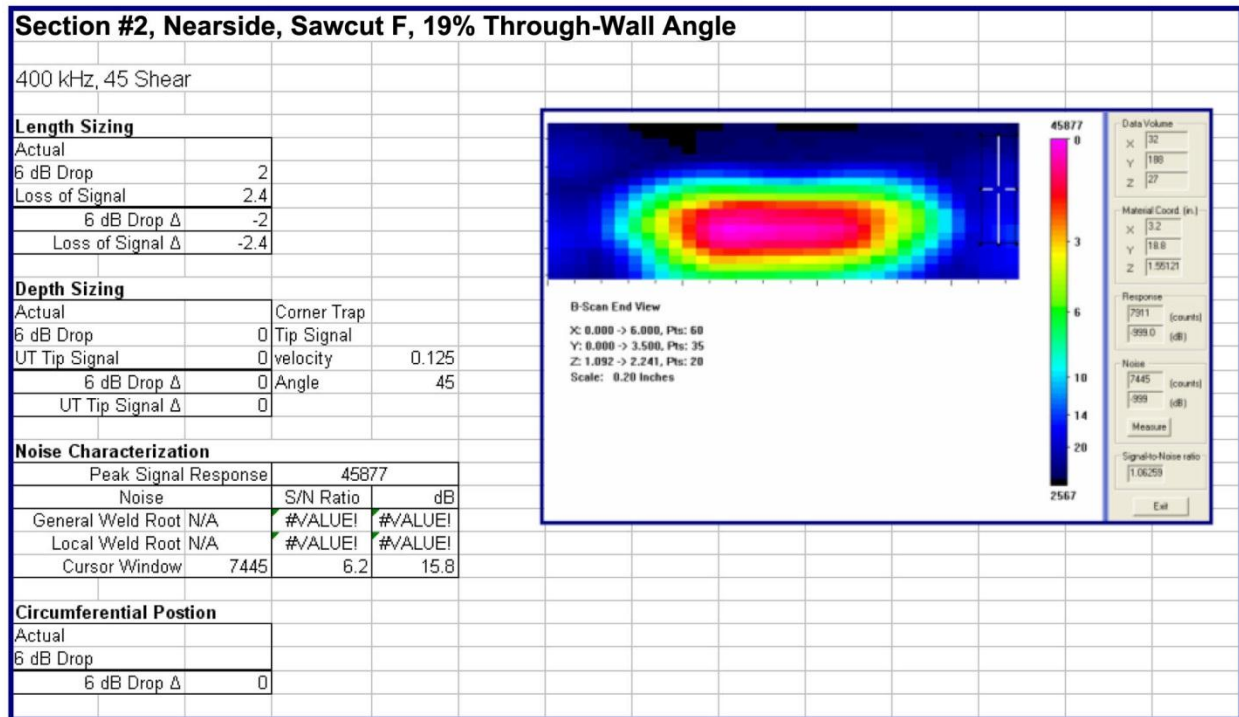
Figure 7.10 Excel Spreadsheet and Associated Magnified B-scan End-View for S Analysis and Detailed Calculations for Length Sizing and Recording of Positional Data
