An Evaluation of Ultrasonic Phased Array Testing for Cast Austenitic Stainless Steel Pressurizer Surge Line Piping Welds

ABSTRACT

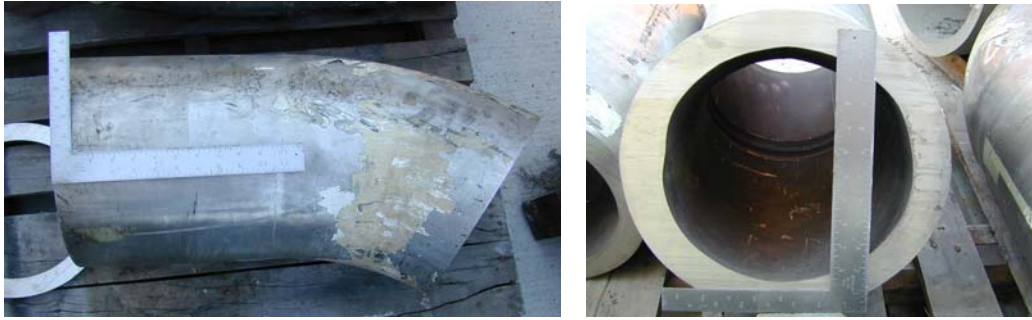
Figure 4.1 Photographs of the Side-View (left) and End-View (right) of the CASS PZR Ring Segment (specimen 7C-059)

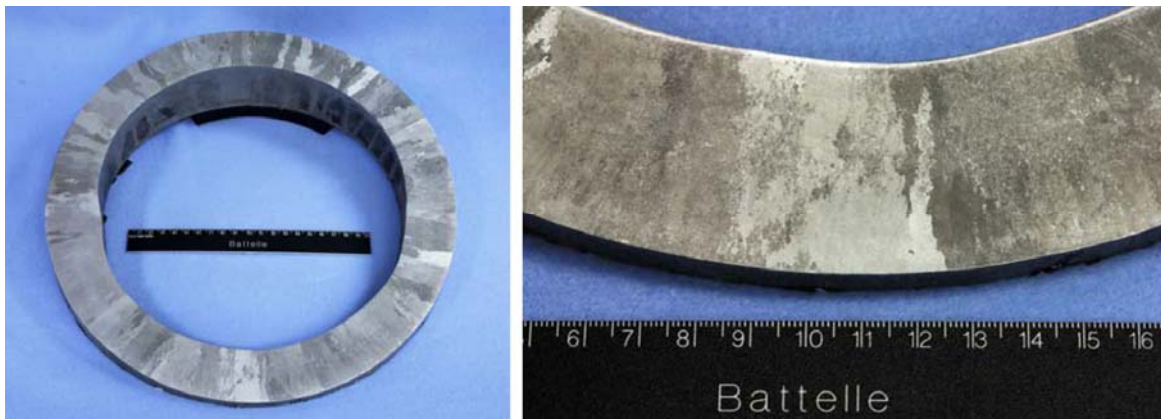
Figure 4.4 WNP-3 Surge Line Elbow Microstructure

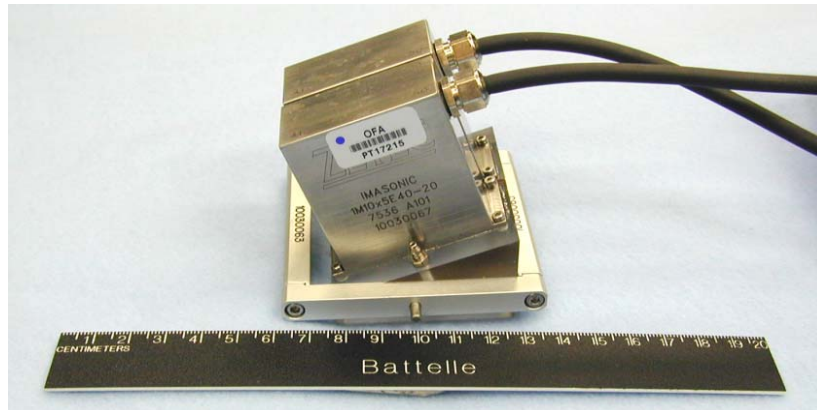
The 1.0-MHz TRL array (Figure 5.7) was originally designed for evaluating inspection effectiveness of PA methods on components with inlays, onlays, and overlays. It consists of two 5-element by 10-element matrix arrays. One array is used for transmitting, the other for receiving ultrasonic signals. This probe has a 58% BW at -6 dB and an approximately 50-mm^2 (1.97-in.^2) footprint with a customized wedge for data collection in tight geometrical configurations. The probe's nominal wavelength in stainless steel is 5.31 mm (0.21 in.) at its average center frequency of 1.1 MHz. Skew angles of ± 20 degrees were possible with this array.

Figure 5.7 1.0 MHz, Phased-Array Probe, Originally Developed for Inlays, Onlays, and Overlays

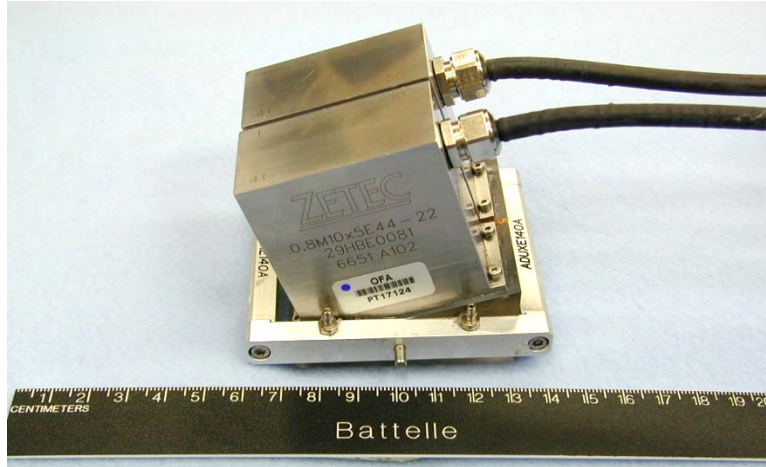
The 800-kHz probe was designed to provide a more optimal wavelength to allow ultrasonic penetration in the large grain structure of CASS, while maintaining suitable flaw resolution. The probes are mounted on a Rexolite wedge side-by-side to operate in a pitch-catch mode and are shown in Figure 5.9. The wedge dimensions were 63 × 63 mm (2.48 × 2.48 in.). The transmit-and-receive probes are identical in design and consisted of a 10 × 5 element array with an active area of 43.2 × 21.2 mm (1.70 × 0.84 in.) and a greater than or equal to 50% bandwidth at -6 dB. The wedges are curved to match the approximate 318-mm (12.5-in.) diameter of the surge line specimens.

Figure 5.9 800-kHz TRL Probe

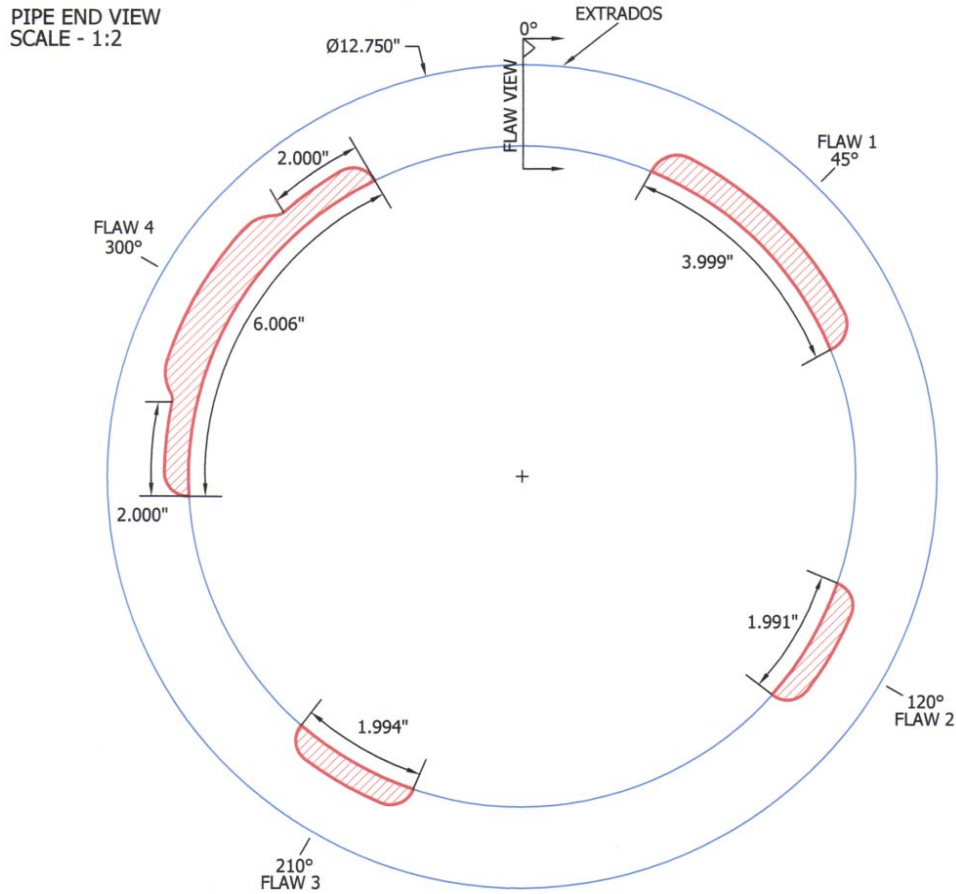
A schematic (side view illustration) of the four TFCs depicting flaw position relative to the weldment and flaw depth is provided as Figure 7.2. Figure 7.3 shows a full circumferential view of all flaw positions and extents on specimen 7C-059. This pipe end-view depicts the circumferential extent (length) of the implanted ID surface-connected cracks, relative to the radial position along the pipe circumference.

Figure 7.3 End View Illustration of All Four Thermal Fatigue Cracks Implanted into PZR CASS Specimen 7C-059 (courtesy of FlawTech, Inc.)

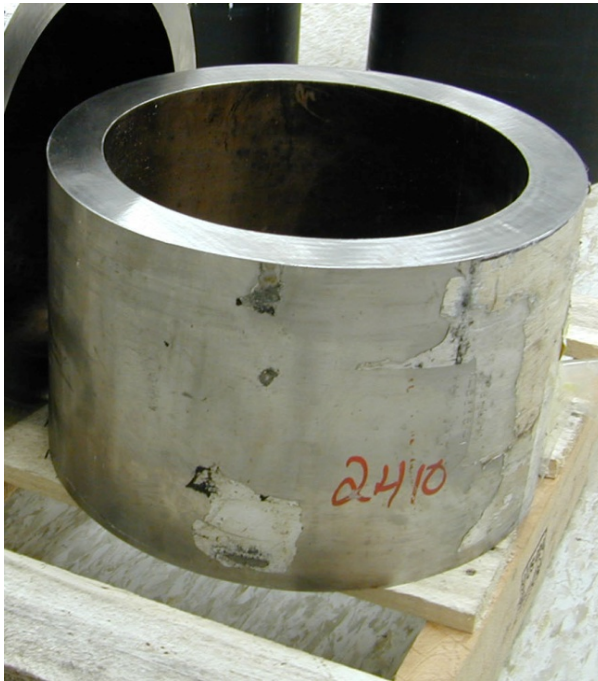
Figure 7.8 CASS Validation Specimen

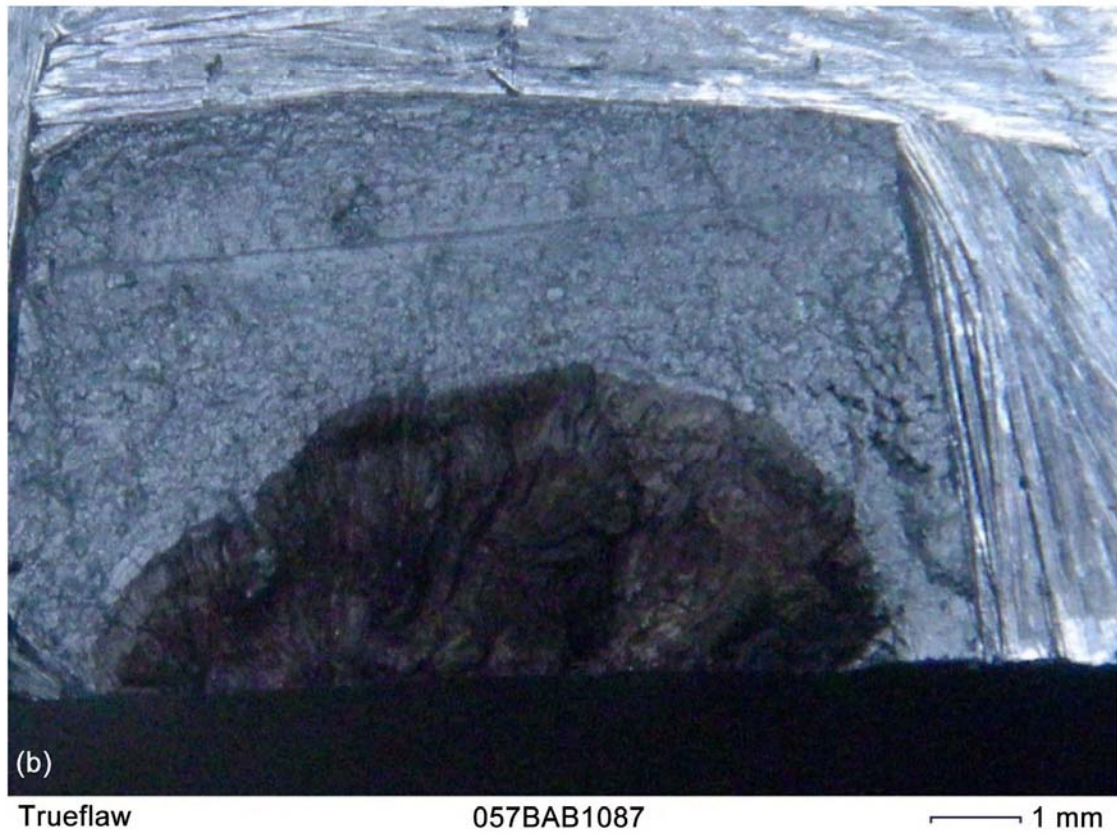
Figure 7.9 Validation Flaw 1087. (a) ID penetrant image; (b) DE fracture surface image.

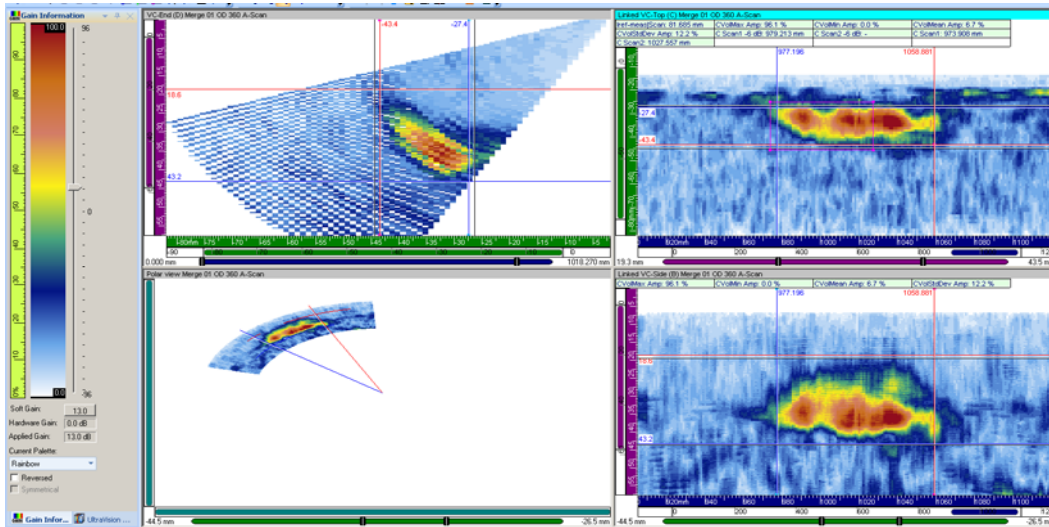
Figure 8.1 800-kHz Data on Pipe Side of 9C-002, Flaw #1, Merged Image for Length Sizing

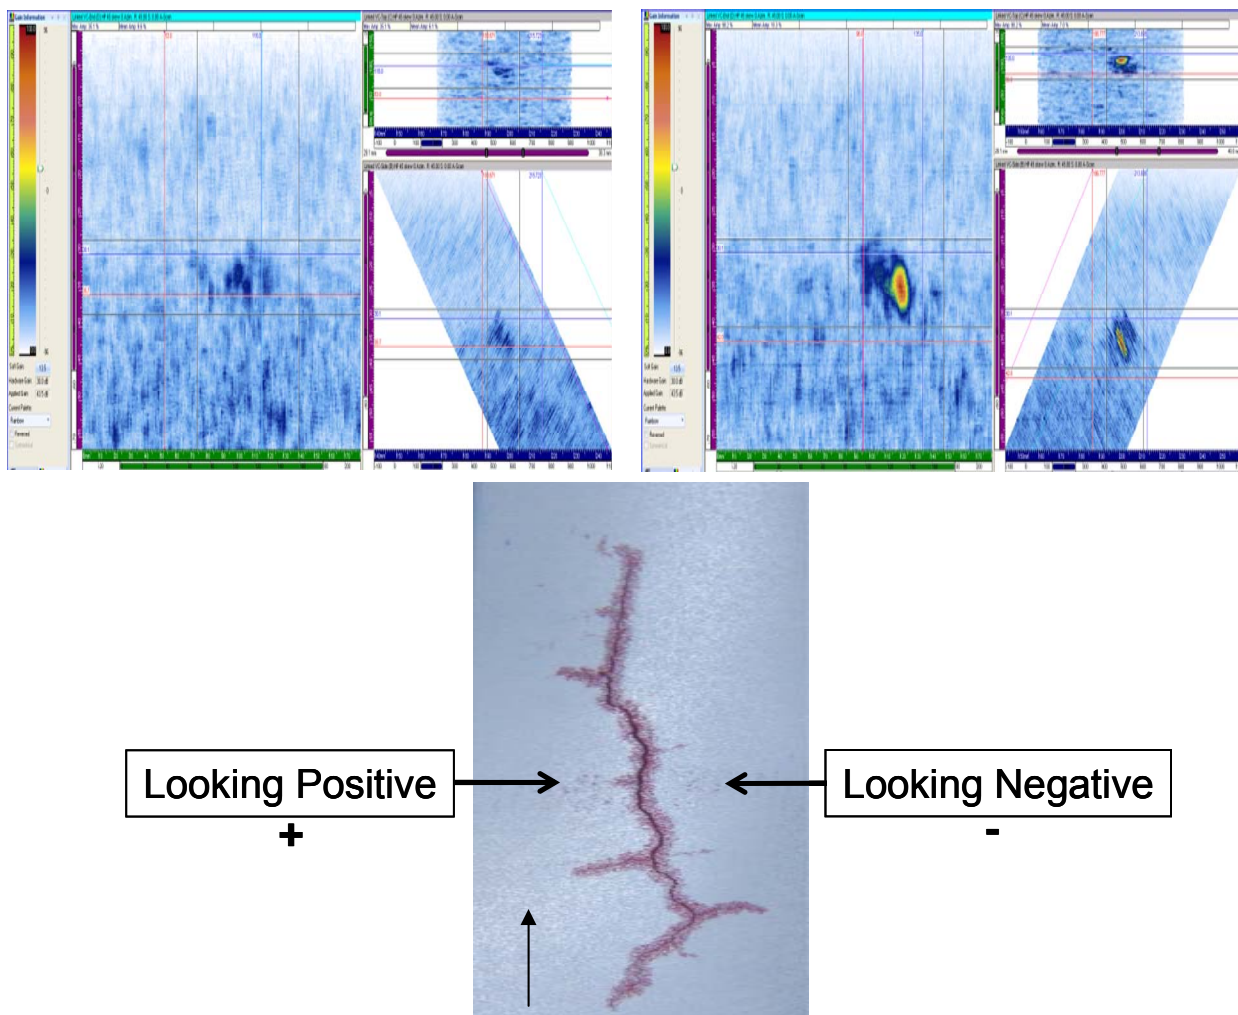
Figure 8.35 2.0 MHz Raster Data Collected from Both Sides of Flaw 1110. Left data were acquired looking positive; right data were acquired looking negative. Below is the ID liquid penetrant image of the crack with the vertical arrow showing the direction of the circumferential axis.

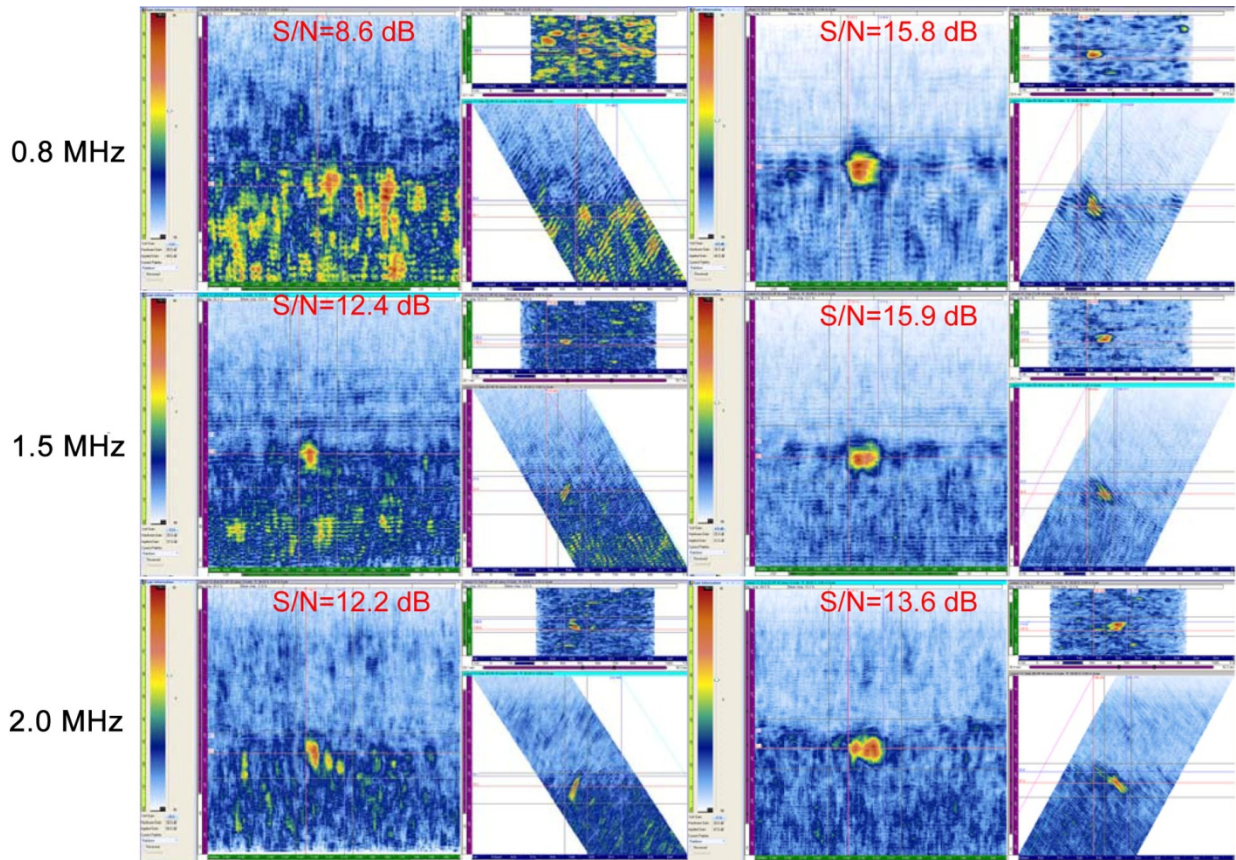
Figure 8.37 Raster Data on Flaw 1102. Left side looking positive; right side looking negative.
