Reliability of Ultrasonic In-Service Inspection of Welds in Reactor Internals of Boiling Water Reactors

Instances of stress corrosion cracking in reactor pressure vessel internal components have been found, especially in the boiling water reactor (BWR) core shroud. Results from in-service inspection are an important aspect of integrity evaluations. One of the major goals of the work described in this report is to quantify the crack detection reliability and sizing error of ultrasonic inspection methods for reactor internals. A mockup is described, along with its application to the assessment on nondestructive evaluation reliability for in-service inspection of reactor internals. The mockup of a BWR core shroud includes cracks in some of the 40 welded assemblies selected to represent field conditions. The selected material and geometry include most conditions and alloys used in the core shroud and its support structure. This report provides an overview of the work being performed and focuses on the parametric study results relating ultrasonic response and its variance to inspection effectiveness. Results of a blind test of an in-service inspection vendor's phased array technique ar

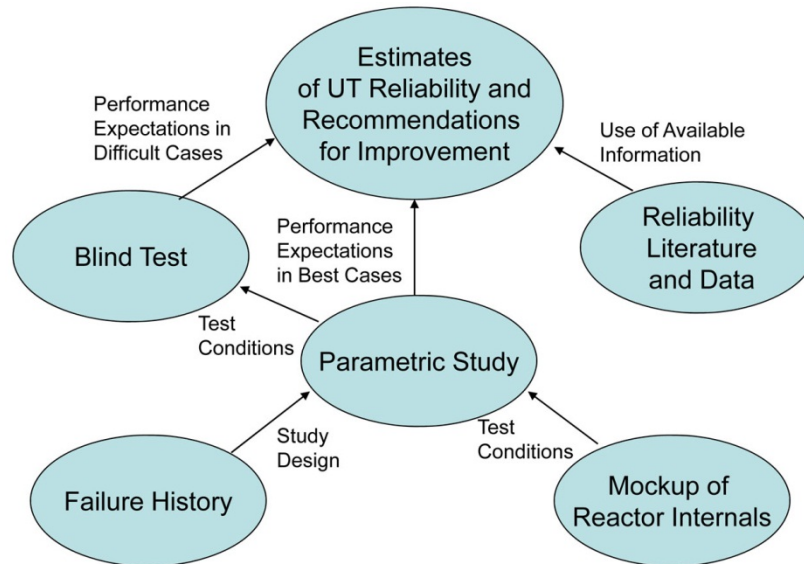
Figure 1-1 Conceptual Diagram for Study of UT-ISI Reliability as Applied to Reactor Internals

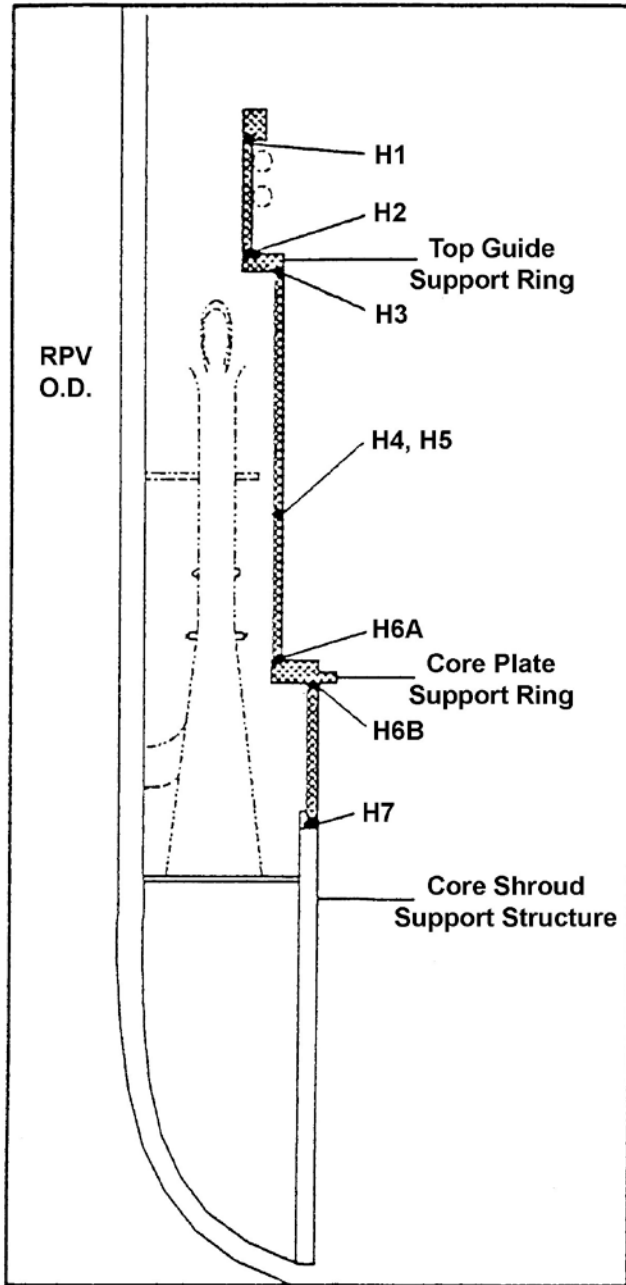
Figure 2-2 Cutaway View of Typical Core Shroud. Source: Baker and Van Hoomissen (1994), copyright © 1994 Electric Power Research Institute (EPRI), Inc.; reproduced with permission.

Figure 2-2 illustrates the typical BWR shroud layout with major circumferential welds. The weld locations for typical General Electric shroud designs for BWR models 3, 4, 5, and 6 are shown. The core shroud is a cylindrical, stainless steel assembly surrounding the core and provides a barrier for separating upward flow through the core from downward flow in the annulus.

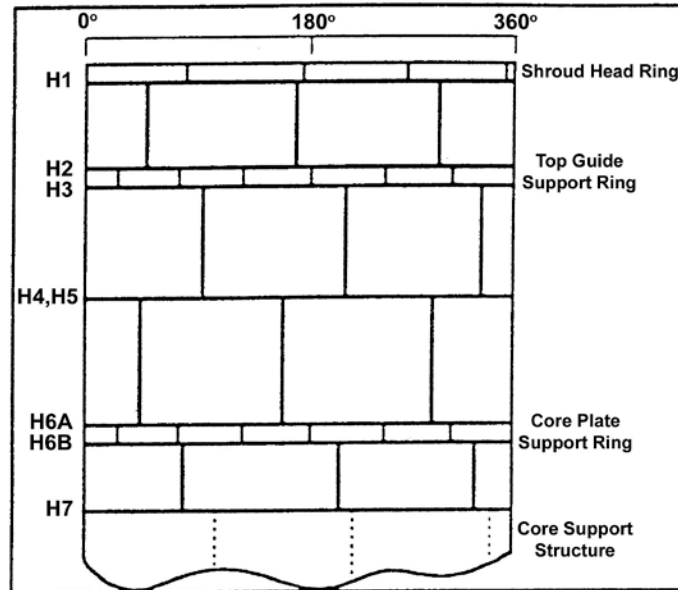
Figure 2-3 Typical BWR Shroud Weld Layout. Source: Baker and Van Hoomissen (1994), copyright © 1994 Electric Power Research Institute (EPRI, Inc.; reproduced with permission.

The core shroud is made up of several panels, two support rings (at the core plate and top guide elevations), and a third ring and steam dam at the shroud head. This entire assembly is held together by numerous vertical and circumferential welds (seams), as shown in Figure 2-3 welds (permission to use this copyrighted material is granted by the Electric Power Research Institute). In a typical BWR, there are seven or eight circumferential welds, and these welds are where cracking has been found.

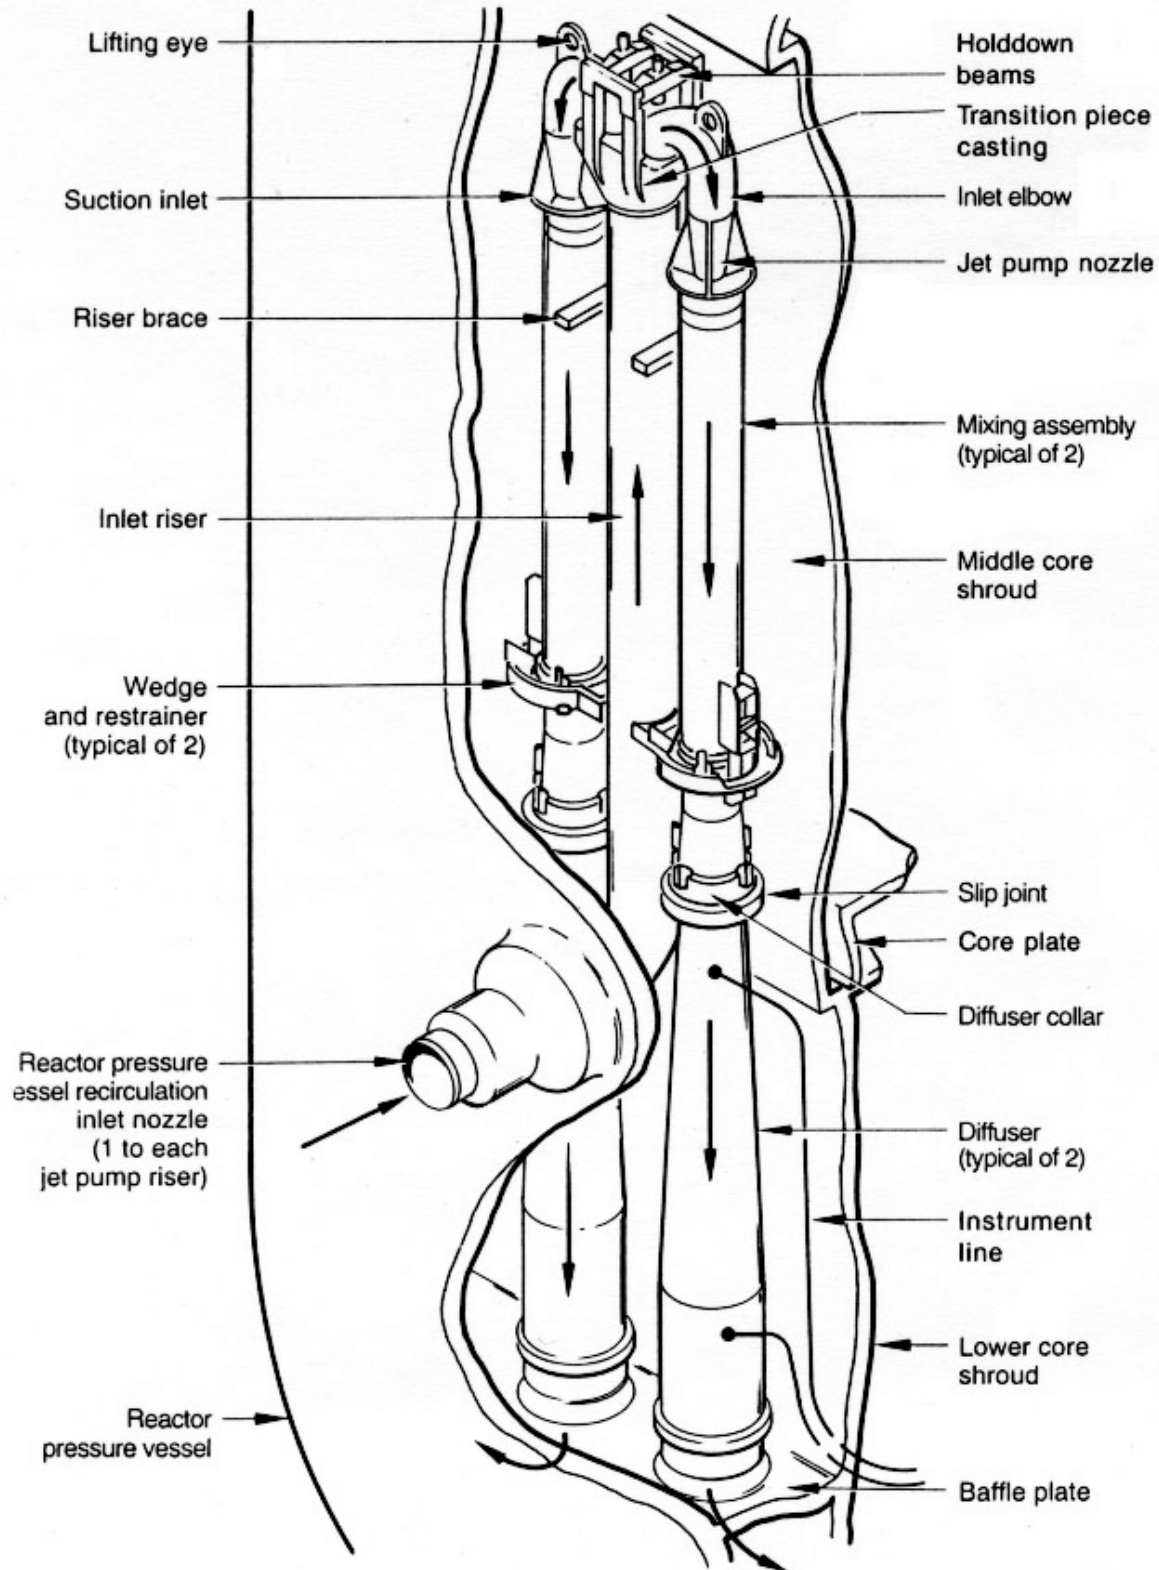
Figure 2-4 Cutaway View of Jet Pump Assembly (USNRC Technical Training Center)

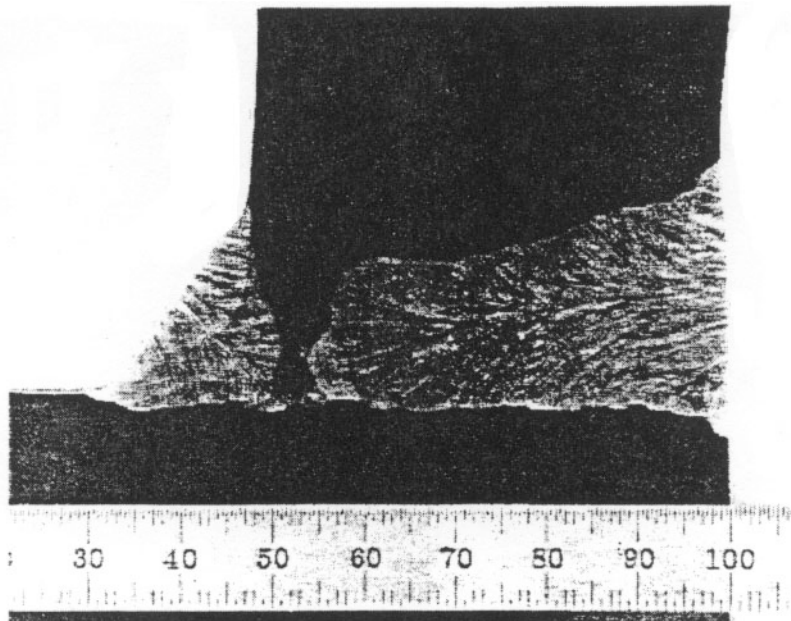
Figure 2-5 Typical Microstructure Content for a Boiling Water Reactor Core Shroud Weld. Source: BWRVIP-03 (1995), © 1995 Electric Power Research Institute, Inc., reproduced with permission.

Figure 2-5 depicts representative weld microstructure of a core shroud weld (permission to use this copyrighted material is granted by the Electric Power Research Institute). The microstructure of the weld metal significantly impedes the propagation of ultrasound. The results of the parametric study, given in Section 6, show the significance of weld microstructure in the detection and sizing of SCC in the heat-affected zone of welds in reactor internals.

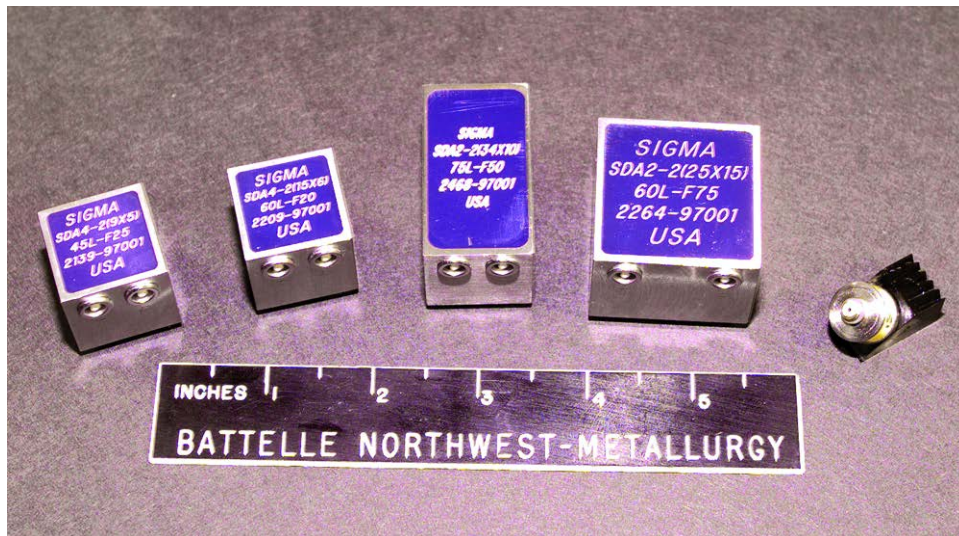
far-surface, dual-element, 2.0-MHz, 60° refracted longitudinal wave probe with a 75-mm focal depth. On the right is a far-surface, single-element, 2.25-MHz, 45° shear wave probe.

Figure 3-1 Commercial Transducers Typically Used for ISI of Austenitic Materials

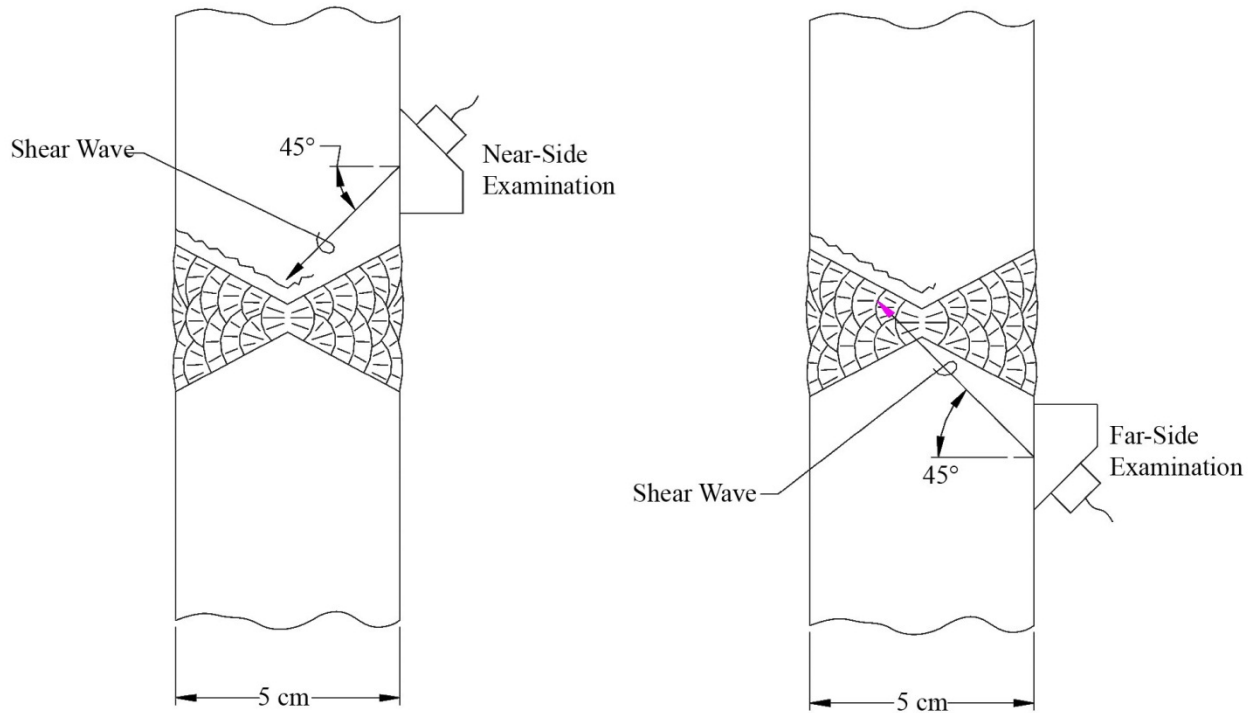
Figure 3-2 Near-Side Access (left) and Far-Side Access (right) Ultrasonic Examination Using Vertically Polarized 45° Shear Waves for Cracks That Are Opposite-Surface Connected (from the transducer)

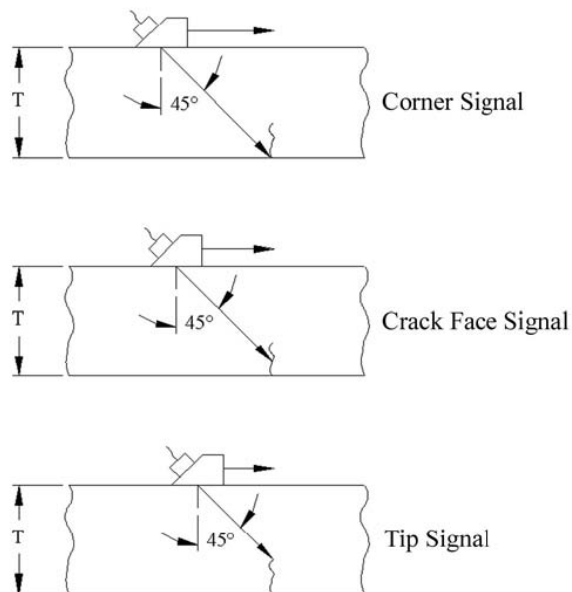
Figure 3-3 Three Ultrasonic Signals (Corner Trap, Crack Face, and Crack Tip) from Opposite-Surface Connected Rough Cracks

Sizing with a 45° shear wave probe is accomplished using ultrasonic energy diffracted from the crack tip, as shown in Figure 3-3. As illustrated, the transducer is moving toward the crack in the three sketches. The top sketch shows the center ray of the transducer striking the corner of the crack with the back wall of the test piece. For 45° shear waves, this corner trap signal will be bright, generally more than 20 dB brighter than other signals from the crack. The middle sketch shows the center ray of the transducer striking the face of the rough crack. Sound will be diffracted from the face of the rough crack and recorded by the transducer. The bottom sketch shows the center ray of the transducer striking the tip of the crack. Sound will be diffracted from this tip, and it can be used to provide an estimate of crack size.

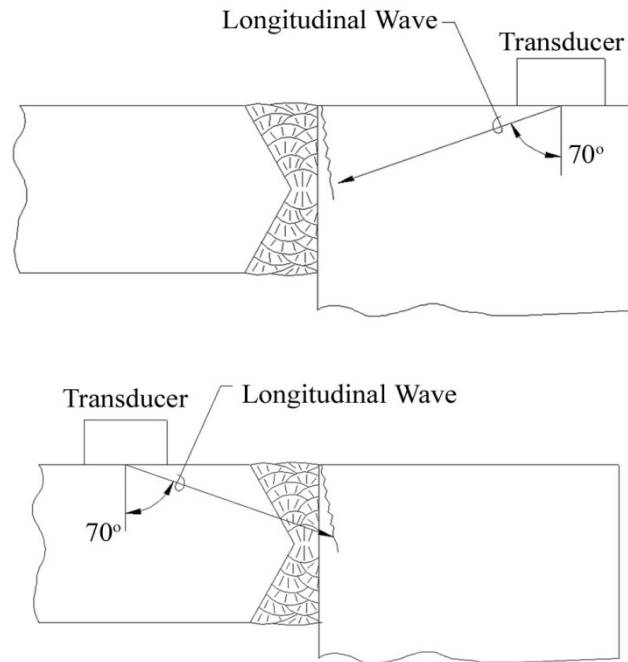
Figure 3-4 Near-Side (Base Metal Access) Shown in Top Image and Far-Side (Weld Metal Access) Shown in Bottom Image Ultrasonic Examination Using High-Angle Compression Waves for Scan-Surface Connected Cracks

High-angle (60° to 70° from surface normal) compression (longitudinal) wave examination is shown in Figure 3-4. The inspection of a K weld profile, typical for a ring-to-cylinder weld in the core shroud, is shown. The crack is located on the ring side of the weld. Inspections are shown for near-side access on the top and far-side access at the bottom. The crack is connected to the same surface that is used for conducting the inspection. Data will show that the crack faces return acoustic energy to the transducer. Little or no corner trap reflection is measured in this case.

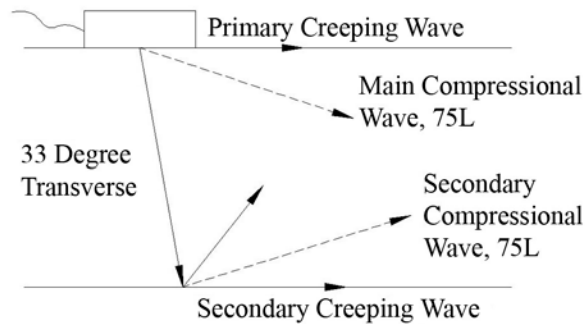
Figure 3-5 Creeping Wave Technique

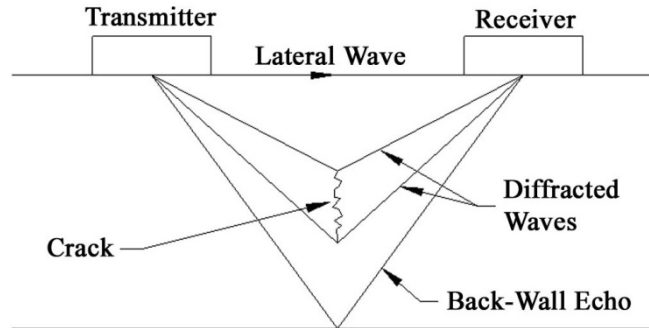
These diffraction signals are used to detect, locate, and size cracks in reactor internals. Finally, a back-wall echo should be available for the case in which no cracks are connected to the opposite surface.

Figure 3-6 Time-of-Flight Diffraction Technique

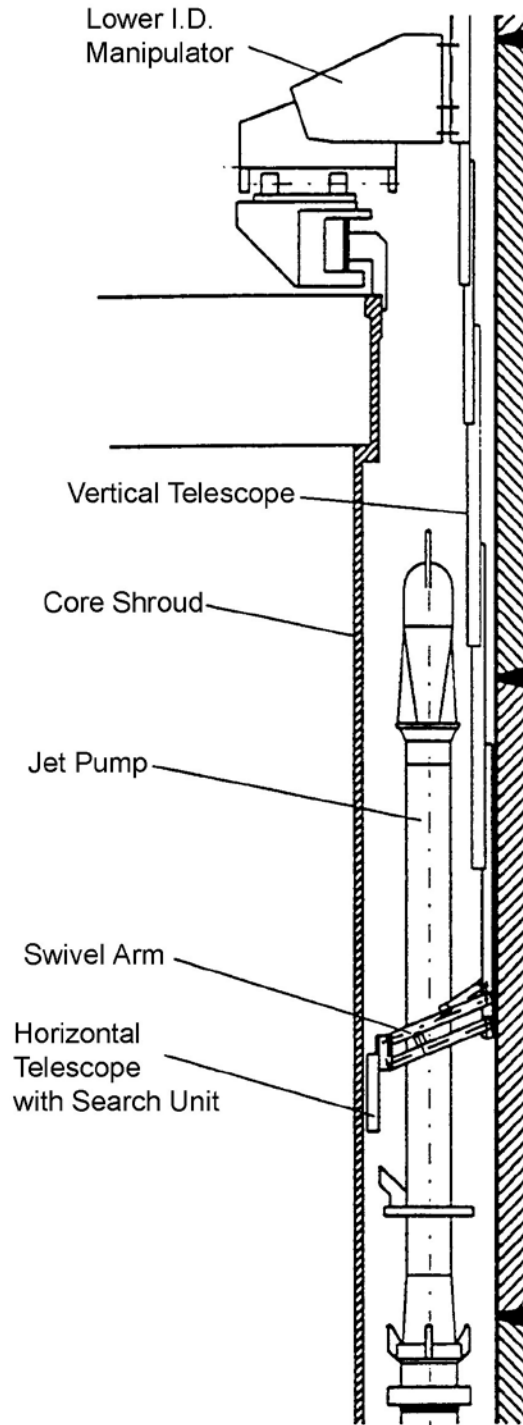
Figure 3-7 Core Shroud Examination Using the Siemens Power Corporation Lower Manipulator. Source: Fisher and Tagliamonte (1994), Electric Power Research Institute, Inc.; reproduced with permission granted by EPRI.

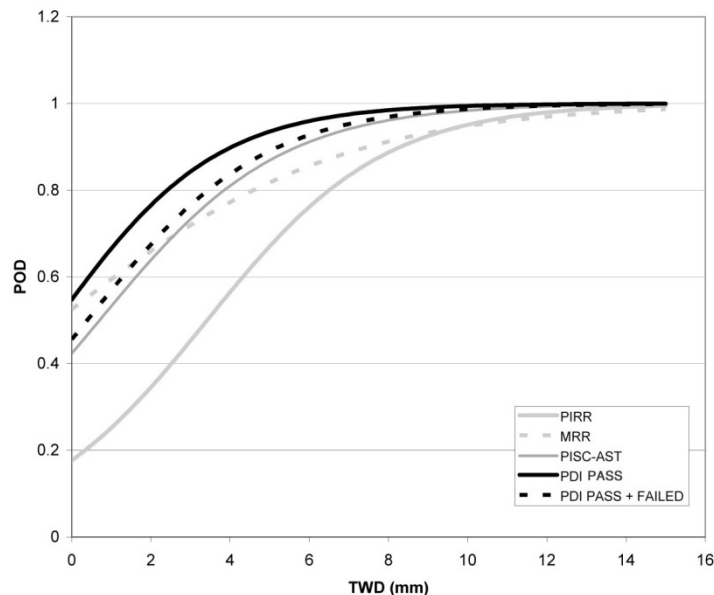
Figure 4-1 Changes in POD versus Through-Wall Dimension of Flaws for Piping Weld Inspection in the Past Two Decades (Doctor and Becker 2002)

Figure 4-1 shows probability of detection (POD) versus through-wall extent of flaws in various studies, over the past two decades, using logistic regression. The lowest performance level is shown for the Piping Inspection Round Robin (PIRR) (Heasler and Doctor 1996) study that took place in 1981. This study is the benchmark of performance in the early 1980s, meeting the 1970s ASME Code Section XI prescriptive inspection requirements. It was just after the PIRR that the issue of inspection reliability became high priority for austenitic welds. The mini-round robin (MRR) (Heasler et al. 1990) results in 1985, following industry-developed training and initial performance demonstration testing, showed that smaller flaws could be more reliably detected with a moderate increase in performance for intermediate flaws. The PISC-AST (Lemaitre 1994) results of 1990 show a significant improvement over the PIRR and, except for very small flaws, show an improvement over the MRR results. There are two results for the Performance Demonstration Initiative (PDI) data (Doctor and Becker 2002), which reflect the performance demonstration testing that is in the ASME Code Section XI, Appendix VIII. The PDI data are plotted for all inspectors who successfully passed the performance demonstration requirements and a second curve for all inspectors who attempted the performance demonstration test (passed and failed). It can be seen that both of these PDI-based curves show improvements over the preceding three round robin studies.

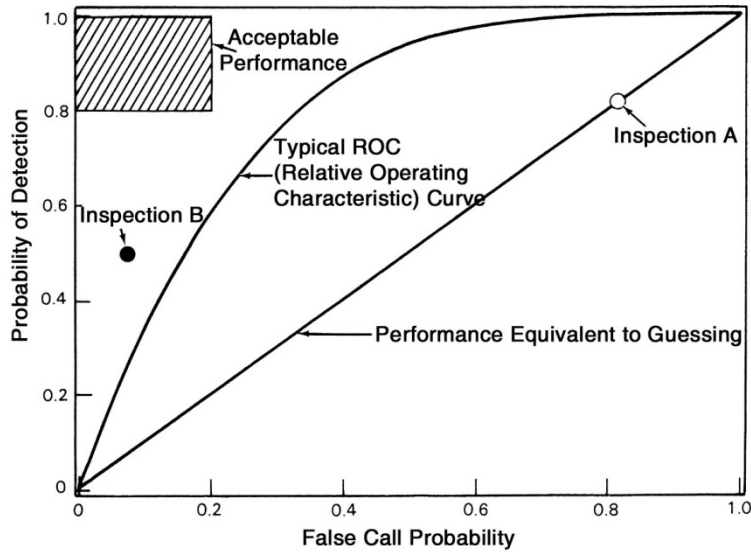
Figure 4-2 Operating Characteristics Diagram (Heasler et al. 1986)

The OC diagram shows that it is not sufficient to examine POD alone. For example, the performance of Inspection A in Figure 4-2 is obviously better than Inspection B, if we consider only POD. But the performance of Procedure A lies on the diagonal, which shows that Inspection A's high POD (and high false call rate) was achieved by classifying blank material as flawed. Inspection B, on the other hand, has demonstrated the ability to more effectively distinguish between cracked and blank material.

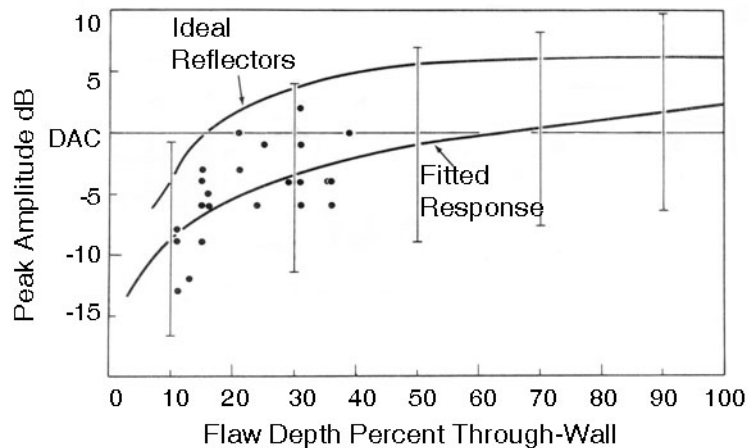
Figure 4-5 Response versus Crack Tightness (Becker et al. 1981)

Figure 4-5 shows the effect of a 75% compressive stress on the measured signal response. Although a 75% yield compressive stress may appear very conservative, it should be noted that the data are for dry fatigue cracks. Liquid-filled cracks, SCCs, and tight thermal fatigue cracks may produce larger losses in signal amplitude with no external stress applied. The experimental data are shown in Figure 4-5, along with the response curve for ideal reflectors of aspect ratio 0.2 and the fitted curve. The mean of the measured flaws is 7 dB below the ideal response curve, with a standard deviation of 4 dB. The 2σ error bars for this measurement also are shown in Figure 4-5.

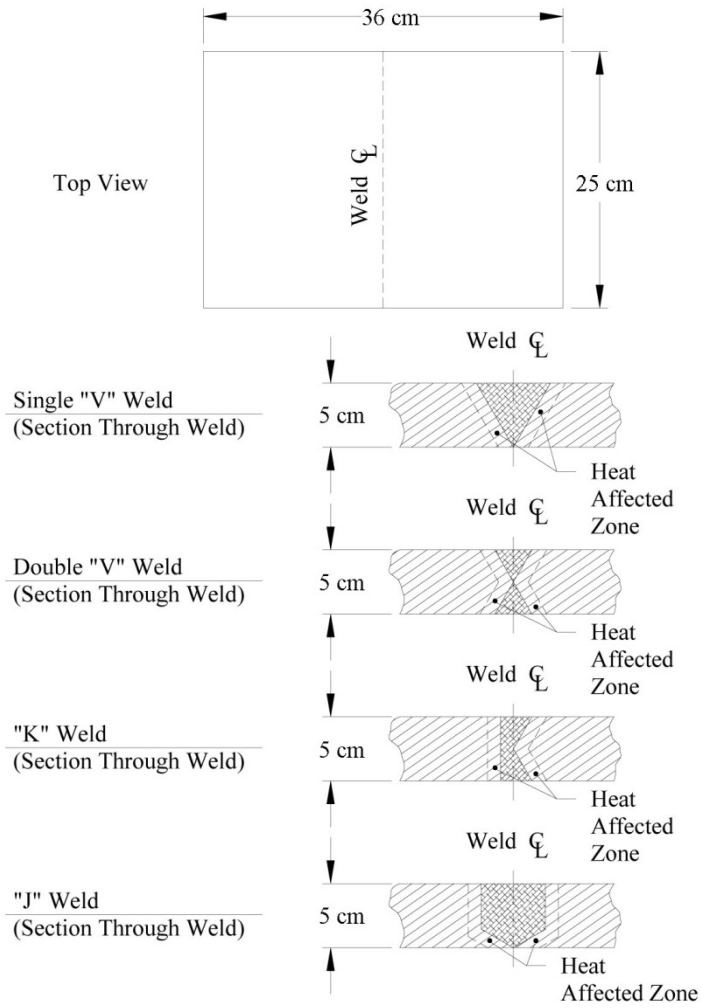
Figure 5-1 Welded Assembly Configuration for Mockup

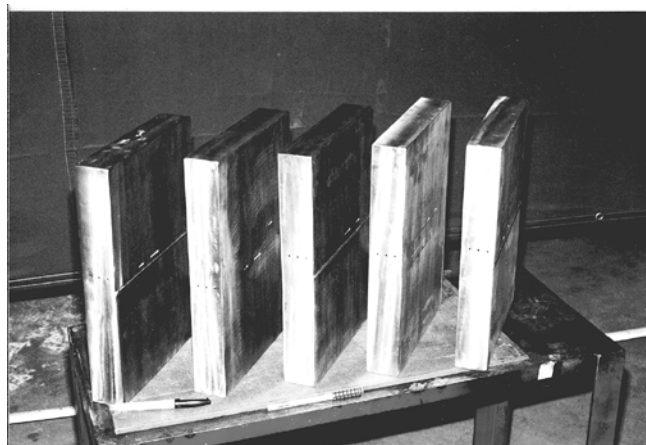
Figure 5-2 First Welded Assemblies

Figure 5-2 shows the first five welded assemblies built to test and assess the mockup design. These assemblies—with various weld profiles, side-drilled holes, notches, and other reflectors—were used to evaluate the usefulness of the assemblies. The welds were fabricated in the vendor's controlled environment using a convenient down-hand welding position. Figure 5-3 shows the welding of one of the reactor internals mockup assemblies. The results of initial testing performed on these assemblies are reported in Section 5.3.

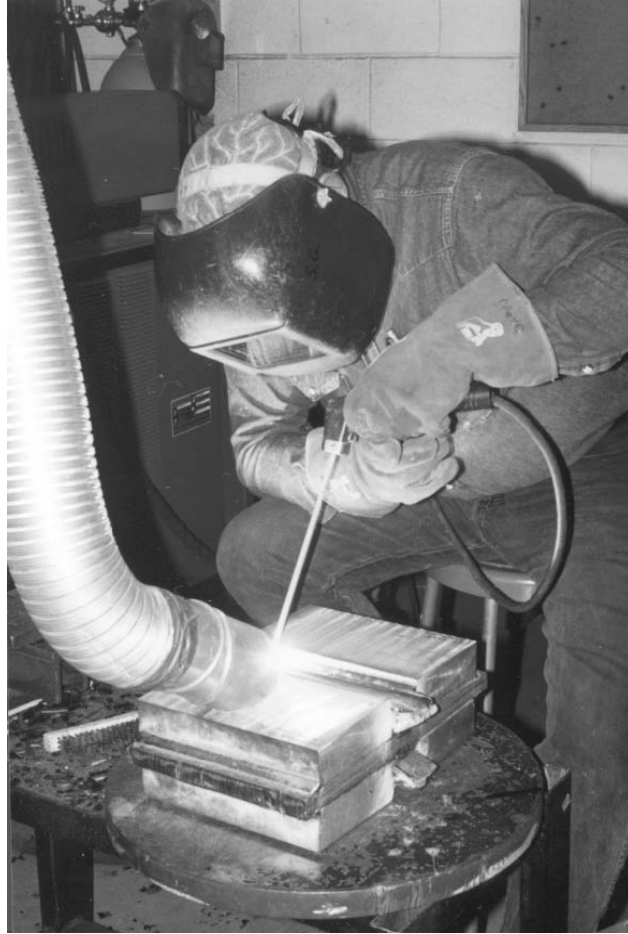
Figure 5-3 Welding of Reactor Internal Mockup Assembly (photo courtesy of FlawTech, Inc., Concord, North Carolina; reprinted with permission)

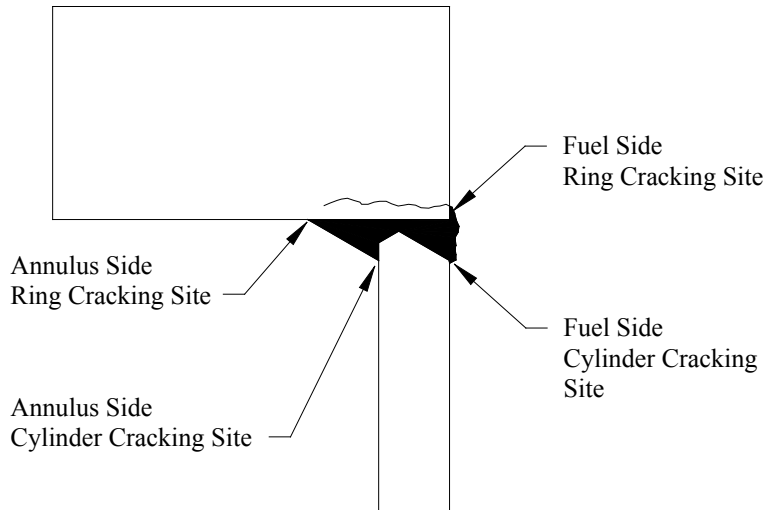
Figure 5-4 Four Crack Initiation Sites

Four crack initiation sites can be expected on welds in the core shroud. Figure 5-4 shows a K-weld profile with a crack initiation from the fuel side of the top guide support ring of a BWR core shroud. In many BWR core shrouds, this weld is labeled the H3 weld. In-service inspection data show that cracks can initiate from the fuel or annulus side of the core shroud. The ring or cylinder side of the weld's heat-affected zone can crack. Four cracking sites should be considered for heat-affected zone cracking of the welds in the core shroud. In this case, the crack originates on the fuel side of the core shroud at the edge of the weld crown, the inside ring cracking site. Again, cracks are most likely to follow the angled weld profile. Weld crowns are variable, and some are not ground flush, which can limit the inspection surface.

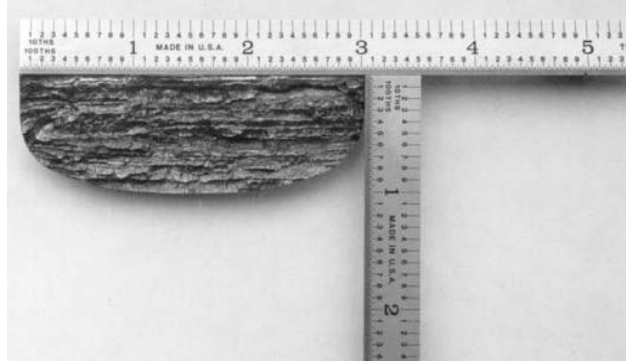
Figure 5-5 Example of Thermal Fatigue Crack Implant (photo courtesy of FlawTech, Inc., Concord, North Carolina; reprinted with permission)

Rough crack faces can be expected in the case of SCC. Figure 5-5 shows that thermal fatigue crack implants can provide such roughness. The shape and size of the crack can be measured before and after the implant in the mockup assemblies.

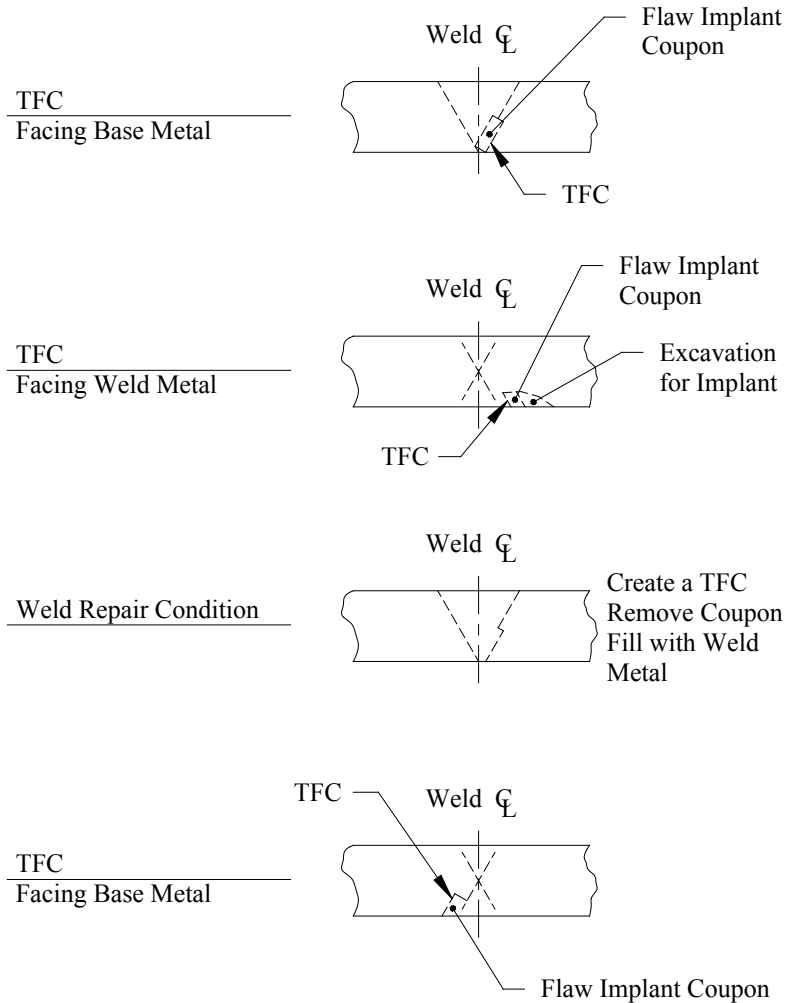
Figure 5-6 Thermal Fatigue Crack Notation

The third illustration in Figure 5-6 is a test of the acoustic properties of the implant process. The crack is formed with a tension bar, but the coupon is not replaced and seal-welded to form a crack. The area where the crack should be is repaired by welding. This approach creates a site for testing for detectable conditions associated with the coupon implant process.

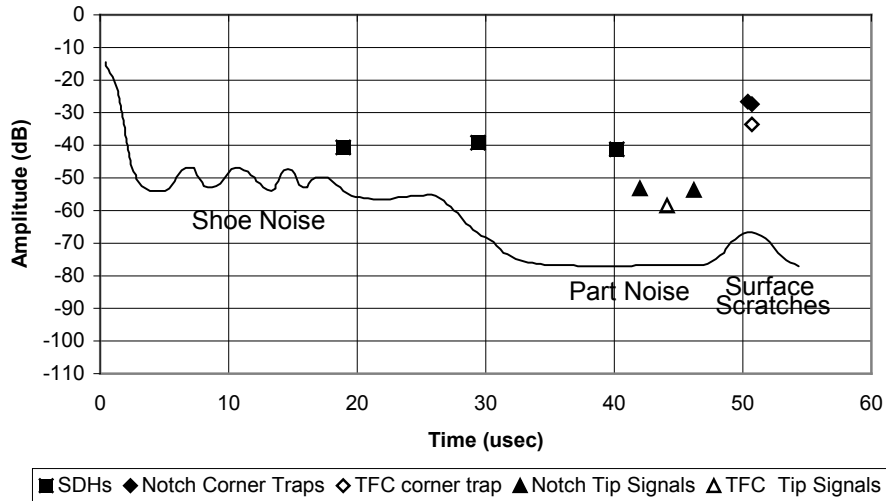
Figure 5-7 Near Side Access (Through Base Metal) Responses from Notches, Side-Drilled Holes, and Thermal Fatigue Cracks Using 45° Shear Waves in a Submerged Arc Single-V Welded Assembly.

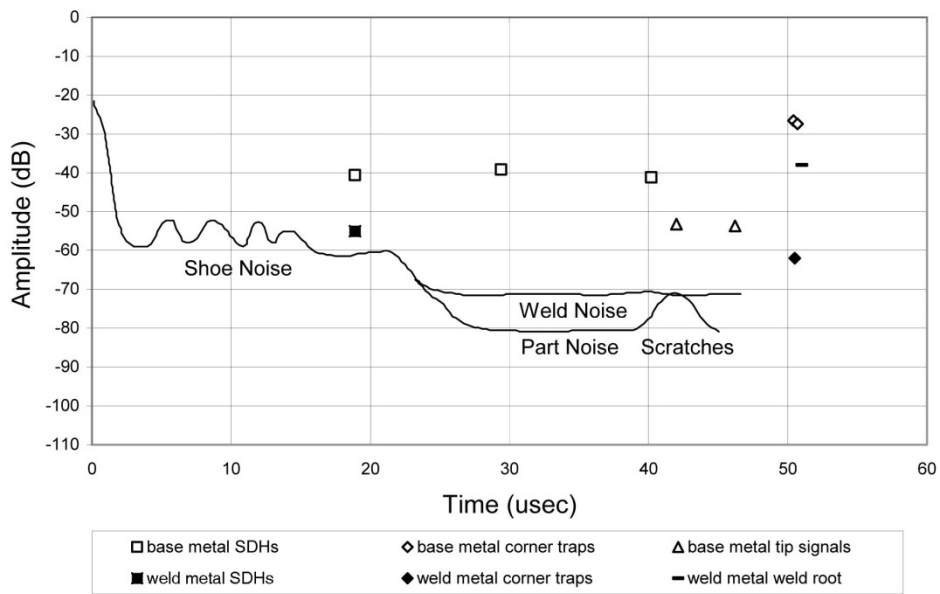
Figure 5-8 Responses Using 45° Shear for Base Metal and Weld Metal Access in a Submerged Arc Single-V Welded Assembly

Figure 5-8 provides the responses using 45° shear waves for base metal and weld metal access. Base metal results (hollow symbols) show that all defects were detected. This includes the notch tip signals that are 25 dB below the corner-trap signals (the TFC data are not plotted but fall approximately 5 dB lower than notch data). The weld metal inspection detected only the one-quarter wall thickness deep side-drilled hole and both notch corner trap signals. These signals are significantly lower than their base metal counterparts (-15 dB and -35 dB, respectively).

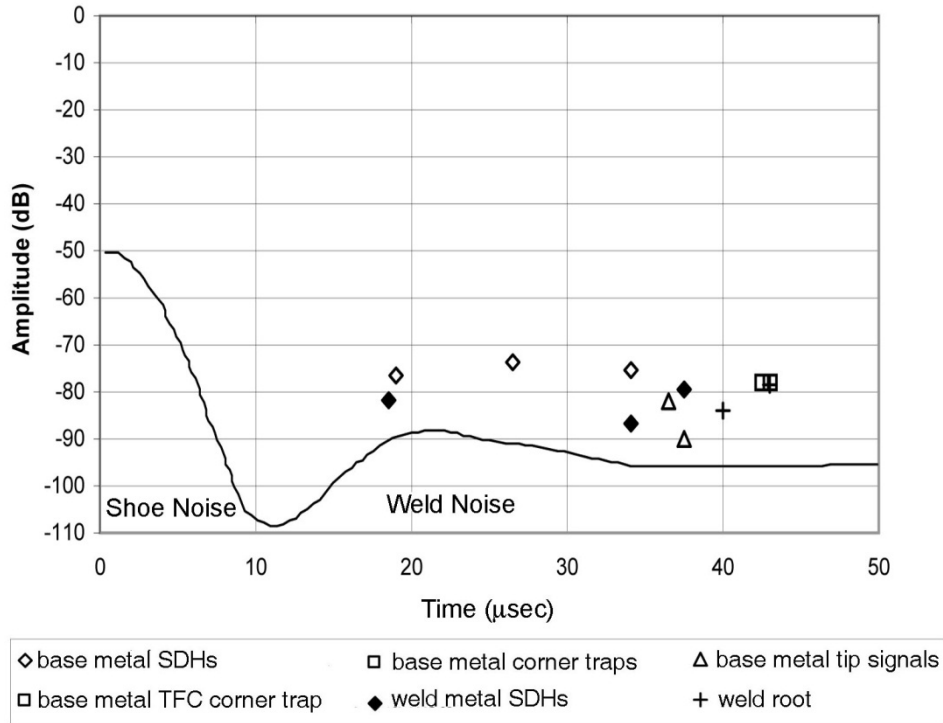
Figure 5-9 Responses Using 60° Longitudinal for Base Metal and Weld Metal Access in a Submerged Arc Single-V Welded Assembly

Data from the 60° longitudinal, 2-MHz, 75-mm focus probe showed that the base metal inspection found the three side-drilled holes (SDHs), the flaw corner-trap, and tip signals. From the weld metal inspection only the one-quarter wall thickness and the three-quarters wall thickness SDH signals were found. Results are shown in Figure 5-9.

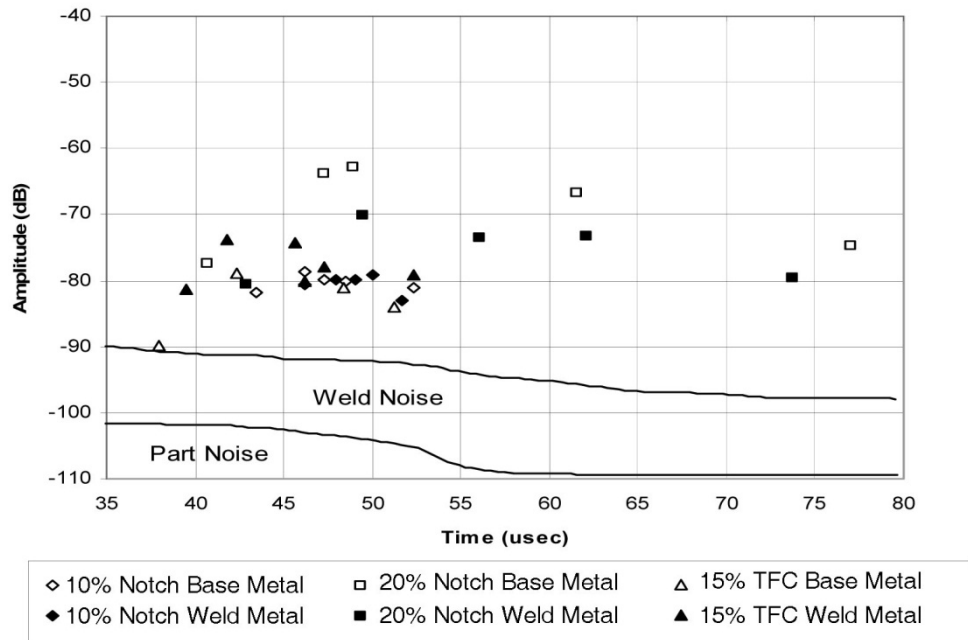
Figure 5-10 Response Using Creeping Wave Probe SH-L-L Mode in a Submerged Arc Single-V Welded Assembly

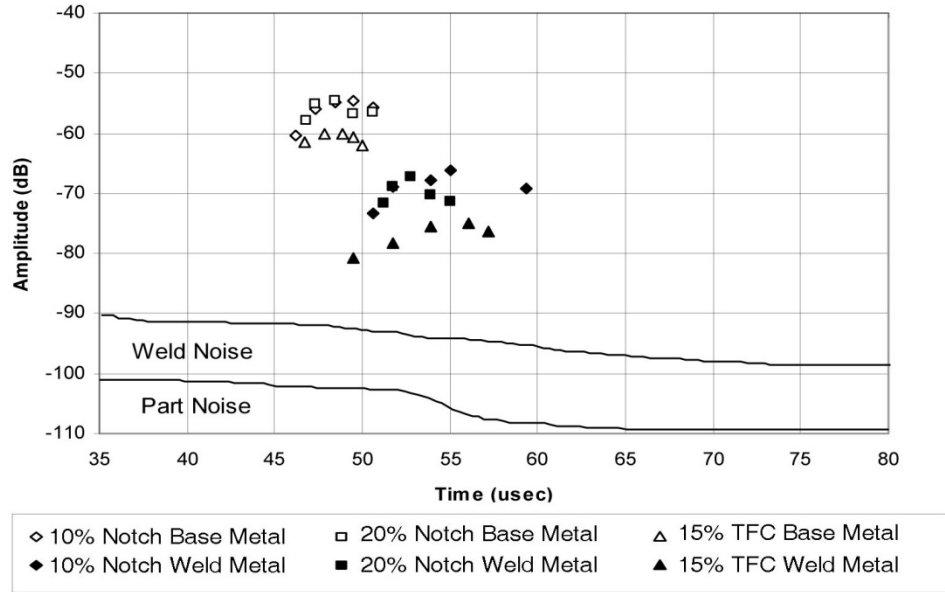
Figure 5-11 Responses Using Creeping Wave Probe 75° Longitudinal Mode in a Submerged Arc Single-V Welded Assembly

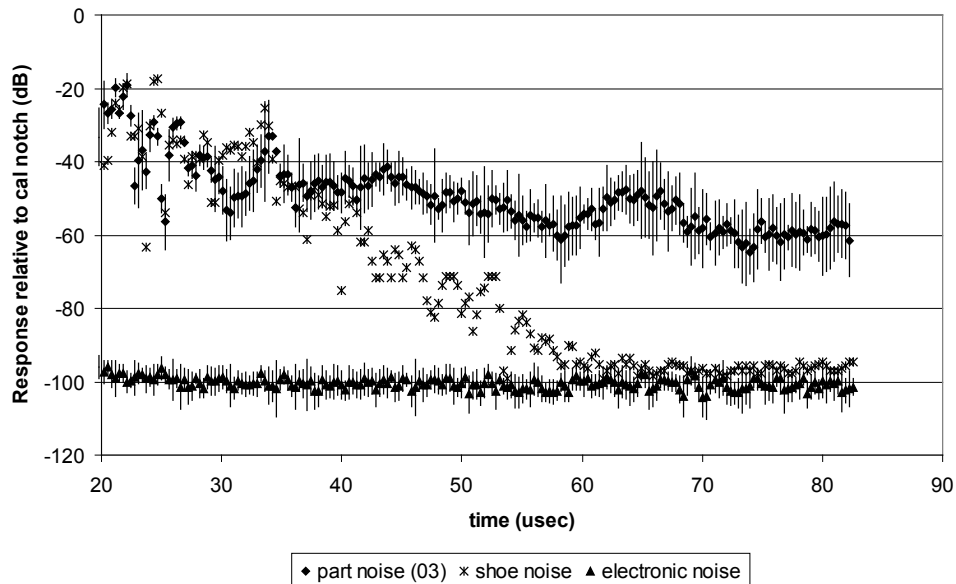
Figure 6-1 Noise Sources Using 45° Shear Waves

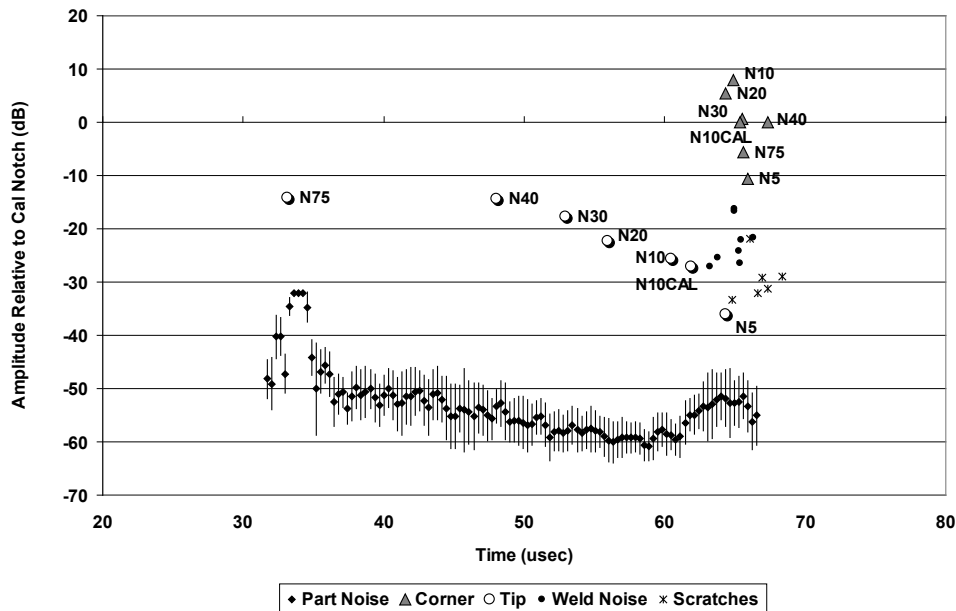
Figure 6-2 Responses of Notches to 45° Shear Wave Insonified Through Stainless Steel Base Metal

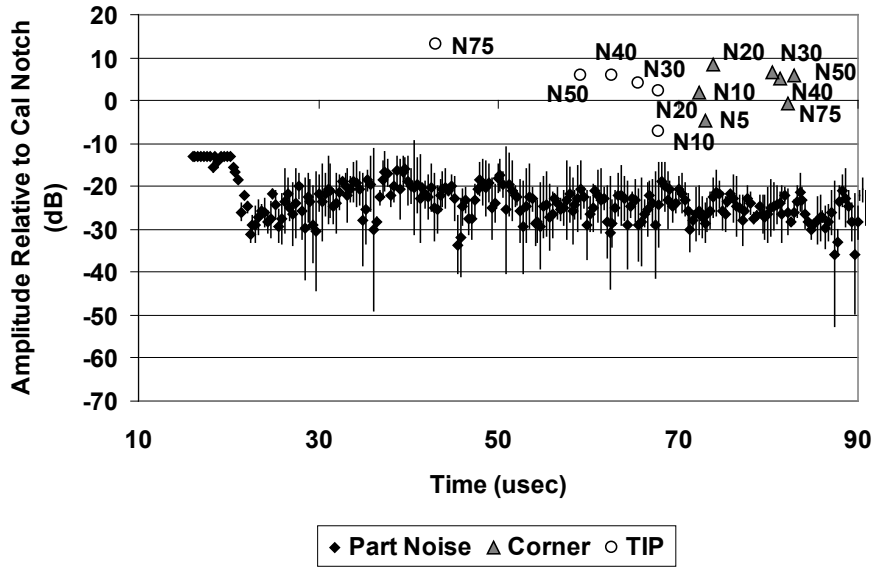
Figure 6-3 Response of Notches to 75° Longitudinal Waves at 2.0 MHz Insonified Through Stainless Steel Base Metal

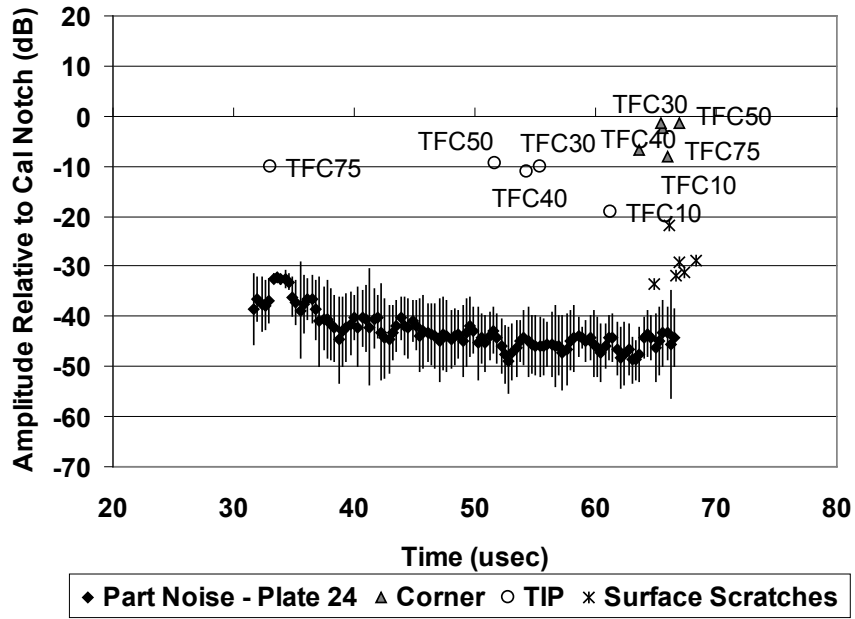
Figure 6-4 Thermal Fatigue Crack Responses to 45° Shear Waves at 2.25 MHz Insonified Through Stainless Steel Base Metal

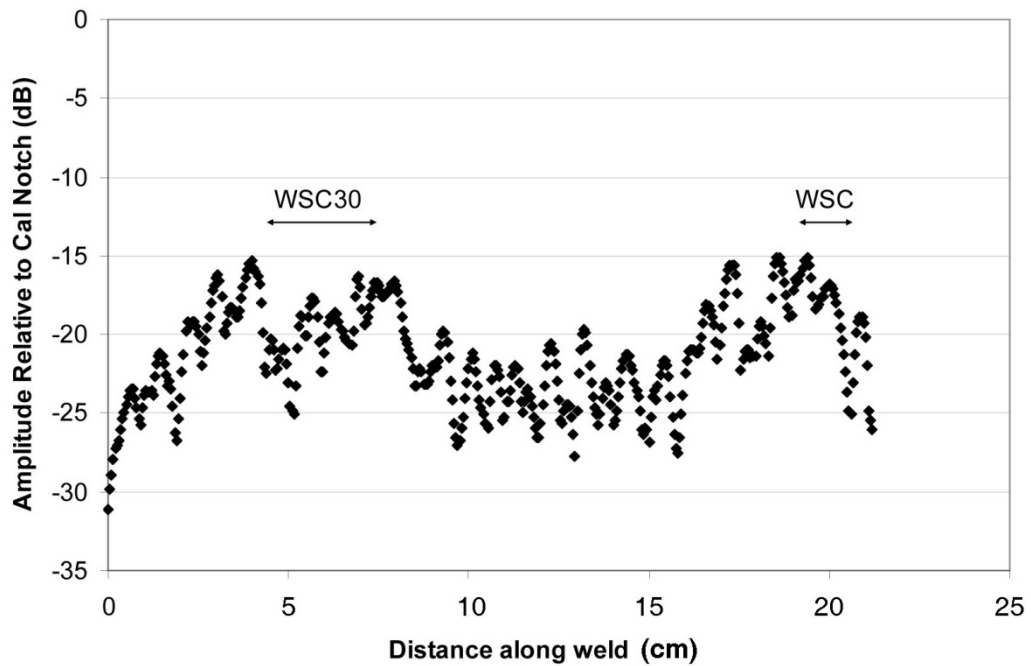
Figure 6-5 Weld Solidification Cracks on the Near Side Using 45° Shear Waves in Stainless Steel

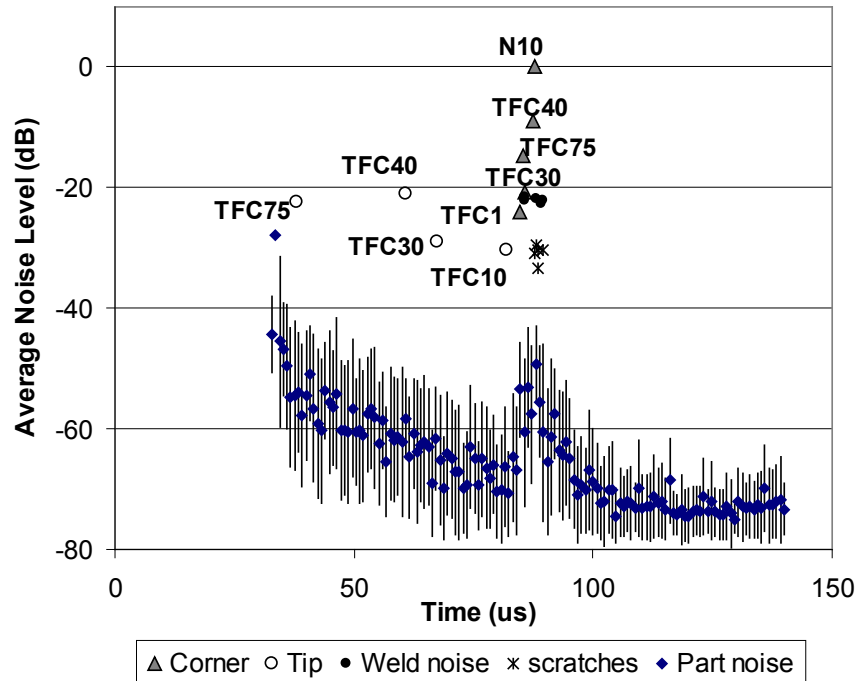
Figure 6-6 Response of Thermal Fatigue Cracks for Near-Side Access in Alloy 600

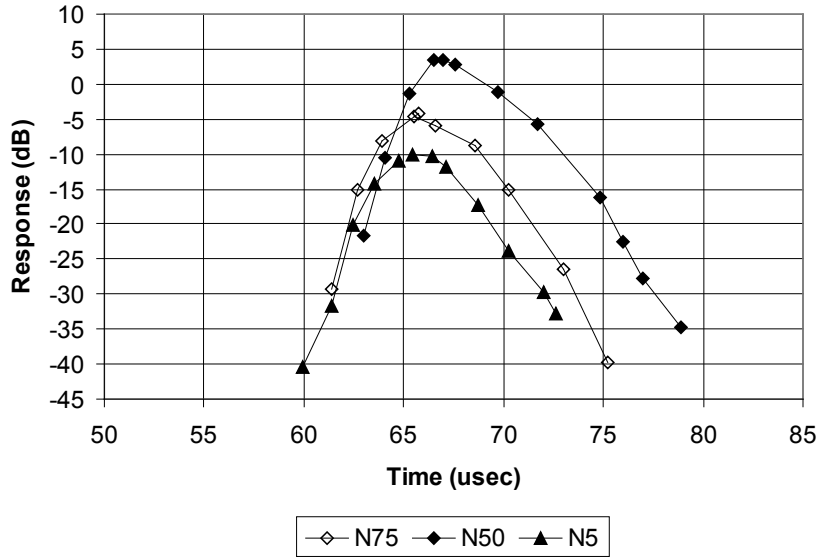
Figure 6-7 Echo-Dynamic Curves for Three Notches in Stainless Steel

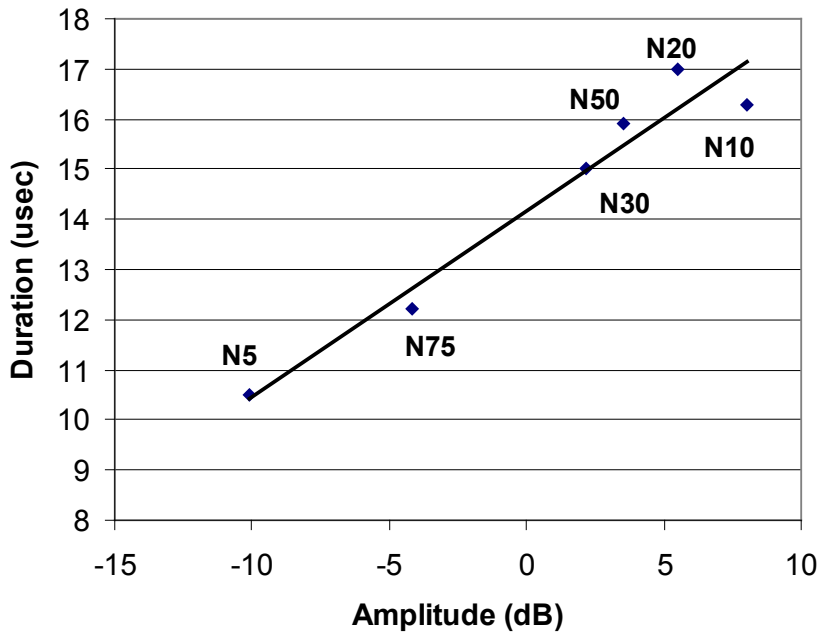
Figure 6-8 Amplitude versus Duration of the Echo-Dynamic Curve for Notches in Stainless Steel

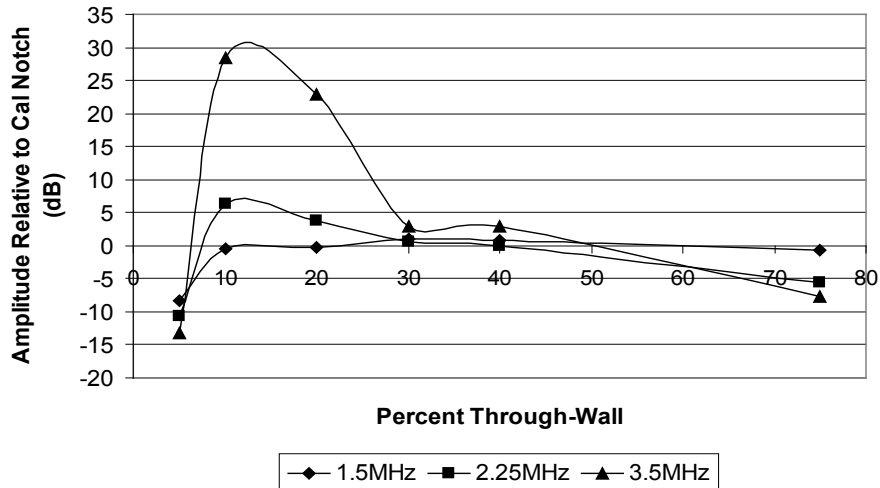
Figure 6-9 Response of Notches in Stainless Steel to 45° Shear Waves at Three Frequencies
