Reliability of Ultrasonic In-Service Inspection of Welds in Reactor Internals of Boiling Water Reactors

Instances of stress corrosion cracking in reactor pressure vessel internal components have been found, especially in the boiling water reactor (BWR) core shroud. Results from in-service inspection are an important aspect of integrity evaluations. One of the major goals of the work described in this report is to quantify the crack detection reliability and sizing error of ultrasonic inspection methods for reactor internals. A mockup is described, along with its application to the assessment on nondestructive evaluation reliability for in-service inspection of reactor internals. The mockup of a BWR core shroud includes cracks in some of the 40 welded assemblies selected to represent field conditions. The selected material and geometry include most conditions and alloys used in the core shroud and its support structure. This report provides an overview of the work being performed and focuses on the parametric study results relating ultrasonic response and its variance to inspection effectiveness. Results of a blind test of an in-service inspection vendor's phased array technique ar

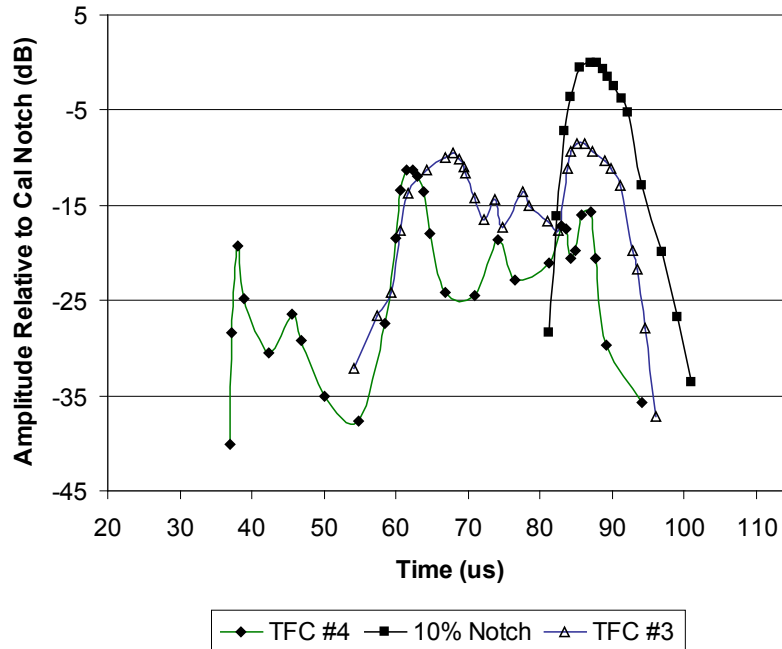
Figure 6-10 Echo-Dynamic Curves for Rough Cracks in Alloy 600 to 45° Shear Waves. Duration of echo-dynamic curves for rough cracks shows some relationship with crack size. TFC 4 is approximately 75% through-wall. TFC 3 is approximately 50% through-wall. The echo-dynamic curve of the 10% notch is shown for reference.

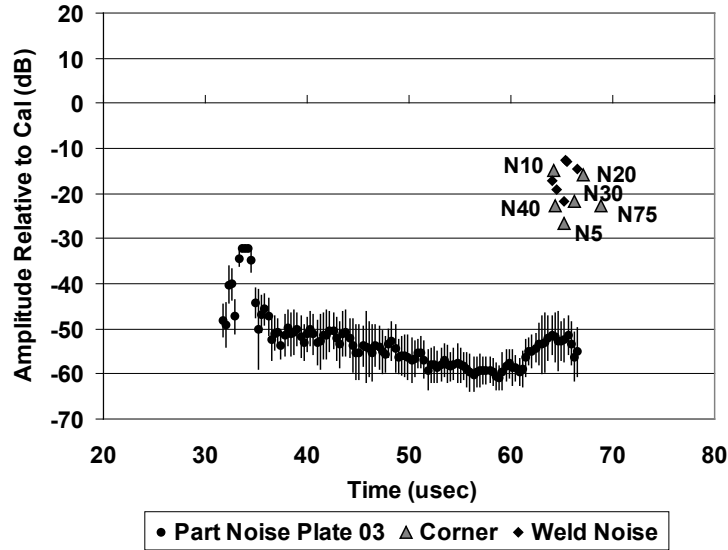
Figure 6-12 Response of Notches to 45° Shear Waves at 2.25 MHz for Far-Side Through-Weld Metal Access in Stainless Steel

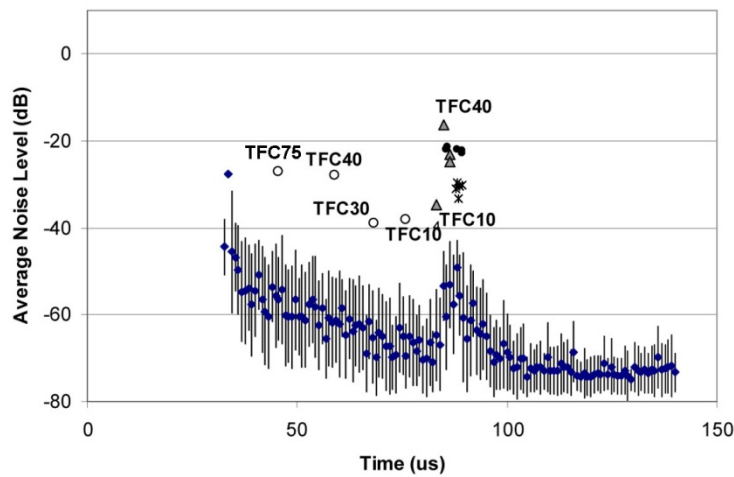
Figure 6-13 Response of Notches to 45° Shear Waves for Far-Side Through-Weld Metal Access in Alloy 600

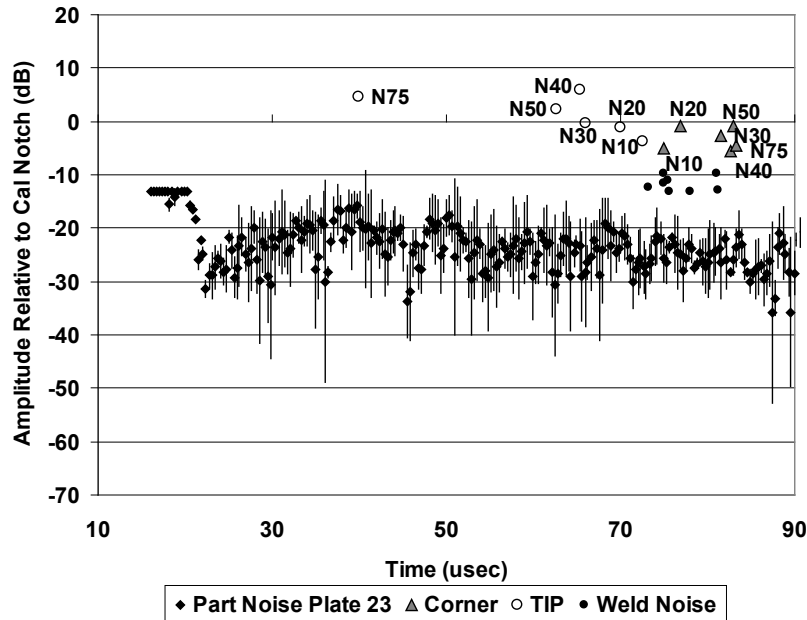
Figure 6-14 Responses of Notches to Creeping Waves at 2 MHz for Far-Side Through-Weld Metal Access in Stainless Steel

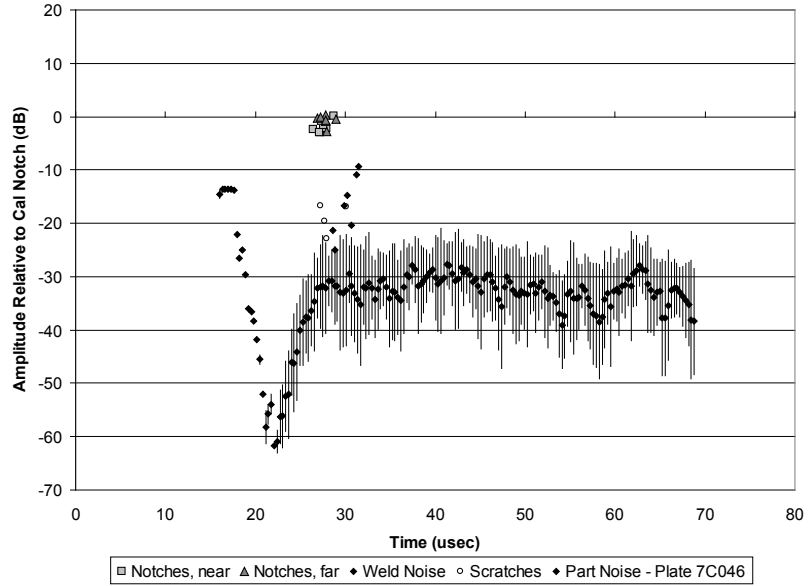
Figure 6-15 Dual-Element Probe, 70° 2-MHz, Detection Results for Notches Connected to Scanning Surface in Stainless Steel

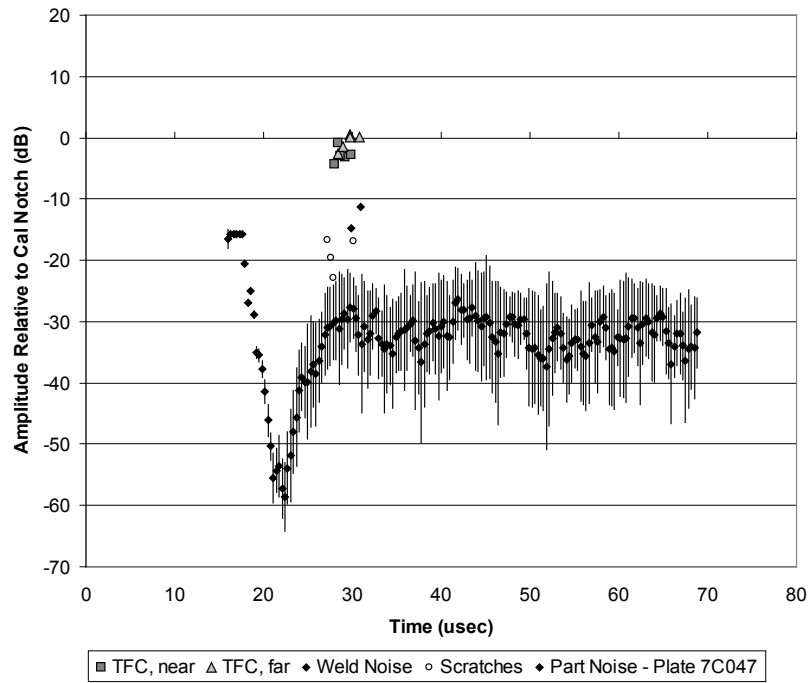
Figure 6-16 Dual-Element Probe, 70° 2-MHz, Detection Results for Thermal Fatigue Cracks Connected to the Scanning Surface in Stainless Steel

Figures 6.16 and 6.17 show the responses for TFCs and WSCs, respectively. The responses from the cracks do not differ from the responses from the notches.

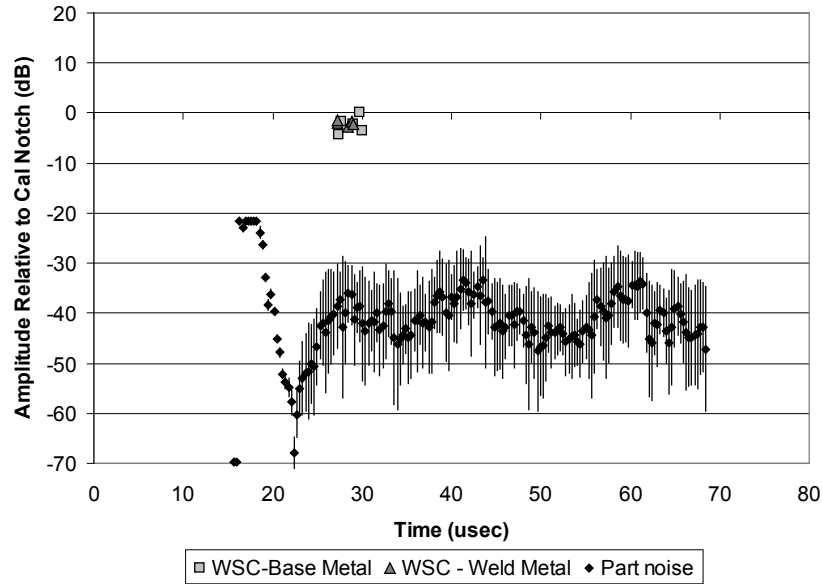
Figure 6-17 Dual-Element Probe, 70° 2-MHz, Detection Results for Weld Solidification Cracks Connected to the Scanning Surface in Stainless Steel

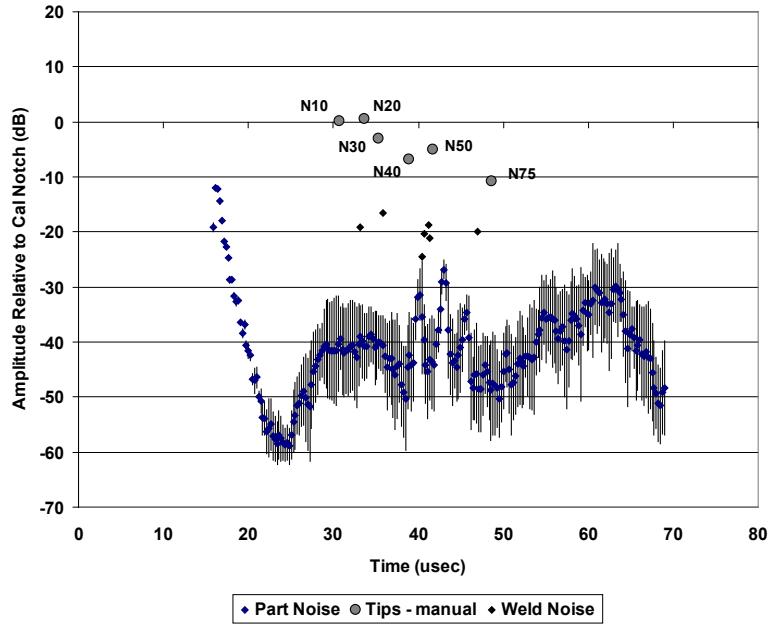
Figure 6-18 Dual-Element Probe, 60° 2-MHz, Notch Tip Responses Through Base Metal for Notches Connected to the Scanning Surface in Stainless Steel

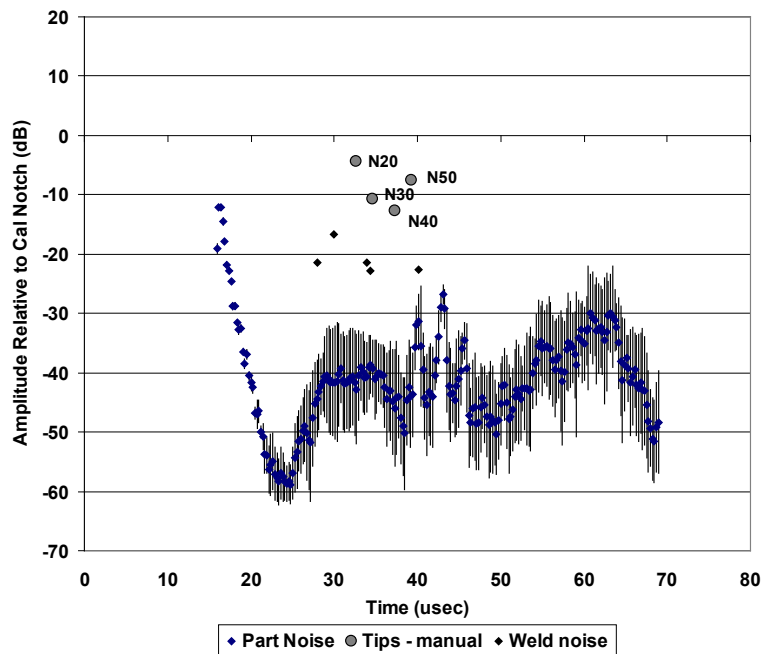
Figure 6-19 Dual-Element Probe, 60° 2-MHz, Notch Tip Responses Through Weld Metal for Notches Connected to the Scanning Surface in Stainless Steel

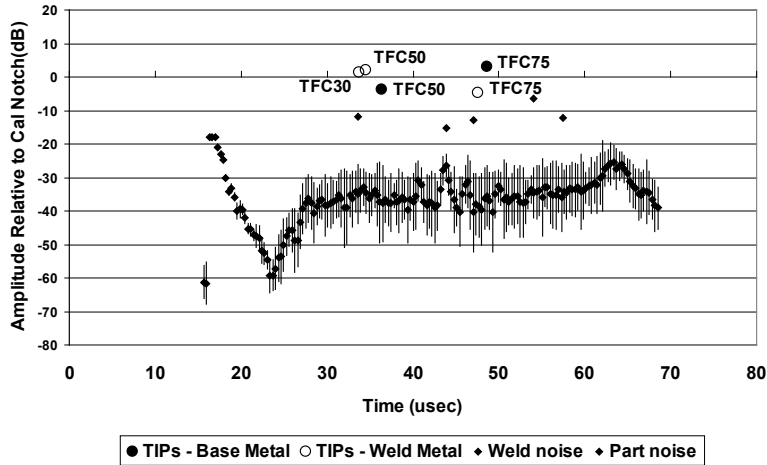
Figure 6-20 Dual-Element Probe, 60° Transmit-Receive Refracted Longitudinal 2-MHz, Thermal Fatigue Crack Tip Responses Through Base and Weld Metal for Cracks Connected to the Scanning Surface in Stainless Steel

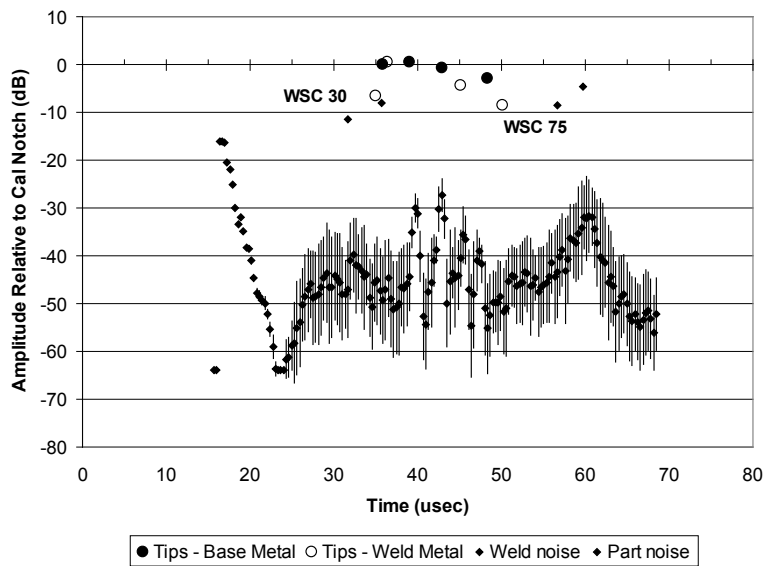
Figure 6-21 Dual-Element Probe, 60° 2-MHz, Weld Solidification Crack Tip Responses Through Base and Weld Metal for Cracks Connected to the Scanning Surface in Stainless Steel

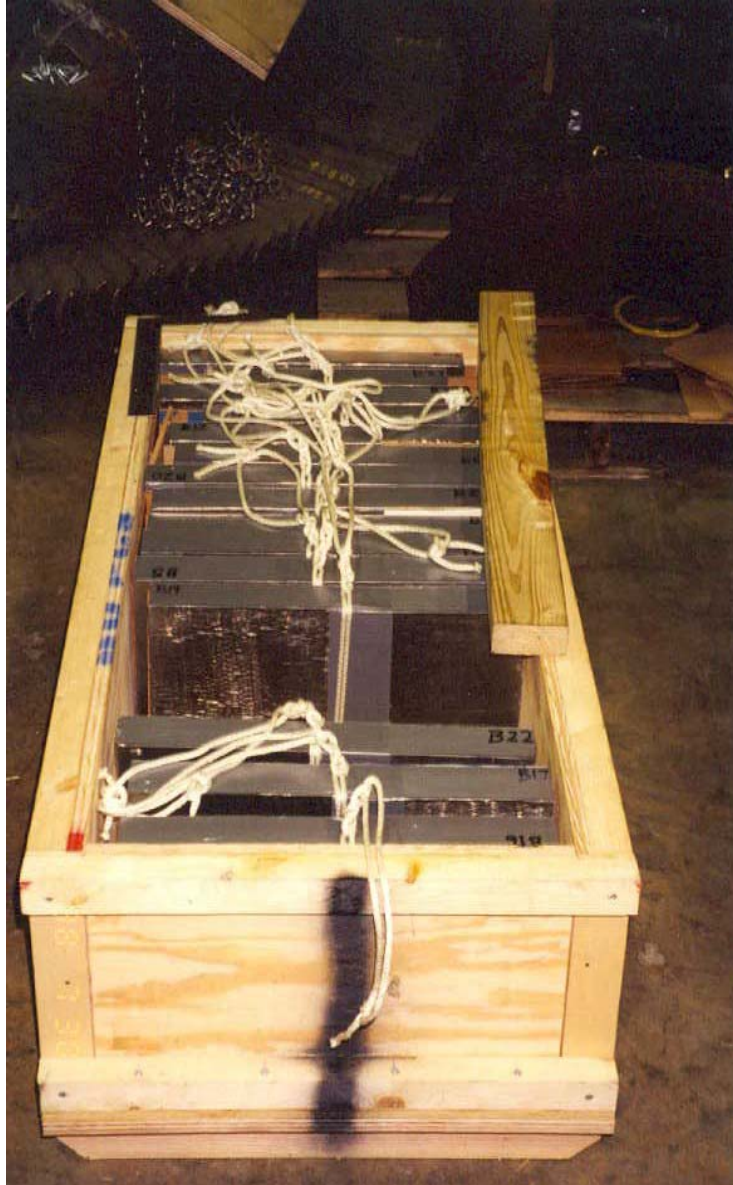
Figure 7-1 PNNL Mockup at EPRI NDE Center

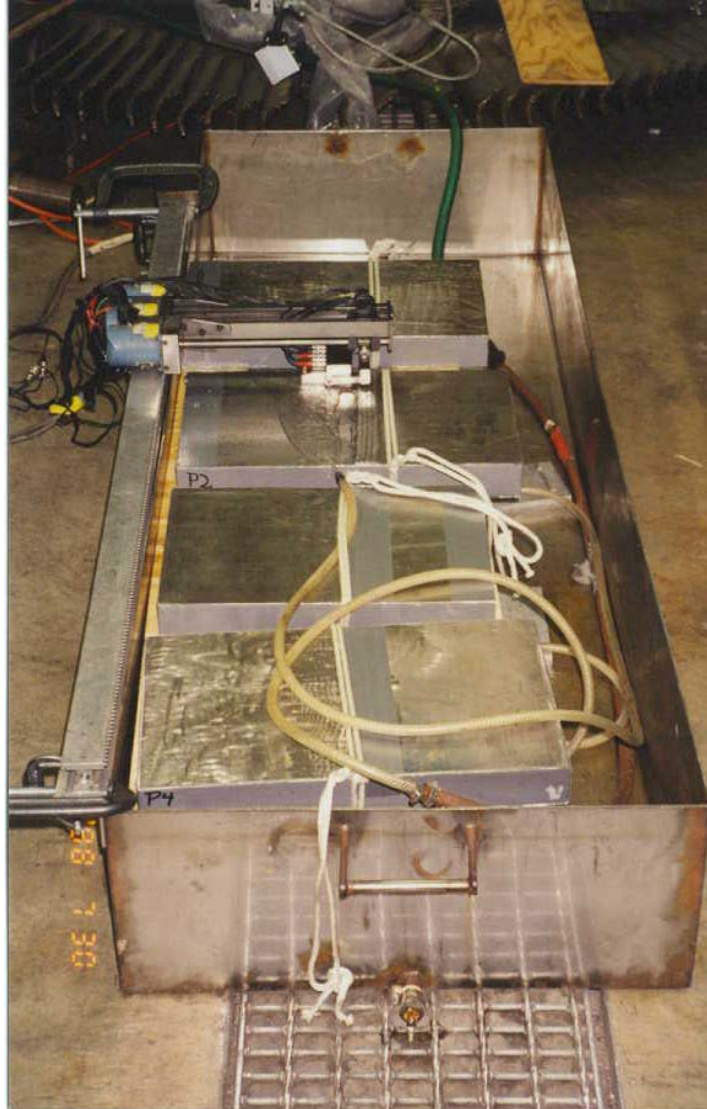
Figure 7-2 Inspection Scanner and Presentation of Specimens in Blind Test

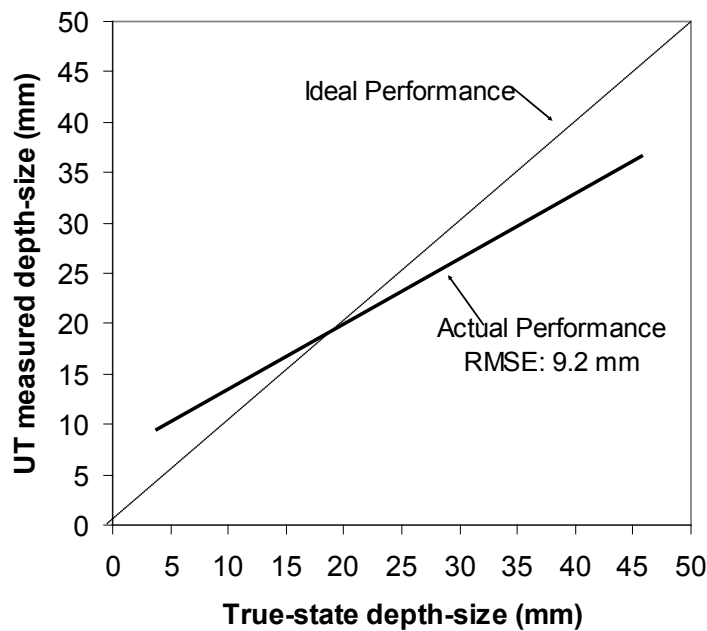
Figure 7-3 Blind Test Depth Sizing Performance for All Detected Cracks

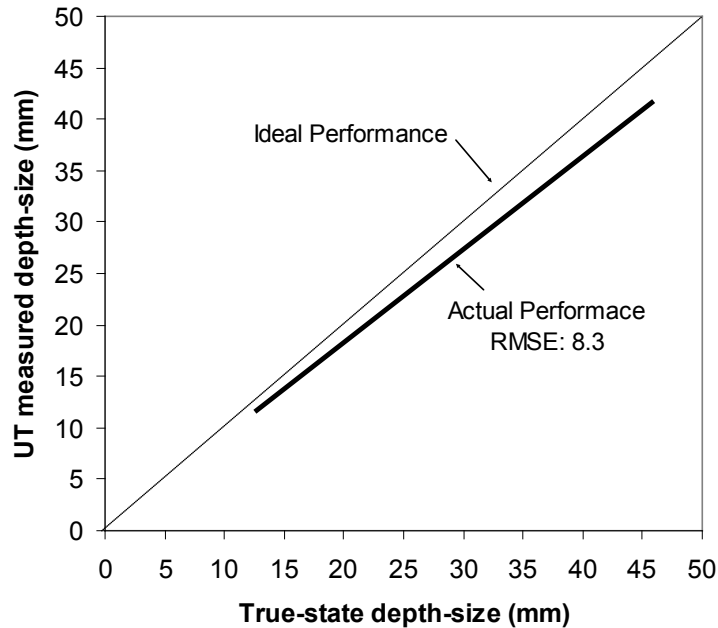
Figure 7-4 Blind Test Depth Sizing Performance Without Small Cracks

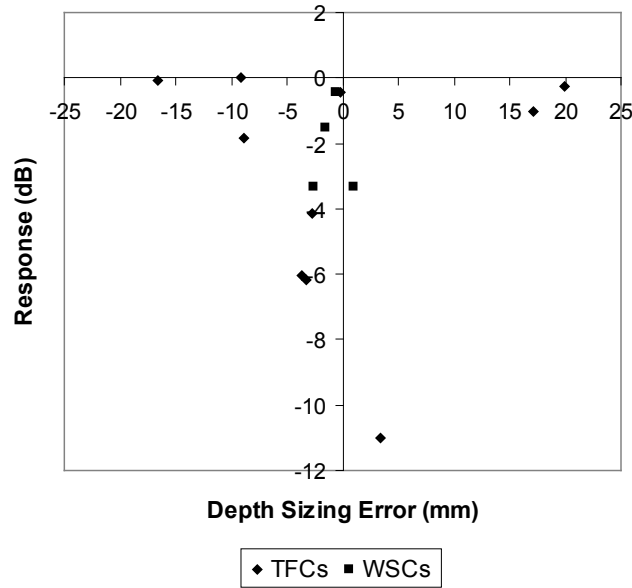
Figure 7-5 Blind Test Dependence of Sizing Error on Tip Response

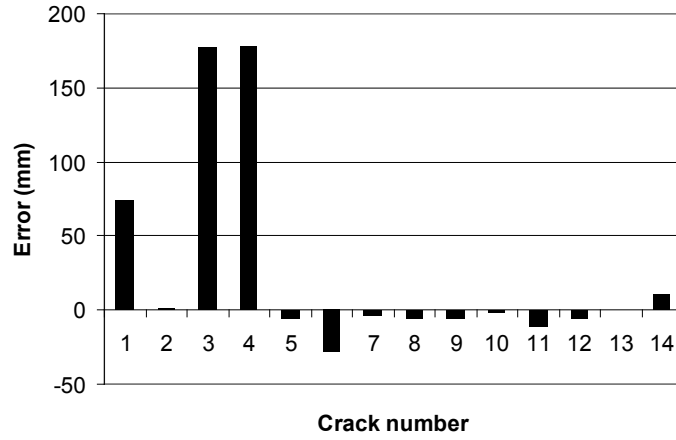
Figure 7-6 Blind Test Length Sizing

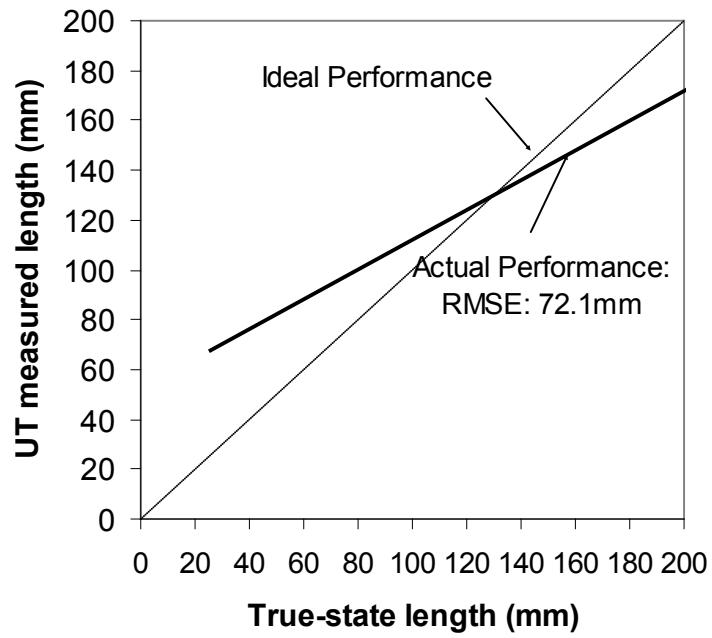
Figure 7-7 Blind Test Length Sizing Performance for All Cracks

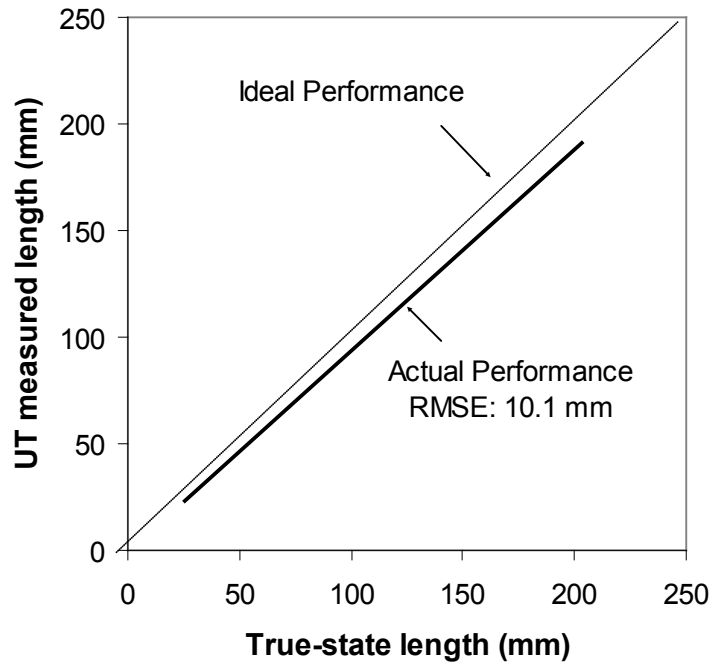
Figure 7-8 Blind Test Length Sizing Performance Without Large Oversizing Errors of Greater Than 50 mm

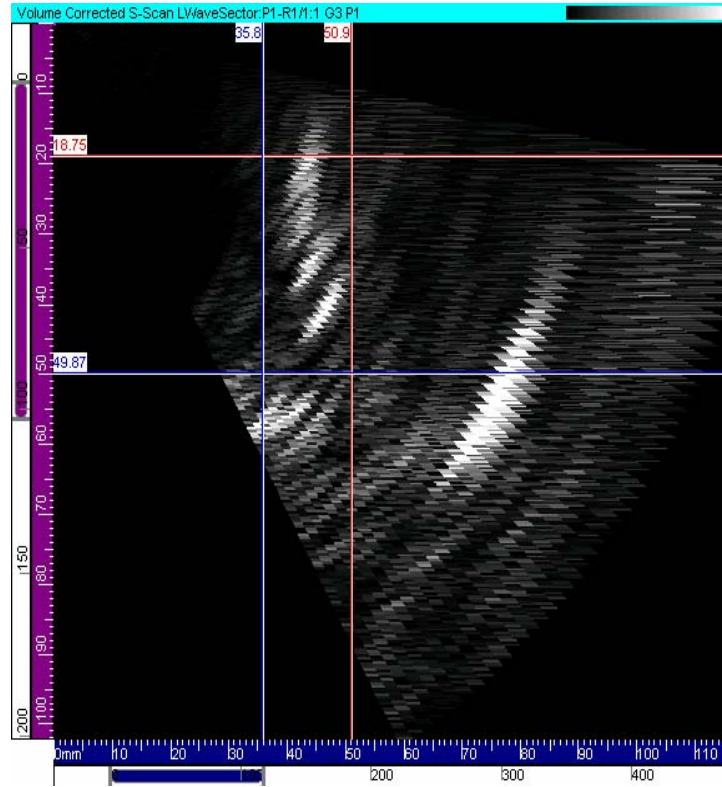
Figure 7-9 Typical Phased Array Image of Crack (units shown in millimeters)

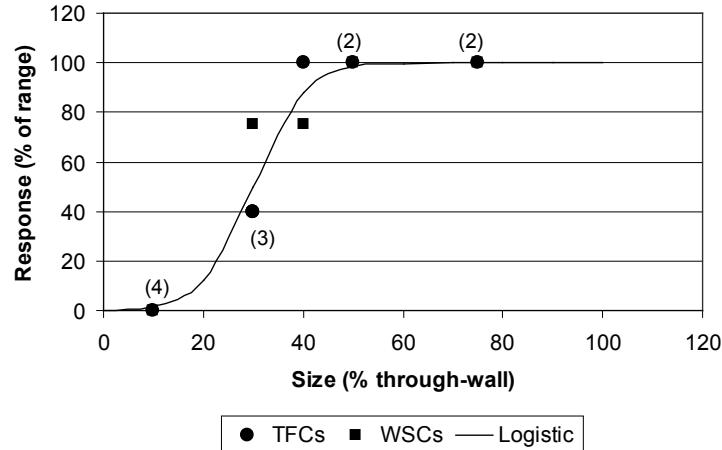
Figure 7-10 Relationship Between Response and Crack Size in Phased Array Blind Test on Stainless Steel in Reactor Internals Mockup
