NRC / NEI / UTILITY MTG 6/11/14 4" & 6" RD/CH Drain Piping Inspection at the Palo Verde Nuclear Generating Station **Utilizing Quest's HYDRA**[™] Intelligent Pigging Technology - Dan Wittas -

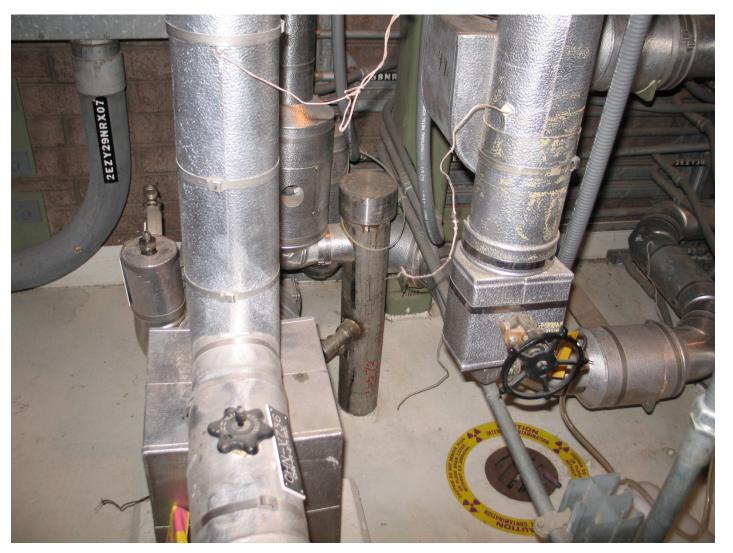
RD LINES 4" THREADED CAP AND FLOOR DRAIN NRC / NEI / UTILITY MTG 6/11/14

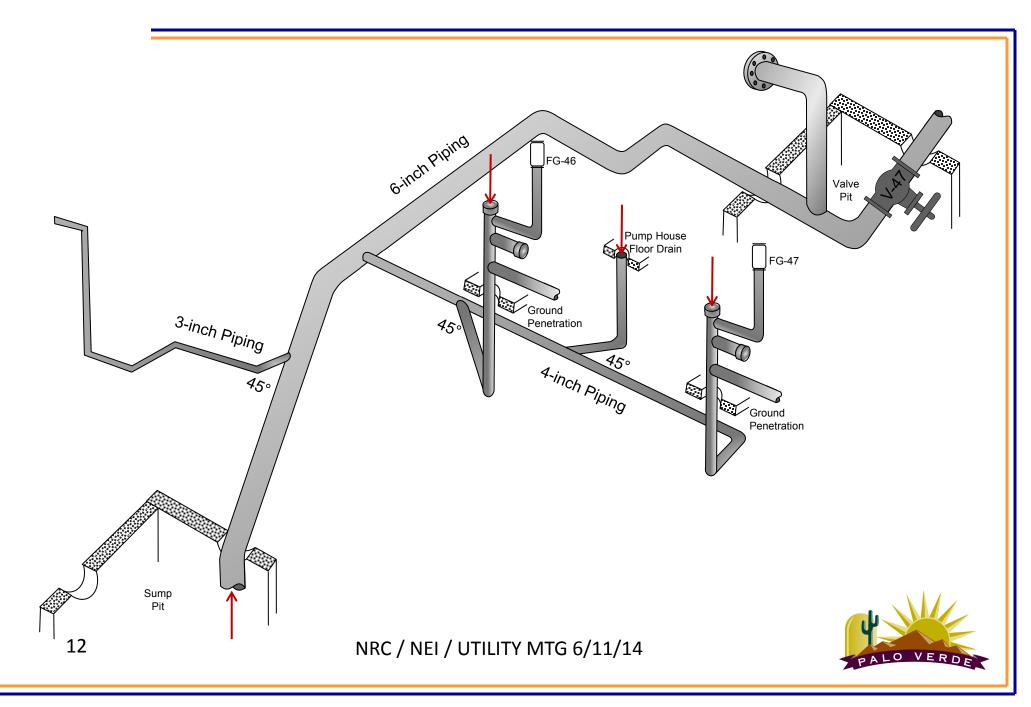
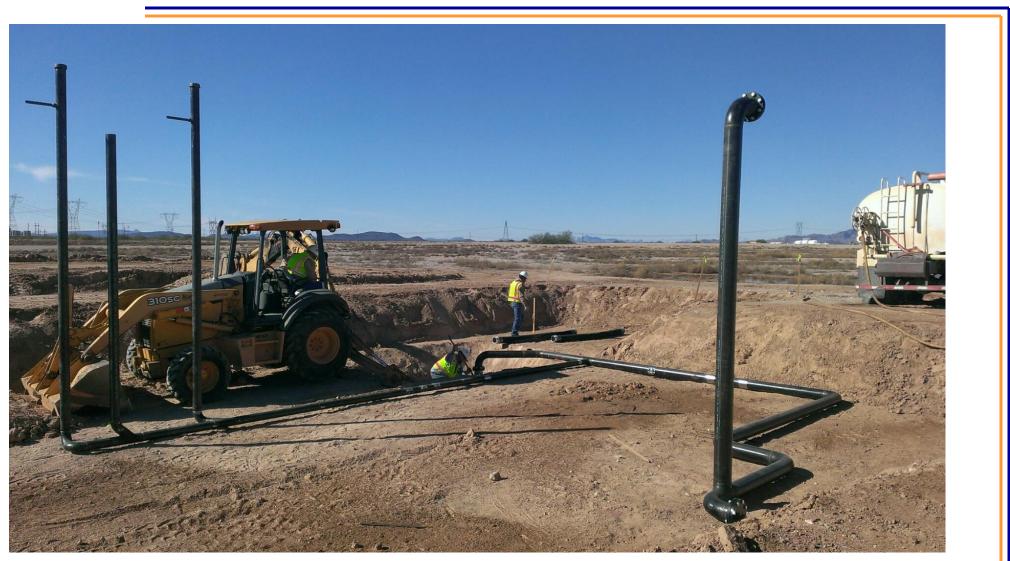
- Full scale mockup for deployment, retrieval and blind flaw detection capability
 - The inspection tool could be deployed and retrieved, thru 90s and a tee.
 - The Quest Hydra[™] UT inspection tool detected 26 of 34 flaws. All 8 undetected flaws were below the published detection threshold. 10 flaws below the threshold were detected, including 2 - 1/8" diameter flaws.

FULL SCALE MOCK-UP W/ 32 FLAWS PRIOR TO BURIAL
