# Use of Robotics and Remote Monitoring Equipment for Reducing Dose and Risk Associated with Radiological Work at Ontario Power Generation

Josip Zic

# High Activity Debris Identification

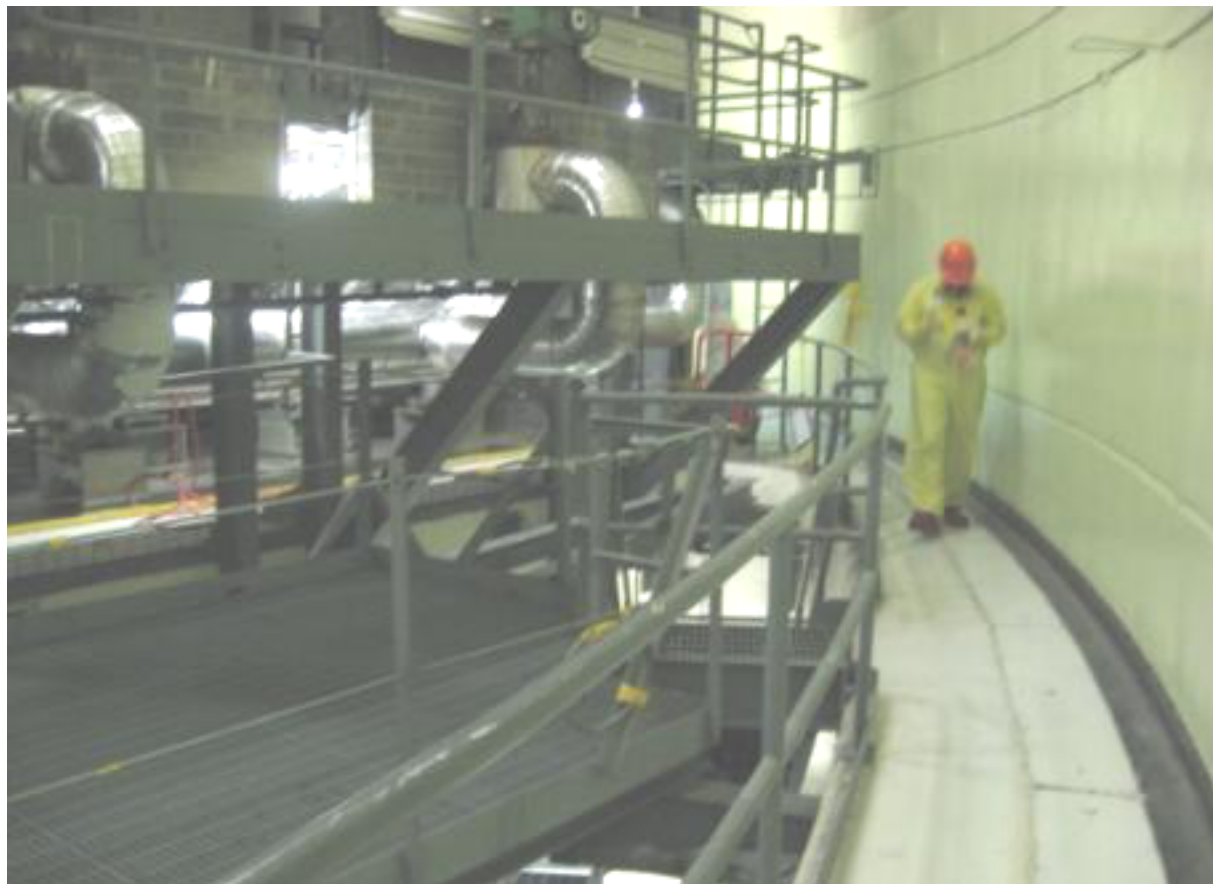
- Radiation

Technician discovers gamma radiation field of 500 mrem/h in an area that is typically 2 mrem/h.

- ALARA later discovers that a worker doing a leak search under the boilers had a peak dose rate of 4,900 mrem/h on their EPD.

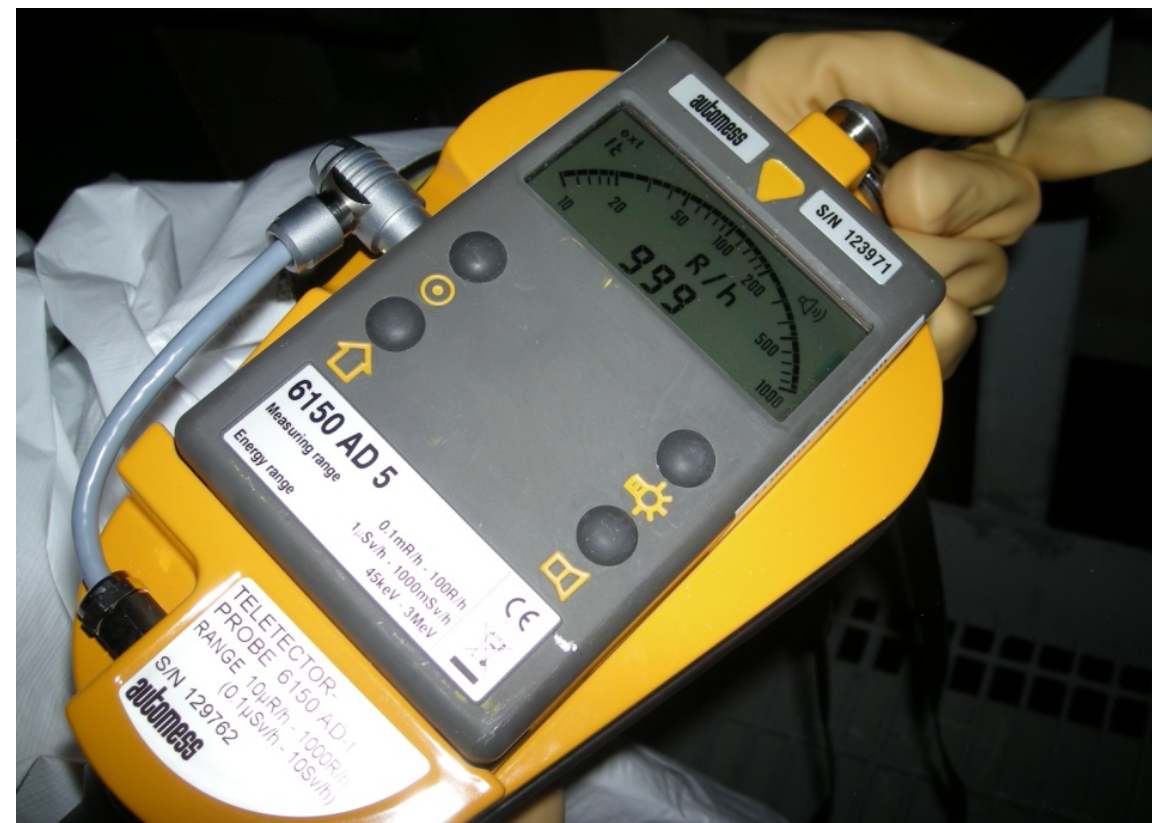
- A high hazard work plan was written to identify the source of the high radiation dose rates.
- Armed with a 14' Automess extension gamma meter the technicians looked for the source in the 80' by 20' maze of pipe work under the boilers.

• Surveys identified that the source of the unusually high dose rate was the Boiler 6 cold leg drain line.

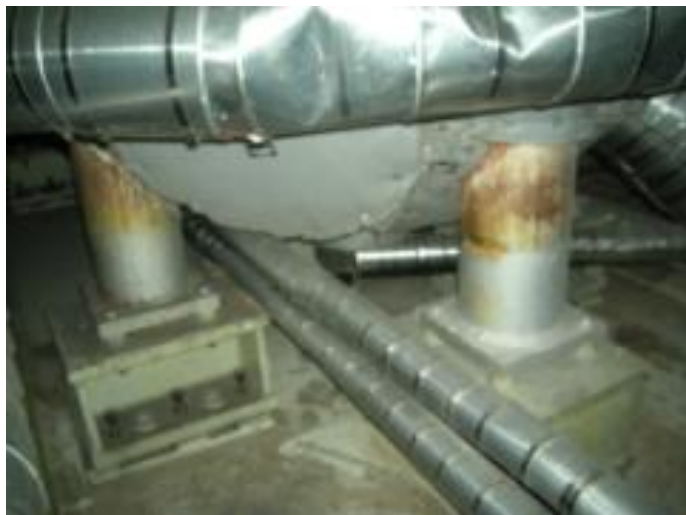
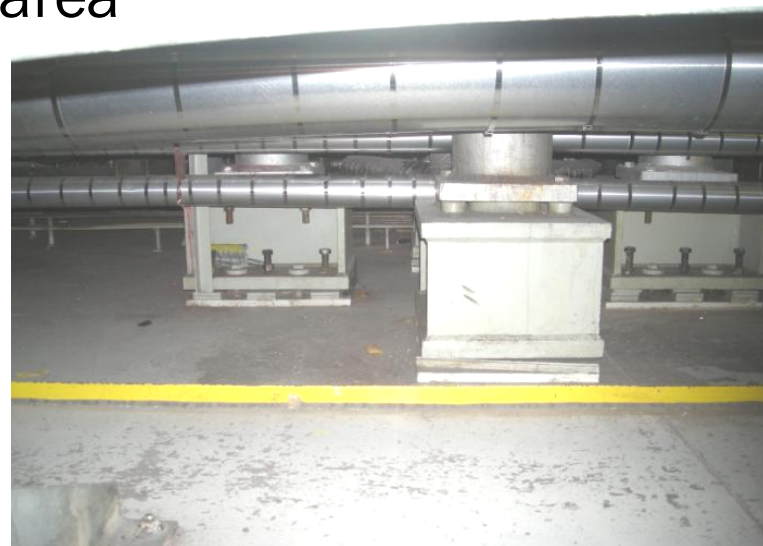
- High activity debris (~35 Ci of Co-60) in the Boiler 6 Cold Leg Drain Line of Unit 4.
  - 500 rem/h working distance
  - 3.5 rem/h at 10'
  - 500 mrem/h at 20'
- Drain line located in very congested area

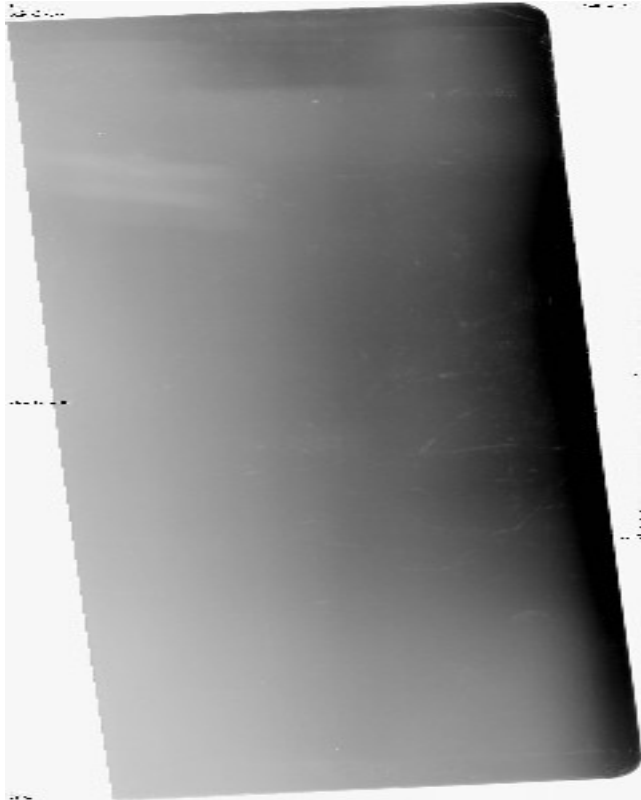
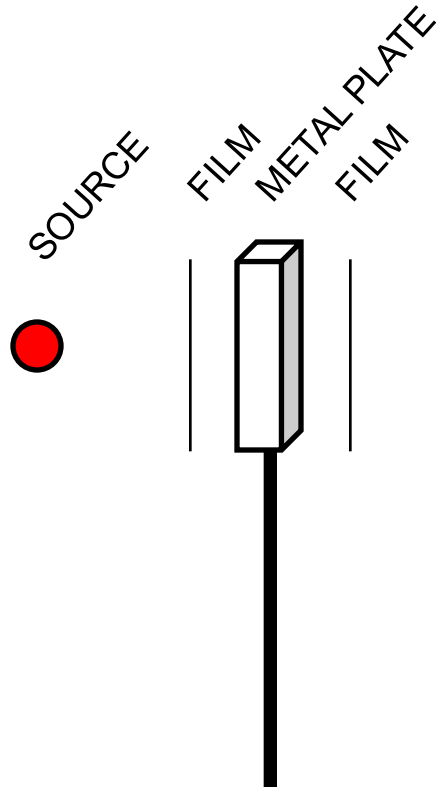
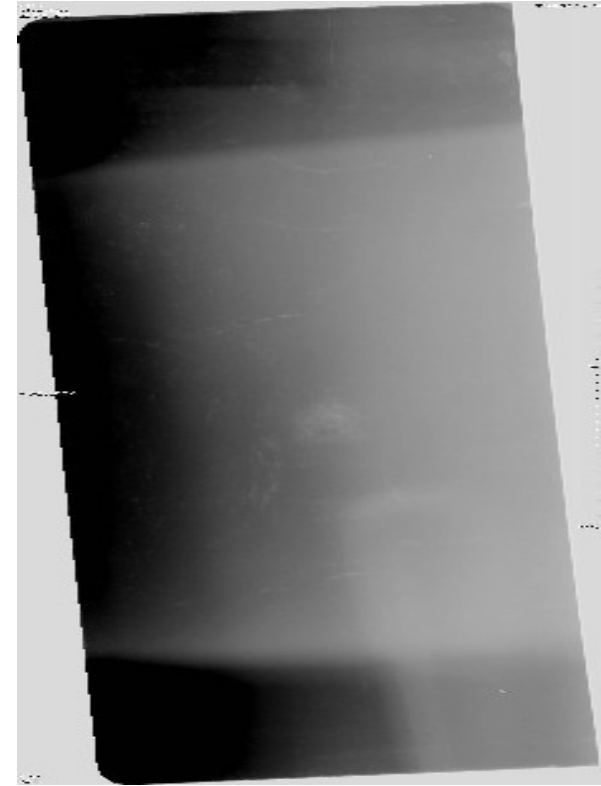
The best indication of the location of the source, prior to execution, came from using radiography film.

COLD LEG

BOILER BOWL

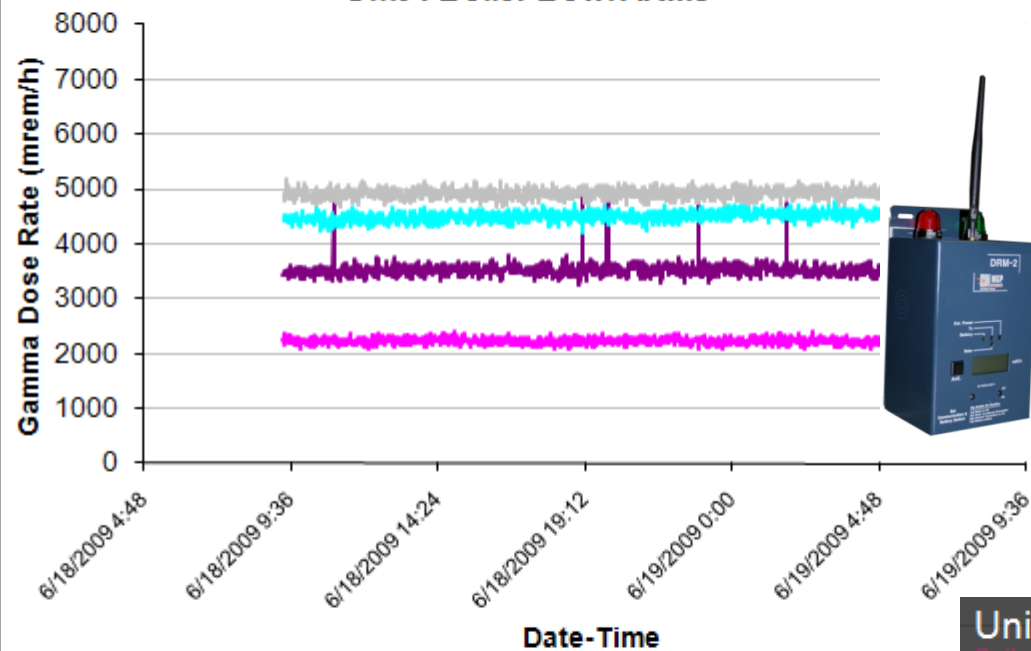
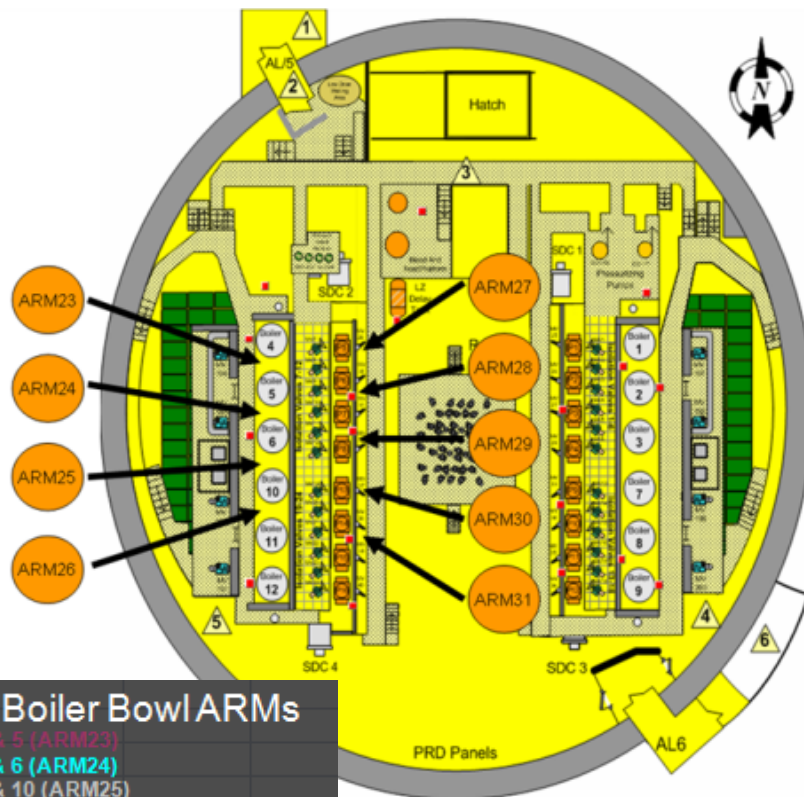
Unit 4 Boiler Bowl ARMs

- Real-time monitoring during Unit operation (DRM-2)

- Boilers 4 & 5 (ARM23)
- Boilers 5 & 6 (ARM24)
- Boilers 6 & 10 (ARM25)
- Boilers 10 & 11 (ARM26)

- PHT Pit MV29 (ARM27)
- PHT Pit MV30 (ARM28)
- PHT Pit MV31 (ARM29)
- PHT Pit MV32 (ARM30)
- PHT Pit MV37 (ARM31)

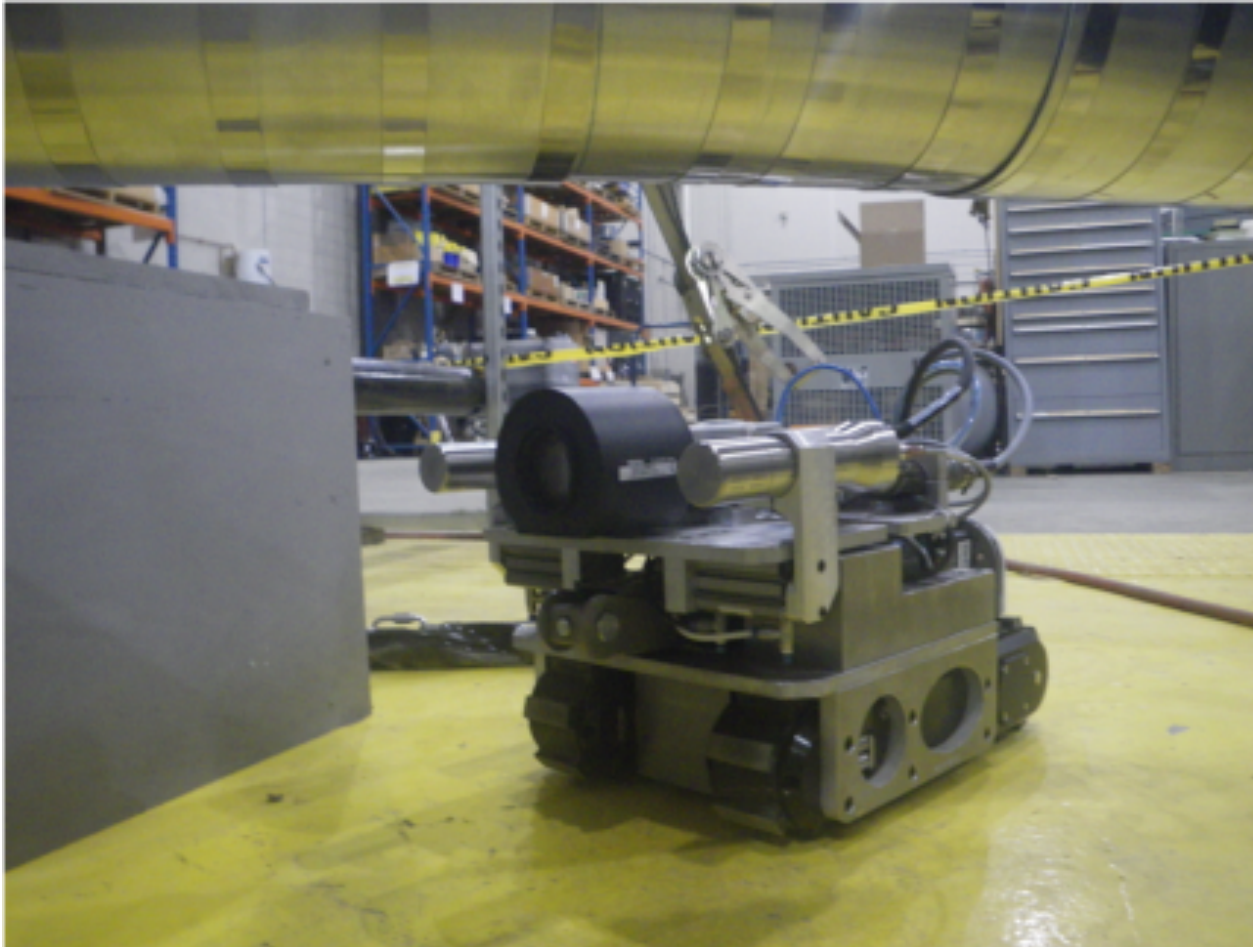
WALL-E

- Gamma Camera Robot

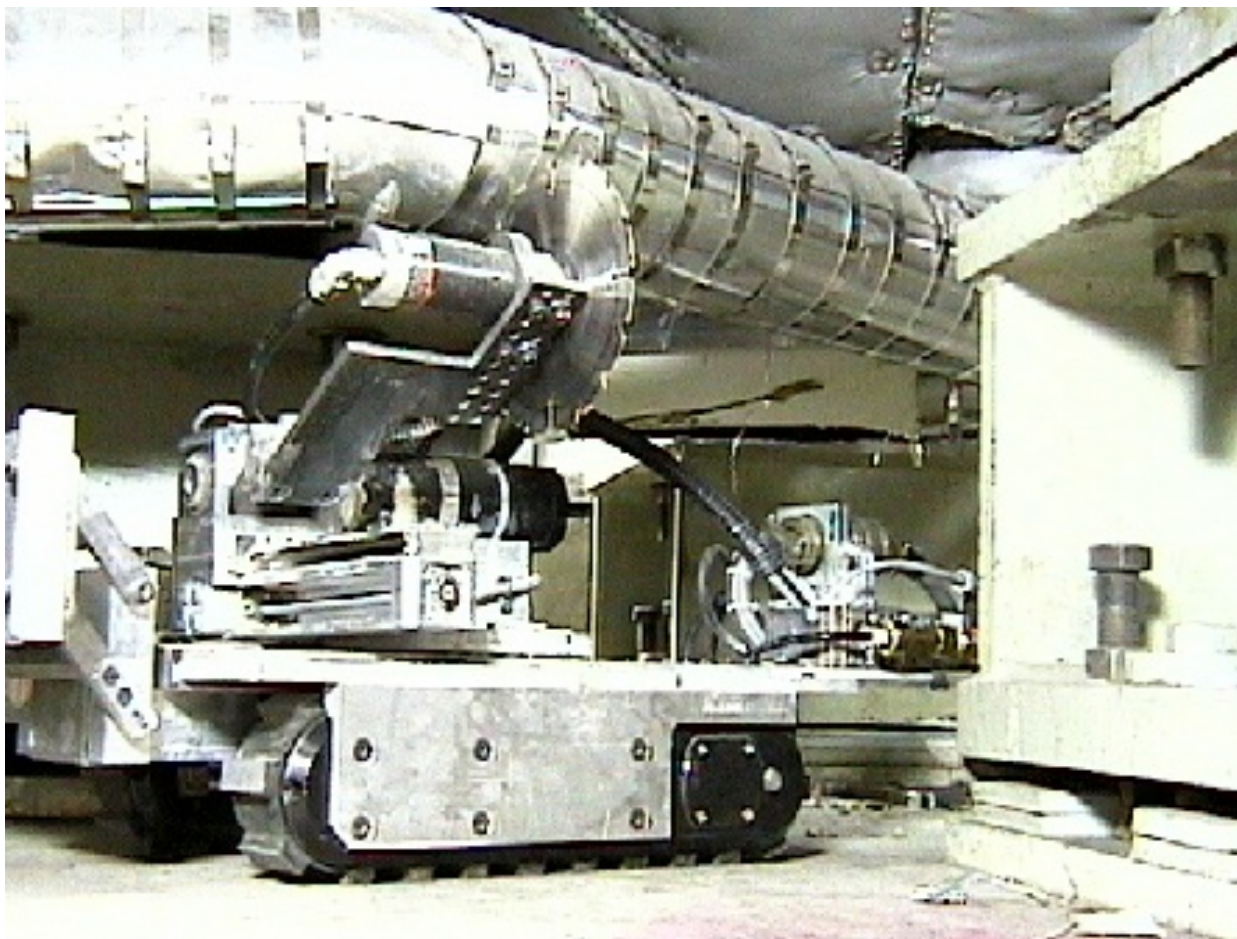
MATER

- Insulation Removal Robot

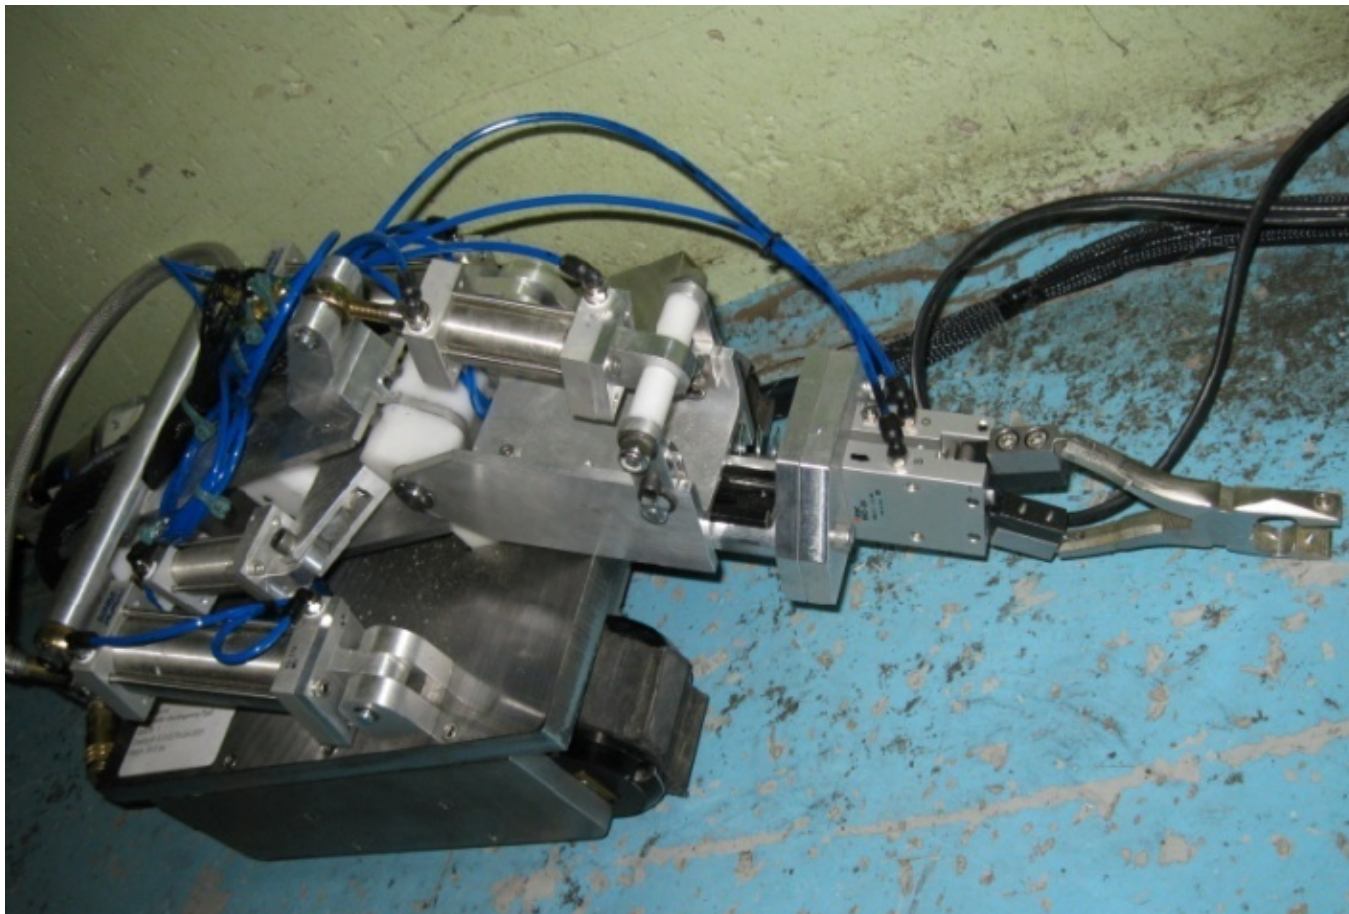
OPTIMUS  
PRIME

- Contingency Robot

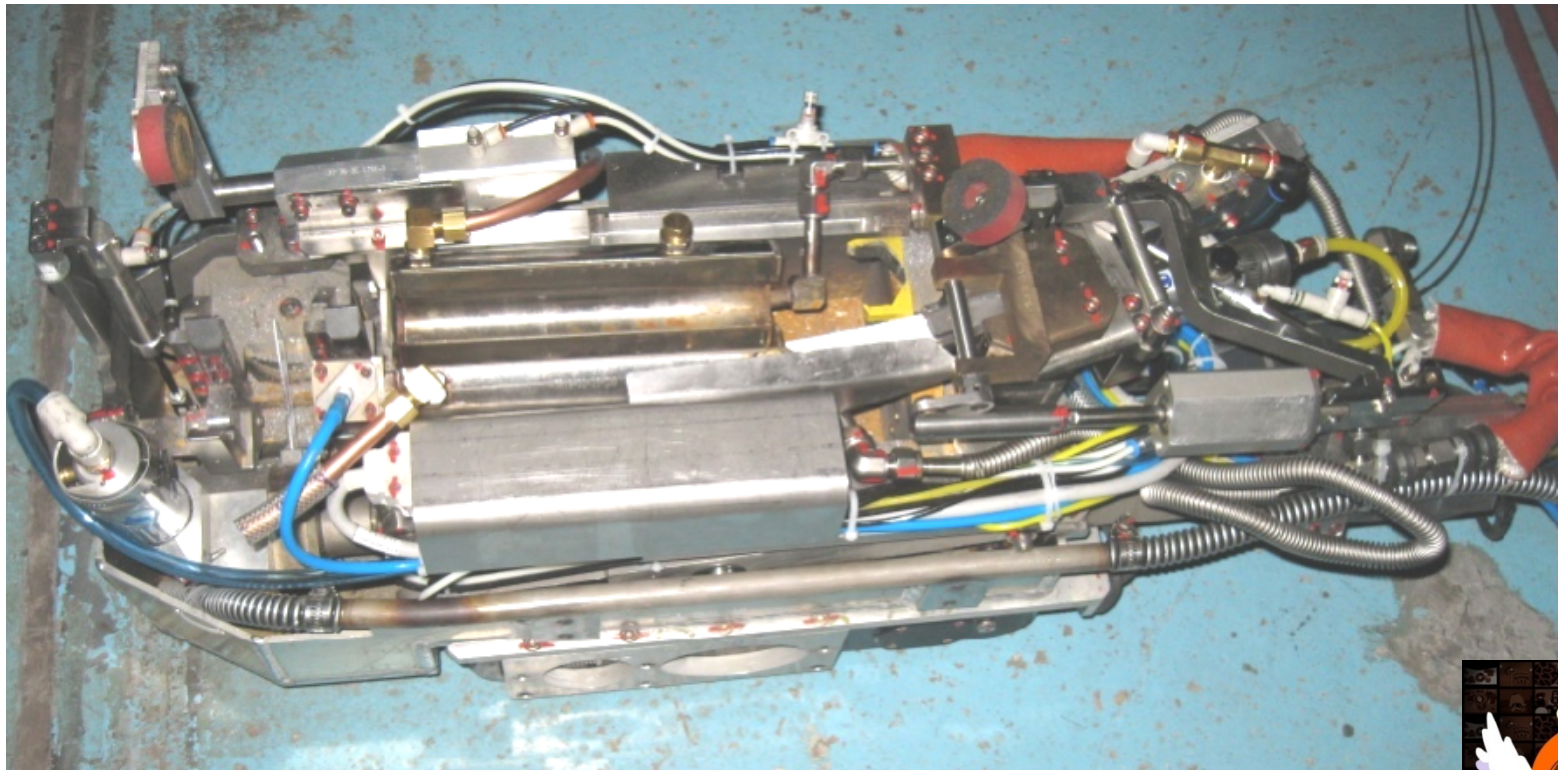
KENNY

- Freeze-Cut Robot

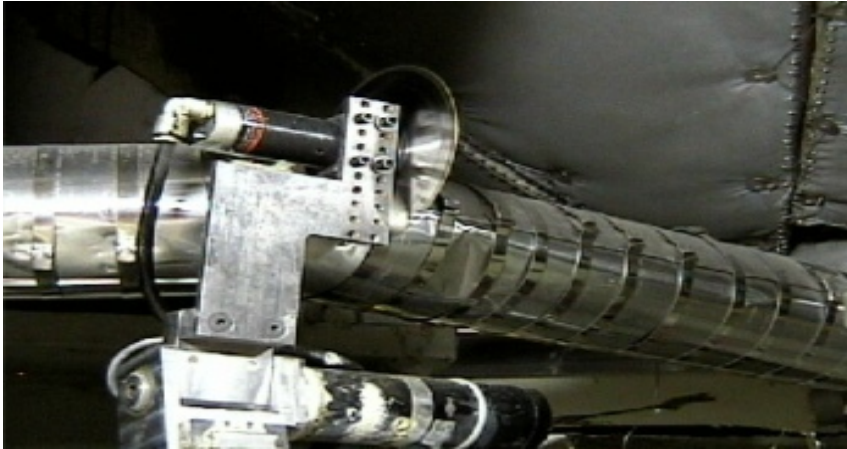
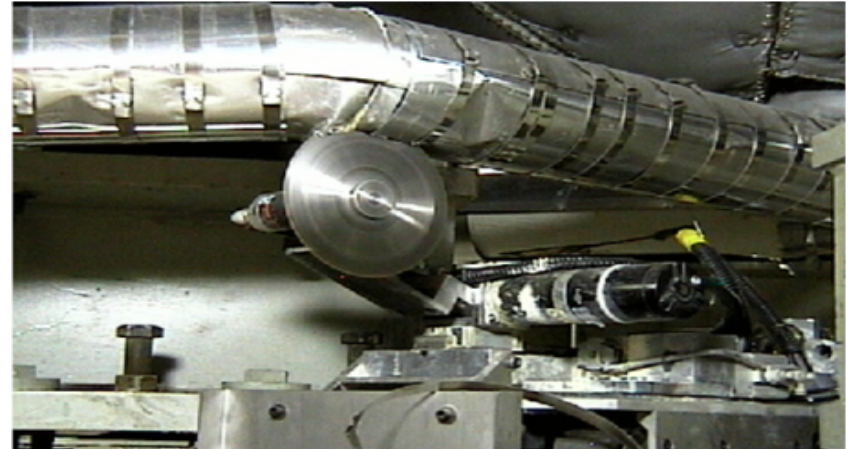
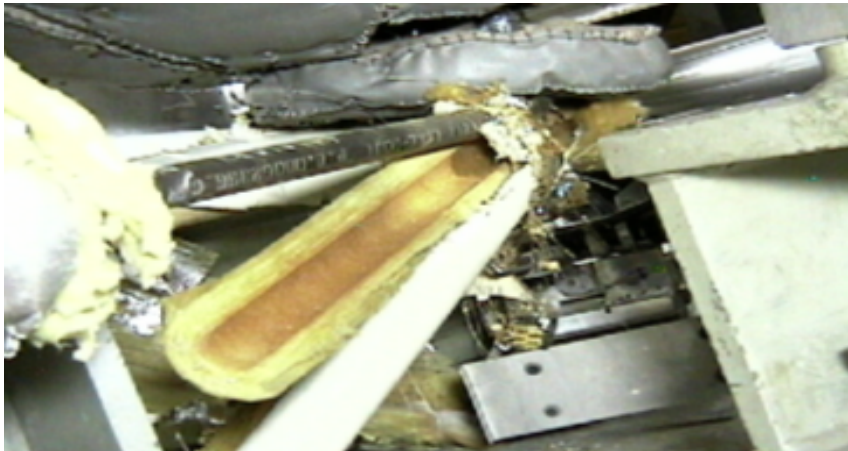
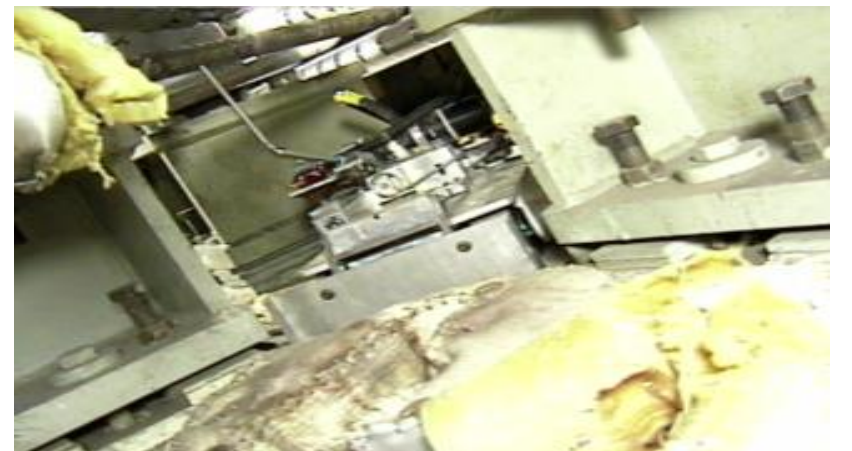
- Insulation Removal

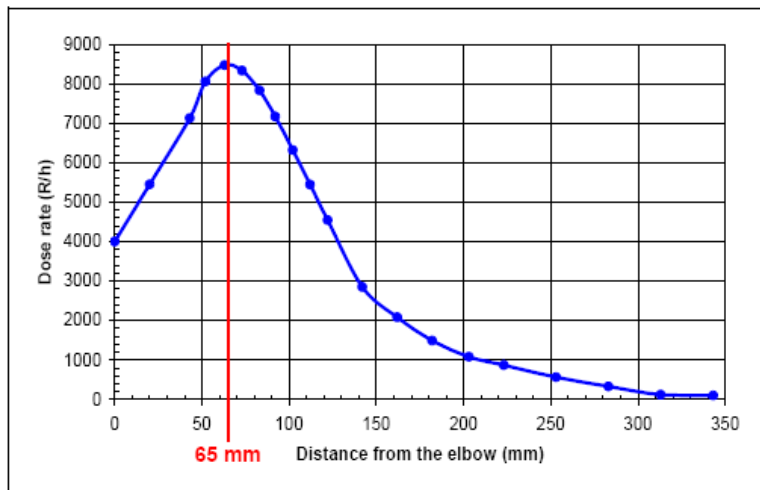
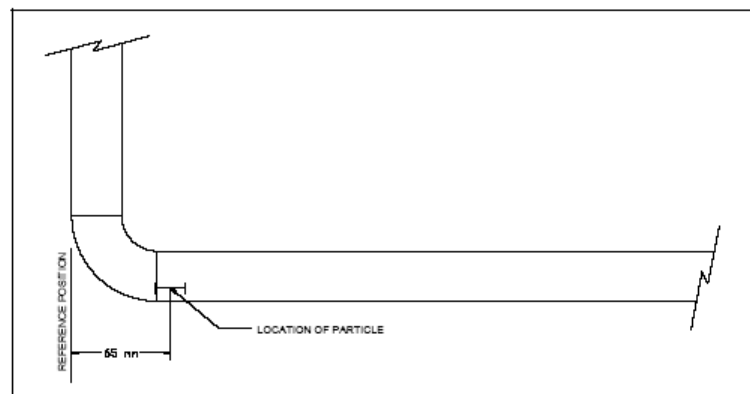
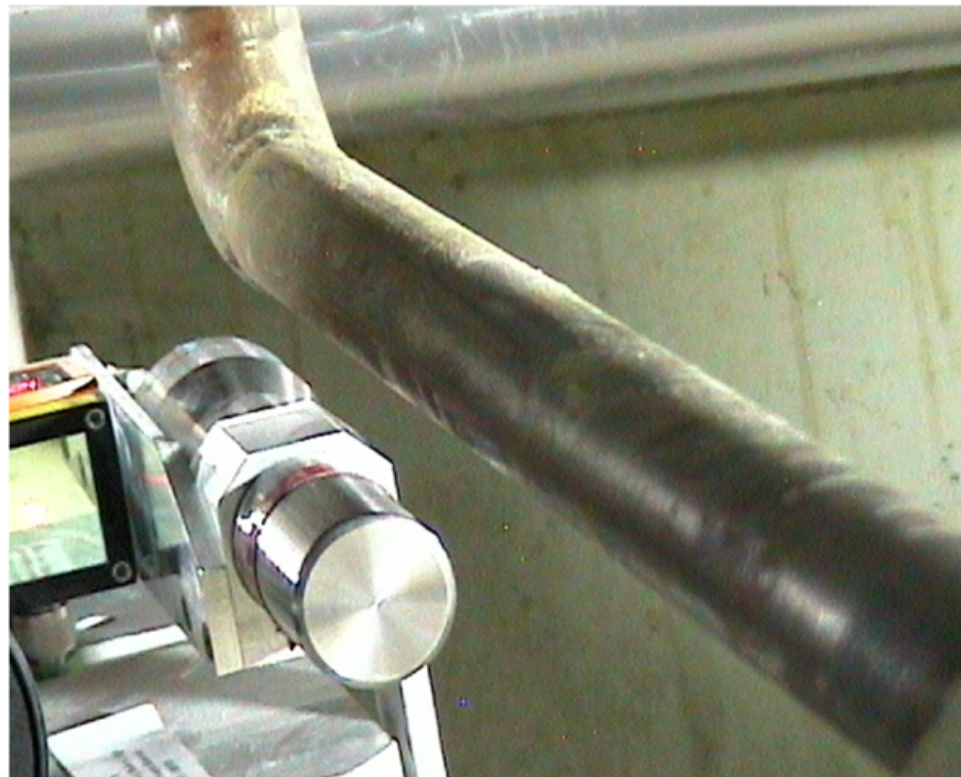
## ■ Verifying Source Location

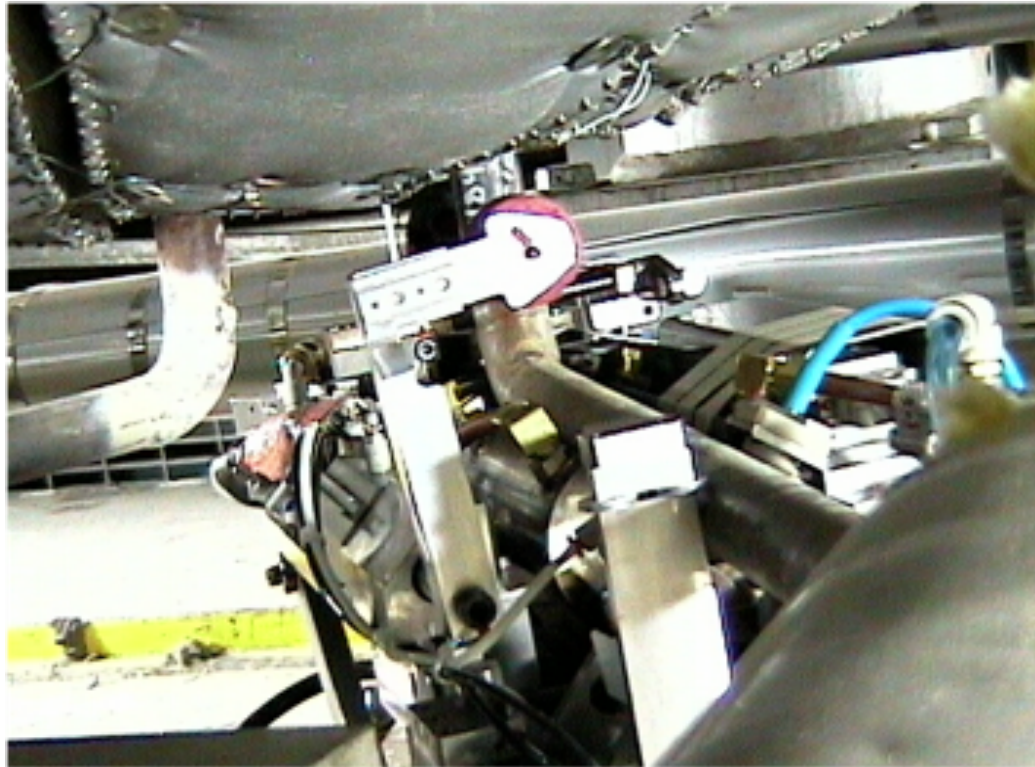
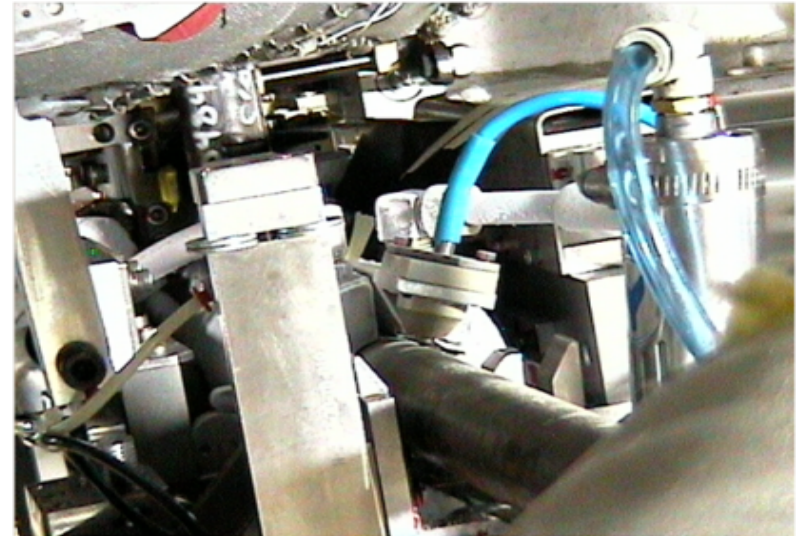
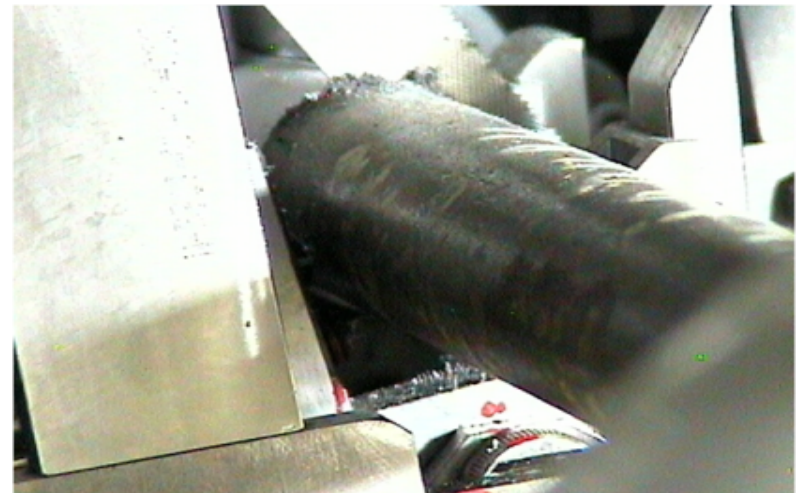
- Freeze Cut and Cap

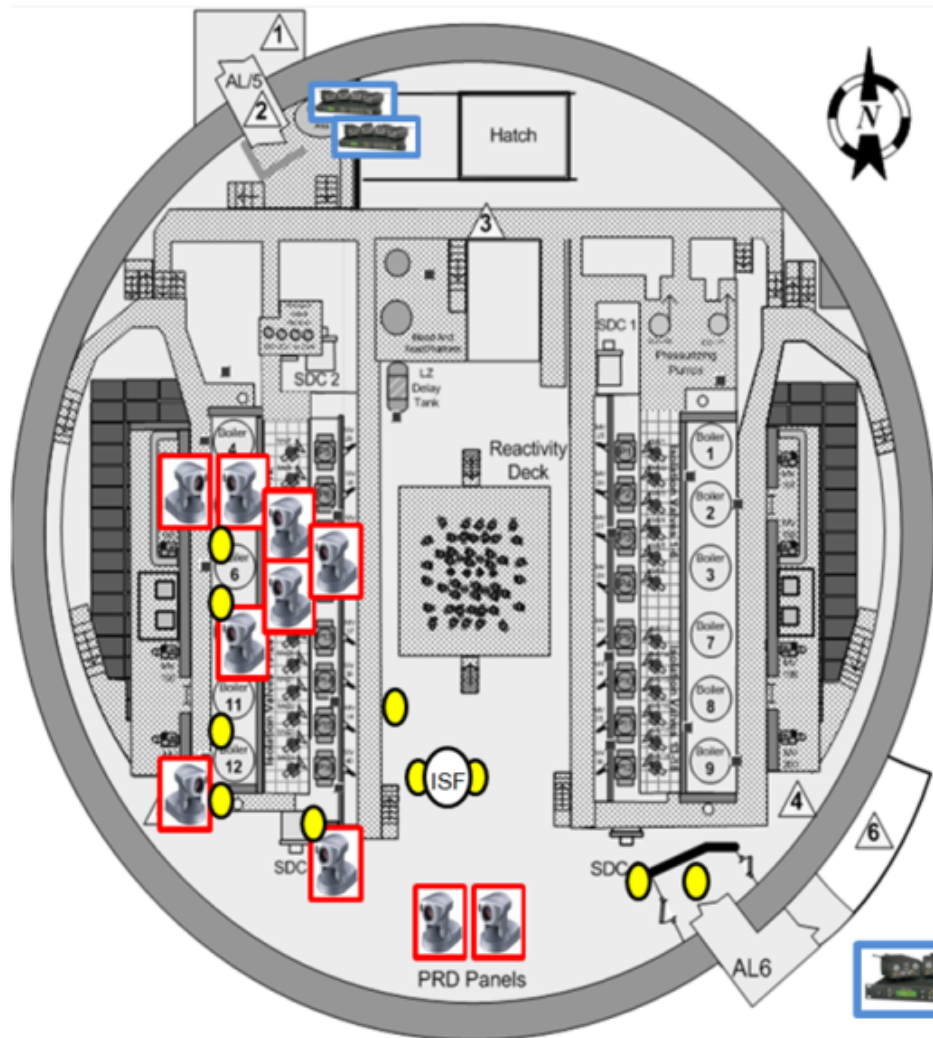
- 10 Video Cameras + 3 Added Later
- 10 Area Radiation Monitors
- 8 Wireless Communication Packs

- Minimize number of staff in area
- Maximize safety of execution staff
- Track movement of High Activity Debris

-   Network Camera
-   Area Radiation Monitor
-   Wireless Communications

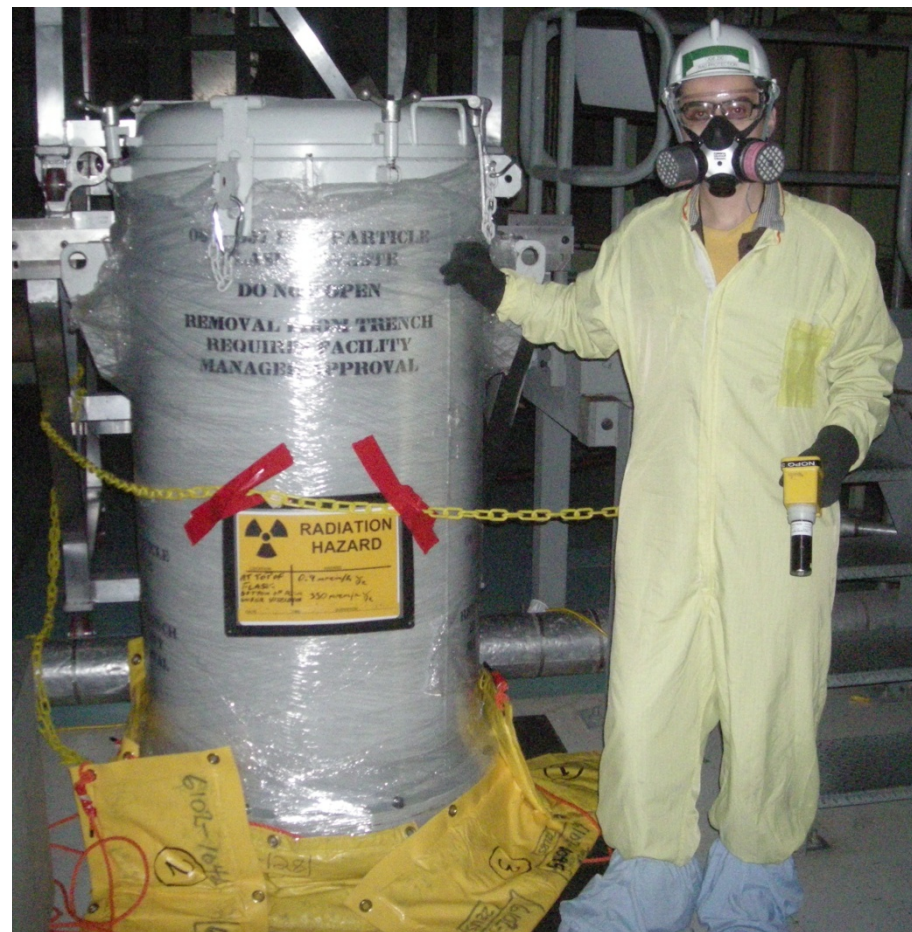
- Average Dose Rates in Work Areas: 5 mrem/h
  - Highest Peak Dose Rate to a Worker: 200 mrem/h
  - Total Dose for Source Retrieval: 151 mrem
  - Dose for Source Containment and shipping: 12 mrem
- Ended up having to do it again in 2014 on Unit 4 Boiler 8

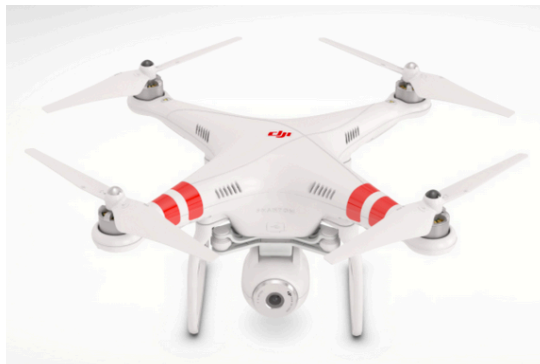
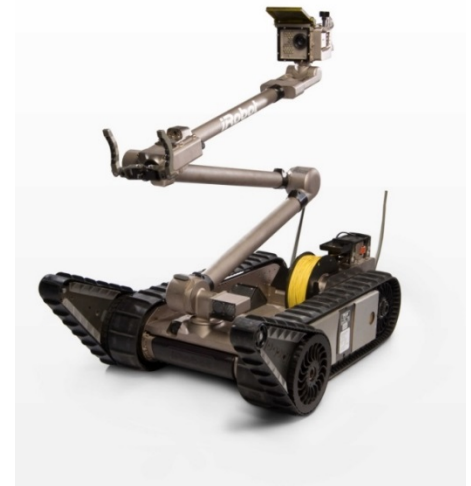
# Quick Wins

- Real-Time Routine Surveys
  - Gamma, tritium, beta airborne, alpha airborne, radioiodine
- Non-Radiological Monitoring
  - iCAM filter head changes, HEPA vacuum on/off, temperature, humidity
- Use of robotics to perform surveys, visual / thermal inspections

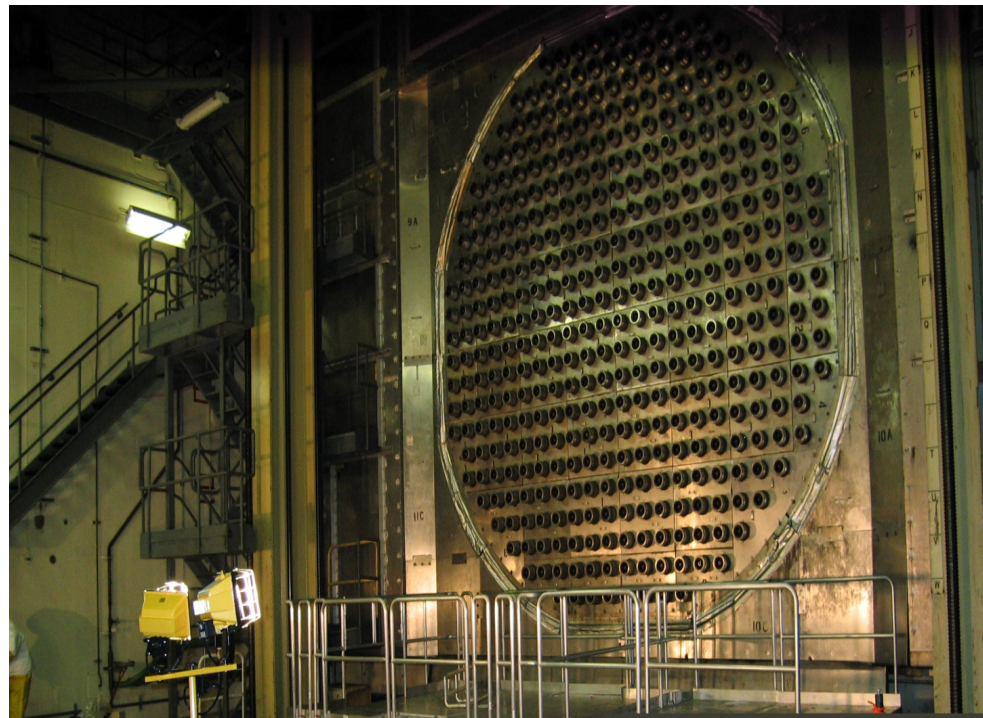
- Current Method:
  - Remote monitors on F/M Bridge
  - 2-3 hours of critical path
- Proposed Method:
  - Automated drones
  - Off-critical path
- Challenges
  - Time required to measure up to 390 channels, with current battery limitations of drones
  - Positioning of drone without GPS
  - Additional weight of gamma detector and transmitter
