REPORT ON HIGH ENERGY ARCING FAULT EXPERIMENTS

Experimental Results from Medium Voltage Electrical Enclosures

Prepared by:
G. Taylor
Office of Nuclear Regulatory Research

NIST Technical Note 2188

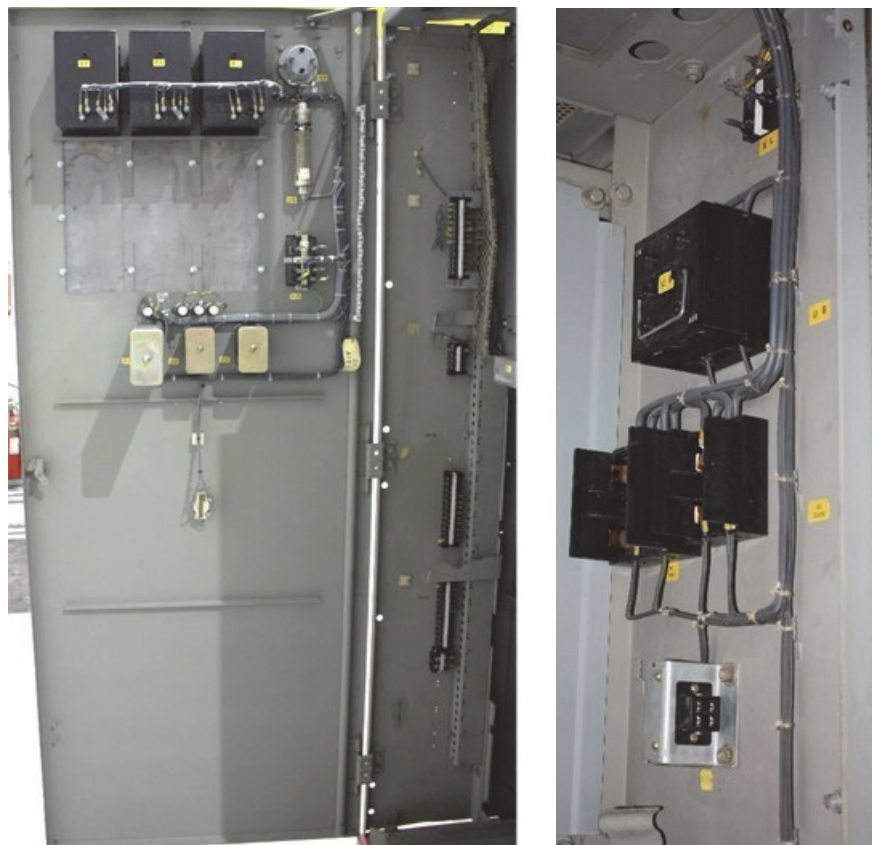
Fig. 9. Photo of combustible component loading in the secondary enclosure

The combustible loading within the enclosure was minimal. The primary enclosure contained polyolefin heat shrink tubing on the bus bars. However, the location where this material was located was separated from the primary cable compartment buses by metal cladding. The material was not on the primary cable compartment buses as discussed previously. The secondary enclosure contained protective relays, fuse holders, control switches, meters, resistors, and associated insulated conductors. The insulation on the SIS-insulated conductors represented most of the combustible loading in the secondary enclosure. Some of the wiring had been cut and removed prior to receipt of the equipment. It was unclear if the equipment supplier removed it, or if it was removed by the previous owner. Although the conductor insulation was most of the loading, the amount varied between enclosures, was limited in total combustible component weight, and separated from the arc location by metal cladding. Fig. 9 shows this loading.

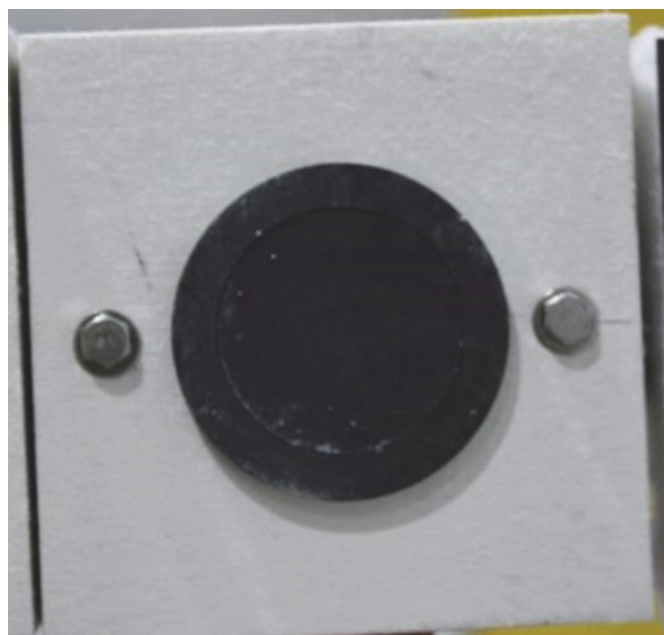
Fig. 11. Cross-section of ASTM Slug (top) nominal dimensions in millimeters, photo of device being prepared in the field (bottom). Note that the two bolts on each side of the device are used for mounting to the DIN rail of the instrumentation rack.

where m is the mass of the copper disc (g), \bar{C}_p is the average heat capacity of the copper disc ($J/g \cdot ^\circ C$), T_f is the temperature of the disc at the end of the arc ($^\circ C$), T_i is the temperature of the disc before the arc ($^\circ C$), and A is the front surface area of the disc (m^2). The total energy per unit area resulting from the arc is reported in a summary table for each sensor location in each experiment. The ASTM F1959 standard also refers to the total energy per unit area as incident energy (cal/cm^2 or kJ/m^2).

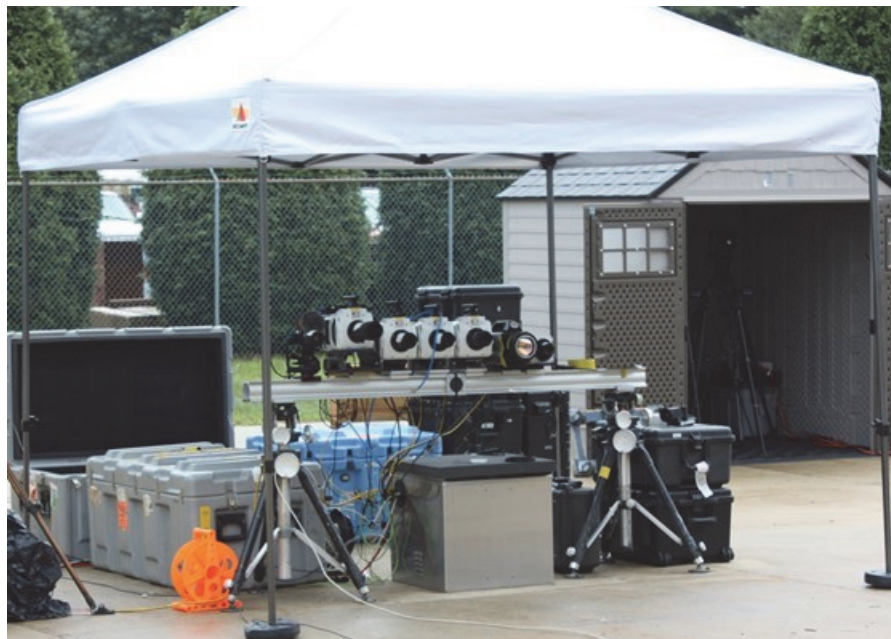
Fig. 17. Camera array located in courtyard. Front tented cameras fielded by SNL. Back shelter camera fielded by NIST.

The evolution of each experiment was documented with stationary high-definition video cameras. Cameras from SNL and NIST were deployed at numerous locations (as shown in Fig. 17 and Fig. 18). Not every camera view was provided in every experiment due to the limited viewing angles available within the test cell. The NIST high-definition video and images can be accessed from the NRC website⁵: <https://www.nrc.gov/reading-rm/doc-collections/research-info-letters/index.html>

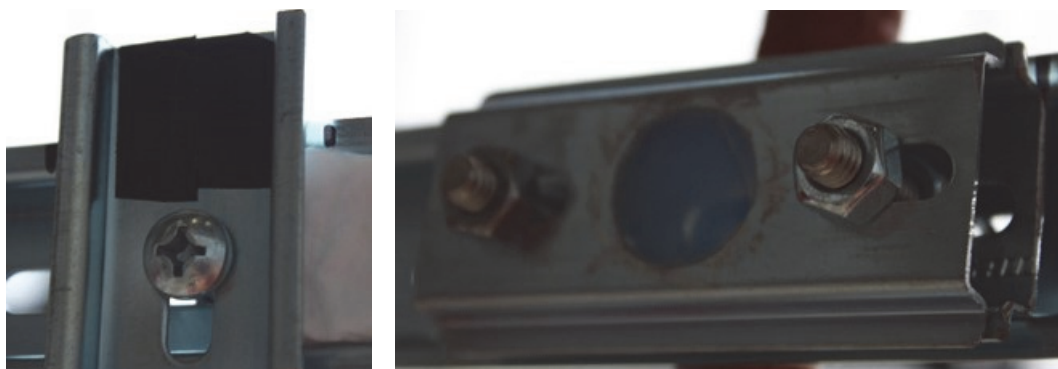
Fig. 19. Photo of carbon tape (left), and aerogel (right) particle collection apparatus

Two types of particle collection devices were deployed during this experimental series to provide redundant and diverse means to collect the particles and preserve the particle characteristics for subsequent analysis. Particles were collected on carbon tape and aerogel collectors for all experiments documented in this report. Photos of each device collection apparatus are shown in Fig. 19. The black carbon tape is a double-sided tape that allows for its placement on a short section (approximately 5 cm [2 in.]) of DIN rail. The short DIN rail is attached to a horizontal DIN rail on an instrumentation rack. During the experimental setup in the test cell, the protective covering on one side of the tape is removed and the tape is adhered to the short DIN rail. Just prior to performing the HEAF experiment, the front protective cover is removed from the tape, exposing the black carbon surface. After the experiment, the short DIN rail section is removed from the horizontal rail with the tape remaining attached and placed into a storage device. The aerogel was placed in a specimen holder constructed of two short sections of DIN rail that were aligned opposing each other. Two slots were used for mounting this assembly to the horizontal DIN rail on an instrumentation rack. On one side of the assembly, a circular hole was drilled. The aerogel is sandwiched between the two DIN rail sections and the hole allows for direct particle transport, impingement, and collection in the aerogel. After the experiment, the aerogel is removed from the holder and placed in a storage container, protecting the sample for subsequent analysis.

Particles were collected to quantify evolved particle sizes and chemical composition. The rack geometry is described below in Section 2.4.2. Racks 1, 2, 4 and 5 were located approximately 92 cm [36 in] from the enclosure surface surrounding the test device. Rack 3 was behind Rack 2 and located approximately 183 cm [72 in] from the surface of the test device. The choice of location for sampling was based on several factors. There was a desire to ensure particle characterization at the same radial location as the active measurement devices (heat flux and incident energy gauges). The number of sample locations was relatively high due to the low cost of these devices and uncertainty about the arc progression and areas where particle data would be of interest. Most racks contained four black carbon tape devices, and two to four aerogel collection devices. On each rack there were locations where the black carbon tape and the aerogel samples were located adjacent to each other to allow for direct comparison between the two sampling methods. Post-experiment analysis indicated that both samples provided clean and consistent particle capture. Due to its relative ease, black carbon tape is the recommended method of particle capture for future experiments.

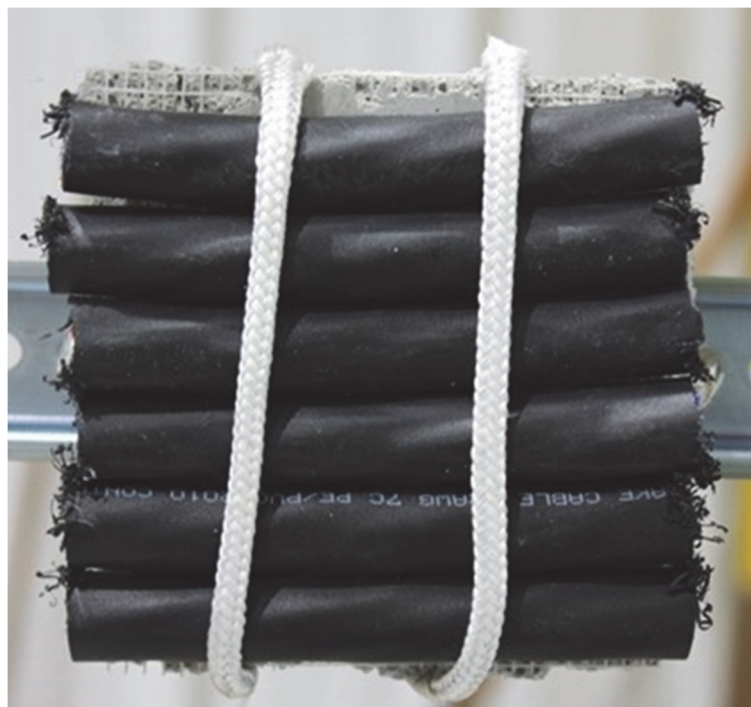
Fig. 22. Cable coupon constructed of seven conductor PE / PVC control cable (Cable 900).
Front view.

The cable coupons were constructed using six or eight segments of cable, approximately 100 mm (4 in) long. The cables were affixed to a square piece of fiberglass reinforced cement board (“Durock™”), measuring approximately 100 mm (4 in) square and nominally 13 mm (0.5 in) thick, using steel wire protected with a glass braid sheath. The wire was also used to connect the cable coupon to the horizontal steel DIN rail. Descriptions and specifications of the cables are listed in Table 6 and Table 7. Face and side views of a typical cable coupon are presented in Fig. 22 and Fig. 23. Photographs of the cable coupons were taken before and after every experiment, and are shown in Appendix D.

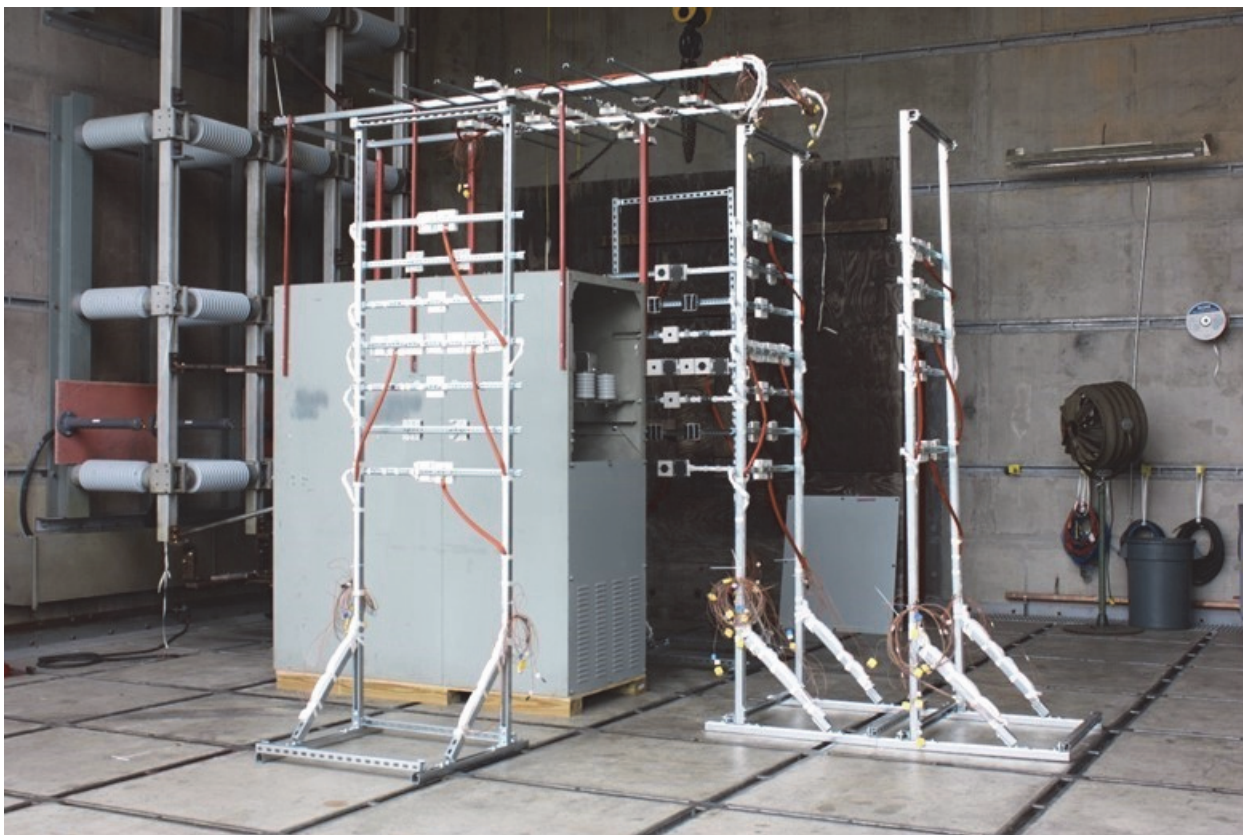
Fig. 35. Photo of Instrumentation Racks during experimental setup.

The majority of the thermal instrumentation devices were located on instrument racks with the face of the instrument located approximately 0.91 m (3.00 ft) from the exterior of the metal clad enclosure. One additional instrument rack (Rack 3) was located approximately 1.83 m (6.00 ft) from the expected arc breach side of the electrical enclosure. Rack 3 had a different physical distribution of sensors to prevent shadowing from the sensors located on the instrument rack located between it and the electrical enclosure. Thus, Rack 3 has a slightly different sensor layout than Racks 1, 2, and 4. An instrumentation rack was also located above the electrical enclosure. This instrumentation rack (Rack 5) was secured to the electrical enclosure with 90-degree angle red GPO-3 board (glass reinforced thermoset polyester) and nominal ¼ in-20 fasteners. The sensors on Rack 5 are located approximately 0.91 m (3.00 ft) from the top of the enclosure metal cladding. This instrumentation rack configuration is shown in Fig. 25. Details of the instrument location are shown in Fig. 27 through Fig. 34, with a photograph showing the instrumentation racks around the test device during setup in Fig. 35. The expanded uncertainty in the measurement of the distances from the instrumentation racks to the electrical enclosure is ± 13 mm (0.5 in) with a coverage factor of 2 and an estimated confidence interval of 95 percent.

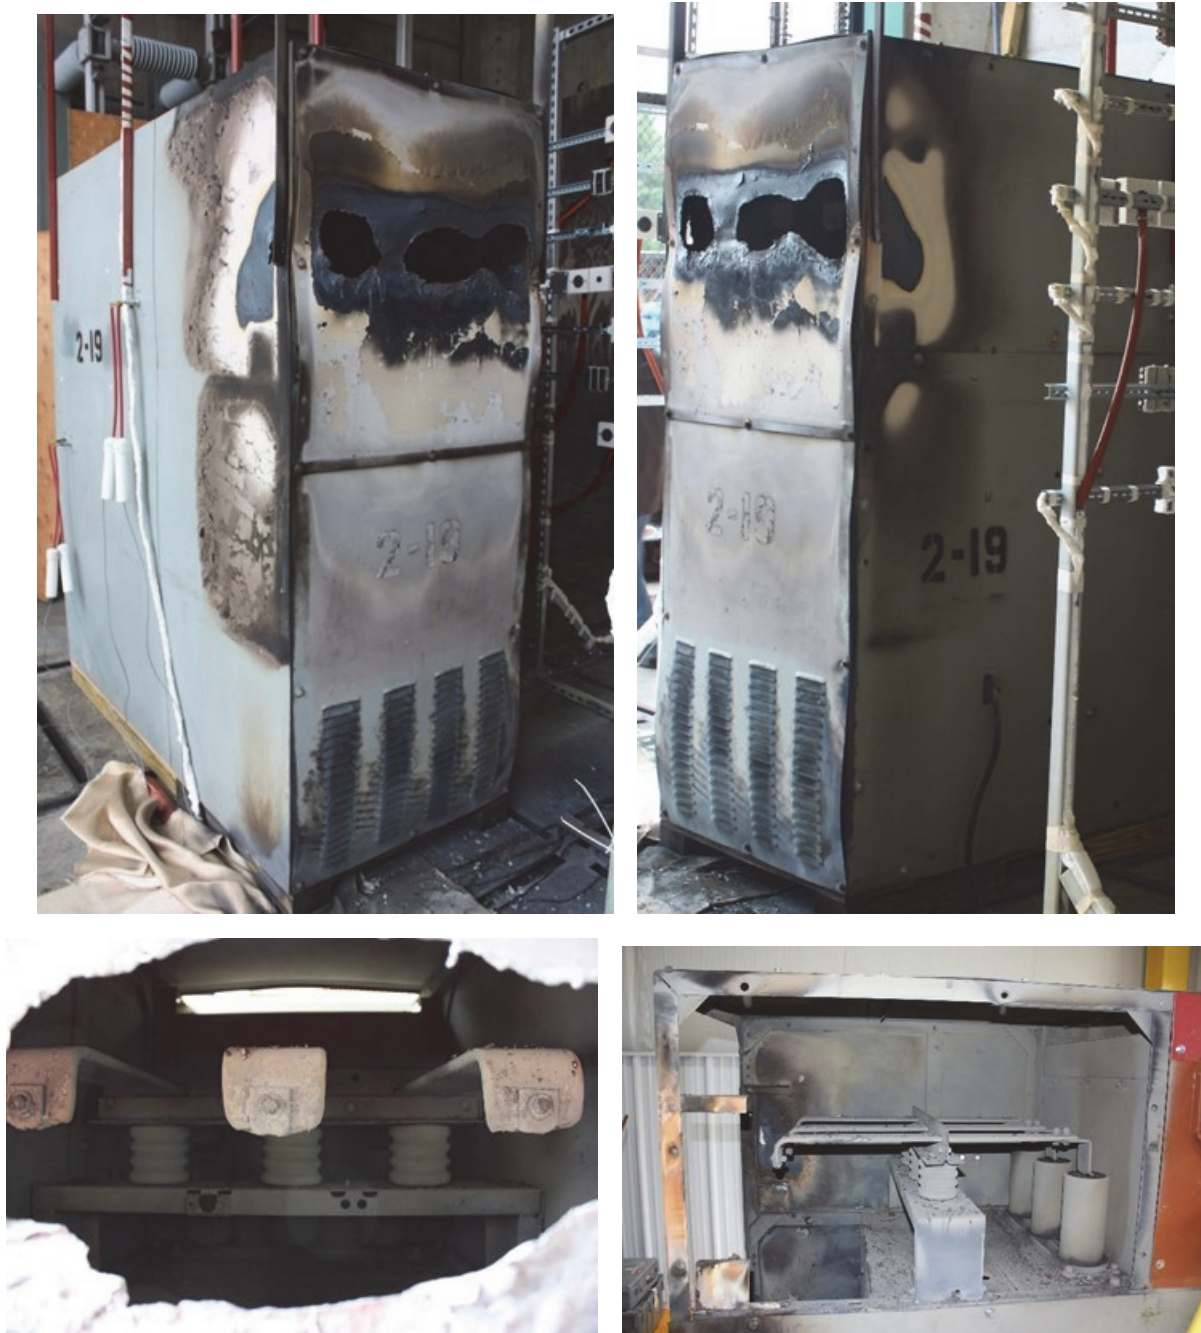
Fig. 38. Enclosure Post-Test 2-19. (Top: back of enclosure; Bottom: remaining bus bar material. Bottom left as viewed from rear of enclosure, bottom right as viewed from the side at the rear of the enclosure with the side panel removed.)

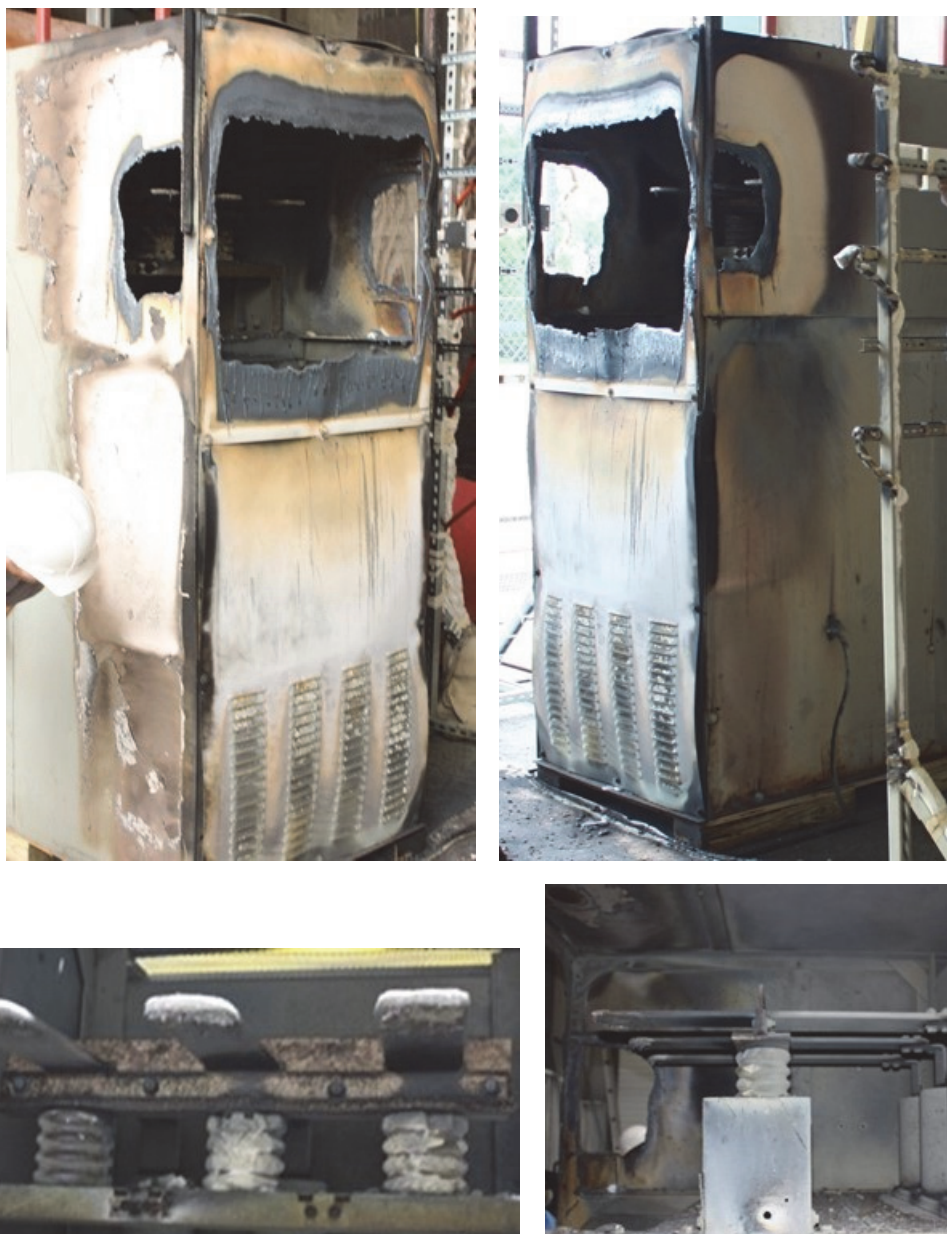
Fig. 48. Enclosure Post-Test 2-21. (Top: back of enclosure; Bottom: remaining bus bar material. Bottom left as viewed from rear of enclosure, bottom right as viewed from the side at the rear of the enclosure with the side panel removed.)

Photographs of damage to the electrical enclosure are shown in Fig. 48. The enclosure breached at the upper rear panel of the primary cable connection compartment. There were also breaches on both sides of the enclosure adjacent to the breach on the upper rear panel. The door on the front of the enclosure with a single quarter turn latch opened during the experiment. As in Test 2-19, internal pressure caused the bottom of the door to push out and the post-experiment inspection indicated that the side of the panel was bowed outward. The combination of these two effects allowed the latch mechanism to slip and the door to open.

the electrical enclosure, there were puddles of solidified aluminum on the enclosure floor. This was later determined to be the aluminum from the rear electrical insulators supporting the bus bars directly below the location of the shorting wire. These insulators are shown in Fig. 8 prior to the experiment.

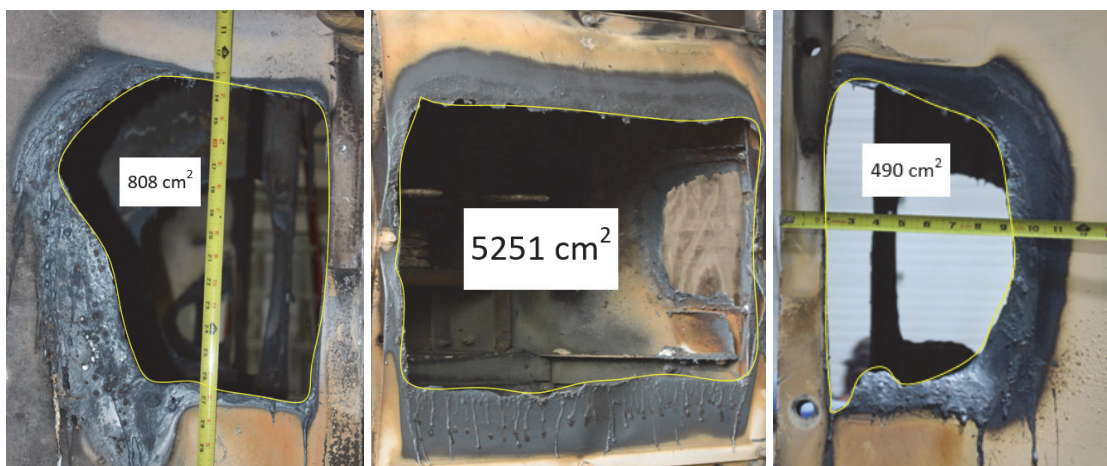
Fig. 51. Photo showing breach opening on far side rear panel (left), upper rear panel (center), and the primary cable compartment bus side upper panel (right). Software used to estimate opening area.

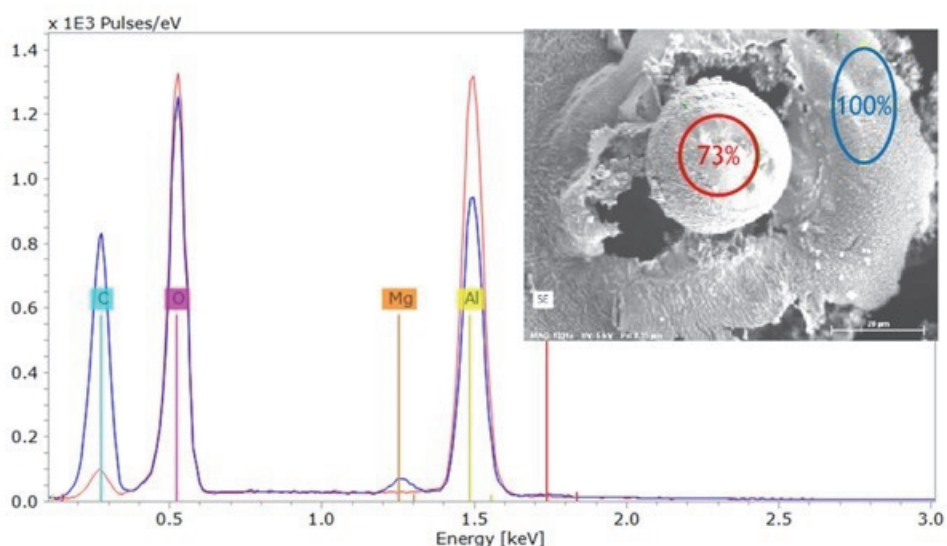
Fig. 52. Scanning electron micrograph showing a roughly 30 μm size particles of partial oxidation, estimated at 73 percent, as well as a nanoscale layer displaying higher oxidation estimated at 100 percent. The carbon tape contains both carbon (C) and oxygen background.

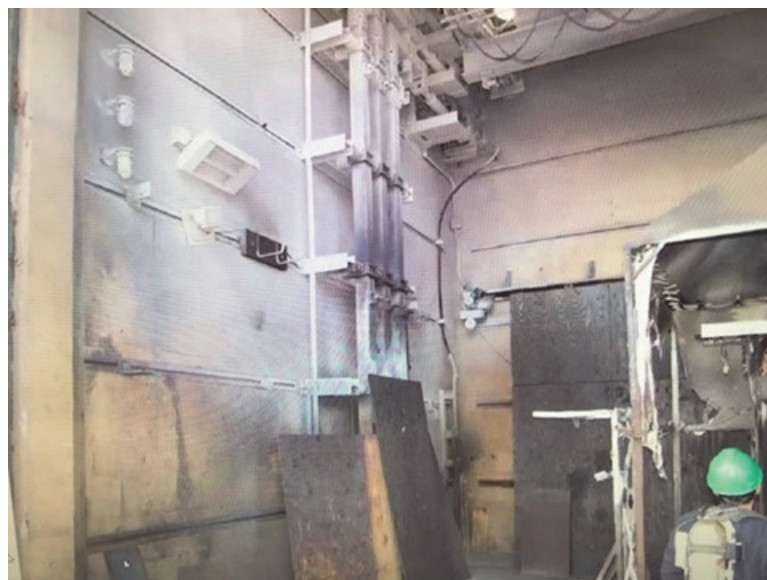
Fig. 58. Conductive white powder residue after previous aluminum bus bar switchgear experiments, which may have consisted of melted Al and evaporated Al_2O_3 . (Photo from Phase 1 experiments [6])

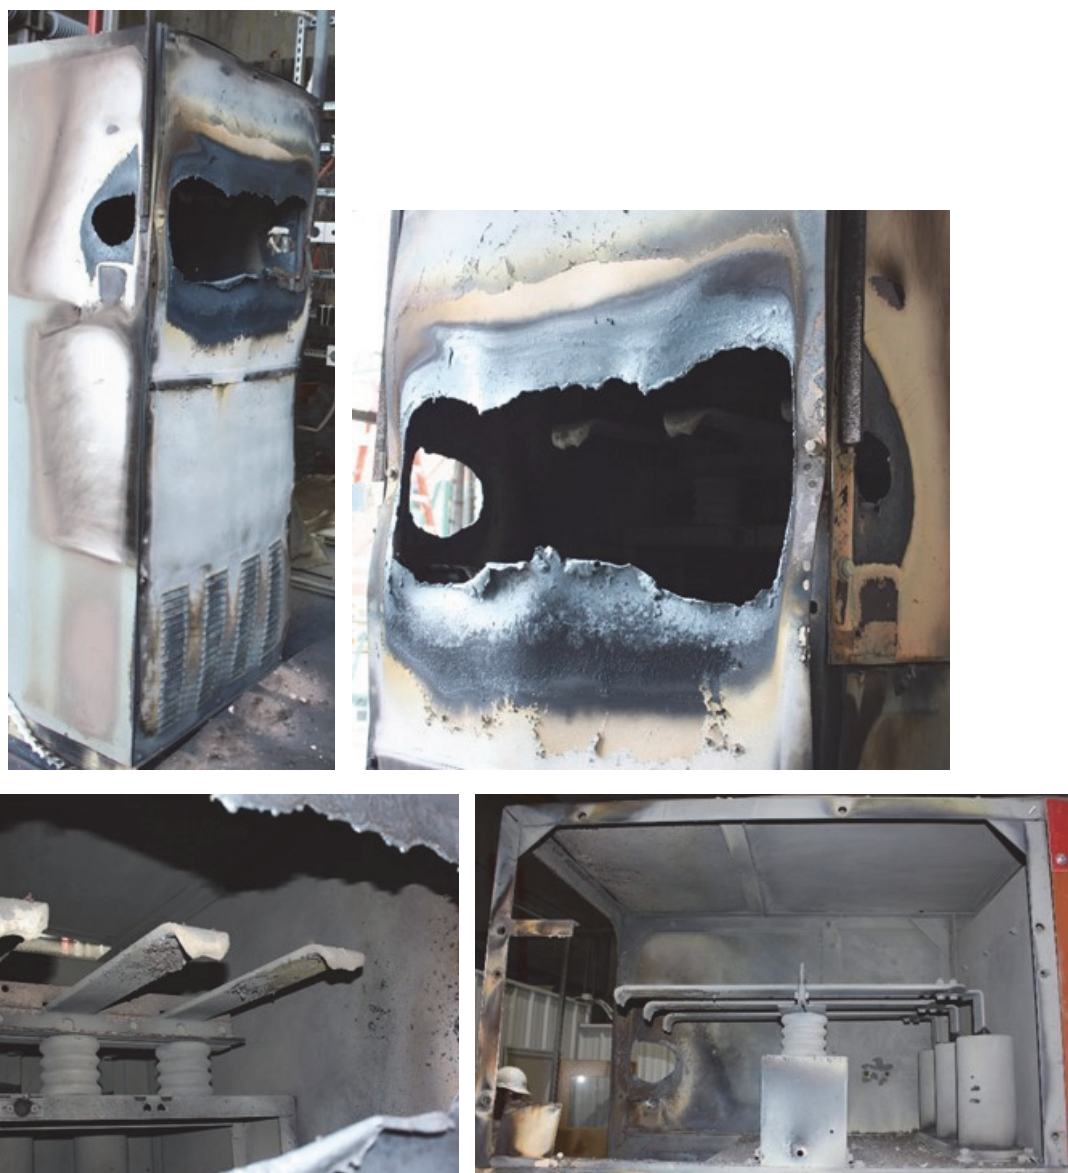
Fig. 69. Enclosure Post-Test 2-22. (Top: back of enclosure; Bottom: remaining bus bar material. Bottom left as viewed from rear of enclosure, bottom right as viewed from the side at the rear of the enclosure with the rear and side panels removed.)

Photographs of damage to the electrical enclosure are shown in Fig. 69. The enclosure breached at the upper rear panel of the primary cable connection compartment. There were additional breaches on both sides of the enclosure adjacent to the breach on the upper rear panel. The door on the front of the enclosure with a single quarter turn latch did open. Just as in Test 2-19 and 2-21, internal pressure caused the bottom of the door to push out and post-experiment inspection indicated that the side of the panel was bowed outward. The combination of these two effects allowed the latch mechanism to slip and the door to open. Following the experiment, no apparent aluminum oxide residue was observed on the test cell wall. Molten splatter beads were present on various instrumentation rack coupons. Passive cable samples experienced thermal stress, but the cable jacket was intact and not breached.

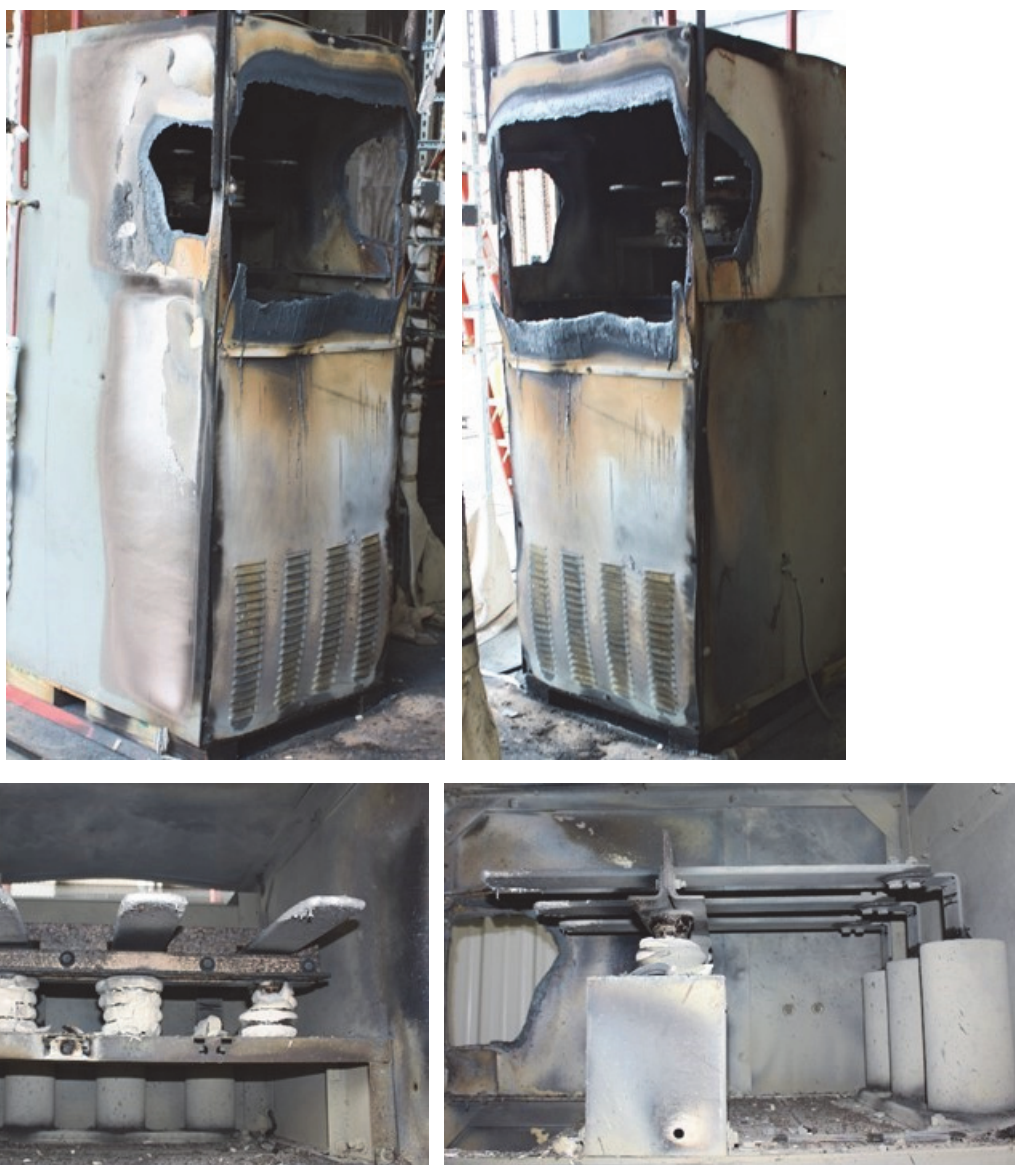
Fig. 79. Enclosure Post-Test 2-24. (Top: back of enclosure; Bottom: remaining bus bar material. Bottom left as viewed from rear of enclosure, bottom right as viewed from the side at the rear of the enclosure with the side panel removed.)

Photographs of damage to the electrical enclosure are shown in Fig. 79. The enclosure breached at the upper rear panel of the primary cable connection compartment. There were also breaches on both sides of the enclosure adjacent to the breach on the upper rear panel. The electrical enclosure in this experiment experienced the most material loss from the enclosure metal cladding. The door on the front of the enclosure with a single quarter turn latch did open. Just as observed on all three previous experiments, internal pressure caused the bottom of the door to push out and post-experiment inspection indicated that the side of the panel was bowed outward. The combination of these two effects allowed the latch mechanism to slip and the door to open.

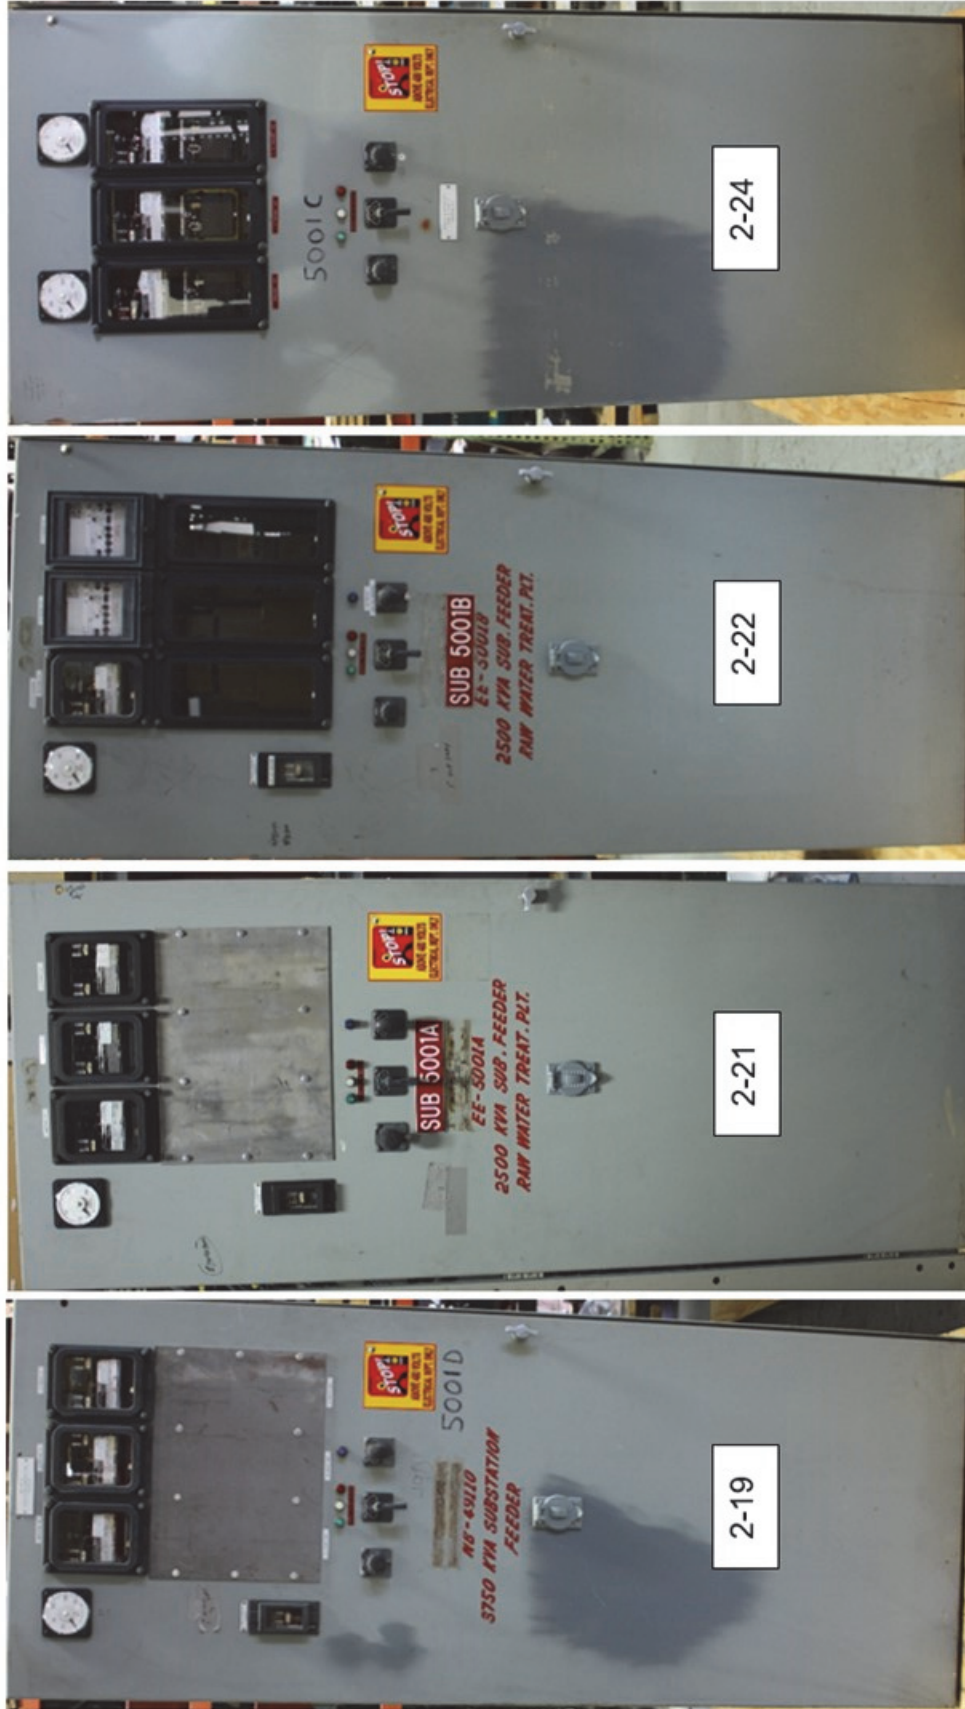
Fig. 90. Photographs of front door of test device

The instrumentation on the front of the vertical sections of switchgear had minor variations between switchgear samples. Table 30 identifies the number of each type of device located on the front panel of each switchgear. Photographs of the front door are provided in Fig. 90 and the internal side of the doors are provided in Fig. 91.

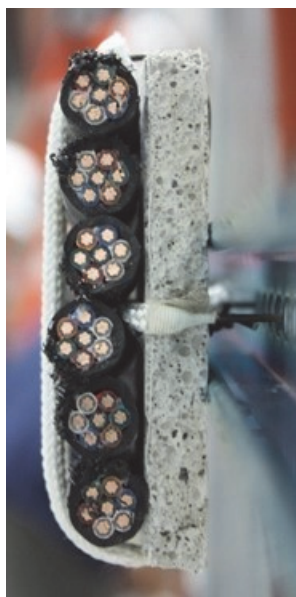
Fig. 109. Cable coupon constructed of seven conductor PE / PVC control cable (Cable 900).
Side view.

The cable coupons were constructed using six or eight segments of cable, approximately 100 mm (4 in) long. The cables were affixed to a square piece of fiberglass reinforced cement board (“Durock”), measuring approximately 100 mm (4 in) square and nominally 13 mm (0.5 in) thick, using steel wire protected with a glass braid sheath. The wire was also used to connect the cable coupon to the horizontal steel DIN rail. Descriptions and specifications of the cables are listed in Table 44 and Table 45. Face and side views of a typical cable coupons are presented in Fig. 108 through Fig. 111. Photographs of the cable coupons were taken before and after every experiment and are shown below.

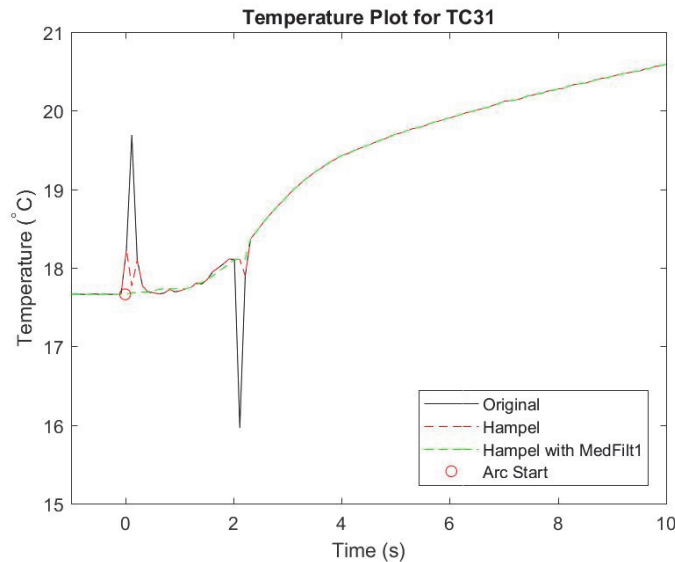
Fig. 132. Raw and filtered temperature data for Tcap 31 for Test 2-19.
