RIL 2021-17  
NIST TN 2197

# REPORT ON HIGH ENERGY ARCING FAULT EXPERIMENTS

## Experimental Results from Low- Voltage Switchgear Enclosures

Date Published: December 2021

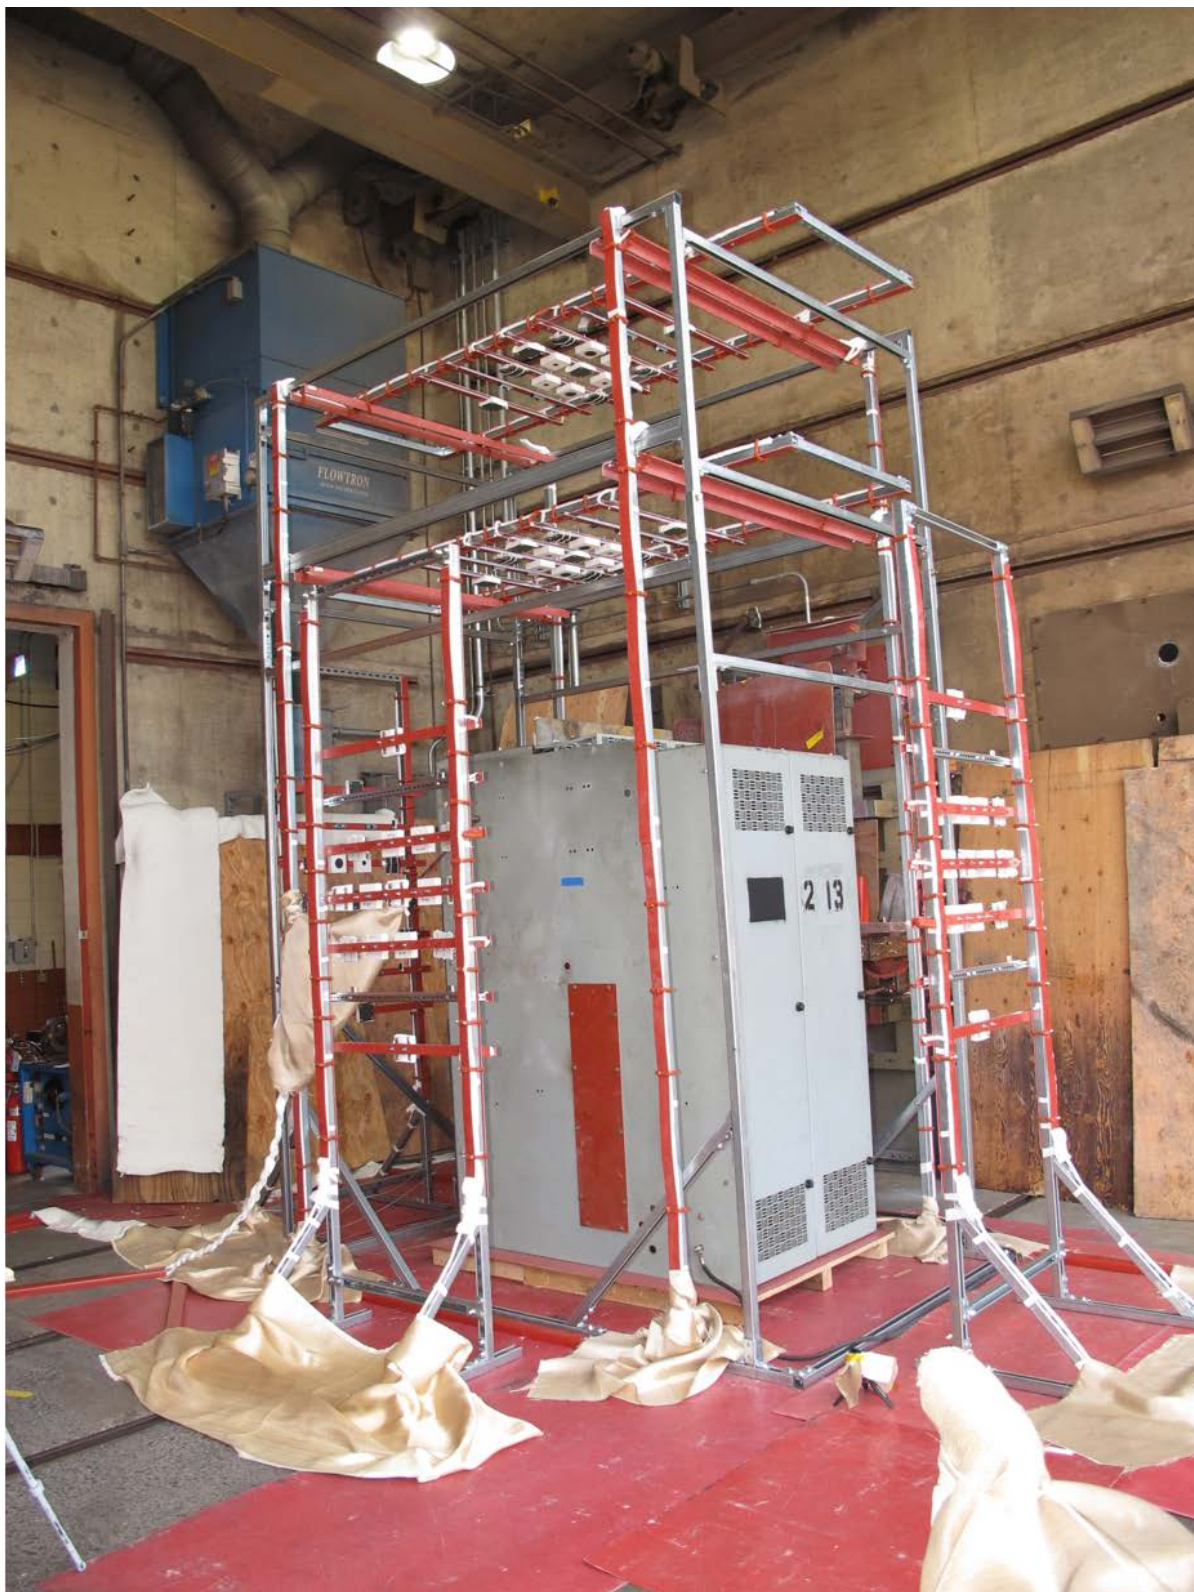
**Fig. 30.** Photo of Instrumentation Racks for Test 2-13A through Test 2-13G.

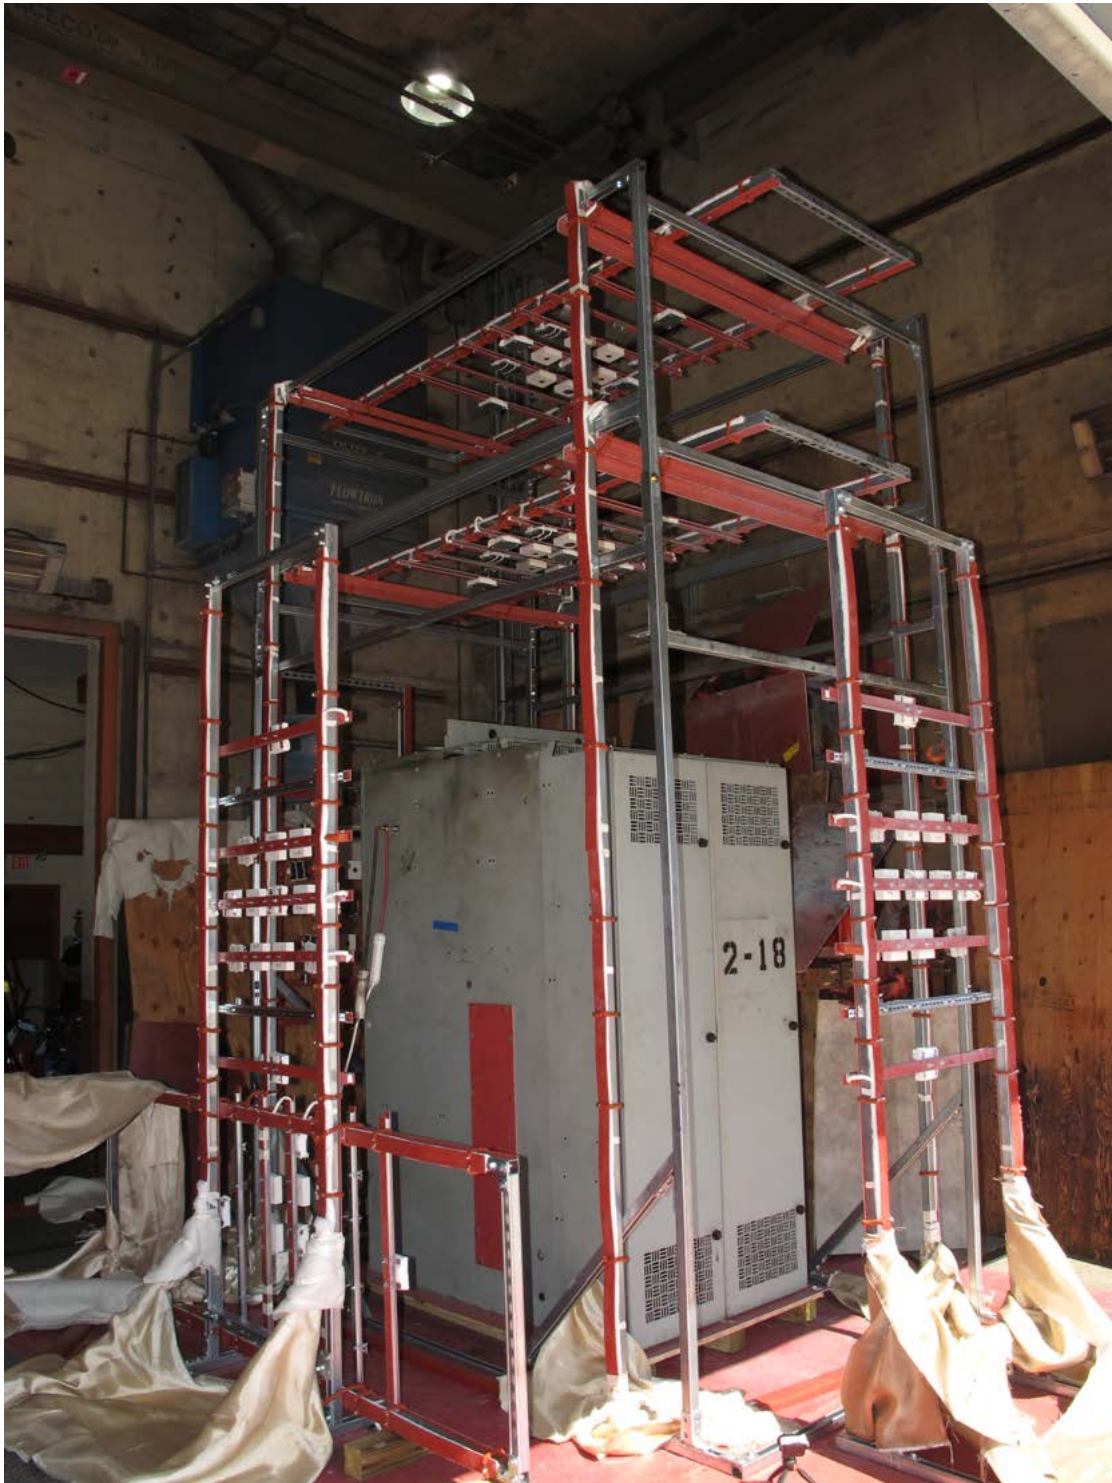
**Fig. 31.** Photo of Instrumentation Racks for Test 2-18A Test 2-18B.

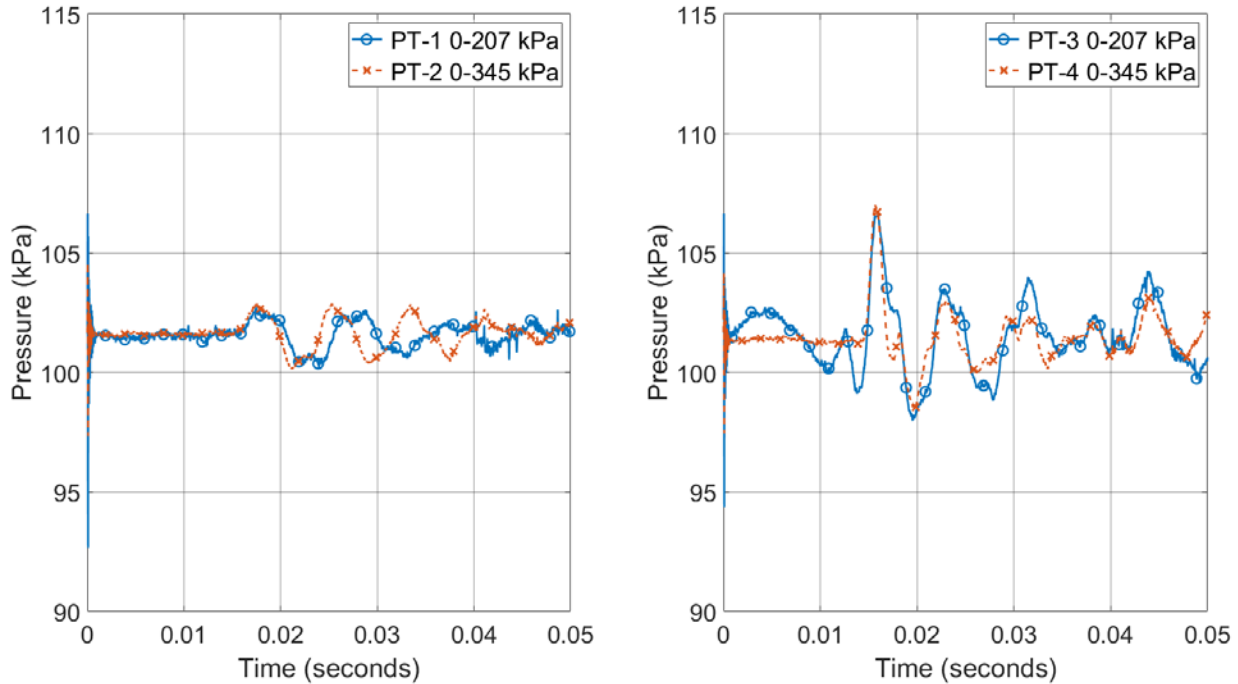
**Fig. 39.** Pressure measurements from Test 2-13B (breaker compartment (left); Main bus [arcing compartment] (right). Measurement uncertainty  $\pm 3$  percent.

The pressure profiles for the first two tenths of a second are shown in Fig. 39. After the initial pressure spike, the pressure rapidly decays to a relative steady state. The peak pressure is higher in the primary cable connection compartment as would be expected since this is the compartment where the arc is initiated. The maximum change in pressure in the main bus compartment is approximately 5 kPa (0.7 psi) above ambient at its peak. The maximum change in pressure in the breaker compartment is approximately 3 kPa (0.4 psi) above ambient. The 0 kPa to 207 kPa (0 psia to 30 psia) and 0 kPa to 345 kPa (0 psia to 50 psia) transducer recordings at a specific location were consistent.

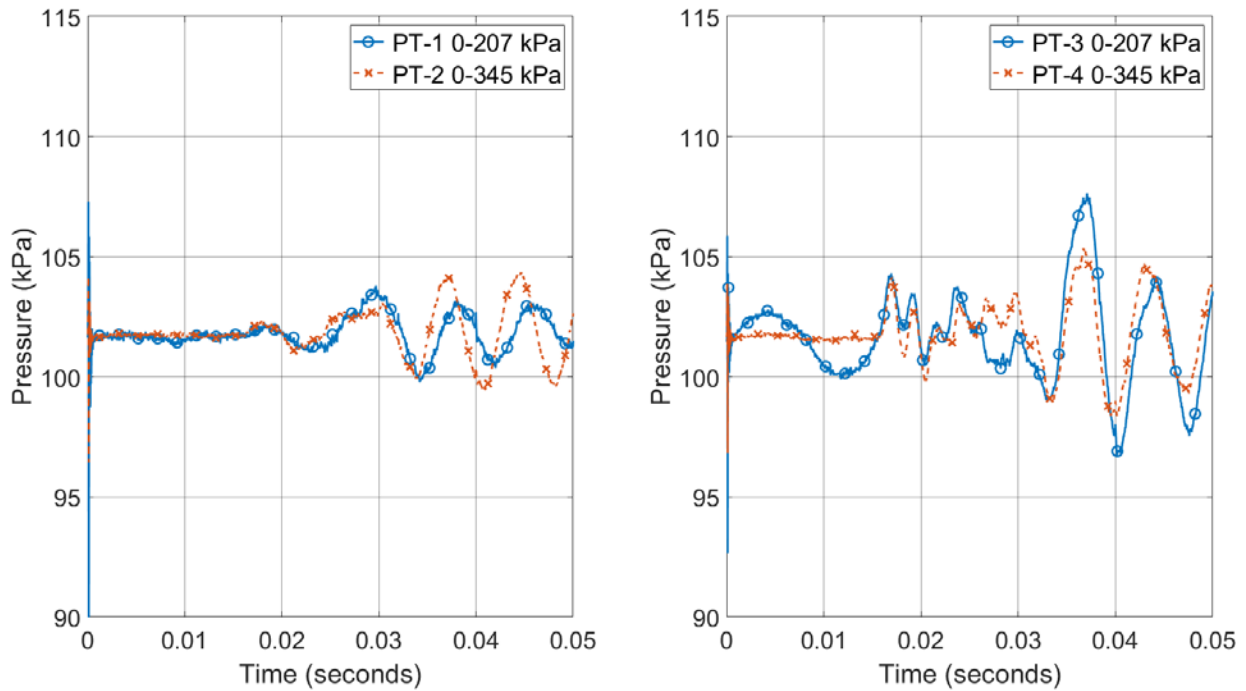
**Fig. 48.** Pressure measurements from Test 2-13D (breaker compartment (left); Main bus [arcing compartment] (right). Measurement uncertainty ± 3 percent.

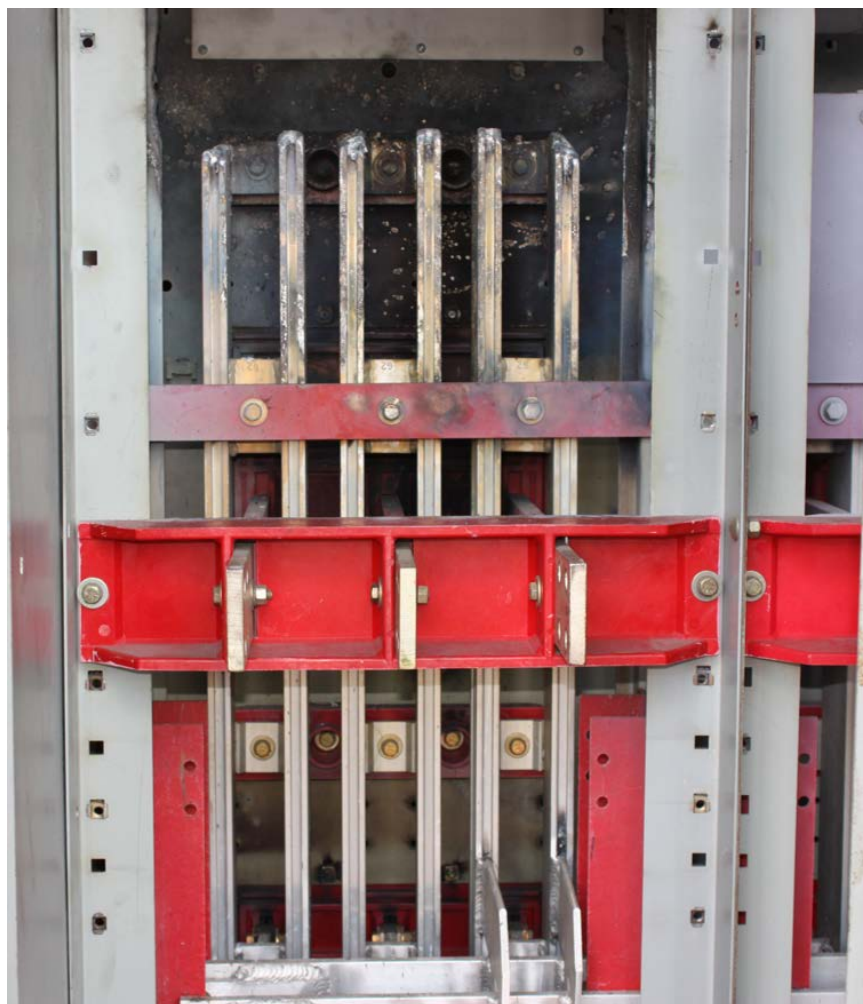
**Fig. 54.** Main bus bar post-experiment.

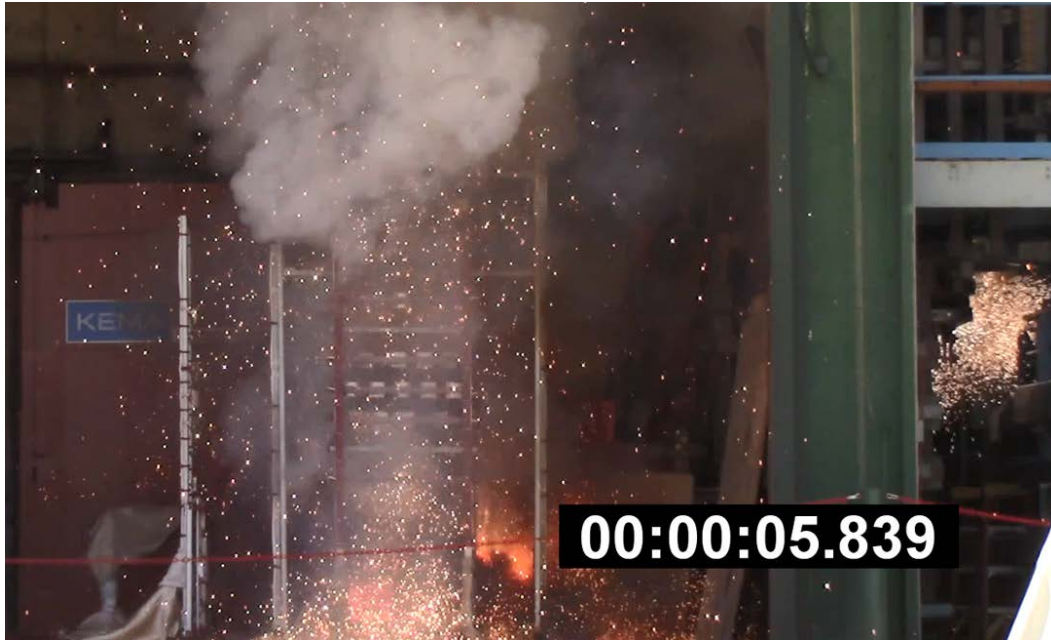
**Fig. 76.** Failure of KEMA cable connection observed as arcing occurring in Cell 8 (non-test cell).
