NUREG-2240

Flood Penetration Seal Testing Protocol Research

Manuscript Completed: August 2021
Date Published: February 2022

Prepared by:
T. Aird

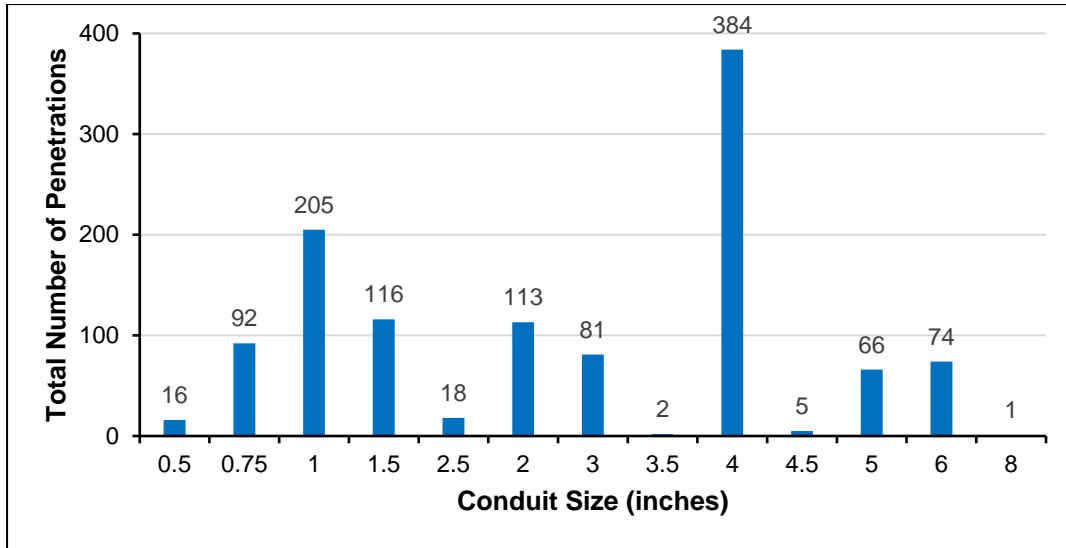
Figure 2-1 Circular Conduit Internal Diameters

The data gathered by this survey of the 10 CFR 50.54 (f) responses provided additional insight for the testing phase of this research project. The main objective of this testing phase was to assess the test protocol using the most common seal types and configurations. The survey data specifically aided in identifying these most common configurations before the construction of the test deck samples.

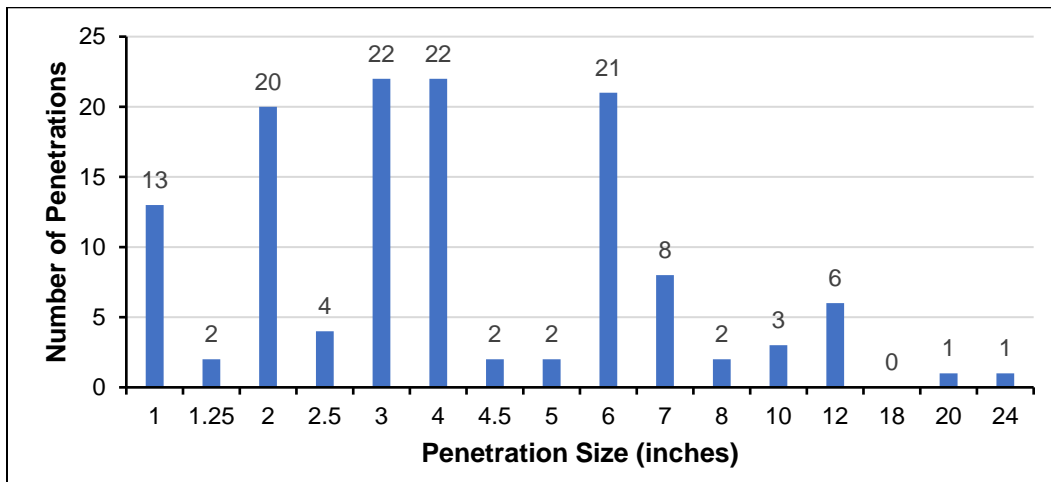
Figure 2-2 Sleeve/Core-Bored Penetration Internal Diameters

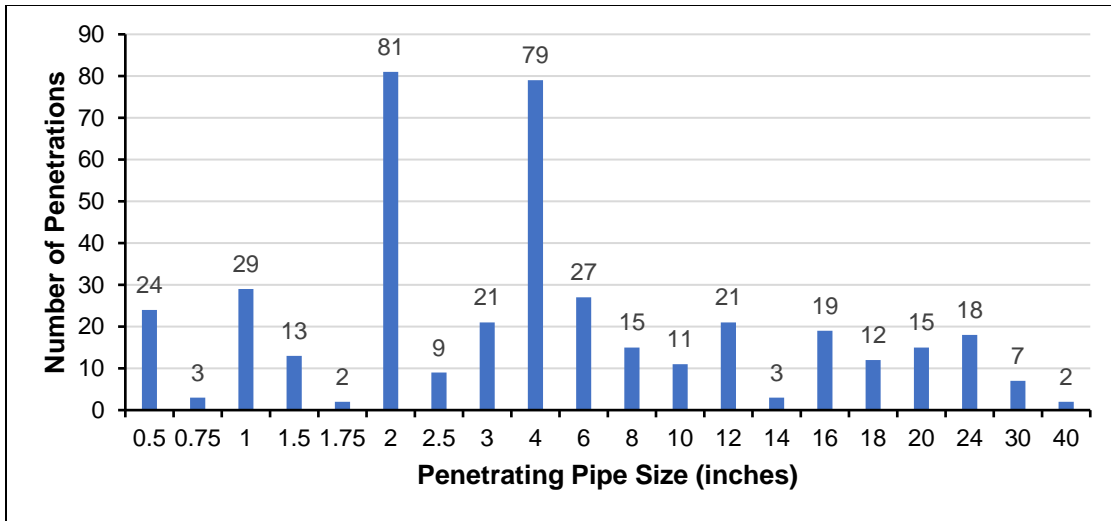
Figure 2-3 Pipe Penetrant Diameters

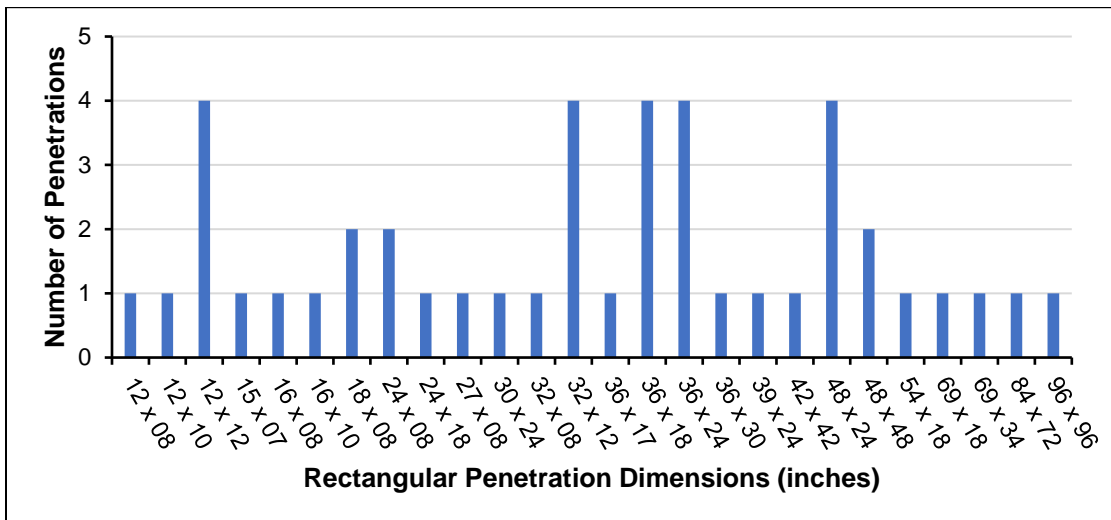
Figure 2-4 Rectangular Penetration Dimensions

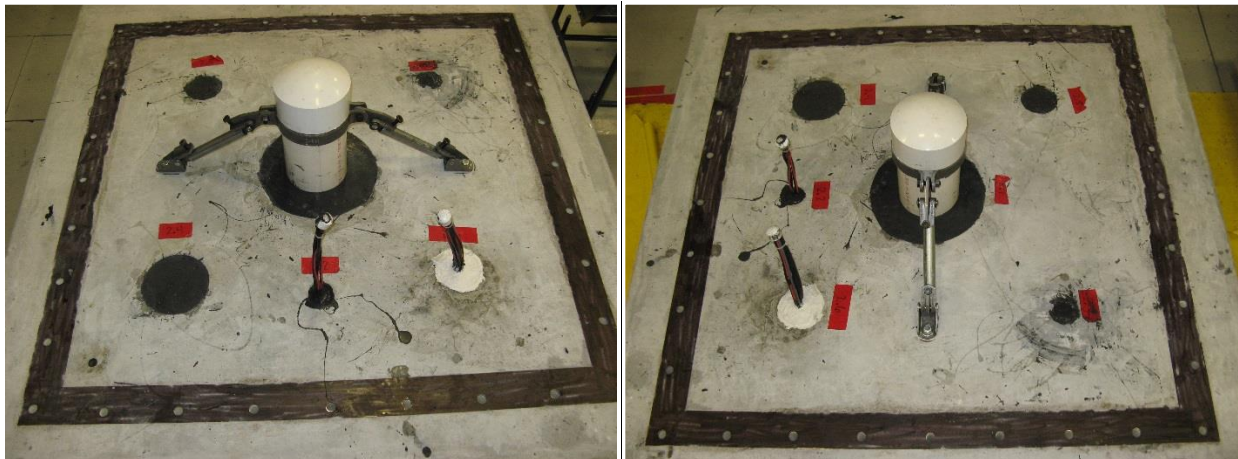
Figure 4-13 Photos of Test Deck 2 After Seal Assembly Installation

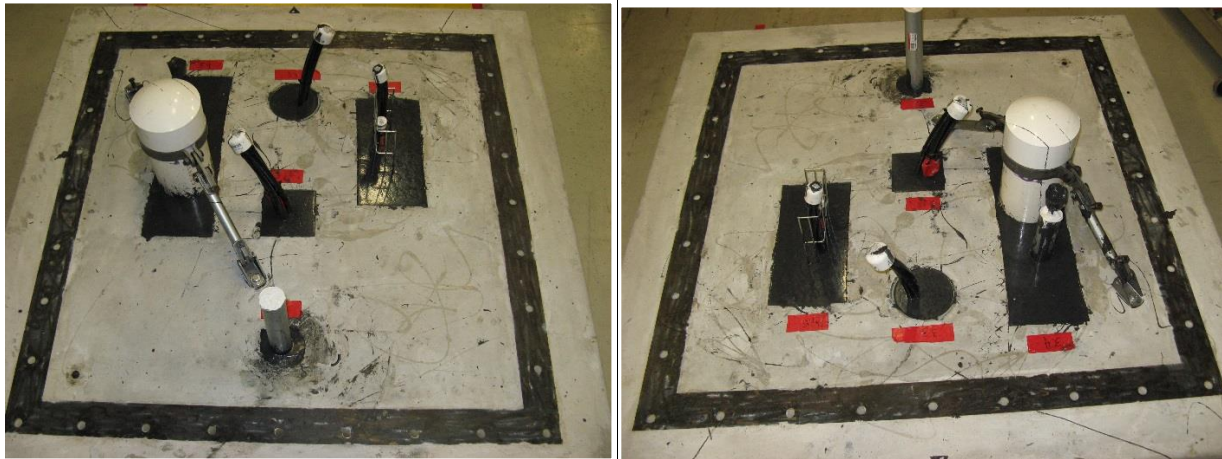
Figure 4-16 Photos of Test Deck 3 After Seal Assembly Installation

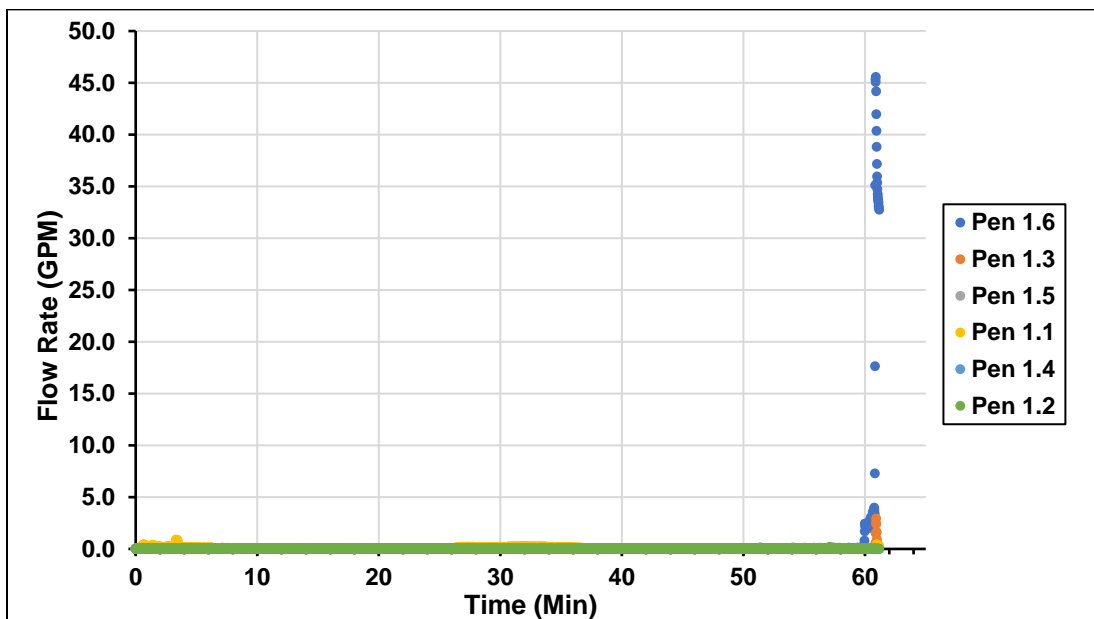
Figure 5-2 Test 1 Flow Rate vs. Time

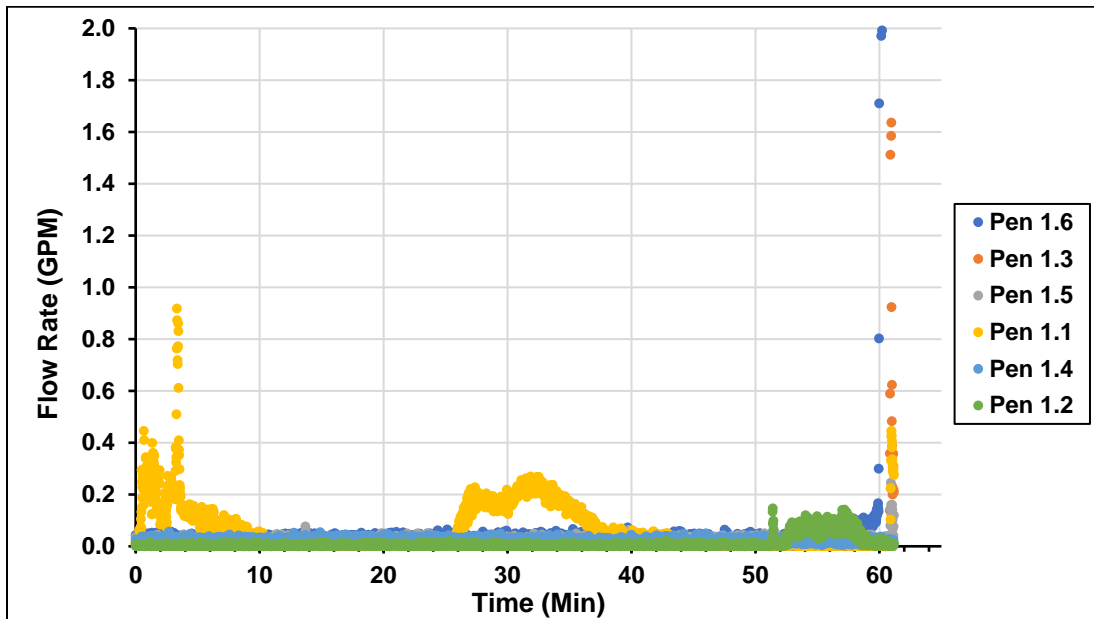
Figure 5-3 Test 1 Flow Rate vs. Time (Truncated Vertical Axis)

Figure 5-3 also shows small increases in the flow rates from the other four penetrations (1.1, 1.2, 1.4, and 1.5) immediately after Penetration 1.6 dislodged. These small flow rates (less than 0.5 GPM) are most likely overflow from the nearby dislodgement, rather than true leakage from these four penetrations. The large, sudden flow rate from the dislodged Penetration 1.6 may be the source of this discrepancy (the design of the leakage collection system did not completely isolate each penetration in the case of an abrupt seal dislodgement causing a very large flow). This explanation is further supported by the lack of any observable damage to Penetrations 1.1, 1.2, 1.4, and 1.5.

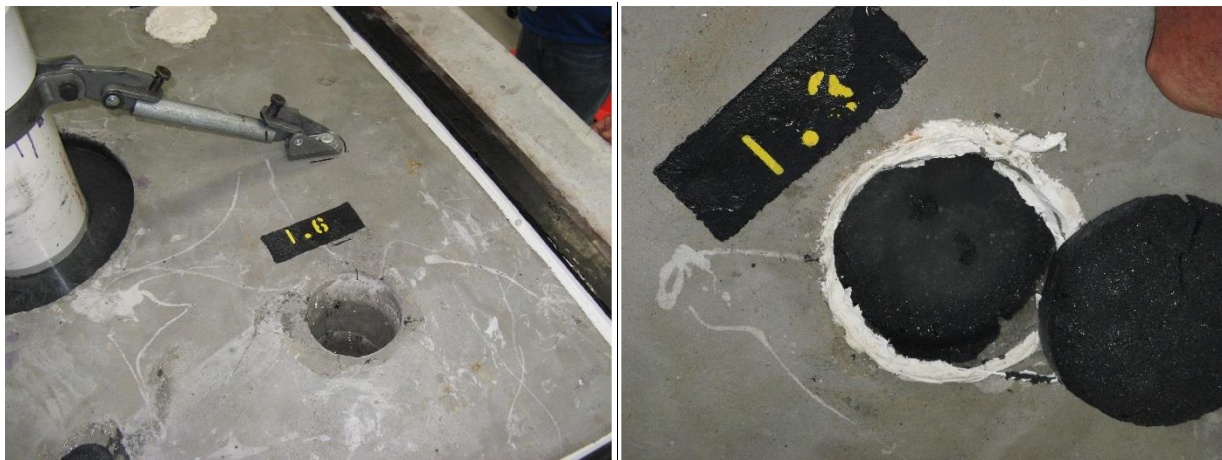
Figure 5-4 Empty Penetration 1.6 (Left Photo) and Damaged Penetration 1.3 (Right Photo)

Following the termination of Test 1, visual inspections were conducted on Test Deck 1 (Figure 5-4). Penetration 1.6 was found to be completely ejected from the test deck and lodged beneath in the leakage collection system. The concrete hole into which Penetration 1.6 had been installed was open and clear of debris. Additionally, the caulk cap of Penetration 1.3 was damaged as evidenced by a large surface crack through the caulk. No damage or other notable discrepancies with the other four penetrations were observed.

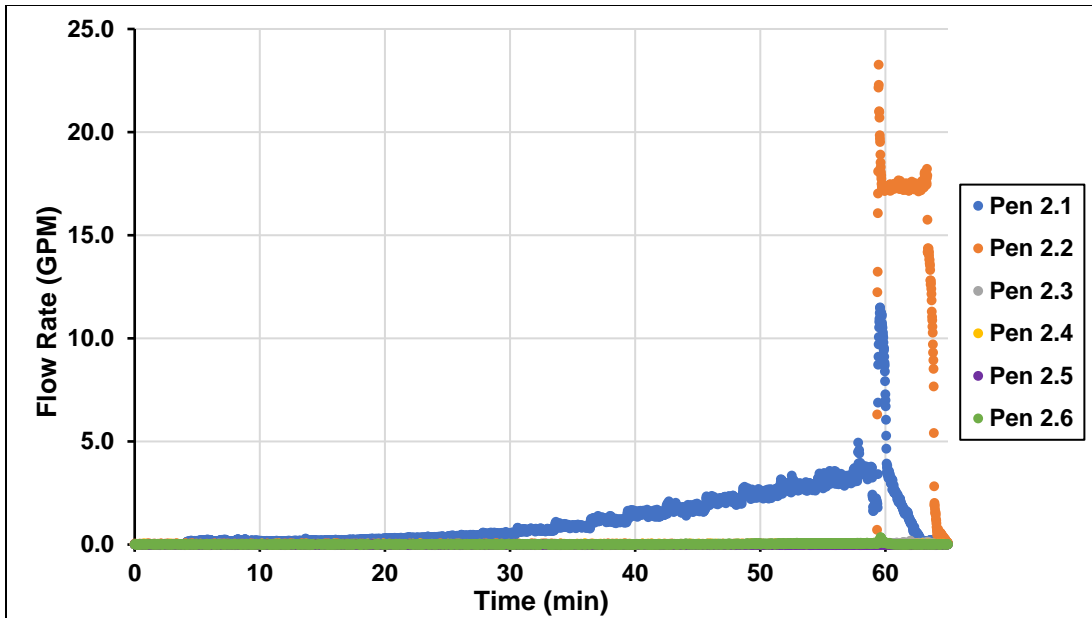
Figure 5-6 Test 2 Flow Rate vs. Time

Flow meters attached to the leakage collection system for each penetration measured and recorded leakage rates. Figure 5-6 and Figure 5-7 depict the flow recordings for Test 2 at different vertical scales. At approximately the 59-minute mark, Figure 5-6 captures the large increase in the flow rate from Penetration 2.2. Figure 5-7 displays the same recorded data as Figure 5-6, but with the vertical axis limited to a maximum of 7 GPM to illustrate the flow rate increases from other penetrations. The sudden pressure change that occurred after Penetration 2.2 dislodged may be the source of the minor spike in the flow rate from Penetration 2.1. After this nonconforming event, flow rates continued to be measured from Penetrations 2.2 and 2.1 for a number of minutes, even with the test chamber depressurized. These flow rates would eventually decrease to zero as the test chamber emptied of water.

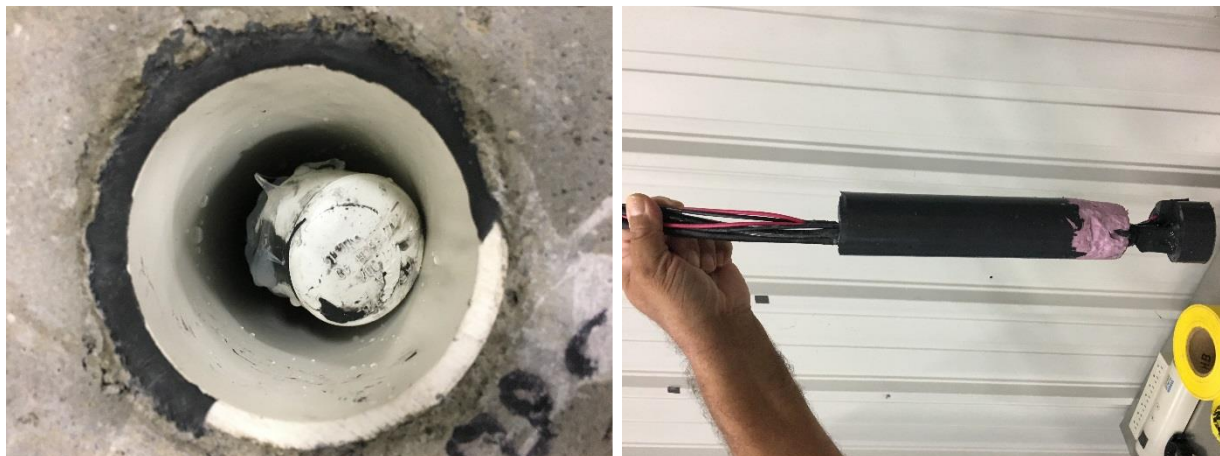
Figure 5-8 Top-Down View (Left Photo) of Penetration 2.2 Dislodged with its White Cable Cap Visible and Penetration 2.2 Removed (Right Photo) from the Test Deck (its White Cable Cap Not Visible)

Following the termination of Test 2, visual inspections were conducted on Test Deck 2 (Figure 5-8). Penetration 2.2 was found to be completely dislodged from its sleeve within the test deck and pushed down into the leakage collection system. No damage or other notable discrepancies with the other five penetrations were observed. The lack of visible damage to Penetration 2.1 indicates that, although it experienced significant leakage during the test, it was not the source of the rapid depressurization within the water chamber, resulting in test termination.

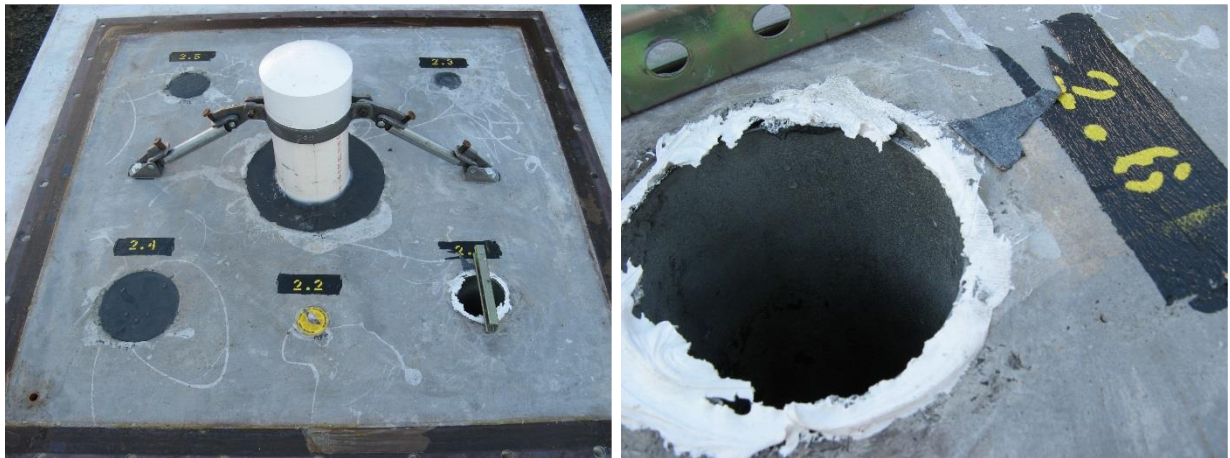
Figure 5-12 Test Deck 2 Post-Test (Left Photo) and Empty Sleeve (Right Photo) for Ejected Penetration 2.6

Following the termination of the pressure test, visual inspections were conducted on Test Deck 2 (Figure 5-12). The yellow object in the left photograph in Figure 5-12 is the permanent plug for Penetration 2.2. Penetration 2.6 was found to be completely dislodged from its sleeve within the test deck and pushed down into the leakage collection system. Figure 5-13 is a photograph of the ejected seal from Penetration 2.6. No damage or other notable discrepancies with the other five penetrations were observed.

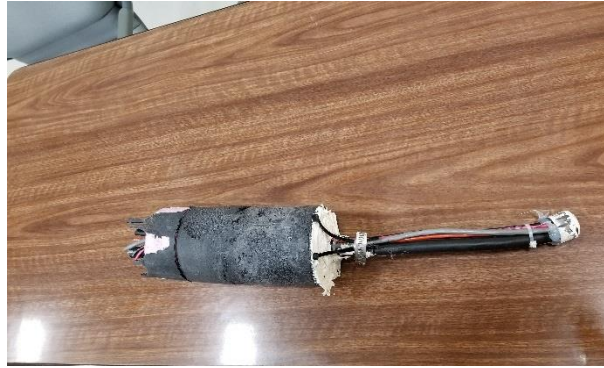
Figure 5-13 Ejected Seal and Penetrant from Penetration 2.6

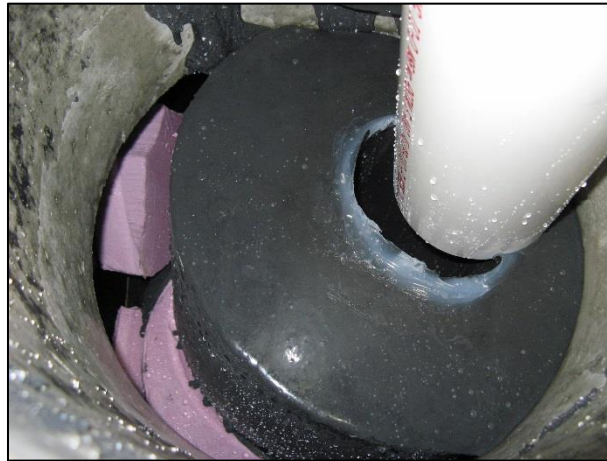
Figure 5-17 Dislodged Penetration 5.2

Following the termination of the pressure test, visual inspections were performed on Test Deck 5 (Figure 5-17). Penetration 5.2 was found to be completely dislodged from its installed position and pushed down into the leakage collection system. No damage or other notable discrepancies with the other five penetrations were observed.

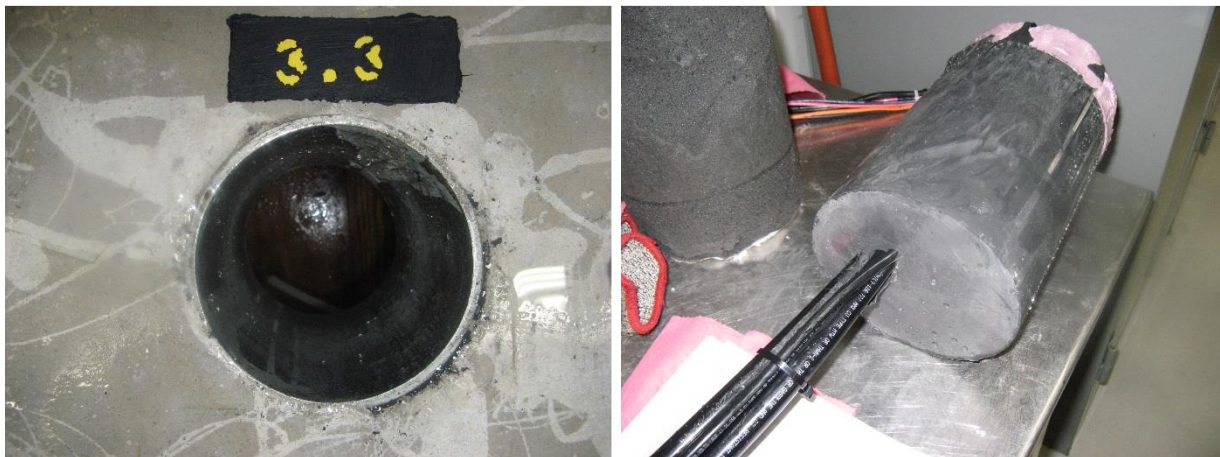
Figure 5-24 Empty Steel Sleeve for Ejected Penetration 3.3 (Left Photo) and Ejected Seal Material and Penetrants for Penetration 3.3 (Right Photo)

Following the termination of the test, visual inspections were conducted on Test Deck 3 (Figure 5-24). The seal in Penetration 3.3 was found to be completely dislodged from its installed position and pushed down into the leakage collection system. No damage or other notable discrepancies with the other five penetrations were observed.

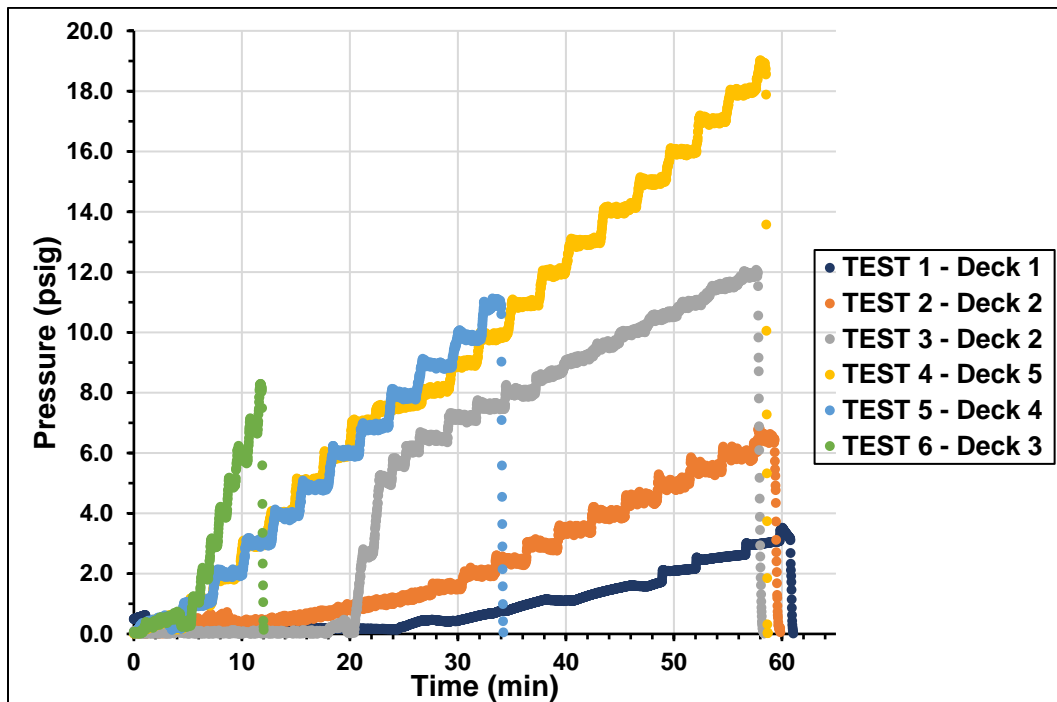
Figure 6-1 Pressure vs. Time Recordings for the Six Tests

The test series was successful in its objective to assess the draft test protocol. The test series demonstrated that the procedures outlined by the protocol were sufficient with regard to measuring and collecting performance data for candidate seal assemblies. Specified parameters such as volumetric leakage rates, applied pressure rates, and water temperatures were all actively measured and recorded. Furthermore, the test protocol's application to a variety of pressure regimes was successful. Figure 6-1 illustrates the pressure versus time recordings for all six tests. Large, sudden increases in applied pressure (Test 6) as well as short, incremental increases (Test 1) were implemented using the test protocol.
