NUREG/CR-7288  
Volume 1

# **Evaluation of In-Service Radon Barriers over Uranium Mill Tailings Disposal Facilities**

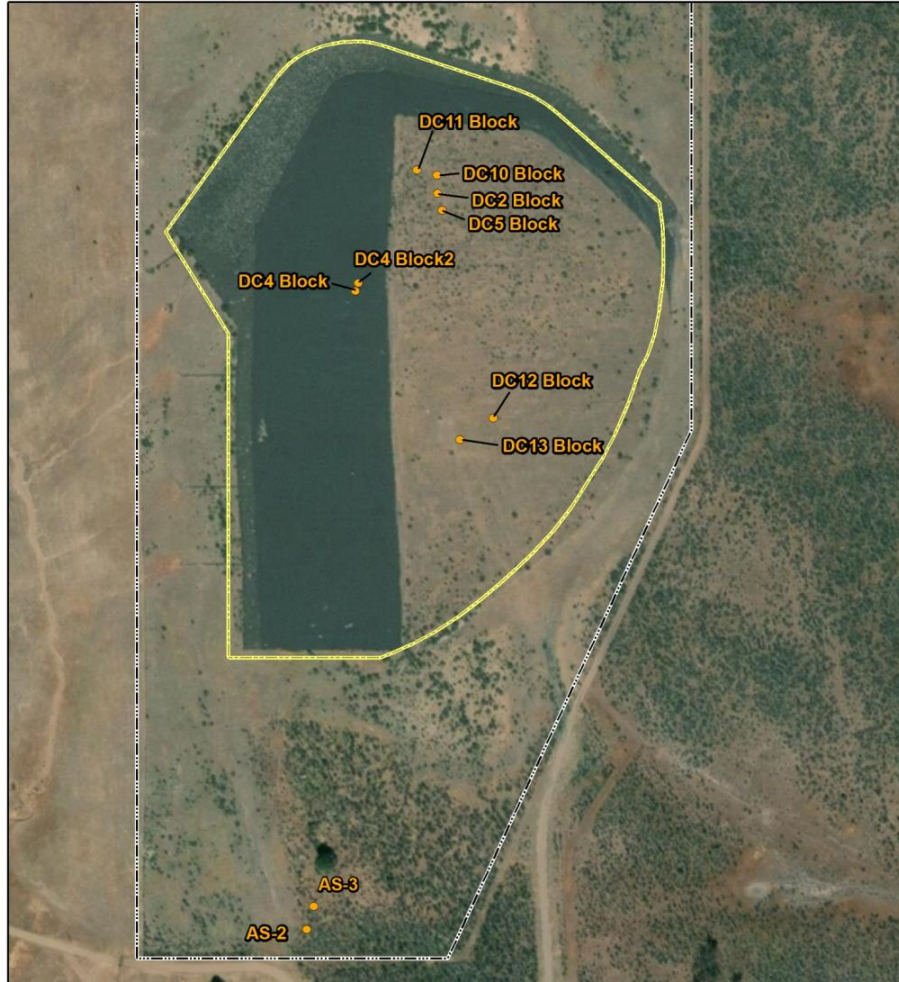
**Figure 2-7 Test Pit Locations on the Disposal Cell Top-Deck, Side Slope, and at Analogue Sites (AS) for Lakeview, Oregon**

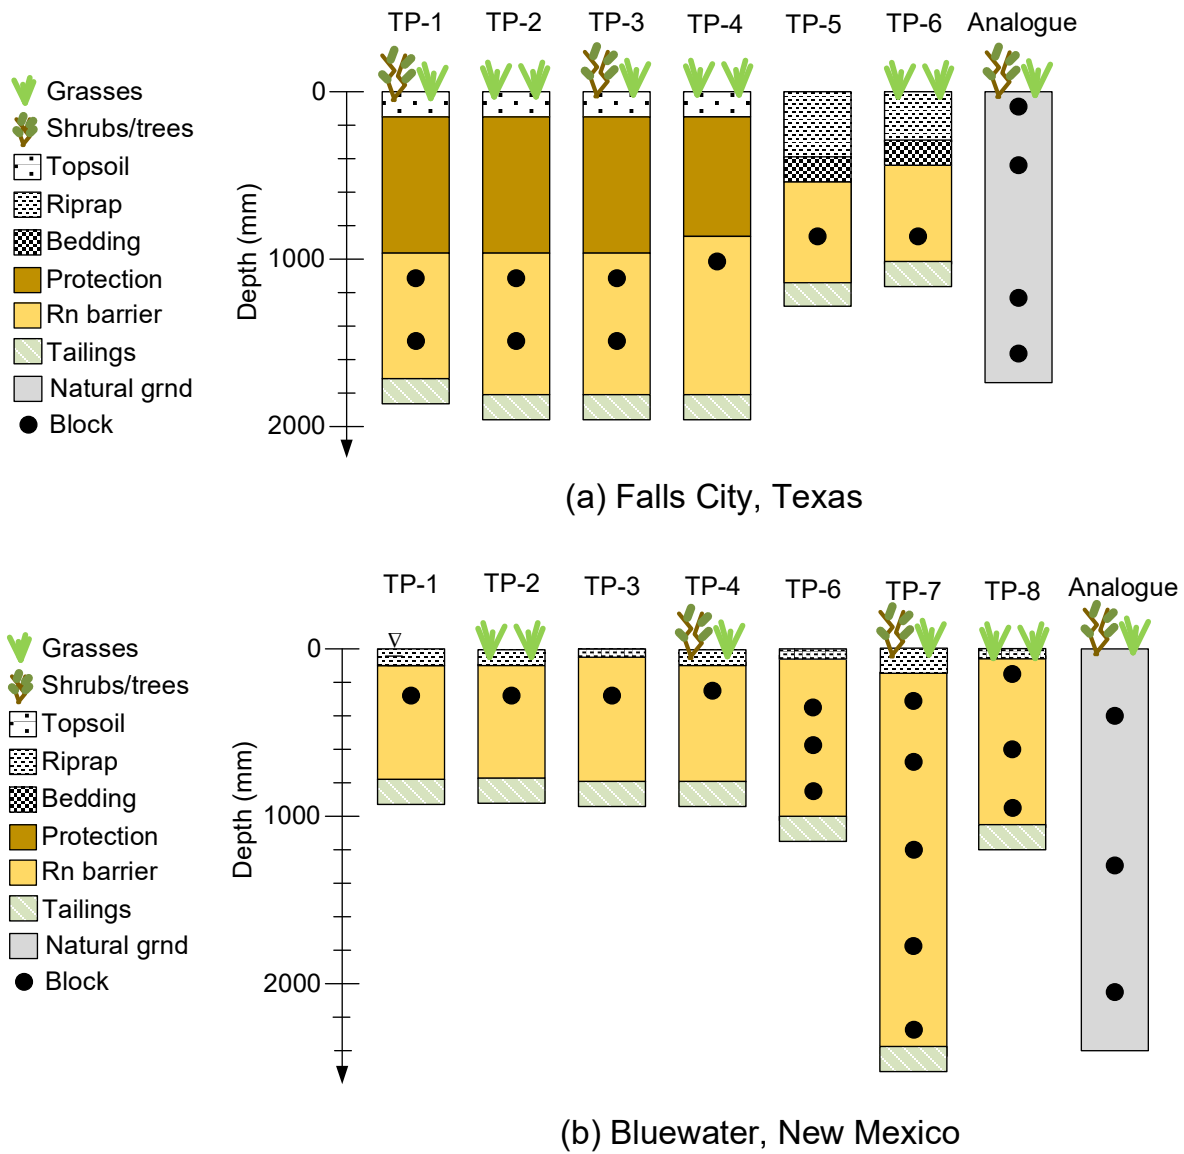
**Figure 3-1 Cover Profiles from Which Block Samples Were Collected: (a) Falls City, Texas and (b) Bluewater, New Mexico** Block Sampling Locations Shown With Solid Circles.

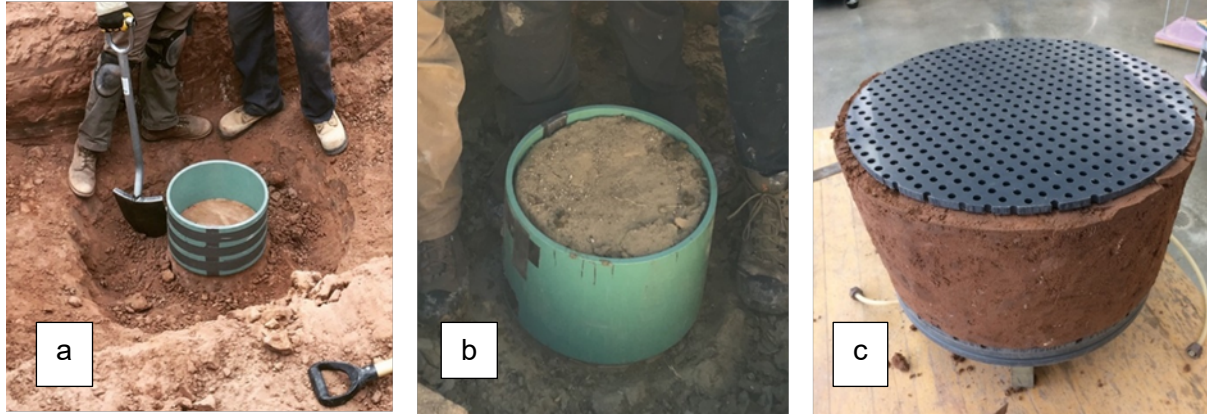
**Figure 3-3 Block Samples from Radon Barriers to Characterize Hydraulic Properties:** (a) trimming block sample into containment ring, (b) block sample within PVC containment ring, and (c) block sample trimmed to 305 mm diameter in the laboratory for hydraulic properties testing.

The samples were collected in polyvinyl chloride (PVC) sampling rings with an inside diameter and height of 400 mm (Figure 3-3a). The procedure consisted of excavating a trench around the soil to be sampled (Figure 3-3a), followed by gradually trimming away soil around the periphery

until the PVC sampling ring could be slipped over the sample while maintaining contact with the soil for confinement (Figure 3-3b). The samples were carefully sealed with plastic after being trimmed into the rings, packed in individual protective pallets, and shipped to the laboratory for testing.

Saturated hydraulic conductivity of each block sample was measured in a large-scale flexible-wall permeameter using the procedure in ASTM D5084. Test specimens were trimmed from the samples by hand to a diameter of 305 mm and aspect ratio of 1. An example of a trimmed specimen ready to be placed in a flexible-wall permeameter is shown in Figure 3-3c.

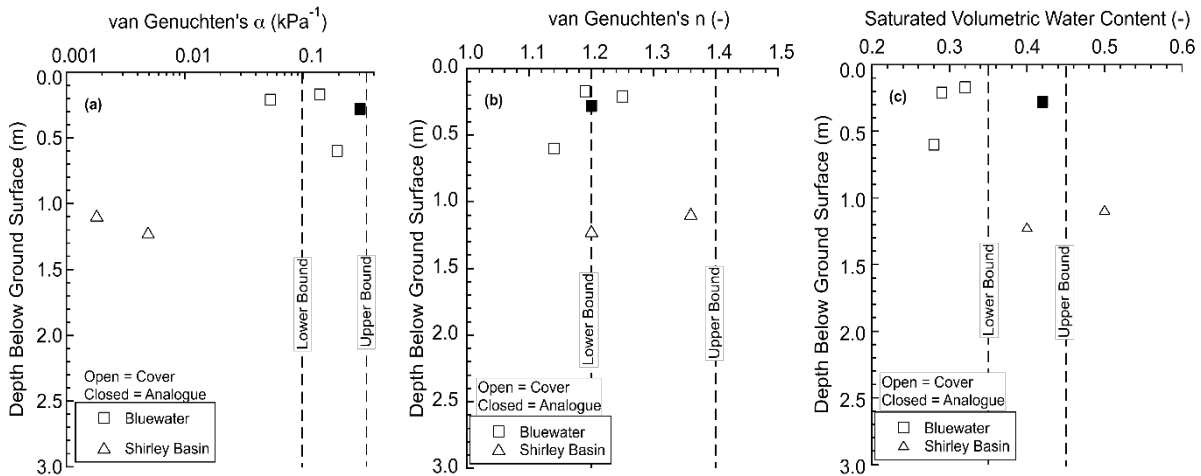
**Figure 3-6 Soil Water Characteristic Curve Parameters for Block Samples Removed from the Bluewater and Shirley Basin Sites: (a)  $\alpha$ , (b)  $n$ , and (c)  $\theta_s$ . Upper and Lower Bounds from Recommendations in NUREG/CR-7028.**

The  $\alpha$  parameter, which is inversely related to the air entry suction (suction beyond which the soil will desaturate), generally falls in the range recommended in NUREG/CR-7028 for the Bluewater site (Figure 3-6a). The  $\alpha$  parameter for the Bluewater analogue site also falls in the recommended range, and near the upper bound. In contrast,  $\alpha$  for the Shirley Basin samples is 50-100 times lower than the range recommended in NUREG/CR-7028.

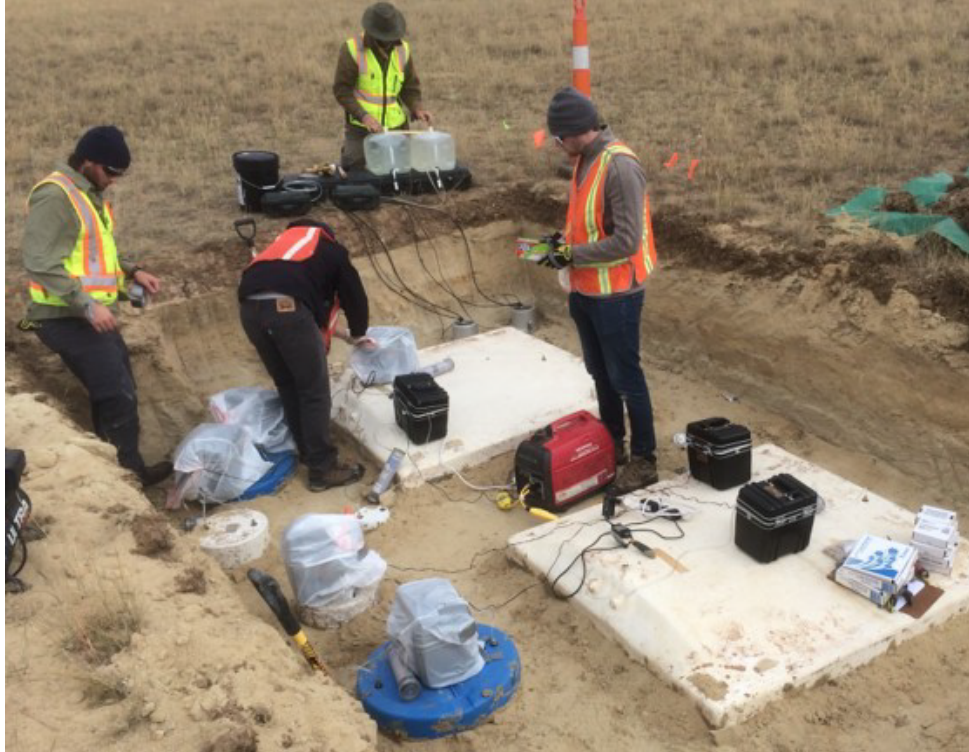
**Figure 4-1 Field Installation of Eight Flux Chambers of Four Sizes on the Top of the Radon Barrier at Shirley Basin South**

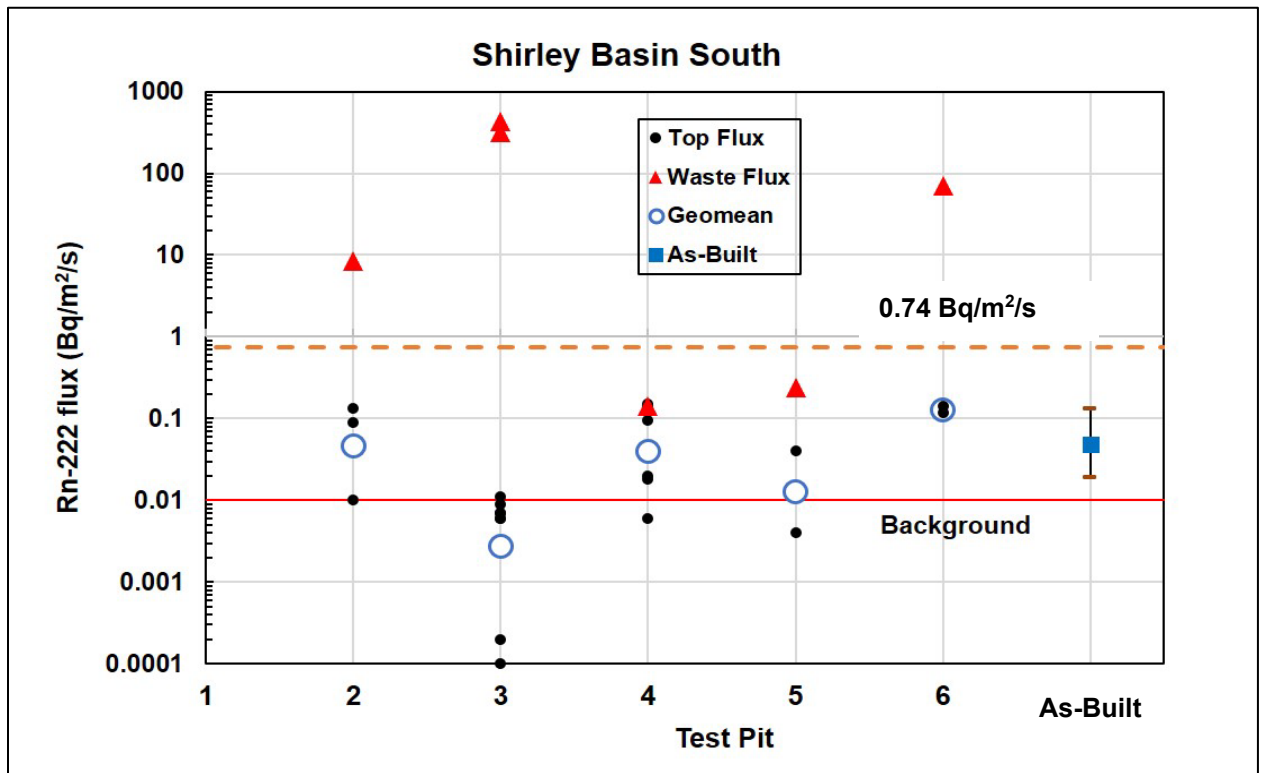
**Figure 4-6 Radon Fluxes Measured at the Shirley Basin South Site**  
 Note that the bottom fluxes are labeled “waste”. The As-Built values are the mean and the range of 101 measurements. Note that one very high as-built flux has been deleted. That location of the barrier was rebuilt after the high flux was found.

Bottom fluxes at some locations were very high. The radon barrier here was placed directly over tailing ponds. For some locations this allowed visual observation of the waste (light gray coarse sand size particles) and confidence that the bottom fluxes at those positions were unattenuated. For example, at DC-3 replicate bottom fluxes were 334 and 457 Bq/m<sup>2</sup>/s, the highest measured in this project.

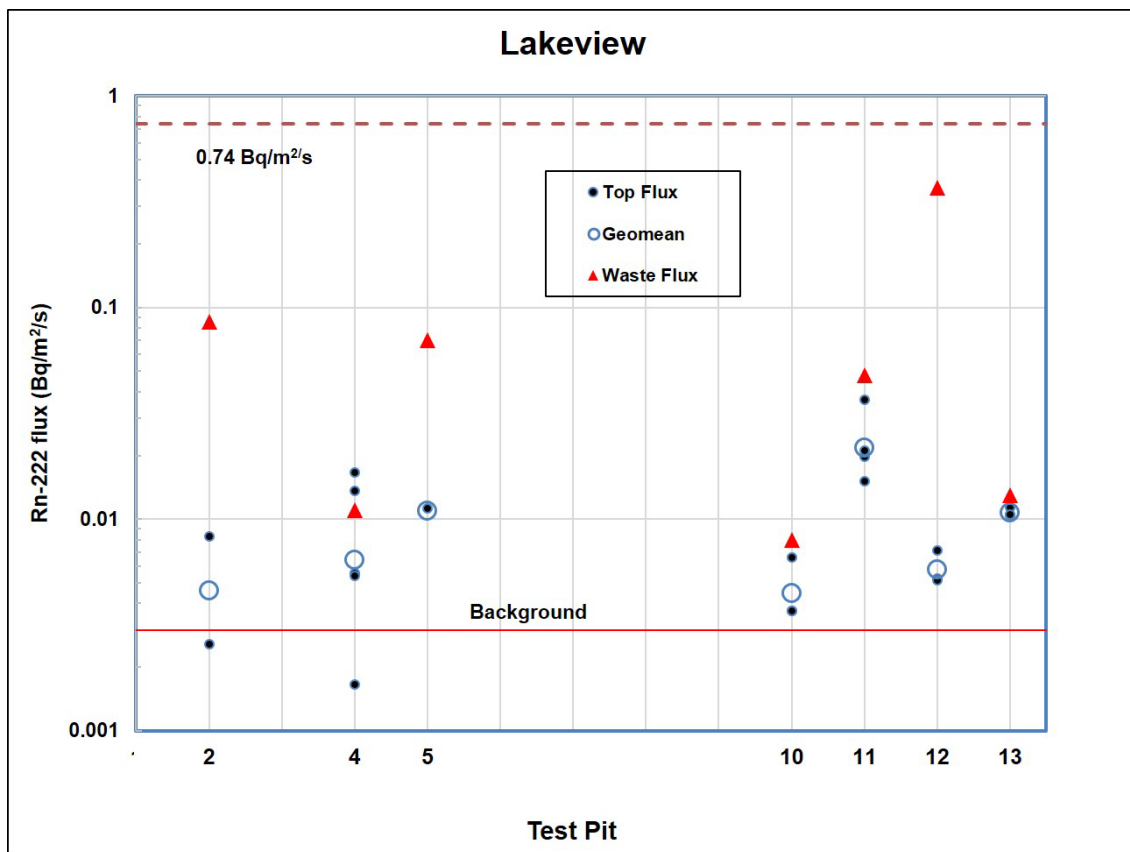
**Figure 4-7 Radon Fluxes Measured at the Lakeview Site**

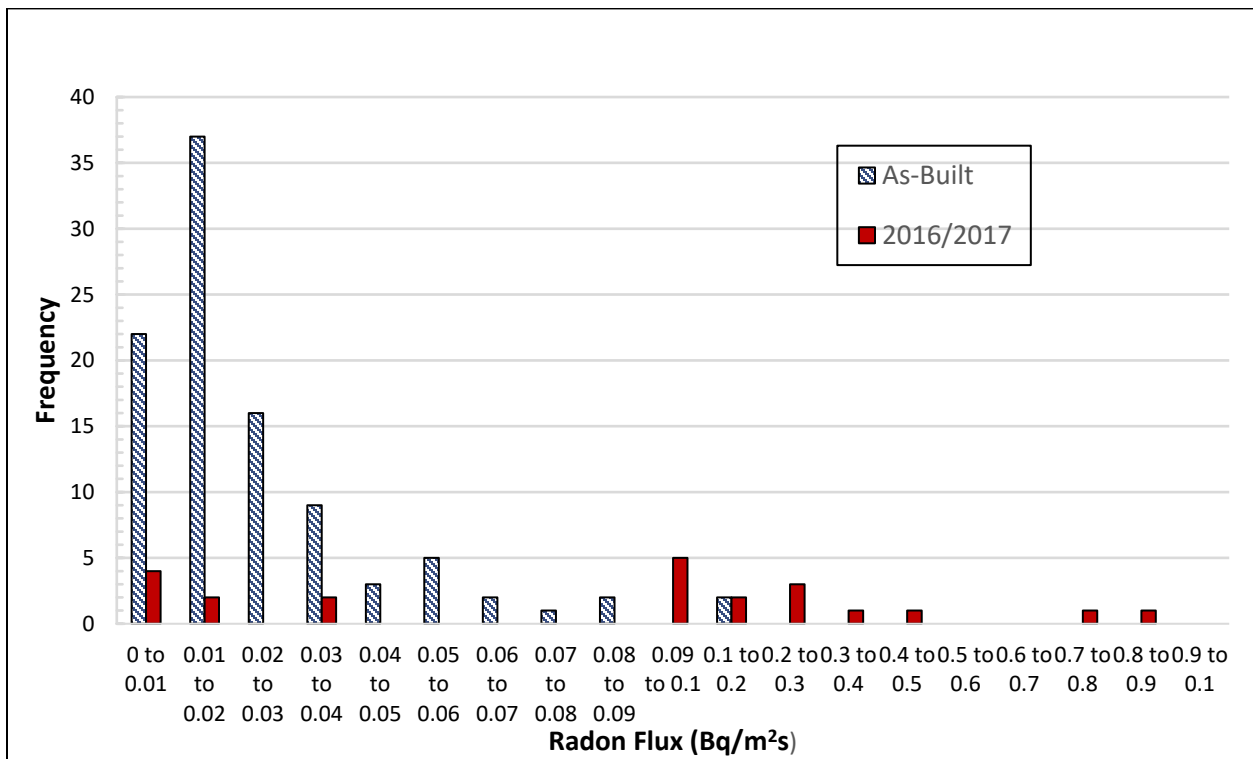
**Figure 4-9 Frequency of Falls City Radon Fluxes for As-Built and In-Service Conditions** Compares the as-built flux measurements made at the time of closure and then 22 years later, in this work. Note the bin change at 0.1 flux.

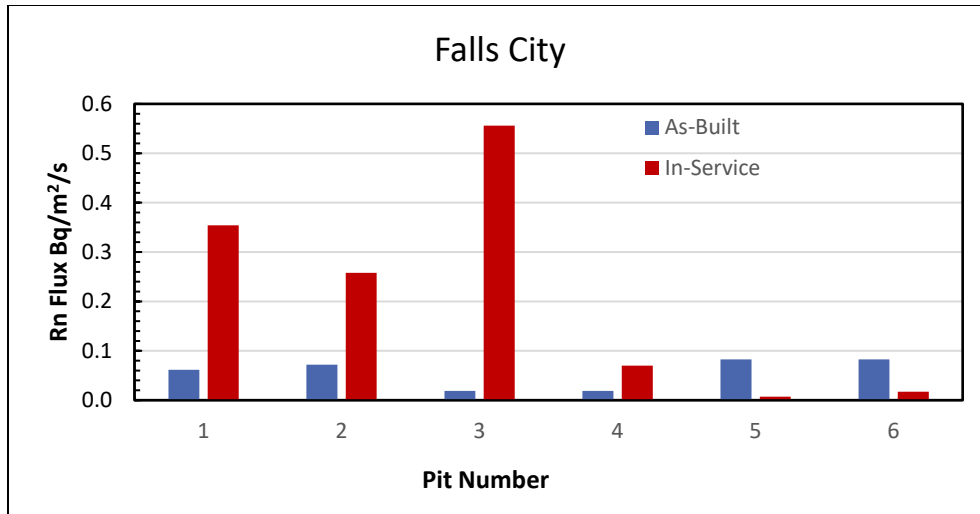
**Figure 4-10 Comparison of In-Service Fluxes to As-Built Fluxes from Near-by Measurement Locations**

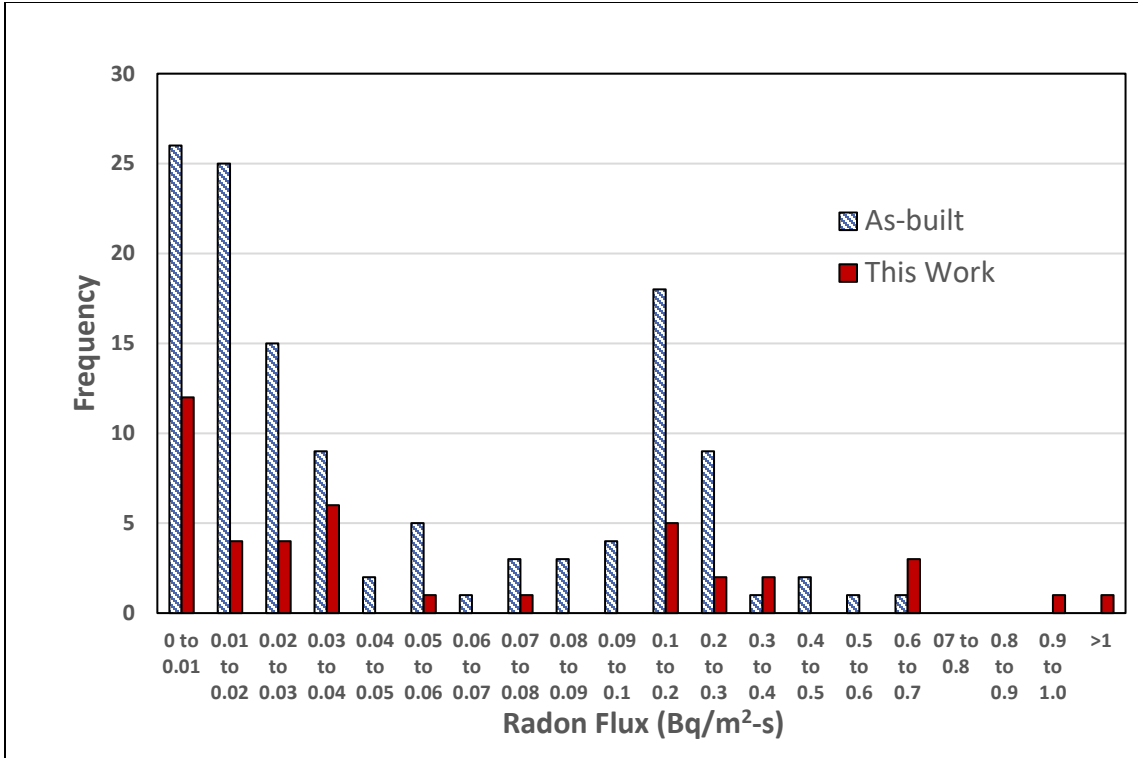
**Figure 4-11 Frequency of Bluewater Main Tailings Pile Radon Fluxes for As-built and In-service Conditions** Compares the as-built flux measurements made at the time of closure and then 22 years later, in this work. Note the bin change at 0.1 flux.

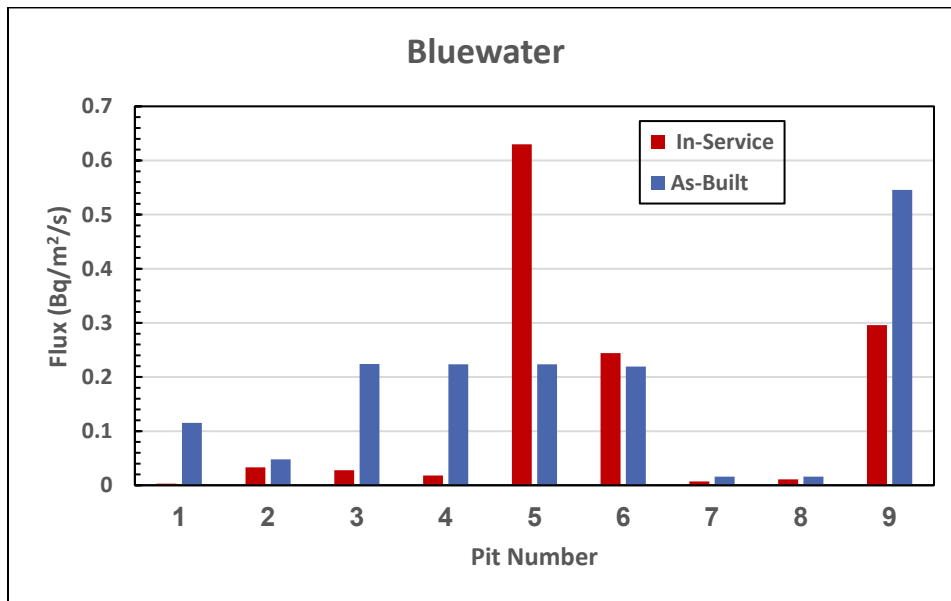
**Figure 4-12 Comparison of Bluewater In-service Fluxes to As-built Fluxes from Near-by Measurement Locations** The in-service flux for pit 1 is 0.003 Bq/m²/s, low enough that it does not appear on the plot.

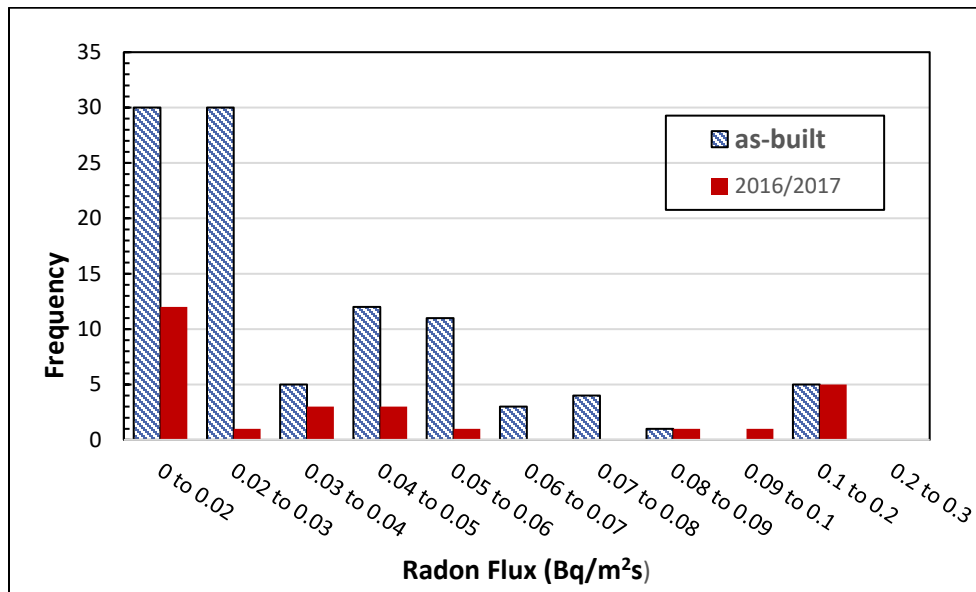
**Figure 4-13 Frequency of Flux Values at Shirley Basin South (Petrotoomics) Comparing As-built to 2016/2017 In-service Data** Note the bin change at 0.1.

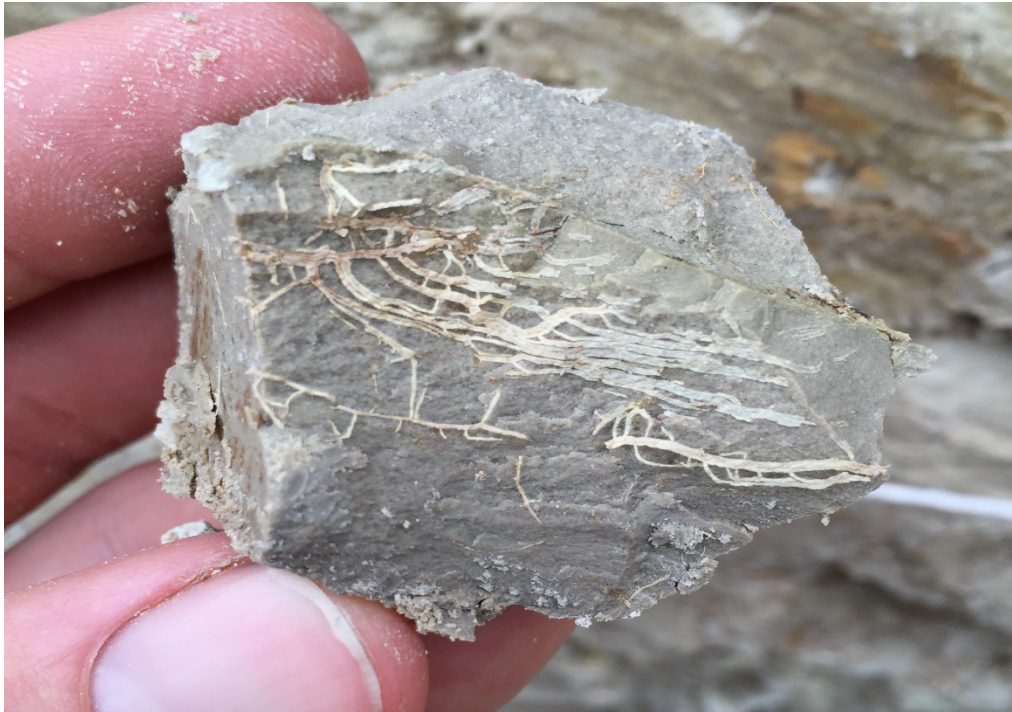
**Figure 4-16 Small Roots Grow in Thin Structural Cracks in the Radon Barrier at Falls City TP-4** These cracks are common along the edges of clay clods that remain from construction. TP-4 was a control, located many meters from a mesquite bush.

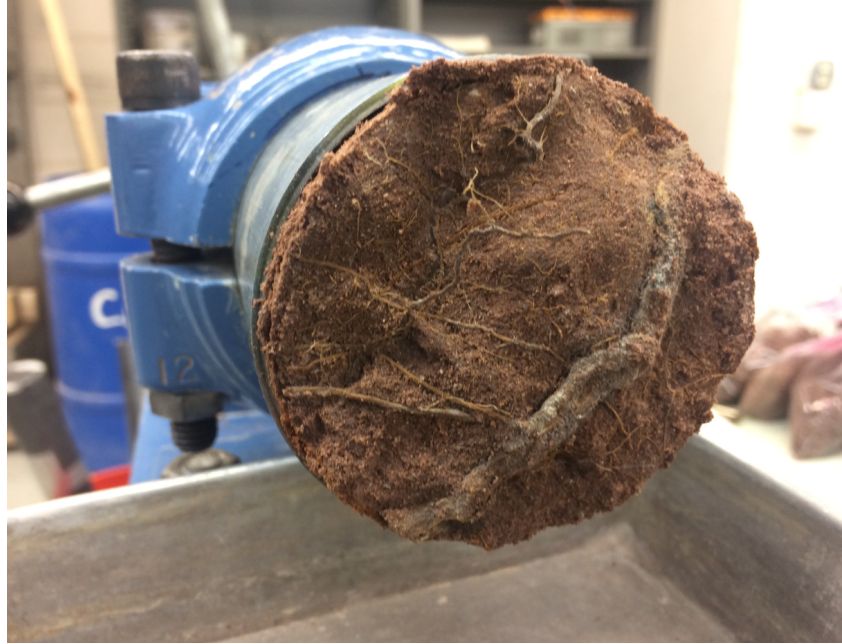
**Figure 4-18 Large Root in the Radon Barrier in a Shelby Tube Sample from Bluewater Test Pit 5 here Fluxes were High and Exhibited a Wide Range**

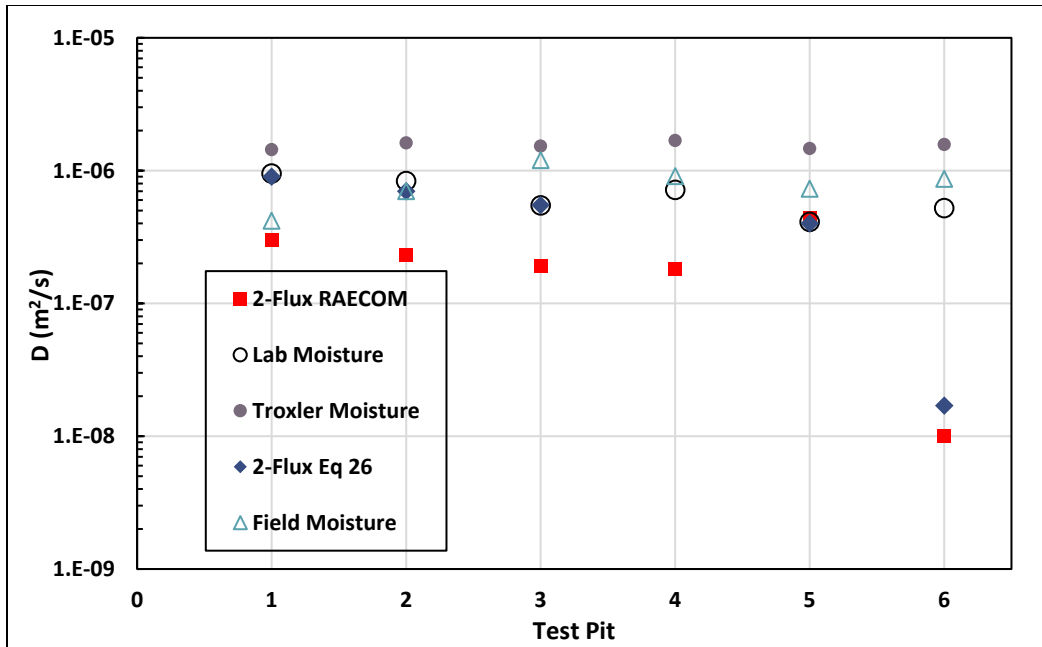
**Figure 4-20 Diffusion Coefficients Calculated in Several Ways for Test Pits at the Falls City Site**

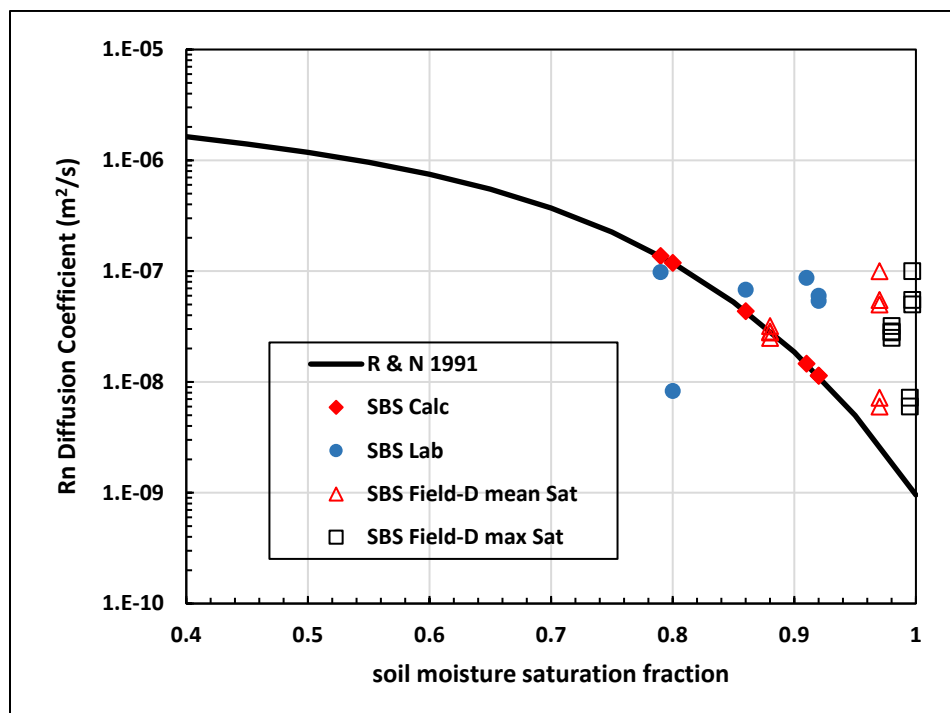
**Figure 4-22 Comparison of a Curve Calculated from Eq. 6 with Samples Taken from the Shirley Basin South Site**

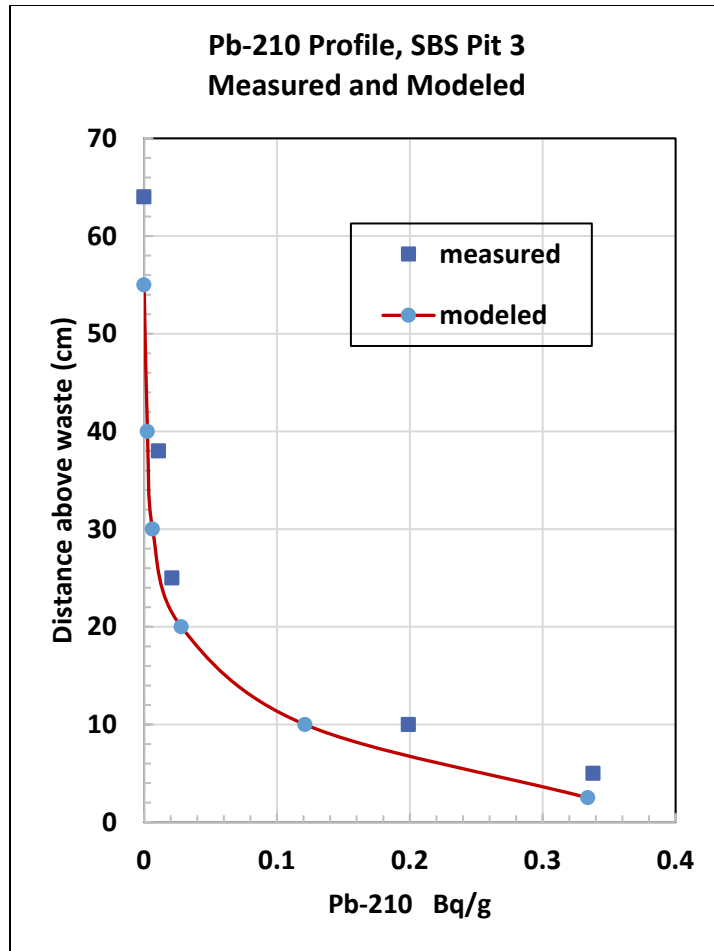
**Figure 5-15 Measured and Modeled Pb-210 Profiles from Pit 3 at the Shirley Basin South Site** Modeled Rn concentrations within the barrier are based on site-specific Rn flux measurements.

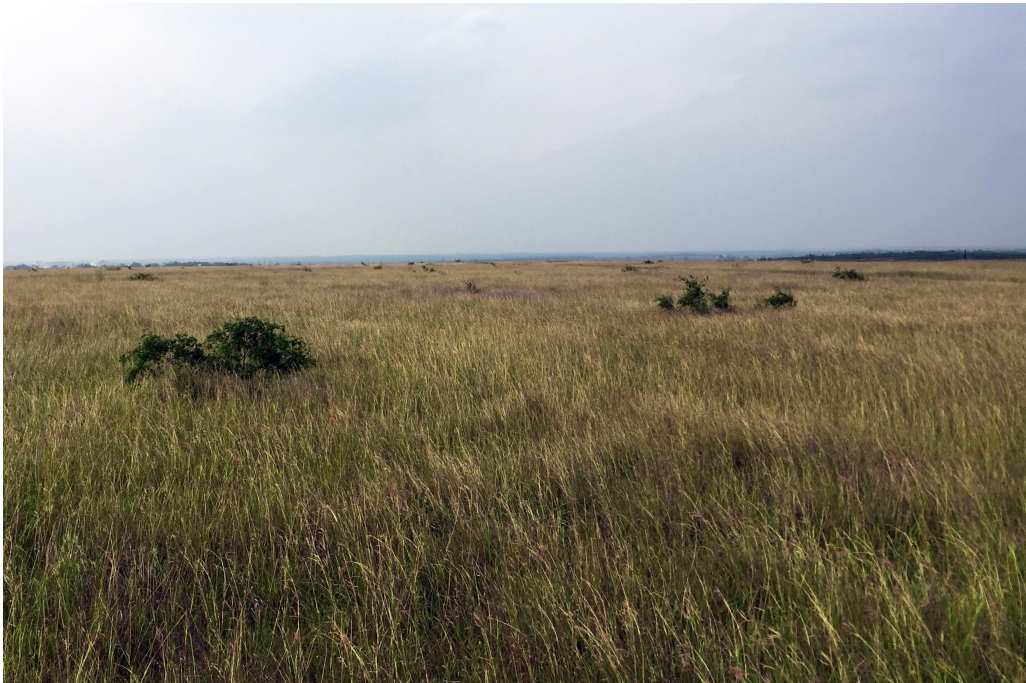
**Figure 6-4 Representative Surface and Vegetation Condition on the Disposal Cell at Falls City, Texas**

The top deck of the disposal cell at the Falls City site is a vegetated topsoil cover, while the side slope is made of riprap with bedding cover. On the top deck of the disposal cell, measured topsoil thickness ranged from 240–250 mm while the thickness of the overburden layer ranged from 680–750 mm. The depth from ground surface to the top of the radon barrier ranged from 930 mm–1000 mm. Radon barrier thickness ranged from 460–920 mm. Individual lift-and-compaction events were largely indiscernible in the radon barrier.

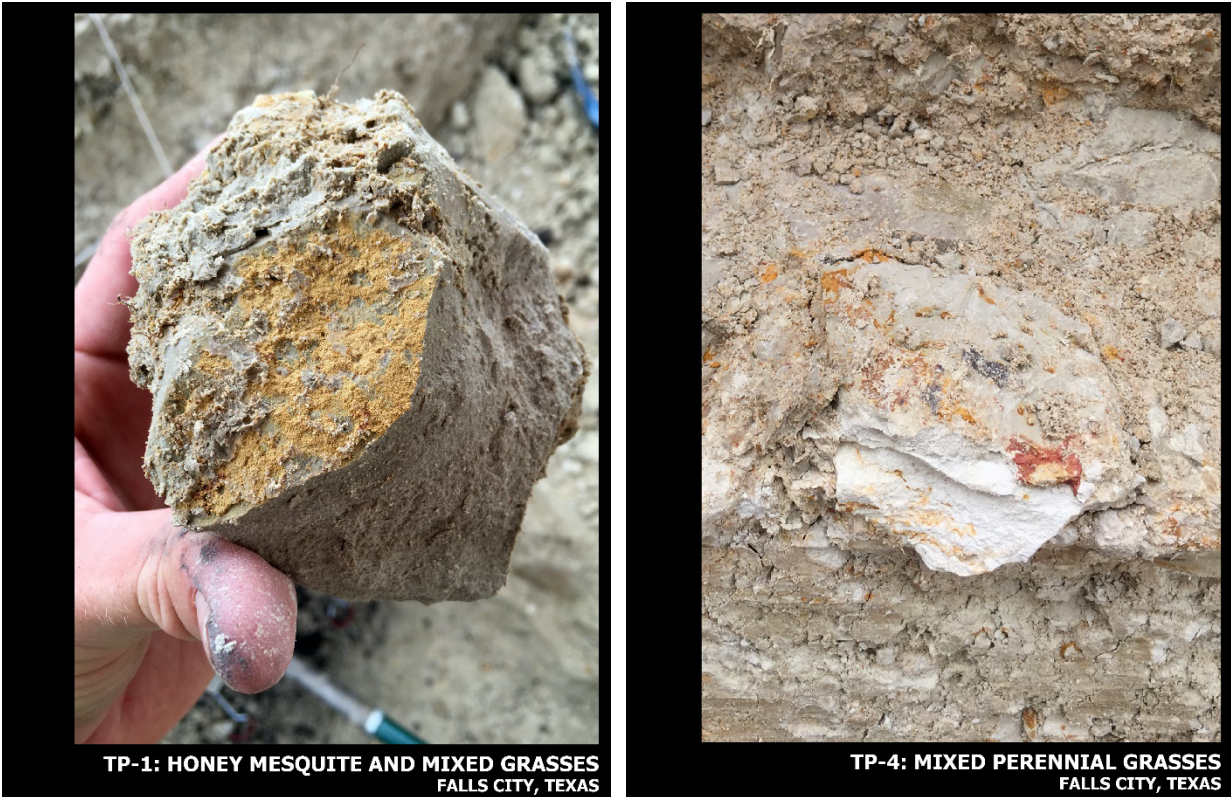
**Figure 6-5 Remnant Soil Structure in the Radon Barrier at Falls City, Texas**

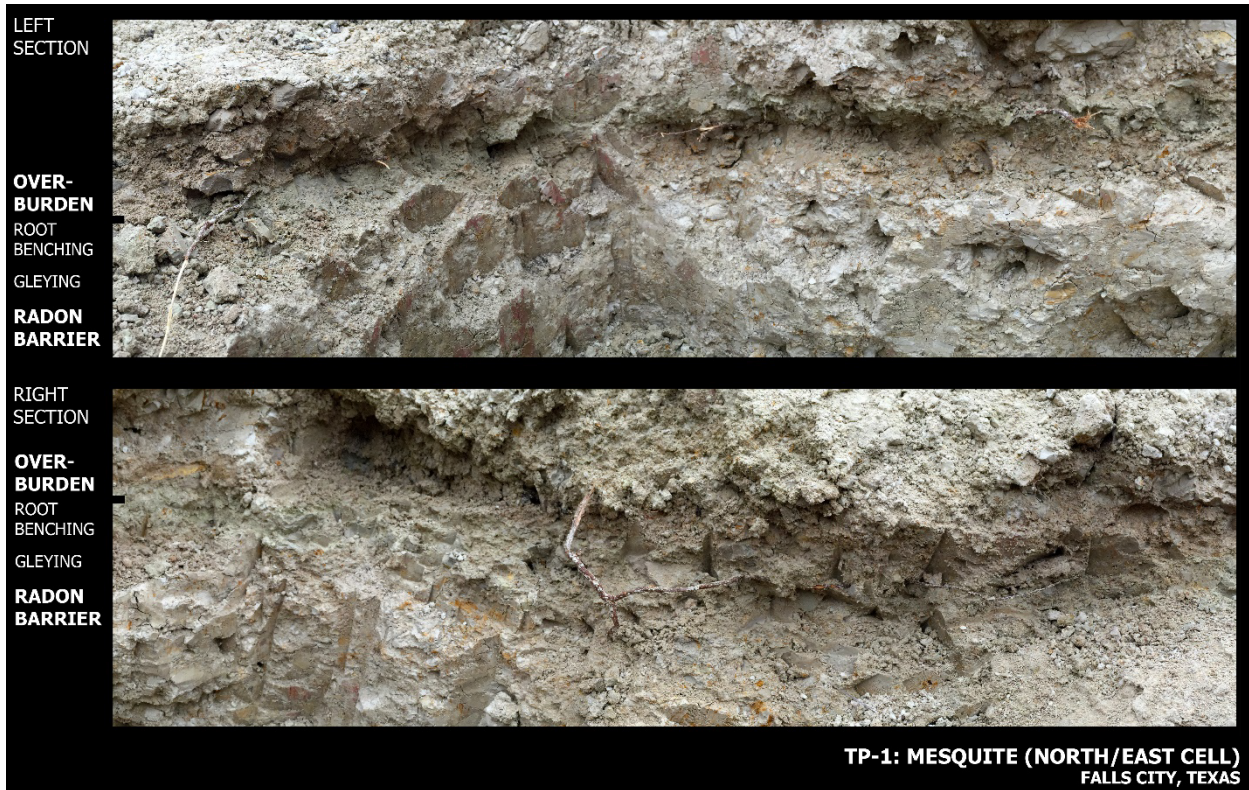
Figure 6-7 Honey Mesquite Root Benching and Gleying Along the Top Boundary of the Radon Barrier at Falls City, Texas

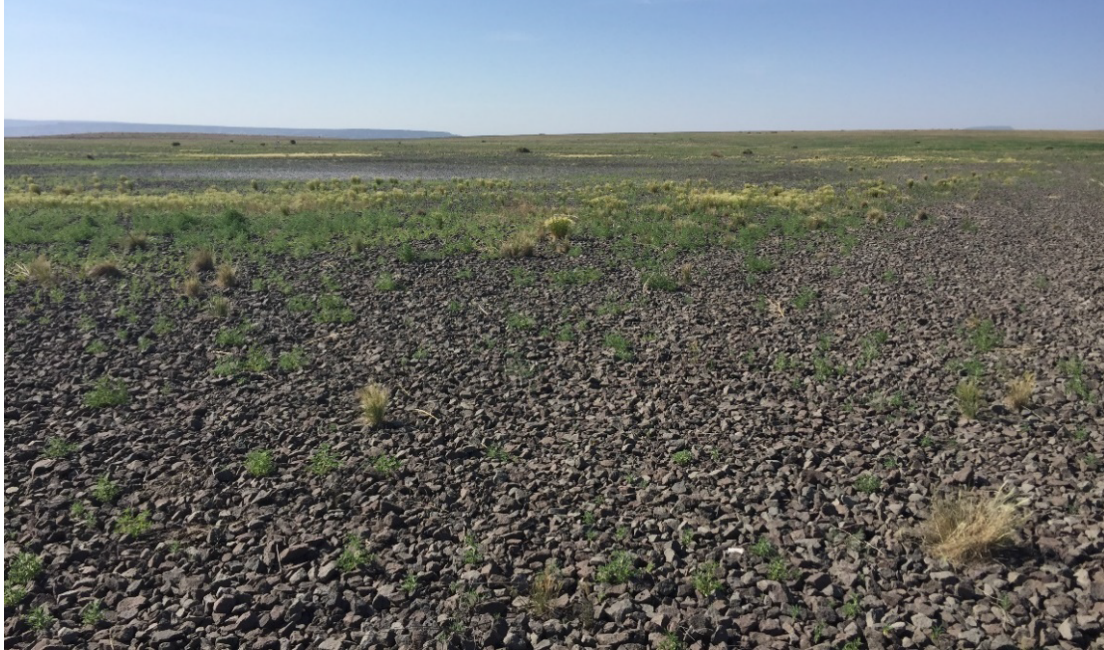
**Figure 6-10 Surface and Vegetation Condition on the Main Disposal Cell at Bluewater, New Mexico**

The main and carbonate disposal cells at the Bluewater site are rock riprap covers. Among the profiles surveyed, rock riprap thickness varied between 80–150 mm. The interstices of the rock riprap were occasionally filled with organic materials from nearby vegetation, blown seeds, animal scat, aeolian dust, rock fines, and anthropogenic debris including blasting caps, ball bearings, scrap metal, tire shards, and survey stakes.

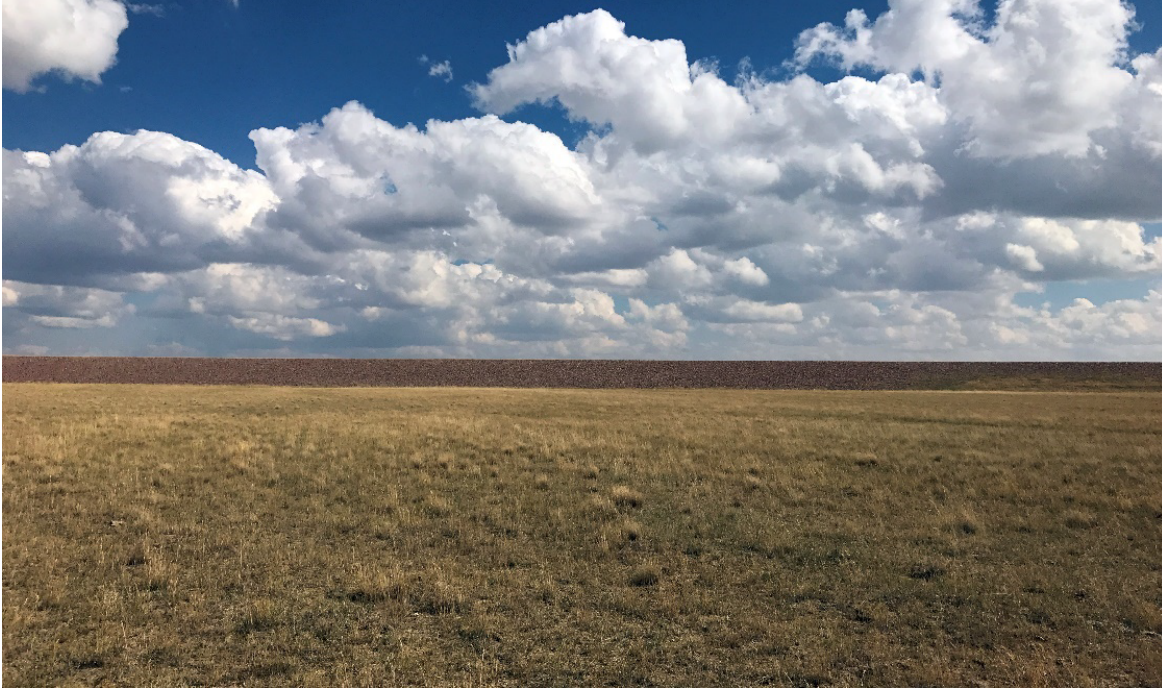
**Figure 6-17 Surface and Vegetation Condition on the Disposal Cell at Shirley Basin South, Wyoming**

The top deck of the disposal cell at the Shirley Basin South site is a vegetated topsoil cover while the side slope is a rock riprap with frost protection cover. On the top deck of the disposal cell, topsoil thickness ranged from 230–410 mm while the thickness of the sandy overburden fill layer ranged from 570–680 mm. The depth from ground surface to the top of the radon barrier ranged from 890–1140 mm. Radon barrier thickness ranged from 480–860 mm, with individual lift events ranging from 60–230 mm. The as-built condition of the cell displayed less profile-to-profile variability in material thickness than the Bluewater or Lakeview sites and was slightly more variable than the Falls City site.

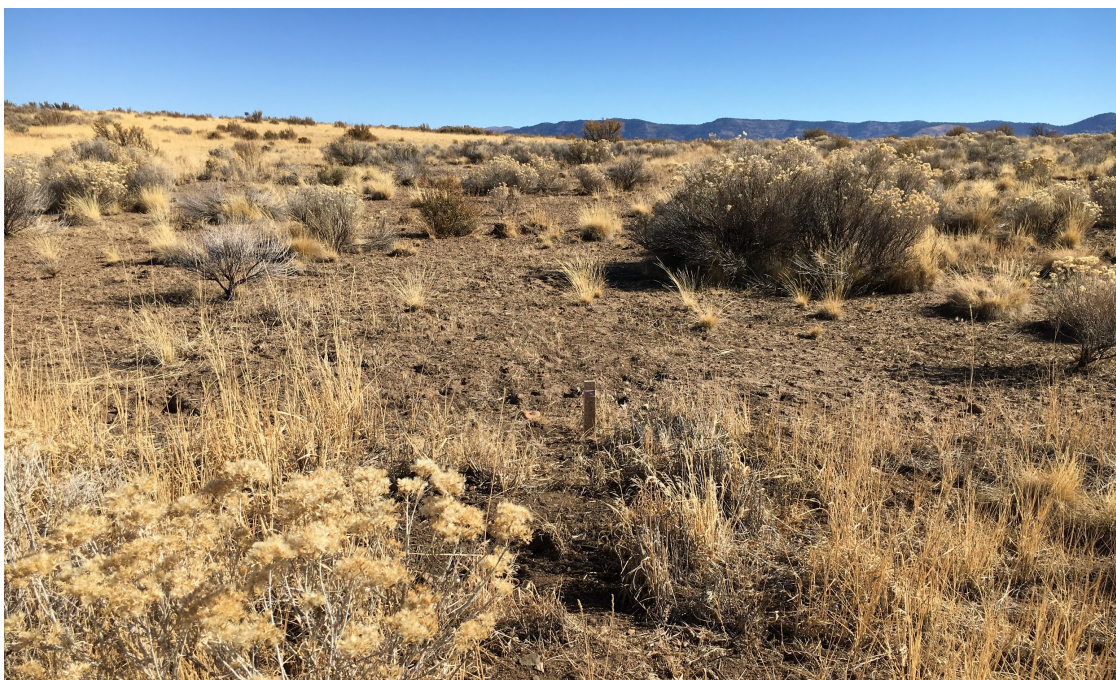
The top deck of the disposal cell at the Lakeview site is a vegetated rock-soil multicomponent cover, while the side slope is a rock riprap with bedding cover. On the top deck of the disposal cell, topsoil thickness ranged from 10–270 mm. Topsoil application, surface erosional scouring, and downward infill of topsoil into the interstices of riprap and gravels was inconsistent across the cell. An organic horizon composed of leaf litter was frequently observed in profiles associated with shrubs and ranged in thickness between 0–70 mm, with decreasing thickness at an increasing distance from the base of the tap root. The depth from ground surface to the top of the radon barrier ranged from 510–780 mm. Radon barrier thickness ranged from 330–650 mm. Variation in the as-built condition was evident in inconsistent lift-and-compaction horizon thickness (70–160 mm), color of radon barrier lift events, radon barrier gravel content, and variation in remnant soil structure within radon barrier lift-and-compaction events.

**Figure 6-21 Representative Surface and Vegetation Condition on the Disposal Cell at Lakeview, Oregon**

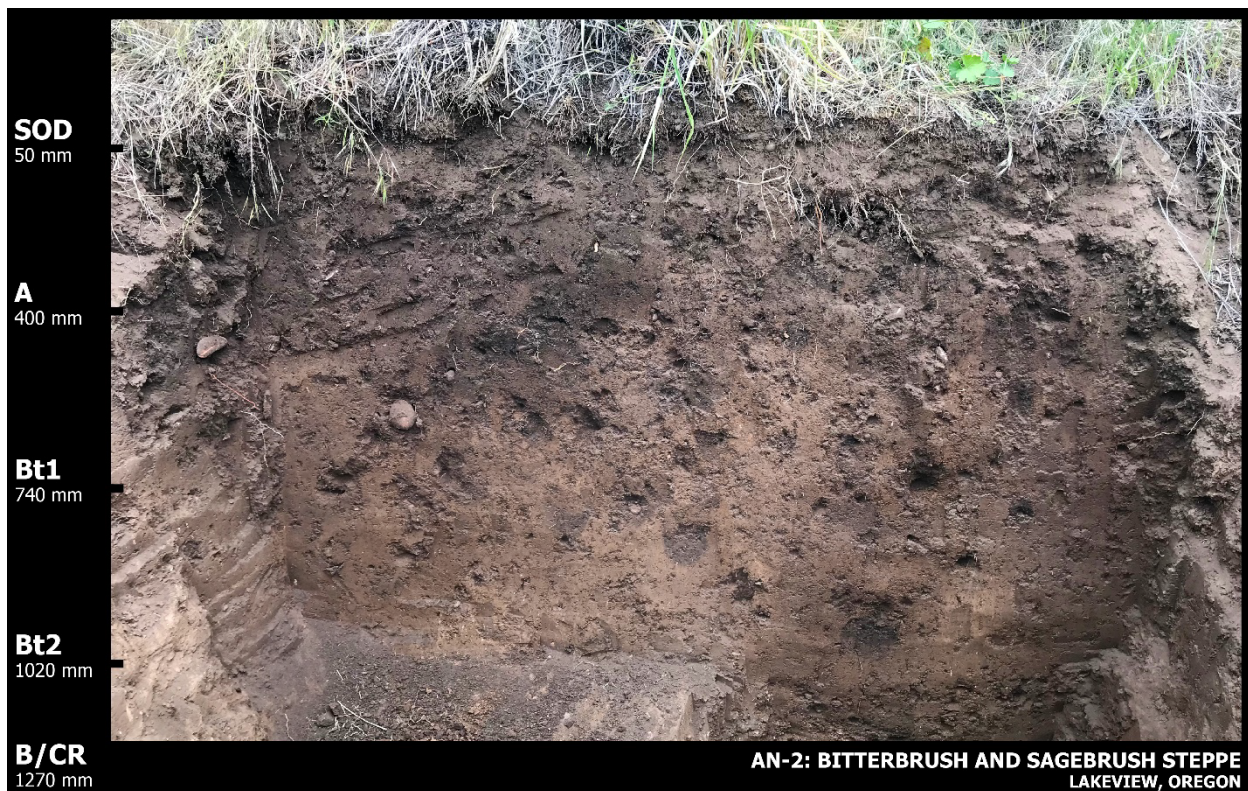
The sagebrush steppe natural analogue soil profile is presented in Figure 6-26. The soil structure in the analogue is composed of blocky structures of mixed sizes (fine to medium) that slightly increase in size and decrease in grade with depth (to 1270 mm). Bioturbation by insect, earthworm, and rodents is very common to a depth of 1020 mm. Root size, quantity, and class slightly decrease with depth, with coarse, medium, fine, and very fine roots occurring through the depth of the observed profile (more than 1270 mm).

**Figure 6-26** Natural Analogue Soil Profile at the Lakeview Site

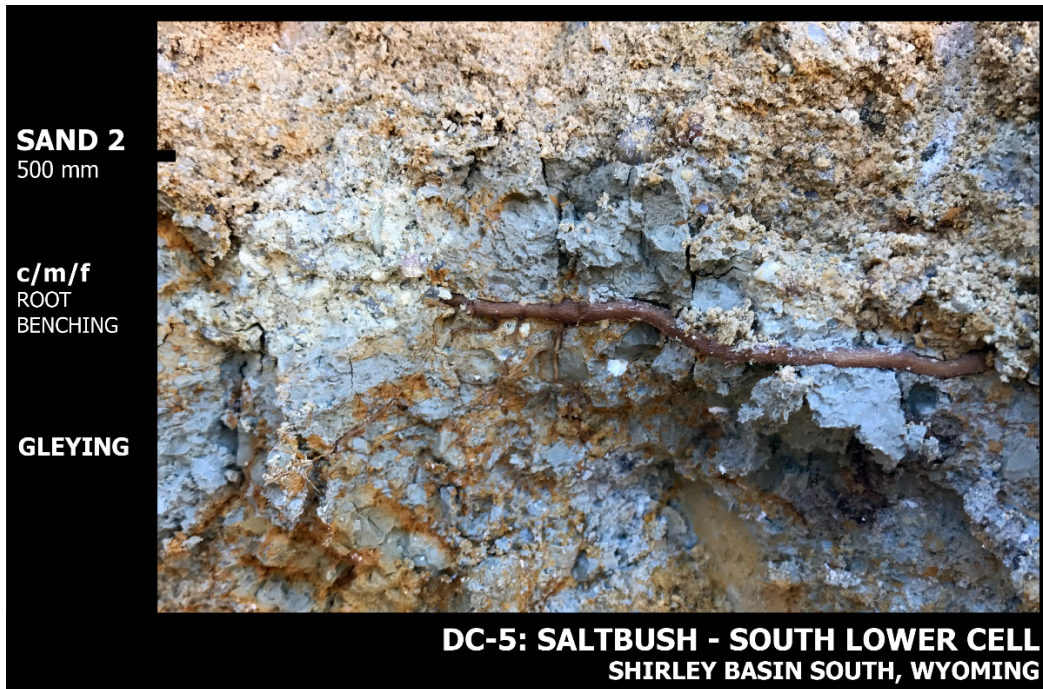
**Figure 6-34 Gleying in a Clay Lens Located Above the Radon Barrier at Shirley Basin South, Wyoming**
