# Target Fragilities for Equipment Vulnerable to High Energy Arcing Faults

RIL 2022-01

EPRI 3002023400

Final Report, May 2022  
NRC Research Information Letter

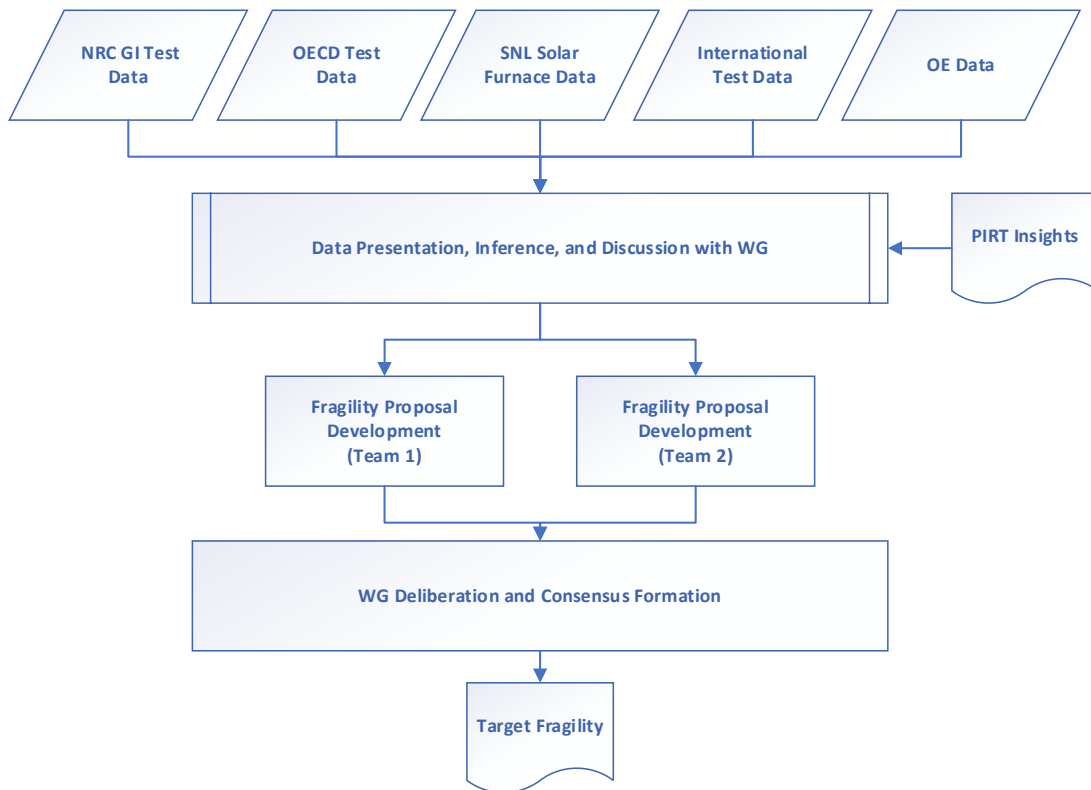
**Figure 2-1**  
**Target fragility flowchart**

The NRC developed a target fragility plan and shared the plan with EPRI for feedback and improvement. Appendix A reproduces that plan. Figure 2-1 outlines the general approach taken by the WG. This approach consists of a sequence of activities discussed below to support the fragility determination.

The approach follows a logical progression of tasks, including (1) identify and compile data sources, (2) present the data to the WG through summary reports, (3) propose and develop an agreed-upon approach for reaching a consensus, (4) assign individual WG member roles to perform the activities, (5) develop proposals, (6) deliberate and refine the proposals until the final consensus position on target fragility is achieved.

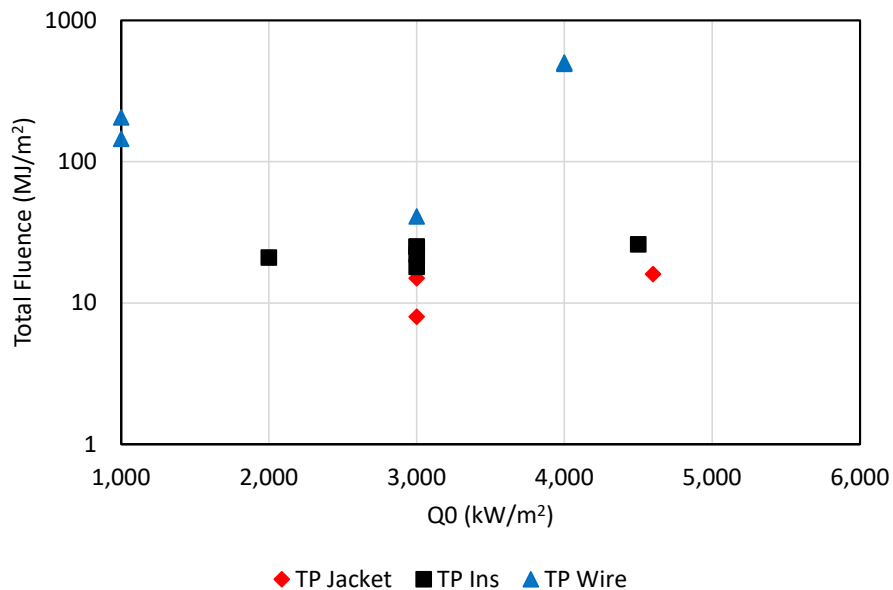
**Figure 3-3**  
Thermoplastic cable results from SNL solar furnace testing

A key indicator of cable damage is the breaching of the outer protective jacket and exposure of the underlying insulated conductors. The jackets tend to be black and the conductor insulation is multi-colored, making it relatively easy to determine that the jacket is breached. According to Figure 3-3, for TP cables, the fluence at which this occurs is approximately 15 megajoules per meter squared (MJ/m<sup>2</sup>) and Figure 3-4 for TS cables the value is approximately 30 MJ/m<sup>2</sup>.

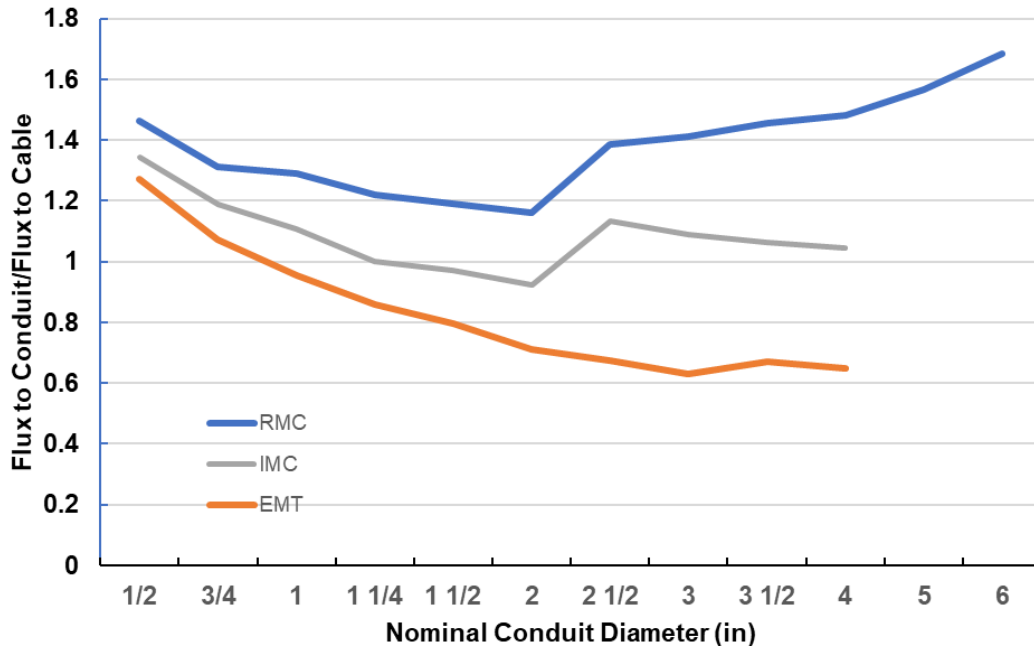
**Figure 5-3**  
**Ratios of  $q_{con}/q_{cab}$  for RMC, IMC, EMT**

The bracketed expression on the right-hand side of this equation is approximately 1.5 for the parameter values chosen. Figure 5-2 shows the ratios of  $q''_{con}/q''_{cab}$  for RMC, IMC, and EMT for a range of conduit diameters.

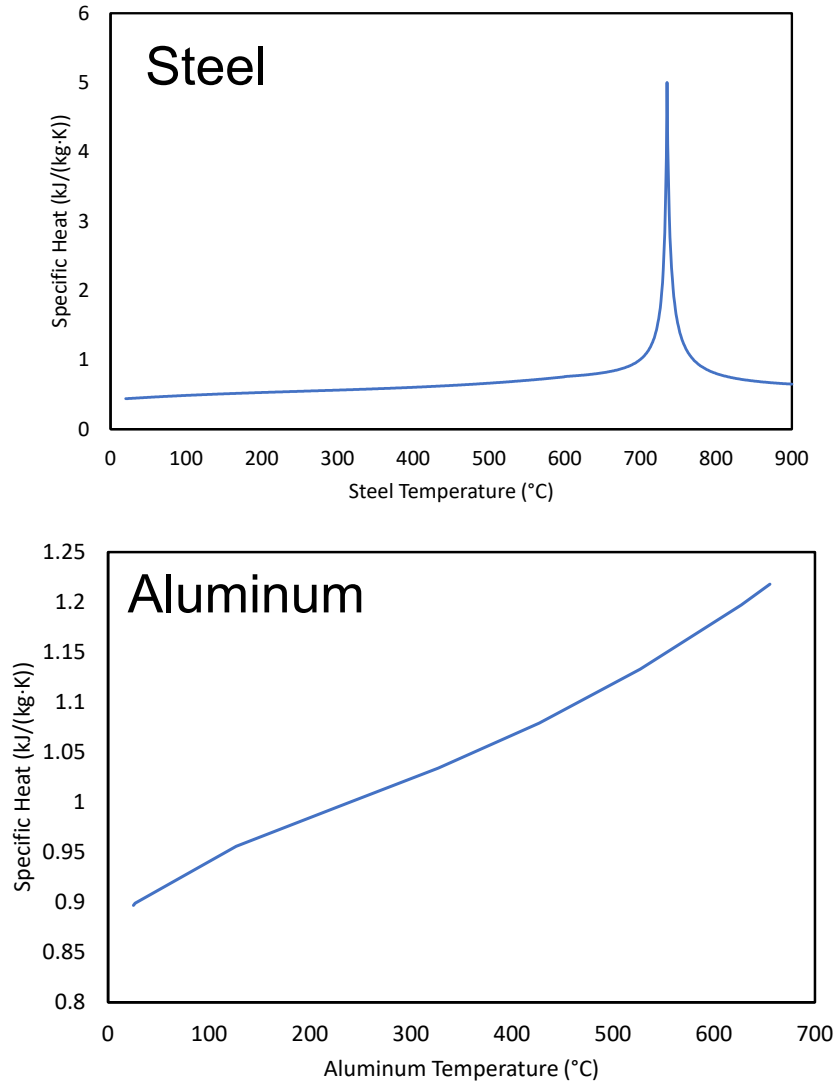
**Figure 5-4**  
**Specific heat of steel [26] (top) and aluminum [27] (bottom)**

Figure 5-4 shows the specific heat for steel [26] and aluminum [27]. The average values over the range of interest are 0.697 kJ/(kg·K) for steel and 1.01 kJ/(kg·K) for aluminum. The spike seen in the steel data is an endothermic change in the crystalline structure of carbon steel.

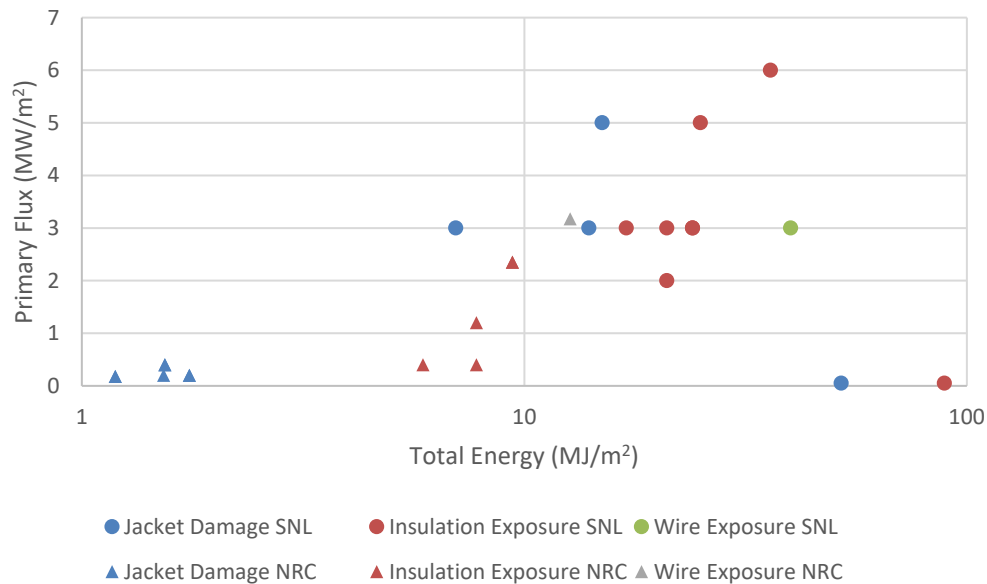
**Figure B-1**  
Thermoplastic dataset by flux and incident energy (note  $\log_{10}$  scale for total incident energy)

TP data are presented first, as they are the largest data set and provide a convenient comparison between test series. Figure B-1 presents the available dataset categorized by damage state and plotted by flux and incident energy. Figure B-2 presents the available TP data in a box plot split by test series (NRC or SNL) and damage characterization (IE – insulation exposure, WE – wire exposure). Note that jacket damage (JD) is not included as it was considered it to be a “catch-all” category and the qualitative characterization of the lower limit is difficult to characterize. Thus, any estimate of data quartiles for the JD case was viewed to have little meaning and has been excluded from the box plot. It should also be noted that the WE damage state was limited to one data point for each test series. In addition, several data points in the NRC data set are estimates due to the fact that the active measurement system (TC wire), while protected, was damaged during the event and incident energy could not be reported. From this graph there is an apparent systemic difference between the two data sets. The NRC data appears to show damage at a lower incident energy level than the corresponding SNL data of the same damage state. Possible reasons for this difference are discussed next.

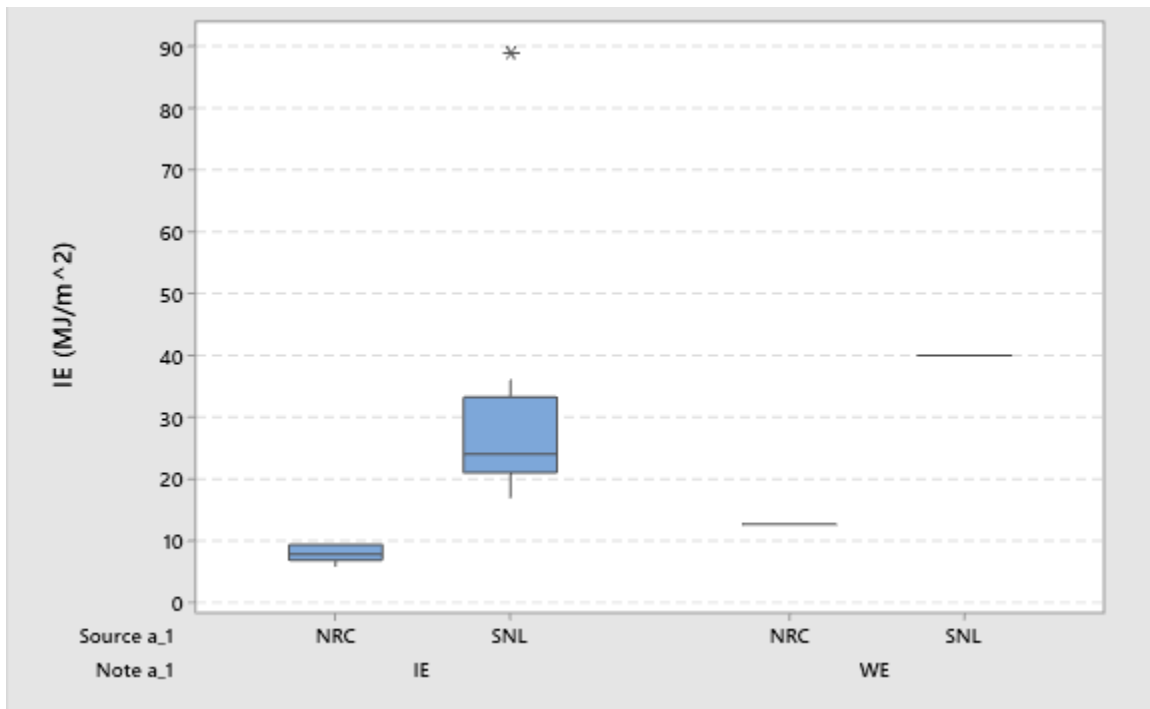
**Figure B-2**  
**Box plot presenting thermoplastic data**

Exposure conditions could contribute to the differences presented in Figure B-2. The SNL tests were a purely radiant exposure using solar energy as the source of thermal stress. In the NRC tests, the cable coupons were exposed to radiant and convective heating, along with mechanical forces, such as momentum-driven flows from the arc plume (jet) and particulate erosion from the molten metal particles within the HEAF plume (jet). Visual comparisons of cable samples between the two-test series indicated that the SNL samples appear to exhibit a larger char layer than that observed from the NRC testing. Figure B-3 is a photograph of the lower left TP cable sample (1-23) from Test 2-21, which received approximately  $7.8 \text{ MJ/m}^2$  of energy. Figure B-4 is a photograph of the TP cable sample used in SNL Test 1-34 which received approximately  $25 \text{ MJ/m}^2$  of energy. Both example photos are from the upper region of the box plot for their respective test series and the insulation exposure category. As can be seen in the SNL example, the char layer is more substantial than that observed in the NRC test. While both cases involve localized melting, the char layer is, for all practical purposes, nonexistent in the NRC test compared to the SNL test, where it is easily identified. The development of the char layer in the SNL tests likely has a primary effect on the heat transfer characteristics within the cable sample. That is, the char layer is acting as a thermal shield and limiting the heat transfer inward to the cable. One likely cause for the lack of the char layer on the NRC cable is the effect of particulate erosion at the surface of the cable. The HEAF plume (jet) being a momentum-driven flow consisting of hot molten metal particulate from the electrode and enclosure effectively acts as an erosion mechanism that removes the char layer and minimizes the thermal shielding effect.

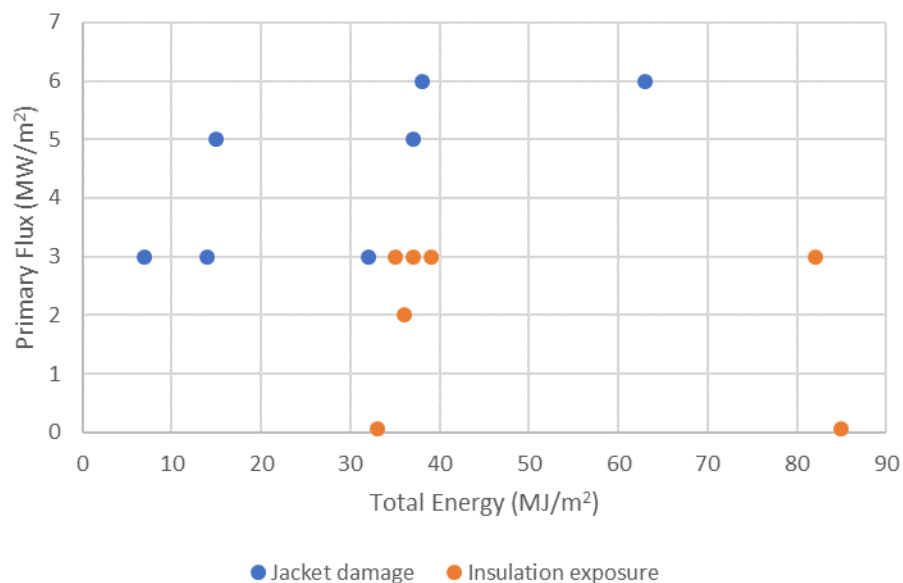
**Figure B-6**  
Thermoset damage as a function of heat flux and total energy

For the TS case, given that a similar data set for TS material is not available from the NRC data, the logic developed for the TP case is again used. Figure B-6 shows the damage state of the samples as a function of the total energy (x-axis) and nominal primary heat flux (y-axis). As shown, the data line up nicely in terms of an energy exposure threshold. The minimum energy exposure that resulted in insulation exposure is 33 MJ/m<sup>2</sup>. Alternatively, the maximum energy exposure below the insulation exposure damage level that resulted in only jacket damage (that is less than the 33 MJ/m<sup>2</sup> value) is 32 MJ/m<sup>2</sup>. As with the TP case, using the maximum incident energy below insulation exposure from the SNL tests for TS cable correlates cable damage to when the jacket is no longer present in the SNL tests. However, unlike the TP case, there is no direct comparison between full-scale NRC data and the small-scale SNL solar furnace data set. As such, the team had to assume similar behaviors (shifts in data characterizations) exist for the TS case. With this assumption, the two factors identified in the TP case suggest that using the highest incident energy value of jacket damage below insulation exposure events for the SNL tests is a reasonable approximation for estimating cable damage. As such, the team agreed that 32 MJ/m<sup>2</sup> is a reasonable estimate for the target fragility threshold for TS cable.

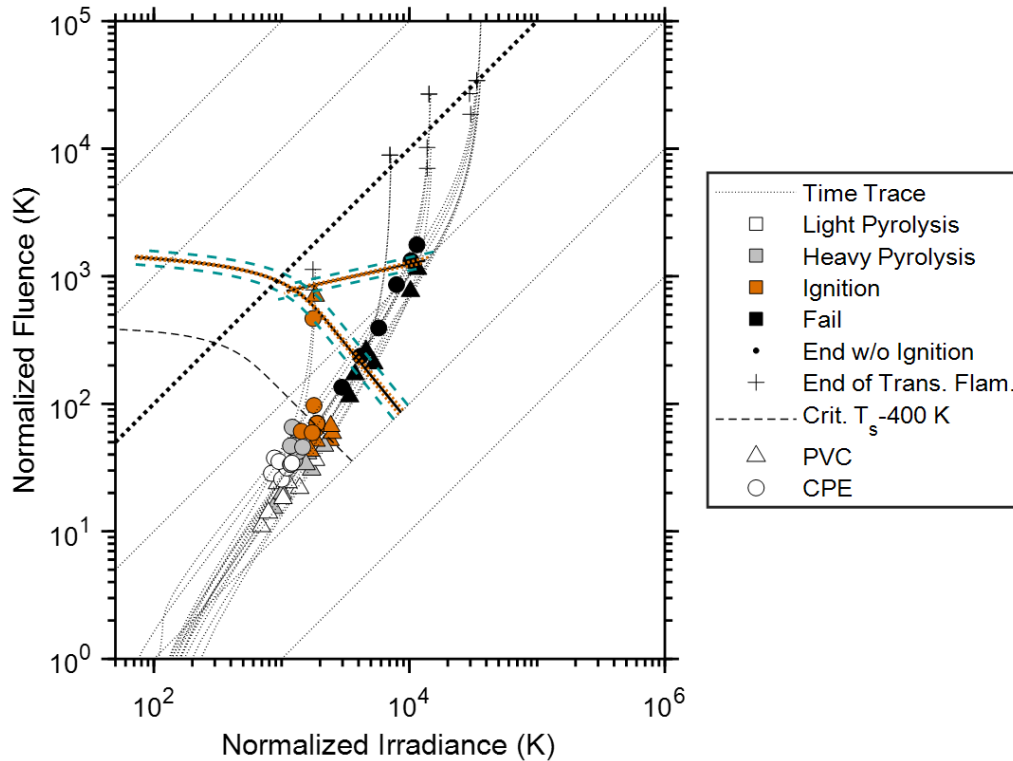
**Figure B-8**  
Chlorinated polyethylene (CPE) and PVC ignition model data

The information provided by SNL suggests that the threshold for ignition should be based on a fluence (energy) and irradiance (flux) relationship. This relationship is characterized in Figure B-8 with the solar furnace test data [8] plotted against the cellulose ignition model.

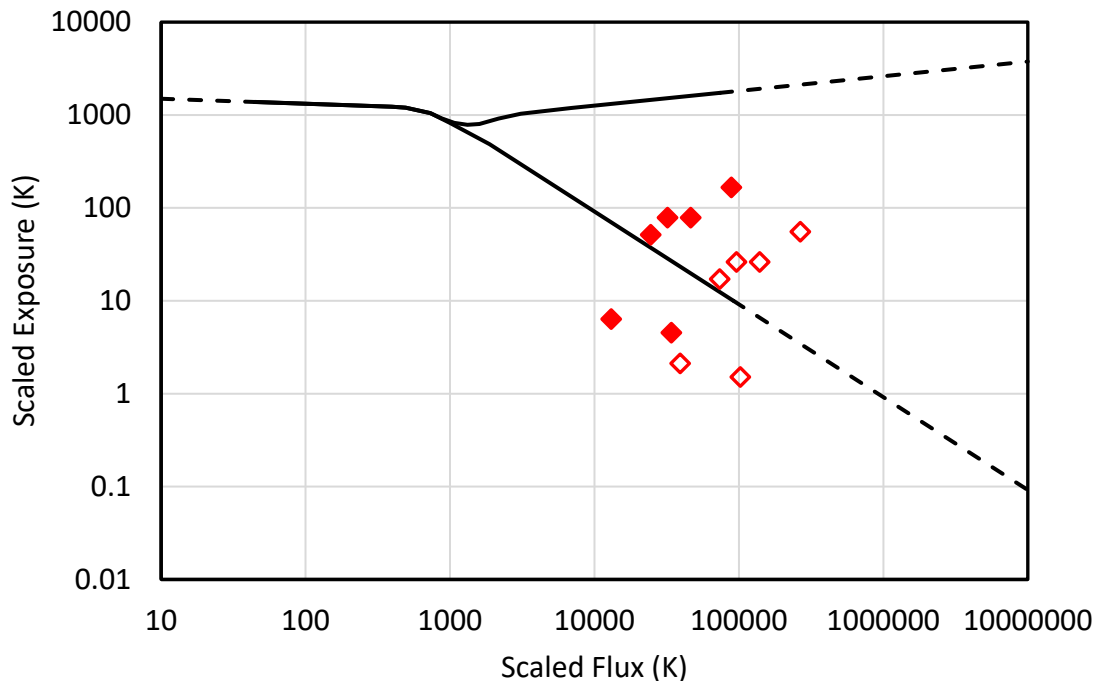
**Figure B-16**  
**JNRA tests (1 cm diameter cables plotted as solid symbols and 3 cm plotted as hollow symbols)**

$Q''$ ( $\text{MJ}/\text{m}^2$ )	$t$ (s)	Scaled Flux 1 cm Cable (K)	Scaled Exposure 1 cm Cable (K)	Scaled Flux 3 cm Cable (K)	Scaled Exposure 3 cm Cable (K)
0.2	0.2	34091	4.5	102273	1.5
5.5	3.1	88710	165.9	266129	55.3
2.6	2.8	46429	78.4	139286	26.1
1.7	3.5	24496	51.3	73487	17.1
2.6	4.1	32020	78.4	96059	26.1
0.2	0.8	13060	6.3	39179	2.1

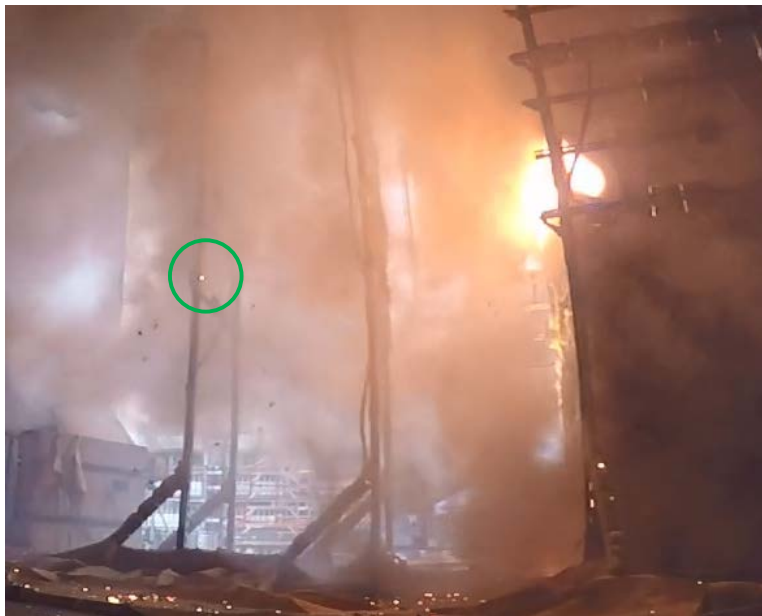
**Figure B-17**  
**Post-test image for Test 2-19**

Figure B-17 shows the view from GoPro camera 1 once obscuration has cleared in Test 2-19, nominal test of 25 kA for 2 s. One glowing spot is seen on Rack 3 at 1.8 m. This spot does not appear to flicker, indicating it is likely a hot piece of debris like that seen glowing on the floor.

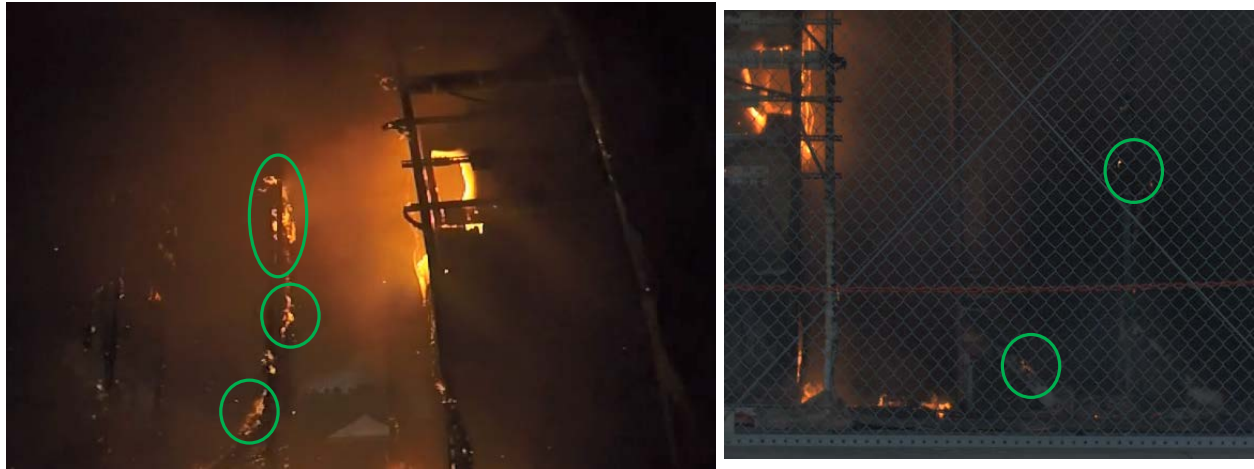
**Figure B-18**  
**Post-test image for Test 2-21**

Figure B-18 shows the post-test conditions for Test 2-21, nominal test of 25 kA for 4 s. The left image is GoPro camera 1, and the right image is from a high-definition video camera. The GoPro shows post-test flaming in locations where there is fiber insulation. The insulation materials are manufactured with a process that involves an organic binder. In typical ordinary fire applications of these insulation materials, this binder slowly off-gases as the insulation heats up. The high exposures during the HEAF appear to have resulted in a large enough rate of off-gassing from the fiber insulation for there to be a sustained flame immediately post HEAF. This fire does not appear to involve the cable coupons.

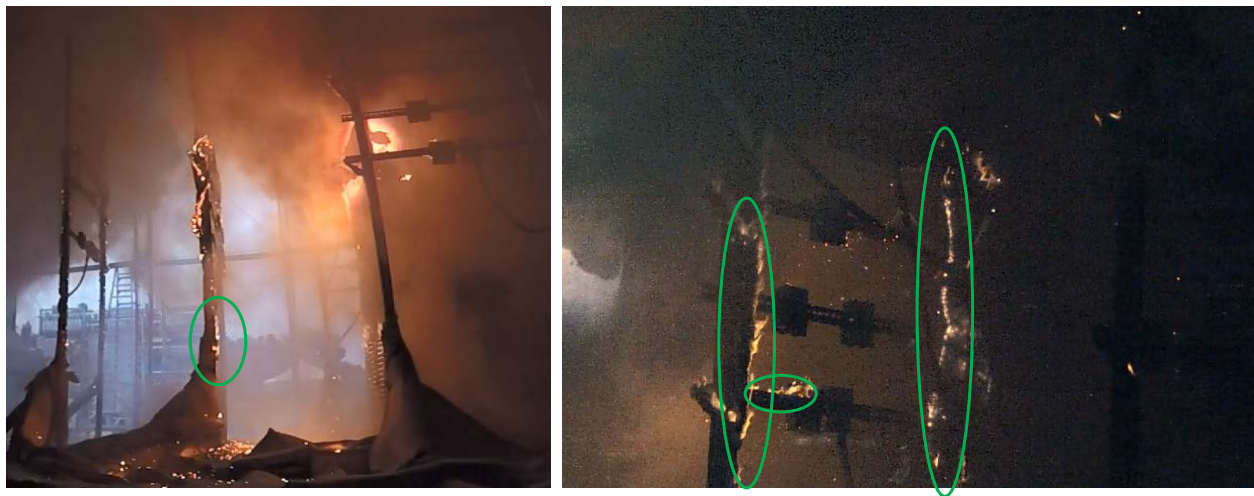
**Figure B-19**  
**Post-test image for Test 2-22**

Figure B-19 shows the post-test conditions for Test 2-22, nominal test of 32 kA for 2 s. The left image is from GoPro camera 1, and the right image is from the interior full camera viewpoint. Both images show flaming combustion after the HEAF. As with Test 2-21, the locations with flame correspond to locations with insulation materials.

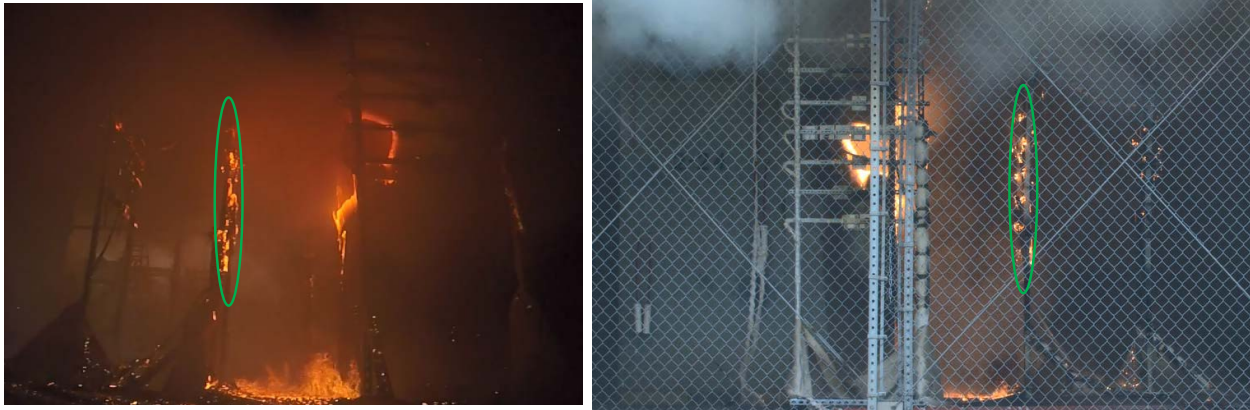
**Figure B-20**  
Post-test image for Test 2-24

Figure B-20 shows the post-test conditions for Test 2-24, nominal test of 32 kA for 4 s. The left is GoPro camera 2 and the right is from a high-definition video camera. The GoPro image shows a number of glowing objects that appear to just be glowing red insulation. The insulation is low density and low conductivity and can heat to glowing temperatures much more easily than the other materials. The image on the right primarily shows glowing materials as well. There are faint signs of flickering in the glowing region, which could be localized flaming; however, the intensity is low and not indicative of something that will sustain itself over time.

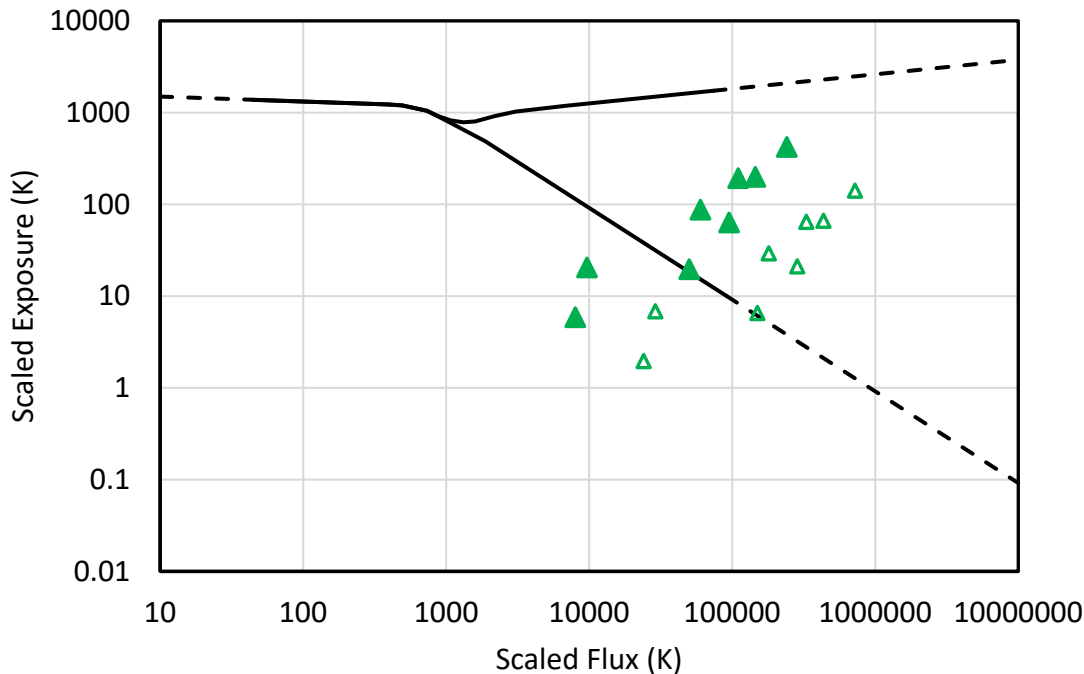
**Figure B-21**  
**MV switchgear tests (1 cm diameter cables plotted as solid symbols and 3 cm plotted as hollow symbols)**

$Q''$ (MJ/m <sup>2</sup> )	$q''$ (MW/m <sup>2</sup> )	Scaled Flux 1 cm Cable (K)	Scaled Exposure 1 cm Cable (K)	Scaled Flux 3 cm Cable (K)	Scaled Exposure 3 cm Cable (K)
0.7	0.2	9650	20.5	28950	6.8
6.6	2.9	145000	199.1	435000	66.4
2.1	1.9	95000	63.3	285000	21.1
14.0	4.8	240625	422.3	721875	140.8
0.2	0.2	8000	5.9	24000	2.0
2.9	1.2	60000	87.5	180000	29.2
0.7	1.0	50000	19.6	150000	6.5
6.4	2.2	110000	193.1	330000	64.4

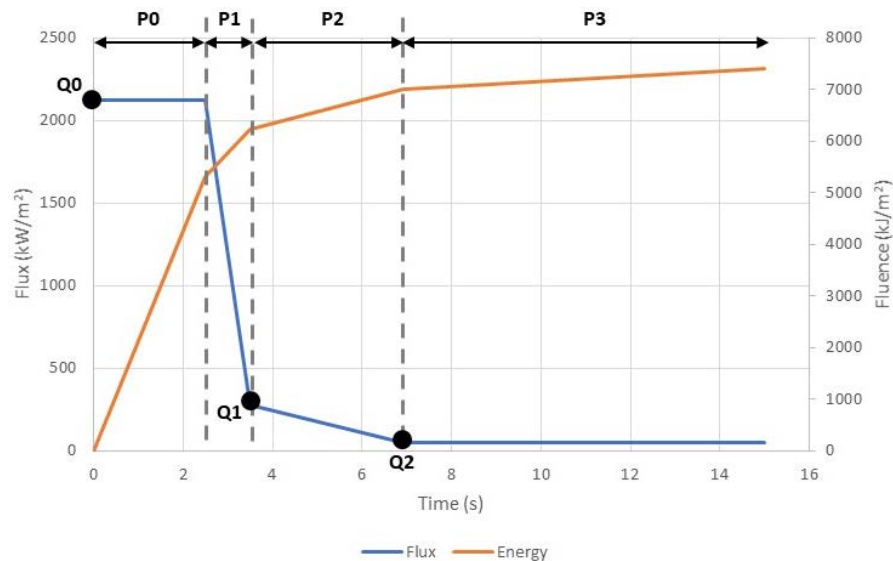
**Figure B-22**  
**Simulated HEAF primary and feedback flux profile**

SNL performed a series of tests using its solar furnace test facility to evaluate the fragility of electrical cables [8]. Figure B-18 provides an overview of the SNL cable fragility test approach. Exposure consisted of one, two, or three parts with the three-part exposure shown in Figure B-22. All tests began with a constant flux exposure labeled as Q0 in Figure B-22. Some initial tests went from Q0 to zero flux as quickly as the solar furnace can change the flux. Some tests went from Q0 to zero flux over a longer duration (P1). P1 was selected to emulate the decay rate seen in the 2018 MV switchgear tests. This profile is referred to as the “simple” profile. Some tests went from Q0 to an intermediate Q1 value to constant Q2 value of 50 kW/m<sup>2</sup>. The value of Q1 and the times for P1 and P2 were selected to approximate the decay seen in the 2018 MV switchgear tests. The 50 kW/m<sup>2</sup> flux represents the combination of some heating from the still hot enclosure plus heat feedback from a postulated sustained flame on a cable tray. This profile is called the “dynamic” profile. During these tests, where video was available, the time when the flame that appeared during Q0 extinguished was recorded. This time of extinguishment can be used to assess whether a sustainable flame was present.

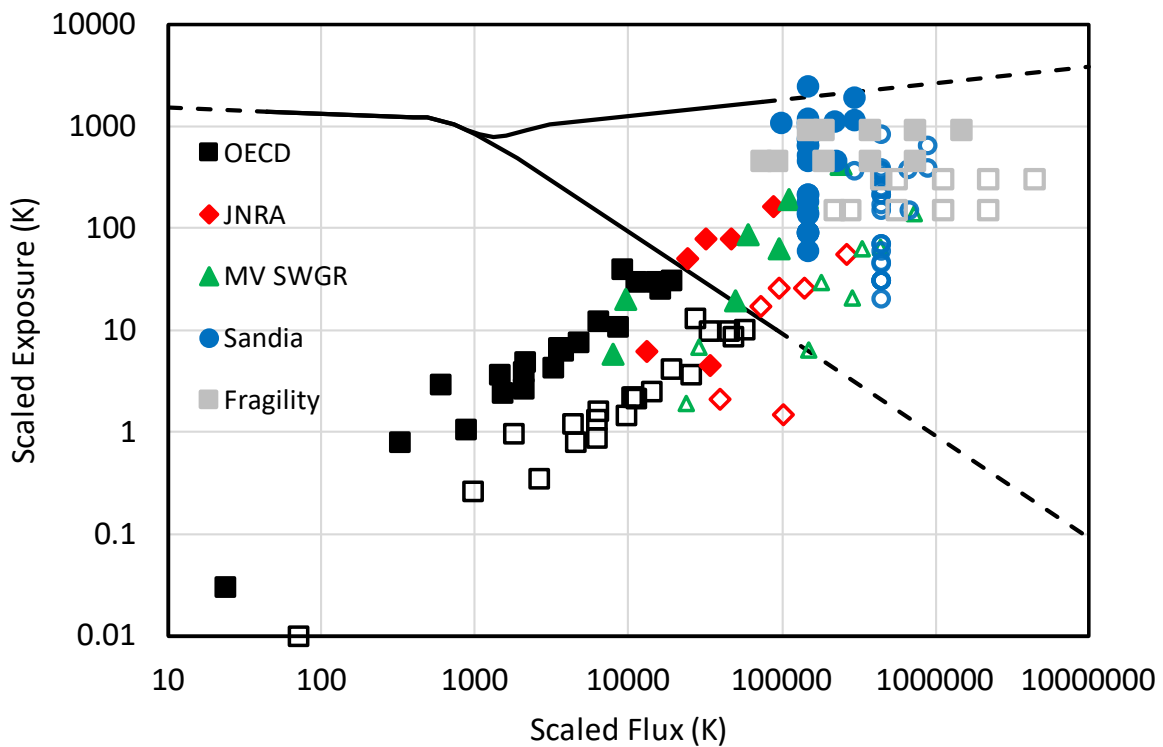
**Figure B-24**  
**Test data plotted using Martin's blackened cellulose curve**

$Q''$ (MJ/m <sup>2</sup> )	$q''$ (MW/m <sup>2</sup> )	T (s)	Scaled Flux 1 cm Cable (K)	Scaled Exposure 1 cm cable (K)	Scaled Flux 3 cm Cable (K)	Scaled Exposure 3 cm Cable (K)
15.0	15.0	1.0	750000	452.5	2250000	150.8
15.0	7.5	2.0	375000	452.5	1125000	150.8
15.0	3.8	4.0	187500	452.5	562500	150.8
15.0	1.9	8.0	93750	452.5	281250	150.8
15.0	1.5	10.0	75000	452.5	225000	150.8
30.0	30.0	1.0	1500000	905.0	4500000	301.7
30.0	15.0	2.0	750000	905.0	2250000	301.7
30.0	7.5	4.0	375000	905.0	1125000	301.7
30.0	3.8	8.0	187500	905.0	562500	301.7
30.0	3.0	10.0	150000	905.0	450000	301.7
