NUREG/CR-7304
PNNL-34367

Evaluating Flaw Detectability Under Limited-Coverage Conditions

Assessing the structural integrity of welded piping components in the U.S. nuclear power fleet ensures safety to the public and environment. When conditions such as outside surface contours, physical obstructions from nearby structures or equipment, or different component metallurgical composition limit the ability to fully examine greater than 90% of a weldment's required examination volume, licensees must request regulatory relief from the Nuclear Regulatory Commission (NRC). Determining the impact on flaw detectability caused by an examination limitation can be complicated for both the licensee in evaluating the extent of examination coverage and for the NRC in determining the potential impact of the area unable to be examined.

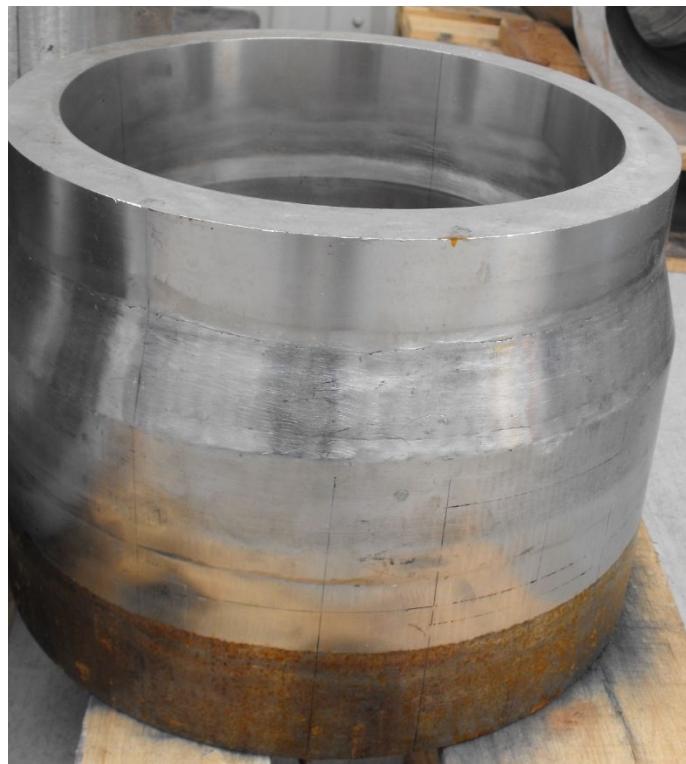
Specimen 8C-032 is a dissimilar metal nozzle to safe-end weld with an average wall thickness of 32 mm (1.5 in.). The nozzle is SA508 carbon steel with Inconel 182 buttering and inside surface cladding, Inconel 82 weld metal to a 316 stainless steel safe-end. The safe-end to pipe taper begins 61 mm (2.4 in.) from the safe-end weld toe and limits the width of the scanning surface on the safe-end side. The weld has been ground flush, representing a typical construction finish in some plants. Even with the surface conditioning, grooves or exposed undercut along the weld toe is present that could potentially cause disruption of ultrasound transmission. Figure 4-1 displays a photograph of this specimen.

Figure 4-1 Specimen 8C-032 – 318 mm Diameter (12.75 in.) Dissimilar Metal Carbon Steel Nozzle to 316 Stainless Steel Safe-End with an Average Wall Thickness of 32 mm (1.5 in.)

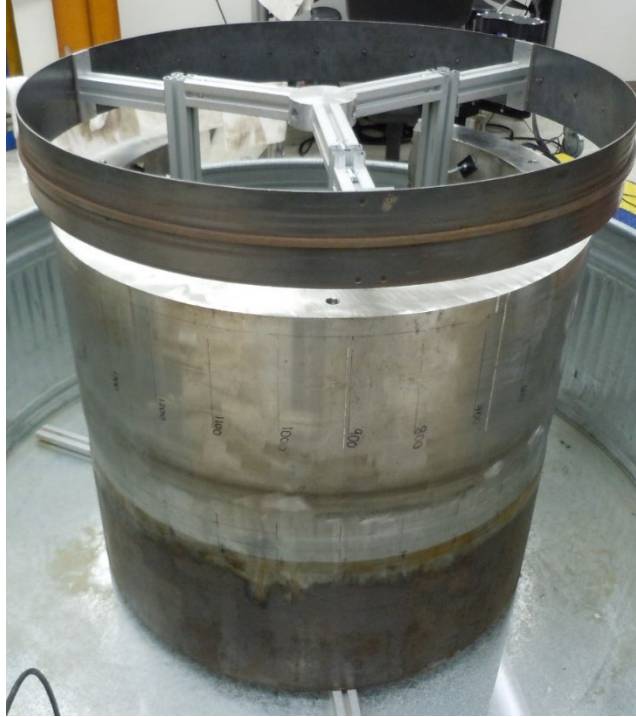
Specimen 14C-146 is a 914 mm (36 in.) diameter carbon steel nozzle to cast stainless steel pipe representative of a PWR primary loop hot leg with an average wall thickness of 84 mm (3.3 in.). The weld has been ground flush, and no geometrical conditions exist on the outside surface. Figure 4-5 is a photograph of this specimen.

Figure 4-5 Specimen 14C-146 – 914 mm (36 in) Diameter, 84 mm (3.3 in.) Wall Thickness, PWR Primary Loop Hot Leg Specimen

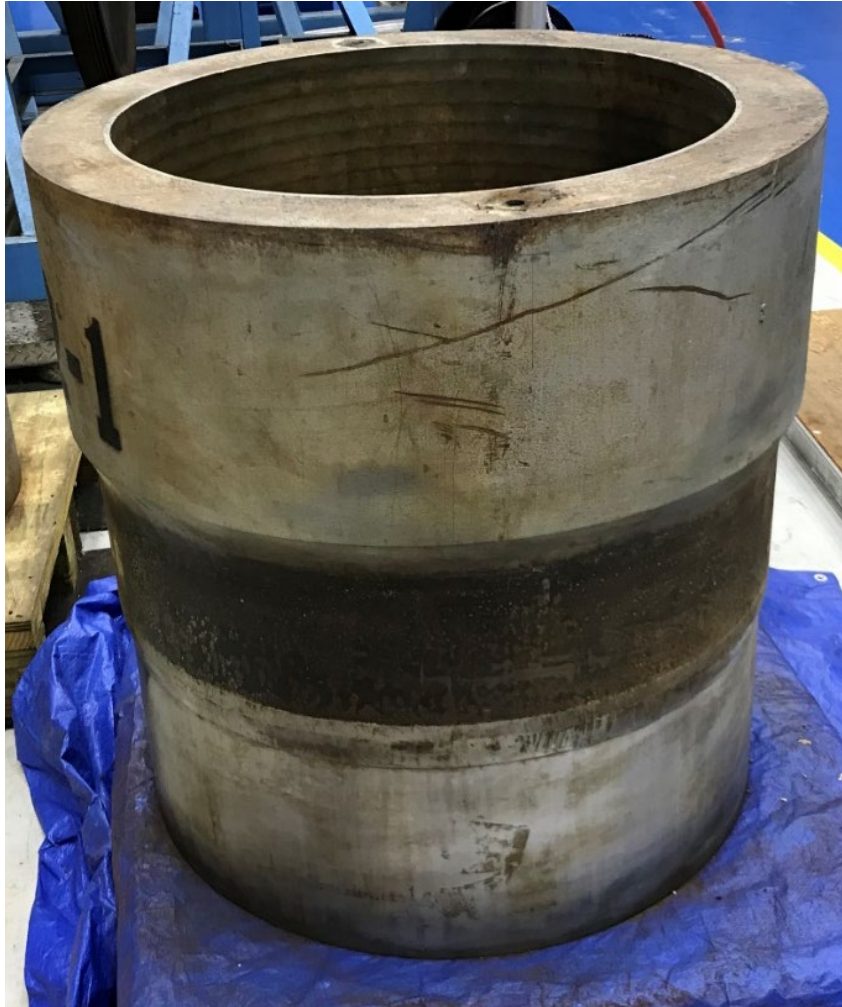
Figure 4-7 Specimen 602—Primary Loop Cold Leg Nozzle to Safe-End Weld with an 864 mm (34 in.) Diameter and an Average Wall Thickness of 74 mm (2.9 in.)

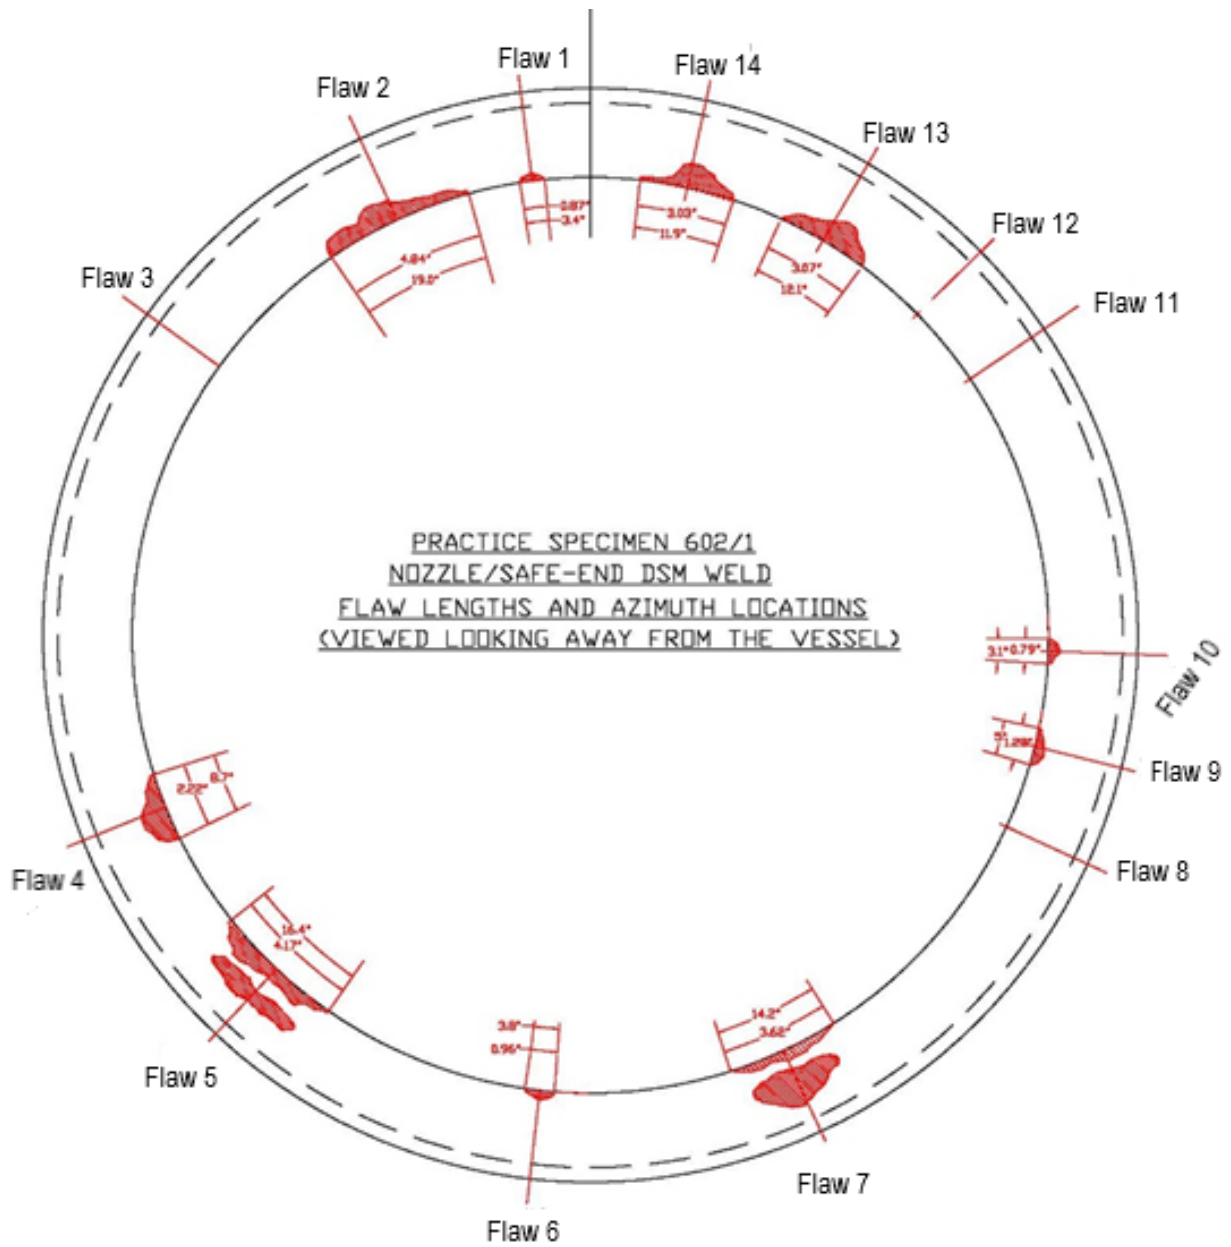
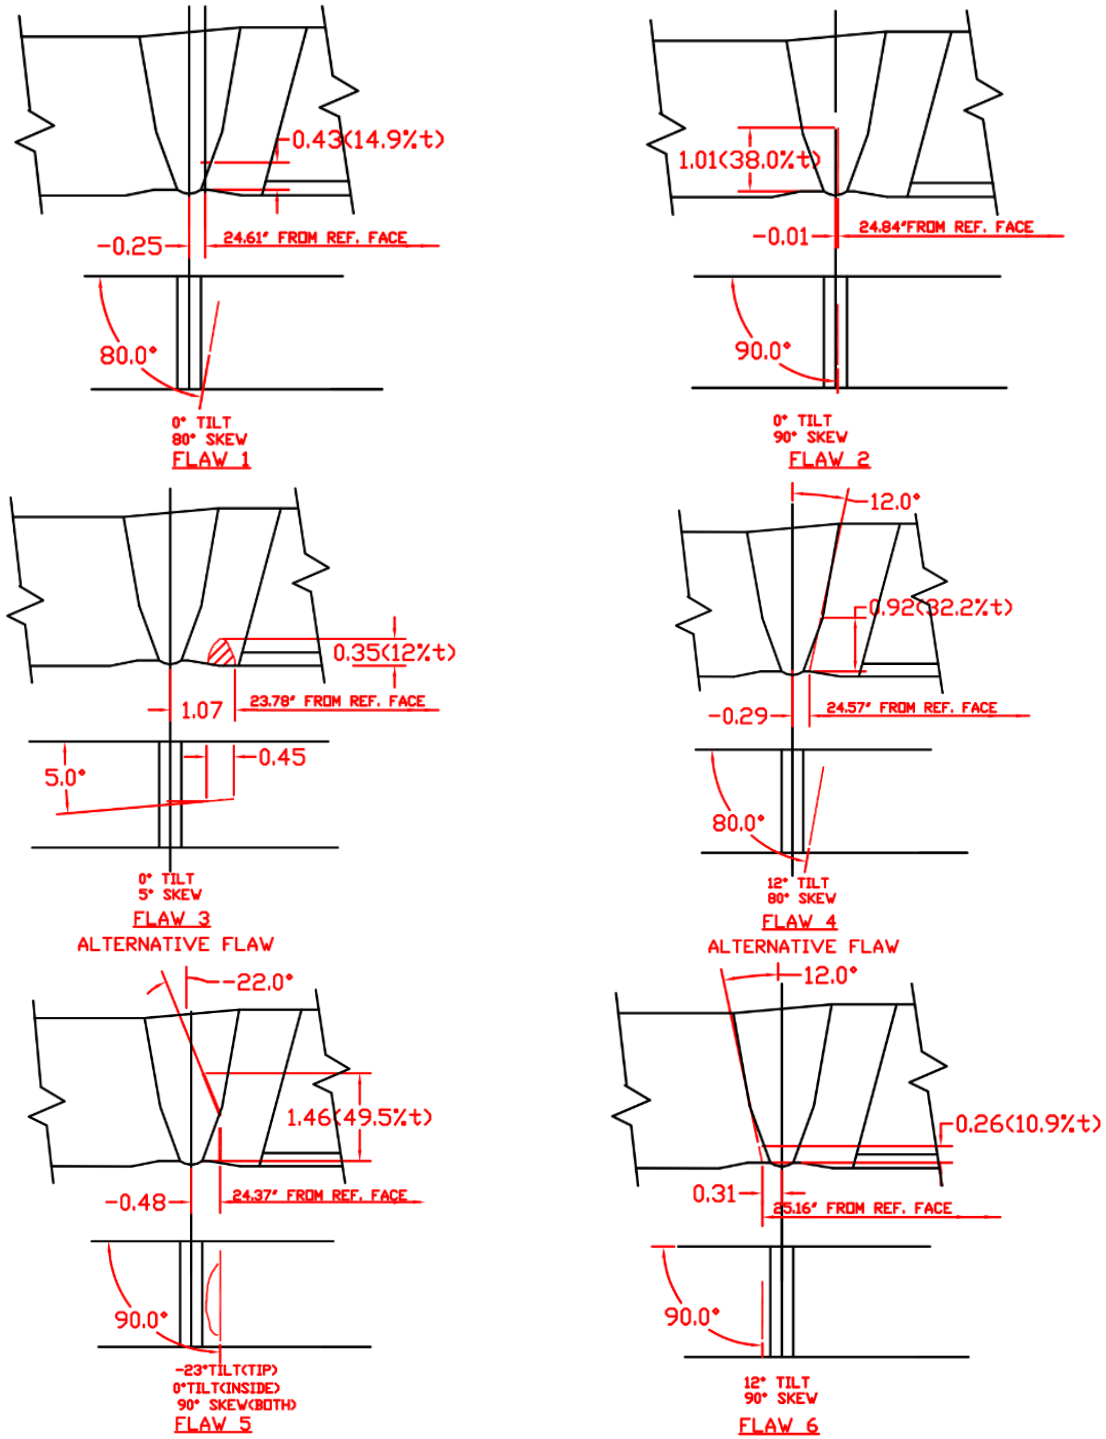
This specimen contains 14 cracks, 10 circumferential and four axial. The circumferential cracks range in length from 20 mm to 122 mm (0.8 in. to 4.8 in.) with TWDs ranging from 6.6 mm (10.9% TWD) to 50 mm (75% TWD) (0.26 in. to 1.96 in.). Four of these flaws exhibit growth that is tilted from perpendicular to the outside surface from 12° to 23°. In addition, four of the circumferential cracks are not parallel to the weld and are skewed approximately 10°. Two additional circumferential flaws exhibit a semi-elliptical growth pattern. Figure 4-8 depicts the flaw location.

Figure 4-8 Specimen 602 Flaw Location From FlawTech Design Drawings

(Note that in the full circumferential view, flaw numbering is in counterclockwise direction starting with flaw one to the left of top center).

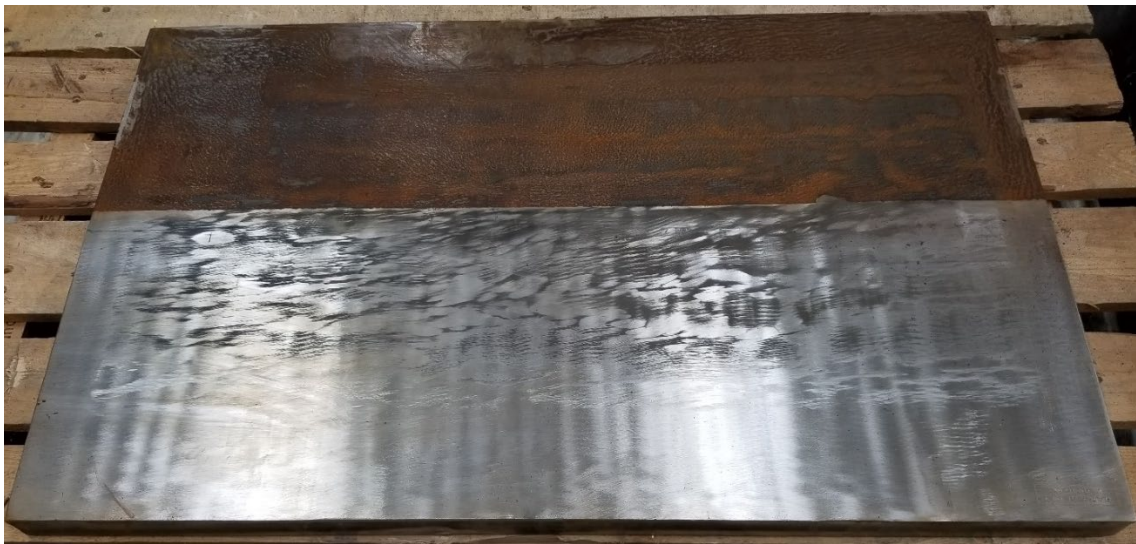
Figure 4-10 Specimen 21C-303-3 1.25 in. Wall Thickness Dissimilar Metal Weld Flat Plate

Discoloration is surface rust from moisture on carbon steel material

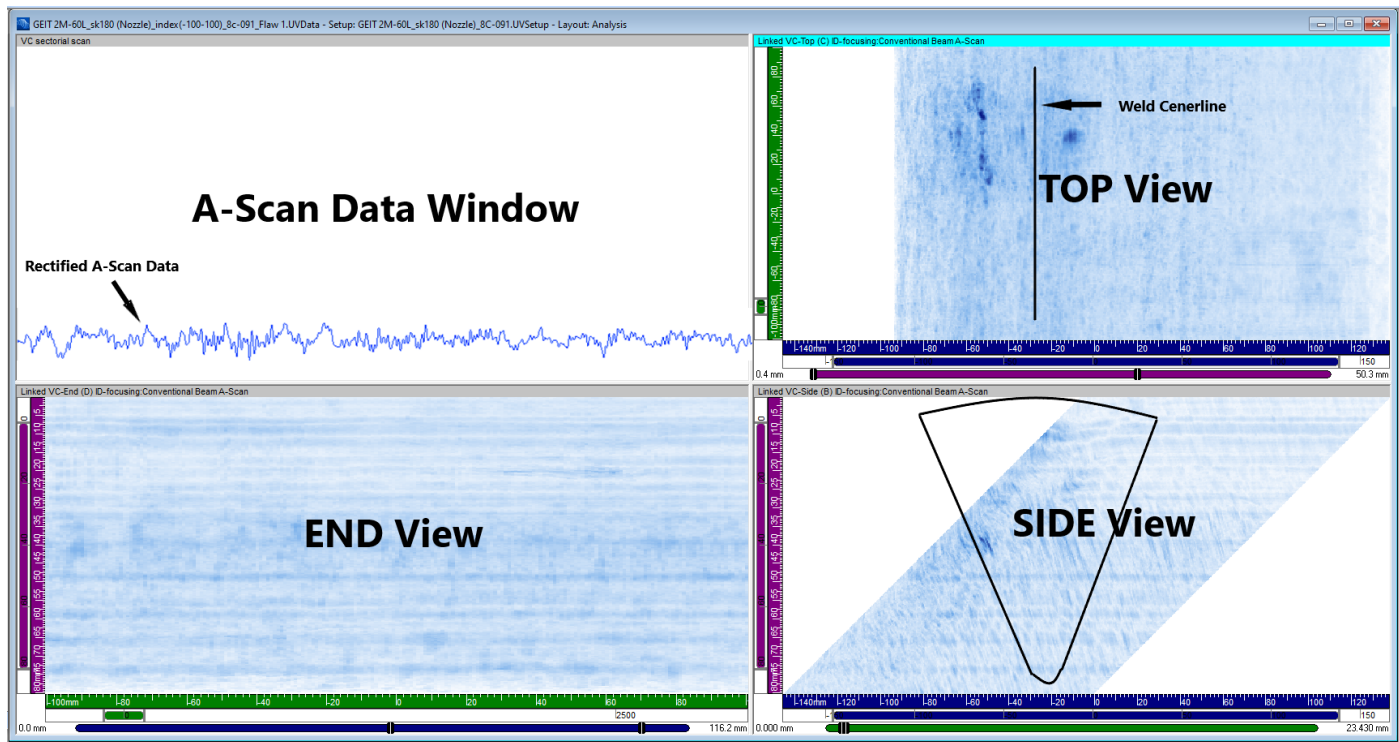
Figure 5-7 UltraVision Display Showing Top, Side, and End View Windows and A-scan Window

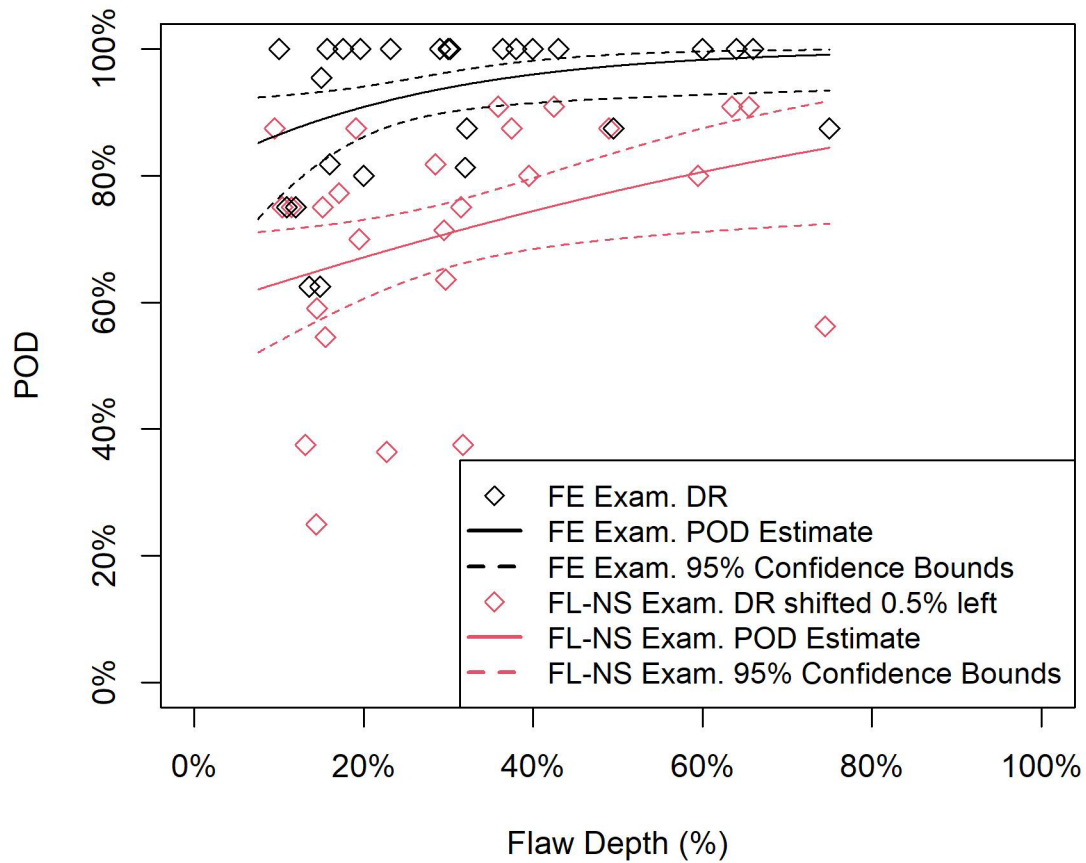
Figure 6-3 FL-NS POD for Phase 1 & 2 Data as a Function of TWD

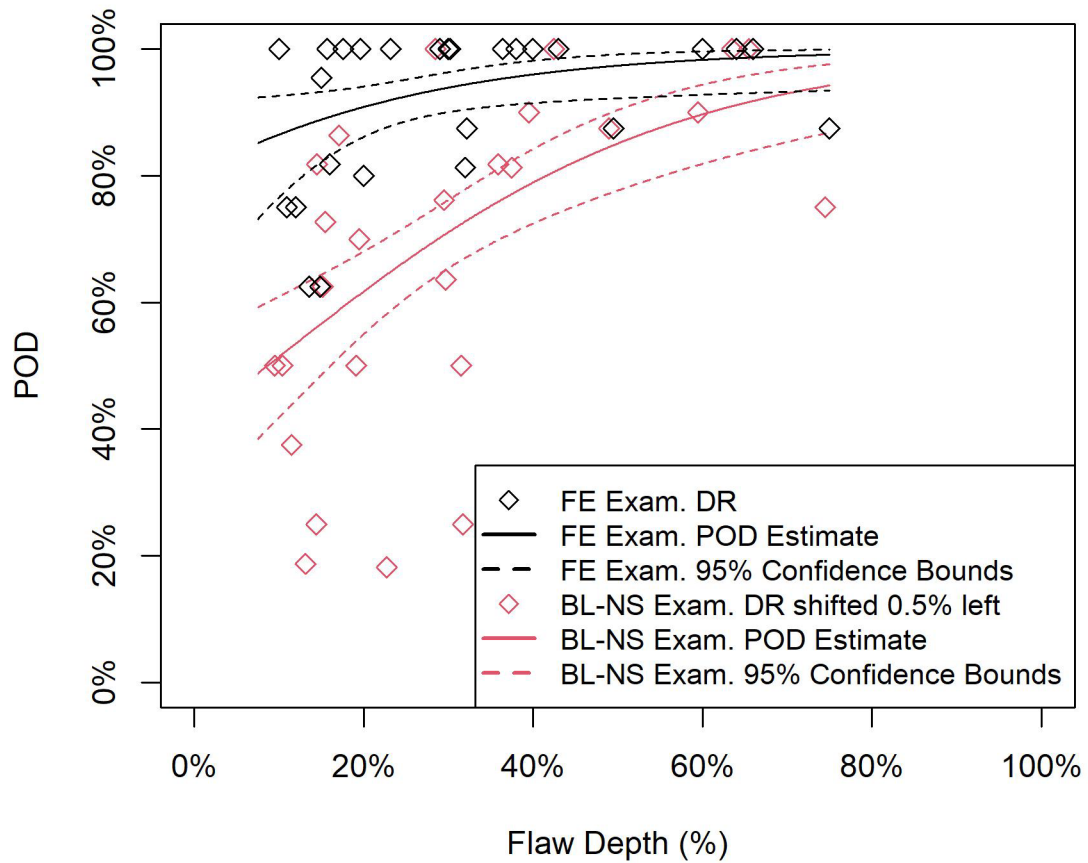
Figure 6-4 The POD for the BL-NS Exam is Significantly Lower than POD for the FE Exam for TWD \leq 55%

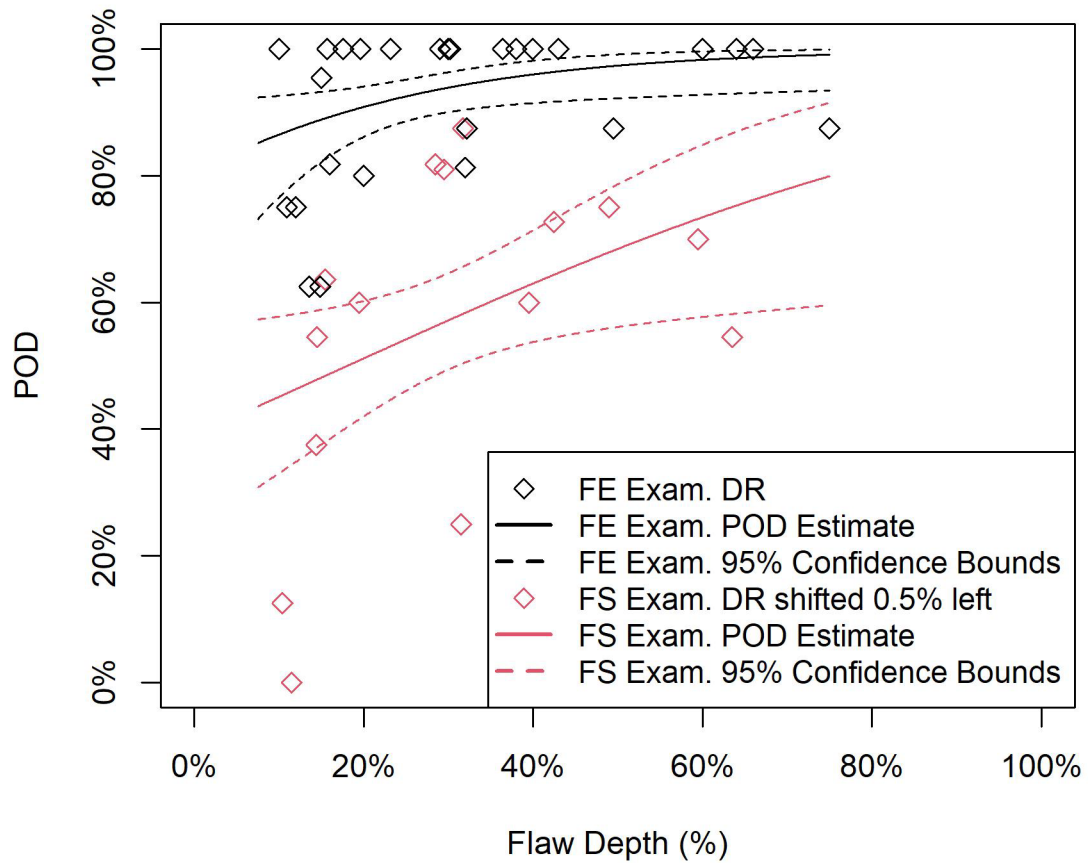
Figure 6-5 The POD for the FS Exam is Significantly Lower than the Result for the FE Exam for the Full Range of TWDs Examined: 7.0% ≤ TWD ≤ 75.0%

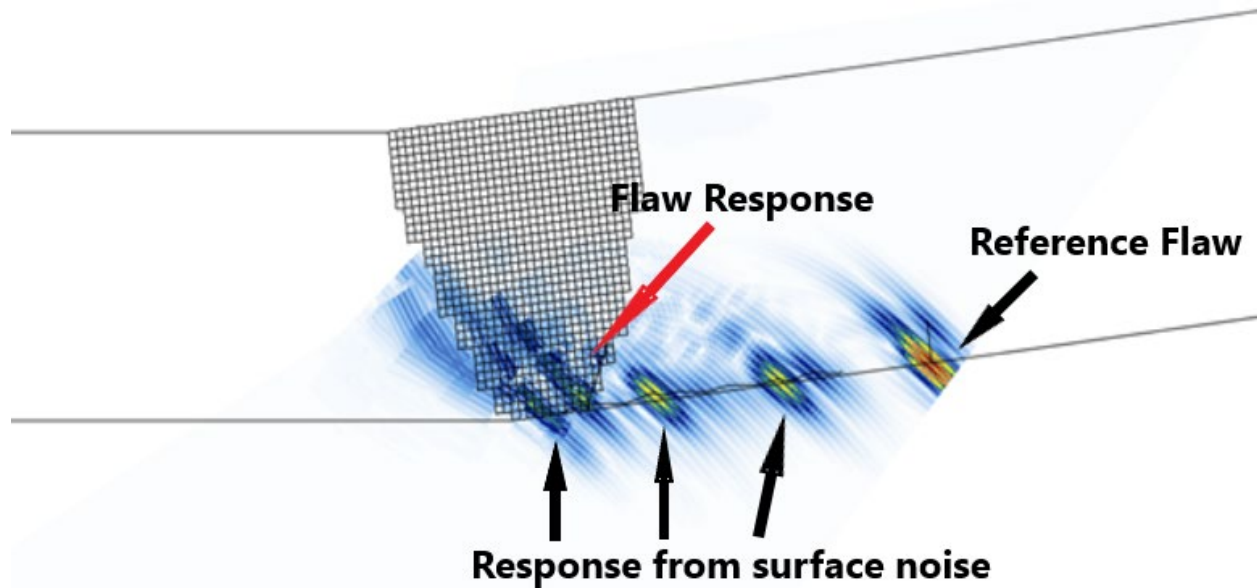
Figure 7-18 Simulation Results with a 19° Tilted Flaw at the Weld Fusion Line and with Surface Noise

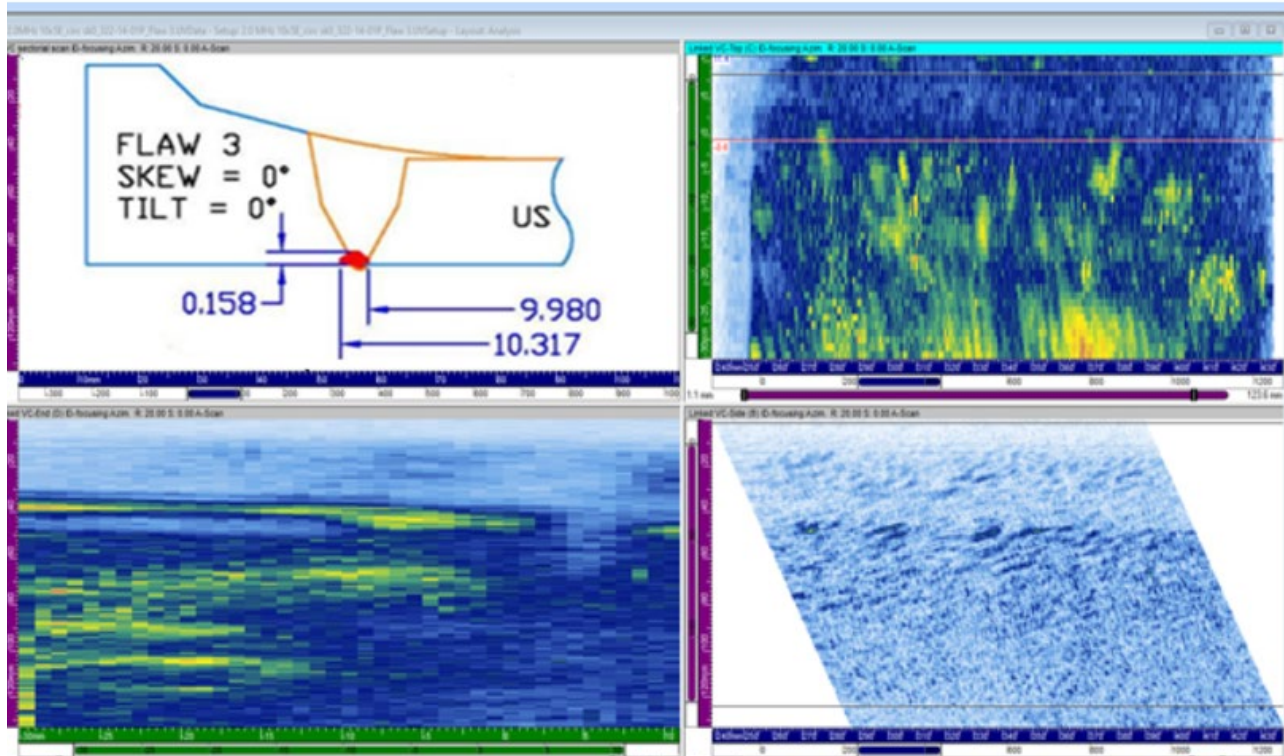
Figure 7-38 No Response from Axial Flaw 3 in Specimen 322-14-01P
