SHERWOOD PROJECT

**RE: Radioactive Materials License WN-I0133-1; License Condition No. 29:
Request for Termination of License WN-I0133-1 Issued for the Sherwood
Project Operated by Western Nuclear, Inc.**

EROSIONAL STABILITY OF TAILING IMPOUNDMENT SWALE FOR AS-BUILT CONDITIONS

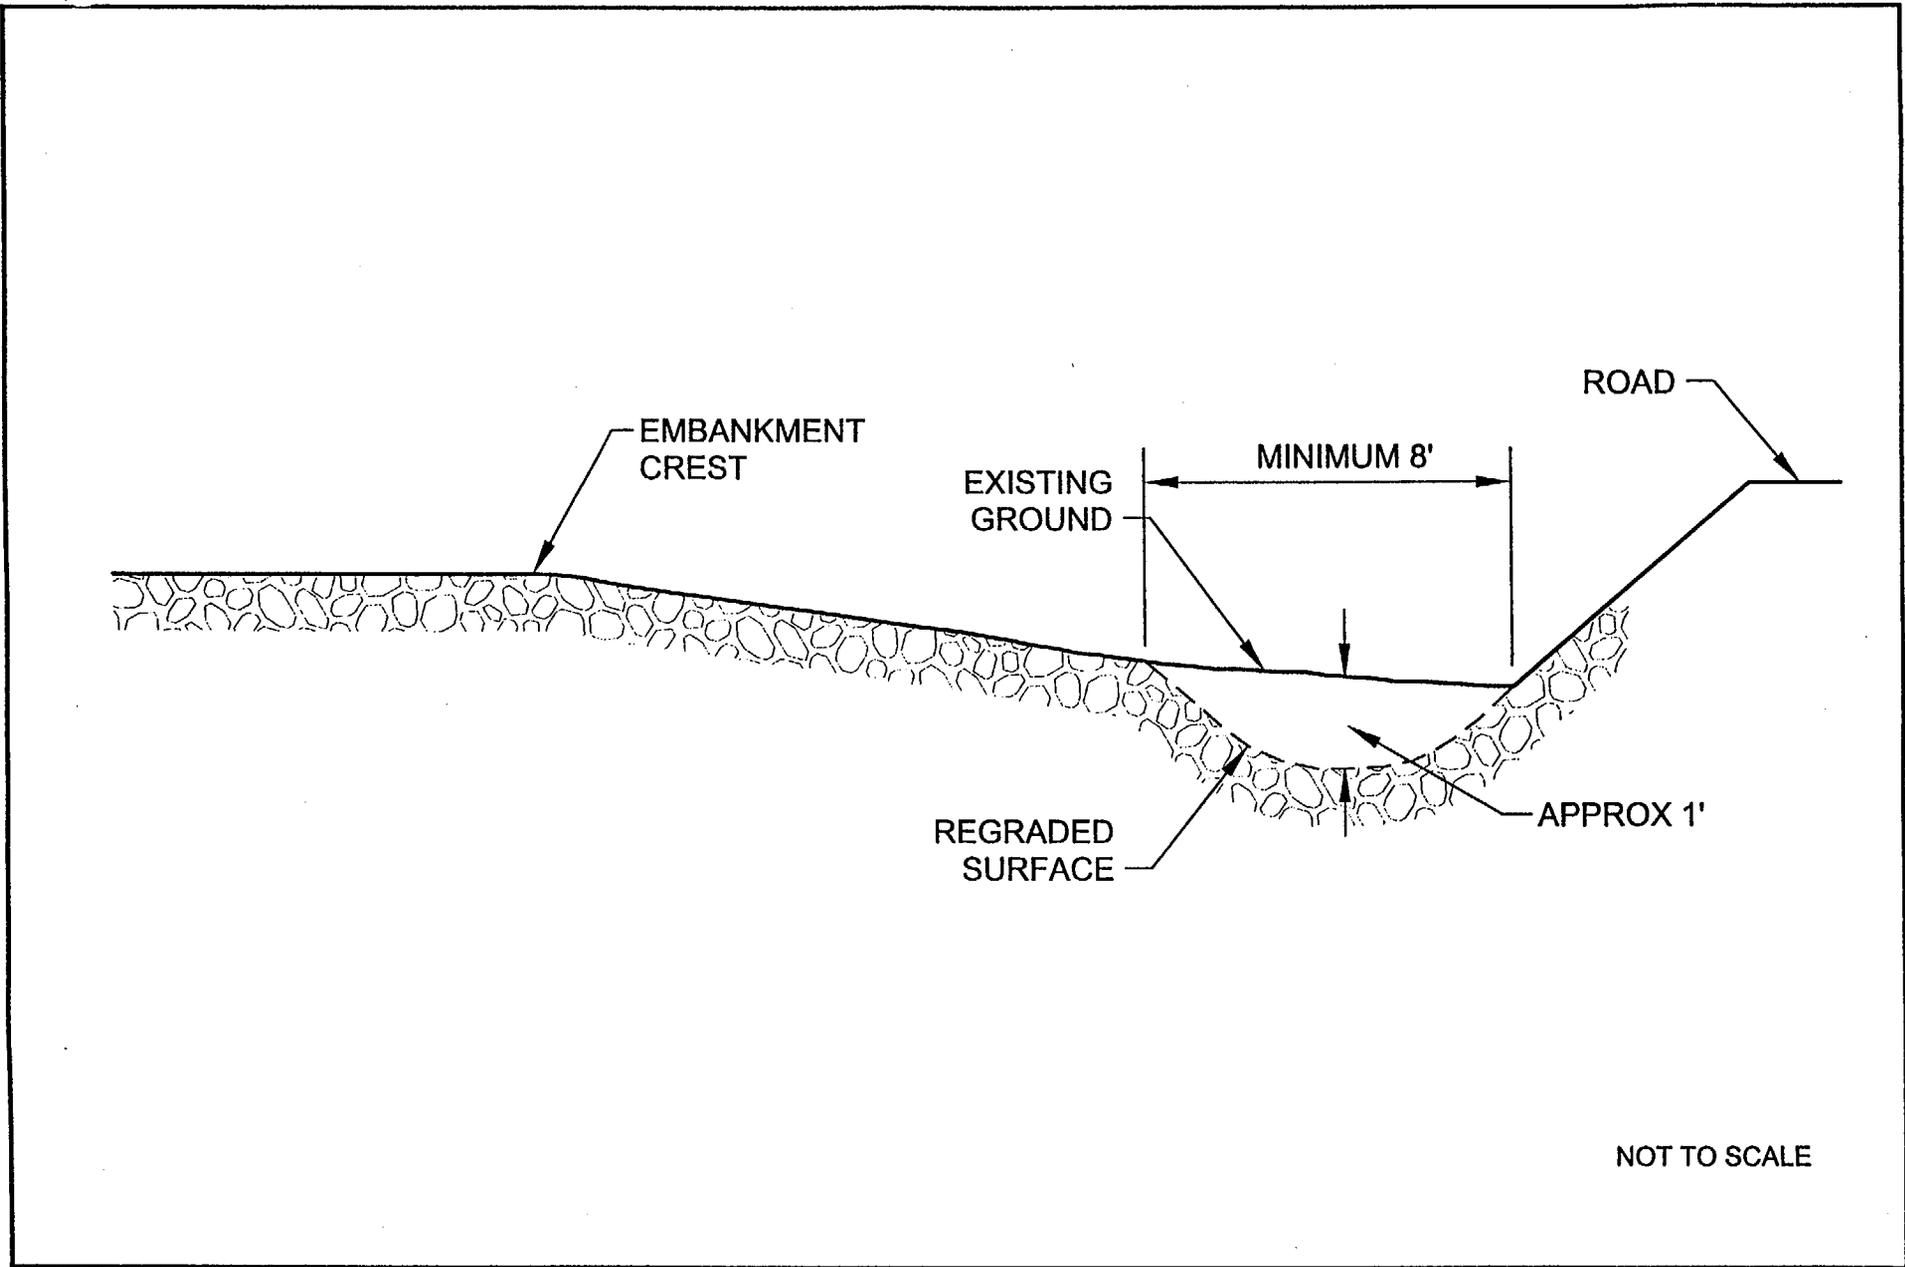
FIGURE 1
TYPICAL CROSS SECTION

Remedial construction was performed in the area to address the WDOH concerns. The design of the remedial construction was included in a letter to WDOH dated October 11, 1999 (Attachment A). Construction was completed on October 20, 1999, and the as-built conditions are included in the final structural stability inspection report dated November 15, 1999, which is included in Section 3 of this submittal.

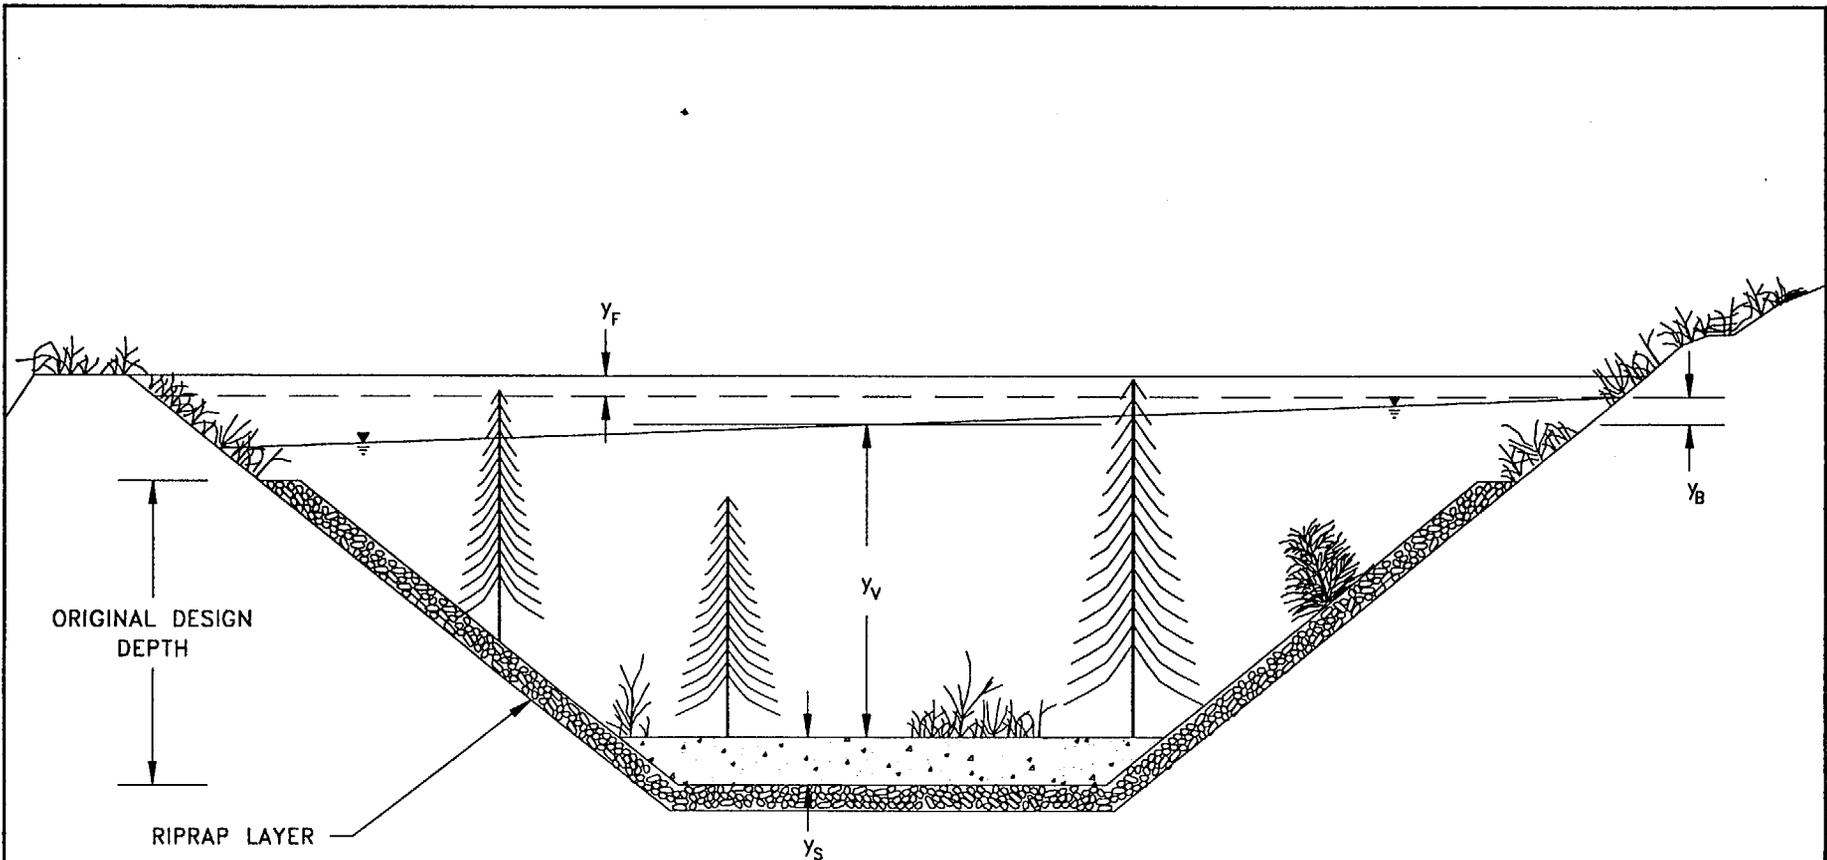
Figure 5.1 shows the modified channel design schematically. The design of the diversion channel is proposed to be modified by increasing the amount of compacted fill on the berm between the channel and the tailings impoundment. Table 5.1 summarizes the changes in design depth for the channel, comparing channel depth as presented in the 12/94 TRP to the modified channel depth designed for sediment, vegetation and superelevation. Table 5.2 is a more detailed summary of the issues investigated in this response report.

ORIGINAL DESIGN DEPTH

RIPRAP LAYER

0.10, 3) superelevation, and 4) 1.0 foot of freeboard. The 1.0 foot of freeboard in addition to considerations for sediment, vegetation, and superelevation, is a final degree of conservatism and provides significant cross sectional area to the channel should it be needed. For example, at the downstream end of the channel, the depth is 22 feet and the top width is 140 feet wide. The cross sectional area in the upper 1-foot of channel is about 137 square feet. This area corresponds to a depth of over 5.8 feet at the bottom of the channel. Therefore, there could be as much as 5.8 feet of sediment in the channel and the PMF would still be contained within the channel freeboard.

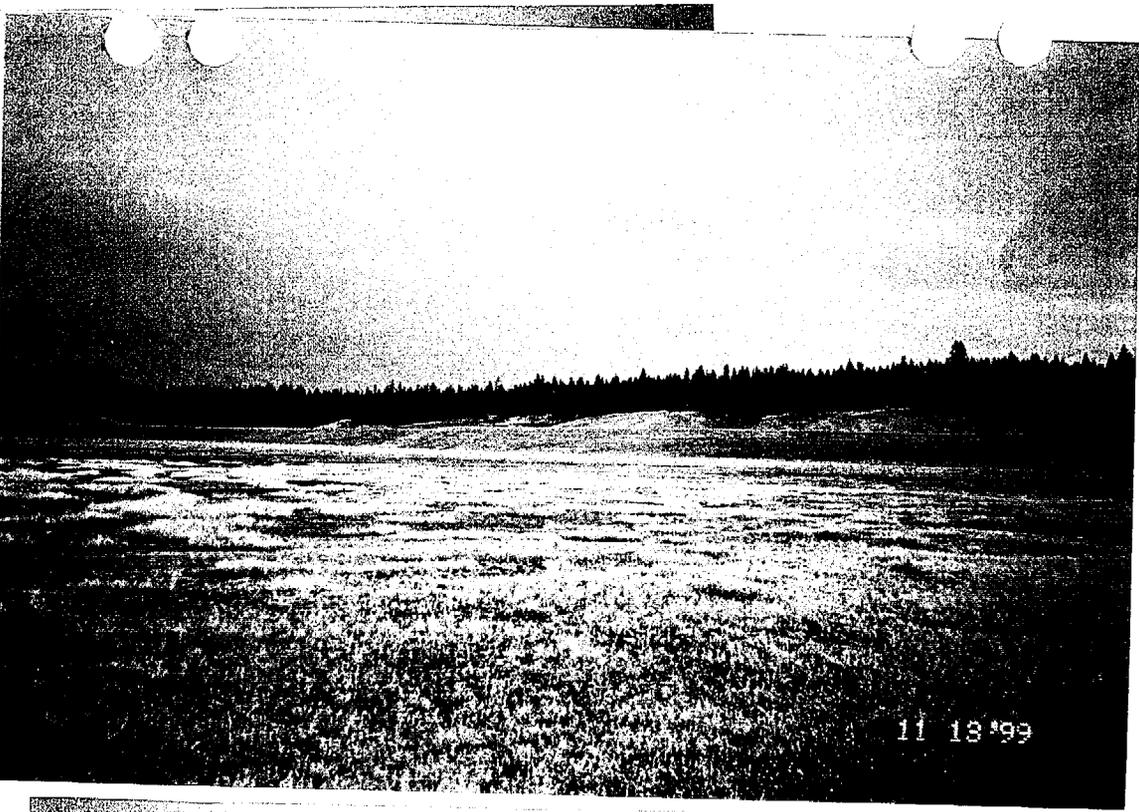
Photo No. 1

No changes from previous inspections were observed in the tailing impoundment surface cover other than continued improvements in re-vegetation. The previously observed settlement area is drier (contains less impounded water than noted during the Spring 1999 inspection). **This area does not pose a structural stability problem** (refer to photo documentation numbers 1, 2, 3, and 4).

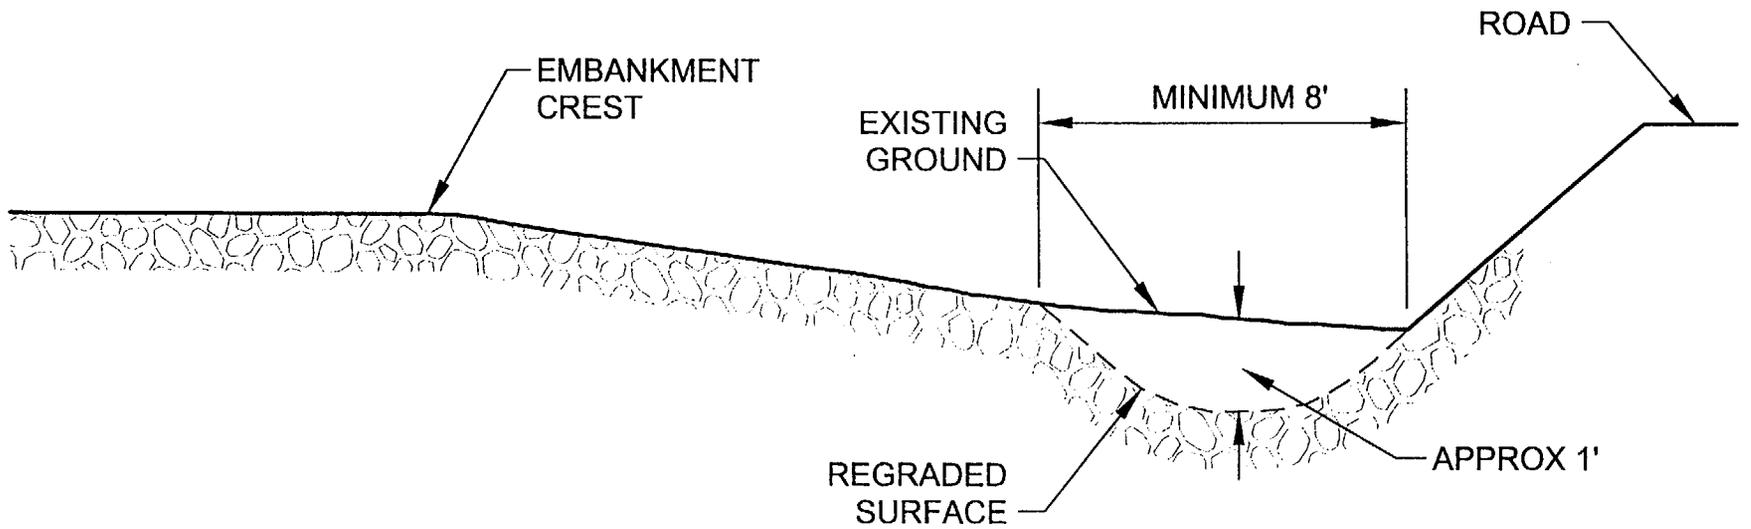
FIGURE 1
TYPICAL CROSS SECTION

Re: WN-I0133-1: License Condition 37; Sherwood Monitoring and Stabilization Plan Inspection; Regrading As-built Report for Two Surface Regrading Issues.

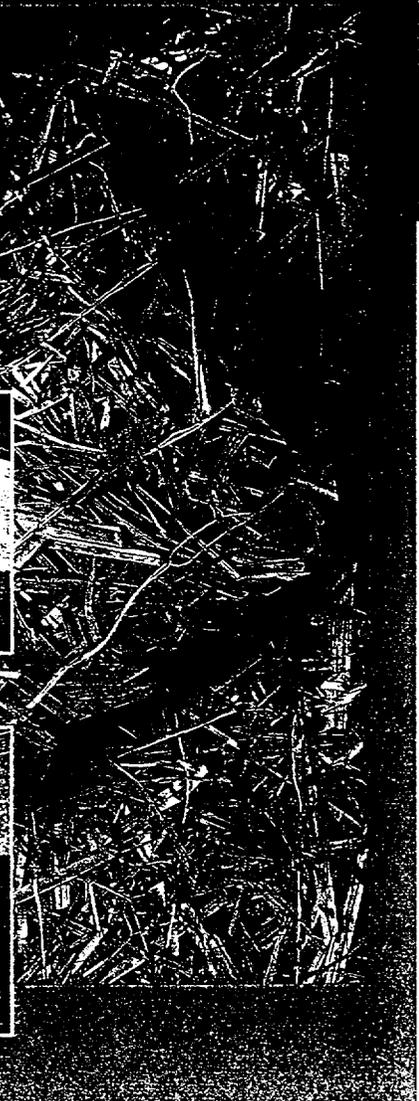
S75 is constructed of 100% agricultural straw and a lightweight, photodegradable, top net. The functional longevity of the blanket is approximately 10 months. The components are sewn together on 1.5 inch centers with degradable thread to ensure blanket durability and performance. The S75 provides effective erosion control and mulching on 3:1 slopes ($\leq 33\%$ slope or ≤ 19 degree slope) and low-flow swales. May be used on steeper slopes. Consult North American Green software for specific recommendations.

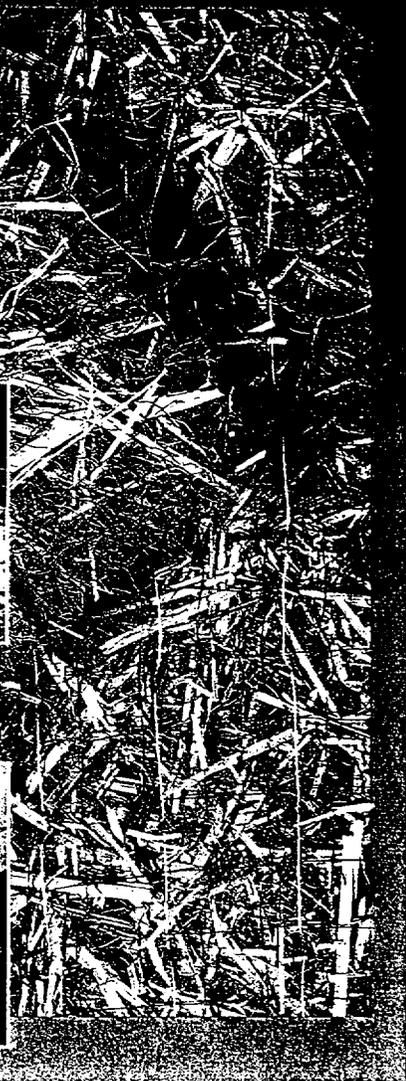
The SC150 is constructed with 70% agricultural straw, 30% coconut fiber encased in a heavyweight, UV stabilized, top net and a lightweight, photodegradable, bottom net. To ensure blanket durability and performance, the components are sewn together on 1.5 inch centers with degradable thread. The long-lasting durability of the heavy-duty top net and added effectiveness of the coconut fiber enable the SC150 to effectively control erosion on more severe 2:1-1:1 slopes (50% - 100% slopes or 27-45 degree slopes), medium discharge channels, and areas where protection is needed for more than one growing season. Consult North American Green software for specific recommendations.

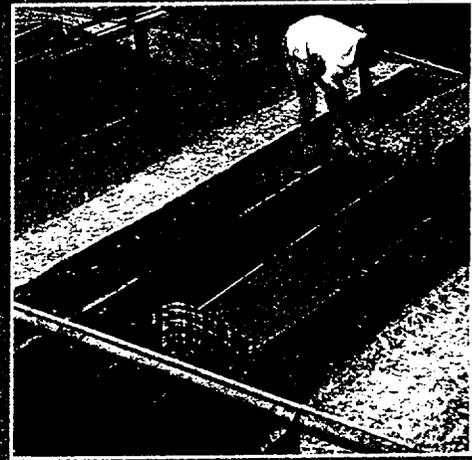
TABLE 4/SLOPE TEST #1

Slope Gradient = 3:1 Slope Length = 20 feet
Soil Type = Sand, 1.5:1 Rainfall Intensity = 4 in/hr

North American Green S75-S150 straw fiber blankets provided exceptional erosion control on the 3:1 test slope, revealing over 99.5% effectiveness as compared to the bare soil control plot. Comparable performance can be expected in similar actual
